**CITY OF SAINT PAUL  
HERITAGE PRESERVATION COMMISSION STAFF REPORT**

FILE NAME: 208-210 Bates Avenue  
DATE OF APPLICATION: February 6, 2014  
APPLICANT: Saint Paul Housing and Redevelopment Authority (HRA)  
OWNER: HRA  
DATE OF PUBLIC HEARING: February 27, 2013  
HPC SITE/DISTRICT: Dayton's Bluff Historic District  
CATEGORY: Pivotal  
CLASSIFICATION: Demolition Permit  
STAFF INVESTIGATION AND REPORT: Christine Boulware  
DATE: February 24, 2014

**Report of:** Phase I Environmental Site Assessment  
208 and 210 Bates Ave., St. Paul, MN 55106  
**Reported to:** City of St. Paul  
Planning & Economic Development, St. Paul, MN 55102

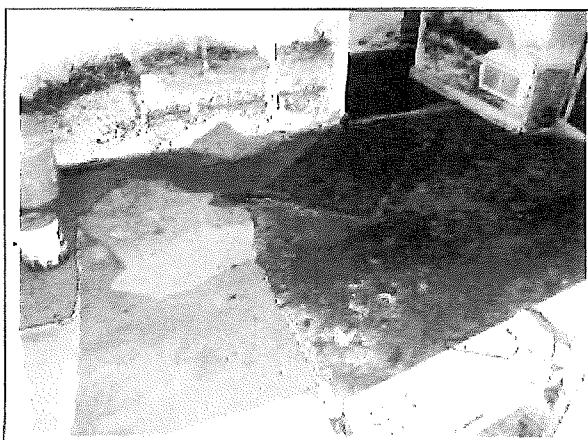
208 First Floor—kitchen: standing water on floors and saturated carpet plus mold were present on the kitchen floor and walls.

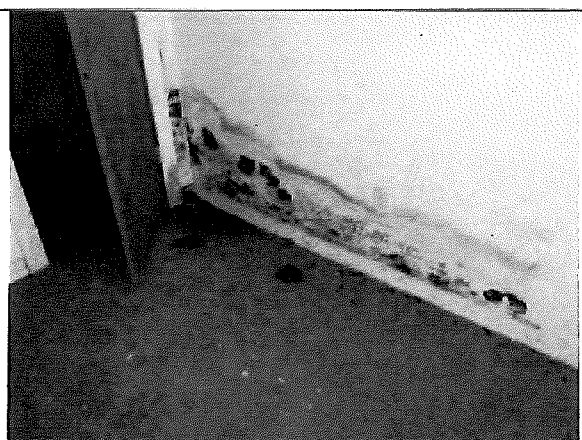
208 First Floor—SE-central room: saturated carpet and wet floors were present with mold located on the lower portion of the walls.

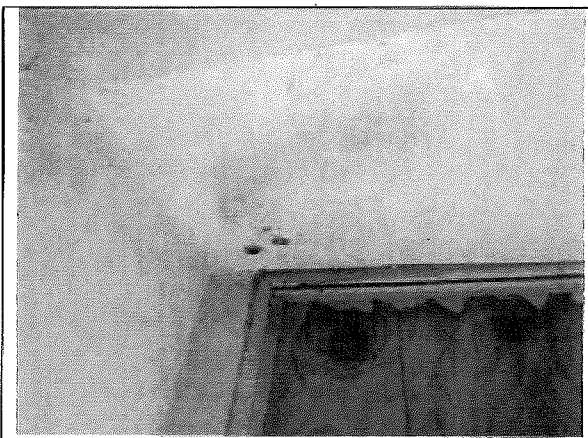
208 First Floor—SE-central room: mold present adjacent to window.

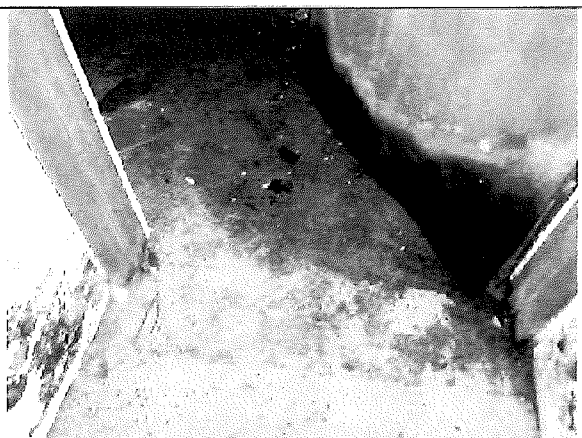
208 First Floor—east room: mold present on walls, flooring, door and door frame. Water present in building materials.

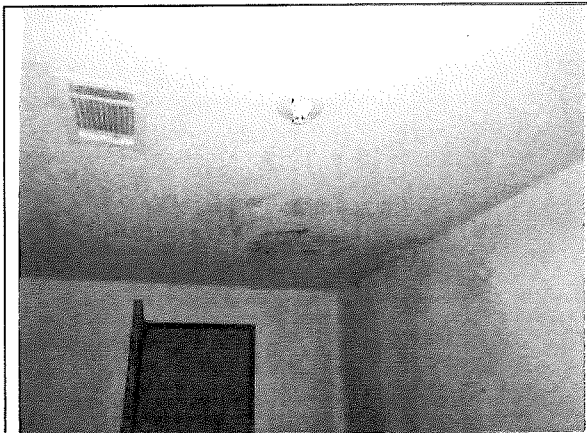
208 First Floor—east room: ceiling and wall mold.

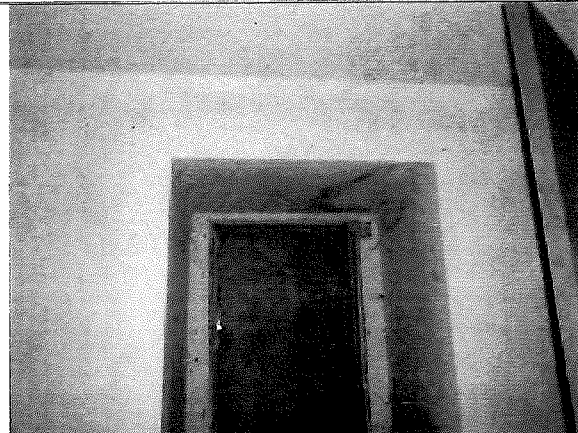
208 First Floor—east room: mold around window area.

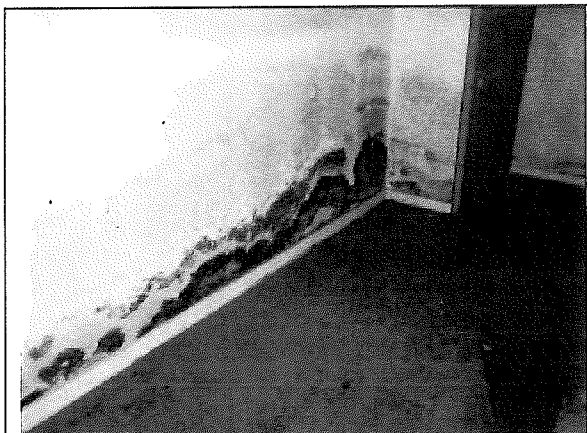
208 First Floor—mold present along lower portion of walls, east room. Floor and wall base were wet at time of visit.

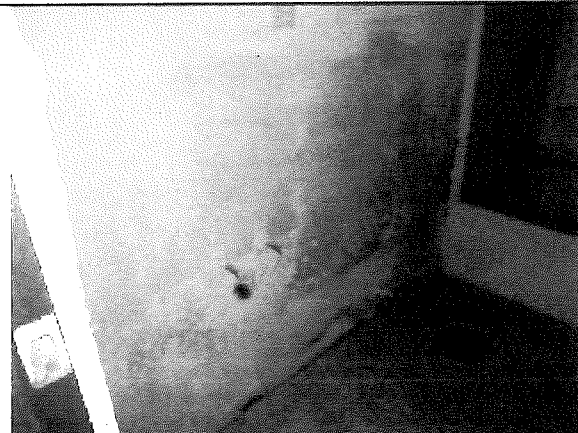
208 First Floor—mold present along bathroom walls.

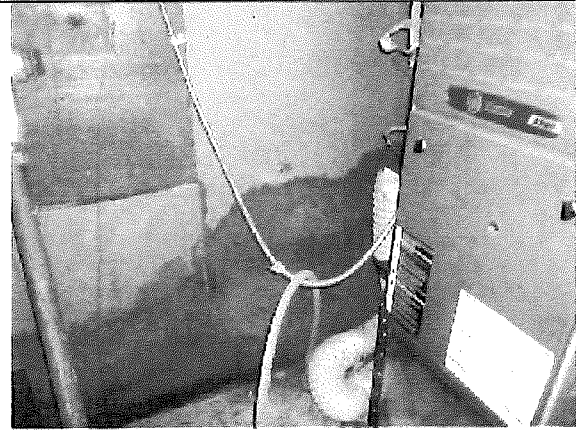
208 First Floor—saturated sheetrock present near furnace in utility room. It was wet at time of visit.

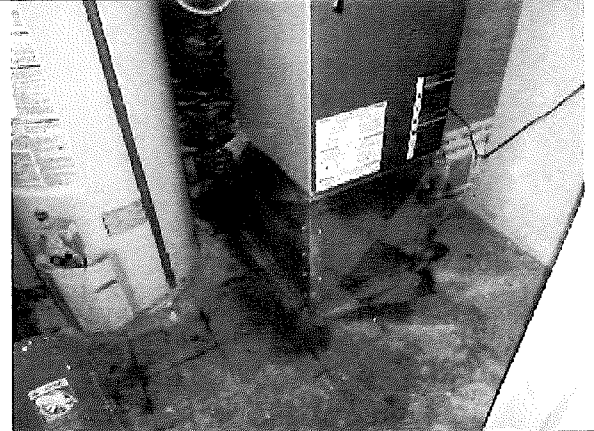
210 First Floor—floor in utility room wet at time of visit.

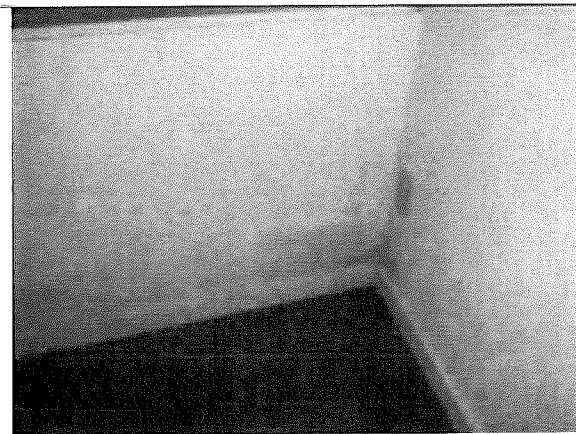
210 First Floor—mold present on the lower portion of the walls in NW-central room.

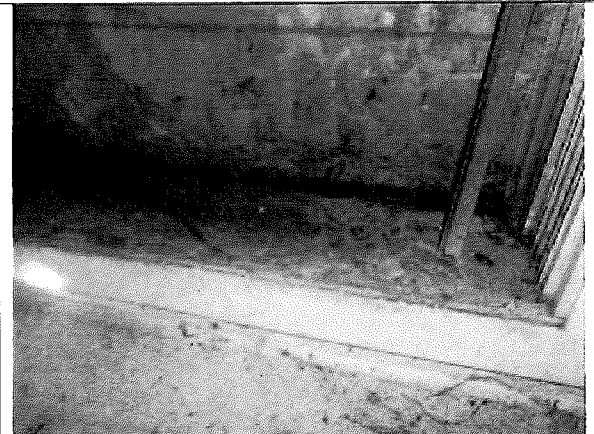
210 First Floor—NW-central room window well: mold

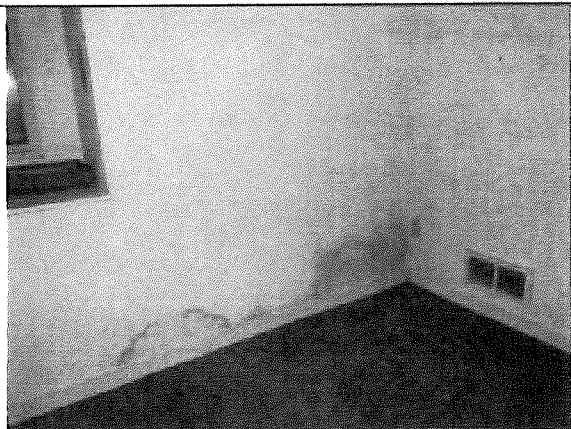
210 First Floor—mold present on the lower portion of the wall NE-central room.

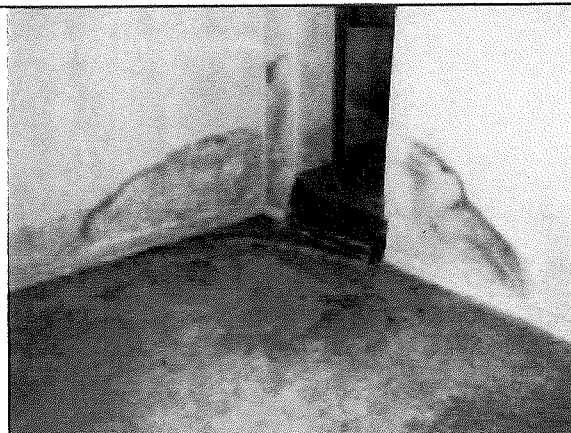
210 First Floor—mold present on the lower and mid portions of the walls in the room off kitchen. Floor was wet at time of visit.

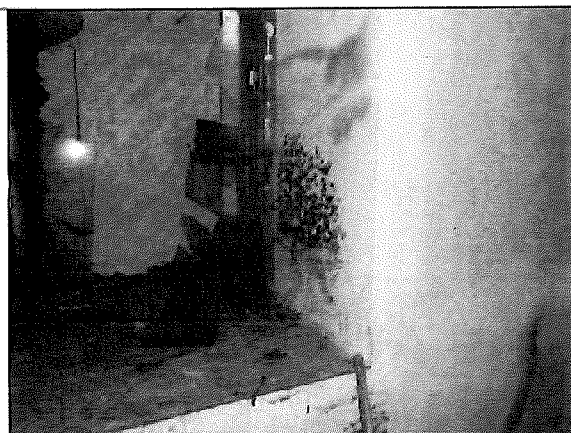
210 First Floor—East room mold present around window.

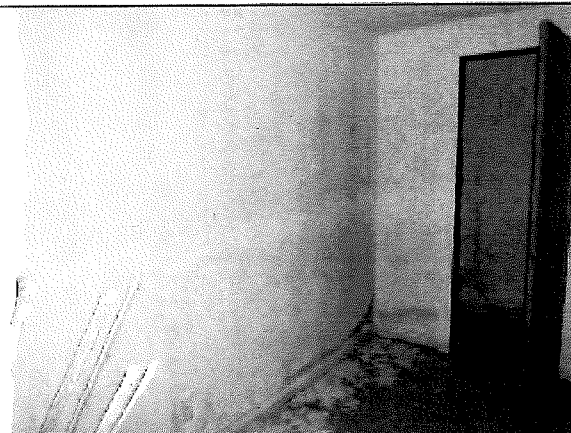
210 First Floor—East room: mold on walls. Note evidence on walls of wet studs. Floor was wet at time of visit.

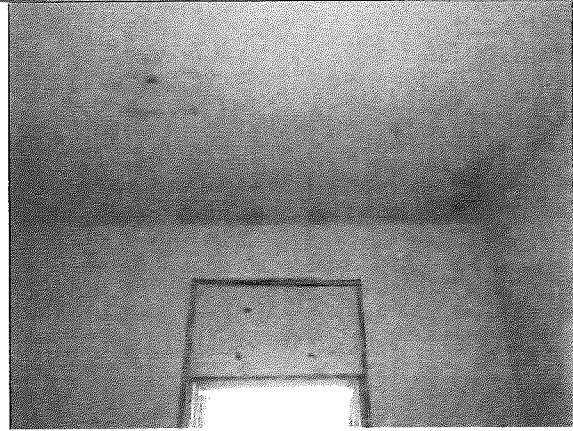
210 2<sup>nd</sup> Floor—NE-central room. Staining and mold present on ceiling.

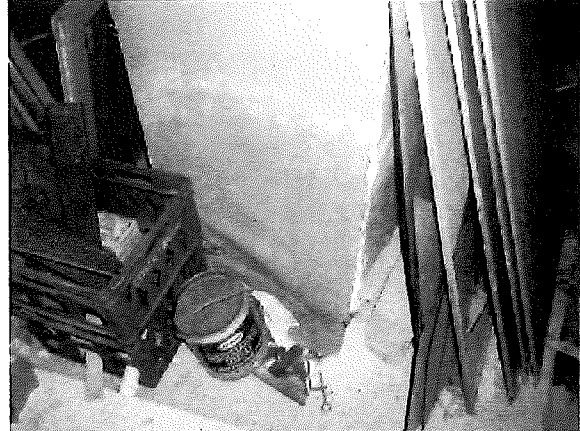
Basement south side—SW area: water damage to sheetrock.

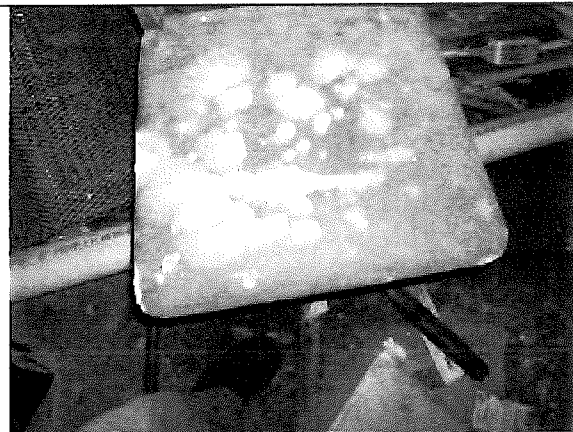
Basement south side—Mold present on table and other materials.

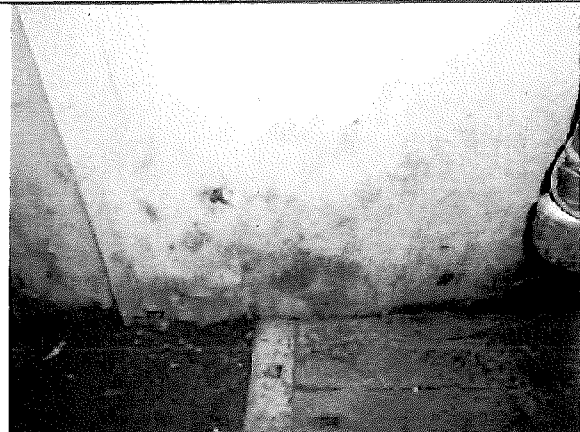
Basement north side—Mold present on the lower and mid portion of the wall as well as water damage to sheetrock.

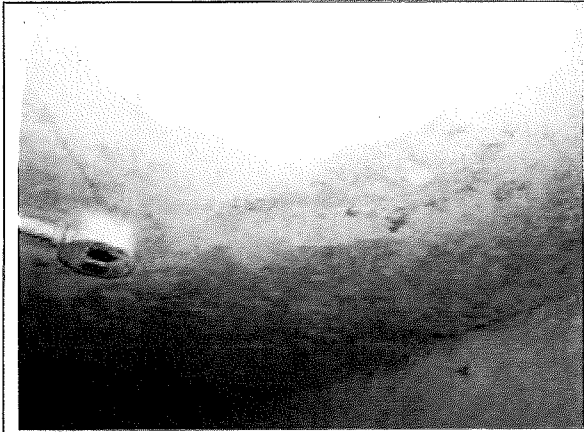
Basement north side—Mold and water damage present on the ceiling sheetrock.

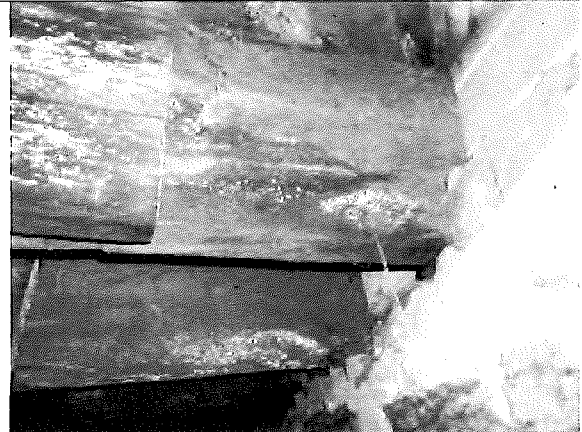
Basement central corridor—mold present on floor joist.

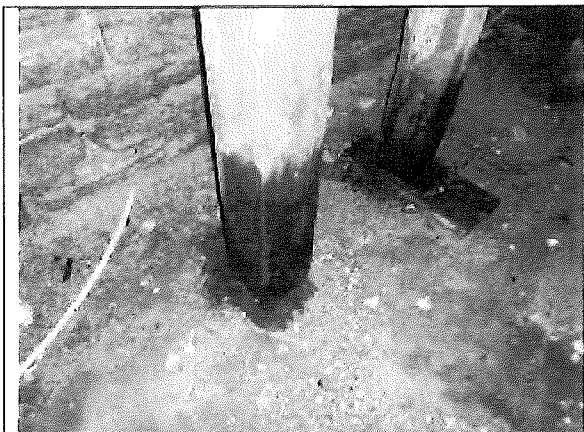
Basement central corridor—water saturated on support beams
