HISTORIC USE VARIANCE APPLICATION

Property Information			
Address/Location: 445 Smith Avenue, Sa	aint Paul MN 5	55102	
Legal Description: E1/2 of L13 and L14, E	BI 9, N. of the S	. 60' of same, Leech's Add'n	
Current Zoning: R4- One-Family			
Proposed Use: T2- Traditional Neighbor	rhood		
Name of Owner: Thomas S. and Ann M. (if different from applicant)		-	
Contact Person: Thomas S. Schroeder (if different from applicant)		Phone: (612) 385-8838	_
Applicant Information			
Name: Thomas S. Schroeder			
Email: Tom.Schroeder@FaegreBD.com		Phone: (612) 385-8838	_
Address: 194 McBoal Street			
City: Saint Paul	State: MN	Zip: <u>55102</u>

Attachment to HUV Application Form

At the request of Yust Architectural Services, I made a visit to the referenced building on August 4, 2014. The purpose of the visit was to perform limited visual observations of the existing framing and foundations of the structure. I have repared this letter to report my observations and to provide opinions regarding the existing structural materials in light of the current development of the site by Tom Schroeder.

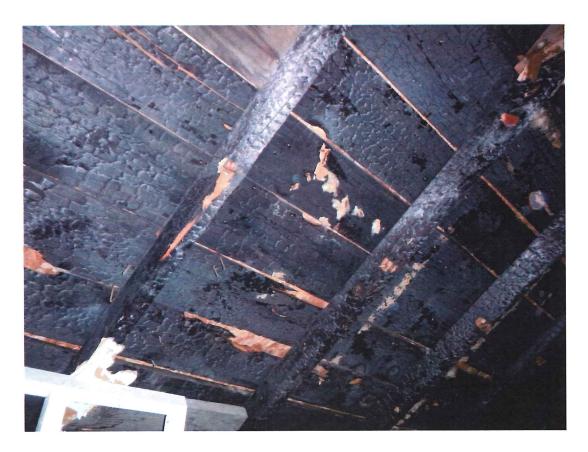
- B. Rafters were damaged by fire throughout the building, with the heaviest damage near the center and west ends of the space (Photo 1). The fire appeared to have caused a significant loss of cross section of many of the rafters and roof sheathing materials.

- C. Roof sheathing was .875" thick wood decking that was placed in various widths. The sheathing had randomly spaced gaps between the boards (Photo 1). There were conditions where the gaps between the sheathing boards were practically tight and there were conditions where I measured 1.5" wide gaps.

- i. The roof rafters were too badly damaged by fire and moisture infiltration to reuse the members for any proposed development of the structure. In addition, the members would require significant reinforcement to support loads per the MSBC.

Photo 1- Fire damage at roof level

- I. Recommendations for reinforcement or replacement of existing roof structure in kind
 - i. The existing roof framing and sheathing materials would need to be removed due to the extent of the fire damage and cannot be reused.

- ii. Option 1 for replacing the existing roof framing: Provide new wood roof trusses at 24" on center with new 5/8" thick plywood sheathing. Due to the raised ceiling condition there would need to be special consideration for resisting the horizontal forces at the truss bearing conditions along the tops of the exterior stud walls.

- iii. Option 2 for replacing the existing roof framing:
 - Provide a new (3) 1.75"x18" LVL or W14x22 ridge beam- it should be noted that the span of the ridge beam would require relocation of the original chimney stack.

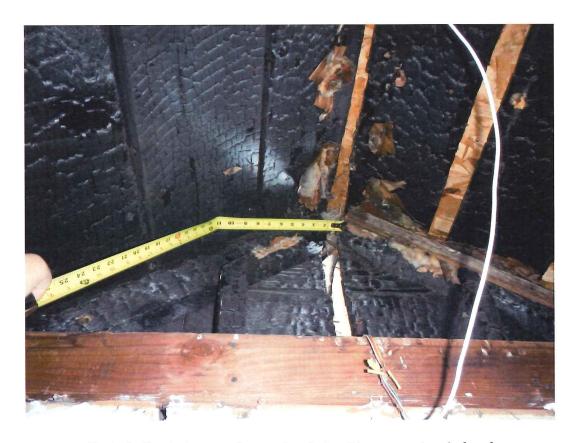
- D. There were gaps between the rafters at the roof peak that appeared to indicate spreading of the roof (outwards movement of the exterior stud walls). The gaps were more open at the base relative to the typically tight condition between the rafters at the top. This type of movement was much more severe

Photo 2- Gap between rafters and wall sheathing on west end of roof

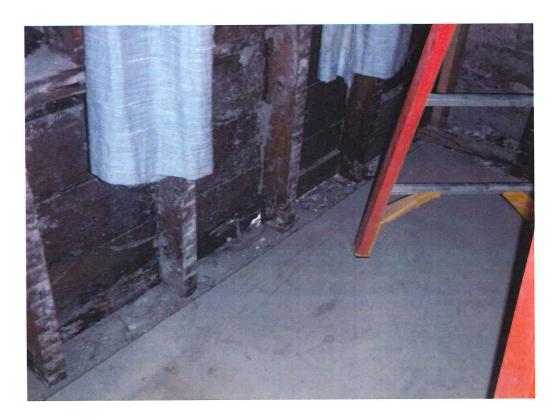
- A. The existing wall studs showed signs of moisture infiltration at many locations throughout the building.
- B. The existing studs had deteriorated due to moisture infiltration along the base of the walls (Photos 3 and 4).
- C. Recommendations for reinforcement or replacement of existing wall studs in kind
 - i. Existing studs that had been damaged by moisture cannot be reused.
 - ii. The existing studs that had been sistered to the original studs along the east gable end of the building during the past remodeling of the original structure should be removed and replaced (Photo 10). This existing condition is not structurally acceptable.

Photo 3- Openings in exterior stud wall

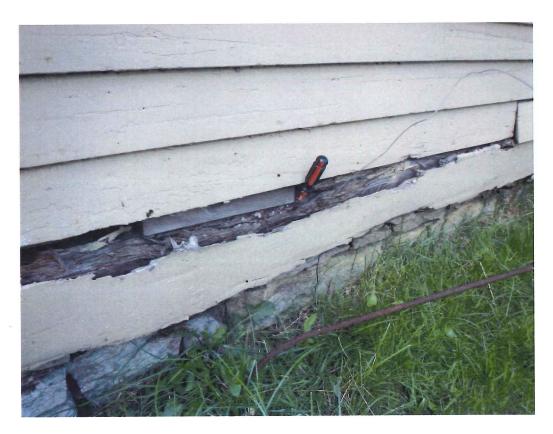
- A. There were signs of moisture damage throughout the first floor level of the building that extended into the foundation materials. These signs included the following:
 - There were holes in walls where the structure had completely deteriorated (Photos 3 and 4).
 - The 8"x6" sills had deteriorated along much of the first floor perimeter (Photos 3 and 4). At some locations the wood had rotted to the point that a screwdriver could be easily inserted into the material that remained (Photo 4).

- It appeared that the heaviest amount of deterioration had occurred along the bases of the stud walls and at foundation conditions where the snow had been in contact with the structure throughout the winter months (Photos 4 and 5). This was especially true along the north wall of the building where maintaining the alley along that side of the building probably exacerbated the problem.

Photo 4- Rotted wood and deteriorated stone materials at base of stud wall

- iv. The existing sill plate at the base of the stud walls would need to be replaced with a continuous treated sill plate. The existing sill plate cannot be reused.
- v. I would not recommend reusing the existing wood flooring at the main floor level. Similar to the recommendations for the second floor level, reusing the existing wood flooring would not provide a reliable diaphragm to resist lateral loads on the structure (Refer to Item 3.C.iii of this report).

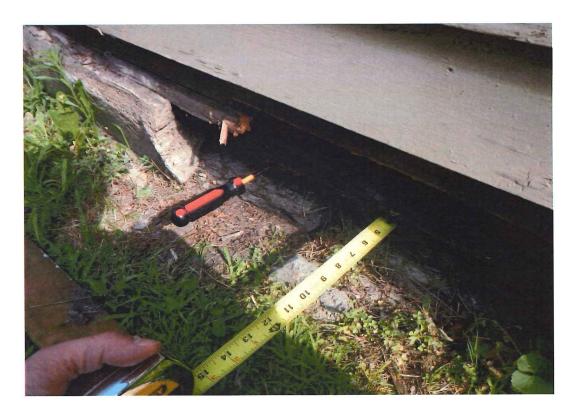
Photo 5- Rotted wood and missing/deteriorated stone materials at base of stud wall

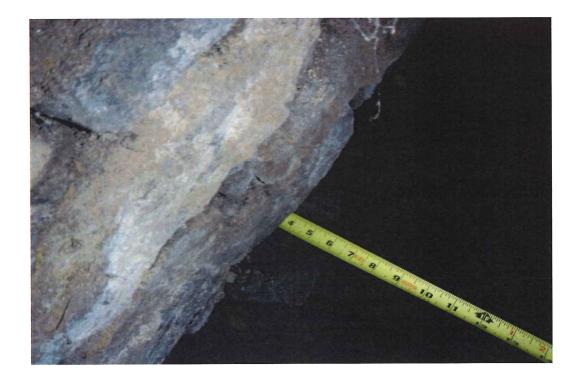
- Where stone foundation wall materials were accessible I was able to move some of the stone with my hand due to the deteriorated joint conditions. In addition, there were locations where large sections of the stone were missing. For instance, there appeared to be a section where 4" of stone had fallen away along the inside face of the foundation wall in the crawl space (Photo 6).

- iv. The deteriorated joints and loose materials in the stone foundation walls make it extremely risky to reuse the walls with any redevelopment of the building. It would be difficult to simply grout

open joints in the walls due to the relatively massive width of the walls- it would not be possible to confirm that all open voids within the wall system were filled during the re-grouting efforts. Any open voids would continue to be susceptible to moisture infiltration in the future which could lead to expansion of the materials during freeze events. This is especially true along the existing alley where snow would continue to pile up during maintenance efforts and due to the fact that there is no moisture barrier along the exterior face of the foundation walls.

Photo 6- Looking downwards at a section of stone that had deteriorated along the foundation wall

- iii. The stone foundation walls would be removed and replaced with the following:
 - 24"x12" thick continuous concrete footing with 2-#5 continuous reinforcing bars

- Footing to bear at least 3'-6" below the adjacent finish grade
 - Provide a 12" foundation wall made up of concrete masonry units (CMU). CMU would be reinforced with #5 reinforcing bars placed at 48" on center. The top course of the CMU would be a bond beam with 2-#4 continuous reinforcing bars. A limestone veneer could be included where the foundation wall is exposed above grade.

I would recommend against using a full stone foundation wall system as the material would be susceptible to water infiltration and the unreinforced stone would not be appropriate to resist lateral loads from the adjacent backfill material (Also refer to Section 4.E.iv of this report for further discussion of this topic).

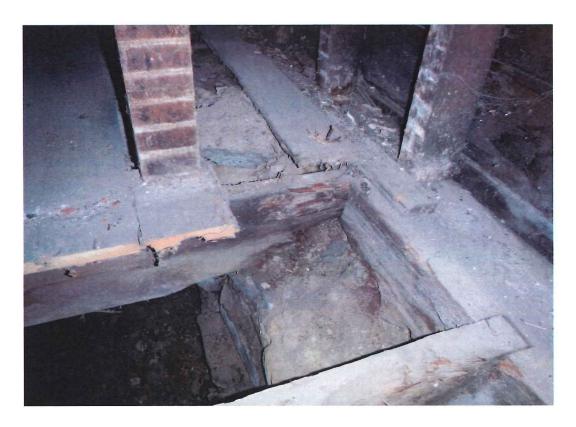
- There were floor joists that were badly deteriorated where they were bearing along the exterior stone foundation wall (Photo 7). No original wood materials would have been treated to resist the effects of exposure to moisture.

- E. General structural condition of main floor framing and foundations in light of proposed development of building:
 - i. Any floor joists with the type of deterioration observed at the bearing along the exterior stone foundation wall shown in Photo 7 would need to be removed and replaced.

Photo 7- Deteriorated joists and sill at bearing on stone foundation wall

- ii. The main floor joists would be replaced with 2x10 floor joists spaced at 16" on center. The existing floor joists were deteriorated and cannot be reused as part of the main floor structural system.

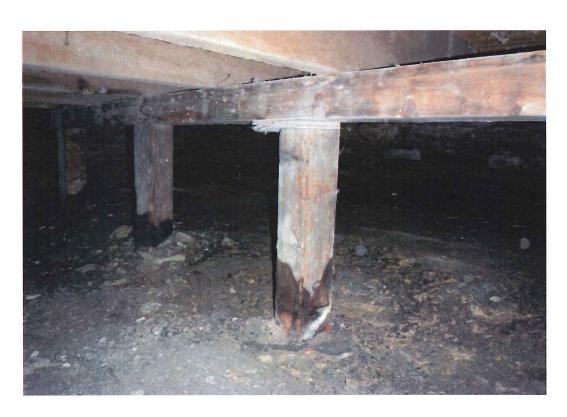
- D. The main floor joists were bearing on a 3.5"x3.5" wood beam that was supported by 3.5"x3.5" wood columns in the crawl space. The bases of the wood columns showed signs of exposure to moisture and it was not apparent what the posts were bearing on (Photo 8).

Photo 8- Signs of moisture on columns in crawl space

- F. Recommendations for reinforcement or replacement of existing main floor structure and foundations in kind
 - The columns supporting the center beam should be removed and cannot be reused. To provide a more efficient structural system, two new 4x4 wood posts would be used to support (2) 1.75"x9.5" LVL beams (currently there are four or five interior columns along the center beam line). These columns would bear on concrete footings that would be 2'-6"x2'-6"x12" thick with 4-#4 reinforcing bars each way at the bottom of the footing.

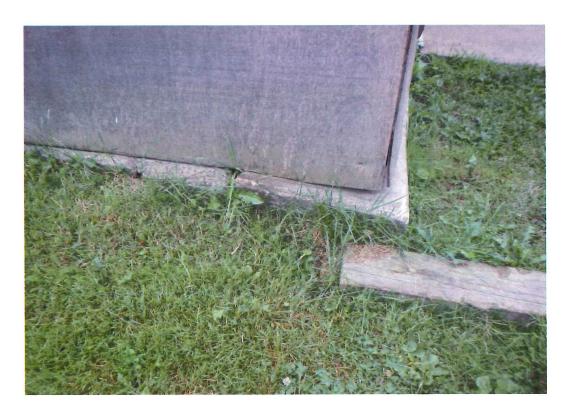
Photo 9- Signs of movement in concrete supporting stud walls of one story shed on west side of building

ii. There were no signs of a true foundation system supporting the stud walls of the one story shed. A new foundation system would be required for any structure in this location.

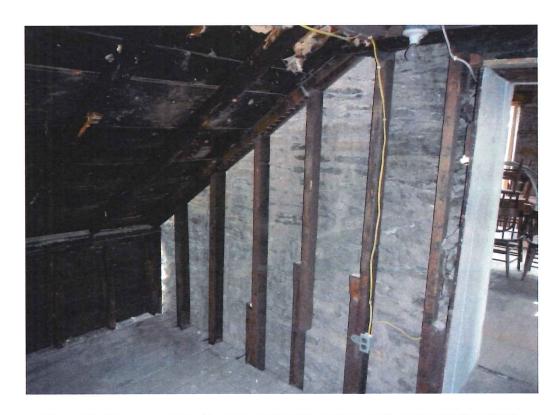
Photo 10- Sistered wall studs along east gable end at previous remodeling efforts
