**CITY OF SAINT PAUL  
HERITAGE PRESERVATION COMMISSION STAFF REPORT**

FILE NAME: 445 Smith Avenue North  
DATE OF APPLICATION: August 4, 2015 (additional materials 8-11, 8-17, 8-20)  
APPLICANT: Thomas Schroeder  
OWNER: Thomas and Ann Schroeder  
DATE OF HEARING: August 27, 2015  
HPC SITE/DISTRICT: *pending* Limestone Properties Thematic Nomination (P.O.S. 1850-1899)  
CATEGORY: Contributing  
CLASSIFICATION: Building Permit  
STAFF INVESTIGATION AND REPORT: Amy Spong  
DATE: August 19, 2015

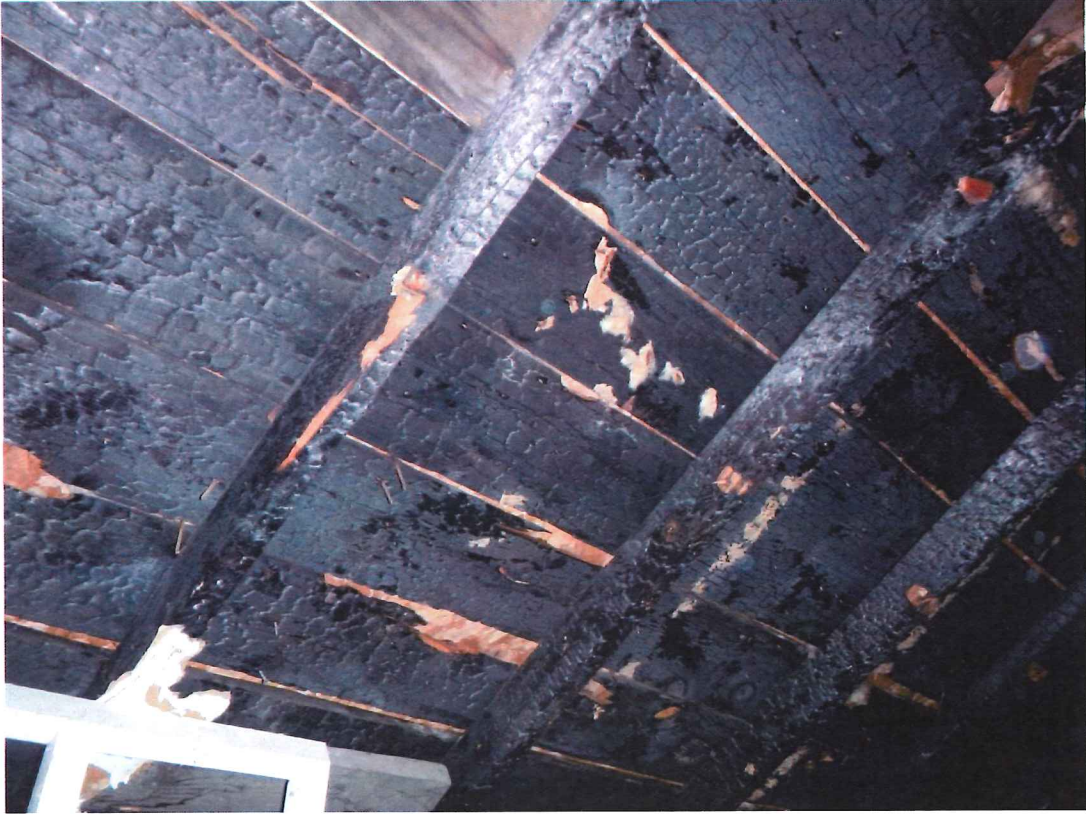
- B. Rafters were damaged by fire throughout the building, with the heaviest damage near the center and west ends of the space (Photo 1). The fire appeared to have caused a significant loss of cross section of many of the rafters and roof sheathing materials.

- C. Roof sheathing was .875” thick wood decking that was placed in various widths. The sheathing had randomly spaced gaps between the boards (Photo 1). There were conditions where the gaps between the sheathing boards were practically tight and there were conditions where I measured 1.5” wide gaps.

- i. The roof rafters were too badly damaged by fire and moisture infiltration to reuse the members for any proposed development of the structure. In addition, the members would require significant reinforcement to support loads per the MSBC.

Photo 1- Fire damage at roof level

- I. **Recommendations for reinforcement or replacement of existing roof structure in kind**
  - i. **The existing roof framing and sheathing materials would need to be removed due to the extent of the fire damage and cannot be reused.**

- ii. **Option 1 for replacing the existing roof framing: Provide new wood roof trusses at 24" on center with new 5/8" thick plywood sheathing. Due to the raised ceiling condition there would need to be special consideration for resisting the horizontal forces at the truss bearing conditions along the tops of the exterior stud walls.**

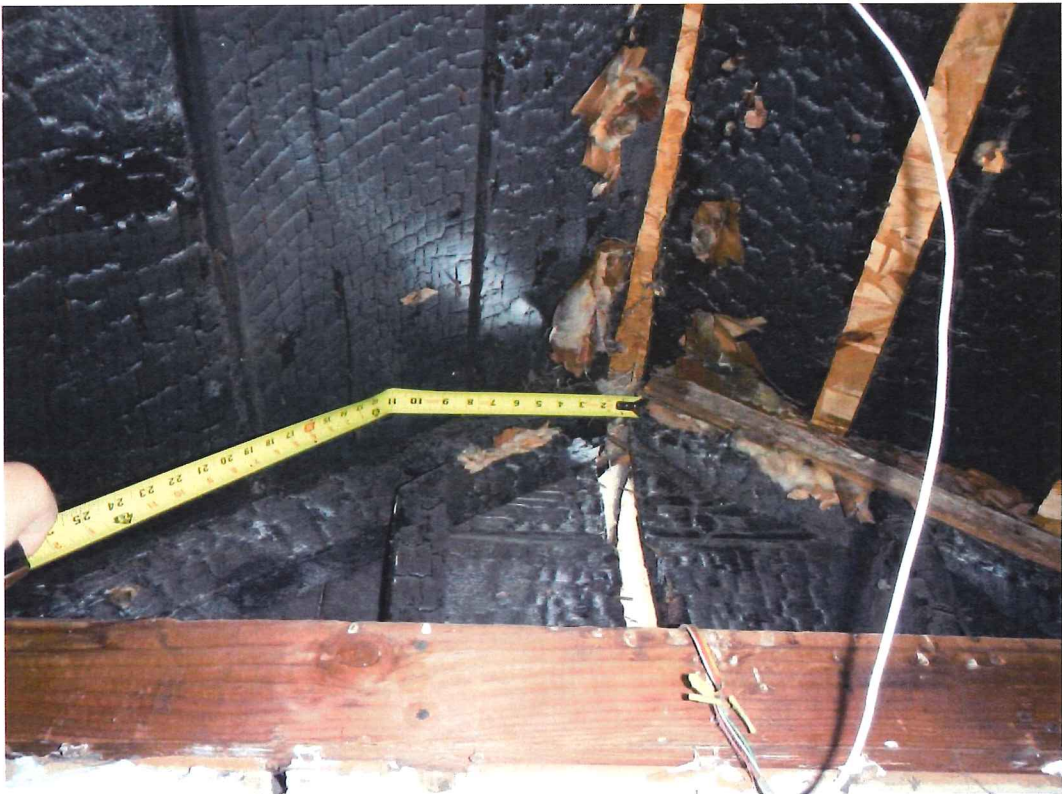
- D. There were gaps between the rafters at the roof peak that appeared to indicate spreading of the roof (outwards movement of the exterior stud walls). The gaps were more open at the base relative to the typically tight condition between the rafters at the top. This type of movement was much more severe

Photo 2- Gap between rafters and wall sheathing on west end of roof

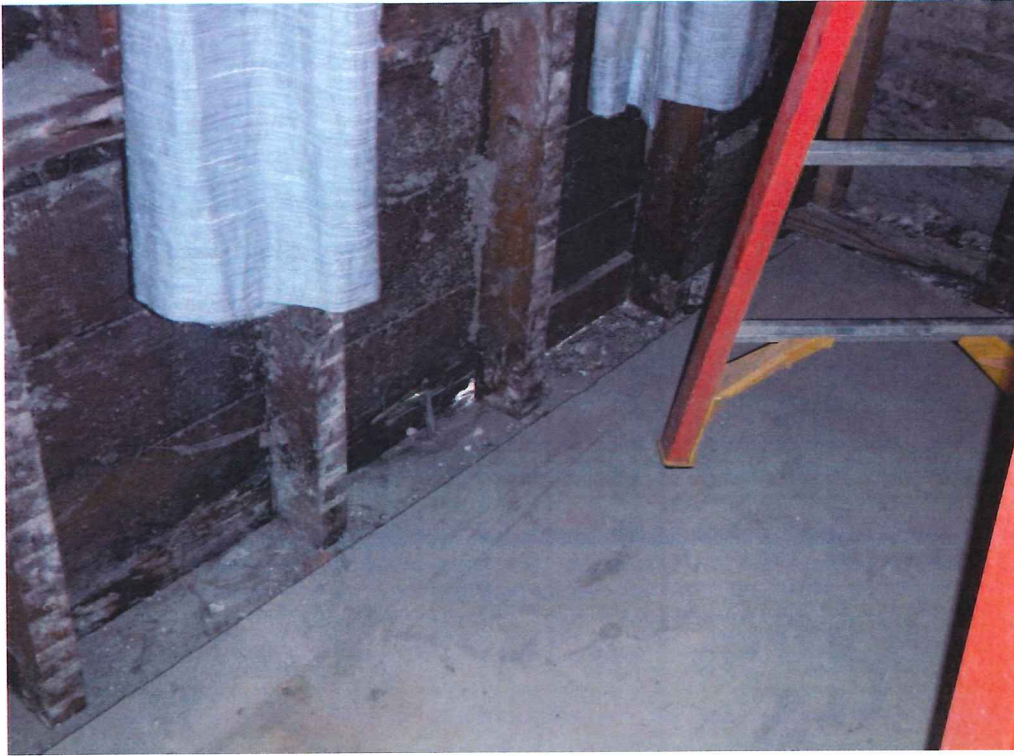
Photo 3- Openings in exterior stud wall

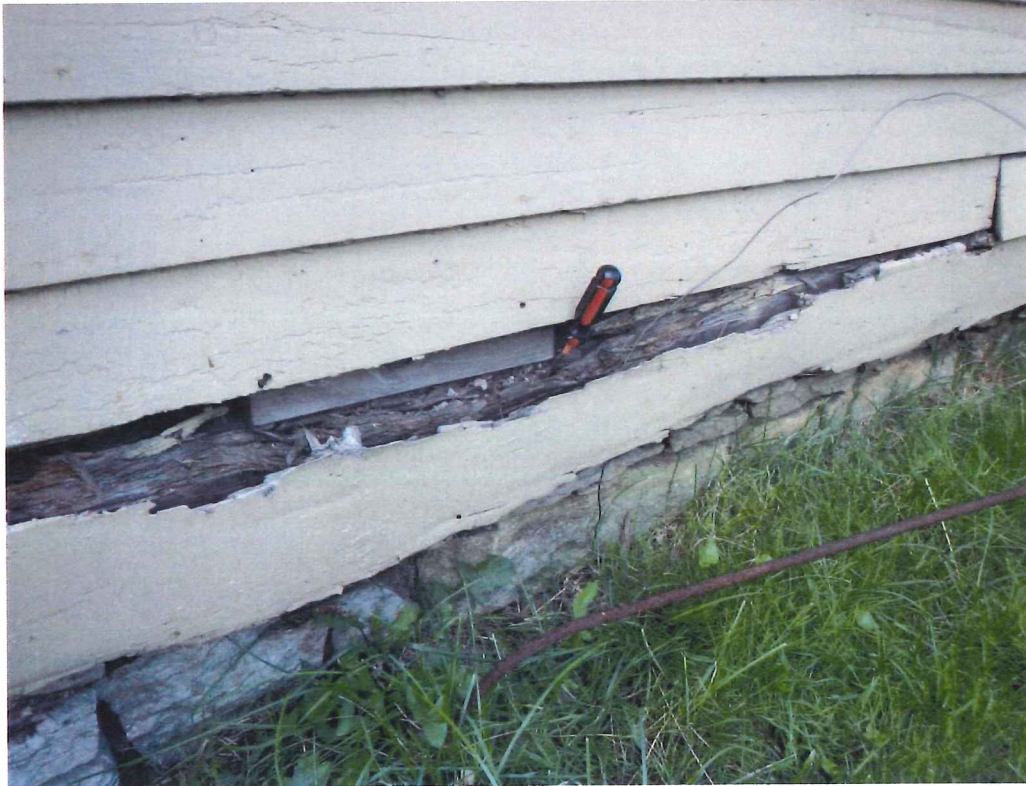
Photo 4- Rotted wood and deteriorated stone materials at base of stud wall

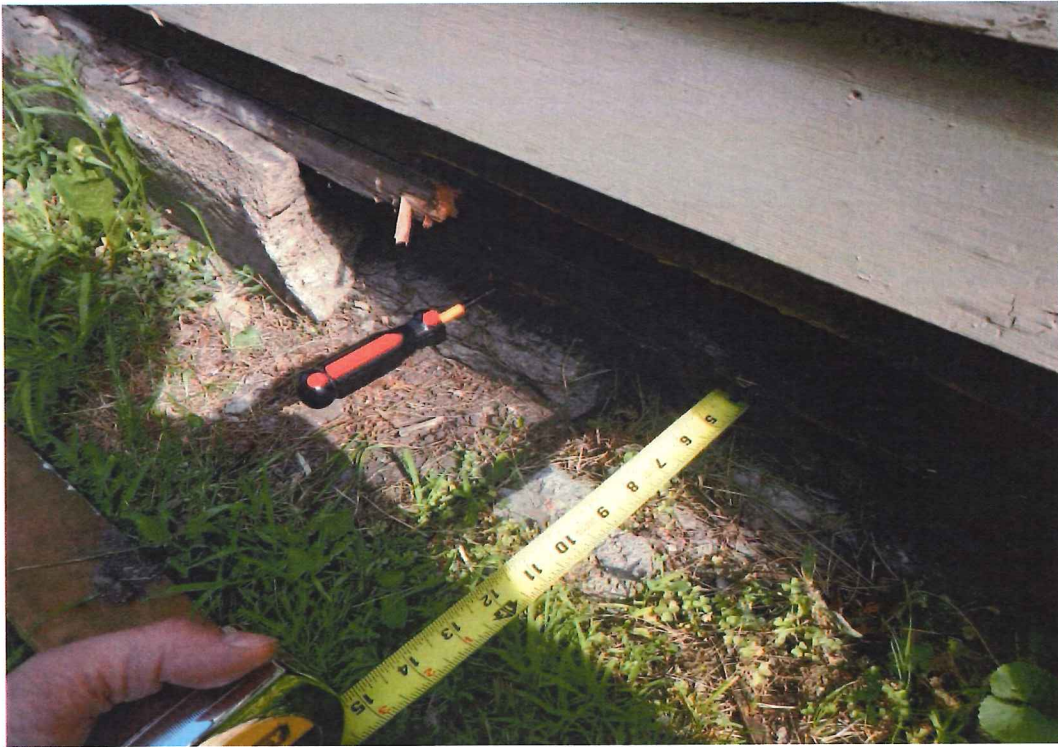
Photo 5- Rotted wood and missing/deteriorated stone materials at base of stud wall

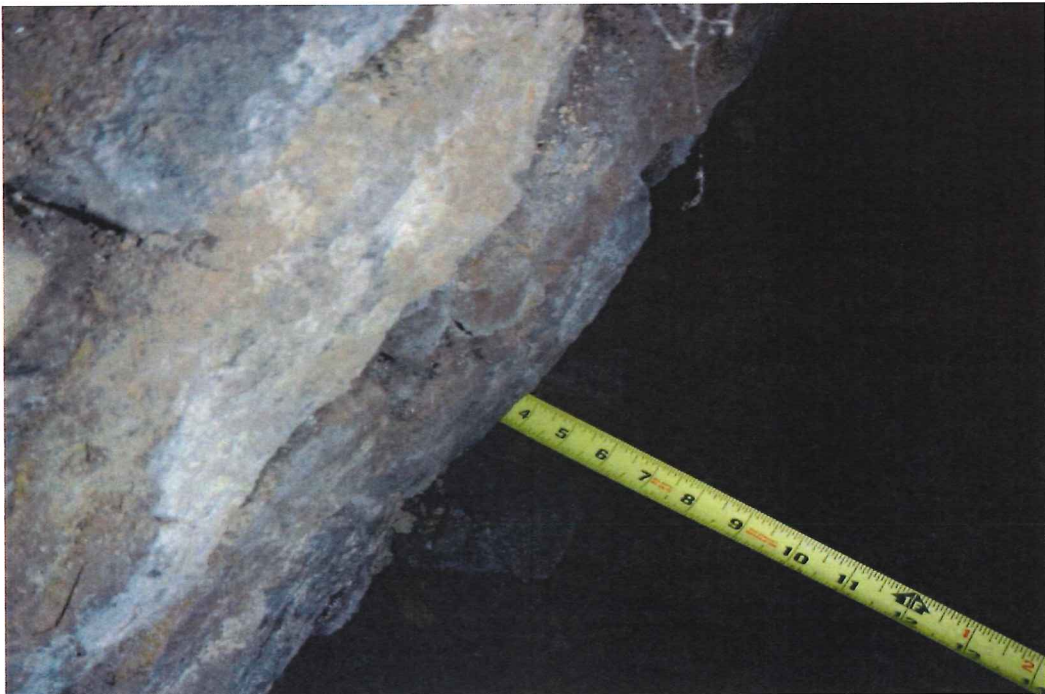
Photo 6- Looking downwards at a section of stone that had deteriorated along the foundation wall

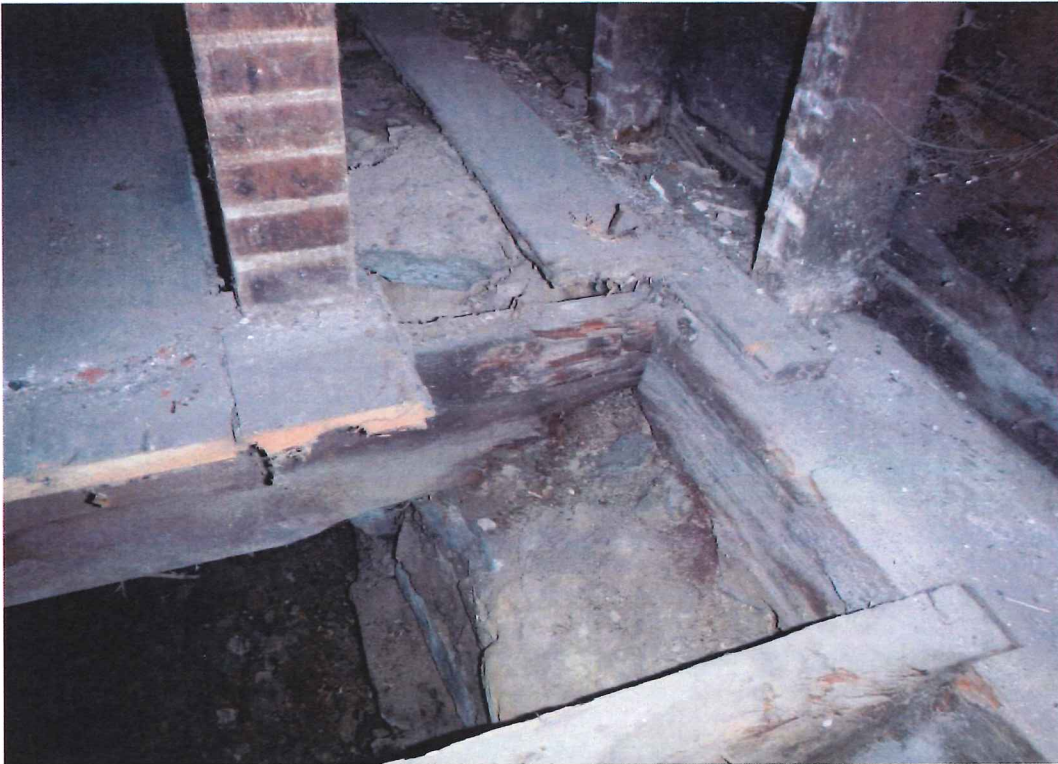
Photo 7- Deteriorated joists and sill at bearing on stone foundation wall

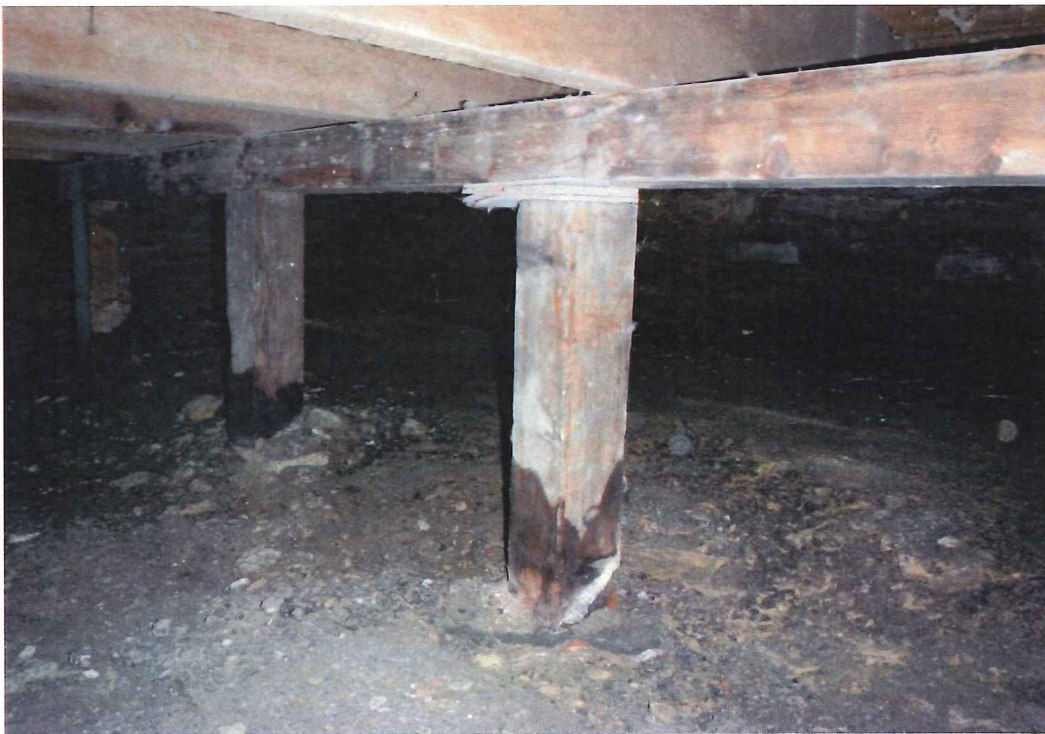
Photo 8- Signs of moisture on columns in crawl space

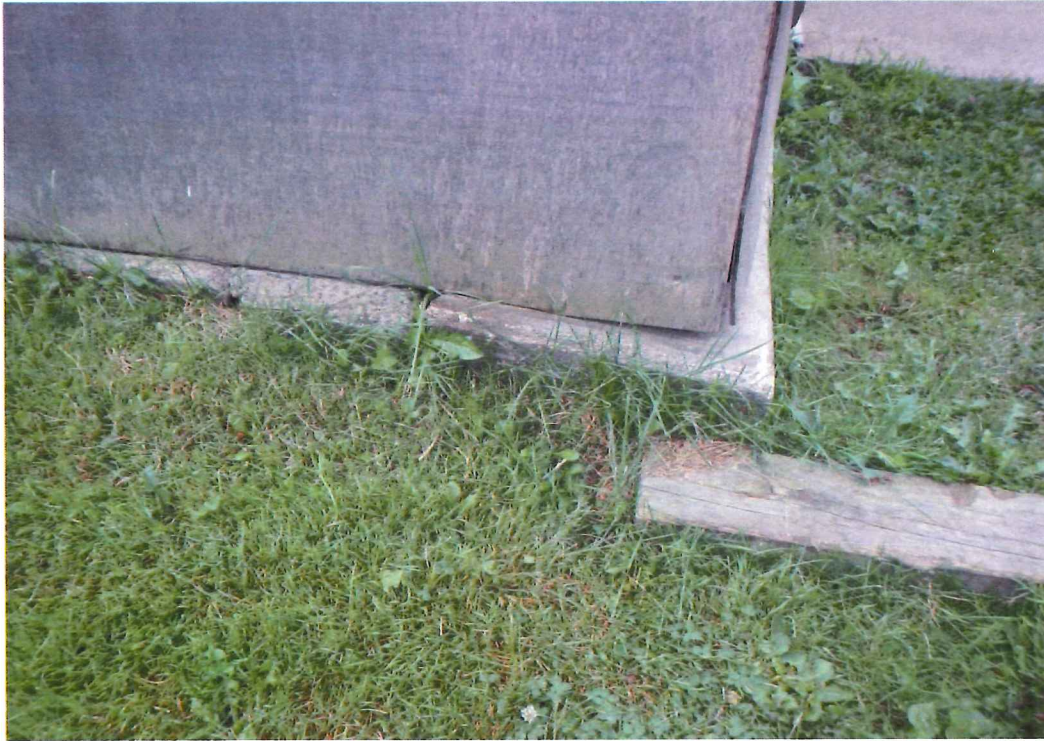
Photo 9- Signs of movement in concrete supporting stud walls of one story shed on west side of building

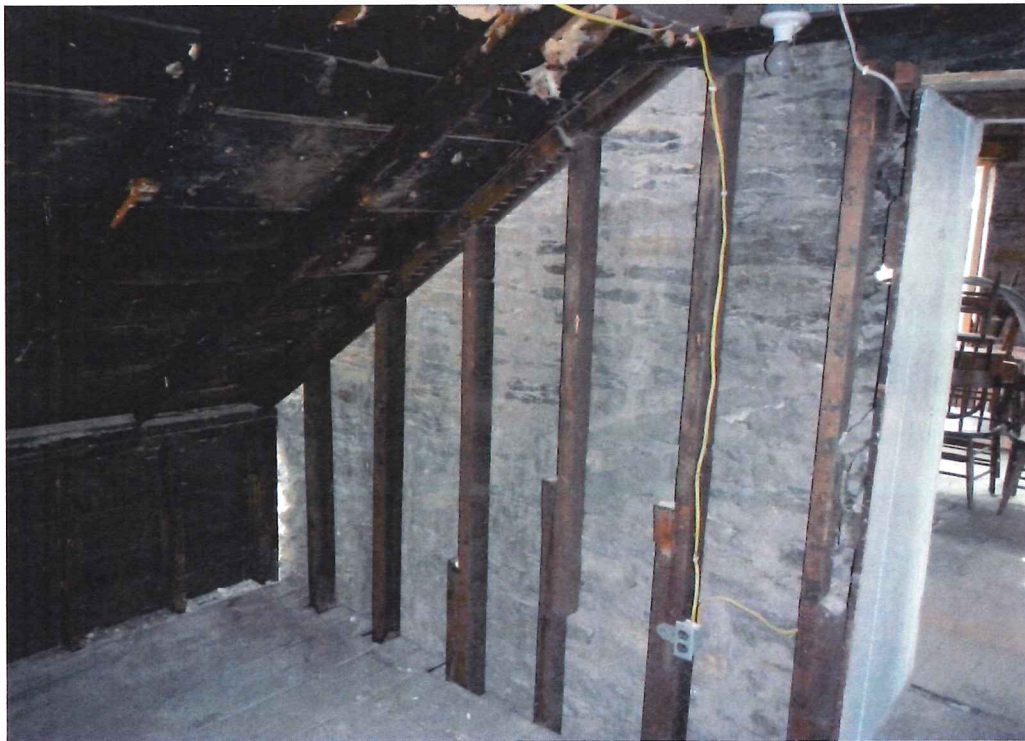
Photo 10- Sistered wall studs along east gable end at previous remodeling efforts

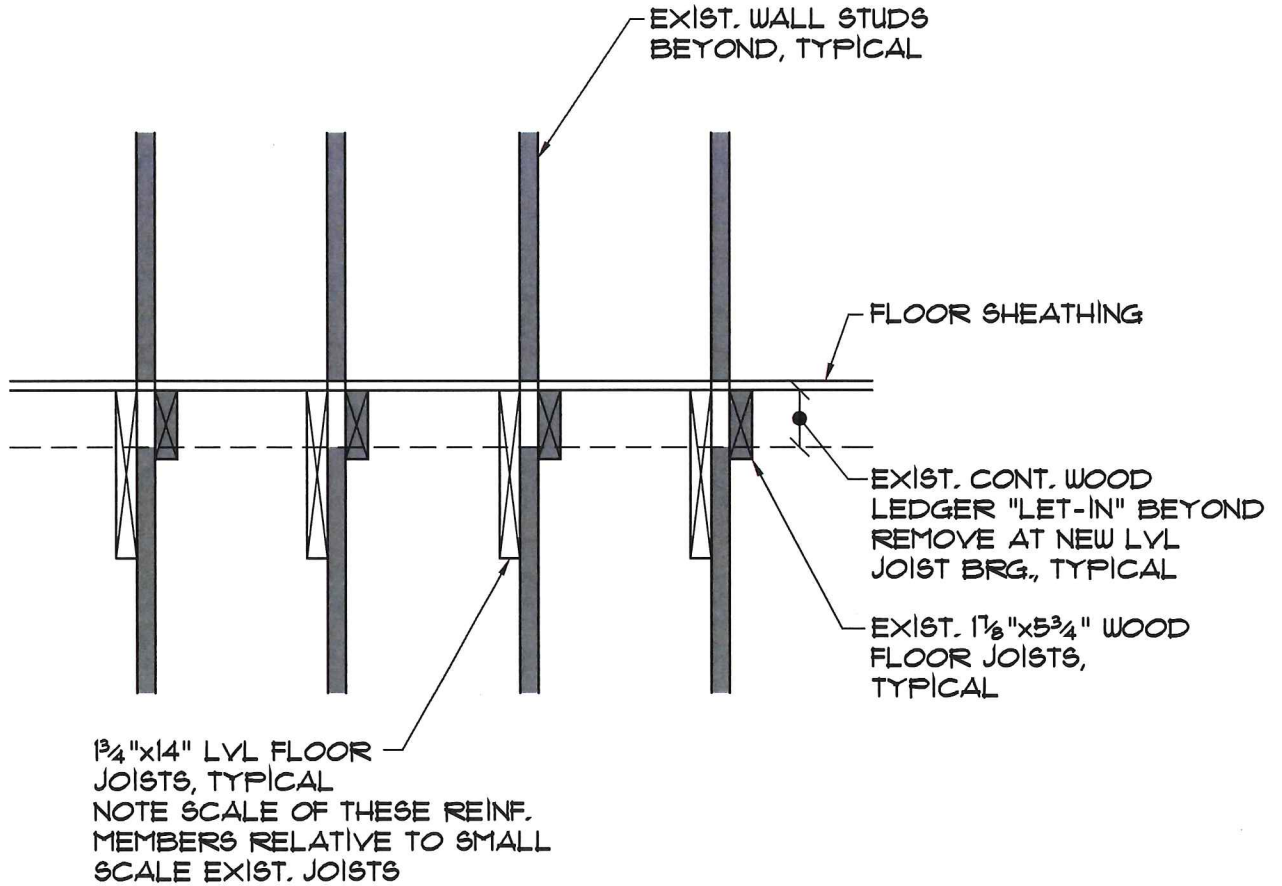
SHEET NO. SK1

- B. General structural condition of the second floor in light of proposed development of building:  
The existing second floor joist framing system was so heavily overstressed that any reinforcement of the current system to support loads per the MSBC would essentially be a completely new system- the existing floor joists would provide an insignificant contribution to any "reinforced" framing scheme.

- C. Recommendations for reinforcement or replacement of existing second floor structure in kind
- i. The existing 1.875"x5.75" floor joists at 16" on center would be reinforced with 1.75"x14" laminated veneer lumber (LVL) floor joists at 16" on center (or 1.75"x11.25" LVL joists at 16" on center for residential reuse of the building). Refer to Section 1/SK1 showing the new and existing joist relationship (Attached to this report).
