**Special Design Review Committee
Of the Saint Paul Heritage Preservation Commission
445 Smith Avenue N.
September 2, 1025
10:00 AM**

**Special Design Review Committee
of the Saint Paul Heritage Preservation Commission
445 Smith Avenue N
September 2, 2015**

TO: Amy Spong, Christine Boulware, Saint Paul HPC
FROM: Bob Frame, Historian
DATE: August 21, 2014
RE: Structural engineer's evaluation of 445 Smith addition

At the request of Yust Architectural Services, I made a visit to the referenced building on August 4, 2014. The purpose of the visit was to perform limited visual observations of the existing framing and foundations of the structure. I have prepared this letter to report my observations and to provide opinions regarding the existing structural materials in light of the current development of the site by Tom Schroeder.

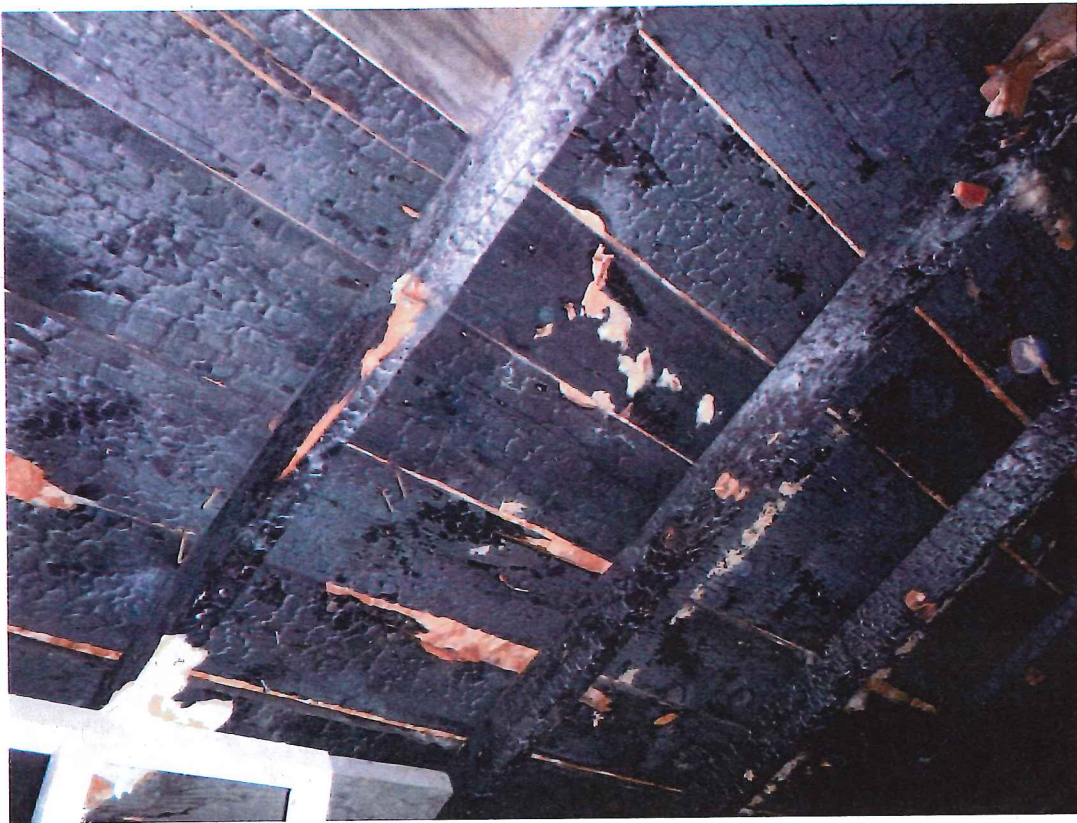
- B. Rafters were damaged by fire throughout the building, with the heaviest damage near the center and west ends of the space (Photo 1). The fire appeared to have caused a significant loss of cross section of many of the rafters and roof sheathing materials.

- C. Roof sheathing was .875" thick wood decking that was placed in various widths. The sheathing had randomly spaced gaps between the boards (Photo 1). There were conditions where the gaps between the sheathing boards were practically tight and there were conditions where I measured 1.5" wide gaps.

- i. The roof rafters were too badly damaged by fire and moisture infiltration to reuse the members for any proposed development of the structure. In addition, the members would require significant reinforcement to support loads per the MSBC.

- A. Roof framing- 0% of the existing structural materials from the roof level can be reused for the proposed development of the building. The existing materials were damaged by fire and cannot be reused.

Photo 1- Fire damage at roof level

- I. **Recommendations for reinforcement or replacement of existing roof structure in kind**
 - i. **The existing roof framing and sheathing materials would need to be removed due to the extent of the fire damage and cannot be reused.**

- ii. **Option 1 for replacing the existing roof framing: Provide new wood roof trusses at 24" on center with new 5/8" thick plywood sheathing. Due to the raised ceiling condition there would need to be special consideration for resisting the horizontal forces at the truss bearing conditions along the tops of the exterior stud walls.**

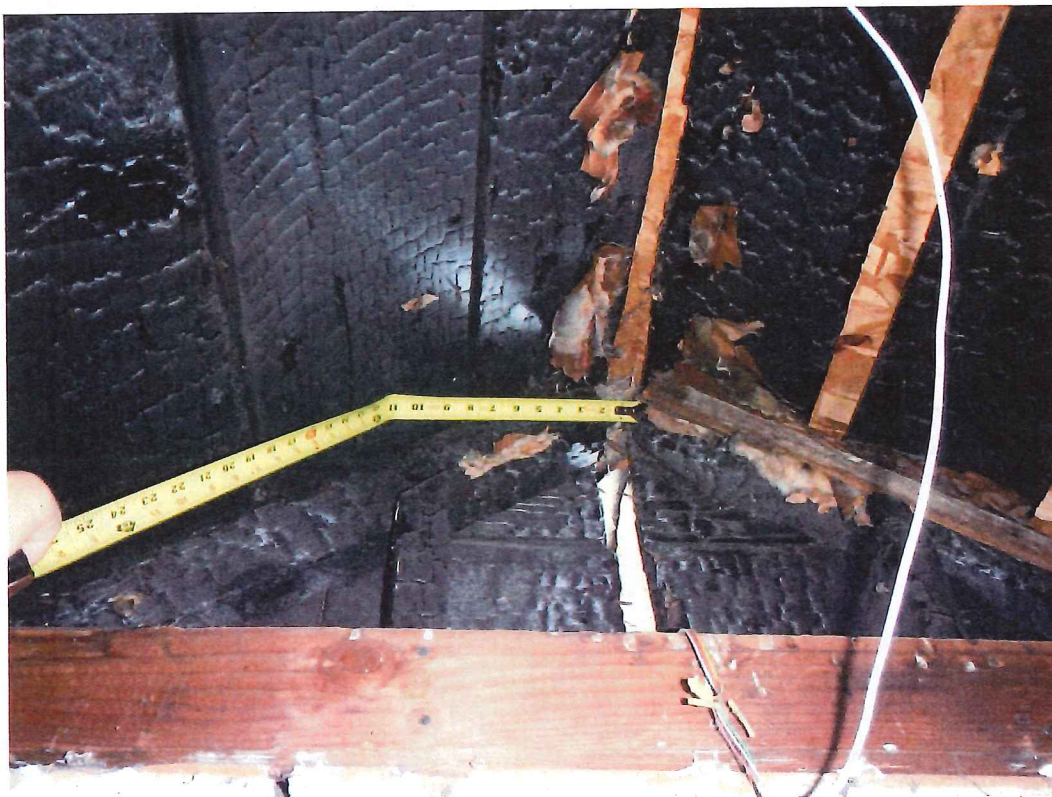
- D. There were gaps between the rafters at the roof peak that appeared to indicate spreading of the roof (outwards movement of the exterior stud walls). The gaps were more open at the base relative to the typically tight condition between the rafters at the top. This type of movement was much more severe

Photo 2- Gap between rafters and wall sheathing on west end of roof

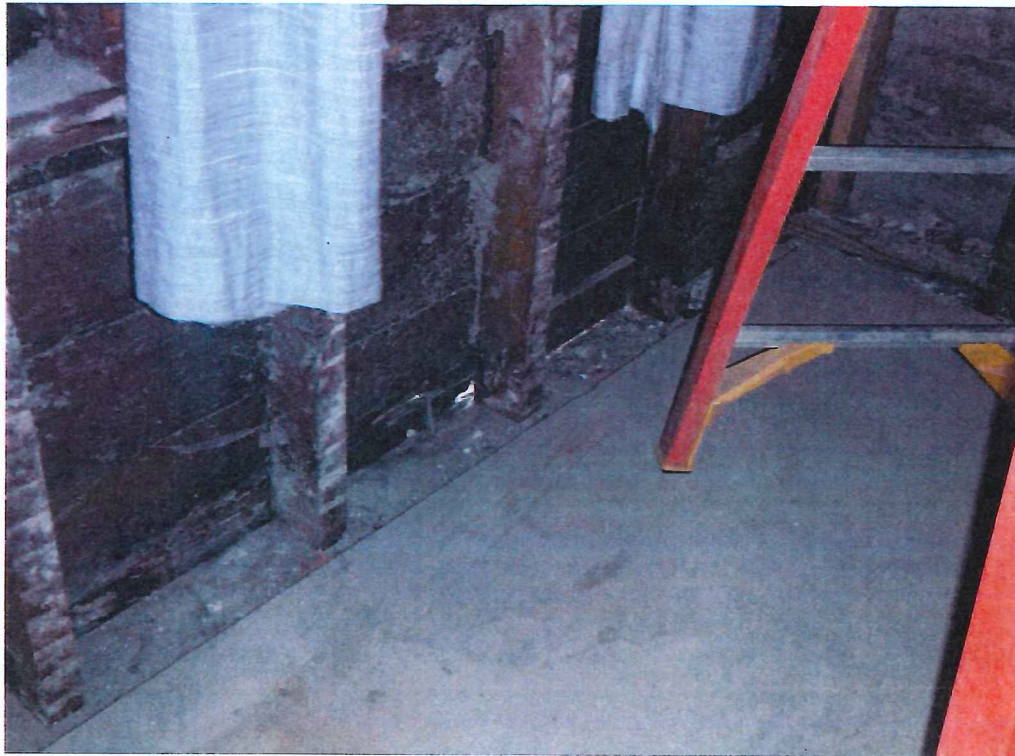
- A. The existing wall studs showed signs of moisture infiltration at many locations throughout the building.
- B. The existing studs had deteriorated due to moisture infiltration along the base of the walls (Photos 3 and 4).
- C. Recommendations for reinforcement or replacement of existing wall studs in kind
 - i. Existing studs that had been damaged by moisture cannot be reused.
 - ii. The existing studs that had been sistered to the original studs along the east gable end of the building during the past remodeling of the original structure should be removed and replaced (Photo 10). This existing condition is not structurally acceptable.

Photo 3- Openings in exterior stud wall

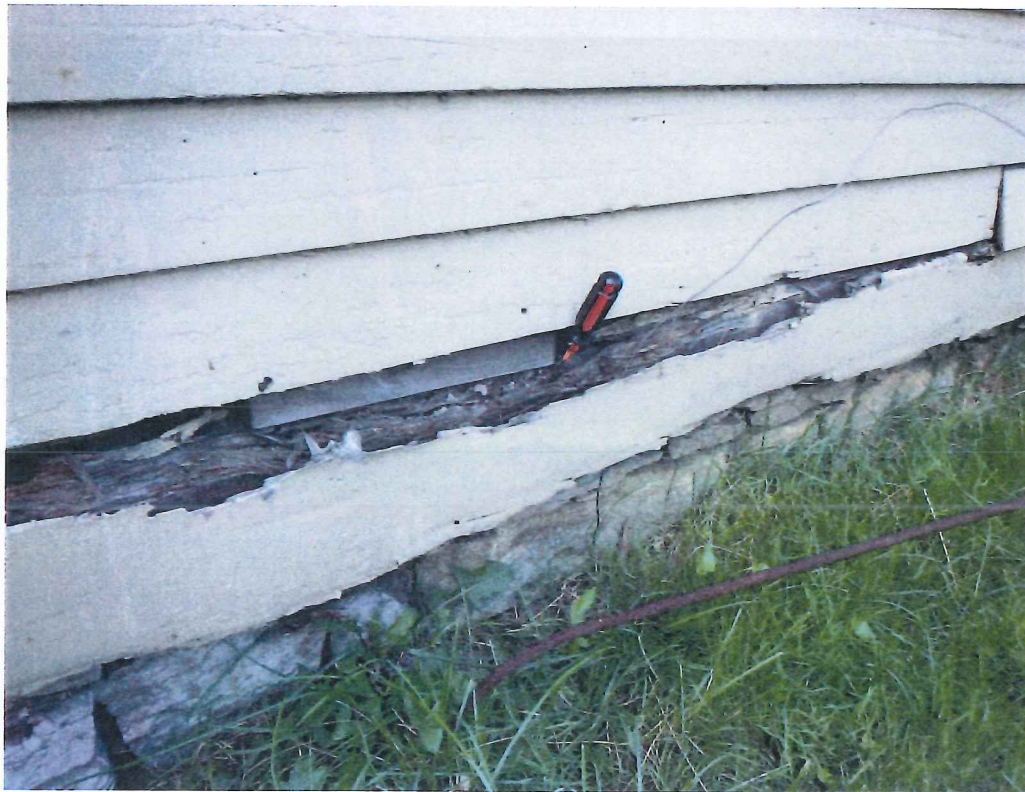
- A. There were signs of moisture damage throughout the first floor level of the building that extended into the foundation materials. These signs included the following:
- There were holes in walls where the structure had completely deteriorated (Photos 3 and 4).
 - The 8"x6" sills had deteriorated along much of the first floor perimeter (Photos 3 and 4). At some locations the wood had rotted to the point that a screwdriver could be easily inserted into the material that remained (Photo 4).

- It appeared that the heaviest amount of deterioration had occurred along the bases of the stud walls and at foundation conditions where the snow had been in contact with the structure throughout the winter months (Photos 4 and 5). This was especially true along the north wall of the building where maintaining the alley along that side of the building probably exacerbated the problem.

Photo 4- Rotted wood and deteriorated stone materials at base of stud wall

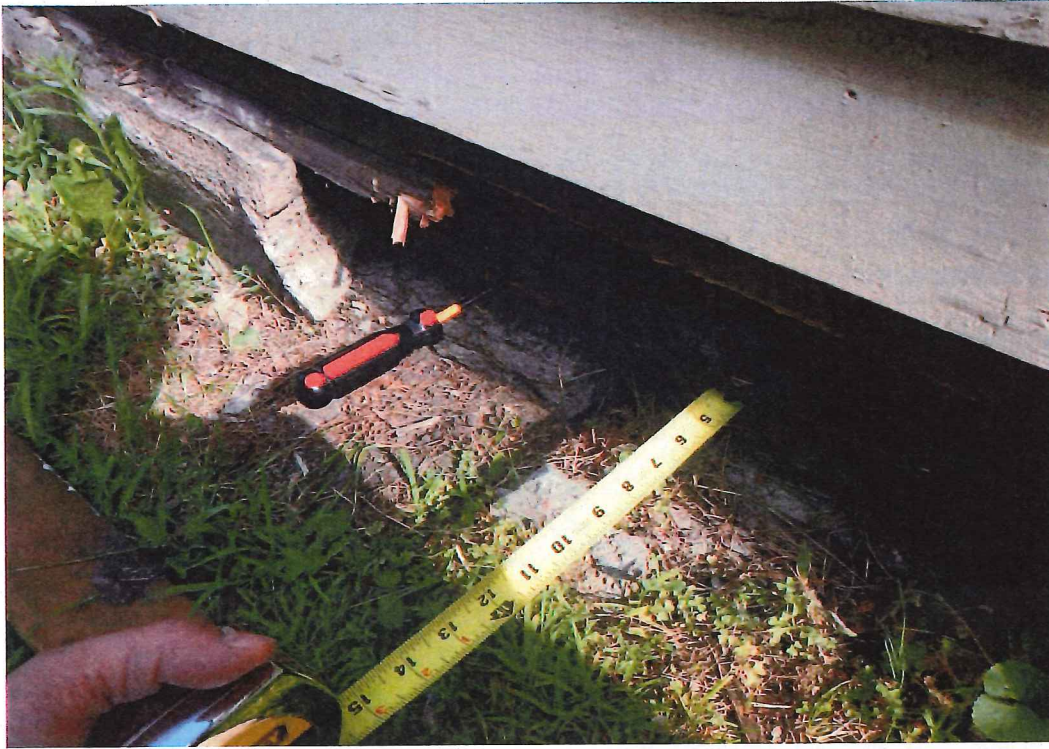
Photo 5- Rotted wood and missing/deteriorated stone materials at base of stud wall

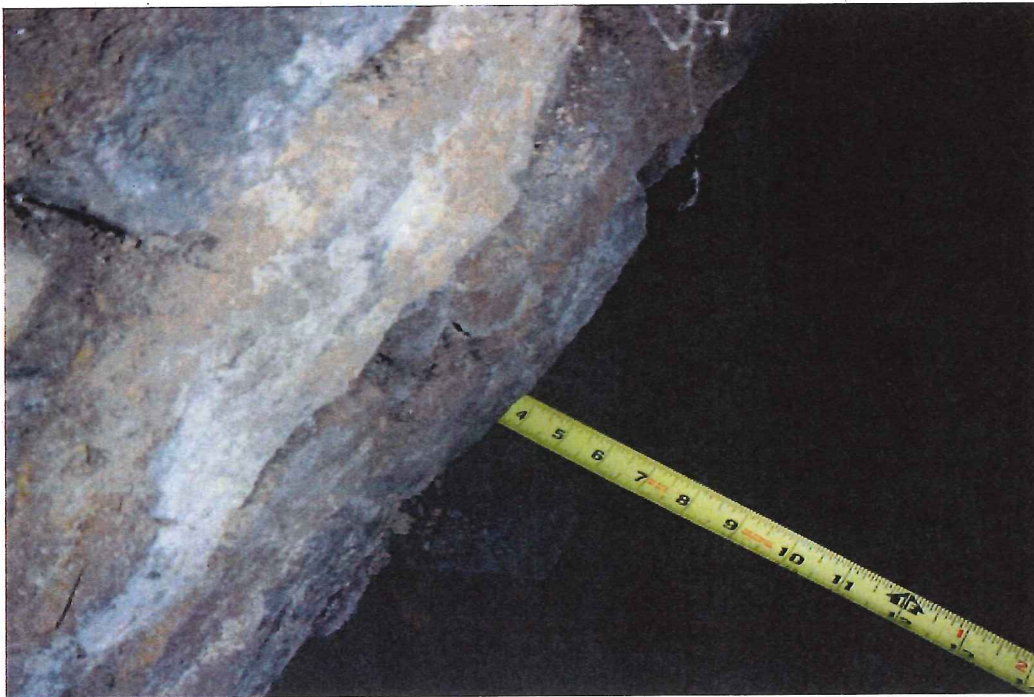
- Where stone foundation wall materials were accessible I was able to move some of the stone with my hand due to the deteriorated joint conditions. In addition, there were locations where large sections of the stone were missing. For instance, there appeared to be a section where 4" of stone had fallen away along the inside face of the foundation wall in the crawl space (Photo 6).

- iv. The deteriorated joints and loose materials in the stone foundation walls make it extremely risky to reuse the walls with any redevelopment of the building. It would be difficult to simply grout

Photo 6- Looking downwards at a section of stone that had deteriorated along the foundation wall

- iii. The stone foundation walls would be removed and replaced with the following:
 - 24"x12" thick continuous concrete footing with 2-#5 continuous reinforcing bars

- Footing to bear at least 3'-6" below the adjacent finish grade
 - Provide a 12" foundation wall made up of concrete masonry units (CMU). CMU would be reinforced with #5 reinforcing bars placed at 48" on center. The top course of the CMU would be a bond beam with 2-#4 continuous reinforcing bars. A limestone veneer could be included where the foundation wall is exposed above grade.

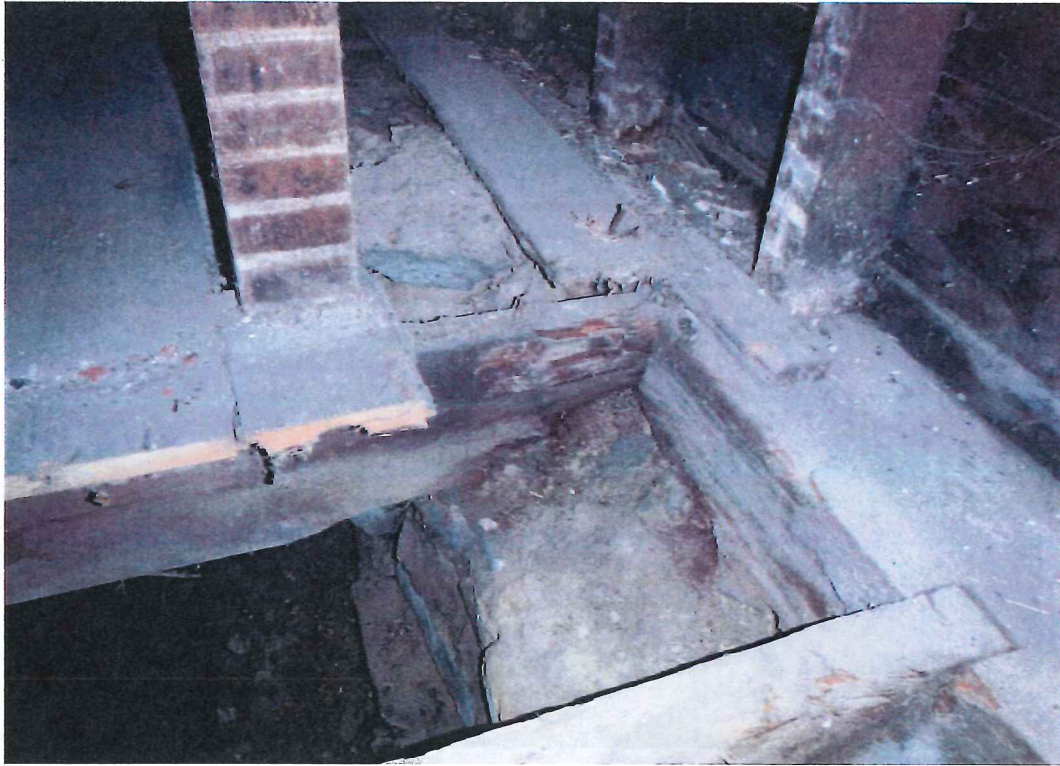
- There were floor joists that were badly deteriorated where they were bearing along the exterior stone foundation wall (Photo 7). No original wood materials would have been treated to resist the effects of exposure to moisture.

- E. General structural condition of main floor framing and foundations in light of proposed development of building:
- i. Any floor joists with the type of deterioration observed at the bearing along the exterior stone foundation wall shown in Photo 7 would need to be removed and replaced.

Photo 7- Deteriorated joists and sill at bearing on stone foundation wall

- ii. The main floor joists would be replaced with 2x10 floor joists spaced at 16" on center. The existing floor joists were deteriorated and cannot be reused as part of the main floor structural system.

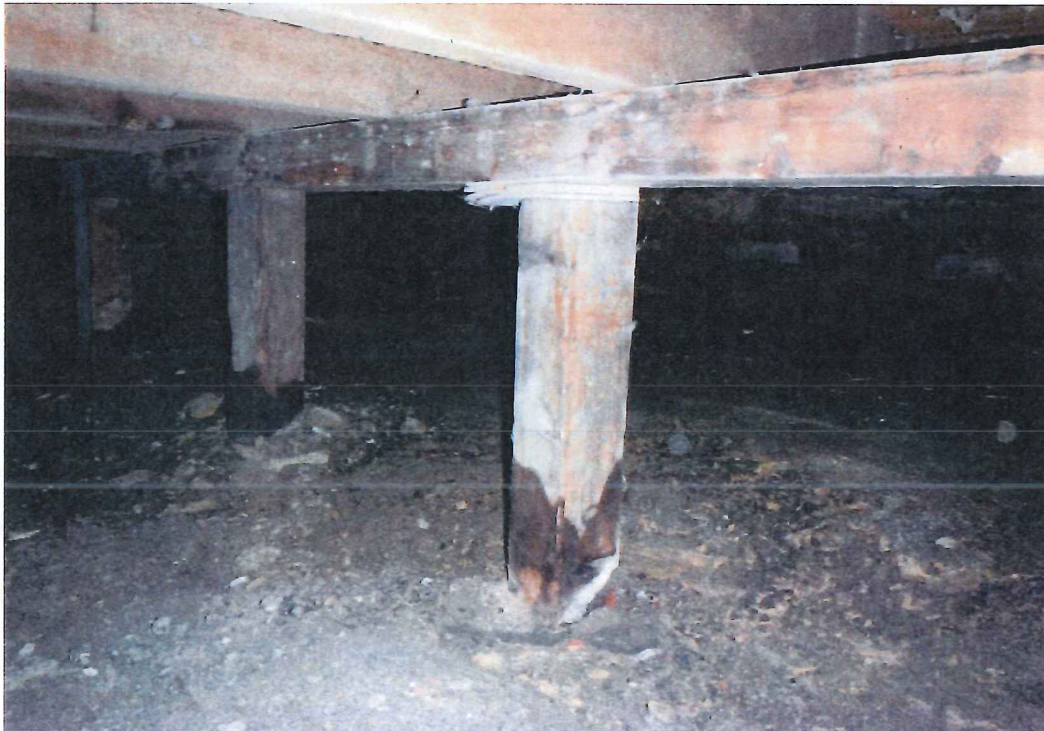
- D. The main floor joists were bearing on a 3.5"x3.5" wood beam that was supported by 3.5"x3.5" wood columns in the crawl space. The bases of the wood columns showed signs of exposure to moisture and it was not apparent what the posts were bearing on (Photo 8).

Photo 8- Signs of moisture on columns in crawl space

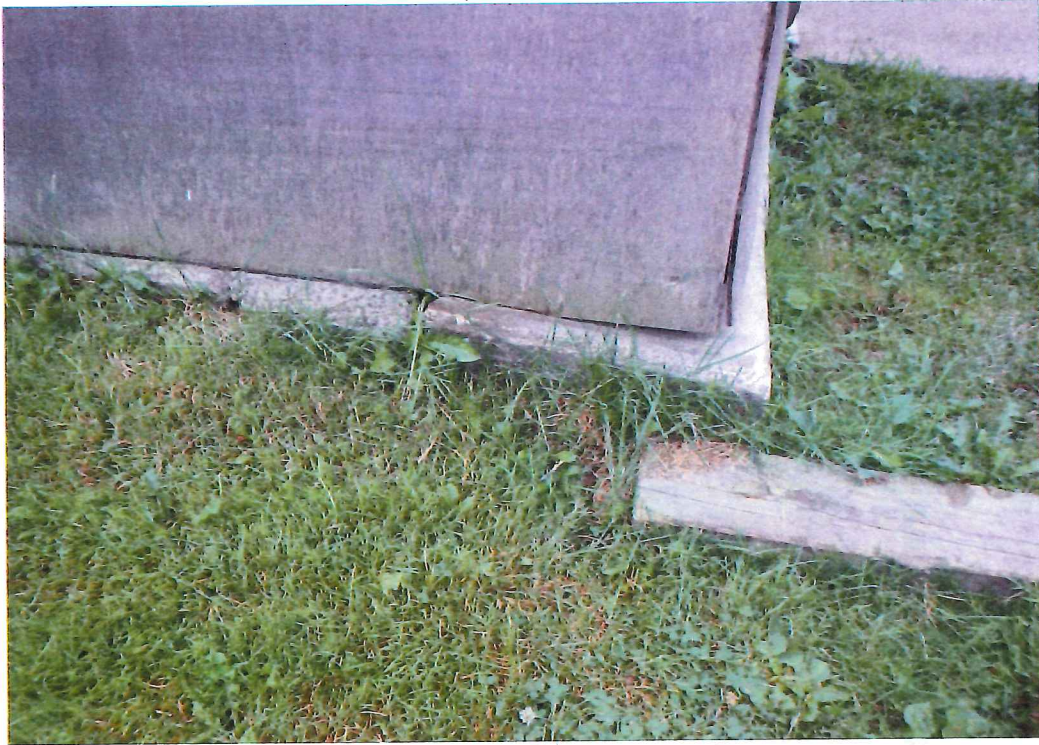
- A. The one story shed on the west side of the building was not constructed along with the original structure.
- B. The wood rafters and wall studs showed signs of moisture infiltration throughout the addition.
- C. It was unclear if there was a foundation system along the exterior stud wall of the shed that extended to frost depth or to the bedrock below. The concrete below the stud wall was cracked and appeared to have undergone excessively differential movement along the length of the wall (Photo 9)
- D. General structural condition of shed in light of proposed development of building:
 - i. The existing framing materials at the one story shed have been exposed to so much moisture over the years I would recommend against reuse of the materials for any development of the building.

- ii. There were no signs of a true foundation system supporting the stud walls of the one story shed. A new foundation system would be required for any structure in this location.

Photo 9- Signs of movement in concrete supporting stud walls of one story shed on west side of building

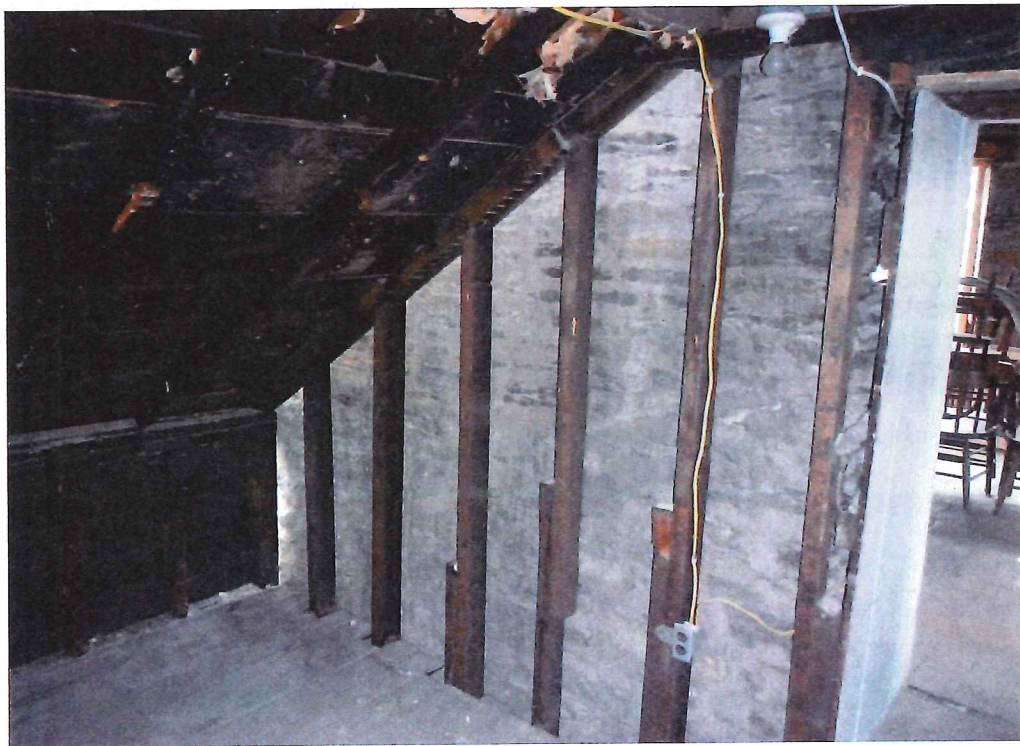
Photo 10- Sistered wall studs along east gable end at previous remodeling efforts

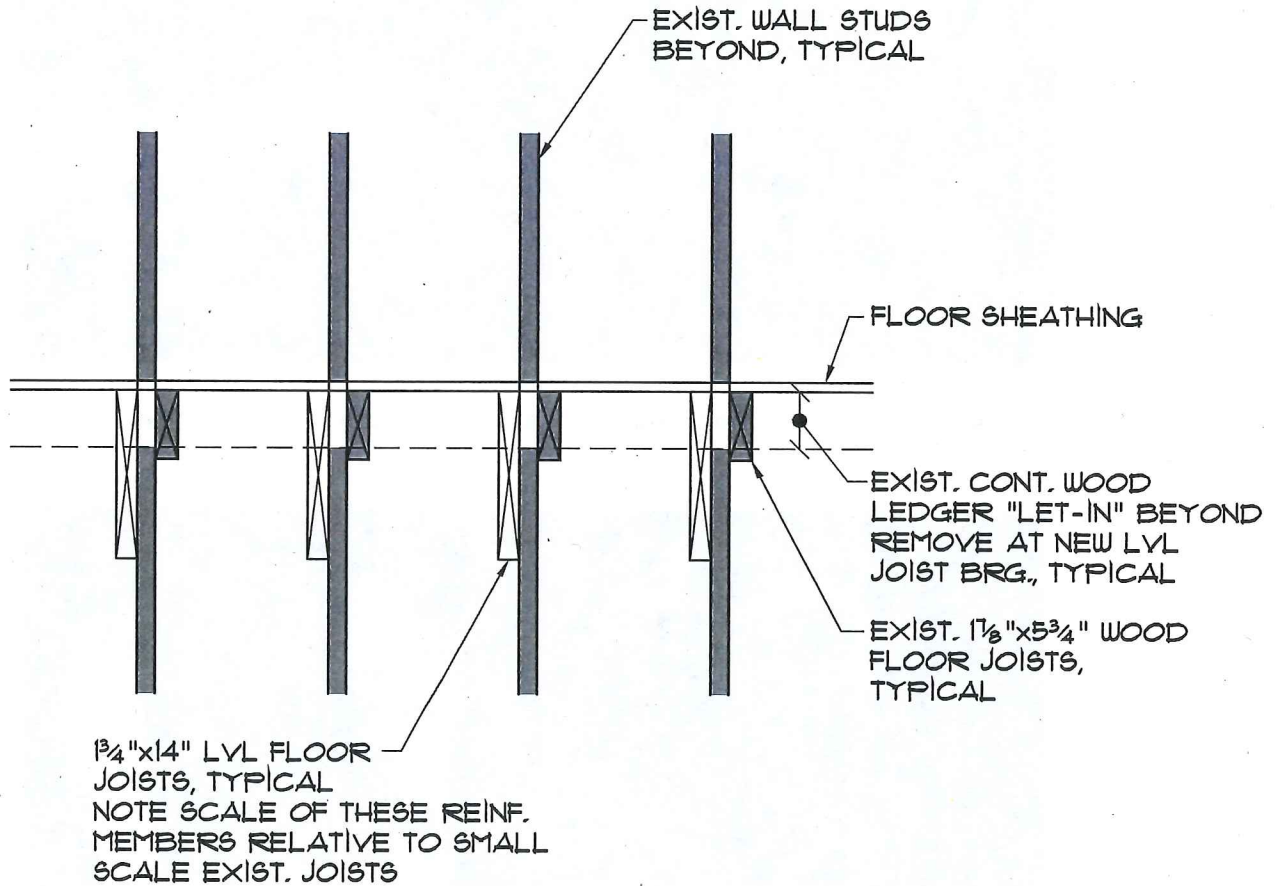
SECTION AT SECOND
FLOOR JOIST REINFORCEMENT

- B. General structural condition of the second floor in light of proposed development of building:
- The existing second floor joist framing system was so heavily overstressed that any reinforcement of the current system to support loads per the MSBC would essentially be a completely new system- the existing floor joists would provide an insignificant contribution to any "reinforced" framing scheme.

- C. Recommendations for reinforcement or replacement of existing second floor structure in kind
- i. The existing 1.875"x5.75" floor joists at 16" on center would be reinforced with 1.75"x14" laminated veneer lumber (LVL) floor joists at 16" on center (or 1.75"x11.25" LVL joists at 16" on center for residential reuse of the building). Refer to Section 1/SK1 showing the new and existing joist relationship (Attached to this report).
