CITY OF SAINT PAUL
HERITAGE PRESERVATION COMMISSION STAFF REPORT

FILE NAME: 716 Wilson Avenue, Schornstein House
DATE OF APPLICATION: September 17, 2015
APPLICANT: Saint Paul Housing and Redevelopment Authority (HRA)
OWNER: HRA
DATE OF PUBLIC HEARING: October 22, 2015
HPC SITE/DISTRICT: Dayton's Bluff Heritage Preservation District
CATEGORY: Non-Contributing
CLASSIFICATION: Demolition Permit
STAFF INVESTIGATION AND REPORT: Christine Boulware
DATE: October 2, 2015

Project No.: 15535.00
Re: Structural Condition Review of the building at 716 Wilson Ave.

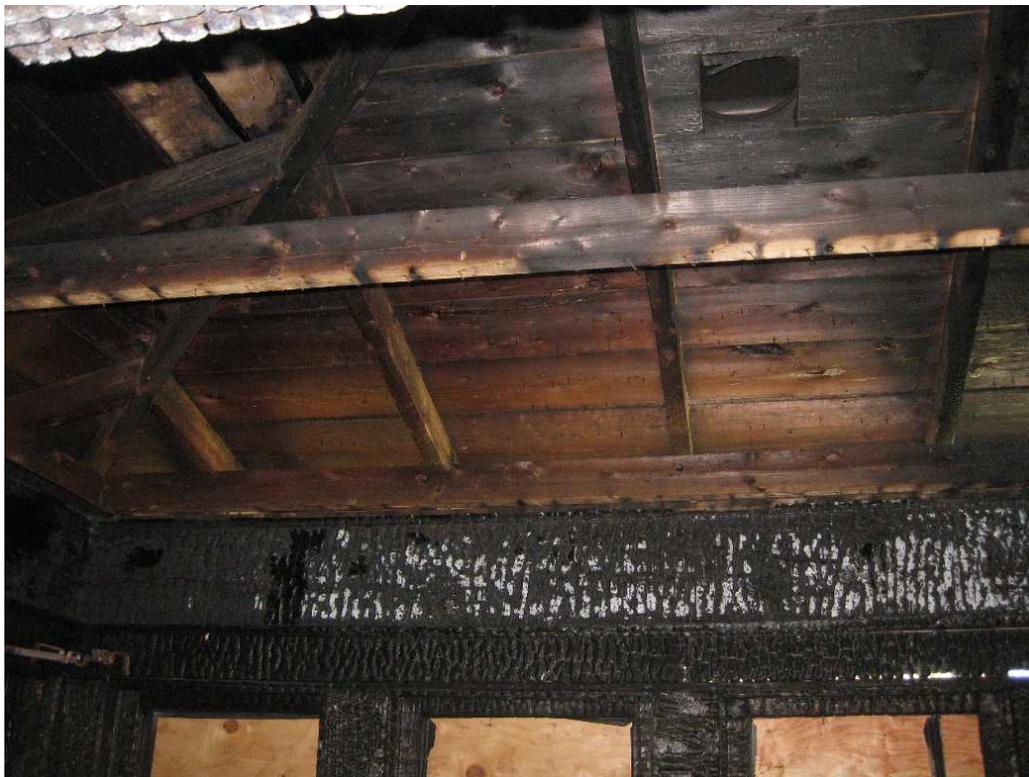
There is fire damage throughout the northeast end of the building, primarily the porch. Picture 1 and Picture 2 show the fire damage from within the home. The fire damage affected all of the beams that were visible in the front porch. It is also likely that the fire damaged more structural elements that were covered both in the porch and the main house. Fire damage can be seen on the finish throughout the building. Picture 3 shows the exterior elevation of the house at the north corner.

The fire damage to the structure in is mostly to the porch posts and lintels where the black char and ash is seen in Picture 1. Those members likely require replacement.

Other members such as floor joists that are just darkened or slightly charred could be kept but would require soda blasting or some other procedure to remove the smoke smell.

Picture 1 – Front Porch Fire Damage

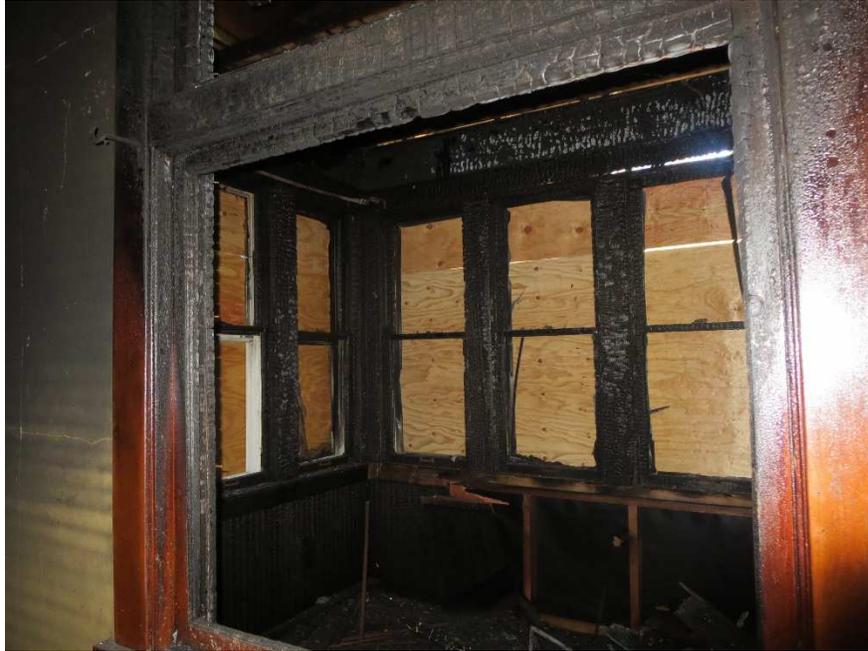
Picture 2 – Front Porch Fire Damage

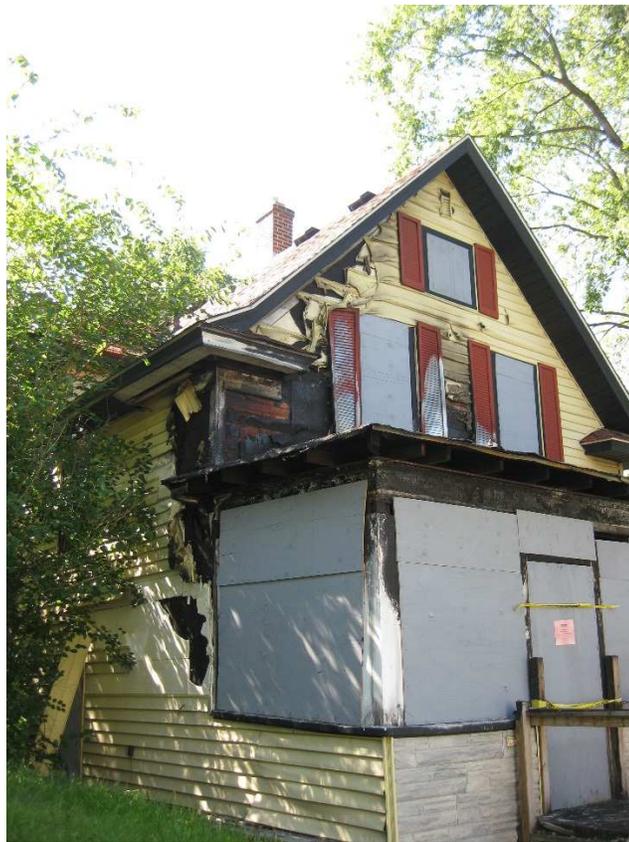
Picture 3 – Fire Damage, Northeast Elevation

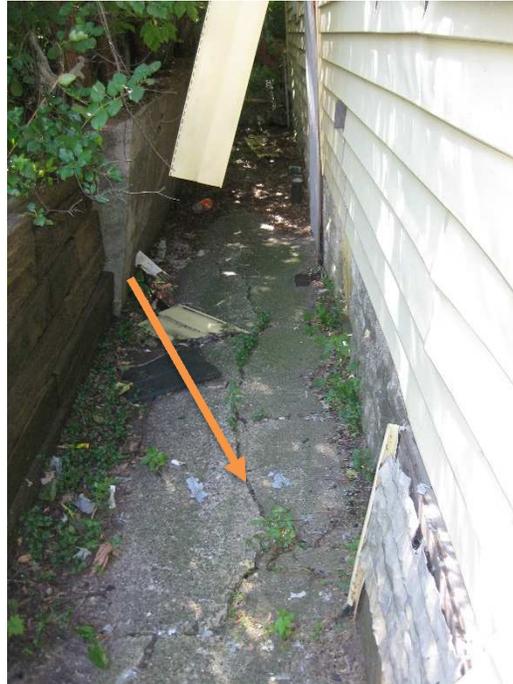
The exterior sidewalk of the northeast side of the house has a crack that runs through the center of it. The portion of the sidewalk closest to the house slopes down toward the foundation. The foundation of the porch is unknown. It is likely that the porch is settling, which is causing the soil to move and the crack to appear. Water drainage is also an issue. Due to the slope, water will drain towards the house. The water will infiltrate the basement through the foundation walls and likely cause damage to the walls over time. Picture 4 shows the crack at the northeast corner of the house.

Picture 4 – Crack in Sidewalk at Northeast Corner

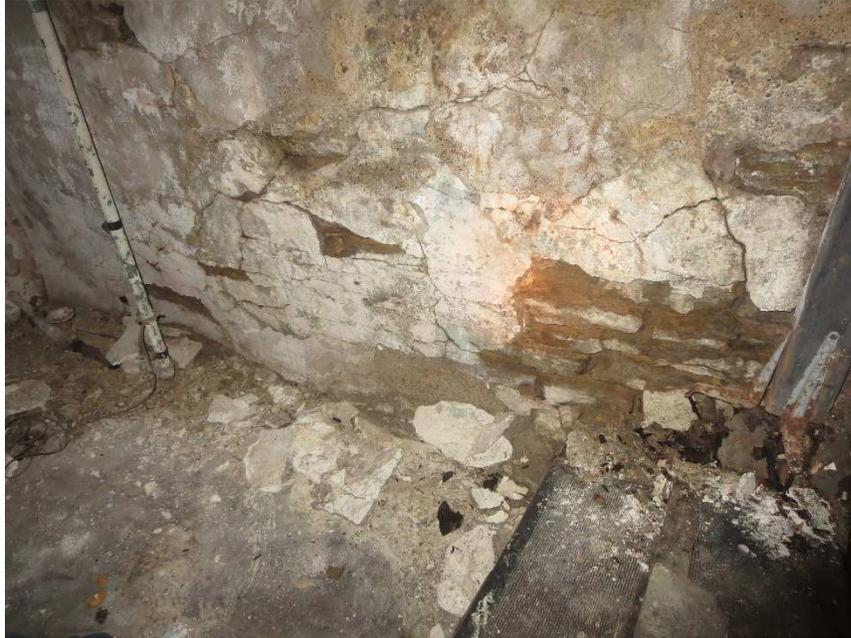
The interior sides of the foundation walls are in poor condition. There is cracking and spalling of the walls that can be seen throughout the basement. Picture 5 and Picture 6 show the faces of two of the foundation walls that are typical throughout the basement. The exterior of the foundation walls are also in need of repair. There are joints between the masonry units that are missing mortar. Picture 7 and Picture 8 show gaps between masonry units where mortar should be. The limestone walls are likely 16 to 20 inches thick so are not necessarily unsafe or insufficient, however they would require repairs.

Picture 5 – Interior Foundation Wall

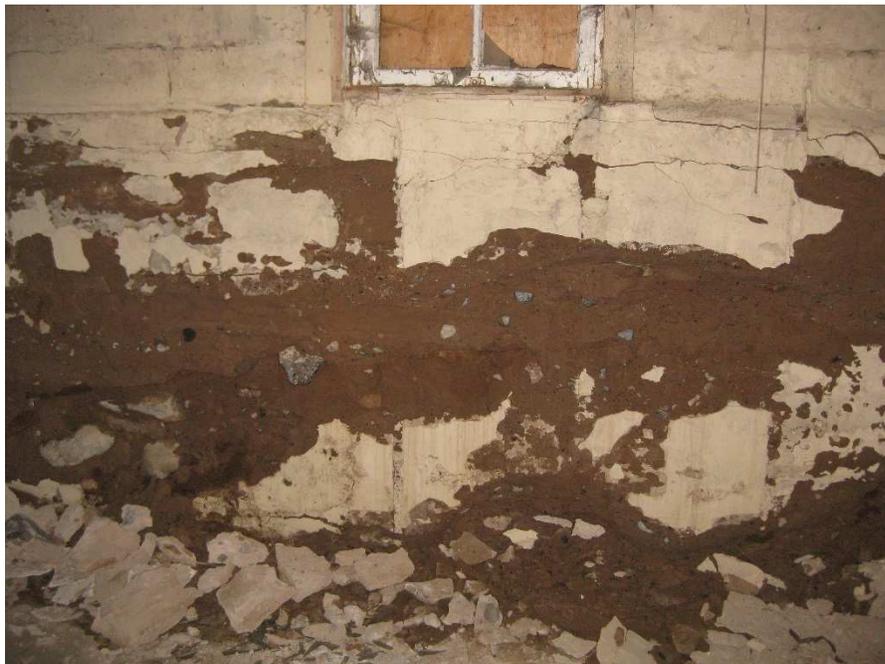
Picture 6 – Interior Foundation Wall

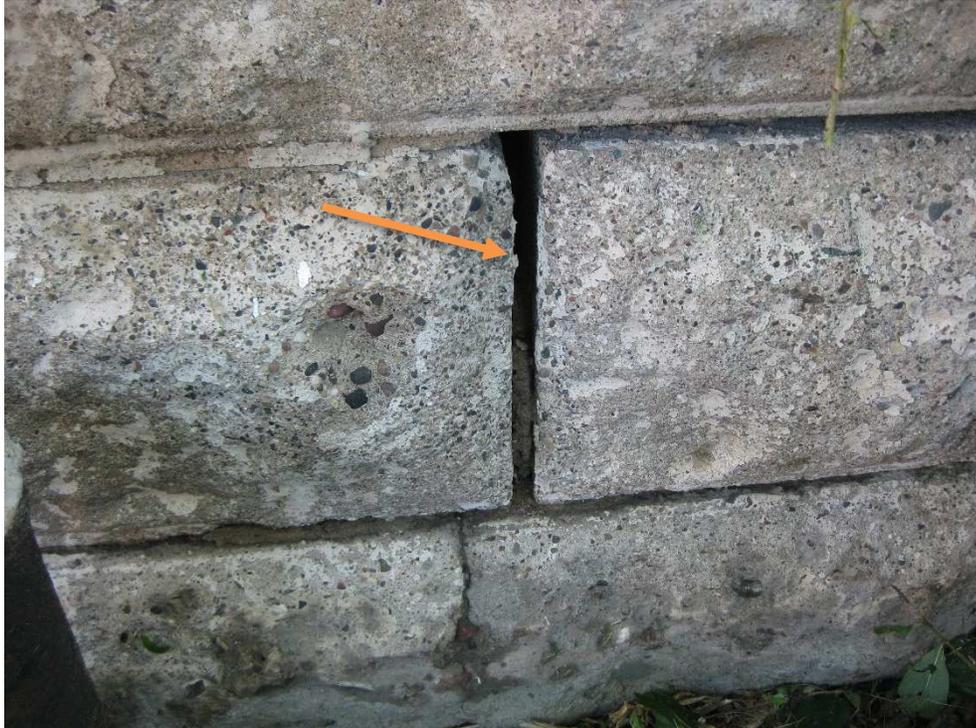
Picture 7 – Exterior Foundation Walls

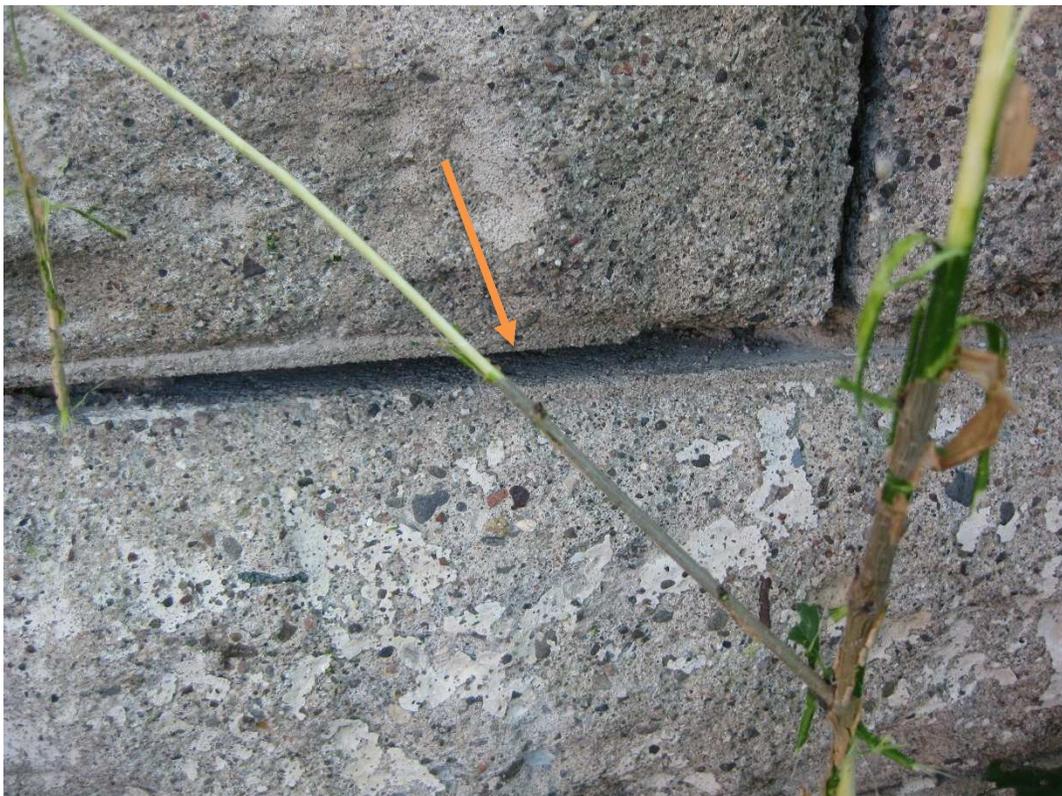
Picture 8 – Exterior Foundation Walls

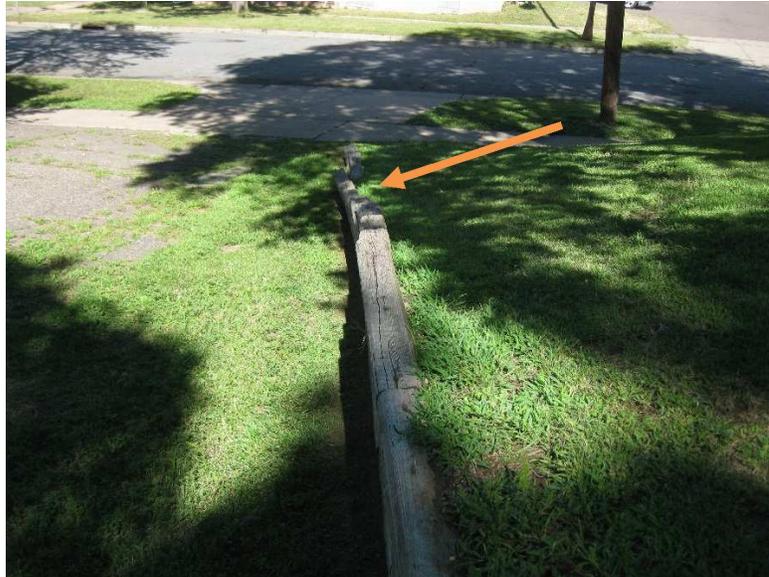
We observed issues with both of the retaining walls at the exterior of the house, they have essentially failed structurally. The timber retaining wall on the southwest side of the building is out of plumb. Along with that, some of the members of the timber wall are out of plane relative to each other. Picture 9 shows the wall with some of the members out of line. Picture 10 shows an up-close look at the end of the retaining wall and illustrates the displacement that has occurred between some of the members. Picture 11 is similar to Picture 9, but as seen from the opposite angle, the displacement of the wall as a whole can more easily be seen.

Picture 9 – Timber Retaining Wall

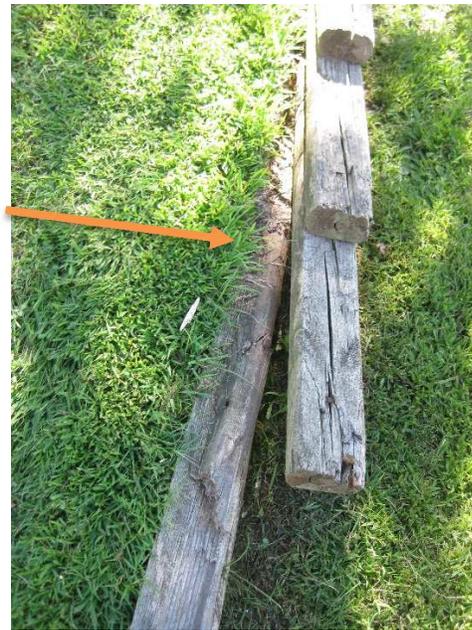
Picture 10 – End of Timber Retaining Wall

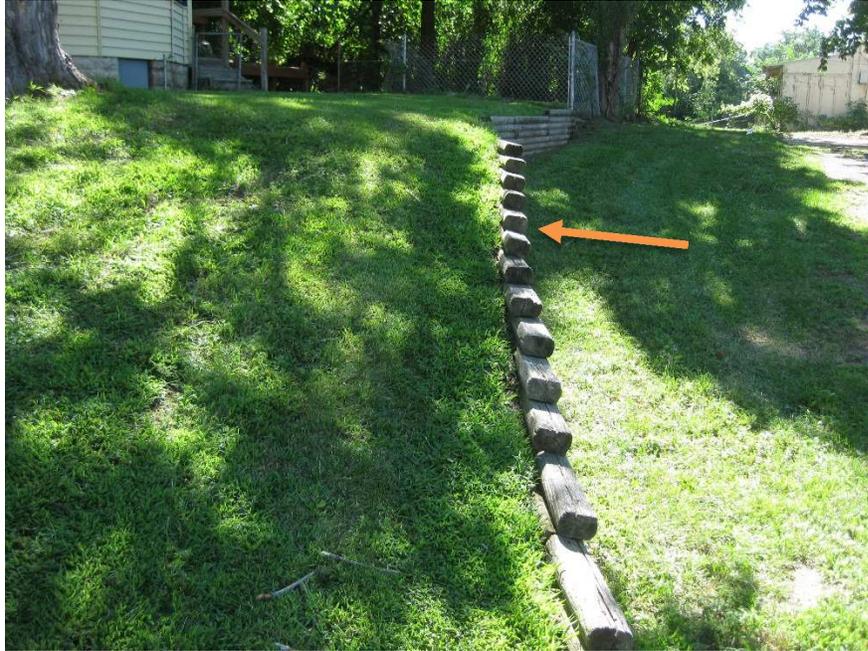
Picture 11 – Timber Retaining Wall

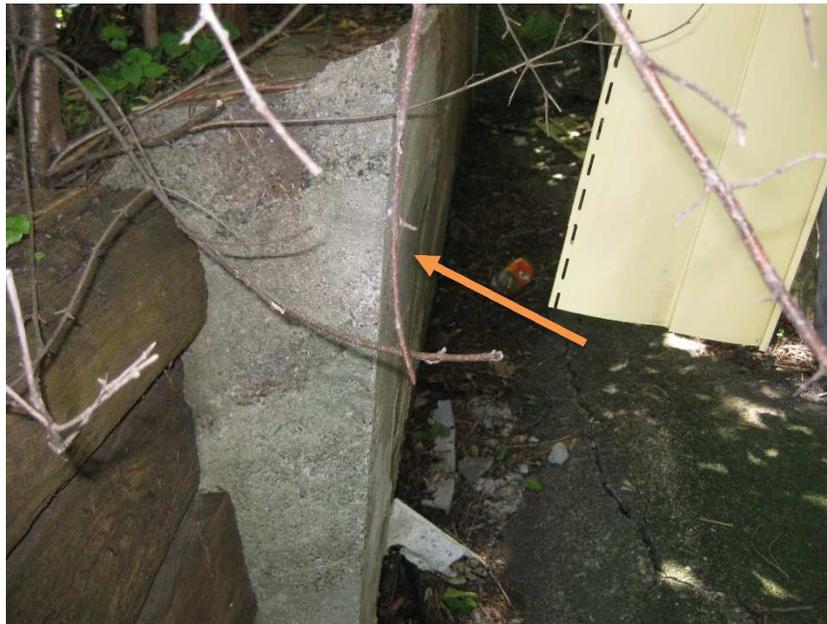
The concrete wall on the northeast of the house is also out of plumb. The wall itself appears to be sturdy, as evidenced by the lack of cracking or breaking, but its foundation has rotated. Picture 12 shows the wall out of plumb and the same wall can also be seen in Picture 4.

Picture 12 – Rotated Foundation Wall

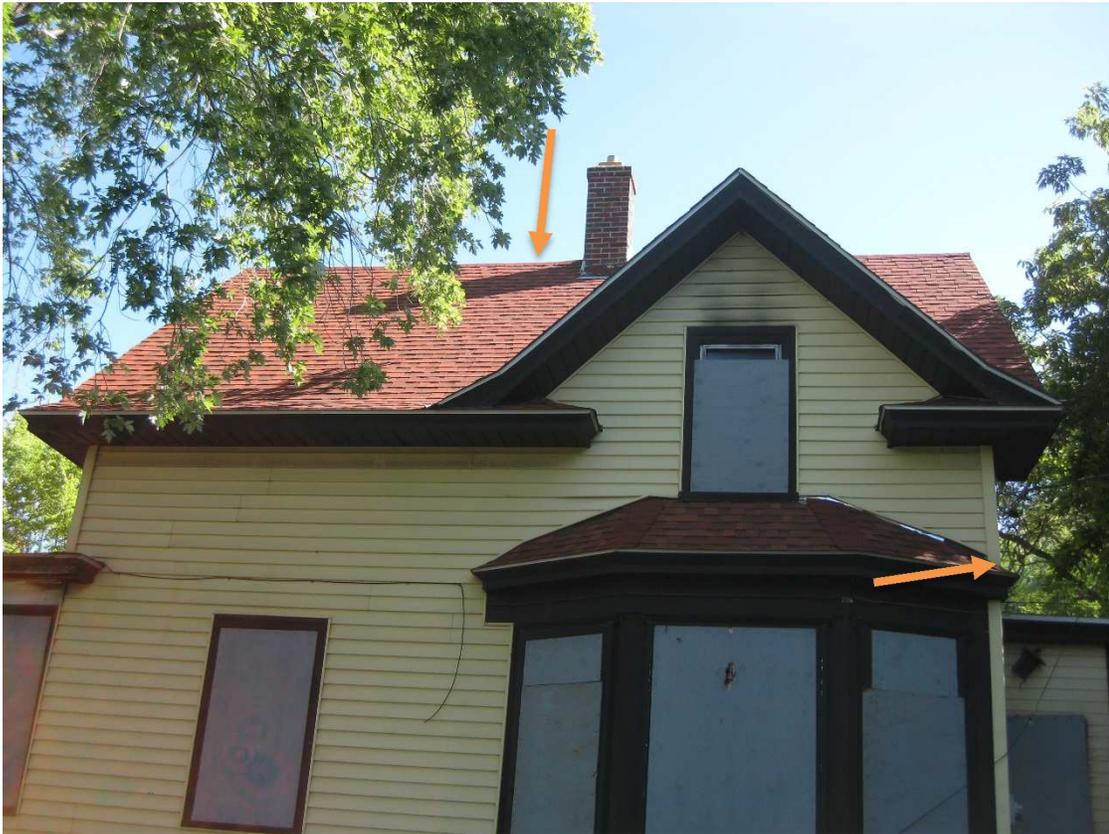
The roof and exterior walls, as observed from the outside, appeared to be in good condition. The roof was flat and there were no obvious problems. The exterior walls appeared to be plumb. Picture 13 shows one such roof and wall.

Picture 13 – House Roof and Exterior Wall
