**CITY OF SAINT PAUL
HERITAGE PRESERVATION COMMISSION STAFF REPORT**

FILE NAME: 767 Fourth Street East
DATE OF APPLICATION: September 15, 2015
APPLICANT: Saint Paul Housing and Redevelopment Authority (HRA)
OWNER: HRA
DATE OF PUBLIC HEARING: October 8, 2015
HPC SITE/DISTRICT: Dayton's Bluff Heritage Preservation District
CATEGORY: Contributing
CLASSIFICATION: Demolition Permit
STAFF INVESTIGATION AND REPORT: Christine Boulware
DATE: October 6, 2015

Project No.: 15539.00
Re: Structural Condition Review of the building at 767 4th St. E.

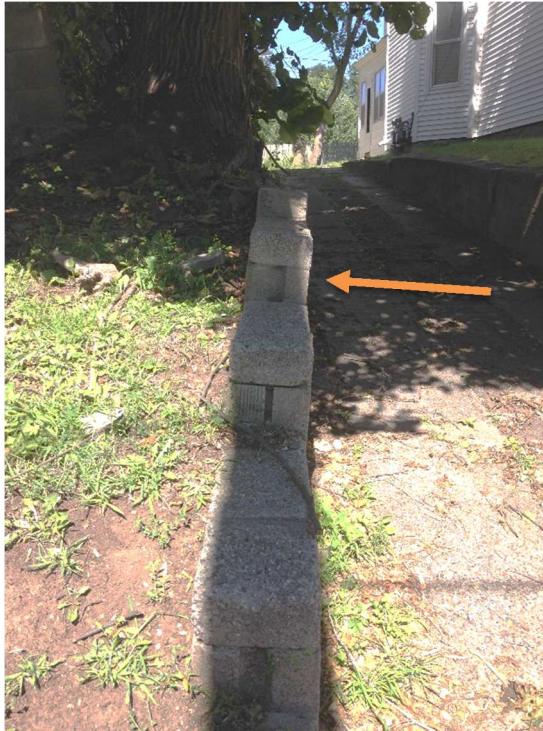
The retaining walls around the house are tipping and need to be replaced. The retaining wall at the front of the house is shown in Picture 1. The retaining wall on the eastern side of the house, between the house and the driveway of the adjacent property, is also in poor condition. Picture 2 is taken along the wall, from the street and shows the top of the wall as it has deflected. There is a tree that is growing between the retaining wall at the driveway and the wall at the stairs. The tree is likely a main cause of the current condition of the walls. Picture 3 gives a different perspective on the wall. The deflection of the wall can be seen farther back and the tree is more easily visible.

Picture 2 – East Retaining Wall

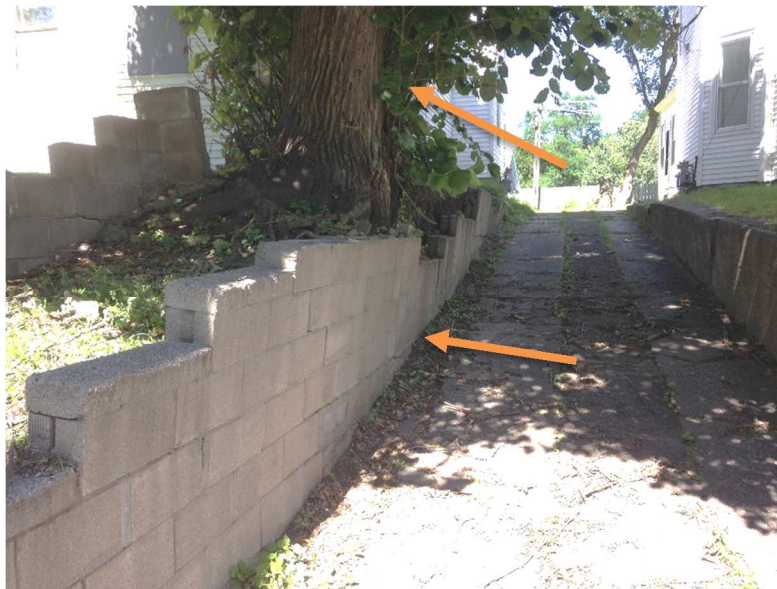
Picture 3 – East Retaining Wall with Tree

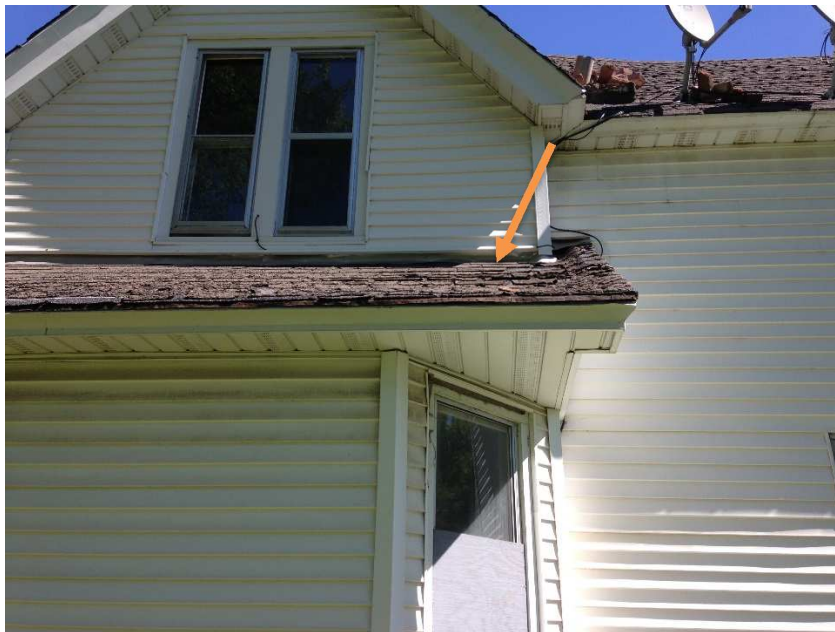
The roofs of the house are in poor condition. Sagging was observed on the roof above the front porch and on the roof at the western side of the house. Picture 8 shows the front porch and Picture 9 shows the west roof. Rot and deterioration were observed as well. The back roof shows signs of rot as well. Picture 10 shows some of the damage to the building. Picture 11 shows the roof as seen from the inside. There are obvious holes through the roof and water damage. Many of the house's shingles are damaged or are missing as well. It is likely that there are multiple places in all of the house's roofs that are damaged and are allowing water in.

Picture 9 – Roof Sag on the West Side

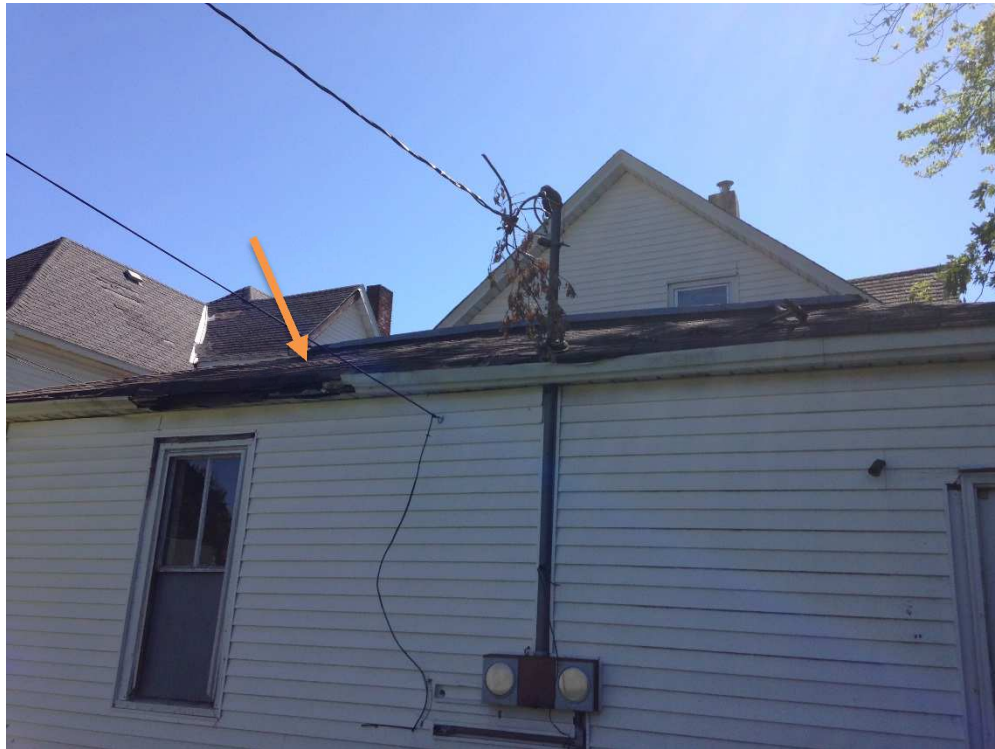
Picture 10 – Rot At Back Roof

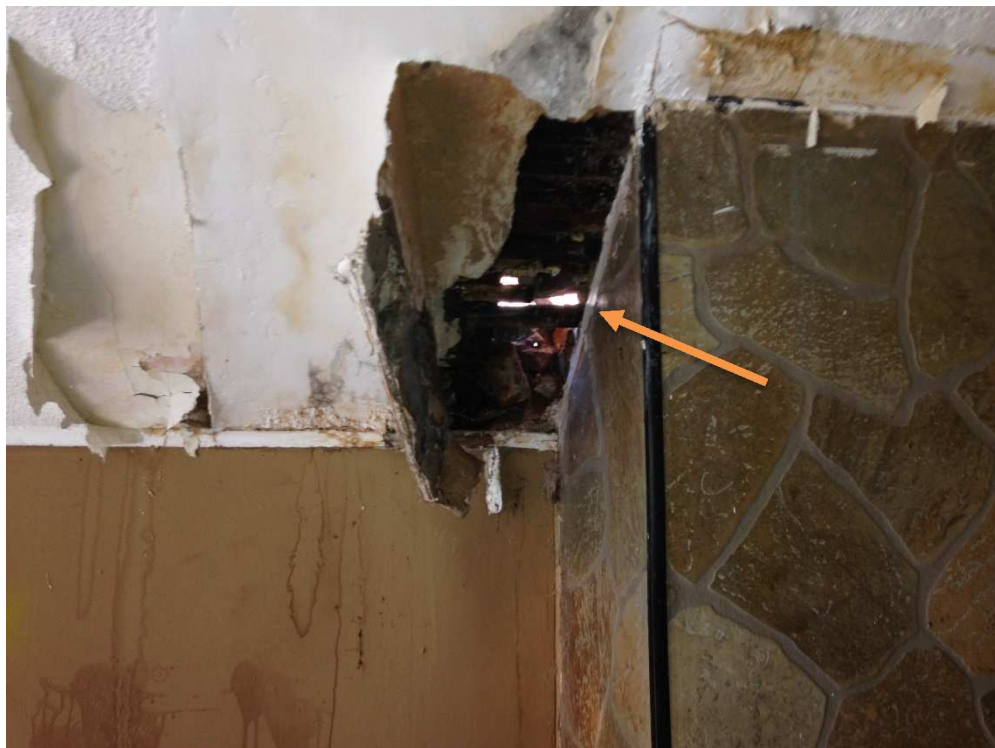
Picture 11 – Rot Through Roof

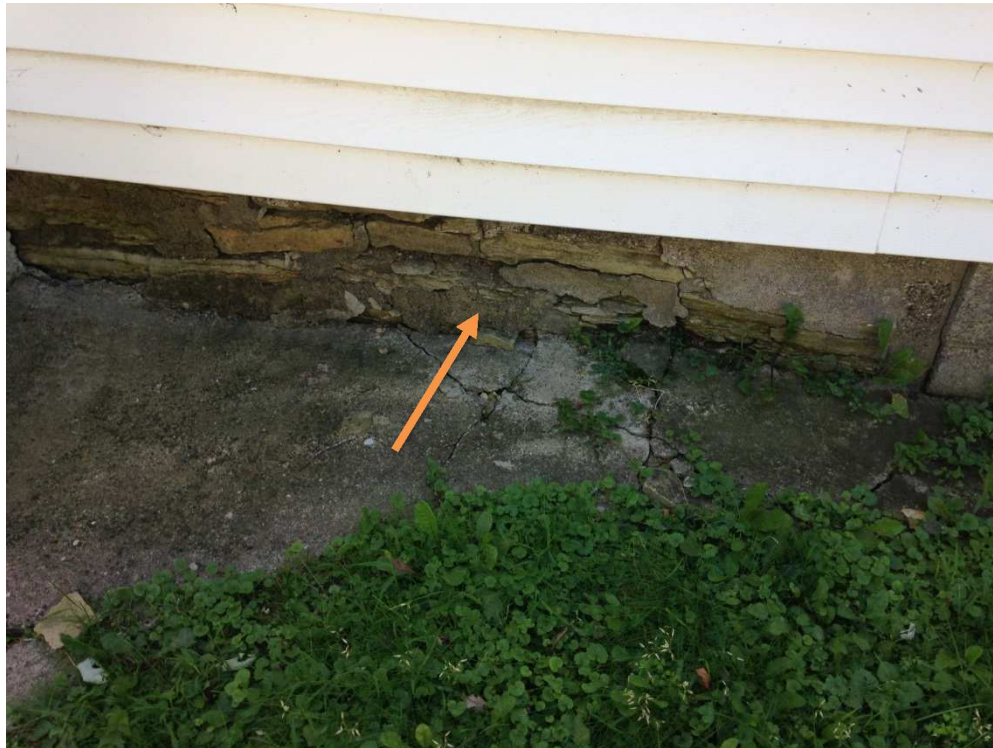
The foundation walls, as observed from outside the house, are also in poor condition. The original limestone foundation walls are deteriorating. Debris from the deterioration of the walls can be found all along the house. Picture 12 shows one such instance. In it, the wall has broken away and has exposed some of the wall's interior. Picture 13 shows a separate instance. More debris and broken foundation wall can be seen. The foundation of the addition on the north side of the house appears to have been installed without mortar between the units. Mortar typically helps a foundation resist loads and keep water out. Picture 14 shows some of the masonry units and the lack of mortar between them.

Picture 12 – Foundation Deterioration

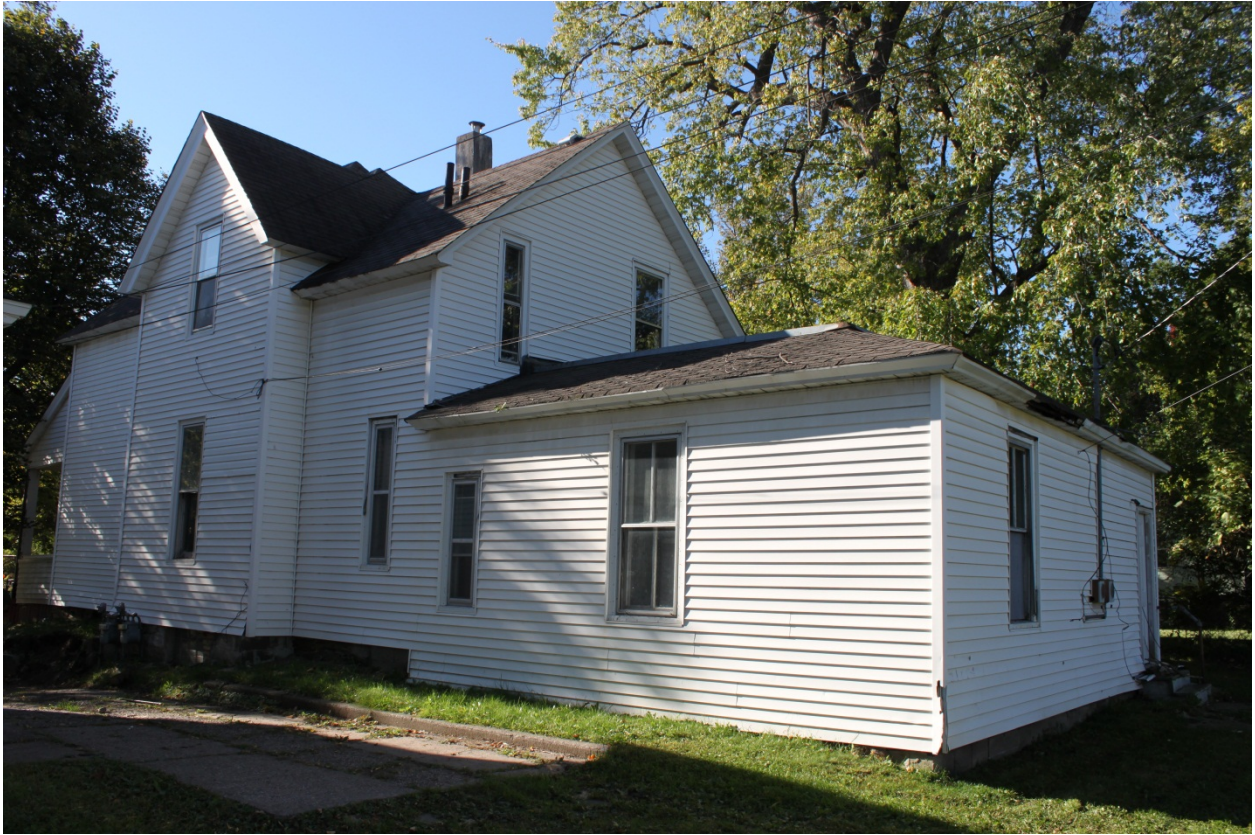
767 4th St E northeast elevations (above), west chimney (below left) and exposed portion of front porch (below right)
