St. Clair Play Area Renovation

October 13, 2009

Existing Conditions

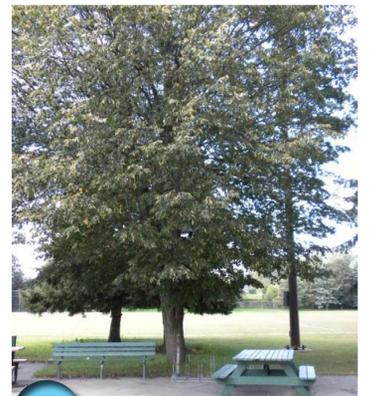
Existing field access between trees
