## Executive Summary

The Brickyard Area of Lilydale Regional Park is an area of both historic and recreational significance for the City of St. Paul. From the 1890s to the 1970s this area was used as a clay-mining and brick-making site. Evidence of that history remains in the three quarry areas (East, Middle, and West Clay Pits) and the ruins of a brick oven. Adjacent to the brick oven is Echo Cave, a man-made feature carved into the white Cambrian sandstone rock. In the early 1900s this rock was mined for its high silica content (used to make glass), supporting the demand for glass bottles from nearby breweries. Four fossil beds near the clay pits offer clues to an even earlier history and are popular with fossil hunters. Recreational features of the Brickyard Area include the popular Brickyard Trail, the Bruce Vento Scenic Overlook, several water falls, and the Middle Clay Pit bluffs which are often used for ice climbing.

to hire Barr Engineering Co. (Barr) to study erosion and slope-stability issues in the area. The primary objective of this study was to develop concept-level stormwater management, erosion-control, and slope-stability recommendations for City use. Specifically

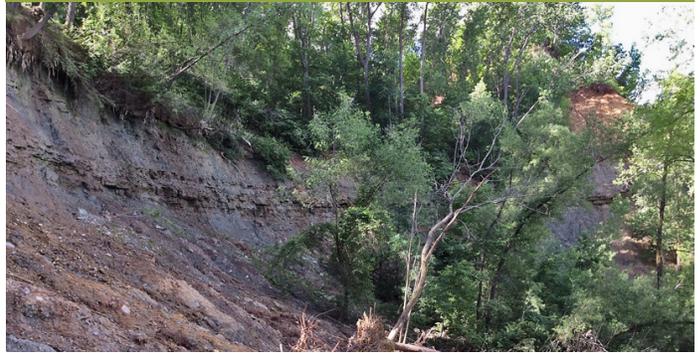
### East, Middle, and West Clay Pits

*Photo: Middle Clay Pit wall with fresh soil scarp in upper-right corner. The slopes above the pits are fairly steep with former scarps evident at numerous locations. Soil slopes at the corners of the clay pits seem prone to instability and failure.*

1. Restrict access to the Middle and West Clay Pit areas and the Bruce Vento Scenic Overlook (area outlined by red-dashed line, Figure 3)
2. Relocate or mechanically stabilize the Bruce Vento Scenic Overlook.
3. Stabilize the section of the Bruce Vento Spur of the Brickyard Trail highlighted on Figure 3.
4. Stabilize a portion of the “connector section” of the Brickyard Trail using vegetated, reinforced soil slopes—assuming the canopy cover does not prevent sunlight penetration. In the interim, remove (or relocate) the park bench downslope of this area. Alternatively, this area could be graded to a stable slope.
5. Stabilize the North Knob by grading to a stable slope.

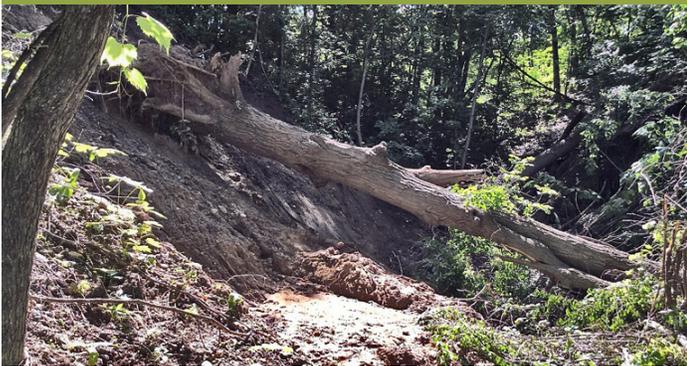
### Cherokee Heights Culvert and Ravine

*Photo: Ravine slope failure. Significant erosion was observed along the ravine side slopes; there are several active slope failures in the ravine.*

1. Restrict access to the Cherokee Heights Ravine, North Ravine, and Lower North Stream Channel (area outlined by red-dashed line, Figure 3). Restricting this area includes closing Fossil Site 2.
2. Stabilize the steep slopes in the North Knob.
3. Re-establish and stabilize the Lower North Stream Channel using river-rock riprap. Boulder riffles could potentially be added for aesthetics and to help reduce flow velocities.
4. Once the stream channel is re-established and stabilized, replace the Brickyard Trail culvert with a small span bridge.

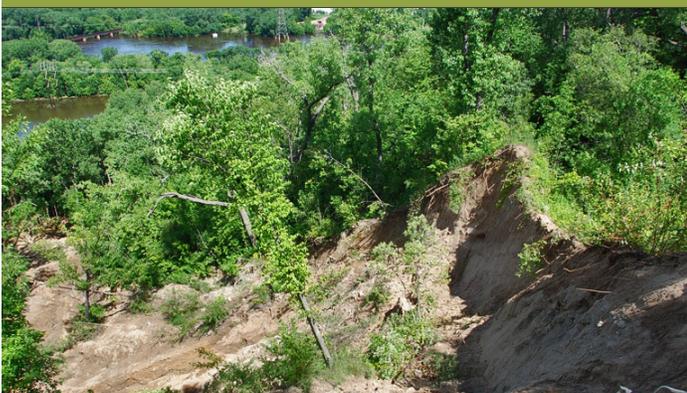
### Northwest Slope Failure Area and Lower North Stream Channel

*Photo: Large slope failure from above. Evidence of historic slope failures was observed. One failure was "reactivated" during a wet period in June 2014; this failure had enough force to topple mature trees along the lower section of the Brickyard Trail.*

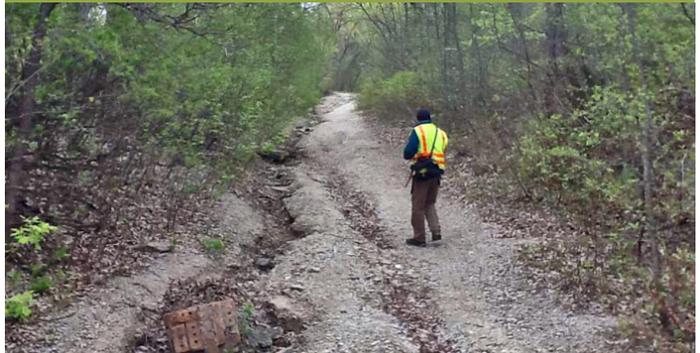
### Brickyard Trail, Including Bruce Vento Spur

*Photo: Erosion on the Brickyard Trail—Fossil/Brick Oven Section. Moderate-to-severe erosion from concentrated stormwater runoff along the straight and steep sections of the Brickyard Trail was observed. A steep slope adjacent to the trail showed evidence of slope failure that was reactivated during a wet period in June 2014.*

1. Install Geoweb to stabilize and reinforce the trail.
2. Repair the trail and install waterbars to deflect water off the trail and reduce future erosion.
3. Install a “side channel” (reinforced ditching) along the side of the trail and resurface this area.

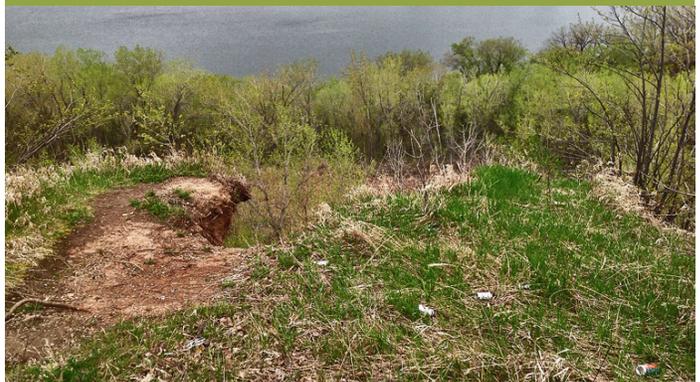
### Bruce Vento Scenic Overlook

*Photo: Soil overhang, from above, at Bruce Vento Scenic Overlook. A mass of overhanging soil, supported by vegetation/root zones was observed. There is potential for this area to fail when the roots eventually give way.*

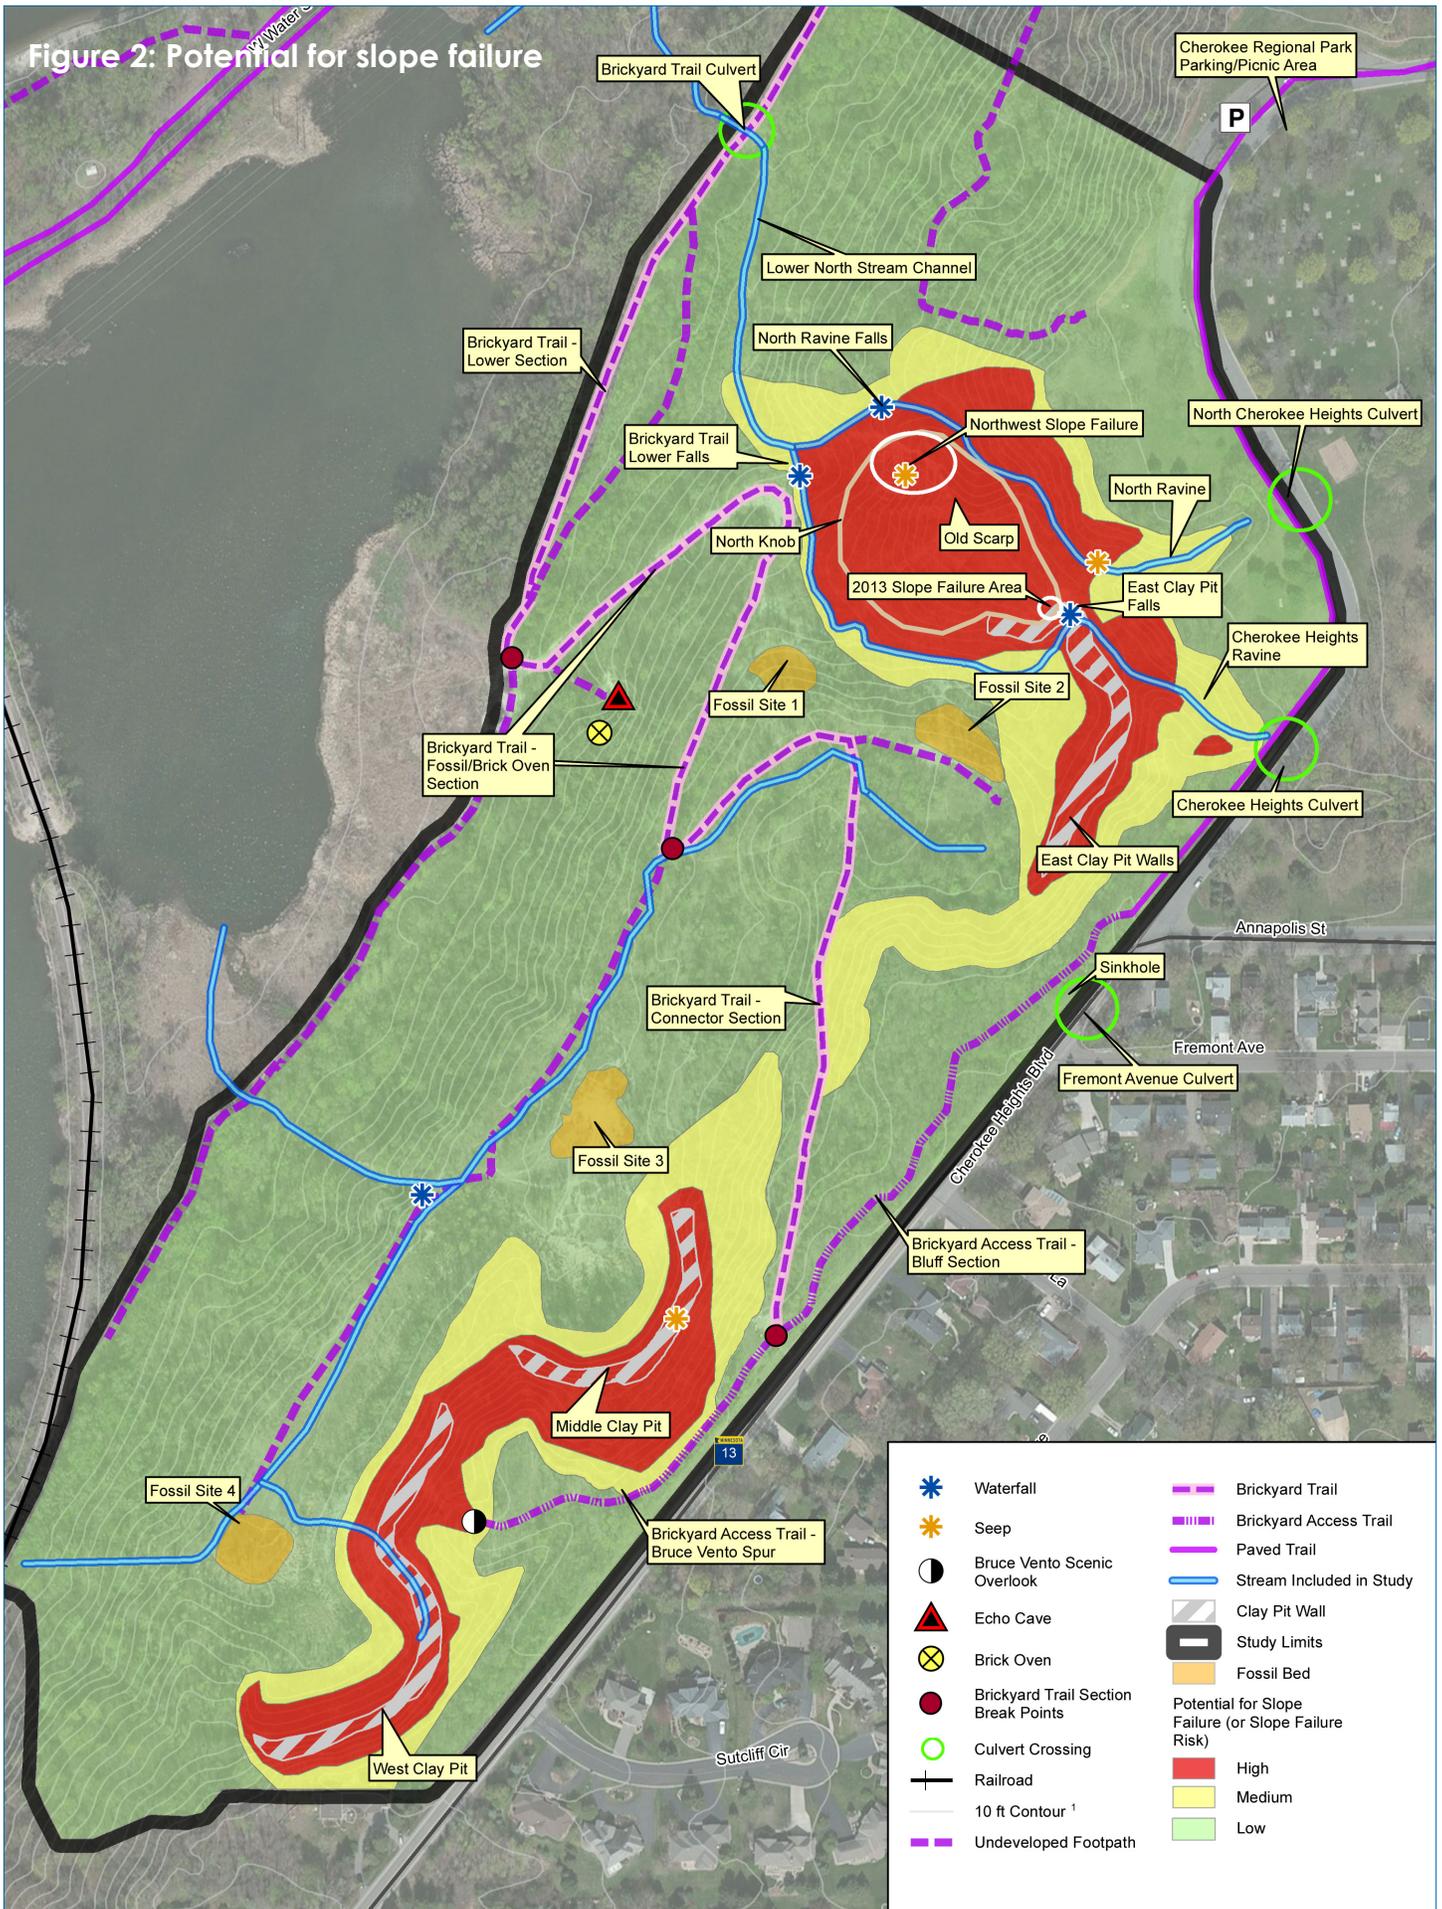
Figure 2: Potential for slope failure

Based on May and July site observations, the results of geotechnical and stormwater analyses, as well as Barr’s experience, conditions in the area (at the time of the study) were categorized as low-risk, moderate-risk, or high-risk (see Figure 2). These rating categories are specific to this project and not based on industry standards. The primary factors influencing risk assessment were likelihood for large-volume landslides, likelihood of soils falling from significant heights, likelihood of persons being caught in a slide from above the failure surface, and a history of previous landslides. No area of the park was considered “no-risk.” The uncertainties of weather, soil type and strength, and human activity always pose some risk of unexpected soil movement. It is also important to note that this is a constantly changing landscape (as evidenced by site changes between May and July site visits). It is impossible to state, with any degree of certainty, that these slopes will or will not fail over time.
