## **Brickyard Area of Lilydale Regional Park**

### ***Stormwater Management and Slope-Stability Analysis***

Prepared for  
City of St. Paul Department of Parks and Recreation

January 28, 2015

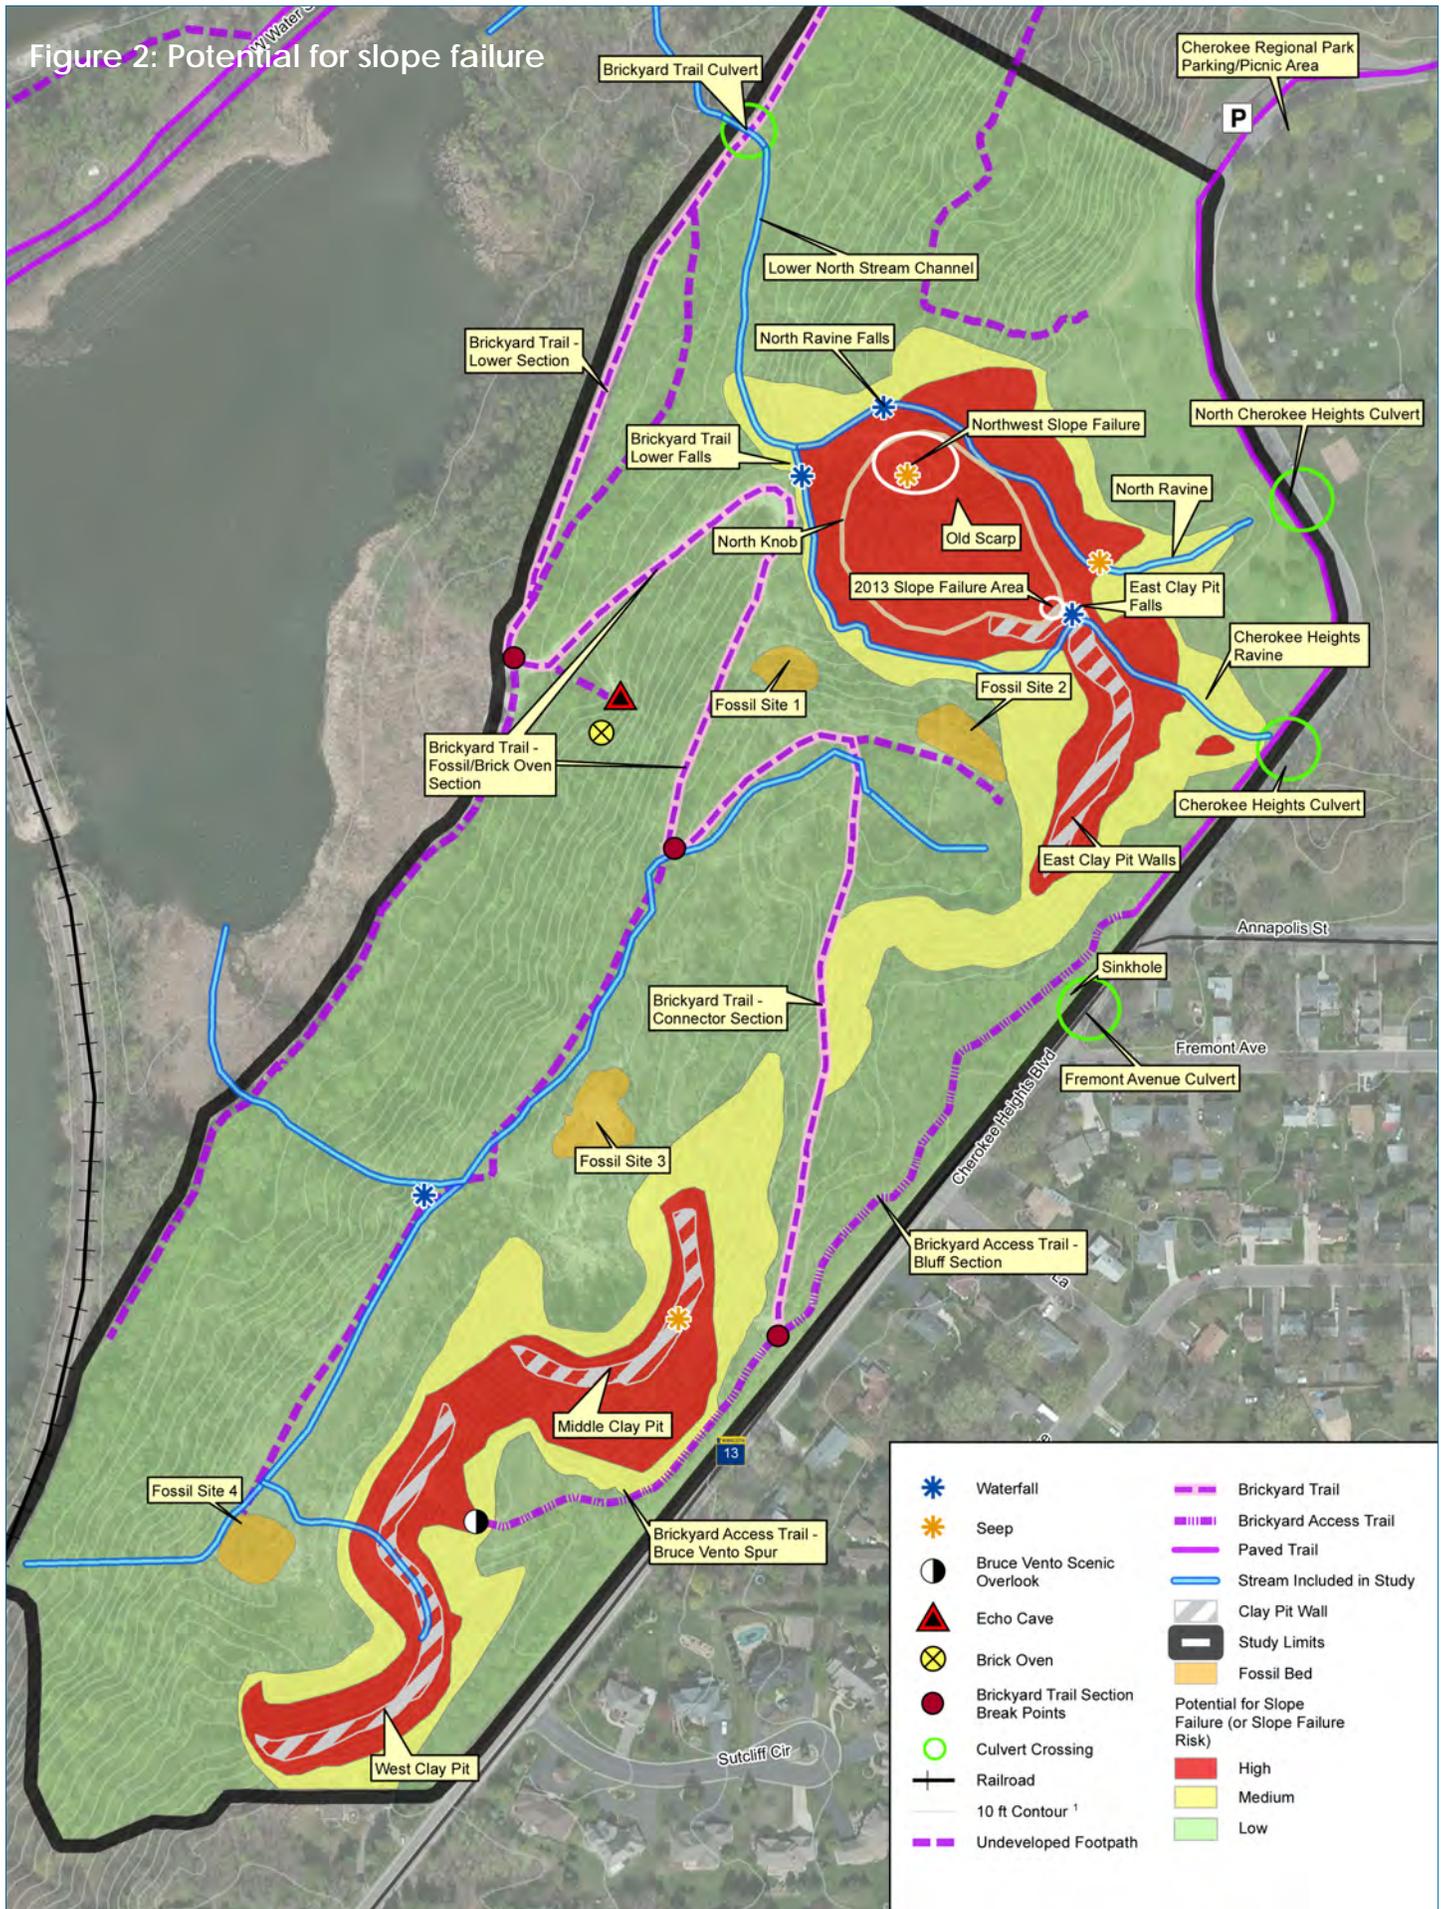
Figure 2: Potential for slope failure

Based on May and July site observations, the results of geotechnical and stormwater analyses, as well as Barr’s experience, conditions in the area (at the time of the study) were categorized as low-risk, moderate-risk, or high-risk (see Figure 2). These rating categories are specific to this project and not based on industry standards. The primary factors influencing risk assessment were likelihood for large-volume landslides, likelihood of soils falling from significant heights, likelihood of persons being caught in a slide from above the failure surface, and a history of previous landslides. No area of the park was considered “no-risk.” The uncertainties of weather, soil type and strength, and human activity always pose some risk of unexpected soil movement. It is also important to note that this is a constantly changing landscape (as evidenced by site changes between May and July site visits). It is impossible to state, with any degree of certainty, that these slopes will or will not fail over time.

One solution for managing high-risk areas is to limit public access. There are two areas in the park where we recommend that restricted access be considered (see Figure 3, page 7). These areas include only one of the four popular fossil sites identified by the City and do not include the Brickyard Trail.

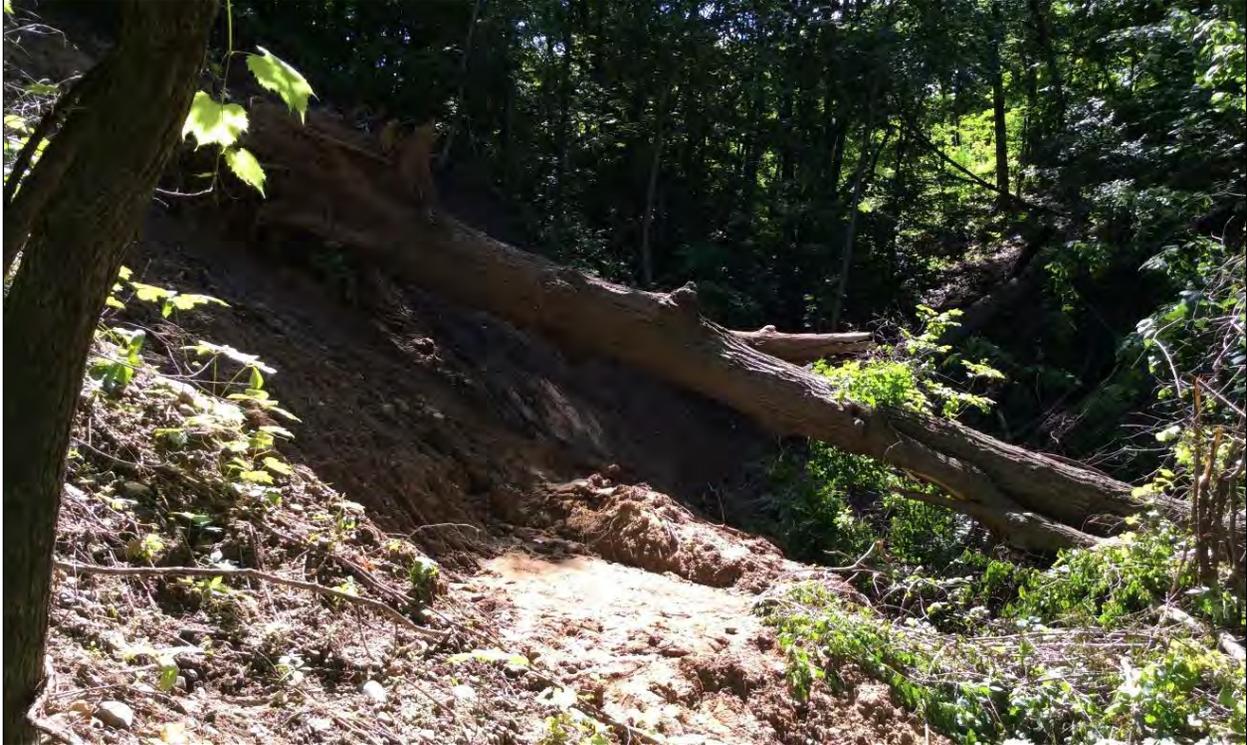
**Photo 2-3 Cherokee Heights ravine slope failure (July 2014 site visit)**

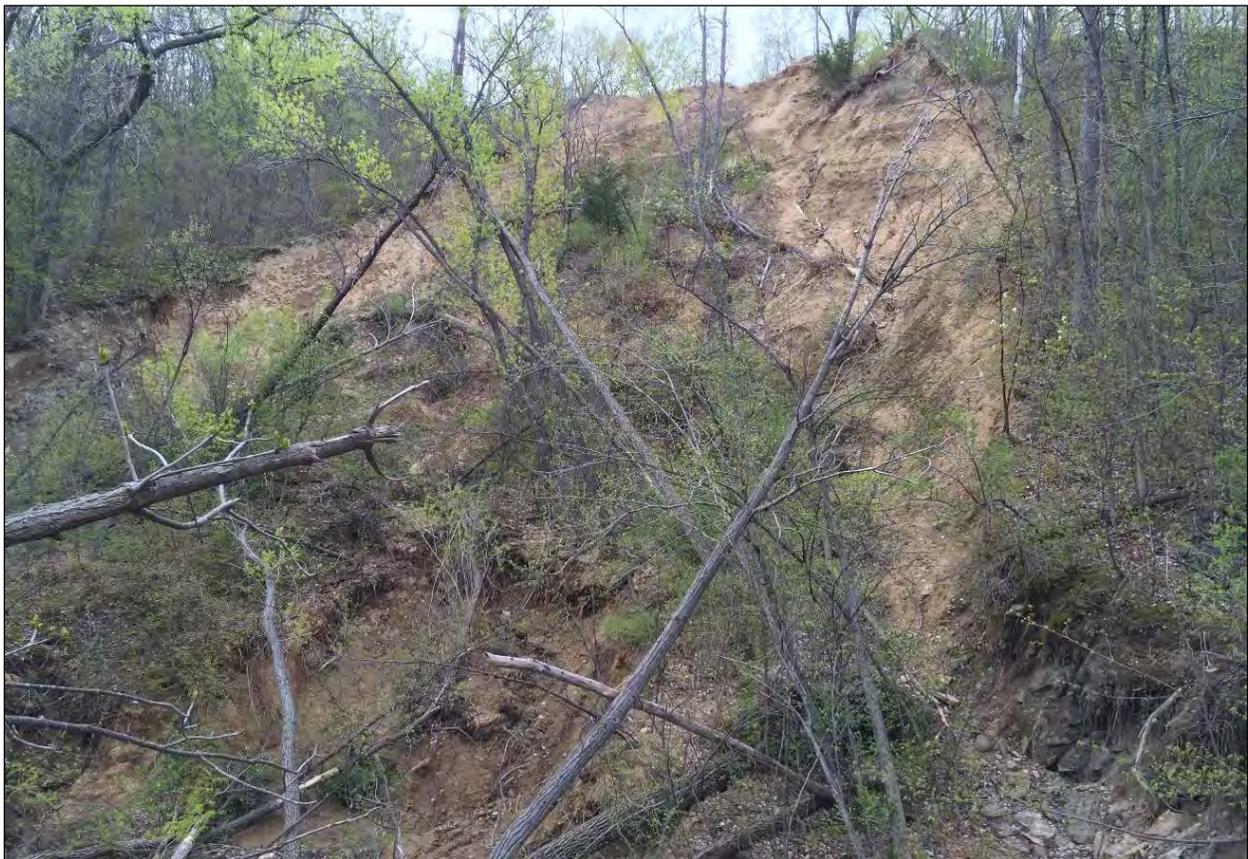
**Photo 2-4** Scarp from pre-2014 slope failure (taken from Brickyard Trail Lower Falls waterfall area during the May 2014 site visit)

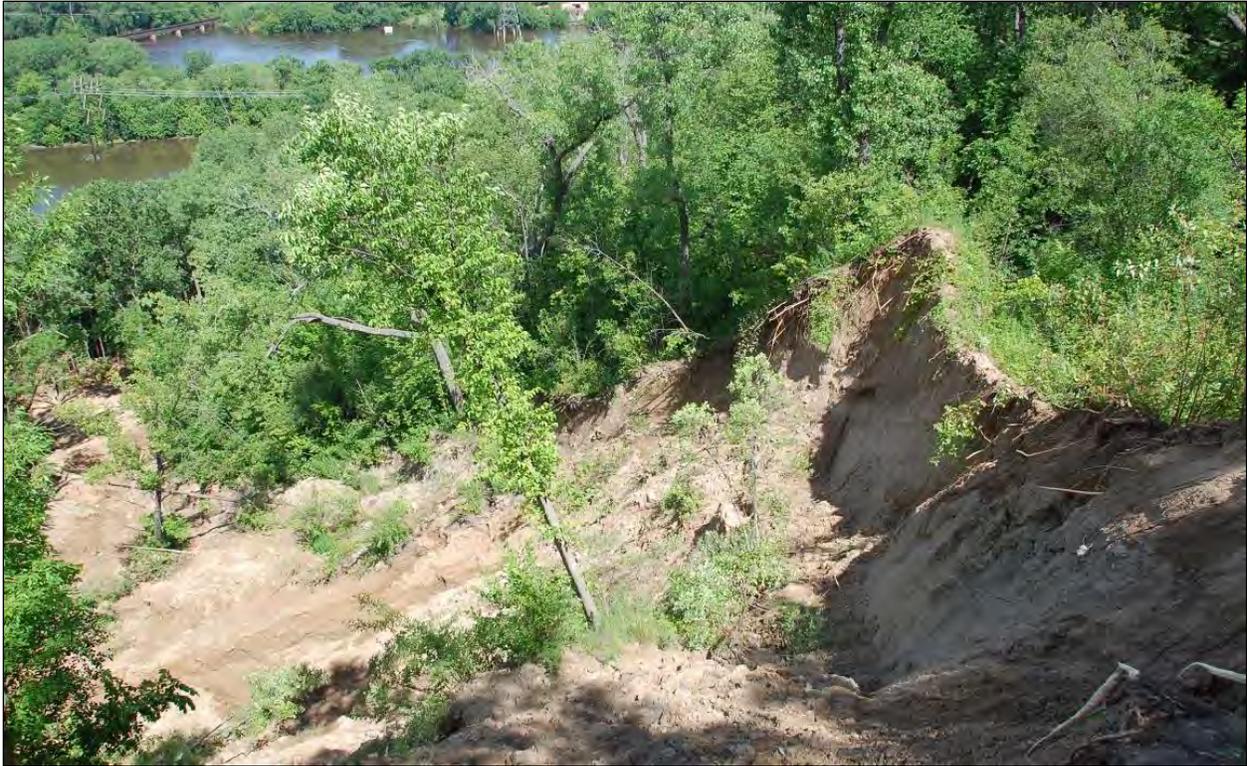
**Photo 2-5** Large 2014 slope failure from above (July 2014 site visit)

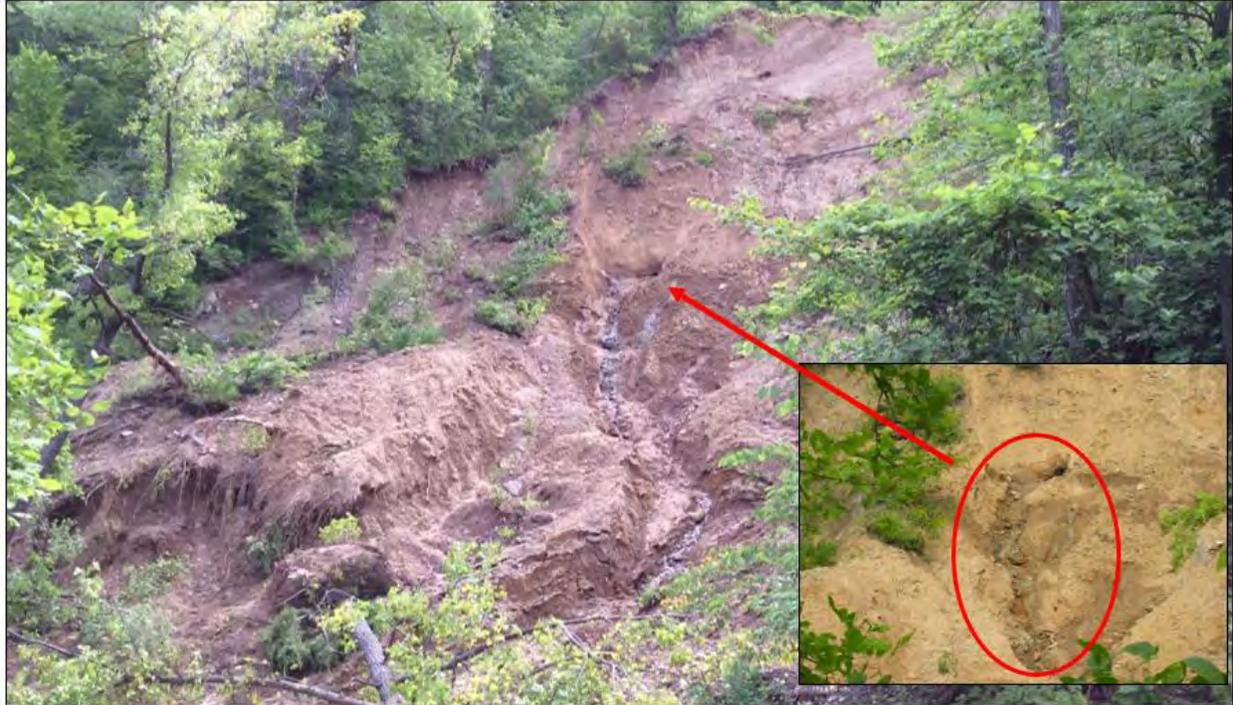
**Photo 2-6** Large 2014 slope failure from below with inset showing seepage (July 2014 visit)

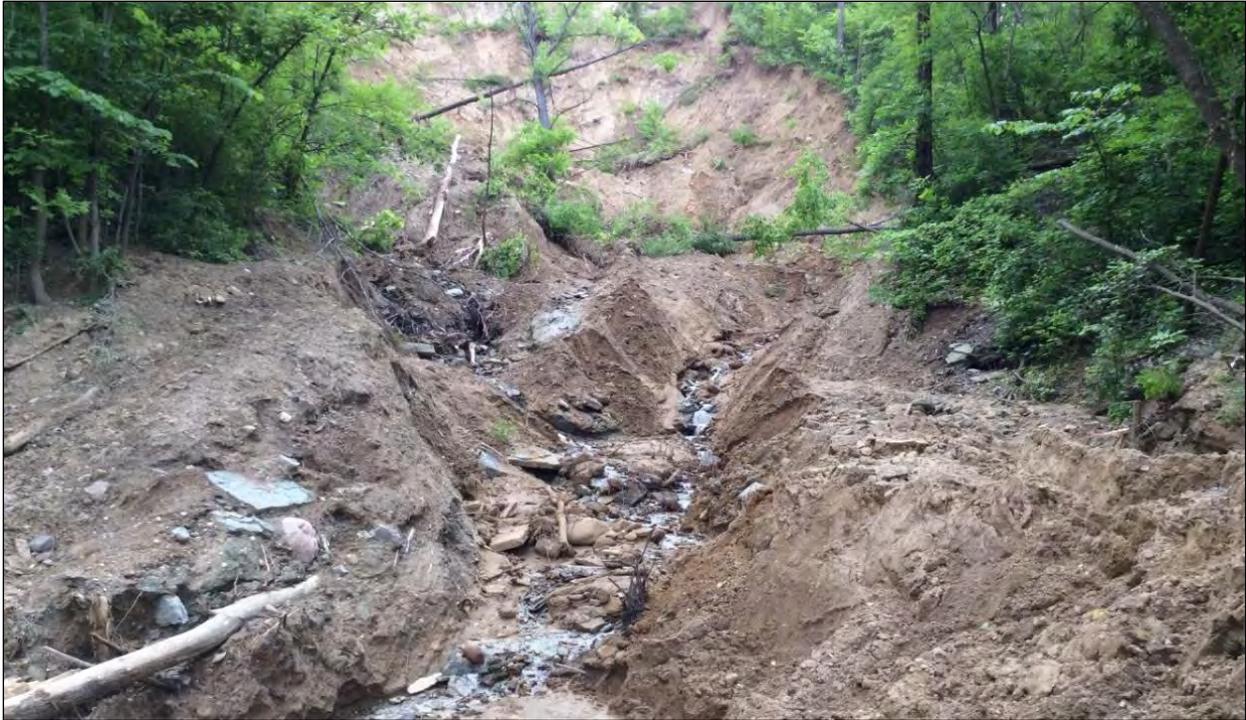
**Photo 2-7** Large slide, looking up through newly eroded stream channel (July 2014 site visit)

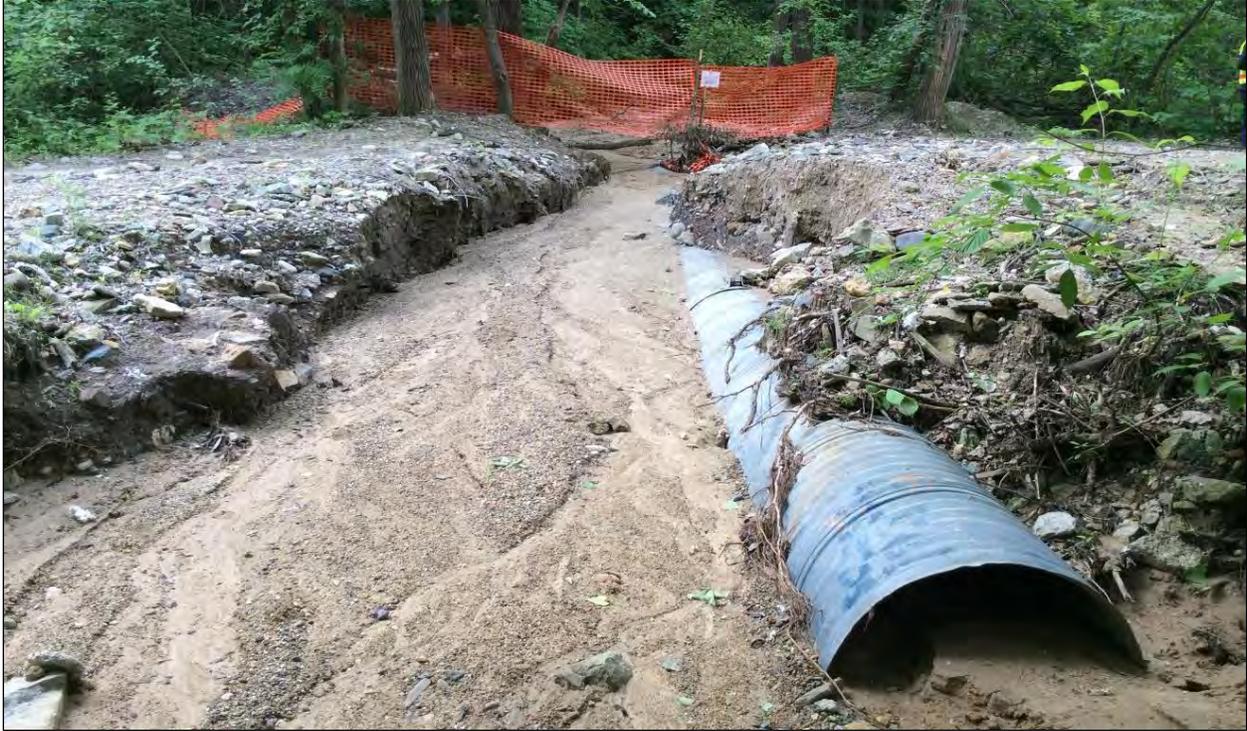
**Photo 2-9** Erosion of the lower section of the Brickyard Trail and plugged culvert, resulting from the Northwest Slope Failure (July 2014 site visit)

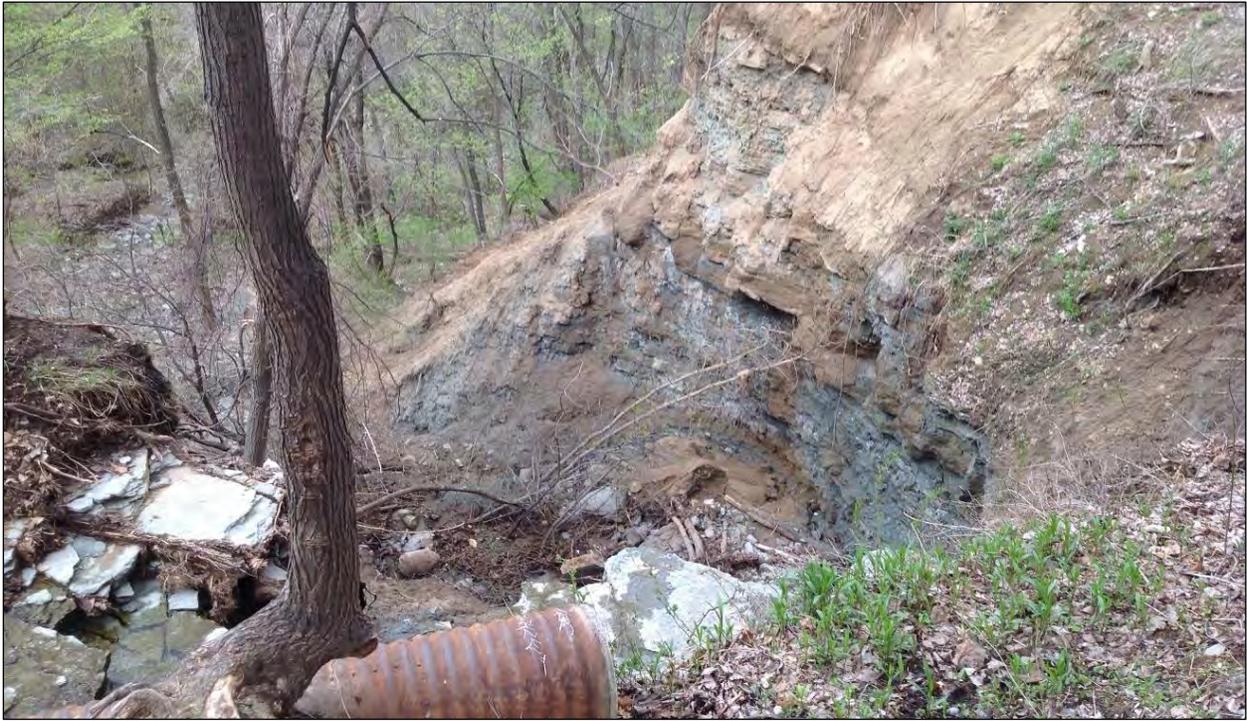
**Photo 2-10** 2013 slide area, from top of East Clay Pit Falls, observed during the May 2014 visit

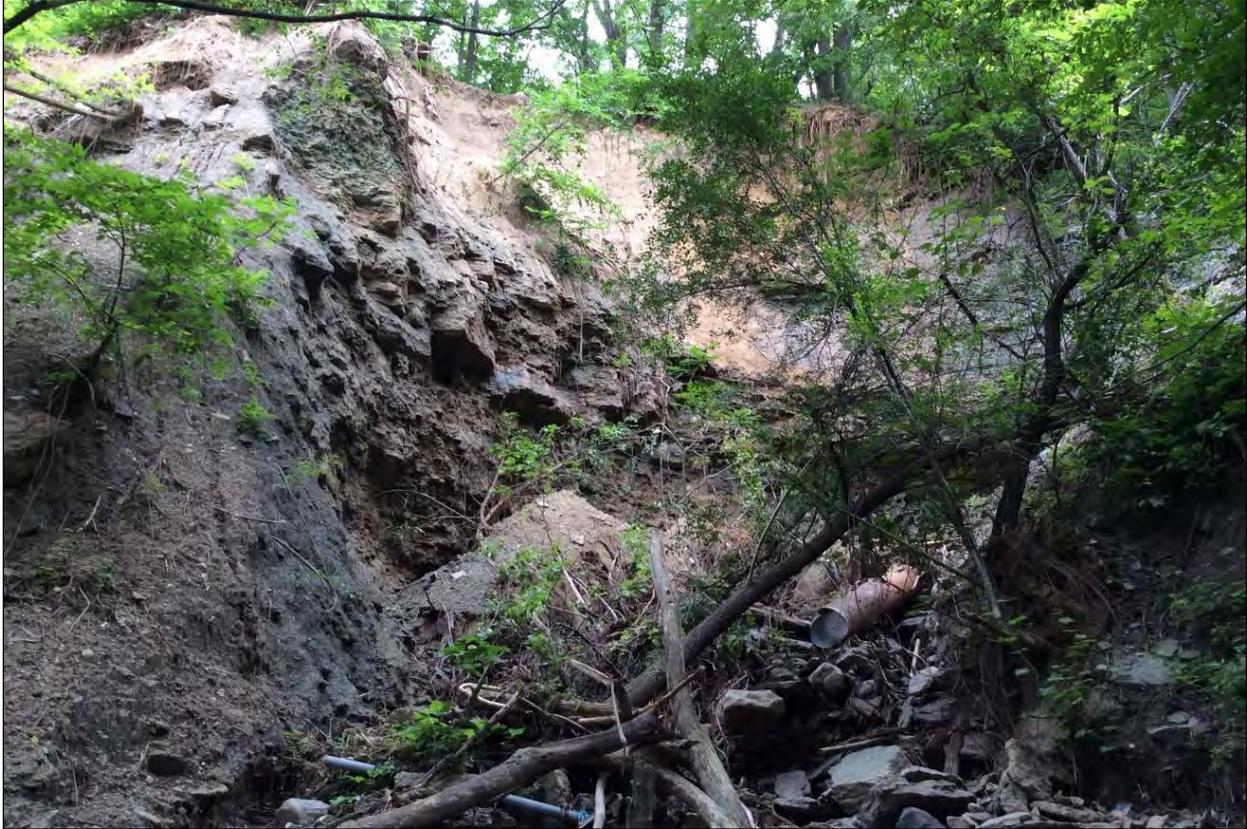
**Photo 2-11** 2013 slide area, from below, as observed during the July 2014 site visit

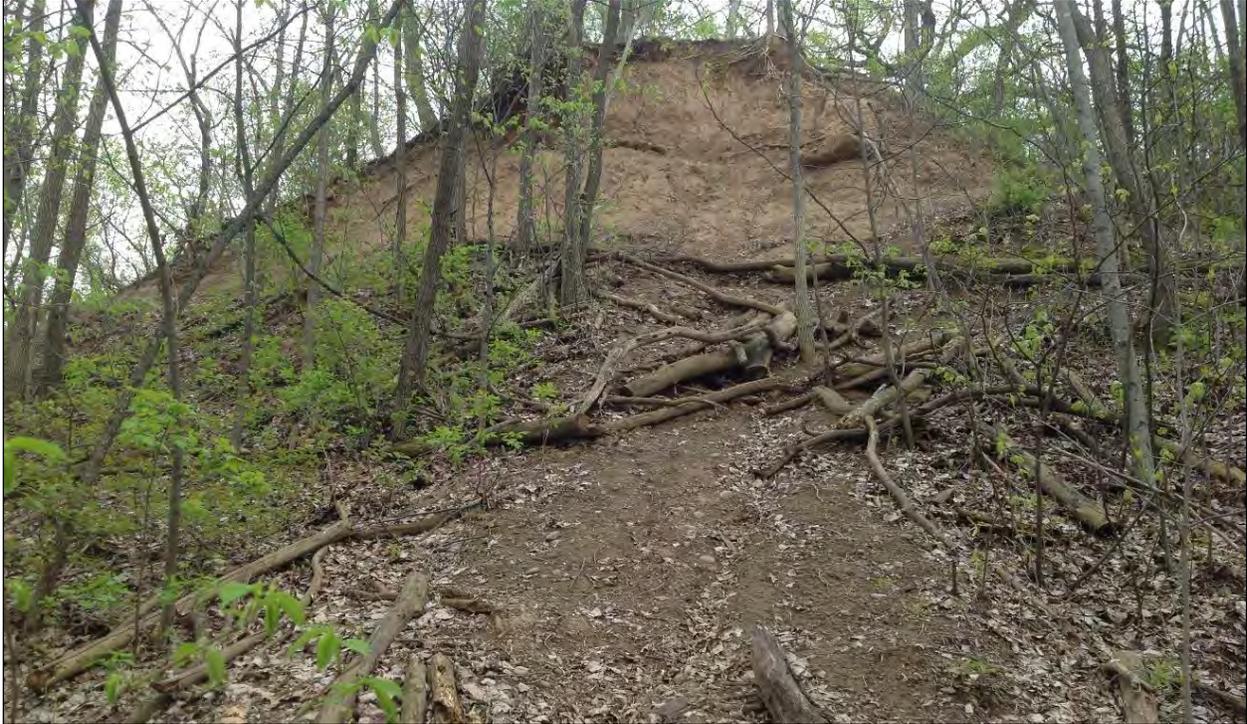
**Photo 2-22** View of slope failure above Brickyard Trail–Connector Section, the source of soil on the trail in Photo 2-23 (May 2014 site visit)

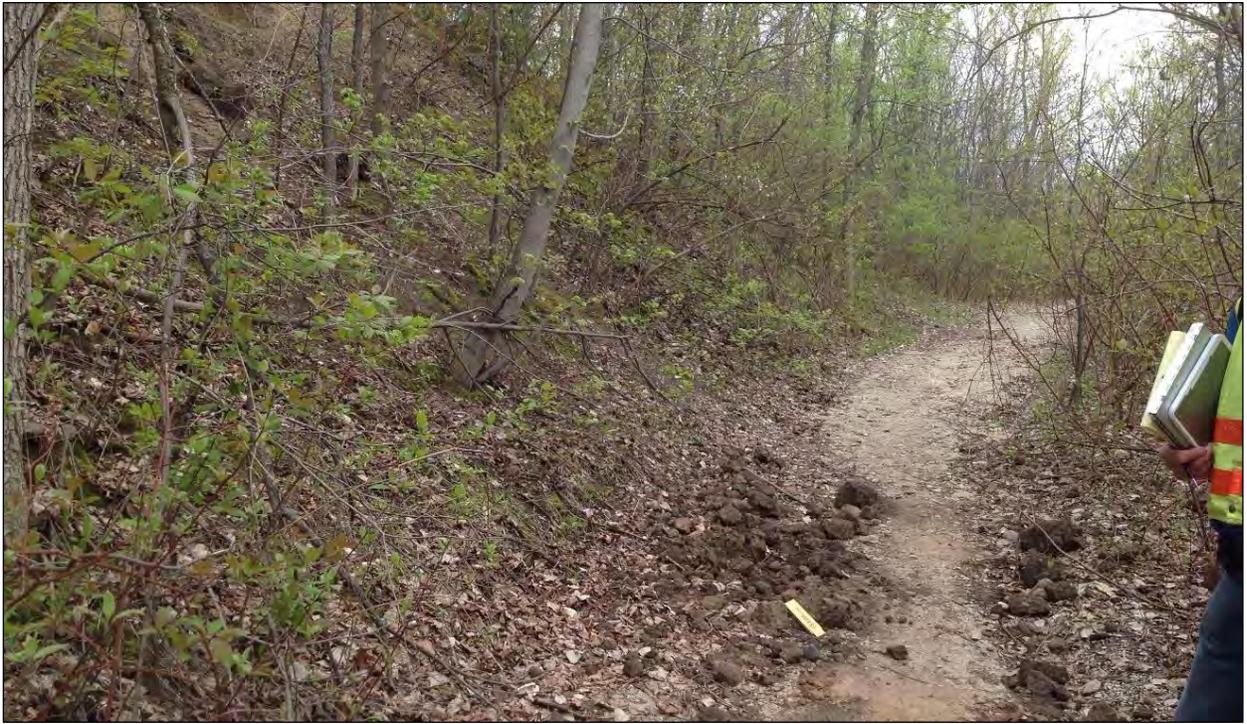
**Photo 2-23** Soil on the Brickyard Trail–Connector Section from slope failure shown in Photo 2-22 (May 2014 site visit)

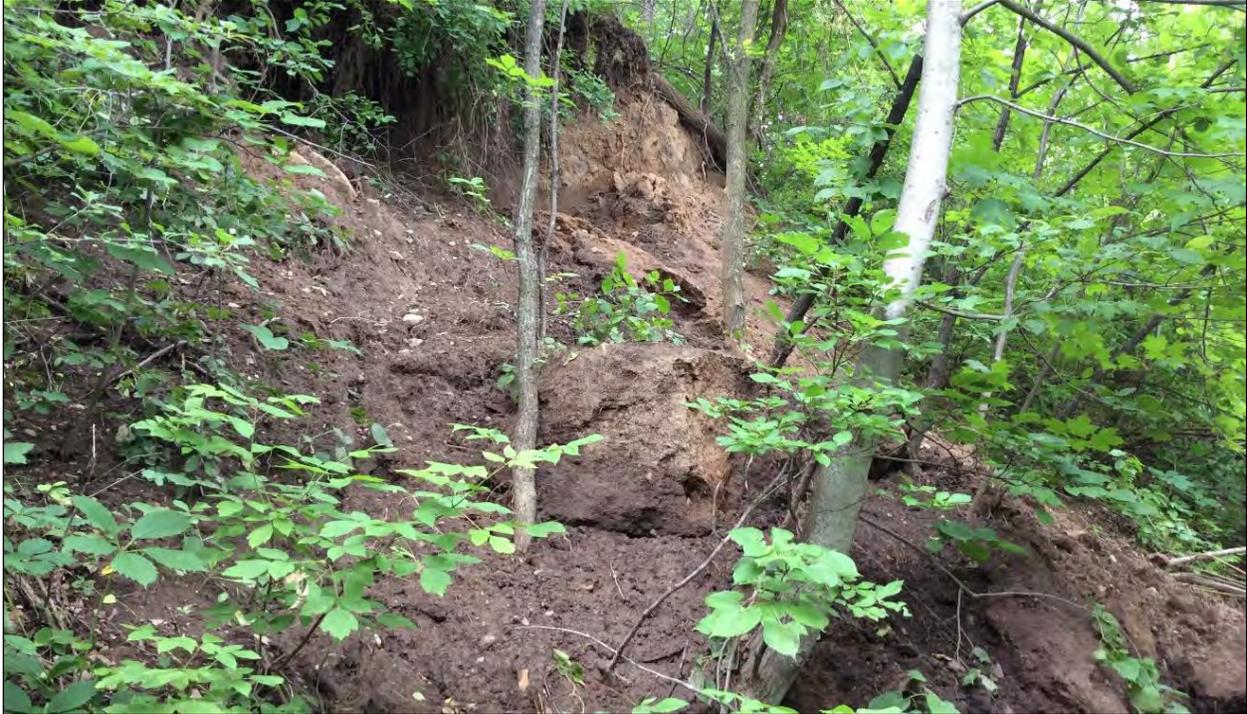
**Photo 2-24** View of slope failure above the Brickyard Trail–Connector Section, the source of soil on the trail in the same location and shown in Photo 2-25 (July 2014 site visit)

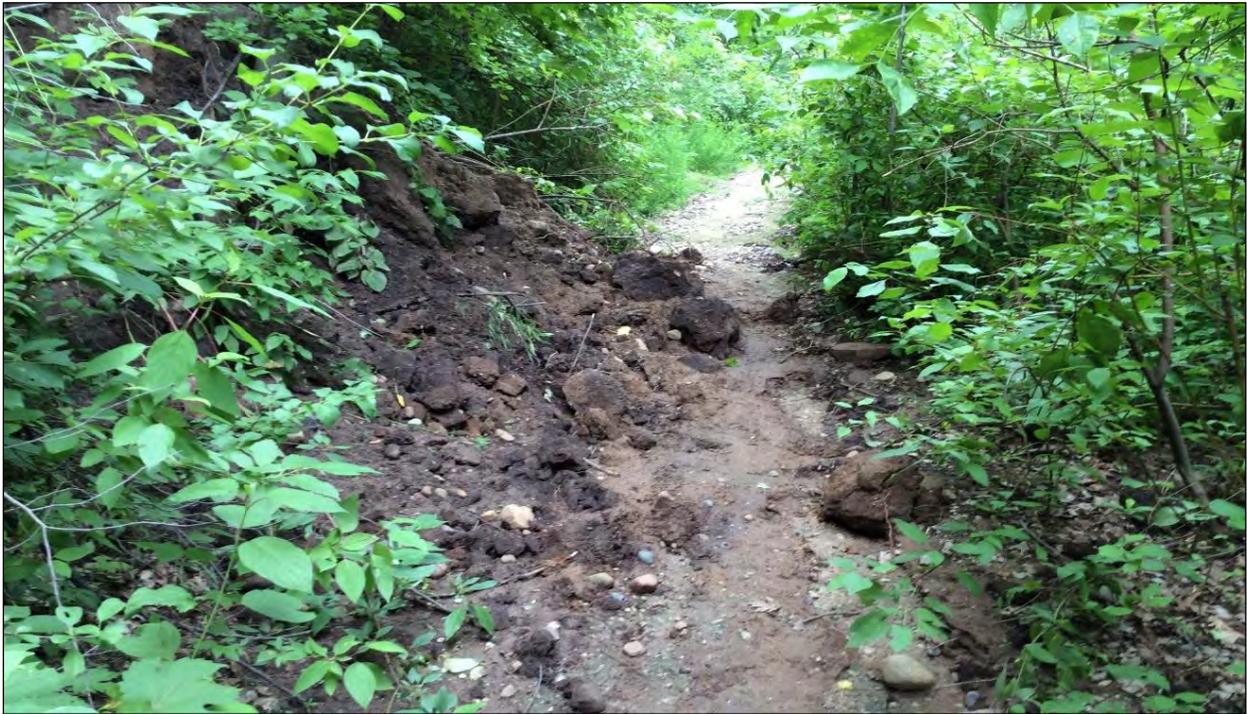
**Photo 2-25** Soil on the Brickyard Trail–Connector Section from slope failure shown in Photo 2-24 (July 2014 site visit)

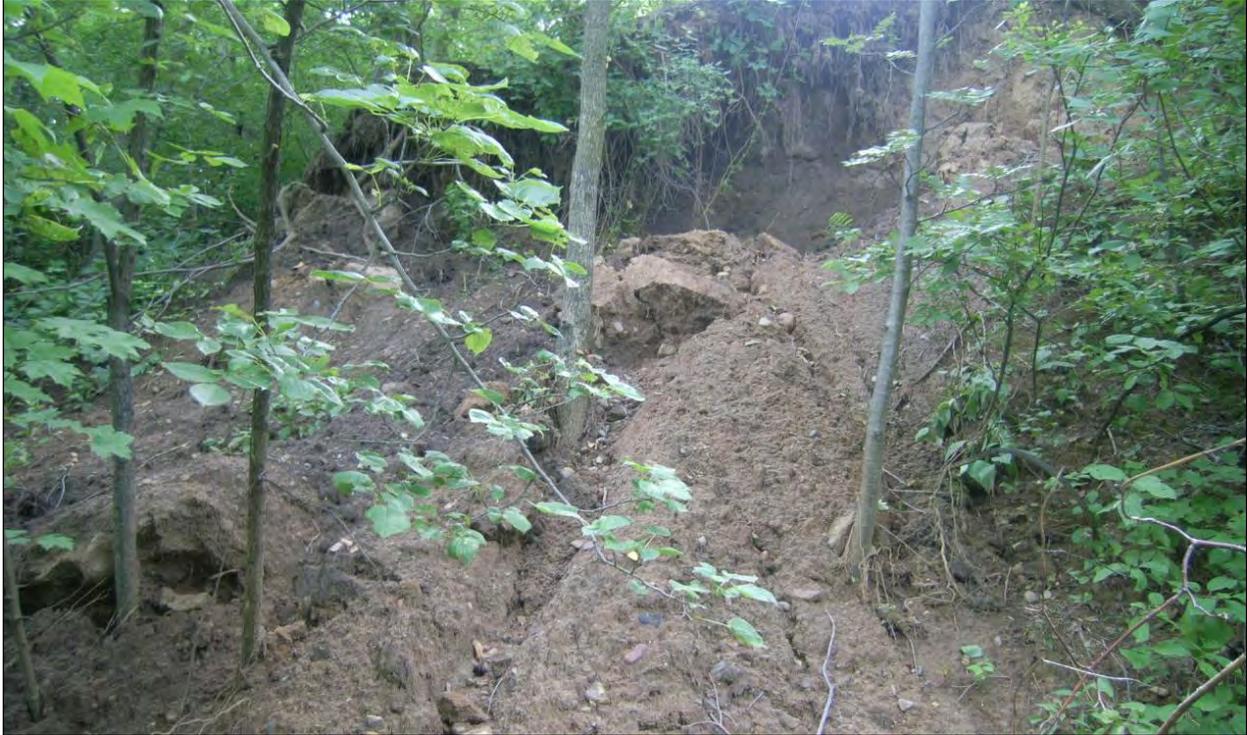
**Photo 2-26** Slide below the Bruce Vento Spur of the Brickyard Access Trail (July 2014 site visit)

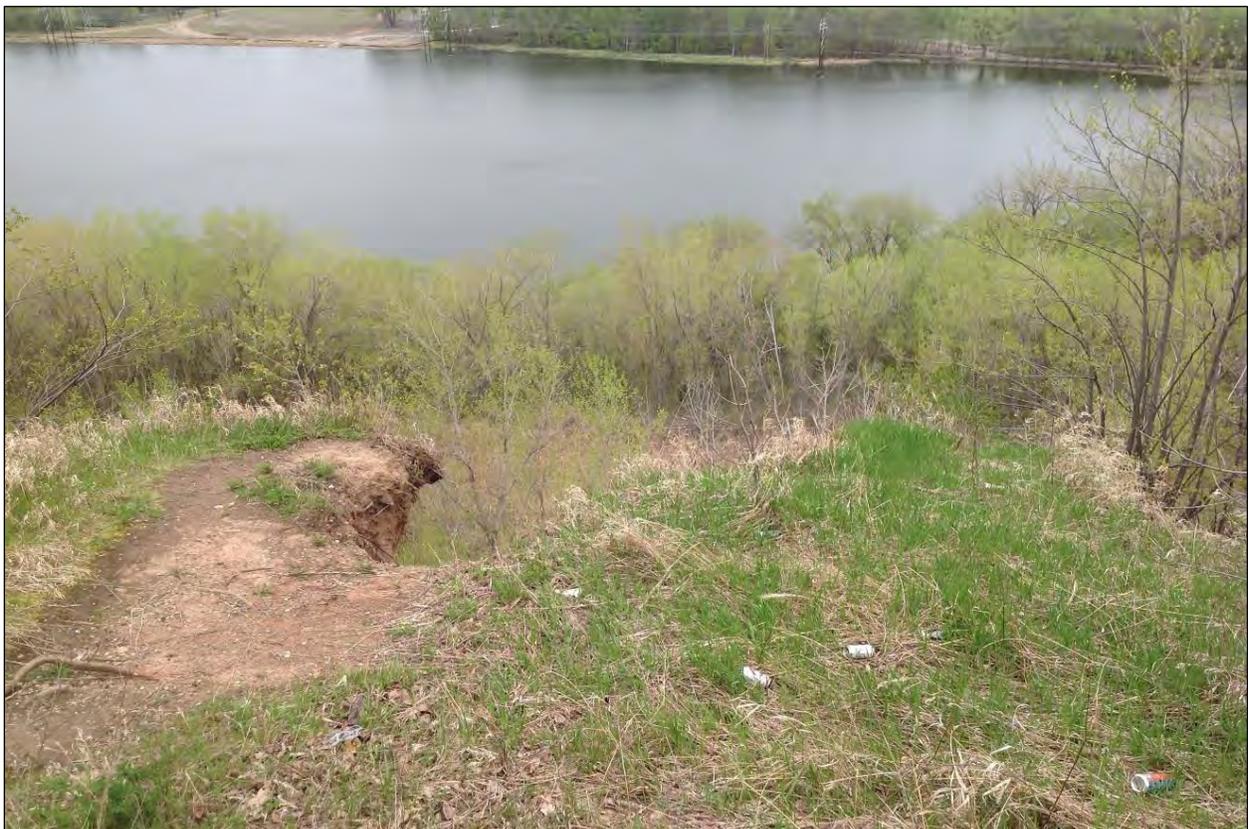
Approximately 4 feet past the overlook fencing, a mass of overhanging soil was observed (Photo 2-28). The soils at this location look to be entirely supported by vegetation/root zones. While the roots appear to have reinforced the surface of the soils, the soils below the effective root zone were not reinforced and have slid/eroded, leaving the overhang. This overhanging soil mass is a concern and, in our opinion, could fail when the roots eventually give way. The situation is made more serious because the roots are storing materials above the failure, which could increase the volume of a potential slide. The vegetation also masks the presence of the overhang, which could lead to park users inadvertently activating a slide. There are numerous examples of vegetation/root mats holding upper soils in the Brickyard Area, presenting similar risks; however, foot traffic near the Bruce Vento Scenic Overlook is likely more prevalent.

**Photo 2-28** Soil overhang, from above, at Bruce Vento Scenic Overlook (May 2014 site visit)

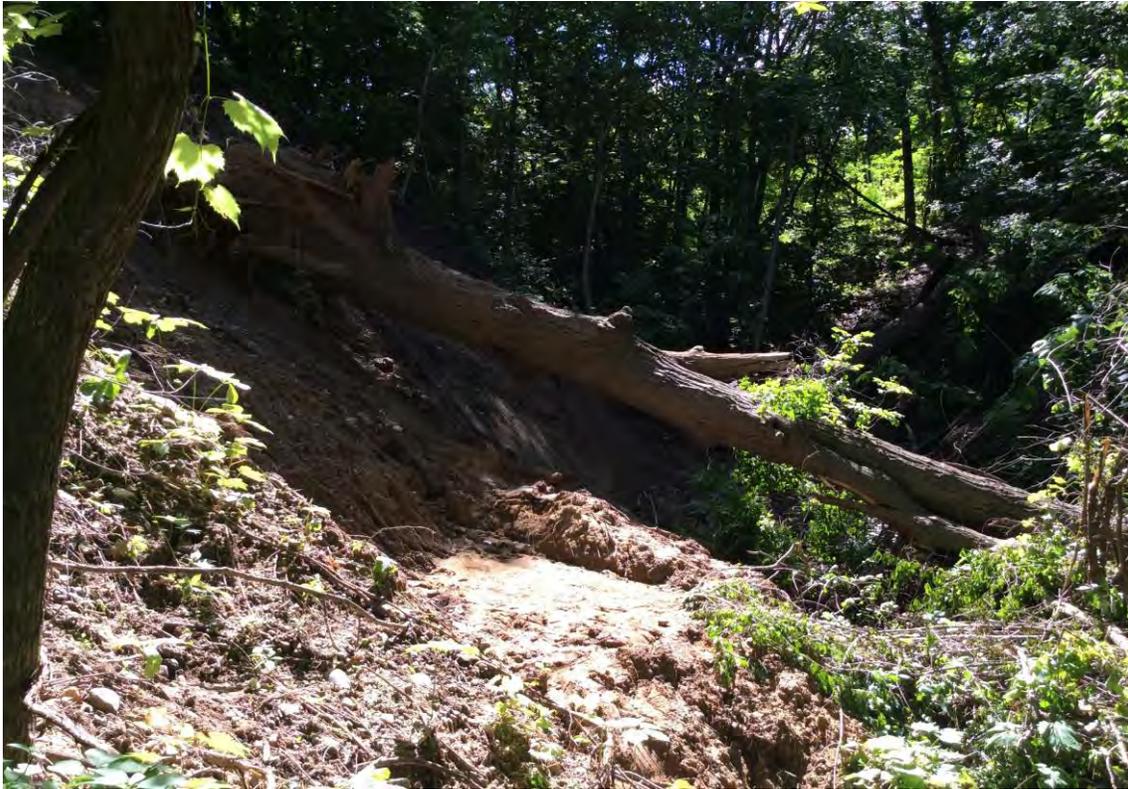
**Photo 3 Cherokee Heights ravine slope failure (July 2014 site visit)**

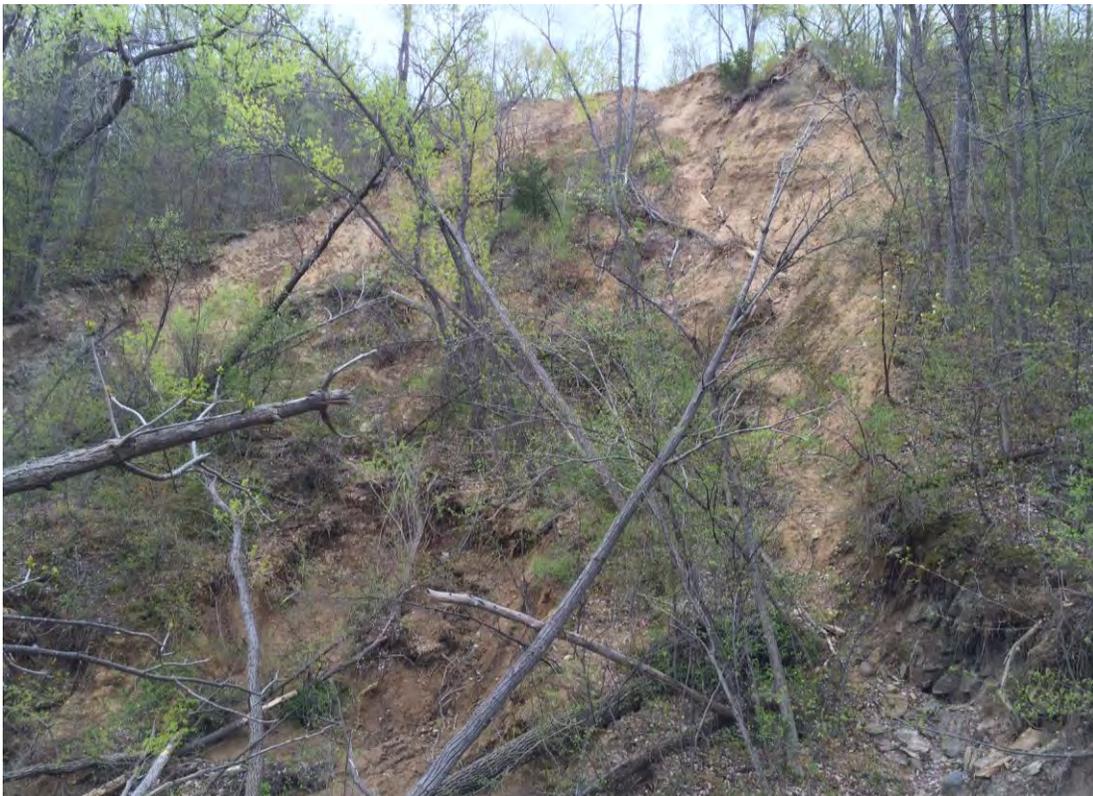
**Photo 4 Scarp from historic slope failure, pre-2014 slide (taken from Brickyard Trail Low Falls waterfall area during the May 2014 site visit)**

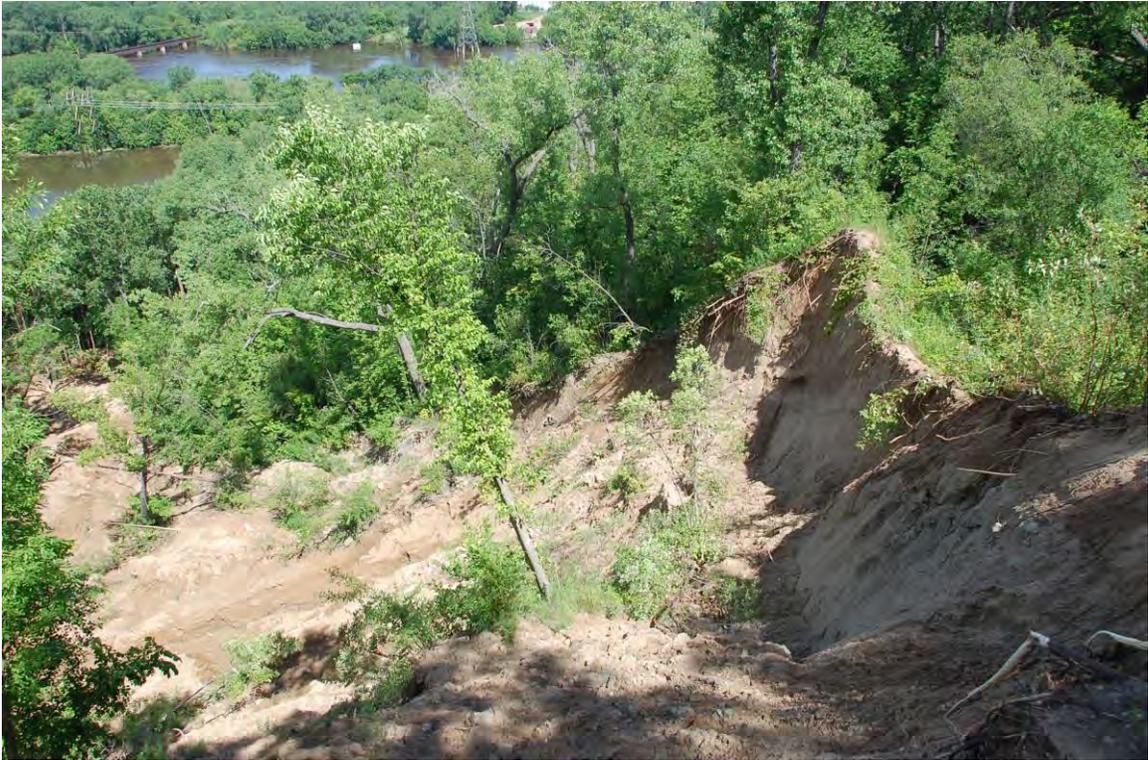
**Photo 5 2014 slope failure from above (July 2014 site visit)**

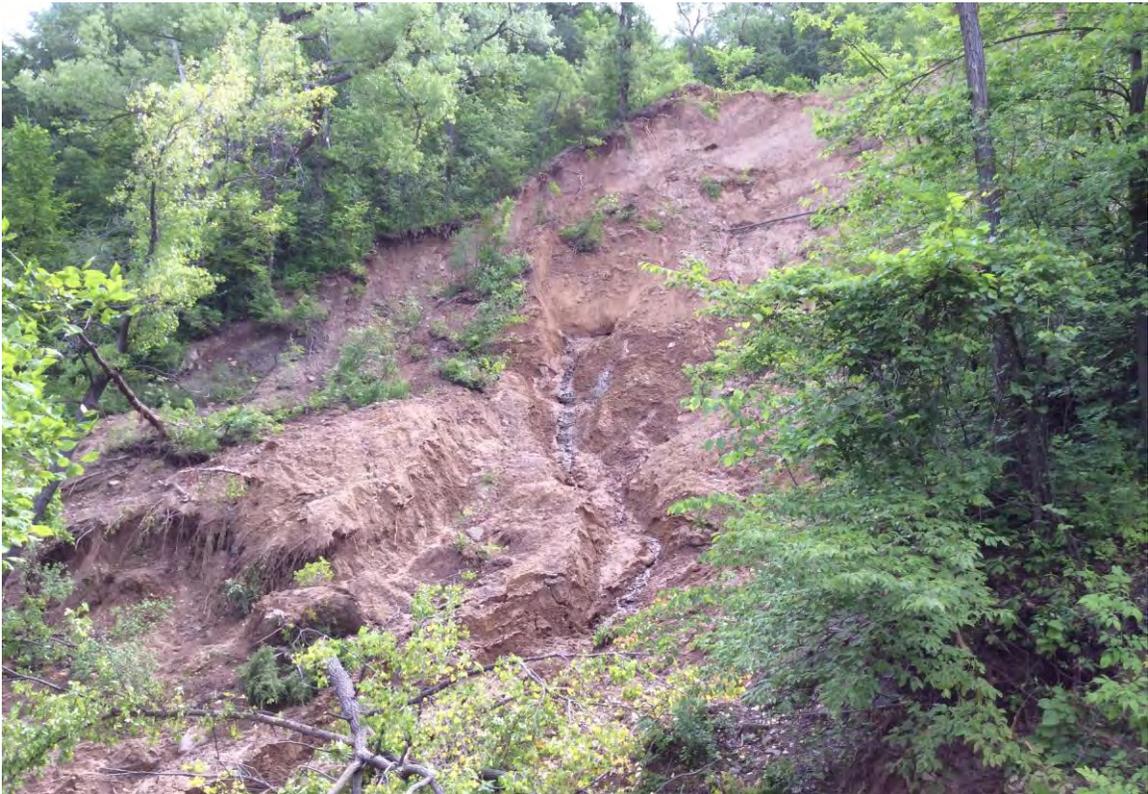
**Photo 6 2014 slope failure from below (July 2014 site visit)**

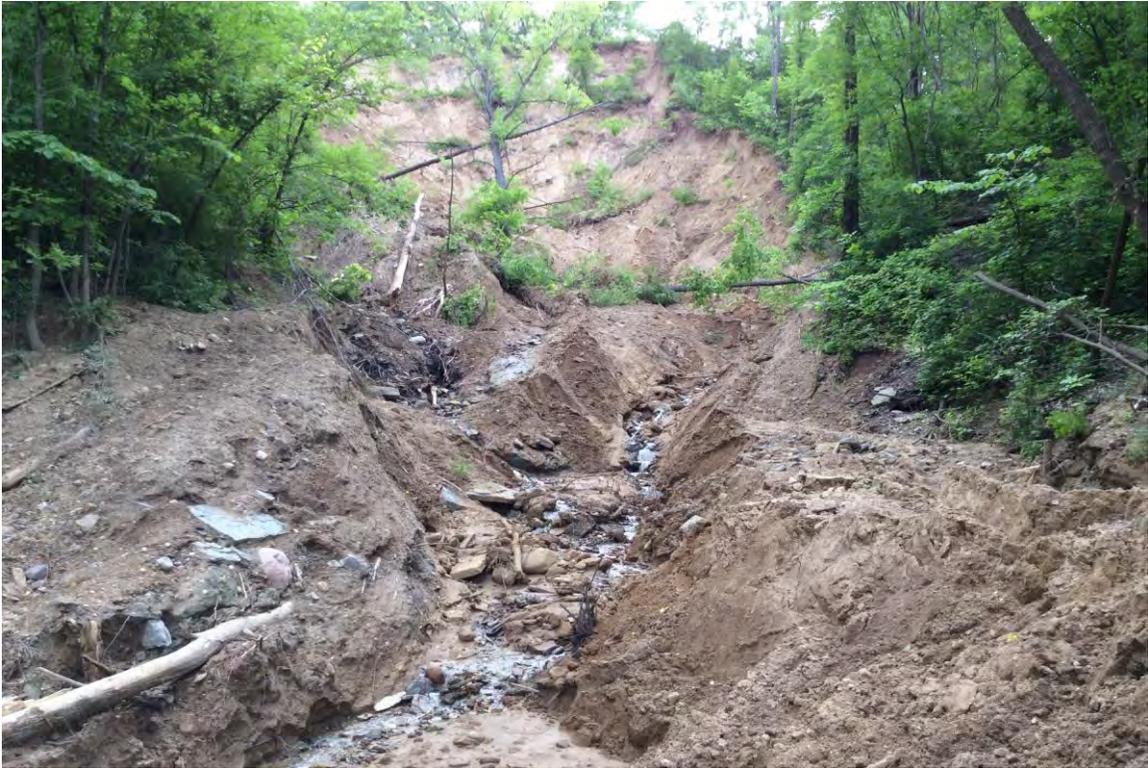
**Photo 7 Large slide, looking up through newly eroded stream channel (July 2014 site visit)**

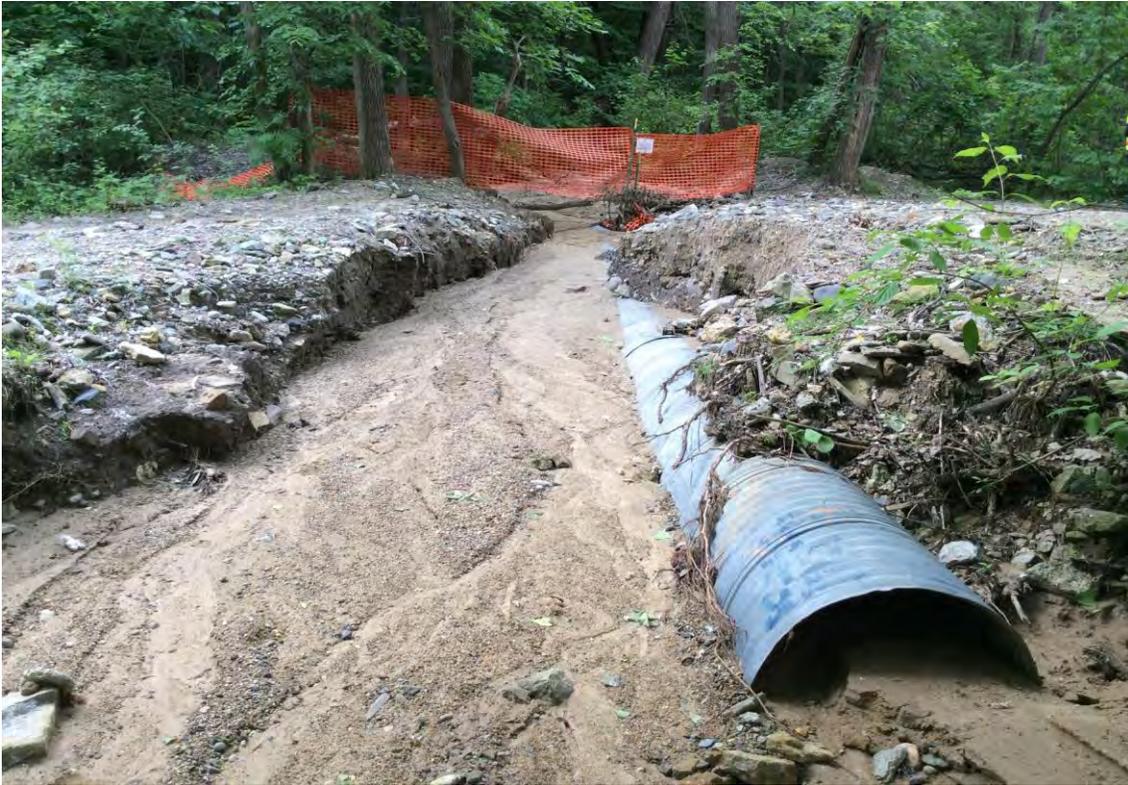
**Photo 9 Erosion of lower Brickyard Trail and plugged culvert resulting from the Northwest Slope Failure (July 2014 site visit)**
