## **Brickyard Area of Lilydale Regional Park**

### ***Stormwater Management and Slope-Stability Analysis***

Prepared for  
City of St. Paul Department of Parks and Recreation

January 28, 2015

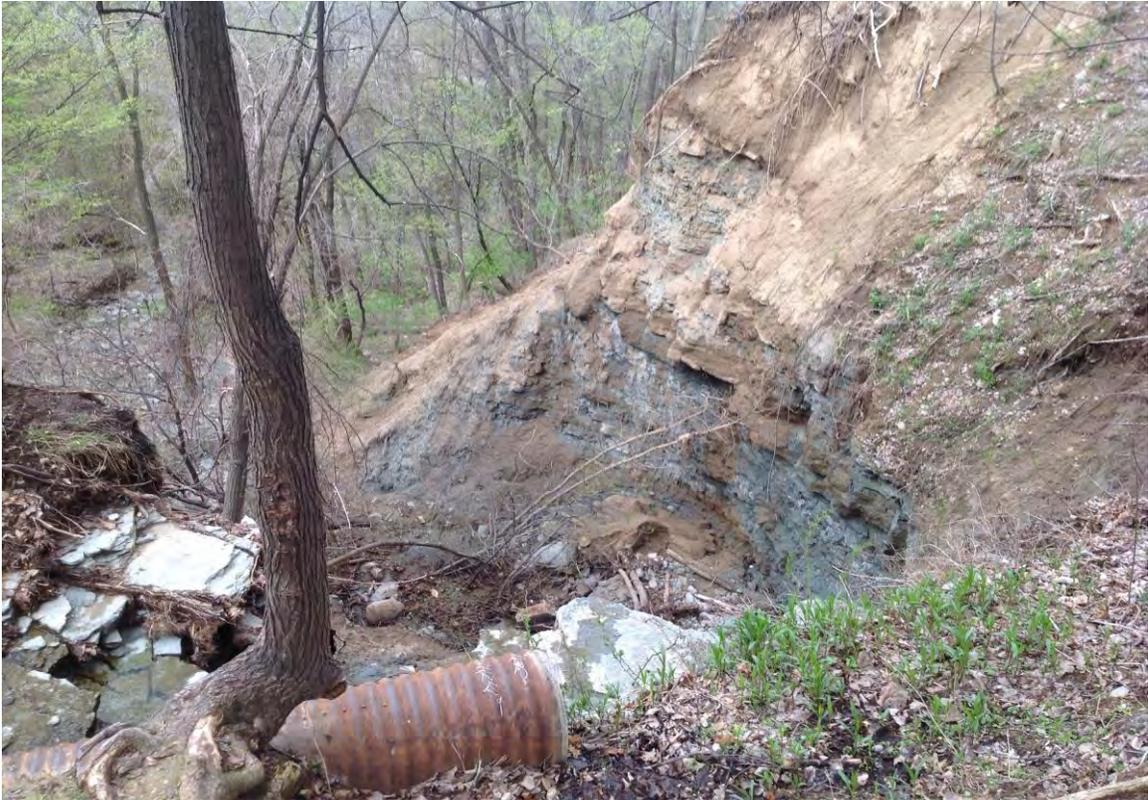
**Photo 10 2013 slide area, from top of East Clay Pit Falls, as observed during the May 2014 site visit**

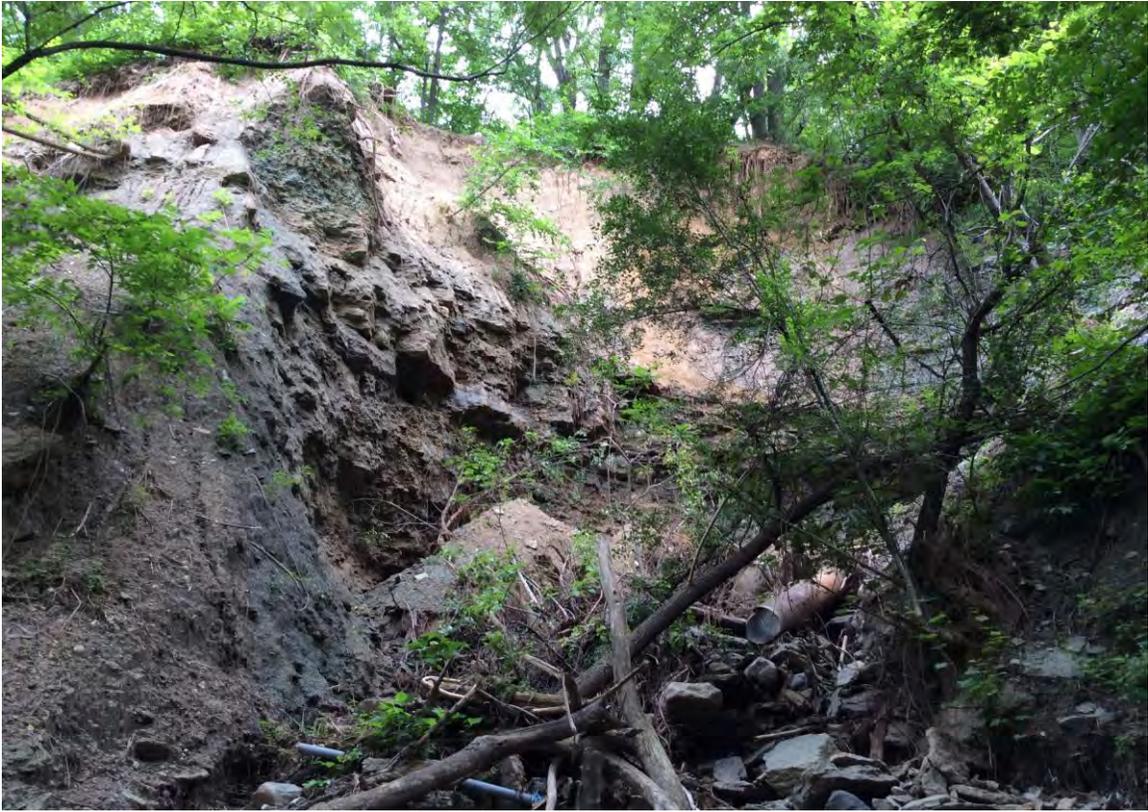
**Photo 11 2013 side area, from below, as observed during the July 2014 site visit**

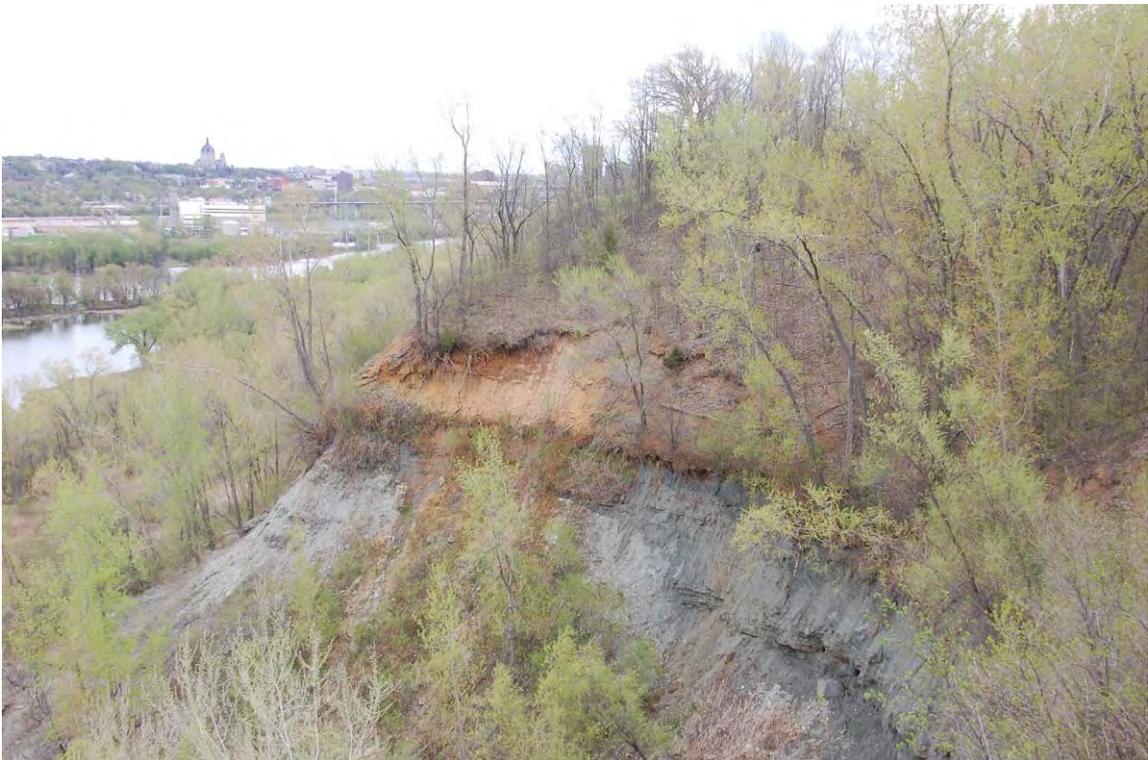
**Photo 12 Silty sand soil over shale bedrock in West Clay Pit (May 2014 site visit)**

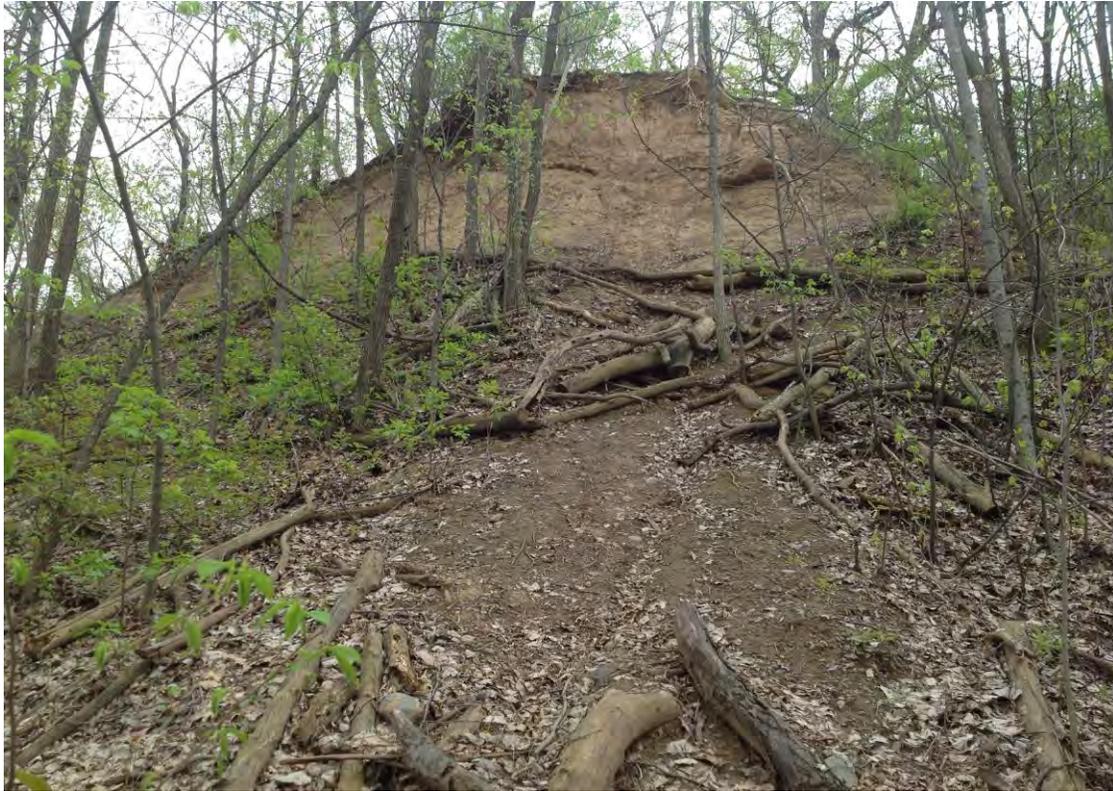
**Photo 17 View of slope failure above Brickyard Trail (this is the source of soil on the trail) (May 2014 site visit)**

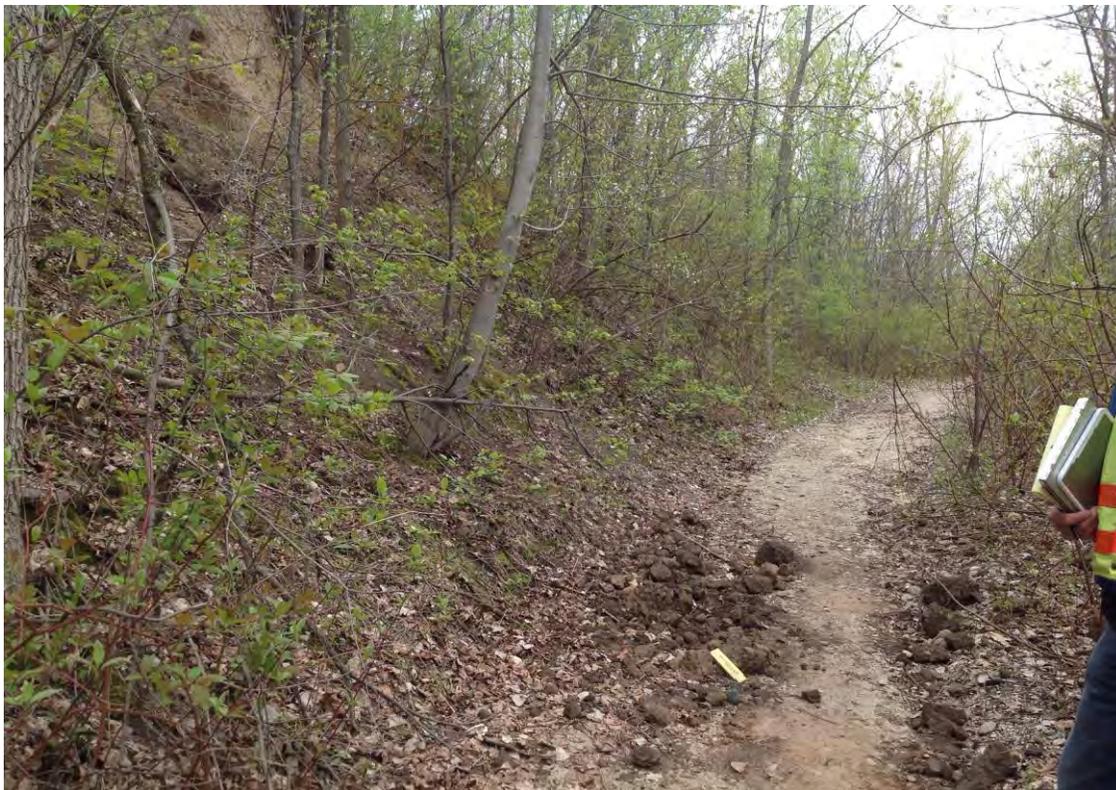
**Photo 18 Soil on Brickyard Trail (May 2014 site visit)**

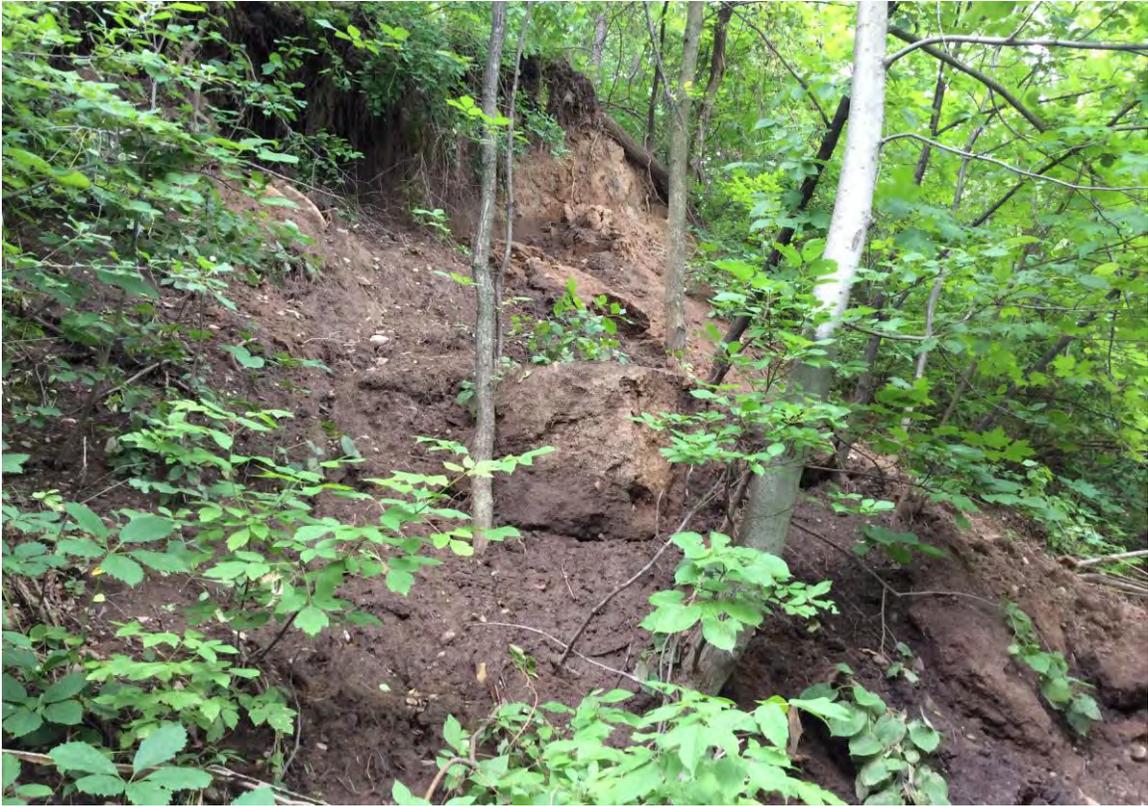
**Photo 19 View of slope failure above Brickyard Trail (this is the source of soil on the trail) (July 2014 site visit)**

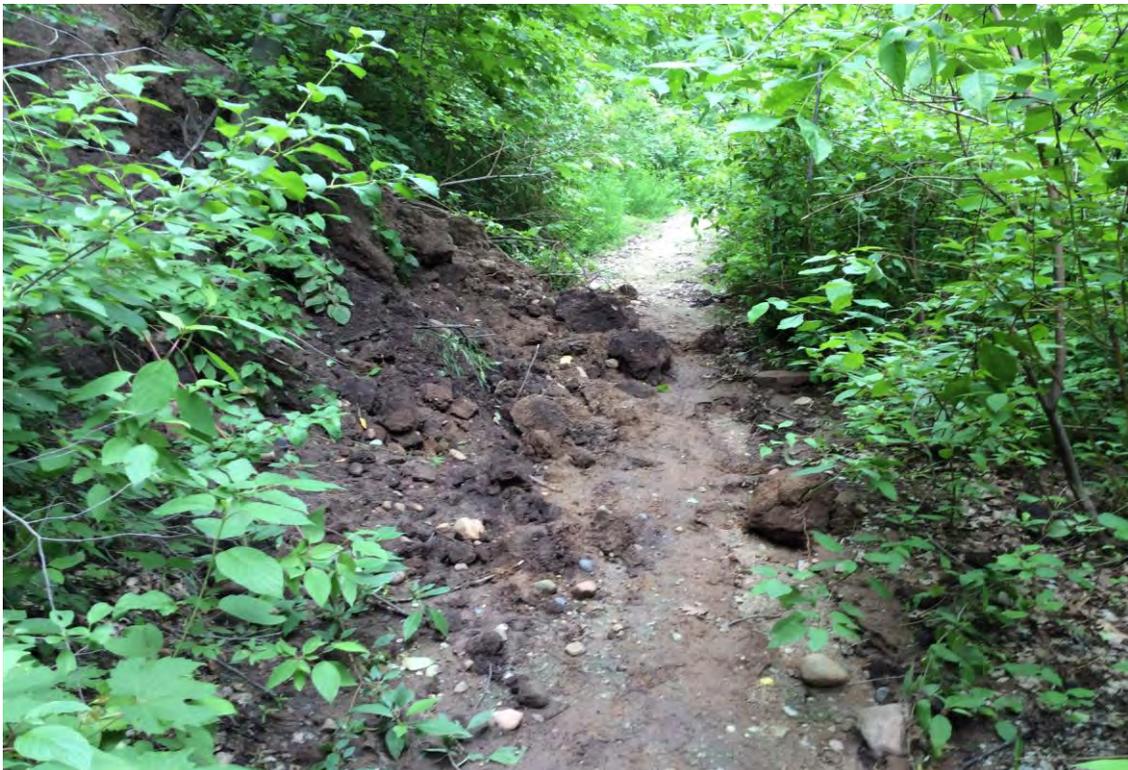
**Photo 20 Soil on Brickyard Trail from slope failure shown in previous photo (July 2014 site visit)**
