Historic Structures Report
Norway Lutheran Church (Muskego)
for
Luther Seminary
St. Paul, Minnesota

Claybaugh Preservation Architecture Inc
Stark Preservation Planning LLC
Barn Repair Specialists
Revised March 2015

Site Inspection Visit & Existing Condition Report
July 16, 2014
Norway Lutheran Church (Muskego) Historic Structures Report
Luther Seminary
2375 Como Ave.
St. Paul, Minnesota 55108

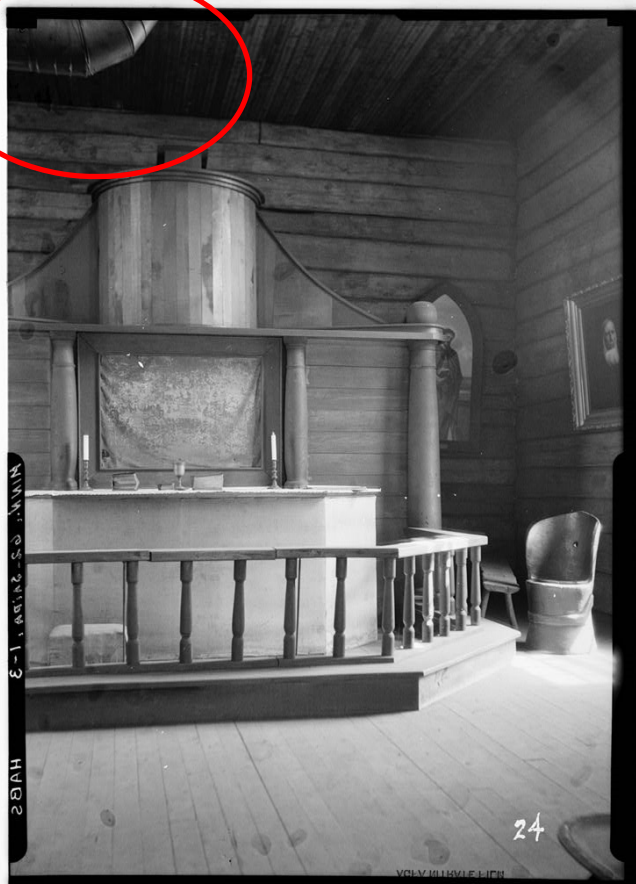
Figure 3. Interior View Dated 1934. Note stovepipe in upper left corner (HABS, Library of Congress).

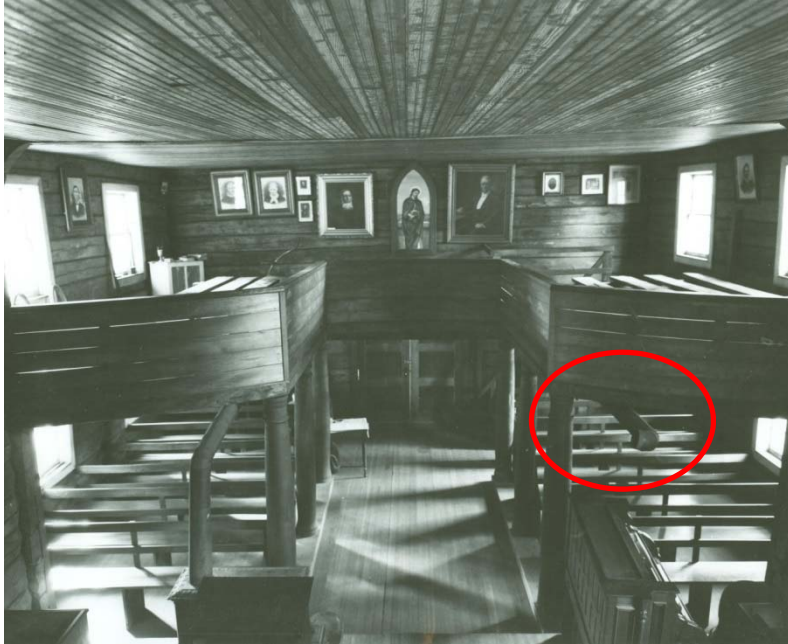
Figure 4. Interior photograph dated 1962. Note terminated stovepipe (Minnesota Historical Society and Luther Seminary Archives)

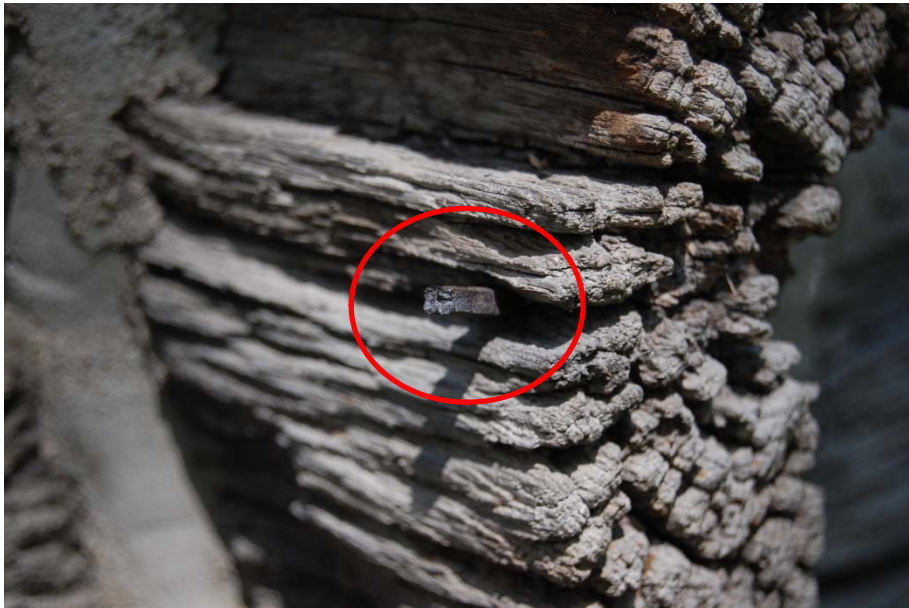
In addition to this documentary evidence, physical evidence of exterior sheathing remains on the building. Several square nails can be found within the log walls (Figure 5). While the nails could be remnants of the c. 1904 sheathing after the move, it would be very unlikely to see this type of nail in the early twentieth century. Square nails of this kind are more likely to be used in the 1850s.

Figure 5. One of several square nails remaining embedded in the log structure.

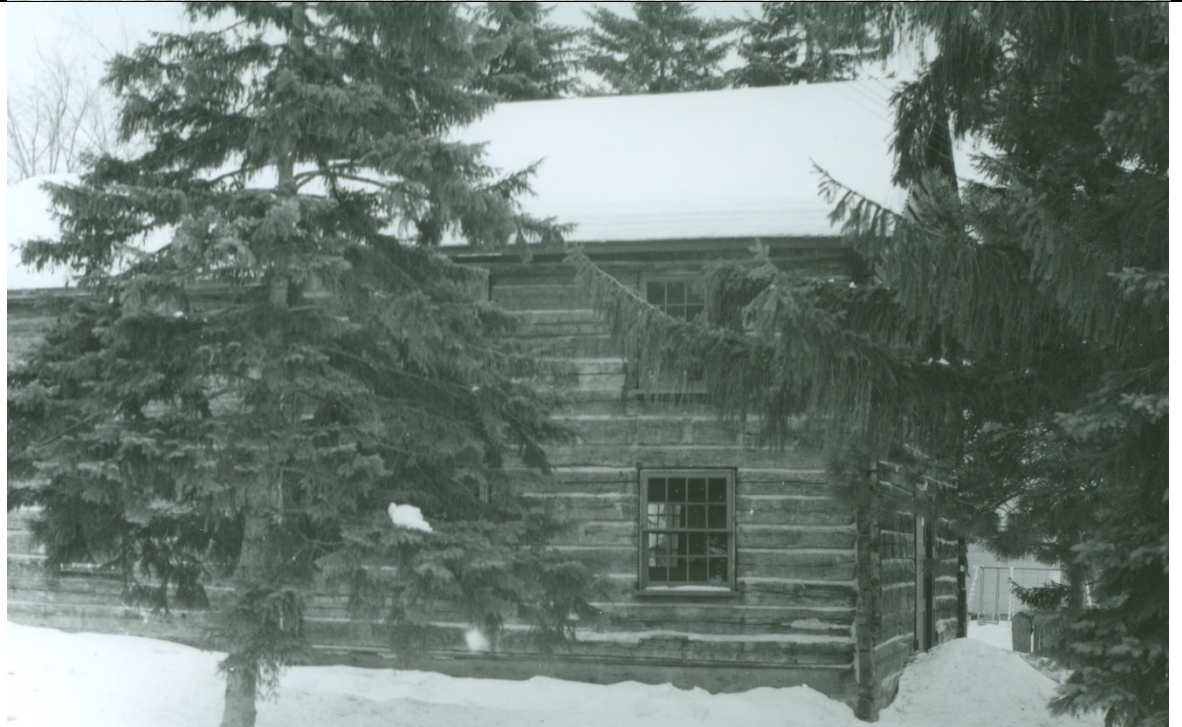
Exterior view of
window and corner.
Undated (after 1974).
Luther Seminary
Archives.

Note chinking patches.
