CITY OF SAINT PAUL PUBLIC WORKS

Walnut Street Stairway

June 13, 2023

Walnut Street Stairway System

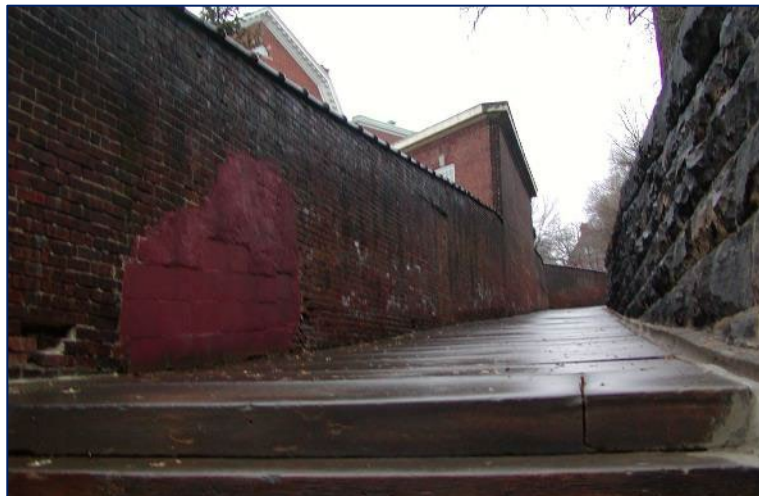
Cracking and mortar failure are among the typical effects of age and weather.

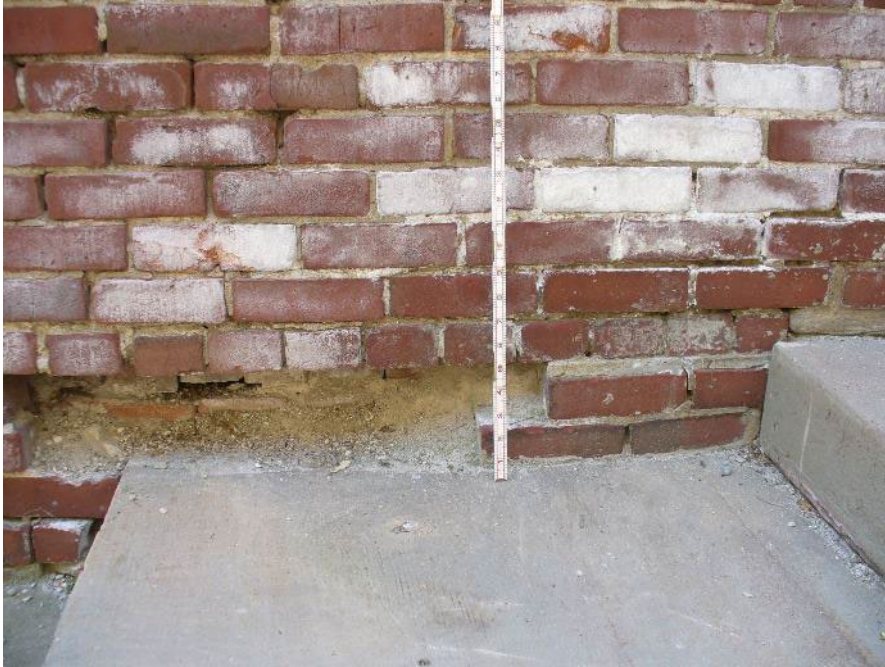
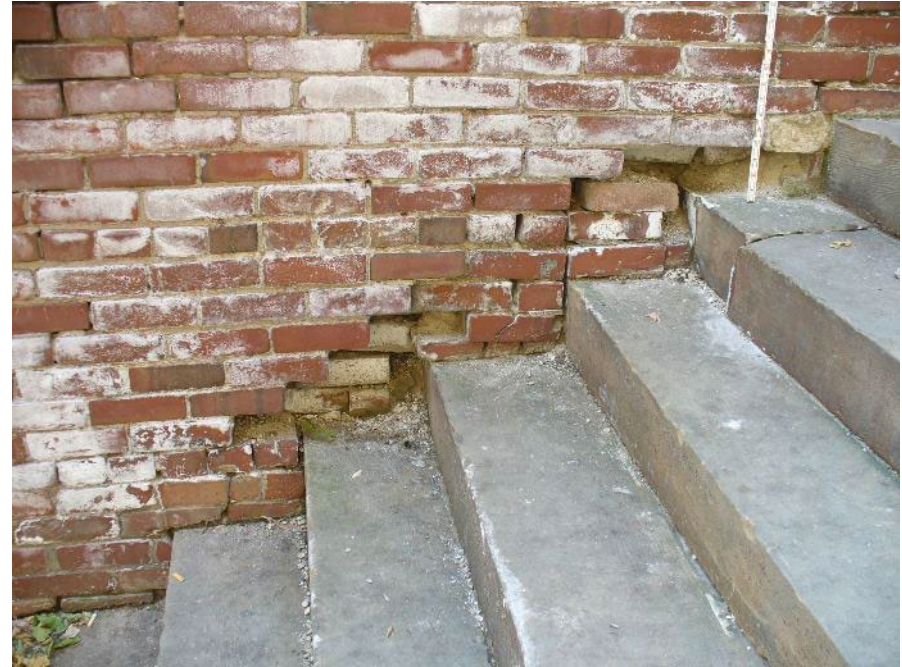
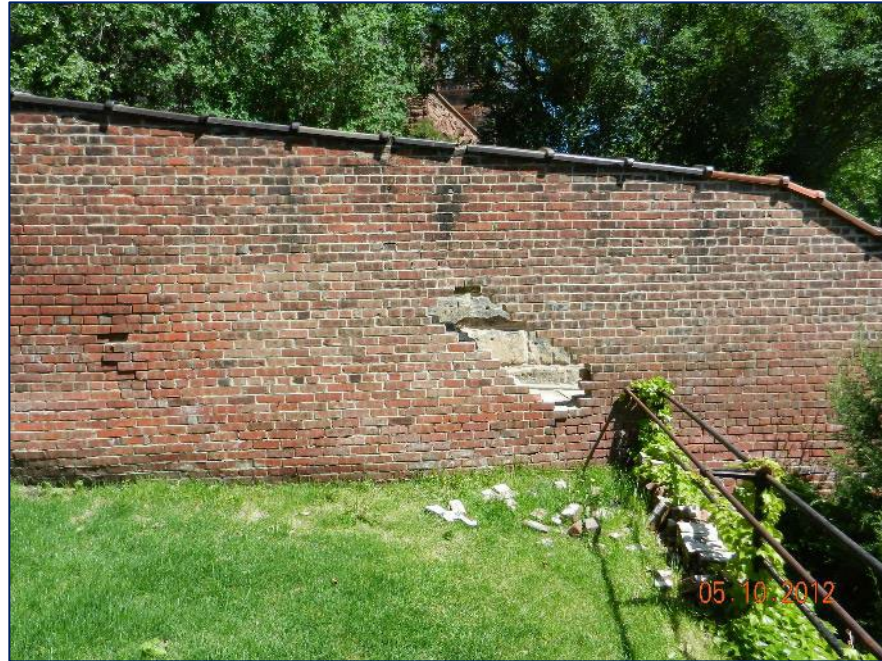
Localized failures present:

- Bulging
- Displacement
- Significant mortar loss
- Missing bricks

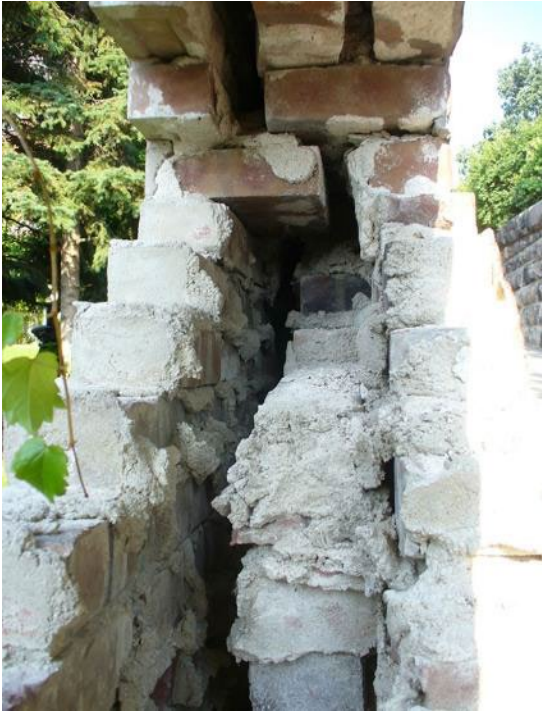
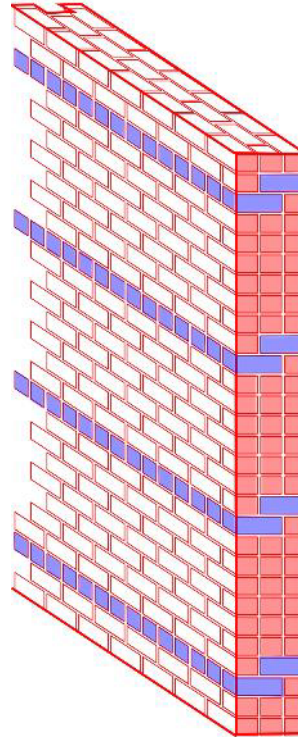
- Bulging or displacement failure can occur when the bonding courses fail

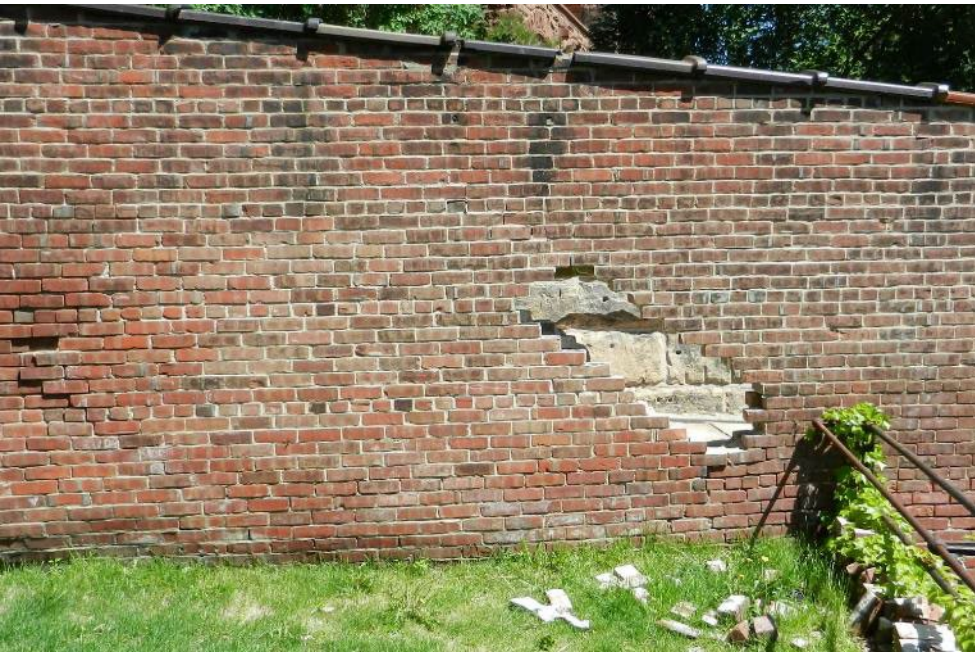
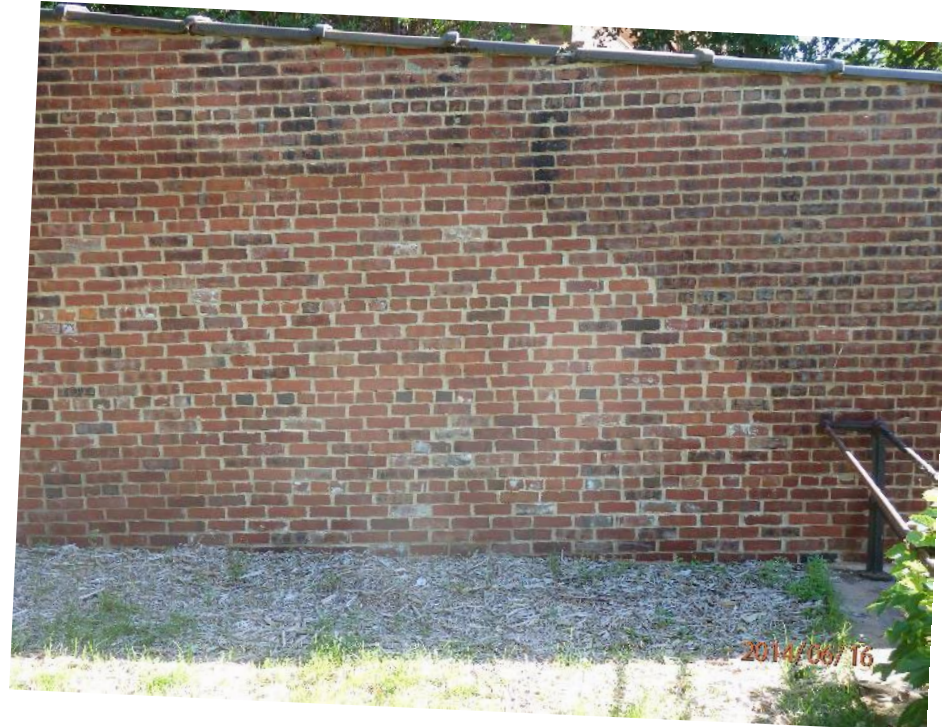
Before

&

After

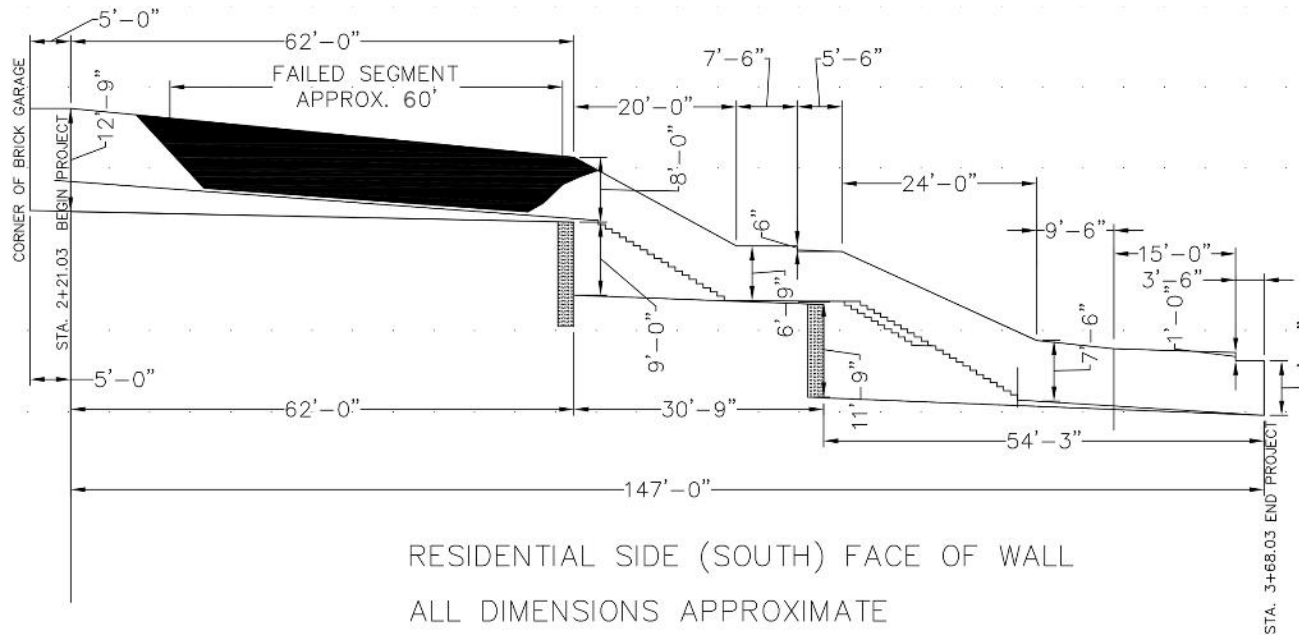
Approximately 60 feet of South Partition Wall fell on July 7, 2020

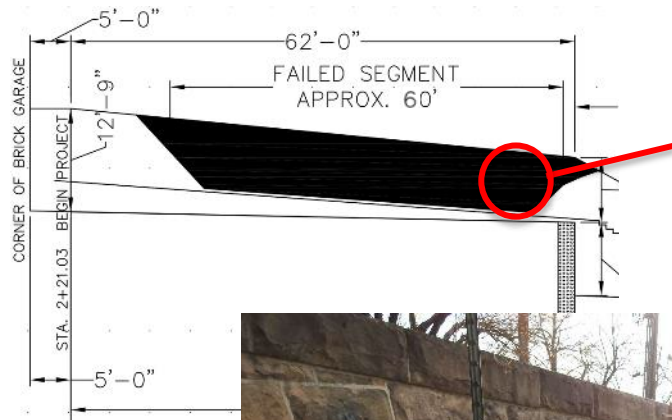
2012

A void and bulge was repaired here in 2013

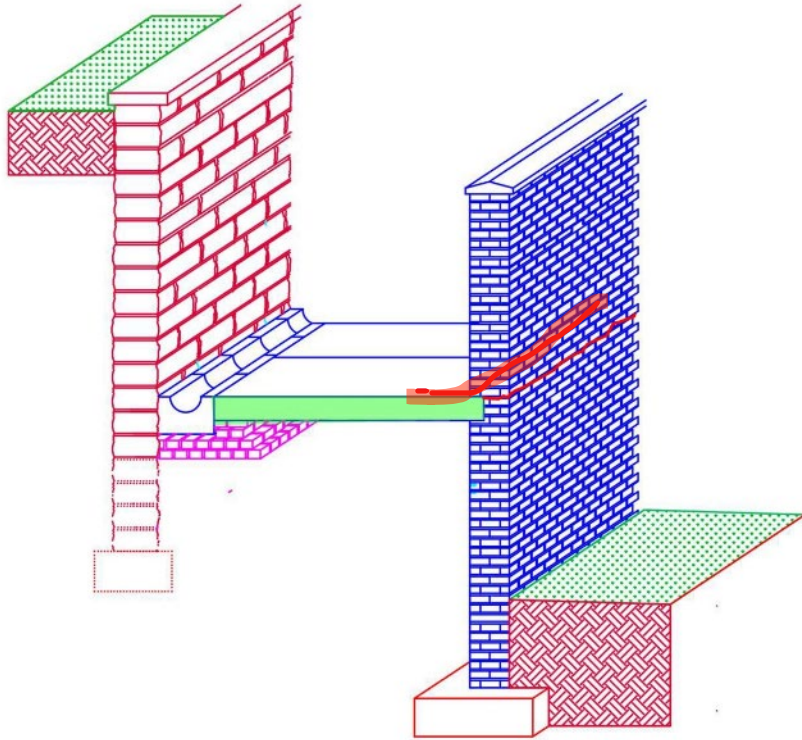
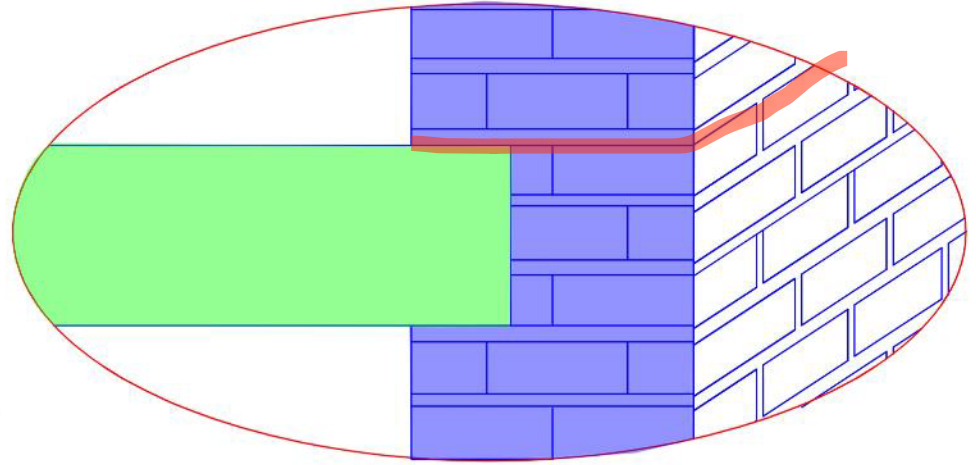
The wall failed at the notch.
Primary failure mode was mortar failure.

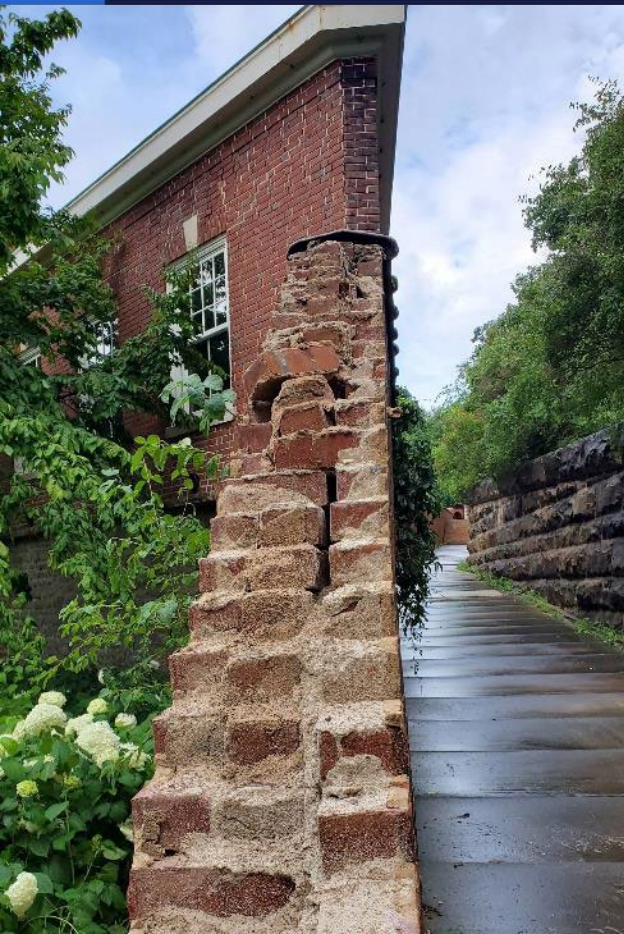
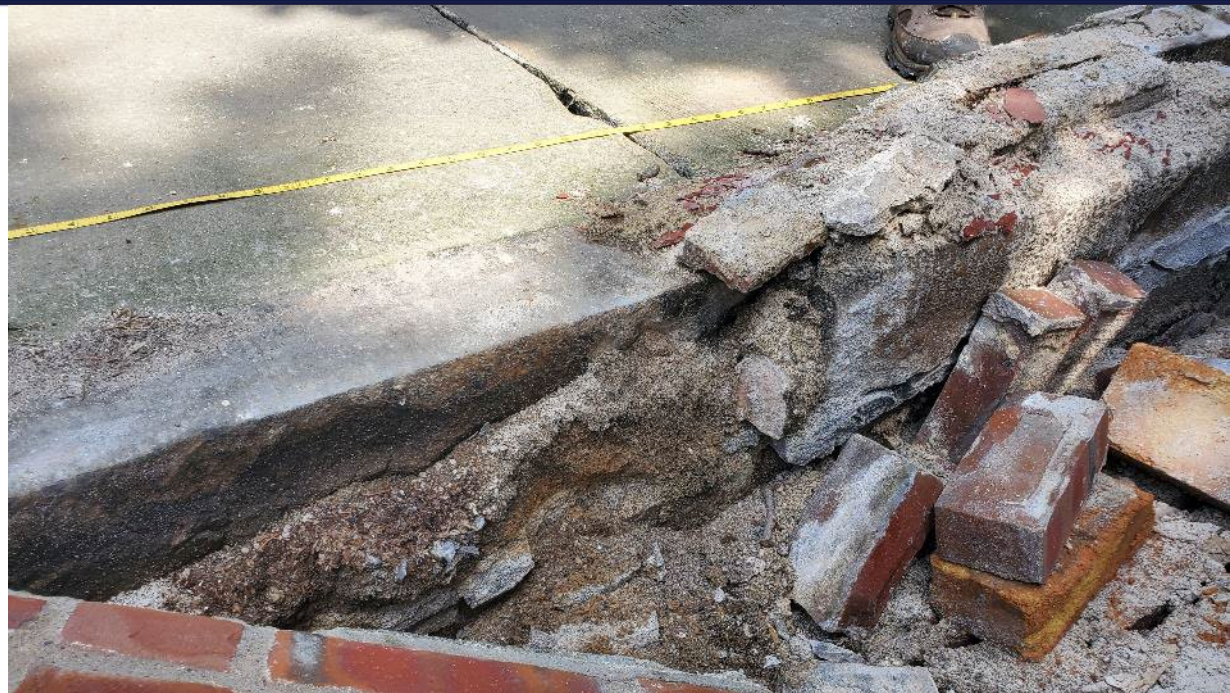
The wall failed at the notch.
Primary failure mode was mortar failure.

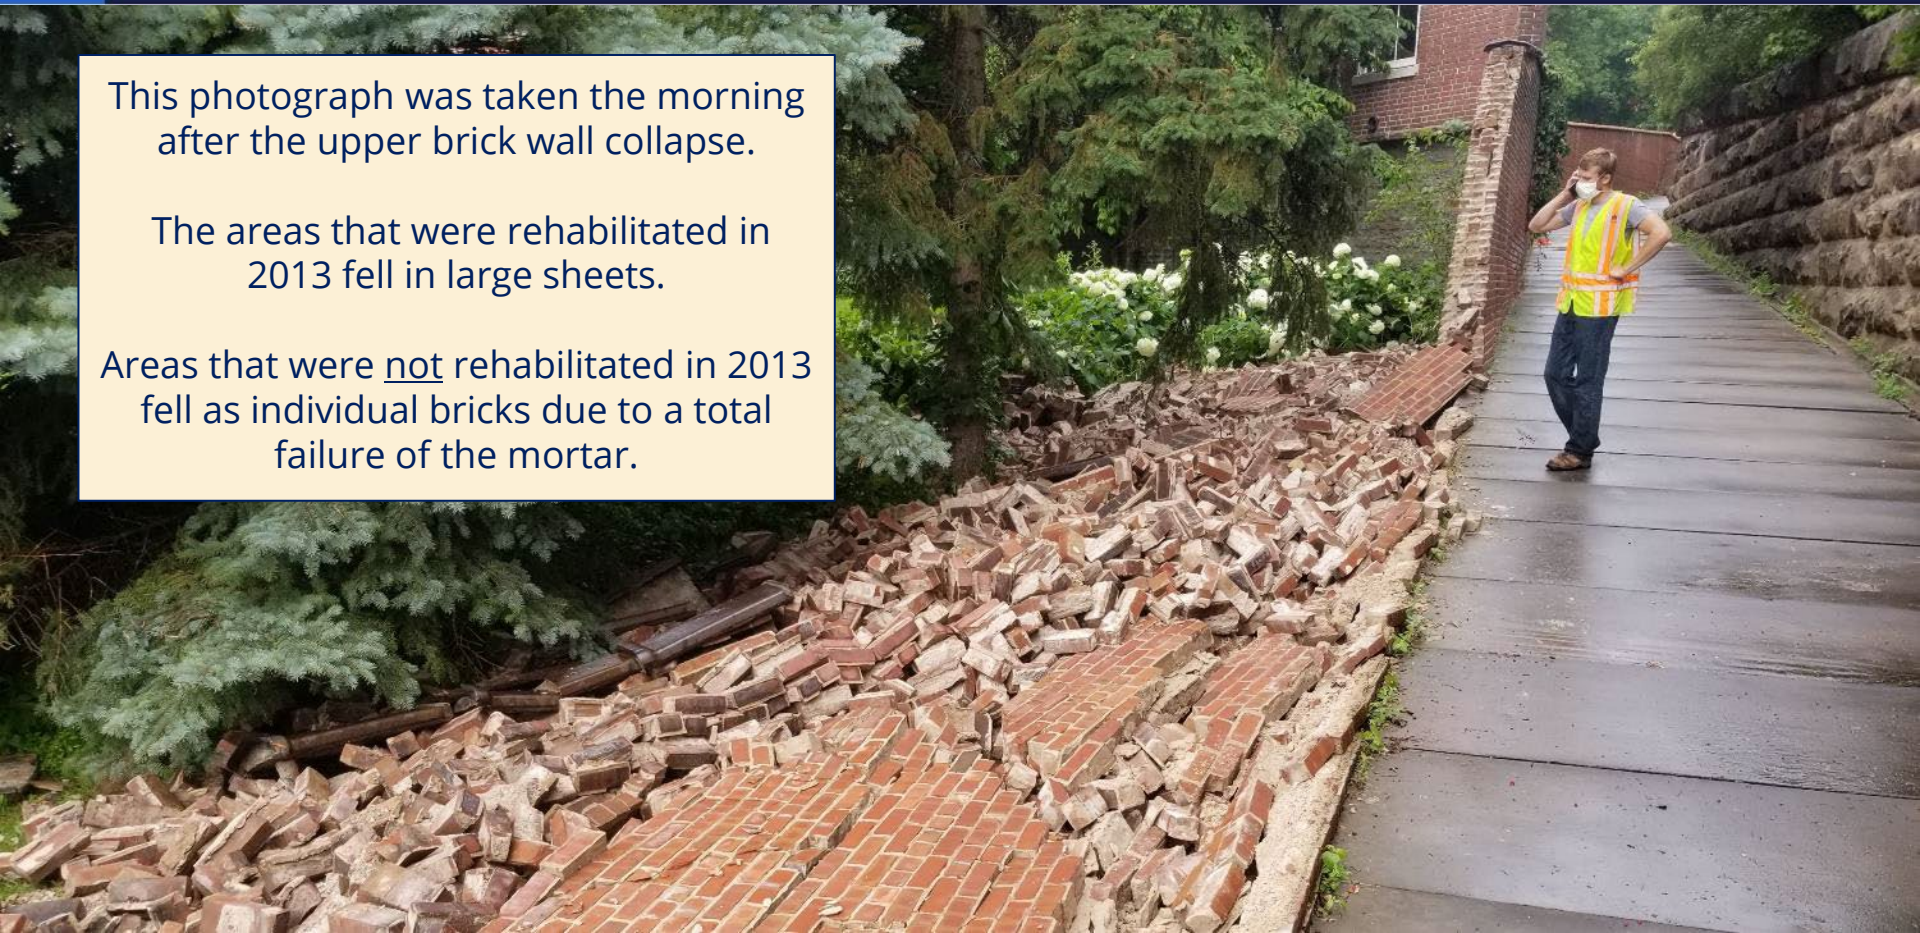
This photograph was taken the morning after the upper brick wall collapse.

The areas that were rehabilitated in 2013 fell in large sheets.

Areas that were not rehabilitated in 2013 fell as individual bricks due to a total failure of the mortar.

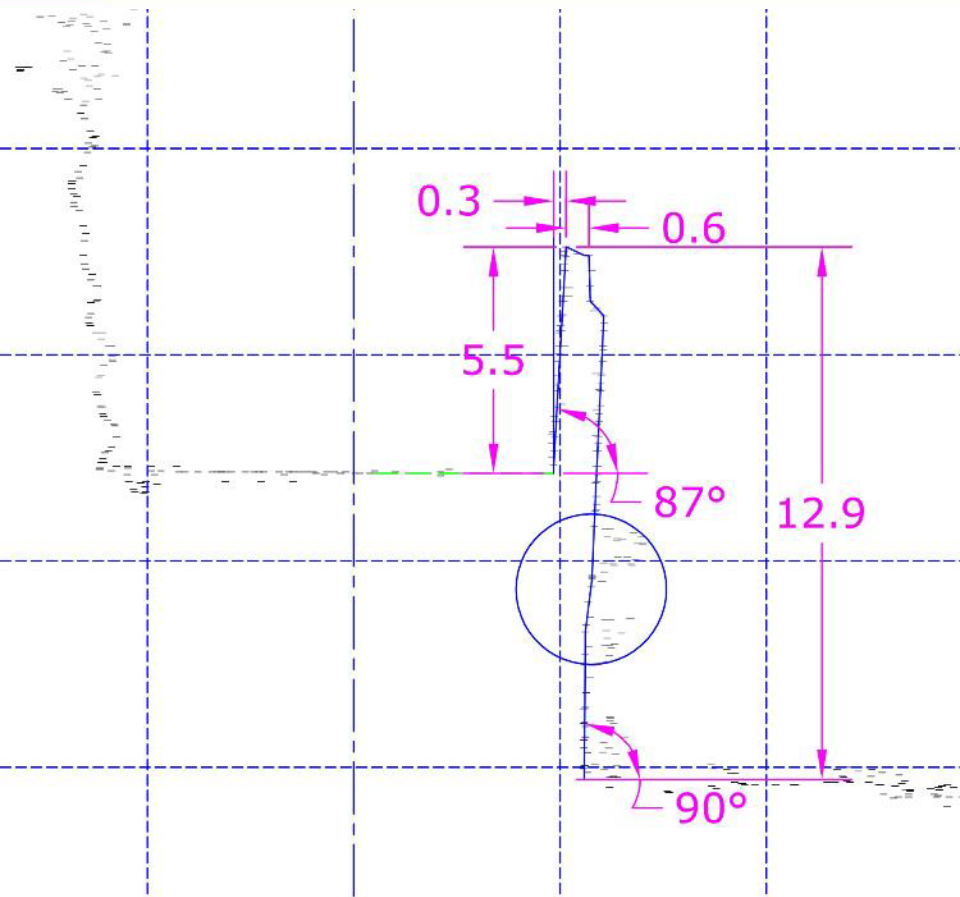
As part of the failure investigation, a Lidar laser survey was conducted.

At this survey location the wall was out of plumb 4" in 5'-6" and indicated a bulge in the back face of the wall.

In summary, the brick wall structure is in a present state of failure and repair is not feasible.

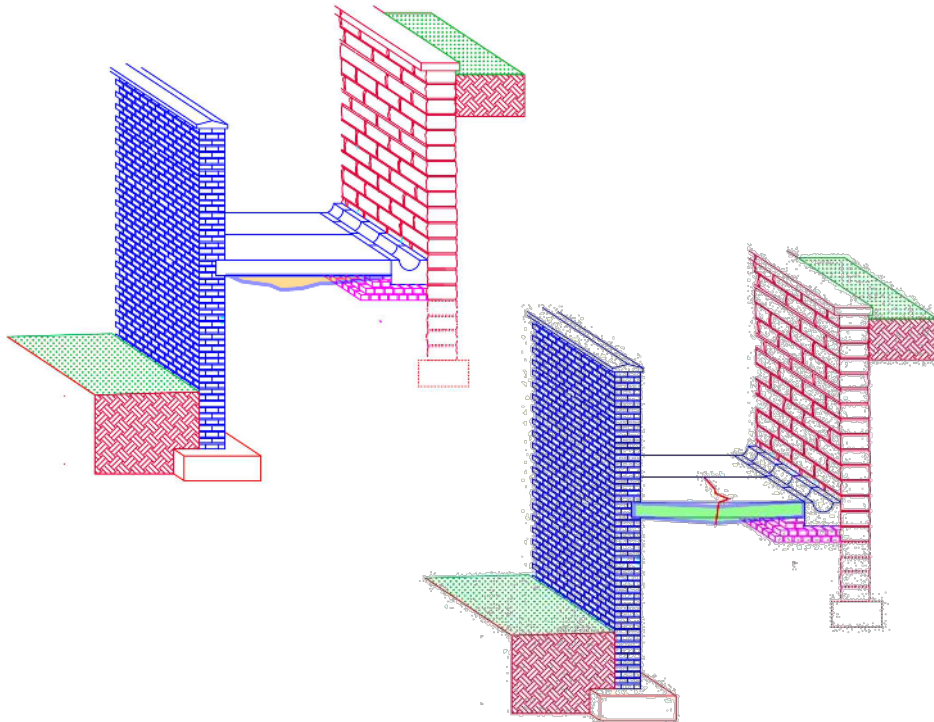
Erosion and settlement under the stairway slabs and treads has caused numerous stones to break.

Treads have shifted out of position, resulting in non-uniform riser heights and depths.

In summary, stone slabs and treads are damaged, displaced, and no longer suitable for public use.

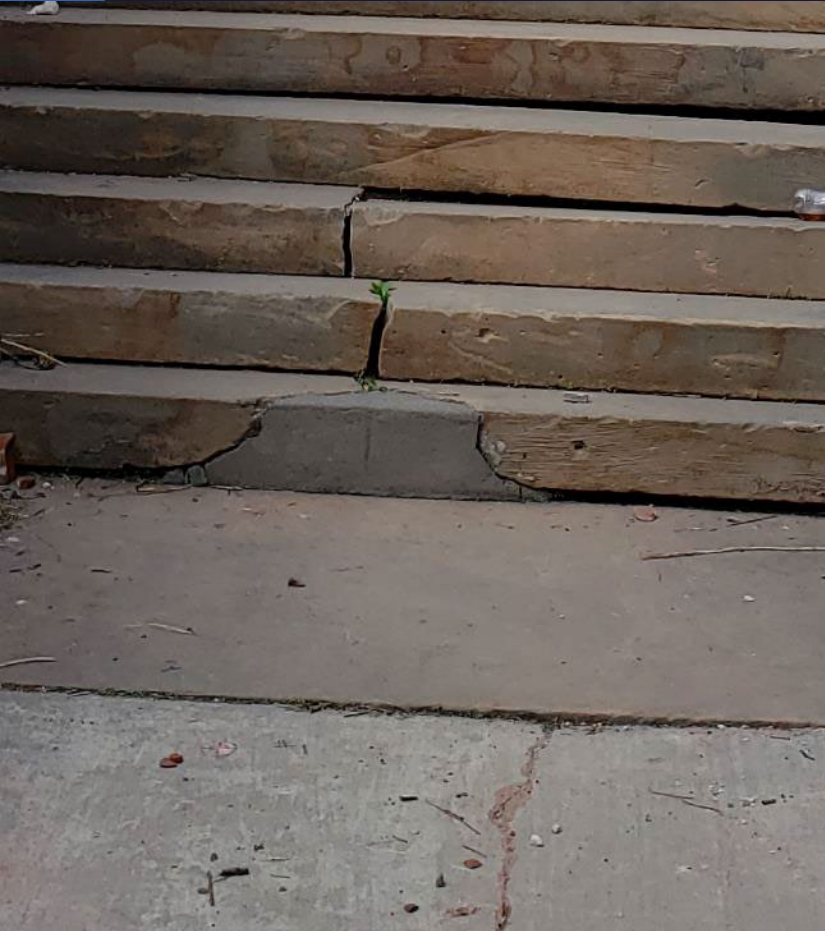
Erosion and settlement under the stairway slabs and treads has caused numerous stones to break.

Treads have shifted out of position, resulting in non-uniform riser heights and depths.
