2023 STORMWATER QUALITY AND QUANTITY MONITORING PROGRAM

CITY OF ST. PAUL

MARCH 22, 2024

WSB PROJECT NO. 022099

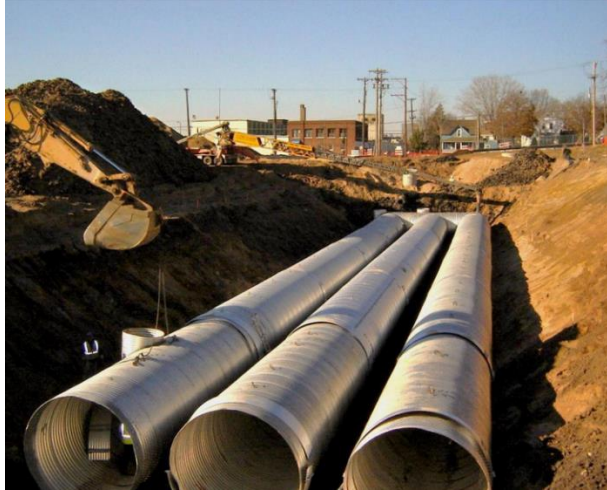
Photo 4-1: Underground Infiltration Chamber (Facing West)

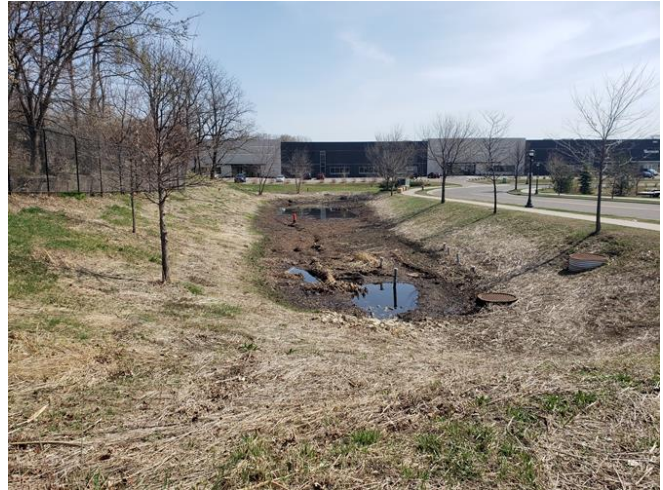
Photo 4-2: Rain Garden Located above Infiltration Chambers (Facing East)

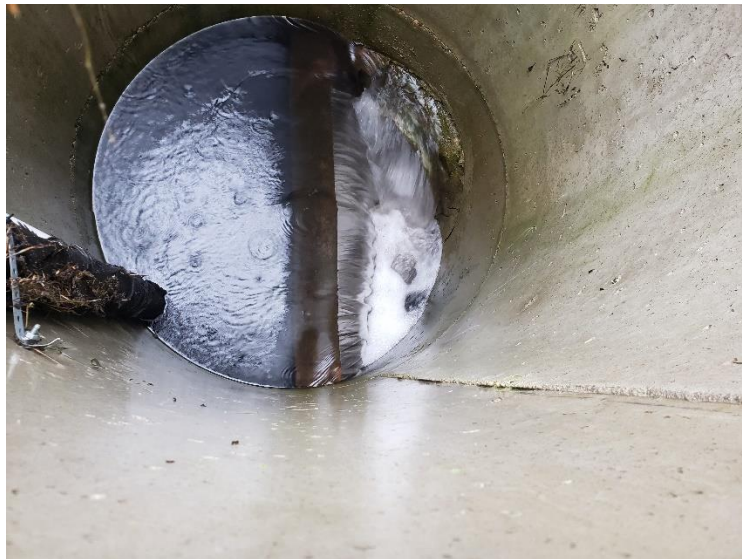
Photo 4-3: Water being conveyed back to the storm sewer from the underground chamber in the outlet control structure.

Overflow in the outlet control structure to the storm sewer, (**Photo 4-3**), occurred during eight treatment events. The 2023 underground chamber infiltration rate and infiltration rate trends are provided on **Charts A.3** and **A.4** of **Appendix A**, respectively. The 2023 average infiltration rate for the BMP Pipe was 0.11 inches per hour (in/hr). This is an increase from the rates observed in 2022 (0.06 in/hr) and 2021 (0.09 in/hr) (**Table 4-2**). Sediment accumulation has been observed ranging from 0.7 ft, across the basin. The 141.5-acre drainage area discharging directly to the pond conveys a significant amount of sediment and debris, which has accumulated primarily around the diversion inlet pipe. Dredge maintenance was completed on the rain garden over the Spring of 2019.

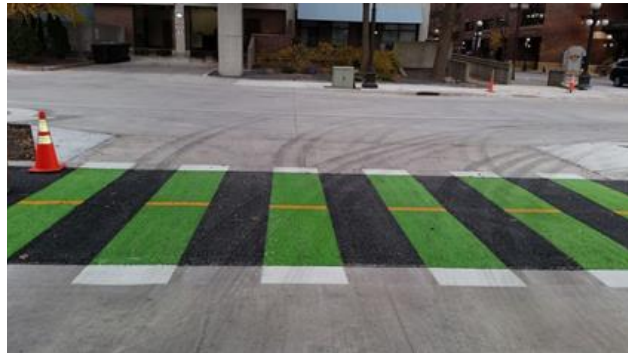
- Low traffic areas had an average infiltration rate of 180.9 in/hr in August 2023 and 187.9 in November 2023.
 - The average infiltration rate in August 2023 was 9% of the infiltration rate observed in November 2016 at low traffic locations.
- Medium traffic areas had an average infiltration rate of 0.0 in/hr in 2023.
 - Locations JS-7 through JS-11 are within the first constructed section of the pervious pavement near the Jackson Street and Kellogg Boulevard intersection. These locations have not shown any infiltration since October 2018.
- High traffic areas had an infiltration rate of 0.0 in/hr in 2023.
 - High traffic locations have not shown any infiltration since November 2017.

Photo 11-7: Test Locations JS-1 and JS-2 (high traffic)

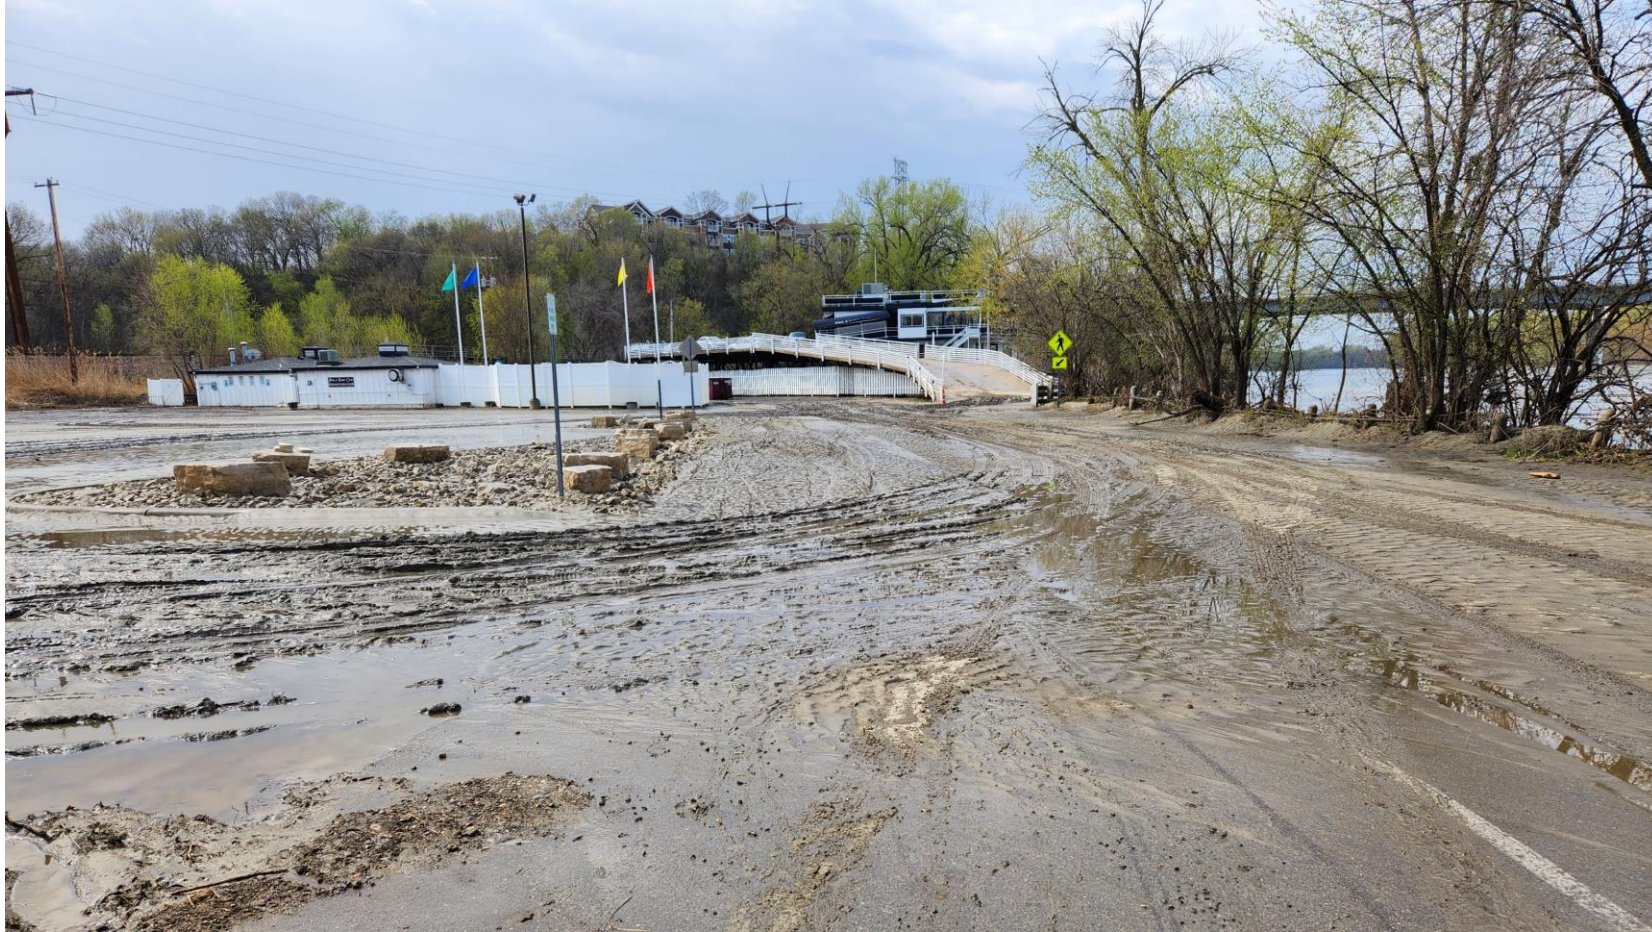
Lilydale Road 5/5/23

Sediment deposited after flooding near the St. Paul Yacht Club

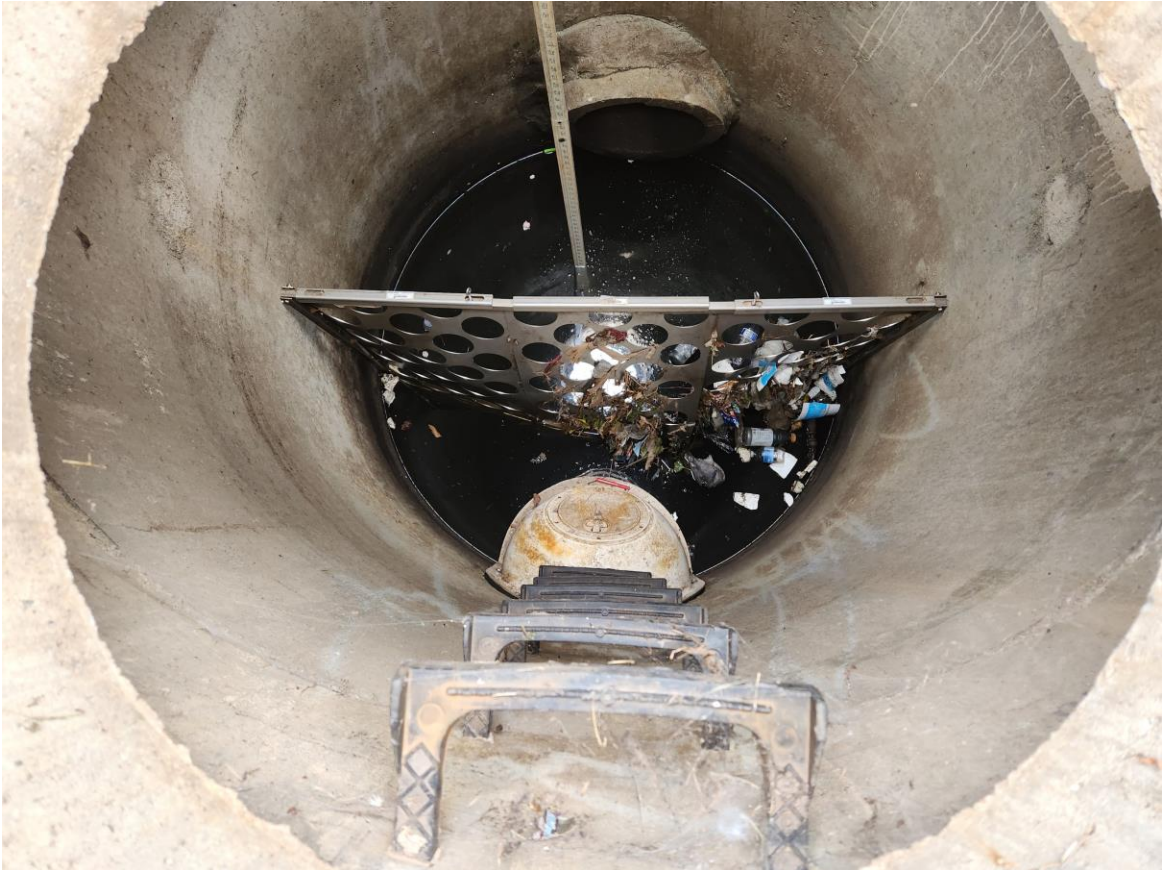
Beacon Bluff SAFL Baffle and Rain Garden - 11/7/23

Date	Sediment Depth in Pre-treatment (ft)	Sediment Depth in Infiltration Gallery (ft) ¹	Standing Water in Infiltration Gallery?	Observations
4/26/23	2.0	NM	Yes	Heavy sedimentation
5/23/23	2.2	NM	Yes	Lots of bottles
6/23/23	2.2	NM	Yes	Stagnant water in pre-treatment
7/27/23 – Pretreatment Cleaned				
8/17/23	0.4	NM	Yes	Dense vegetation in rain garden
11/7/23	0.4	NM	Yes	SAFL baffle bent
