2016 Water Quality & Quantity Monitoring Program

Monitoring Report

June 2017

**PREPARED BY:
WSB & ASSOCIATES, INC.
701 XENIA AVENUE SOUTH, SUITE 300
MINNEAPOLIS, MN 55416**

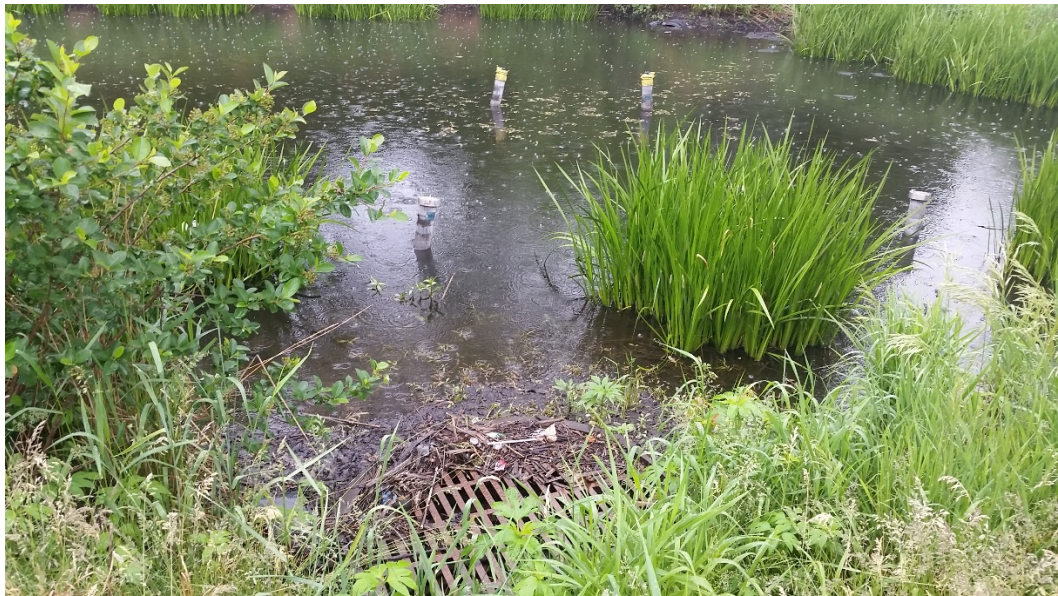
Photo 3-3: Rain garden and IR-32 (underground system) monitoring piezometers (yellow caps), and open grate overflow structure to underground chamber

Water level in the rain garden ranged from 0 feet (ft) to 3.8 ft of depth in 2016. Overflow from the rain garden to the underground system, through open grate structures (**Photo 3-3**), occurred during most treatment events. The 2016 infiltration rate and infiltration rate

trends are provided on **Charts A.3** and **A.5** of **Appendix A**, respectively. The 2016 average infiltration rate for the rain garden was 0.43 in/hr, which is less than the Minnesota Stormwater Manual (MSWM) recommended infiltration rate for SP (poorly graded sand) soils of 0.8 in/hr.

From 2012 to 2016, the infiltration rate in the rain garden decreased from 2.9 in/hr to 0.43 in/hr, with the largest decline following the first year of monitoring in 2012 (see **Table 3-2**). The decrease in infiltration in the rain garden is primarily due to sediment accumulation, which was observed ranging from 0.5 ft to 1.5 ft of depth, across the basin. The 141.5-acre drainage area discharging directly to the pond, conveys a significant amount of sediment and debris, which has accumulated primarily around the diversion inlet pipe. The rain garden was free of standing water for 33 out of 230 days monitored in 2016, primarily in early May and October.

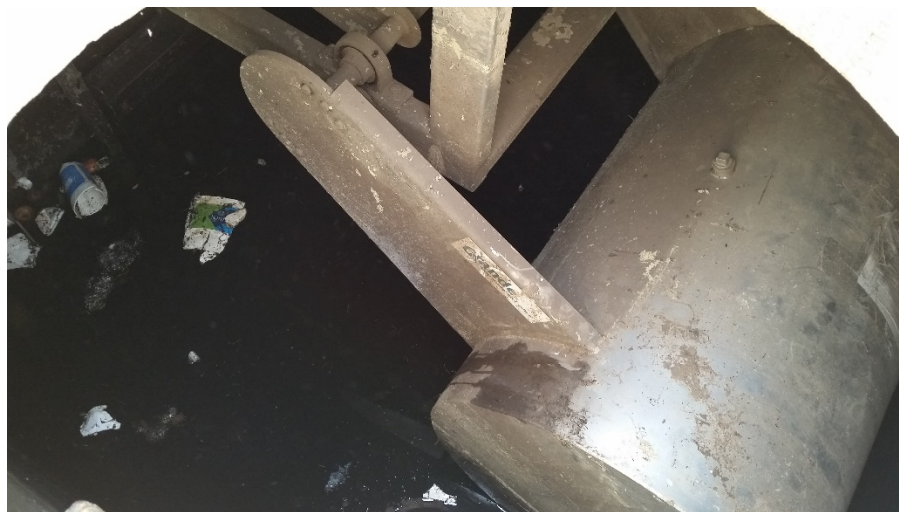
The float mechanism for the system gate valve was inspected regularly in 2016. The float was exercised during multiple maintenance visits in 2016 to ensure that it was not stuck in the closed position, which would result in excess flow bypassing the infiltration system. Maintenance of the float is recommended for 2017. Photos from the inspection visits are included in the photo log (**Appendix D**).

Photo 4-3: System gate valve and float

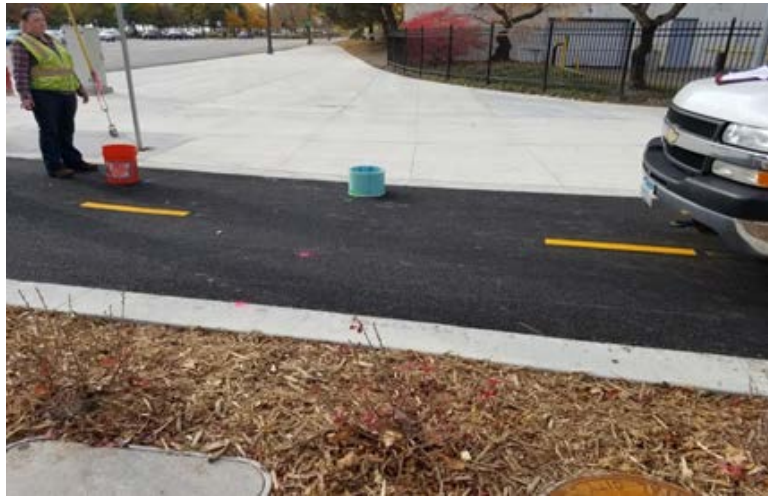
Photo 13-10: Ring is Located on JS-10, Pink Dot on Path is Location of JS-11

During testing, there was significant variability in infiltration rates for a given pavement section. In some instances, visual observations of the surface gave a clear indication as to how well the chosen site would infiltrate. Some testing observations and recommendations are summarized below:
