# 2017 Water Quality & Quantity Program

## Monitoring Report

April 2018

Project No. 01610-10

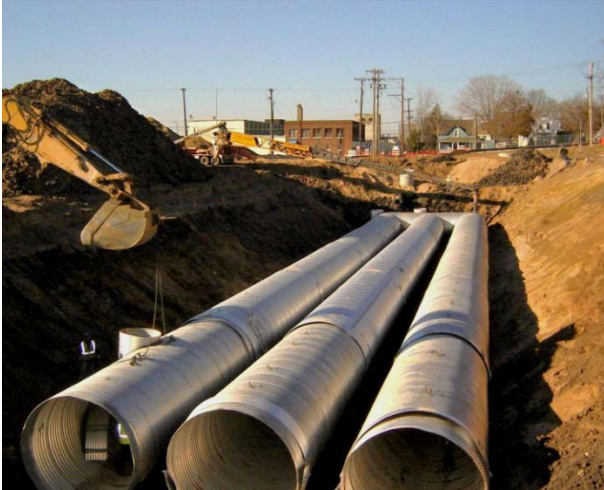
Photo 4-1: Underground infiltration chamber (Facing west)

Water level in the underground system ranged from 6.3 ft to 19.5 ft deep. Depths greater than 10 feet indicate the water is rising into the substrate above the 10-ft diameter corrugated metal infiltration pipes. The data indicates that the system did not drain to empty during the 2017 monitoring period, including over the winter months. The underground system discharged back to the storm sewer (system outflow) during ten storm events in 2017. This is an increase from discharge events occurring in 2012-2014 (zero), 2015 (five) and 2016 (nine). The increased frequency of system discharge events is a result of the standing water in the underground system and the capacity it utilizes. Groundwater elevations at the site were a minimum of 12 ft below the bottom of the underground chamber, which suggests that groundwater mounding is not the cause of standing water in the system.

The 2017 underground chamber infiltration rate and infiltration rate trends are provided on **Charts A.3** and **A.4** of **Appendix A**, respectively. The 2017 average infiltration rate for the was 0.11 in/hr, which is less than MSWM recommended infiltration rate for SP soils of 0.8 in/hr. From 2012 to 2017, the infiltration rate has decreased from 2.6 in/hr to 0.11 in/hr, with the largest decline following the first year of monitoring in 2012. As mentioned above, standing water in the underground system has resulted in a decrease in infiltration rates each year.

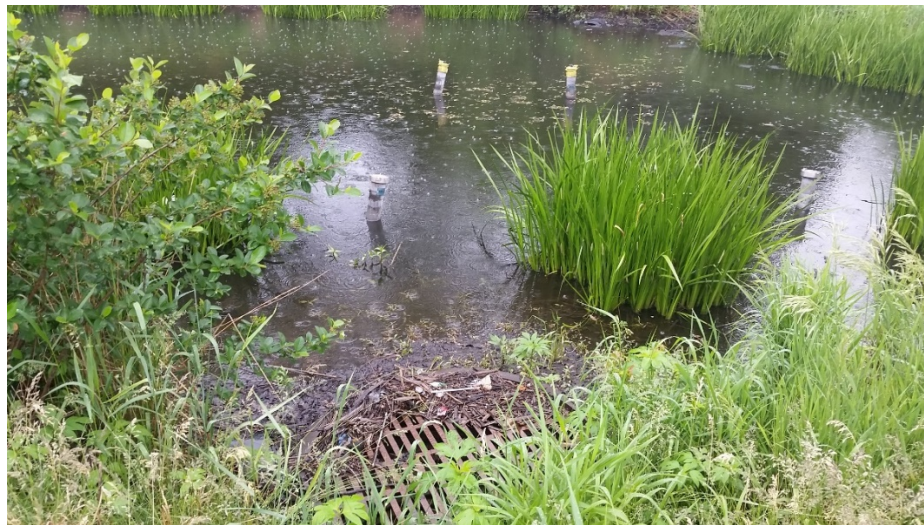
Photo 4-3: IR-31 (Rain garden) and IR-32 (underground system) monitoring piezometers (yellow caps), and open grate overflow structure to underground chamber

Water level in the rain garden ranged from 0.0 feet (ft) to 3.5 ft of depth in 2017. Overflow from the rain garden to the underground system, through open grate structures (**Photo 4-3**), occurred during most treatment events. The 2017 rain garden infiltration rate and infiltration rate trends are provided on **Charts A.5** and **A.6** of **Appendix A**, respectively. The 2017 average infiltration rate for the rain garden was 0.50 inches per hour (in/hr), which is less than the Minnesota Stormwater Manual (MSWM) recommended infiltration rate for SP (poorly graded sand) soils of 0.8 in/hr. This is slightly greater than the rates

observed in 2016 (0.43 in/hr) and 2015 (0.29 in/hr) (**Table 4-2**). Sediment accumulation has been observed ranging from 0.5 ft to 1.5 ft of depth, across the basin. The 141.5-acre drainage area discharging directly to the pond conveys a significant amount of sediment and debris, which has accumulated primarily around the diversion inlet pipe.

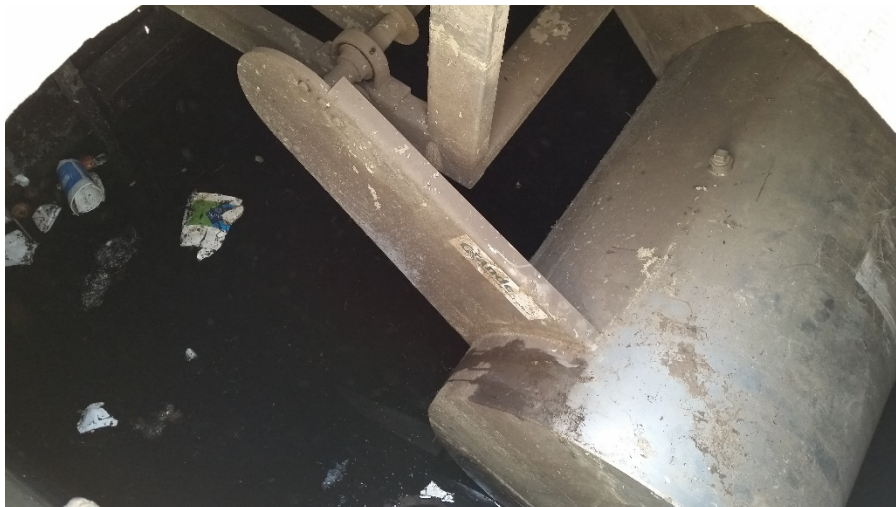
The float mechanism for the system gate valve was inspected regularly in 2017 (**Photo 5-3**). The float was exercised during multiple maintenance visits in 2017 to ensure that it was not stuck in the closed position, which would prevent flow from entering the infiltration system. Photos from the inspection visits are included in the photo log (**Appendix E**).

**Photo 5-3: System gate valve and float**

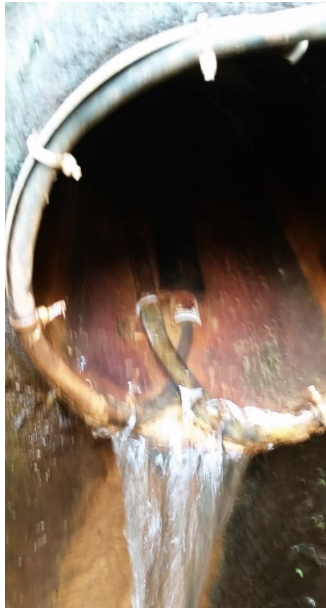
Total iron in the effluent at Magnolia and Jenks Ponds decreased by 45% and 61%, respectively. Iron in stormwater is often particulate-bound, therefore a reduction in suspended solids by filtration will also result in capture of the particulate-bound metals. In comparison, total iron in the effluent at Maryland Pond increased by a median of 29%. The increase in iron is suspected to be related to continuous flow through the IESF media. Additionally, iron precipitate was also observed accumulating at the drain tile outlet (**Photo 11-5**). Based on the analytical data and observed precipitate, it is suspected that continuous flow may be creating anaerobic conditions, which have contributed to the export of iron from the media beds. Additionally, with anaerobic conditions present, iron-bound phosphorus (captured SRP) can become mobile. It is important to note that this may be occurring at only a small portion of the media bed, while other areas of the IESF bench are adequately aerated and functional. It is recommended that the source of the continuous flow be further evaluated in 2018.

**Photo 11-5: Iron Precipitate at drain tile outlet to OCS**

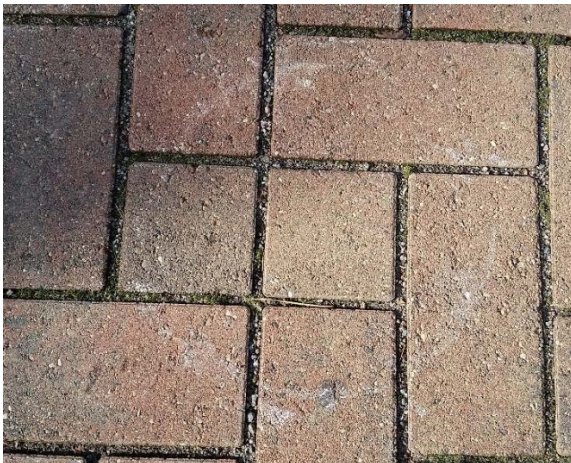
- The overall site infiltration rate decreased from 3.33 in/hr in 2016 to 1.19 in/hr in 2017
- No infiltration was observed at Location D, which is consistent with 2015 and 2016 testing
- Infiltration rates at Locations A, B, and E (**Photo 14-3** and **14-4**) decreased from 2016 to 2017, while Location C remained the same

**Photo 14-3: Location E Pre-test**

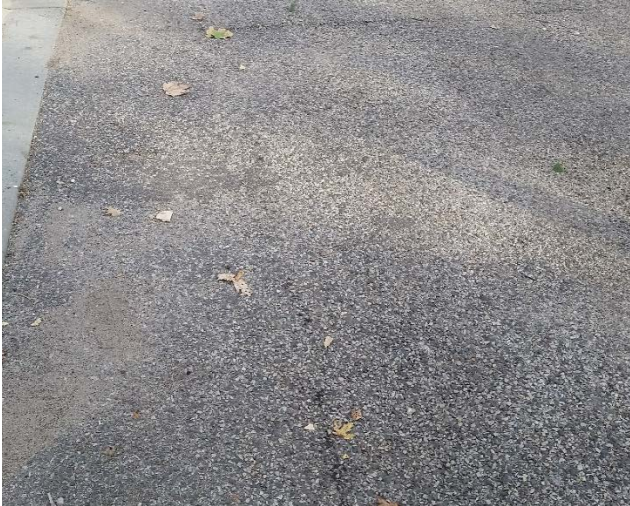
- Rehabilitative maintenance completed at the site prior to the 2016 infiltration testing, did not result in an increase in infiltration rates across the site (City of Saint Paul, 2017). That maintenance was completed in accordance with recommended rehabilitative practices by the Minnesota Department of Transportation (MnDOT) (MnDOT, 2015).

**Photo 14-7: Near IR-4, compaction & heavy silt accumulation**

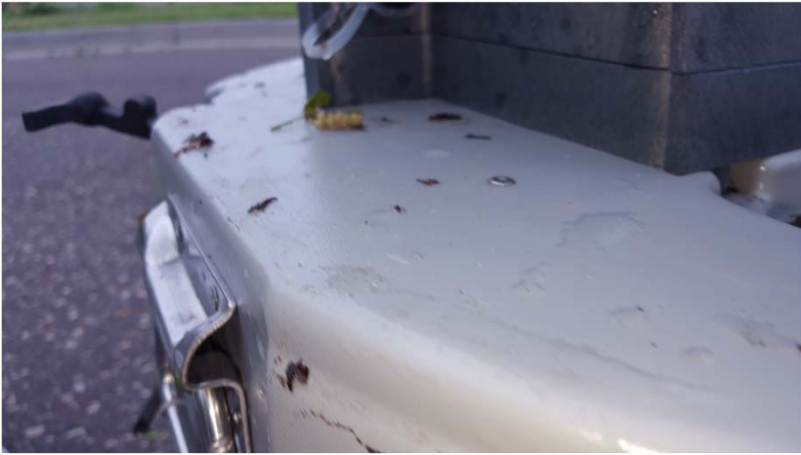
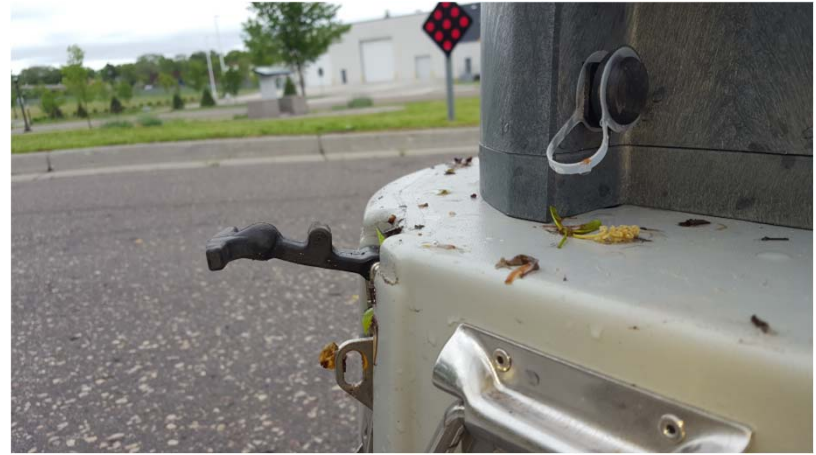
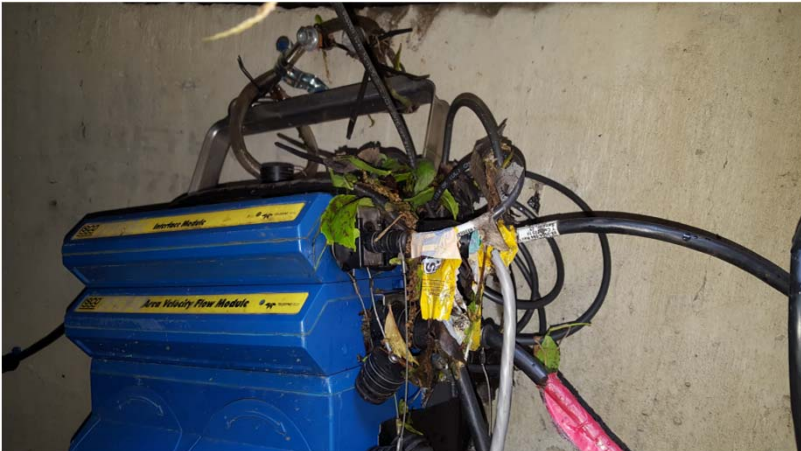
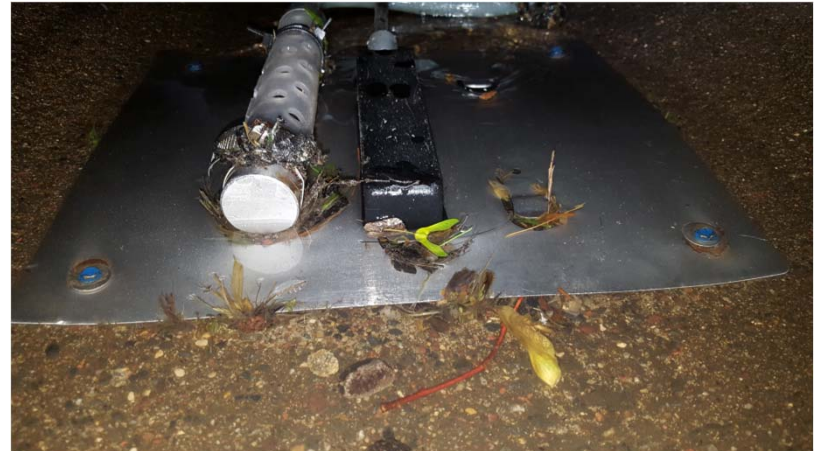
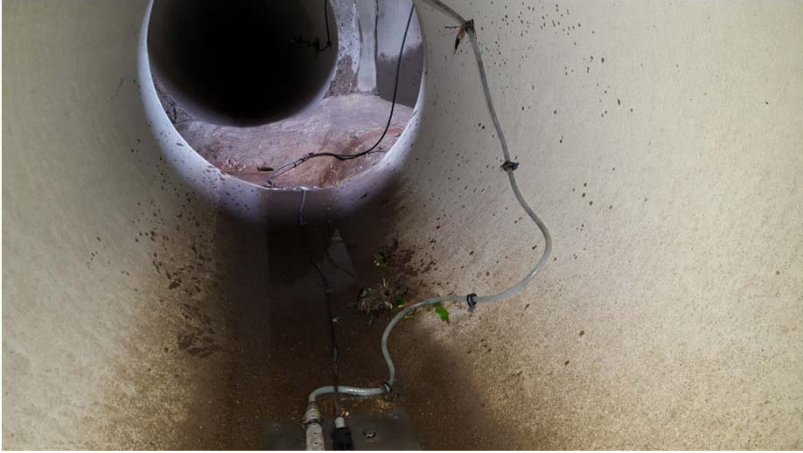
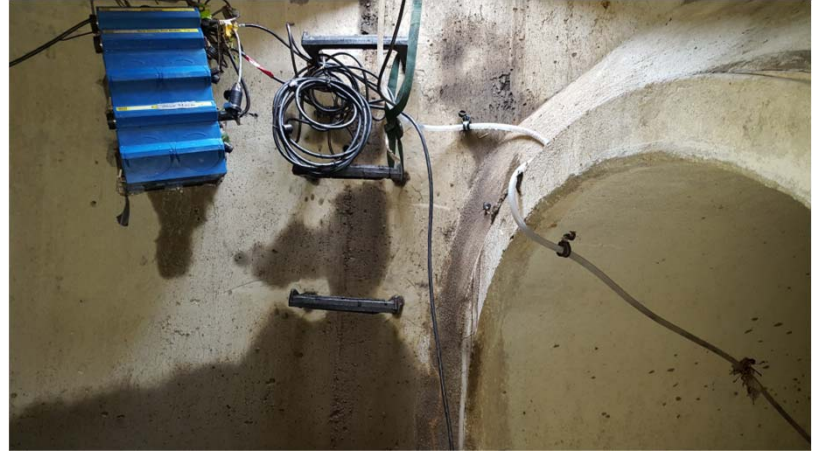
Photos indicating water levels and damage after at 1.54" rain even on 5/17/17  
Beacon Bluff
