**Mattson
Macdonald
Young**
structural
engineers

24 November 2015

Project No.: 15688.00
Re: Structural Condition Review of the building at 208-210 Bates Ave.

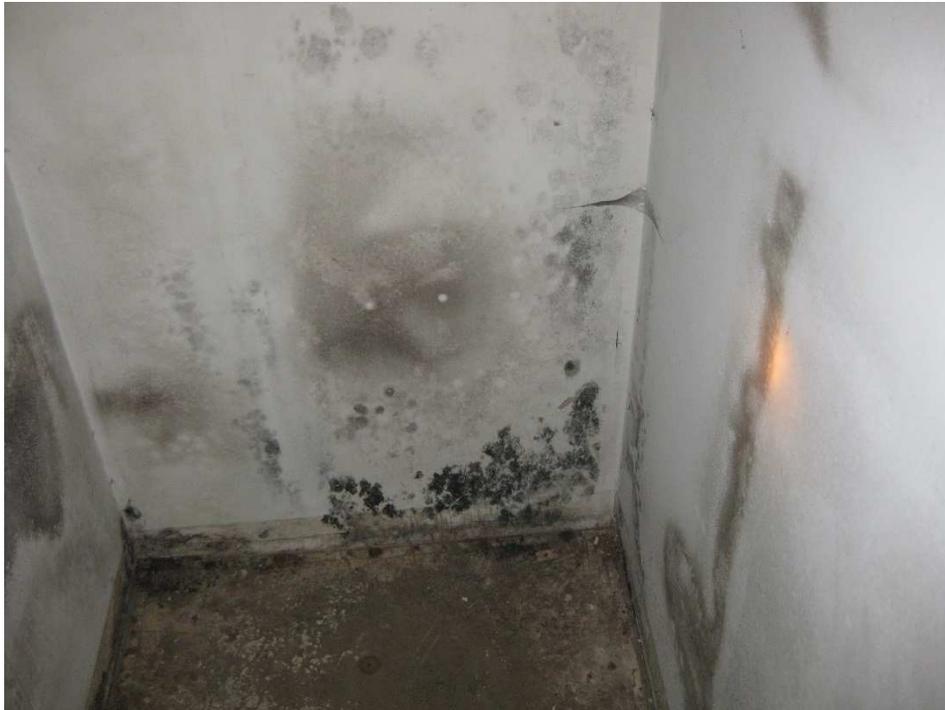
Mold is abundant throughout the building. Picture 1 and Picture 2 show two instances of mold that is growing in the building, which is likely caused by water infiltration. The floor was damp in many places throughout the first level of the building. Dampness to a rug can be seen in Picture 3. Mold was observed on each of the levels including the basement.

Picture 1 – Mold in Building

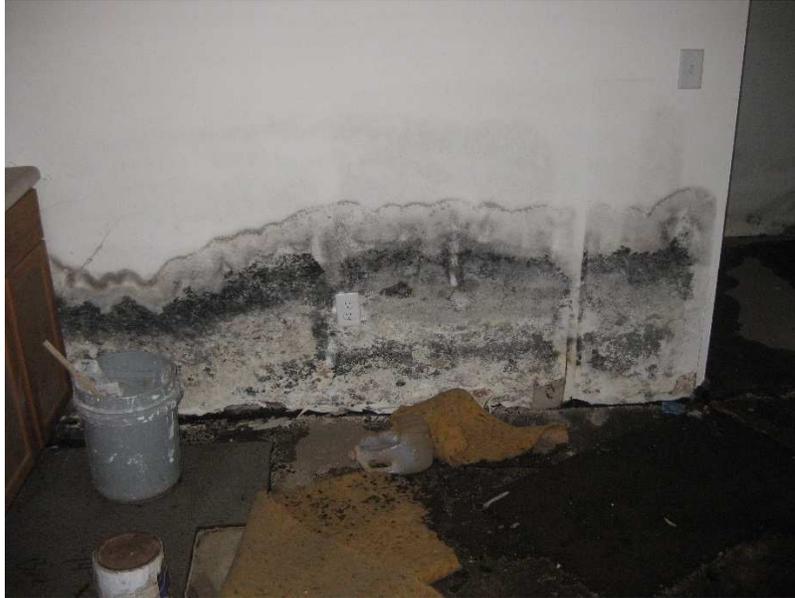
Picture 2 – Mold in Building

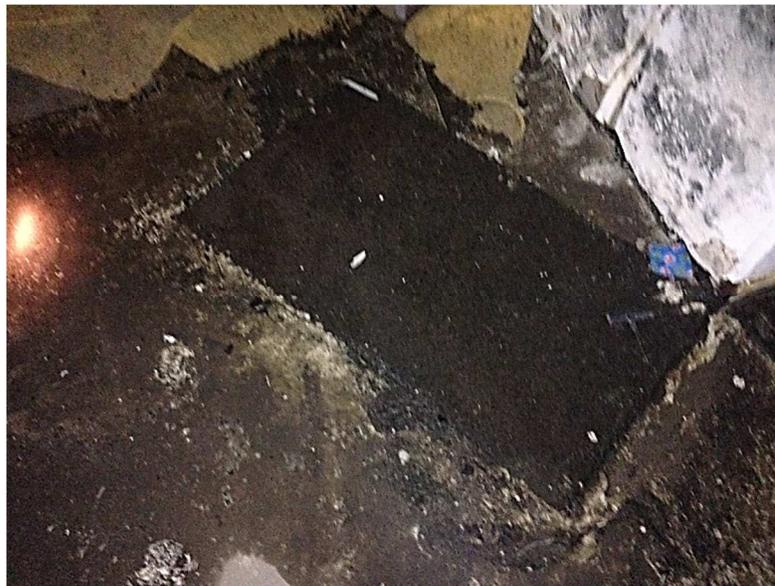
Picture 3 – Dampness to a Rug

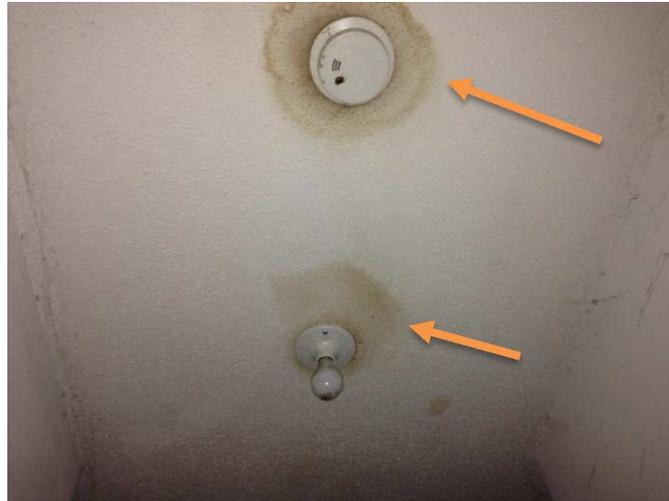
Water damage was also observed in the ceiling at the second floor. Picture 4 and Picture 5 show some of the places where the damage is. The water infiltration is most likely due to an extensively damaged roof. A hole through the ceiling and roof was found. Picture 6 shows the opening. The water damage was observed in most rooms throughout the second floor, so it is likely that the roof is damaged in more than one place. It was also noted that there was no insulation above the ceiling in the location that was open.

Picture 4 – Water Damage at 2nd Floor Ceiling

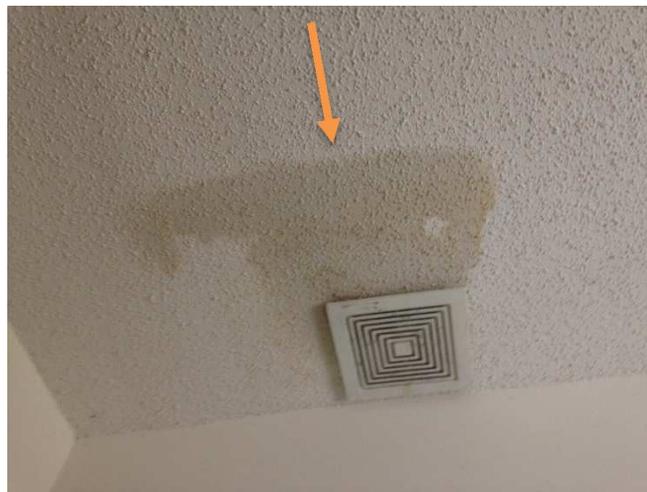
Picture 5 – Water Damage at 2nd Floor Ceiling

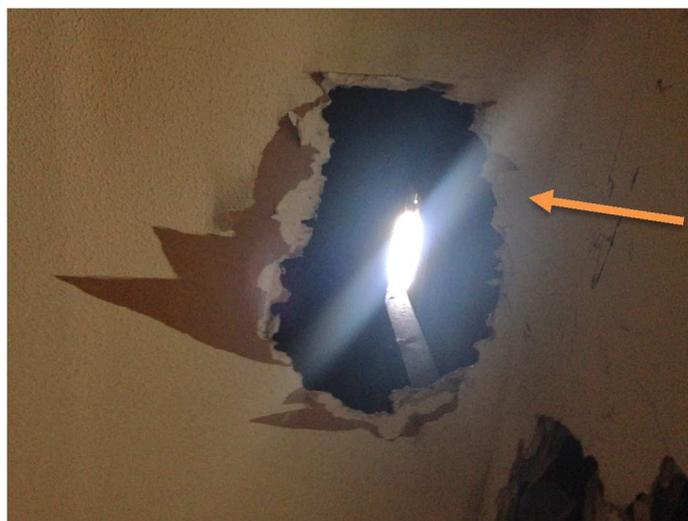
Picture 6 – Hole Through Ceiling and Roof

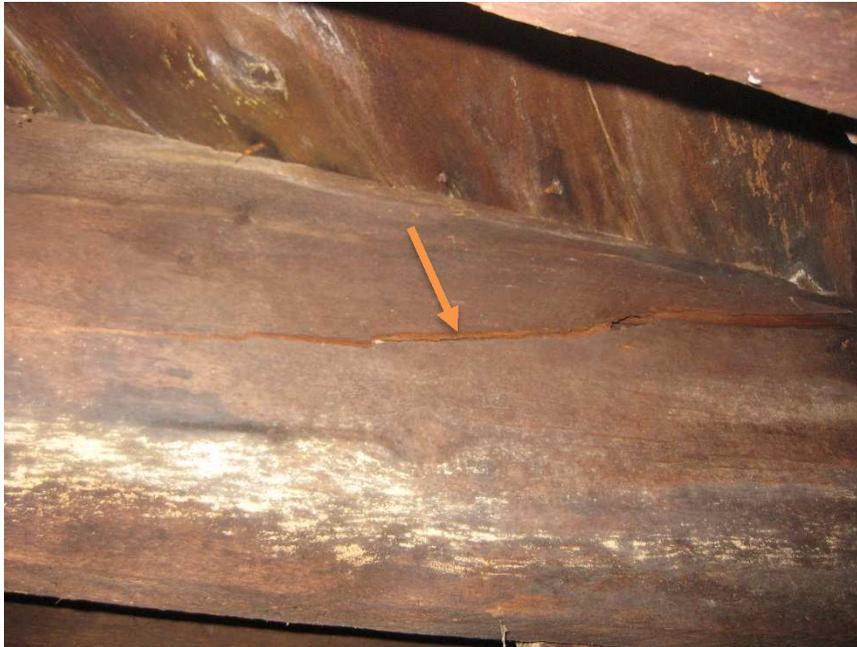
The floors sloped slightly toward the center of the building. The stairs also had a slight sideways slope to them. This is likely due to the settlement of the building along the load resisting system at the center of the building. Most of the joists in the basement appeared to be in good condition. There were a couple of exceptions. One of the joists has a crack in it and another is damaged at the foundation wall. Picture 7 shows the crack and Picture 8 shows the damaged member.

Picture 7 – Crack in Floor Joist

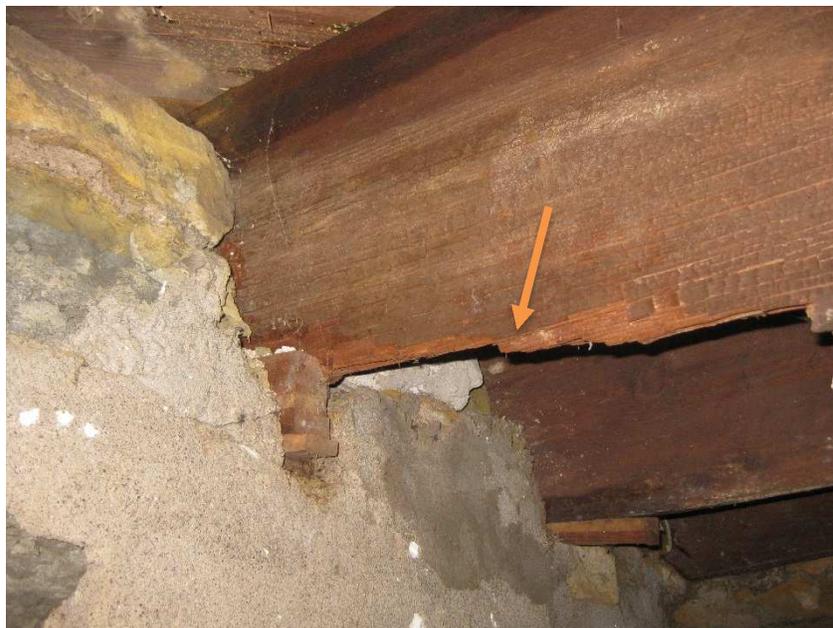
Picture 8 – Damaged Floor Joist

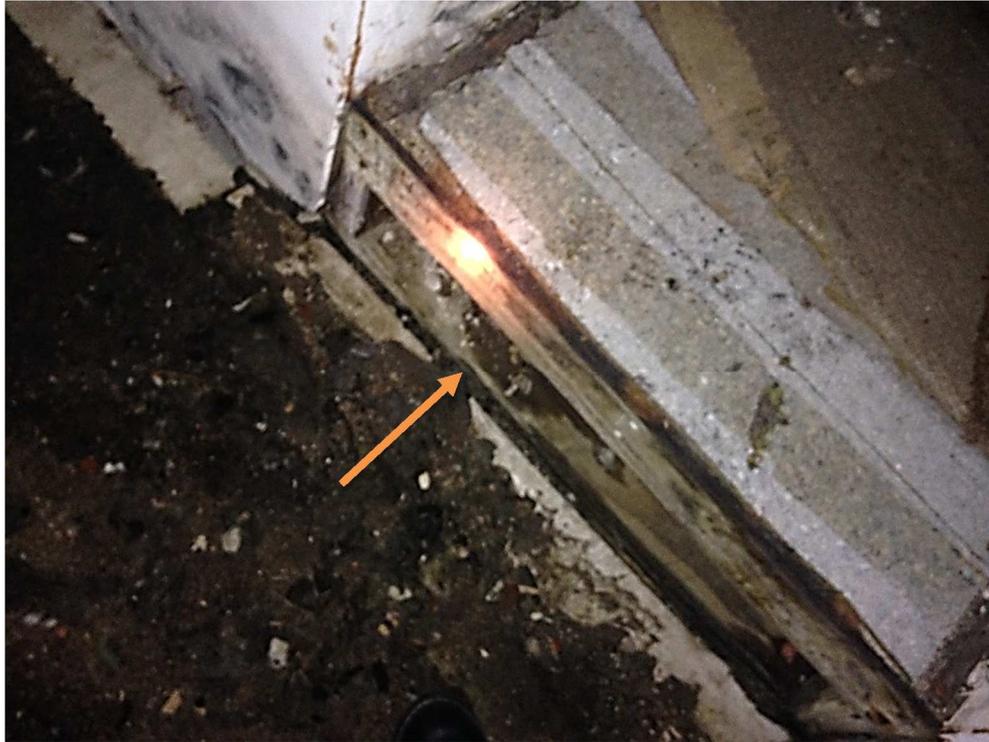
Some of the rooms on the first floor are raised above the rest of the floor by a step. There are many places where the raised flooring is failing. There is significant sagging that can be felt as a person walks through a room that is supported by one of these. It is likely that the OSB and the wood members that support it have extensive water damage. Picture 9 shows one such step up. On the left side of the picture is the standard floor and the right side is the elevated room. The arrow in the picture is pointing at the wood framing that is exposed.

Picture 9 – Raised Flooring

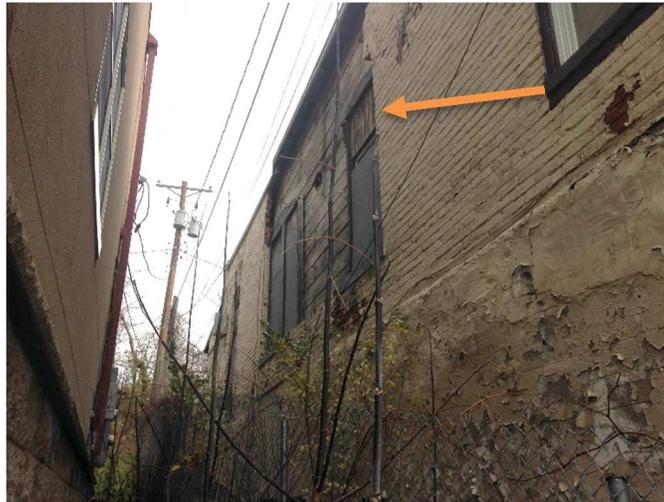
Some of the clay masonry bricks at the northeast face of the building's exterior are missing and some are leaning away from the main structure. Picture 10 shows the northeast face of the building. The missing bricks are apparent in the picture. Picture 11 shows the bricks above the window that are leaning away from the main structure. It is likely that the bricks were improperly tied to the structure or the ties that were used have deteriorated and are no longer functioning properly. The clay masonry bricks at the southwest face of the building have been reinforced to prevent the bricks from falling off the building. Picture 12 shows the bricks at the southeast face along with the reinforcement.

Picture 10 – Northeast Exterior Wall

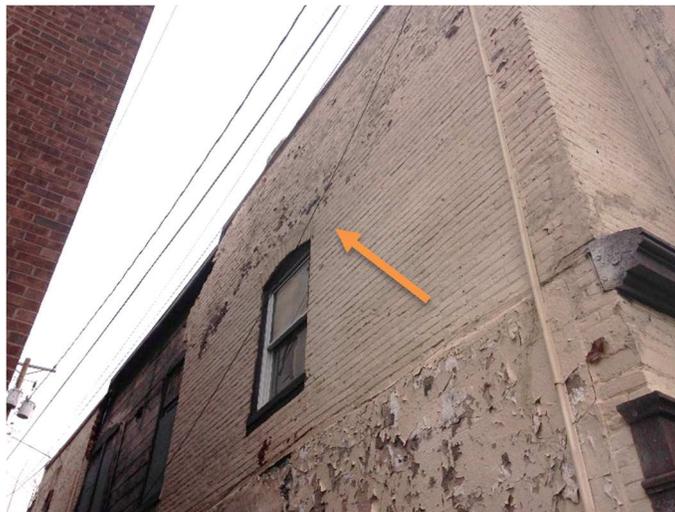
Picture 11 – Leaning Bricks at Northeast Face

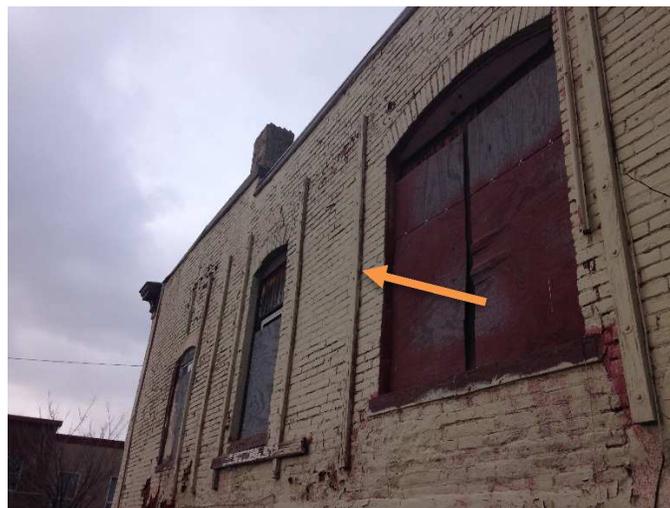
Picture 12 – Reinforced Bricks at Southwest Face

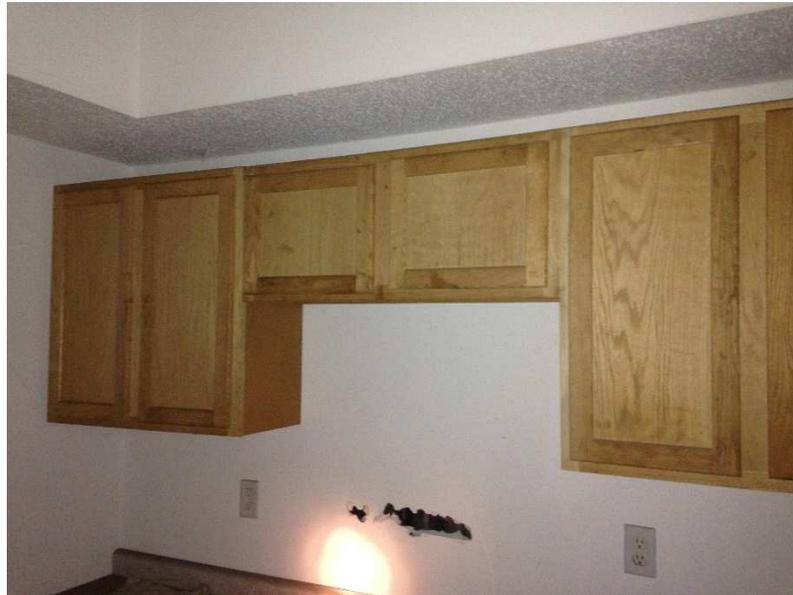
It appears as if a renovation began some time ago in the building, but was never finished. Cabinets, counters, water heaters, and carpeting (in the second floor) all seem nearly brand new. Most of the new material seems salvageable. Picture 13 shows one set of new cabinets that were installed and Picture 14 shows a water heater that appears in good condition.

Picture 13 – Cabinets

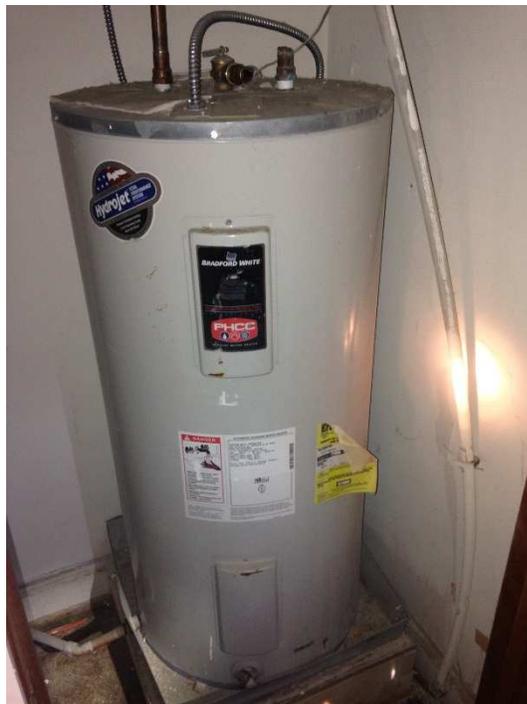
Picture 14 –Water Heater
