**HAZARDOUS MATERIALS SURVEY**

216/218 Bates Avenue  
St. Paul, Minnesota 55106

May 11, 2012

**ASBESTOS and LEAD-BASED PAINT  
PRE-RENOVATION INSPECTION  
SITE EVALUATION**

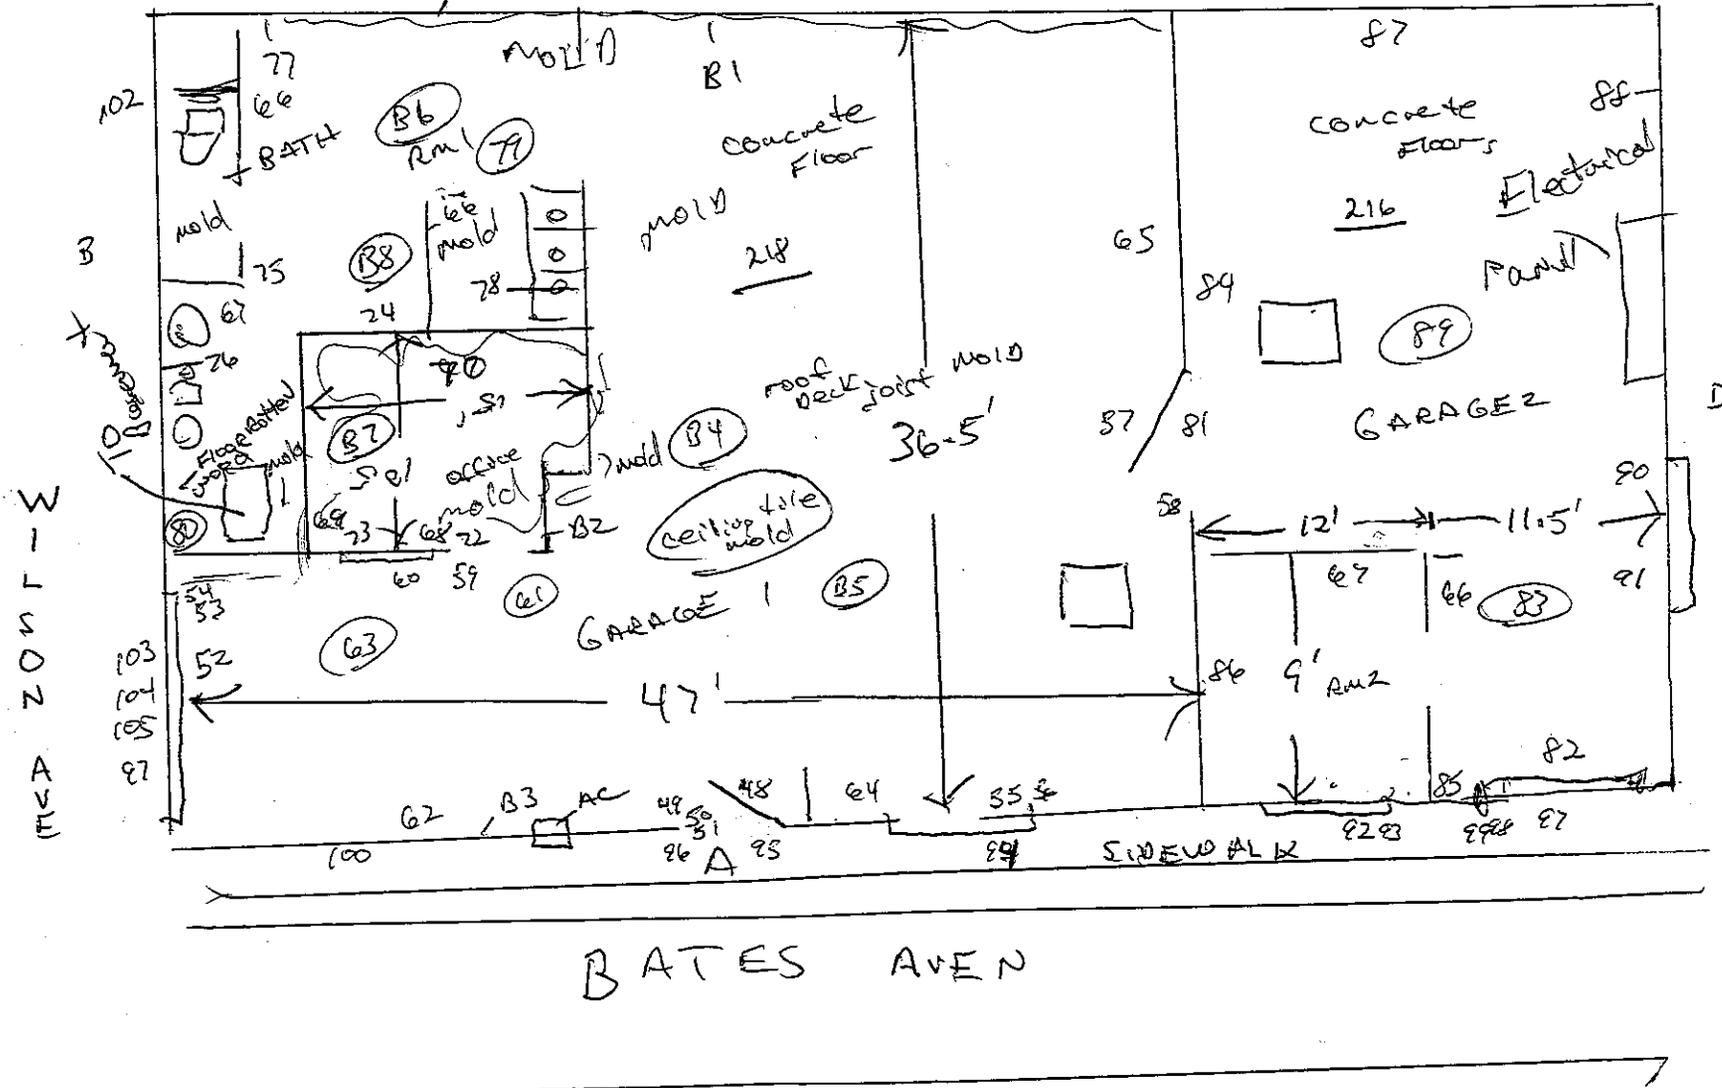
MAIN LEVEL  
 216-218 BATES AVENUE  
 ST PAUL, MINNESOTA  
 SKETCH NOT TO SCALE  
 DRAWN BY: GREG MYERS  
 MIDWEST ENVIRONMENTAL CONSULTING  
 DATE: MAY 7 2012  
 106

856/0512B-B19 5/7/12	South roof flashing sealant	10% Chrysotile in layer 1	Throughout
-------------------------	-----------------------------	------------------------------	------------

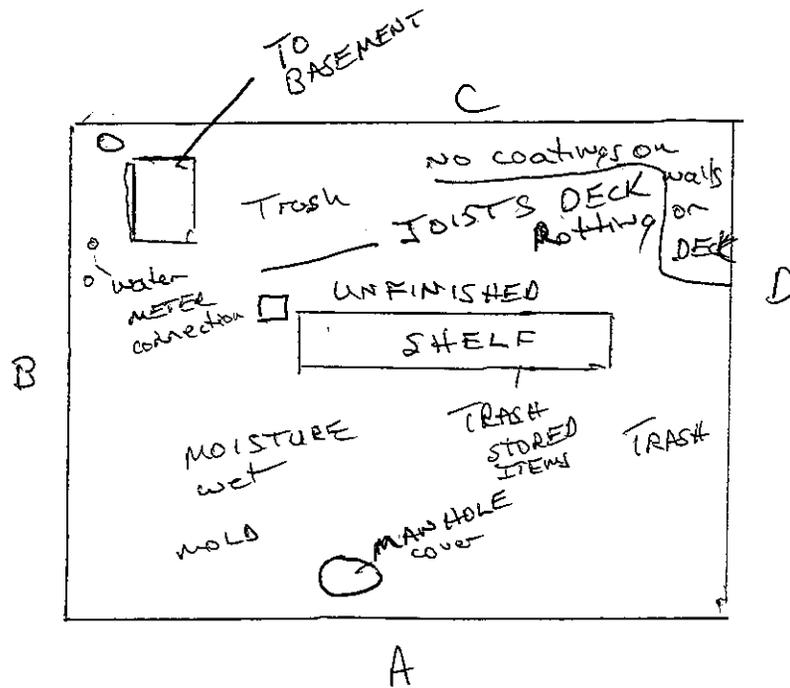
NOTE: CAST IRON  
WASTE LINES  
OFTEN HAVE  
Asbestos oakum  
and lead joints  
not tested - Assumed
