**Mattson
Macdonald
Young**
structural
engineers

14 September 2015

Project No.: 15536.00
Re: Structural Condition Review of the building at 275 Bates Ave.

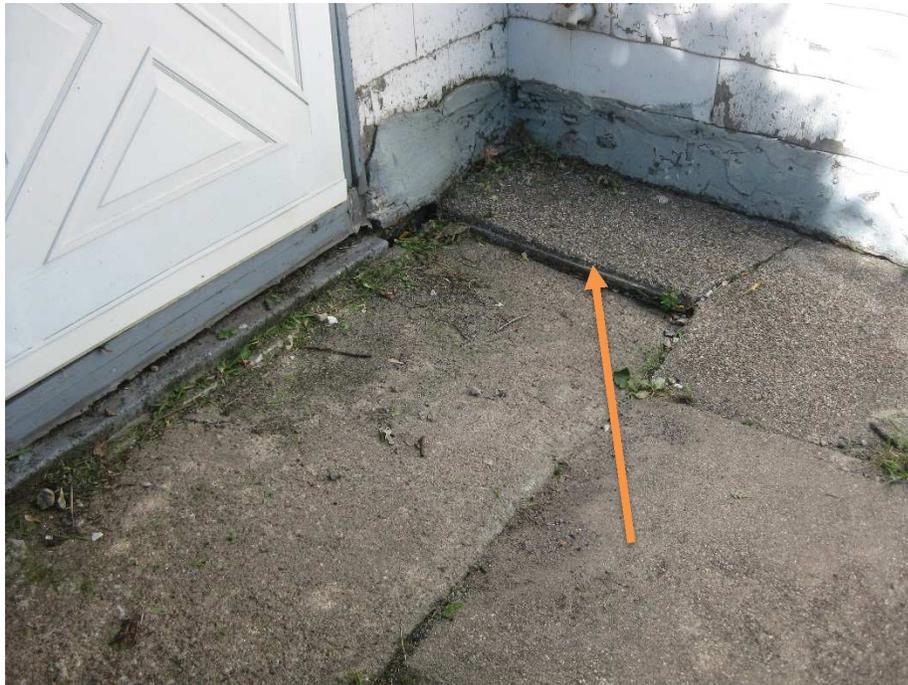
The front porch slab that is assumed to rest directly on grade has settled approximately 1". Picture 1 shows the displacement of a slab joint. The most likely cause of this settlement is water intrusion of the soil below the slab. Picture 2 shows the same slab from a different angle. Runoff along the foundation walls will continue to cause deterioration and may result in freeze thaw damage.

Picture 1 – Front Slab Settlement

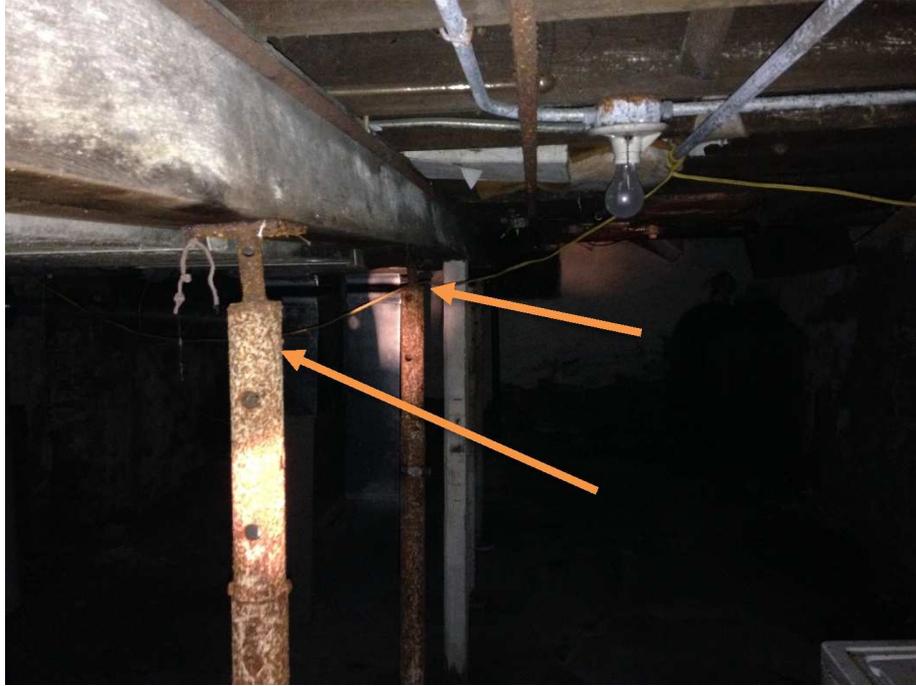
The foundation walls were observed to be crumbling, cracking, and bulging from inside the basement. Pictures 7 and 8 show portions of the walls that are deteriorating. In the basement there are a number of shoring columns that are holding up the beams of the first floor. The shoring columns are rusted and some of them are bent. Picture 9 shows two such shoring columns.

Picture 9 – Shoring Columns Supporting a Beam

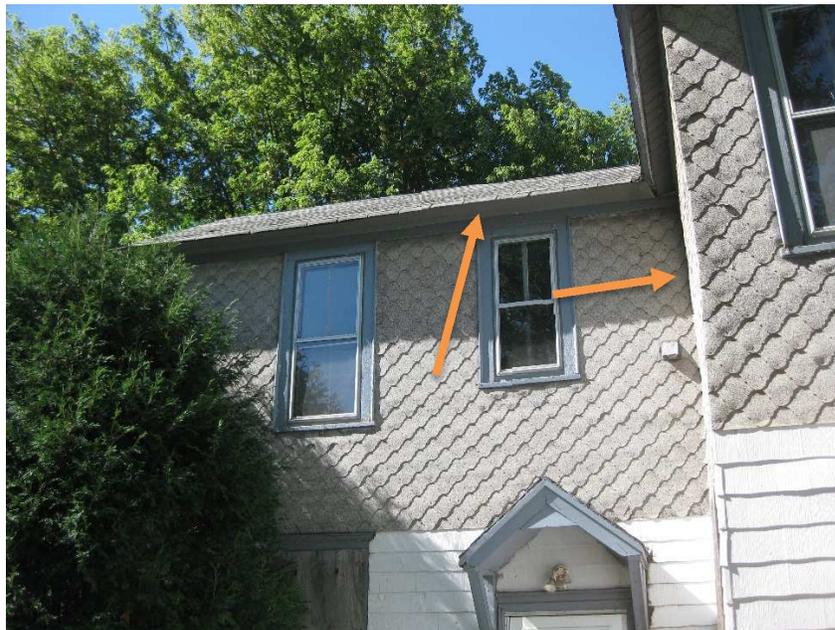
The roof and exterior walls, as observed from the outside, appeared to be in good condition. The roof was flat and there were no obvious problems. The exterior walls appeared to be plumb. Picture 14 shows one such roof and wall.

Picture 14 – House Roof and Exterior Wall
