ASBESTOS AND LEAD-BASED PAINT SURVEY

737 Plum Street
St. Paul, Minnesota

January 27, 2012

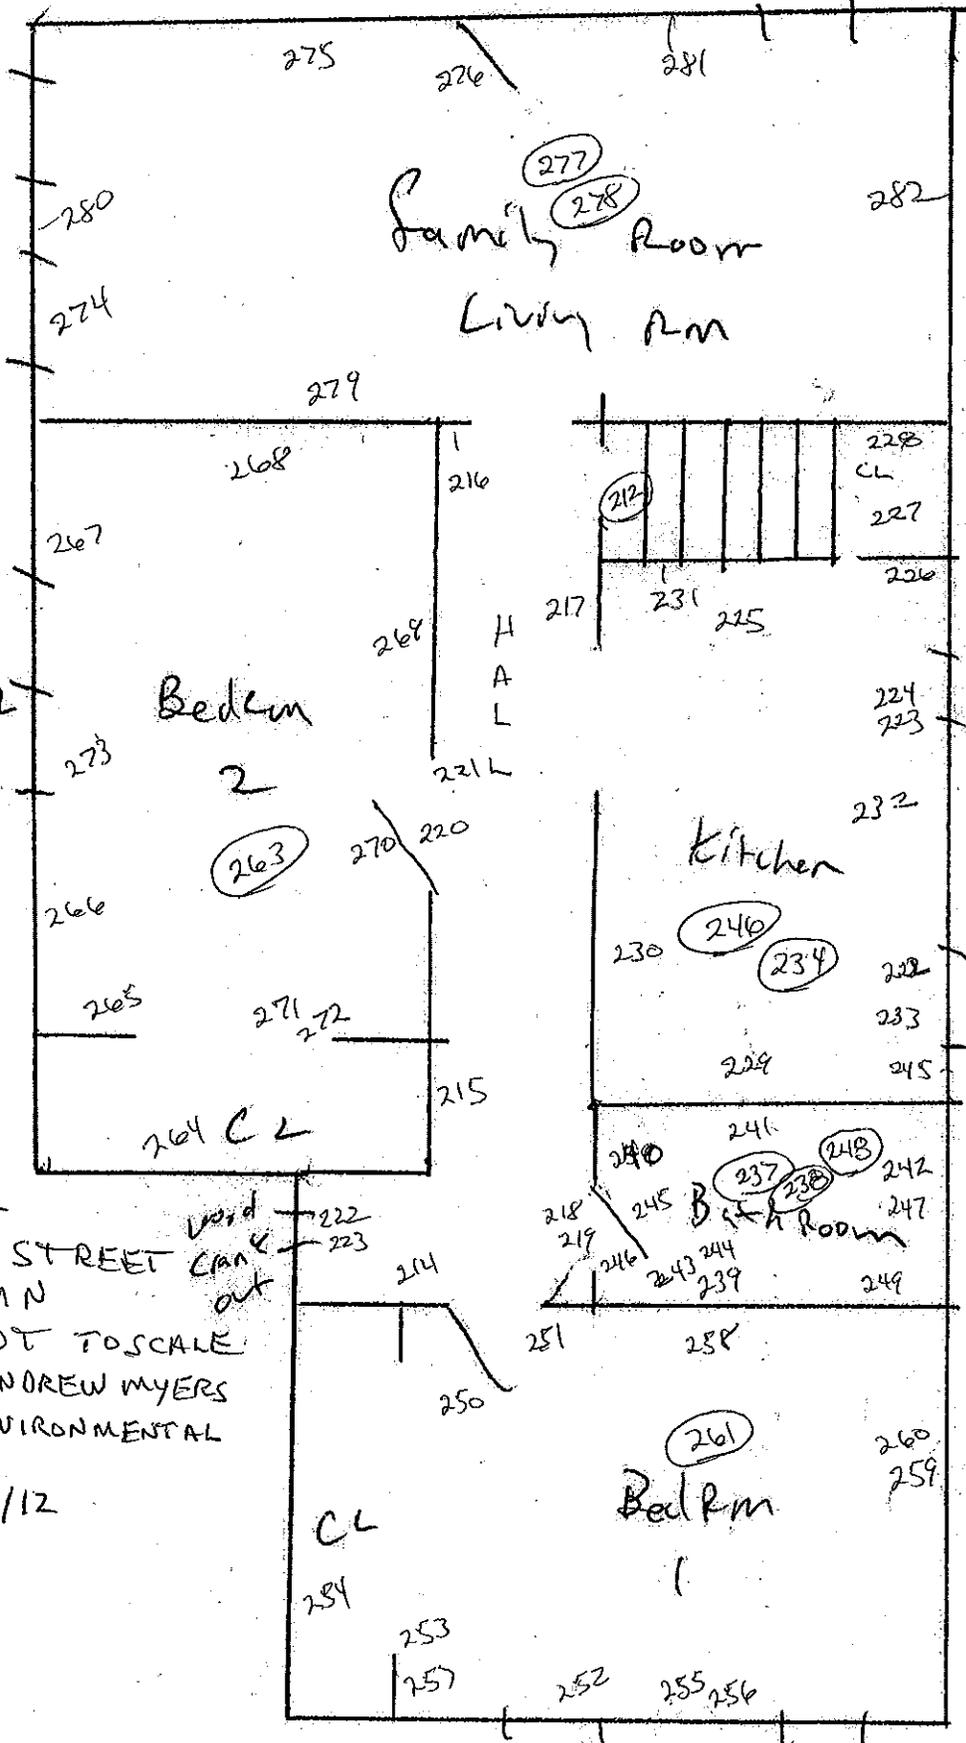
SECOND FLOOR

Wood
Crack
out
