737 Plum Street
Saint Paul, Minnesota

Structural Observations and Report

March 25, 2016

LINDAU
COMPANIES, INC.

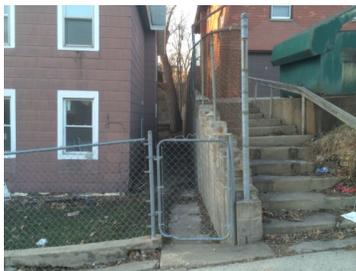
Lot Line Retaining Wall

This earth retaining wall is constructed with 12” concrete masonry units, likely grouted solid in many areas, and reinforced. The wall is approximately 90’ long and retains as much as 9’-8” of earth tapering down to 2’ of retained earth at the southernmost point where the wall intersects the sidewalk on Plum Street. The southernmost 35’ of wall is experiencing bulging, bowing and leaning. Lindau Companies estimates the displacement along the southernmost section of wall to be in the range of 3”-6”. Two large vertical cracks, spaced about 4’ apart, create a clear marker of where the wall transitions from a fair condition to a

distressed condition. The northernmost 55' of wall may be supporting surcharge loading from an adjacent apartment complex. The northernmost 55' of retaining wall has some isolated deterioration and efflorescence, but is generally appears to be in fair condition.

The southernmost 35' of wall is experiencing severe leaning, bowing, and bulging. This portion of wall should be removed and replaced or strengthened. We believe drainage from the apartment complex is exacerbating the retaining wall movement by creating saturated soil conditions and earth pressures that are in excess of the design pressures. The apartment complex roof downspout that is currently draining behind the earth retaining wall should be redirected to avoid saturating the retained earth. The apartment complex pavement has settled and slopes toward the retaining wall. This pavement should be curbed and sloped away from the retaining wall to prevent surface water from saturating the retained soil. The northernmost 55' of retaining wall appears to be stable and in fair condition. This wall should have isolated repair work and preventative maintenance.

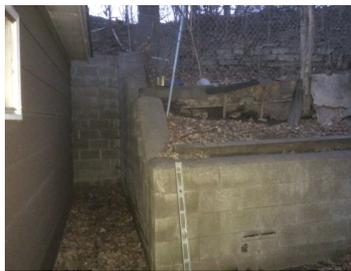
Garage Retaining Wall

The garage retaining wall is a 12" concrete masonry wall with a rounded mortar cap. The wall has four sections connected by three 90 degree angles. The wall retains between 8' and 4' of earth. Lindau Companies did not inspect the westernmost section of wall because the wall is identified on the certificate of survey as being 0.7' west of the subject property line. The wall appears to be in good condition and performing its intended function.

The garage retaining wall appears to be in good condition, performing adequately, and should not require any immediate repairs. A small amount of isolated masonry repair and some preventative maintenance work is recommended.

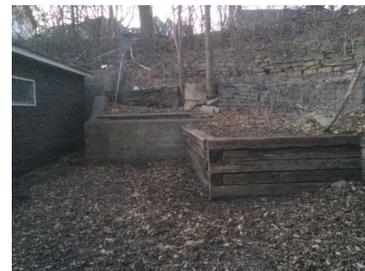
Terraced Retaining Wall

The property has four tiers of terraced retaining walls on the northeast corner. The lowest tier is constructed with railroad ties. The meandering upper three tiers are mostly constructed of limestone with a small amount of concrete masonry segmental retaining wall units. The walls typically retain 3'-4' of earth. The walls are disturbed by tree growth and generally appear dilapidated. Based on visual observation and review of the Certificate of Survey, the hill slope is estimated to be about 30 degrees. There is some evidence of hillside sloughing and sliding, which would indicate that the hillside slope is near or slightly exceeding the angle of repose. If required, this can be verified by a geotechnical evaluation of the soil.

Sections of the terraced limestone dry stack retaining walls are in poor condition and are being damaged by trees. The damaging trees should be removed and the failed sections of limestone walls should be restacked. Because the hillside slope approximately matches the estimated angle of repose of the soil, the terraced limestone walls should not present an eminent safety concern unless the individual stone elements become dislodged and travel downhill., Deferring maintenance in this area will increase the likelihood of this happening and likely lead to increased future repair costs.

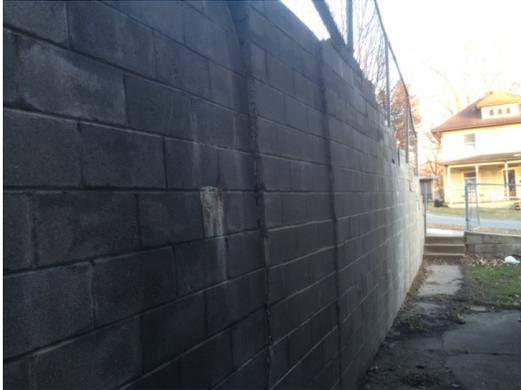
Bulging, bowing, and leaning southern 35' portion of the wall. Two vertical cracks at 4' on center with ~2" of relative horizontal displacement.

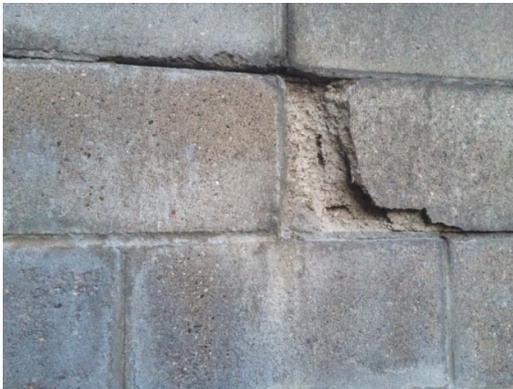
Deteriorated mortar joints and spalled concrete block face shell of the southern 35' portion of the wall.

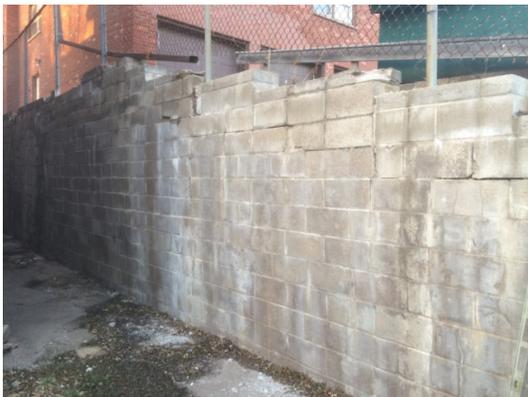
Efflorescence, deteriorated mortar joints, fence post embedment deterioration, leaning, bowing and bulging of the southern 35' portion of the wall.

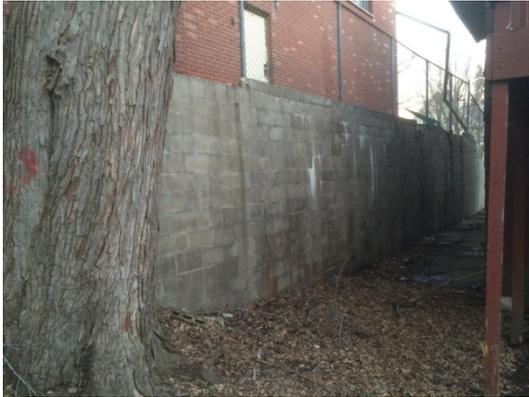
Northernmost 55' of wall is generally in fair condition. Isolated efflorescence and localized deterioration exists.

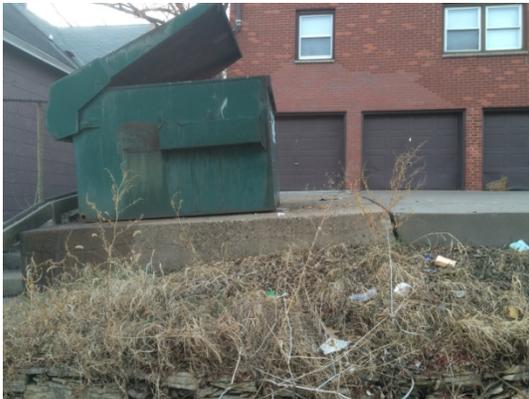
Apartment building appears to have repaired brick veneer in the corner where the pavement is settling.

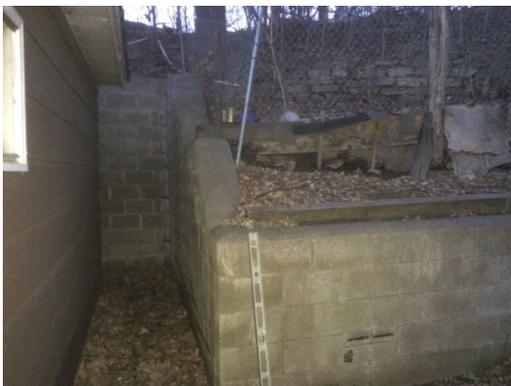
Garage Retaining Wall appears to be in good condition.

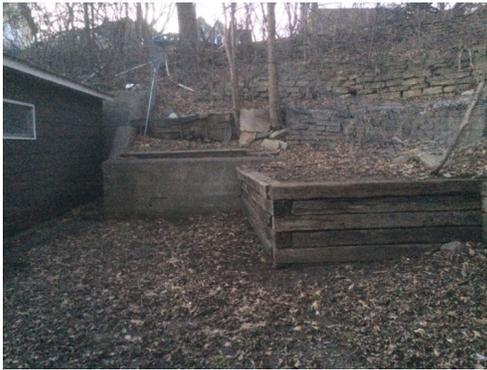
Lowest tier of terraced retaining wall consists of wood railroad ties. Upper tiers consist of dry stacked limestone and segmental concrete masonry units.

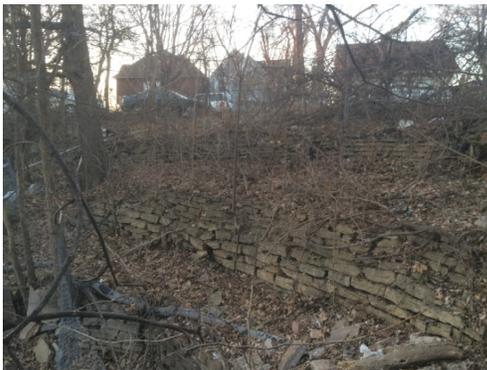
Trees are growing through the terraced walls and compromising their integrity.

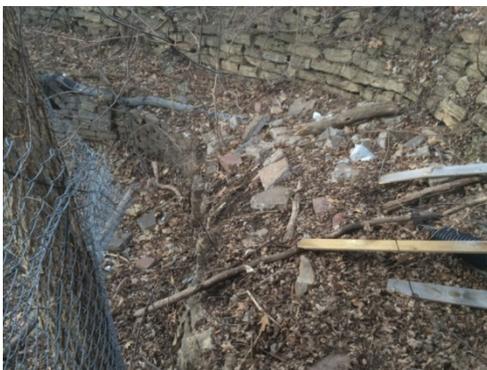
Evidence of hillside sliding and construction debris disposal.

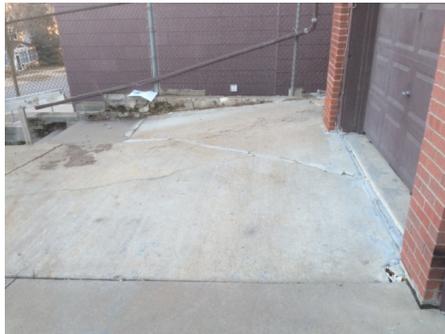
The apartment complex pavement is experiencing settlement cracking and sloped toward retaining wall. The apartment complex downspout is draining behind retaining wall.

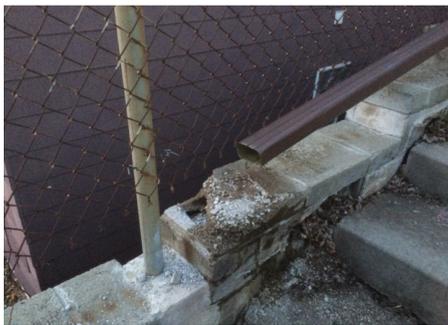
The apartment complex downspout is draining behind retaining wall. This drainage is causing localized wall deterioration and contributing to bowing, leaning, and bulging.

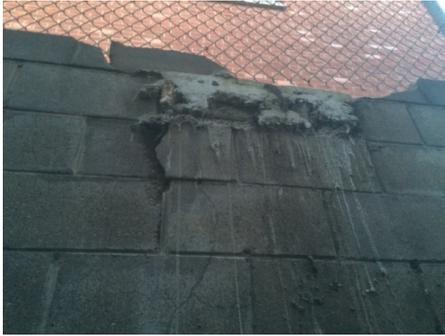
Localized repairs needed in northernmost 55' of wall.

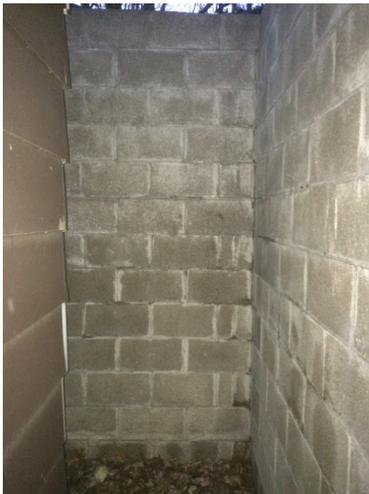
No structural repairs required. Protective concrete and masonry sealer and minor isolated masonry repairs are recommended to increase the durability of this wall.

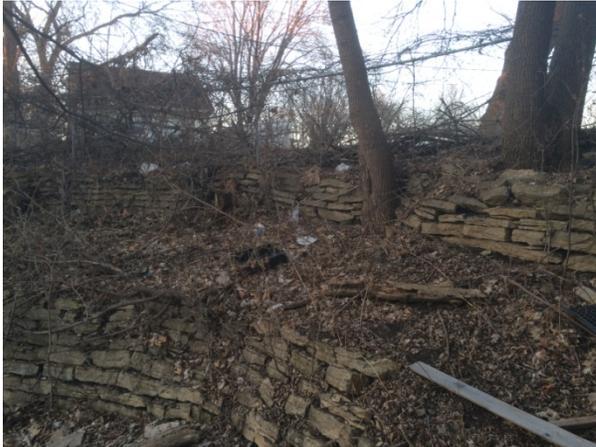
Trees growing through the terraced retaining walls are causing deterioration.
