CITY OF SAINT PAUL HERITAGE PRESERVATION COMMISSION STAFF REPORT

FILE NAME: 882 West Seventh Street INVENTORY NUMBER: RA-SPC-2937

HPC SITE/DISTRICT: Jacob Schmidt Brewing Company Historic District

STAFF INVESTIGATION AND REPORT: George Gause

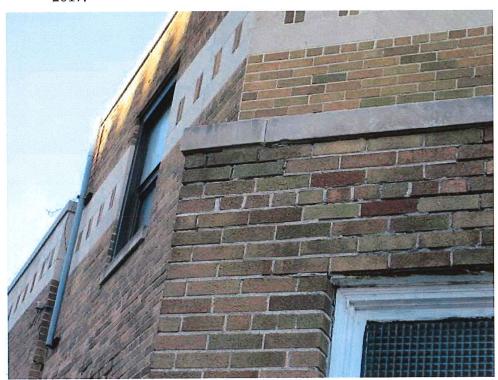
E.08 Detail photo showing masonry condition. Photo taken October 2017.

- Re-pointing and brick replacement will be limited but will occur where necessary. Joint profiles will
 be replicated where re-pointing occurs. Any replacement bricks will match the dimensions and color
 of the existing brick. Replacement masonry unit selection will be submitted to the SHPO for review
 and approval.
- Mortar mixtures will duplicate the original mortar in color and texture and will be appropriate for
 use with historic masonry. Mortar mock-ups will be submitted to the SHPO for review and approval.
- Stone finishes will be repaired where damaged, with the original style, color, and proportion of the existing stone replicated as necessary. Where stone is too damaged for repair, it will be replaced in-

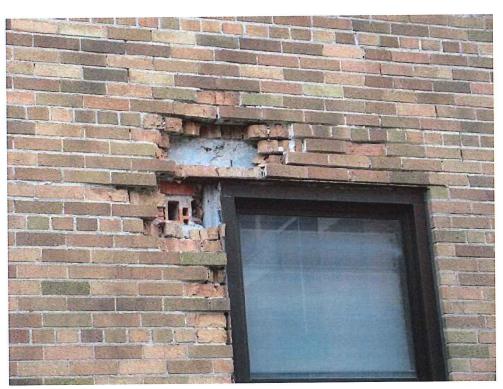
E.09 Photo of missing and damaged masonry units on southeast façade. Photo taken October 2017.

kind to match the existing. Any replacement stone will be submitted to the SHPO for review and approval if needed.

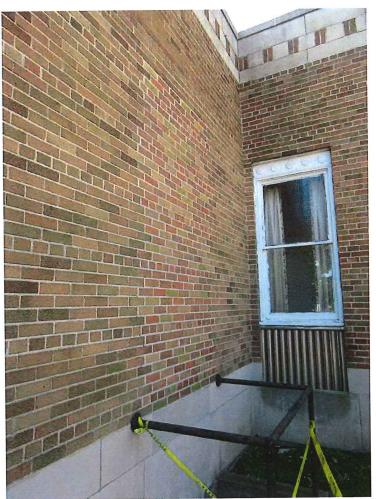
E.10 Photo showing non-historic brick infill on back façade of front portion of office building. Photo taken October 2017.

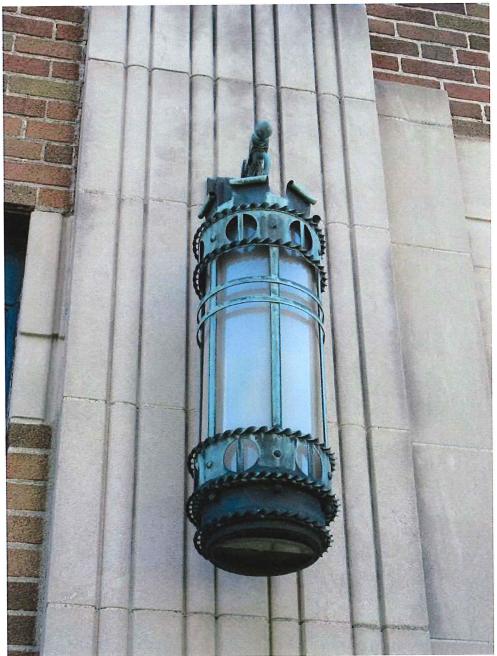
E.12 Detail of original lighting fixtures at main entrance on northwest façade. Photo taken October 2017.

- The main entry, centered on the Seventh Street elevation, currently contains a single-leaf metal
 door that is not original. The original door to this entrance has been found; it will be repaired
 and reinstalled in the existing original opening. The non-historic doorframe will be removed and
 replaced with a frame to match the original design. New hardware will be installed to meet code
 requirements. The stone trim, detailing, and original copper light fixtures at the entrance will be
 repaired and restored.

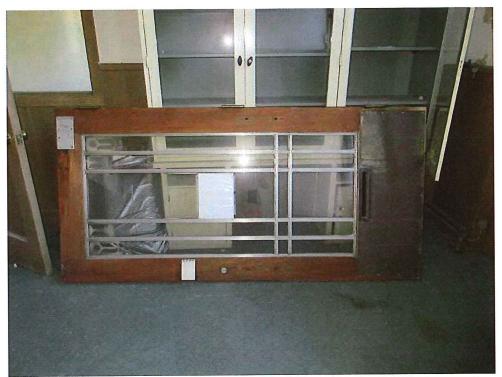
E.13 Original main entrance door to be rehabilitated and reinstalled on northwest façade. Photo taken October 2017.

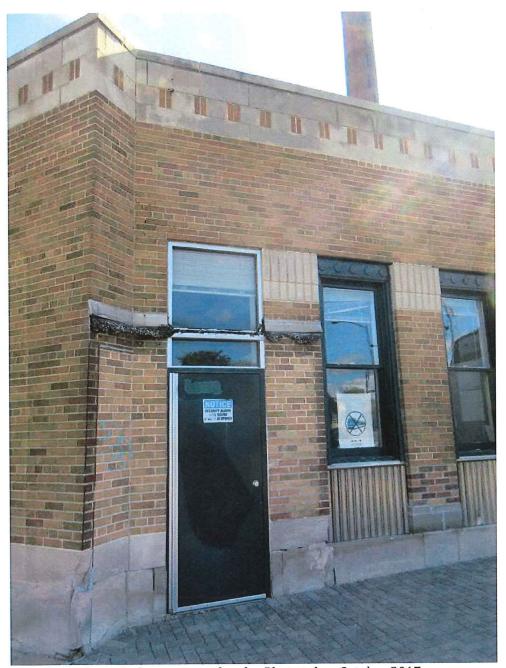
E.14 Non-historic door on west façade. Photo taken October 2017.

- The non-historic metal door located on the building's west elevation will be replaced with a wood frame and door with a full lite and transom. The adjacent head detail will be matched at the window.

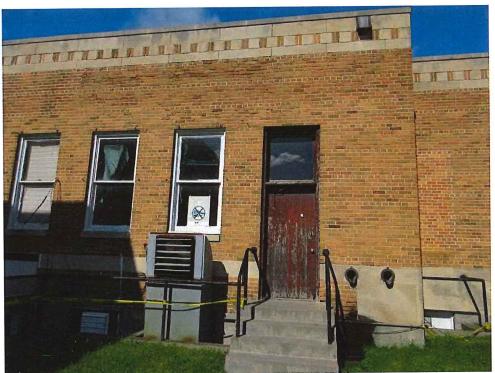
E.15 Entrance off of rear (southeast) facade of the north wing. Photo taken October 2017.

- The wood door on the southeast (rear) elevation of the north wing will be removed and repaired. The swing will be modified to swing out to meet current building code requirements.
 A concrete landing and stair will be installed off of this entrance to exit on the east side of the building.

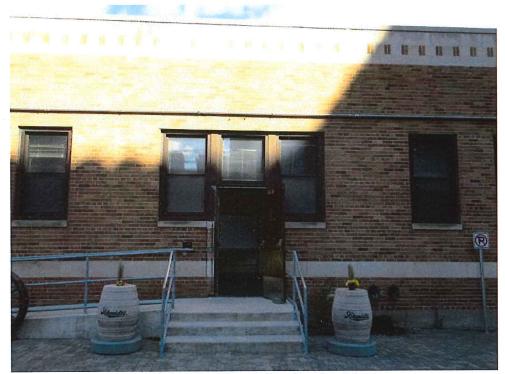
E.17 Entrance on south façade. Photo taken October 2017.

- The entrance on the building's south façade, which contains a non-historic, single-leaf door, will be expanded and replaced with a double-leaf door. The existing ADA ramp and concrete steps will be replaced and the transom will receive a new window.

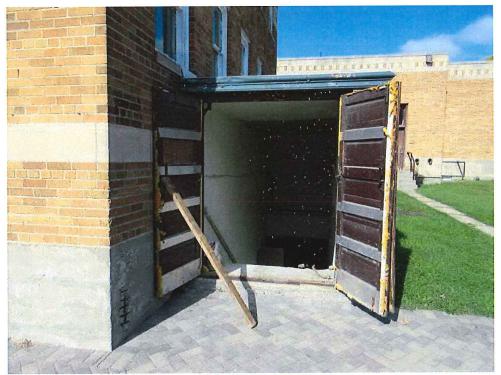
E.18 Entrance to basement on southeast facade. Location where landing will be extended and new exterior walls will be built. Photo taken October 2017.

- The double-leaf door at the east end of the building's southeast façade will be removed and
 replaced with a single-leaf, metal frame, and door. The landing inside of the entrance will be
 extended to three feet to meet current building code requirements. New exterior walls will be
 constructed to enclose this extension. Exterior wall construction will match the adjacent
 existing walls in appearance and material.

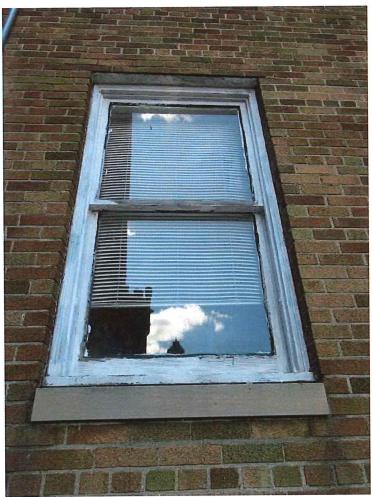
E.19 Detail of the condition of original wood window on southeast façade. Photo taken October 2017.

- The existing, historic wood windows (1/1 windows with double-hung wood sashes) will be retained and repaired as necessary. Repairs include painting and installation of insulated glazing.

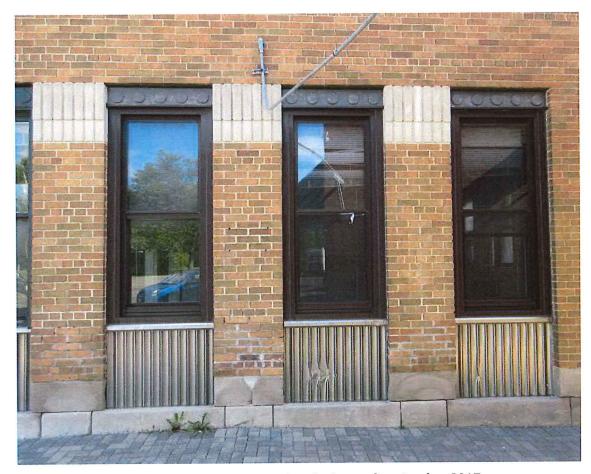
E.20 Aluminum windows on west façade to be replaced. Photo taken October 2017.

- Decorative woodwork above windows on the north and west elevations will be repaired as necessary with materials that match existing.
- The 11 aluminum sash non-historic replacement windows will be removed, and new 1/1 Kolbe & Kolbe wood windows will be installed. New windows will match the existing wood windows in size, proportion, profile, and sash configuration. The finish and color will also match the historic windows.
