**CITY OF SAINT PAUL
HERITAGE PRESERVATION COMMISSION STAFF REPORT**

FILE NAME: 26 Exchange Street

DATE OF PUBLIC HEARING: March 22, 2018

CLASSIFICATION: Restoration / Renovation

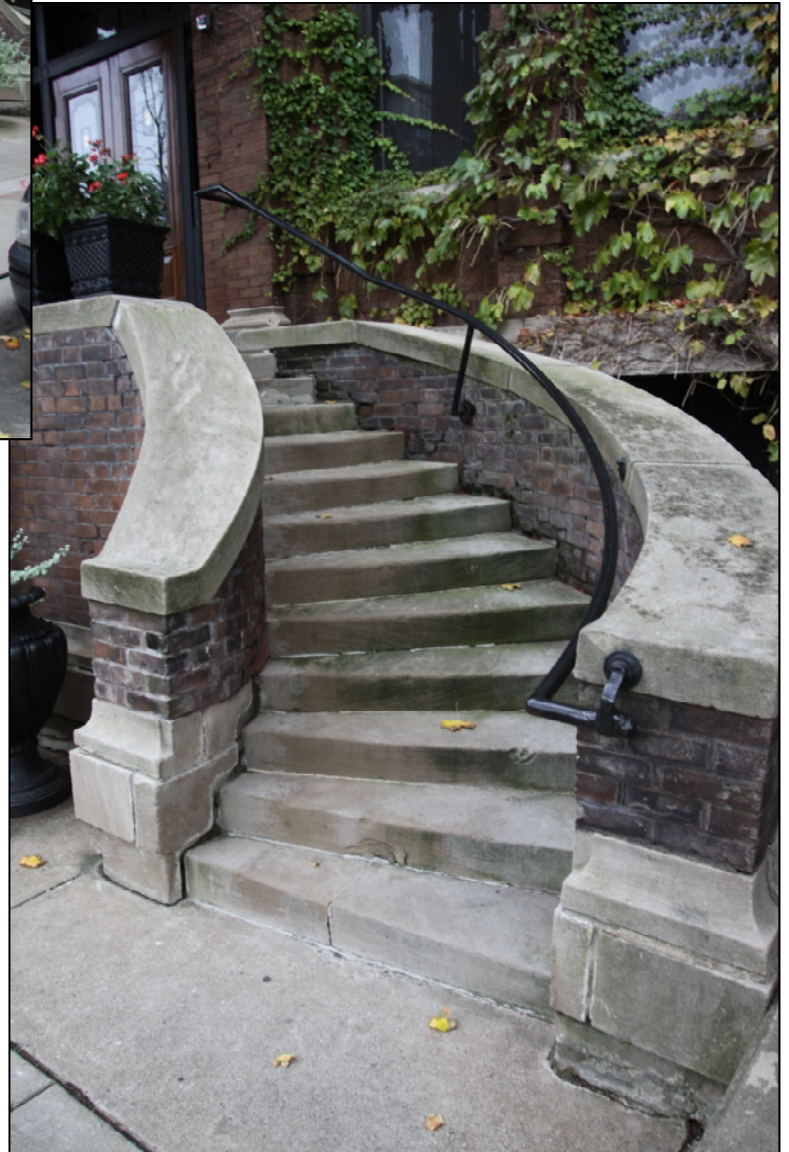
Photo 4 (November 1, 2017)

View: West staircase to entrance portico; looking southeast

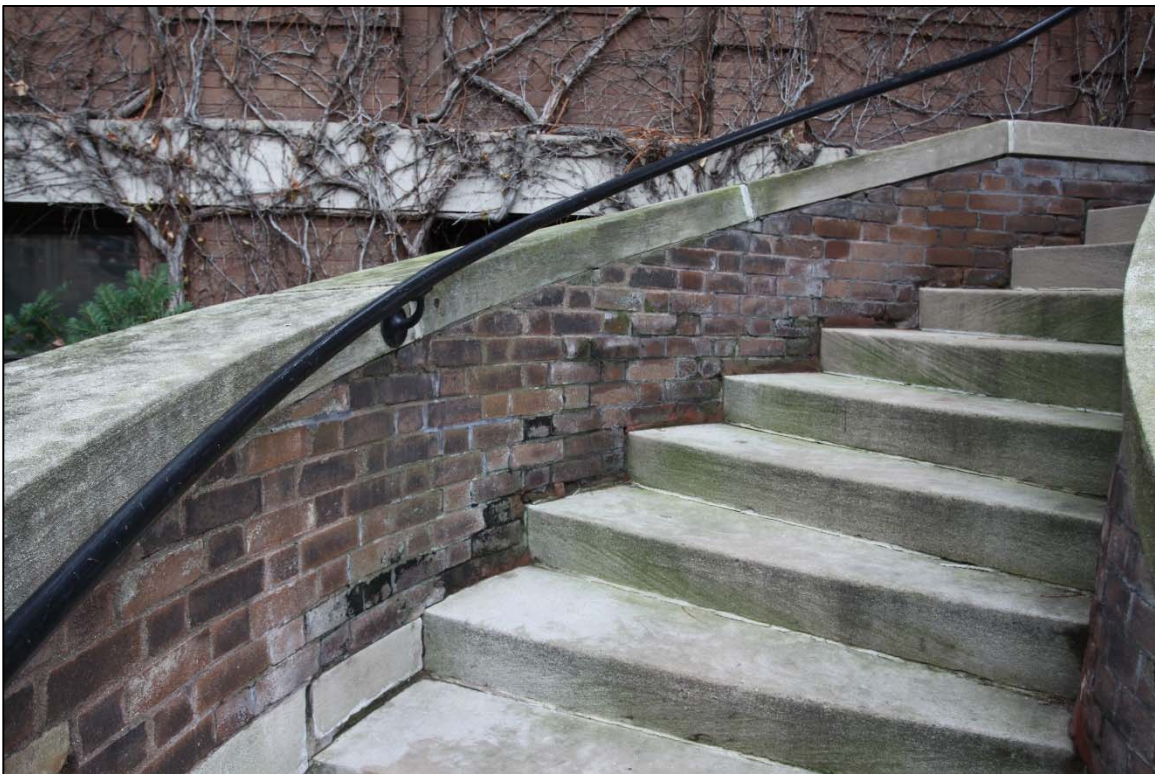
Photo 6 (November 15, 2017)

View: Entrance portico, east staircase; looking southwest

Description: Detail of masonry conditions on the north entrance including discoloration and mortar loss

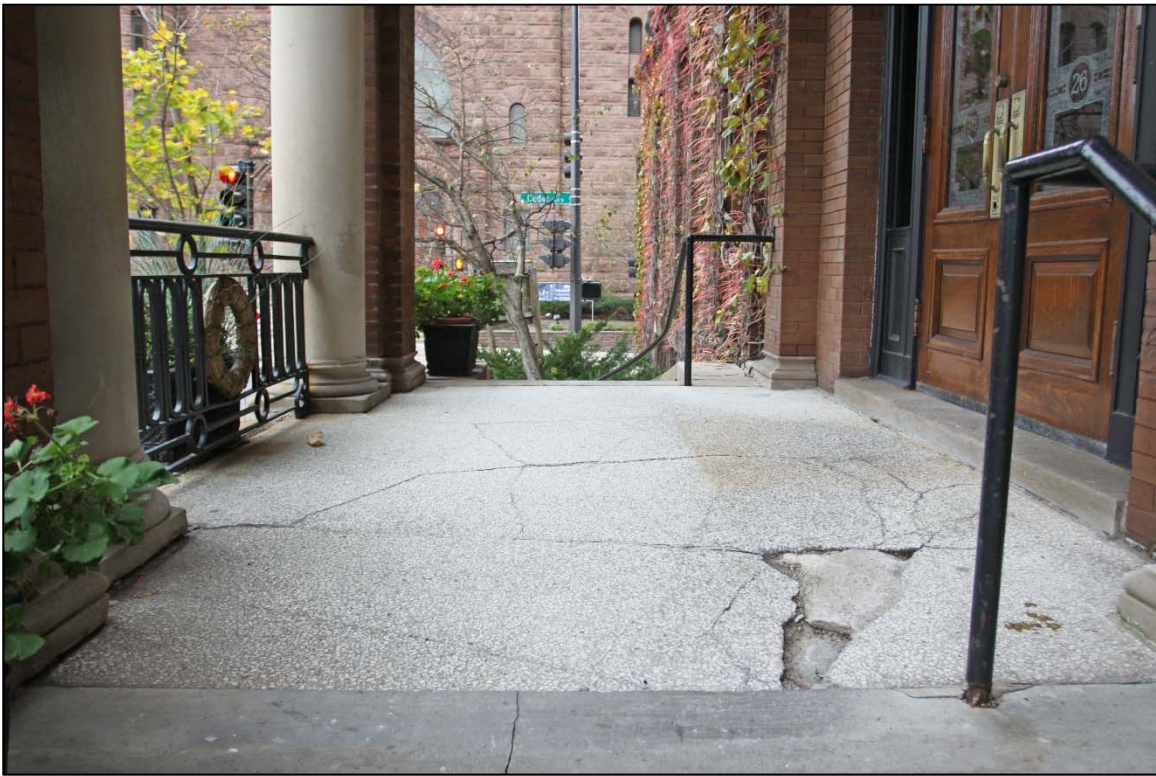
Photo 7 (November 15, 2017)

View: Entrance portico; looking east

Description: Condition of terrazzo floor on the north entrance; the portico has shifted leading to large cracks in the terrazzo

Front portico will be disassembled to repair structural issues and will be rebuilt following the original design. Salvaged materials will be used wherever possible and any necessary brick will match the historic masonry. Jahn patch will be used on any damaged stone. A new roofing system will be installed. Terrazzo floor will be removed and replaced to match the original.

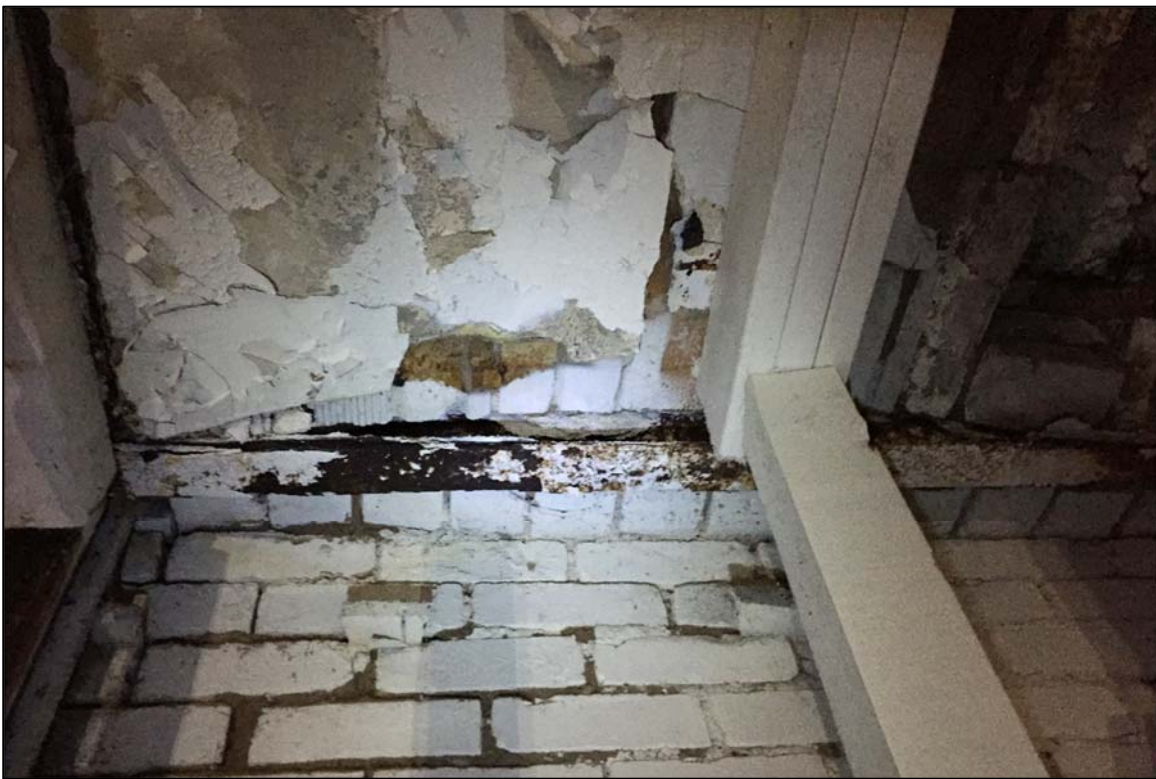
Photo 8 (November 15, 2017)

View: North Building, crawl space beneath portico; looking north

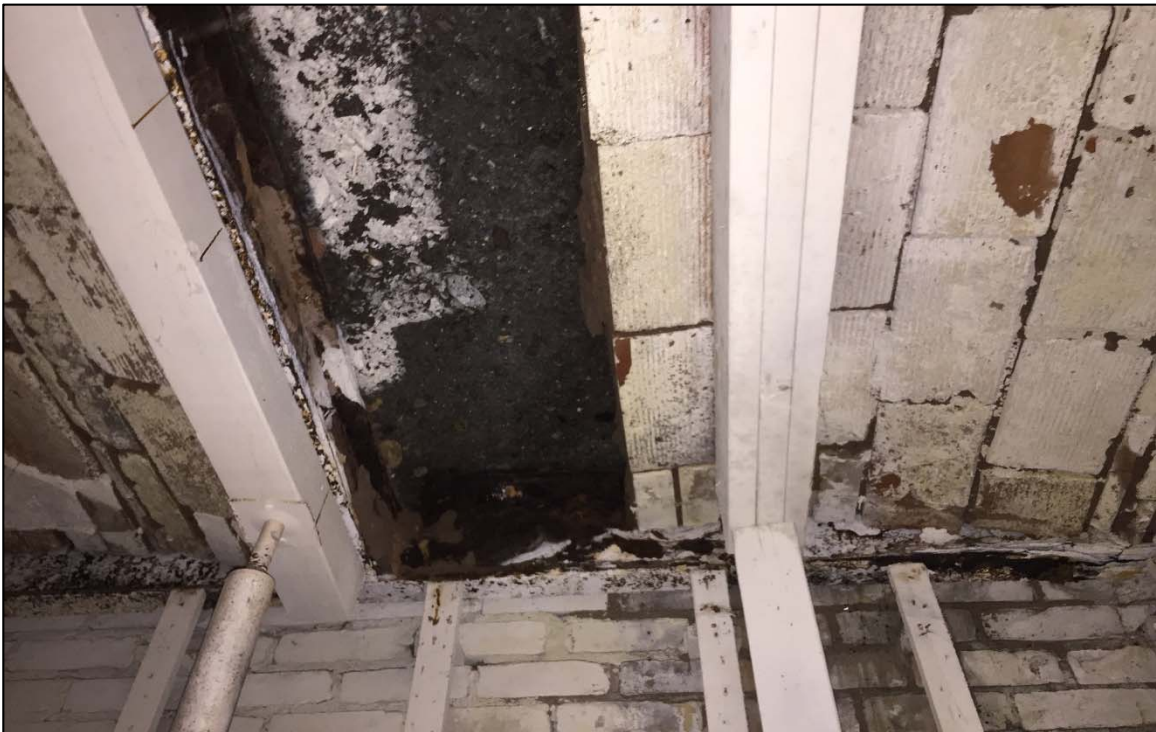
Photo 10 (November 15, 2017)

View: North Building, crawl space beneath portico, looking north

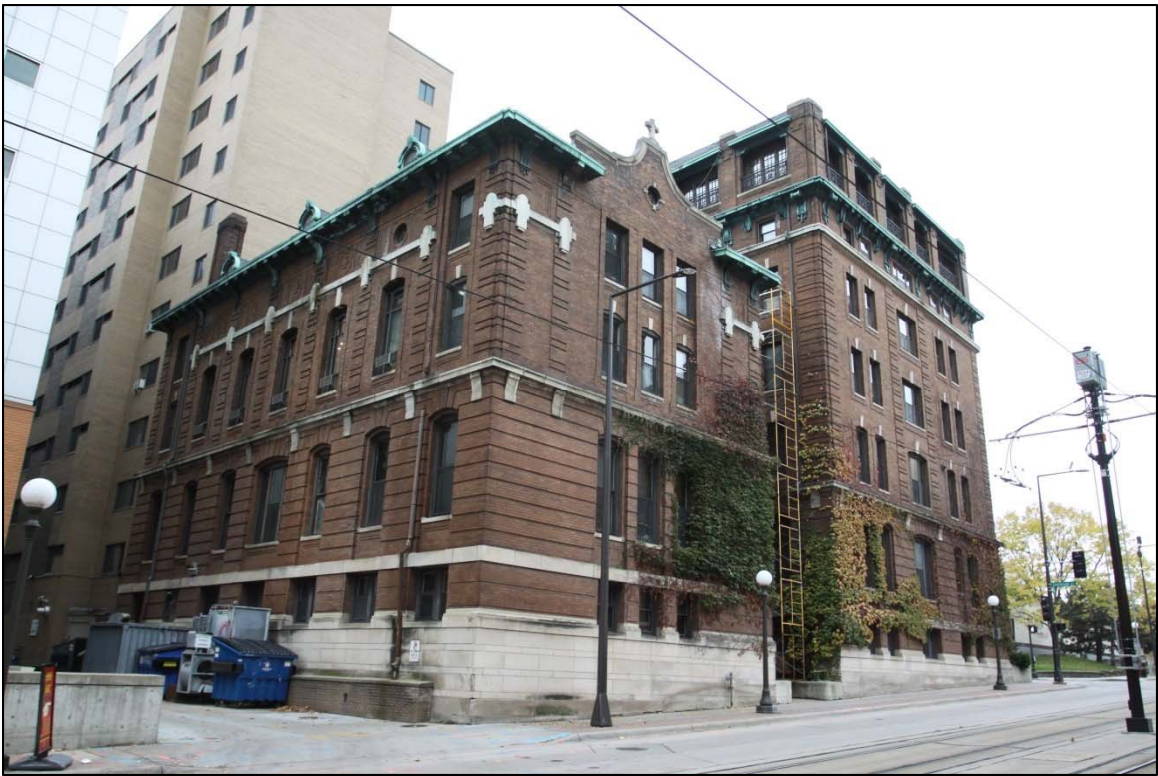
Photo 17 (November 1, 2017)

View: South facade of south building (left) and east facades of both buildings; looking northwest

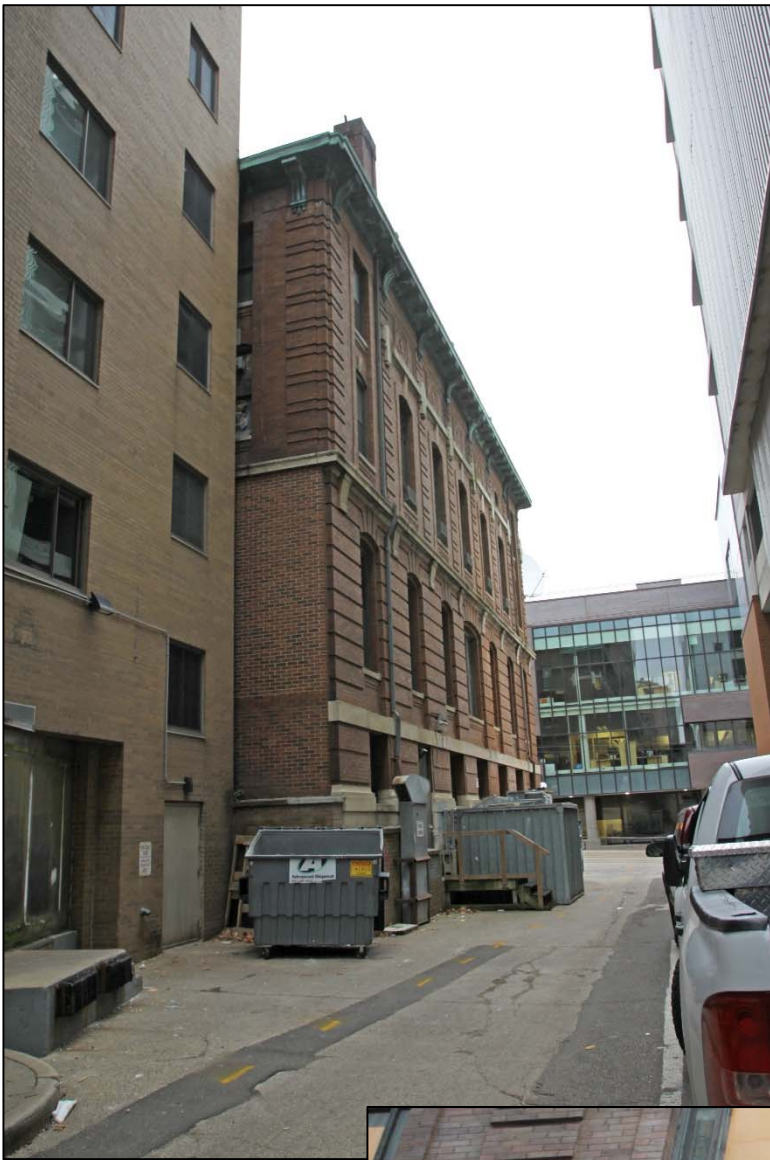
Photo 19 (November 1, 2017)

View: South building, west facade (left) and south facade (right); looking northeast

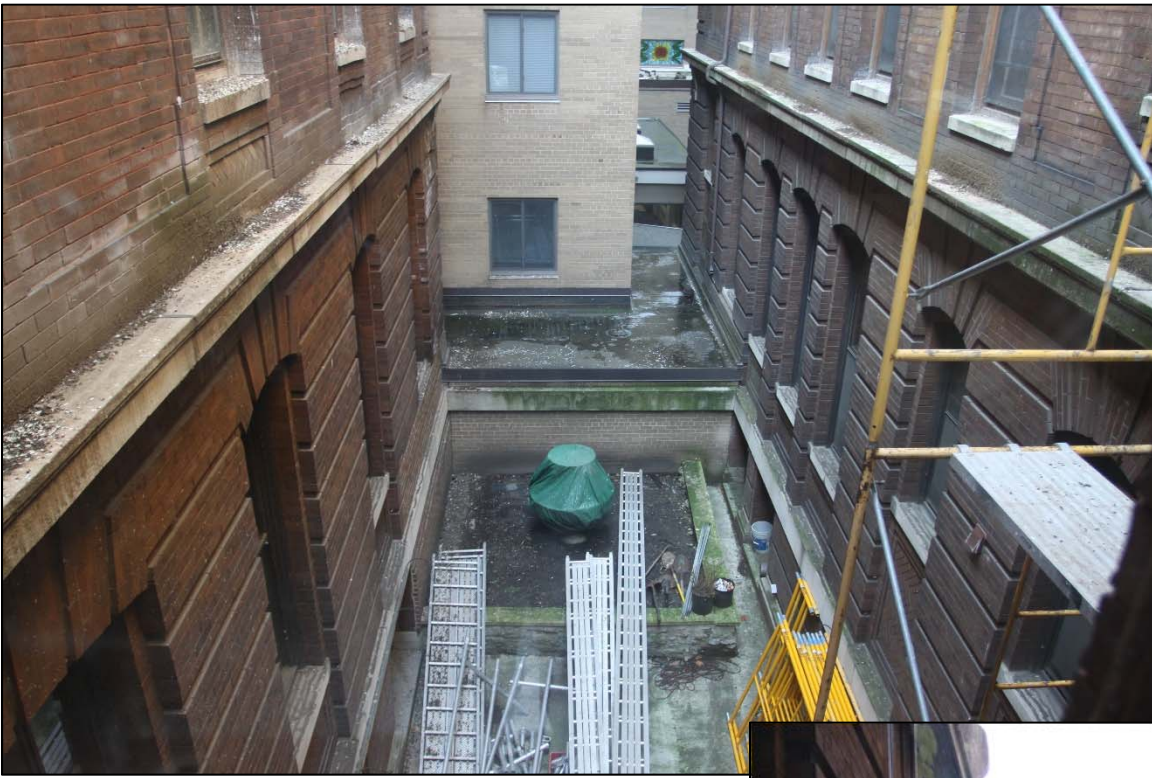
Photo 21 (November 8, 2017)

View: Courtyard; looking west

Description: Looking into the courtyard from the third floor; the north wall of the south building is on the left and the south wall of the north building is on the right; masonry staining is most intense in the courtyard, especially along the stone watertable

Describe proposed work: The courtyard walls will be fully repointed. Damaged mortar will be removed with hand and power tools. The mortar joints will not be overcut and the adjacent masonry will not be damaged. New mortar matching the color, texture, strength, and profile of the historic joints will be used for repointing. All work will follow *Preservation Brief 2: Repointing Mortar Joints in Historic Masonry Buildings*. Test panels of the repointing will be prepared for SHPO to review before work goes forward. The walls will be cleaned using the gentlest effective means and following the guidance in *Preservation Brief 1: Cleaning and Water-Repellent Treatments for Historic Masonry Buildings*. Test panels of the cleaning will be prepared and submitted to SHPO for review. Bricks will be replaced if they are cracked and no longer maintain a weathertight condition. The replacement units will match the size, color, texture, and profile of the historic masonry. Samples of the replacement bricks will be submitted for review. The damaged stone on the basement and watertables will be repaired if possible with stone patches. A Jahn patching product, or something similar, will be used to repair the stone. The damaged stone appears to be repairable, but select units may need to be replaced if they are found to be damaged beyond repair. Samples of the patching and/or replacement materials will be submitted to SHPO for review.

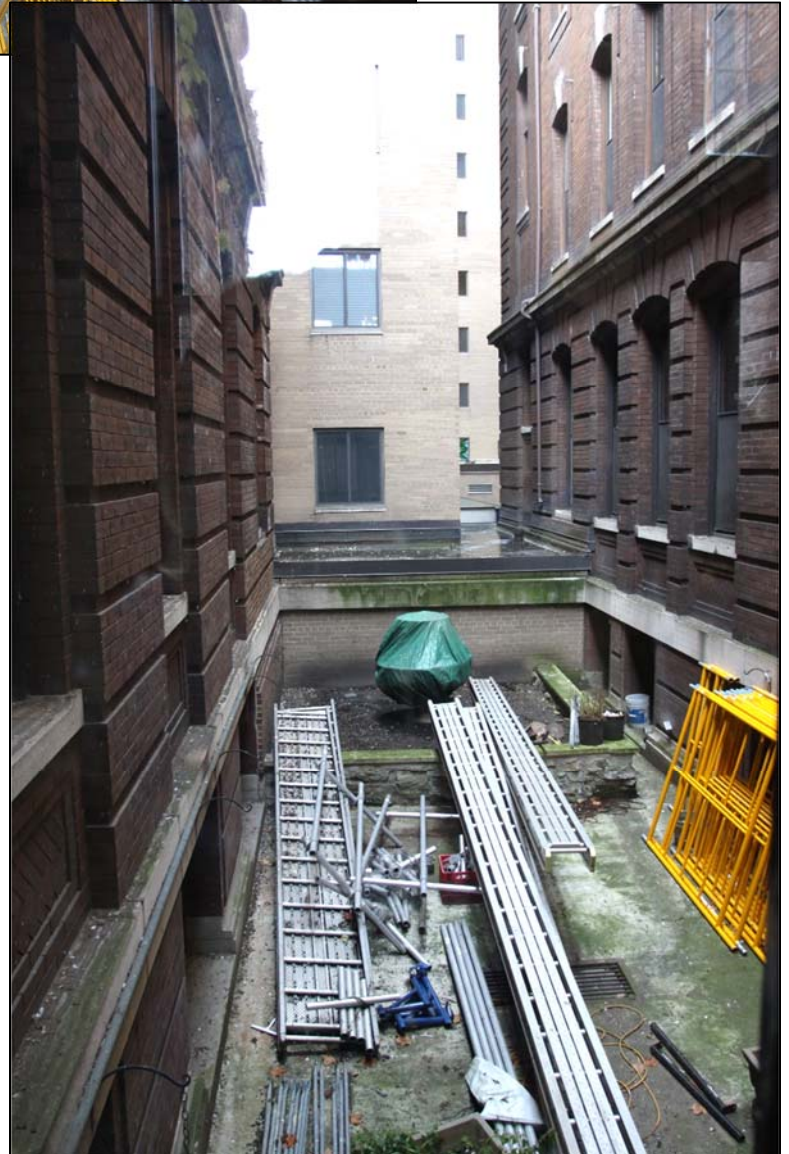
Photo 22 (November 8, 2017)

View: Courtyard; looking west

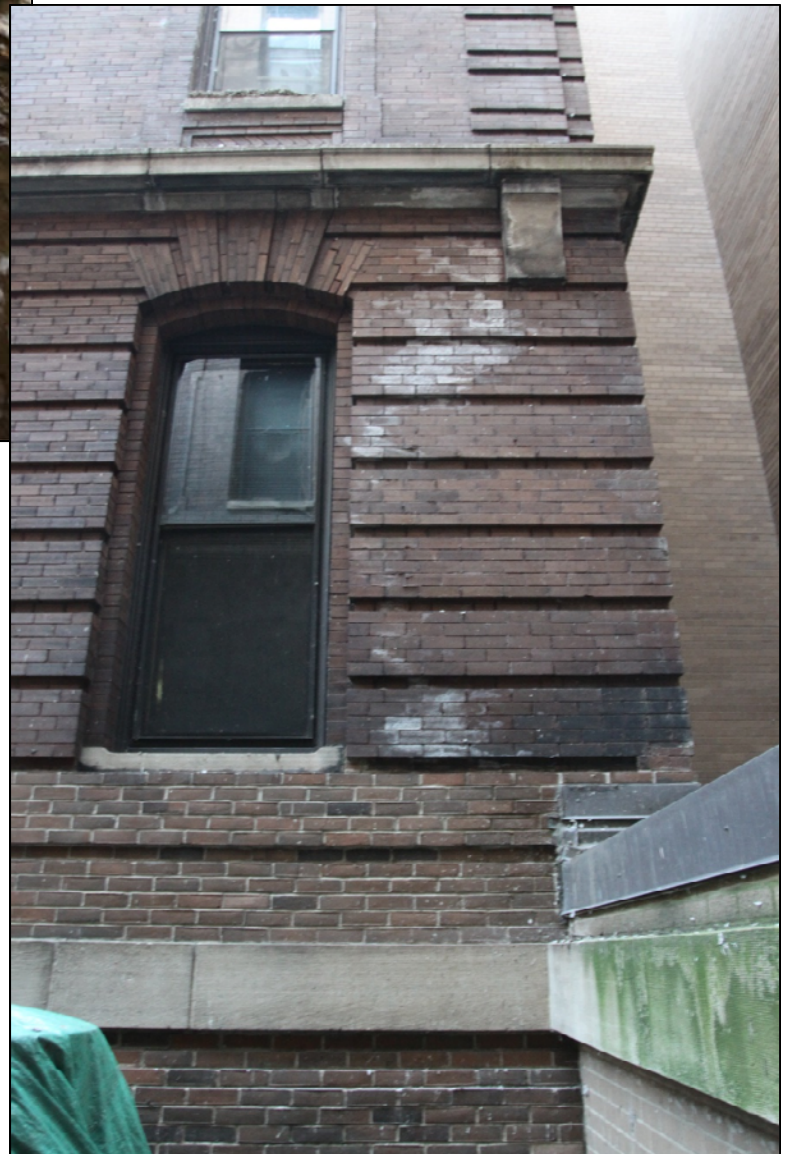
Photo 24 (November 20, 2017)

View: Courtyard, north wall of south building; looking south

Description: Detail of the masonry conditions in the courtyard showing staining, efflorescence, mortar loss, and previous repointing

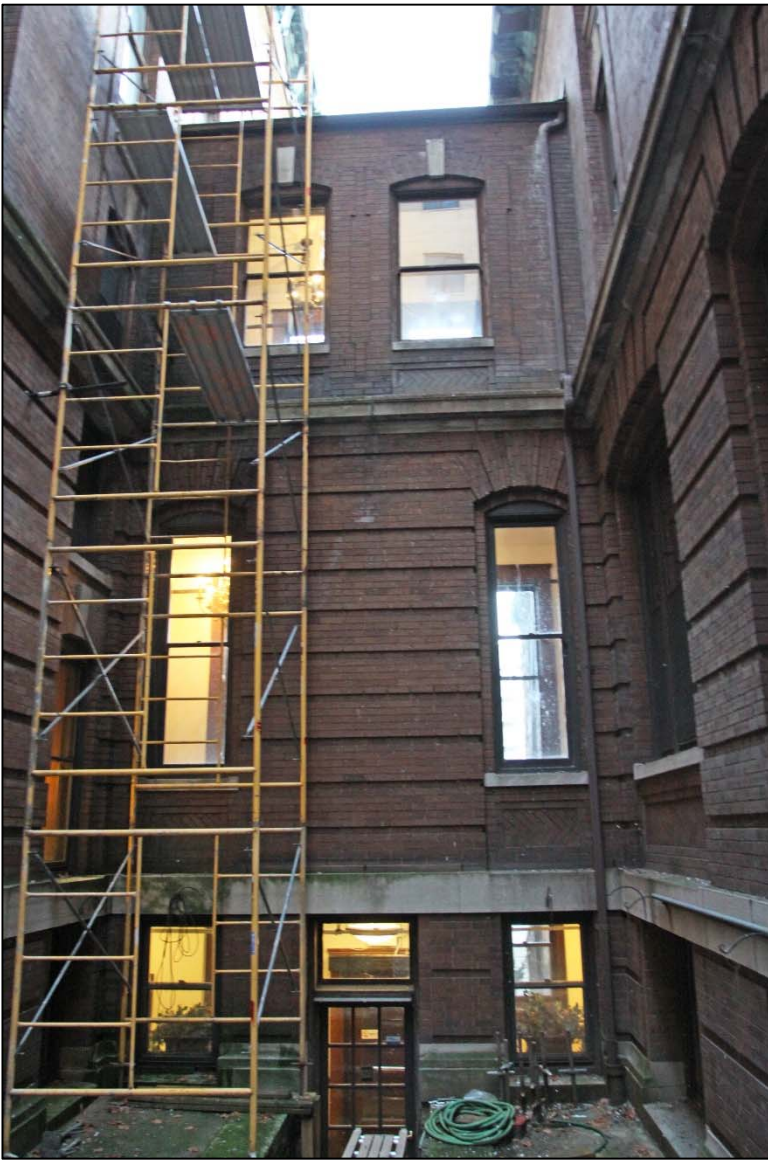
Photo 25 (November 20, 2017)

View: Courtyard; looking east

Description: West wall of link, showing masonry conditions in the courtyard
