RESERVOIR INSPECTION - MAY 2, 1990 PHOTO LOG / CONDITION NOTES

WATER DEPARTMENT - ST. PAUL MINN.
 SHELLING AVE. RESERVOIR
 GENERAL PLAN

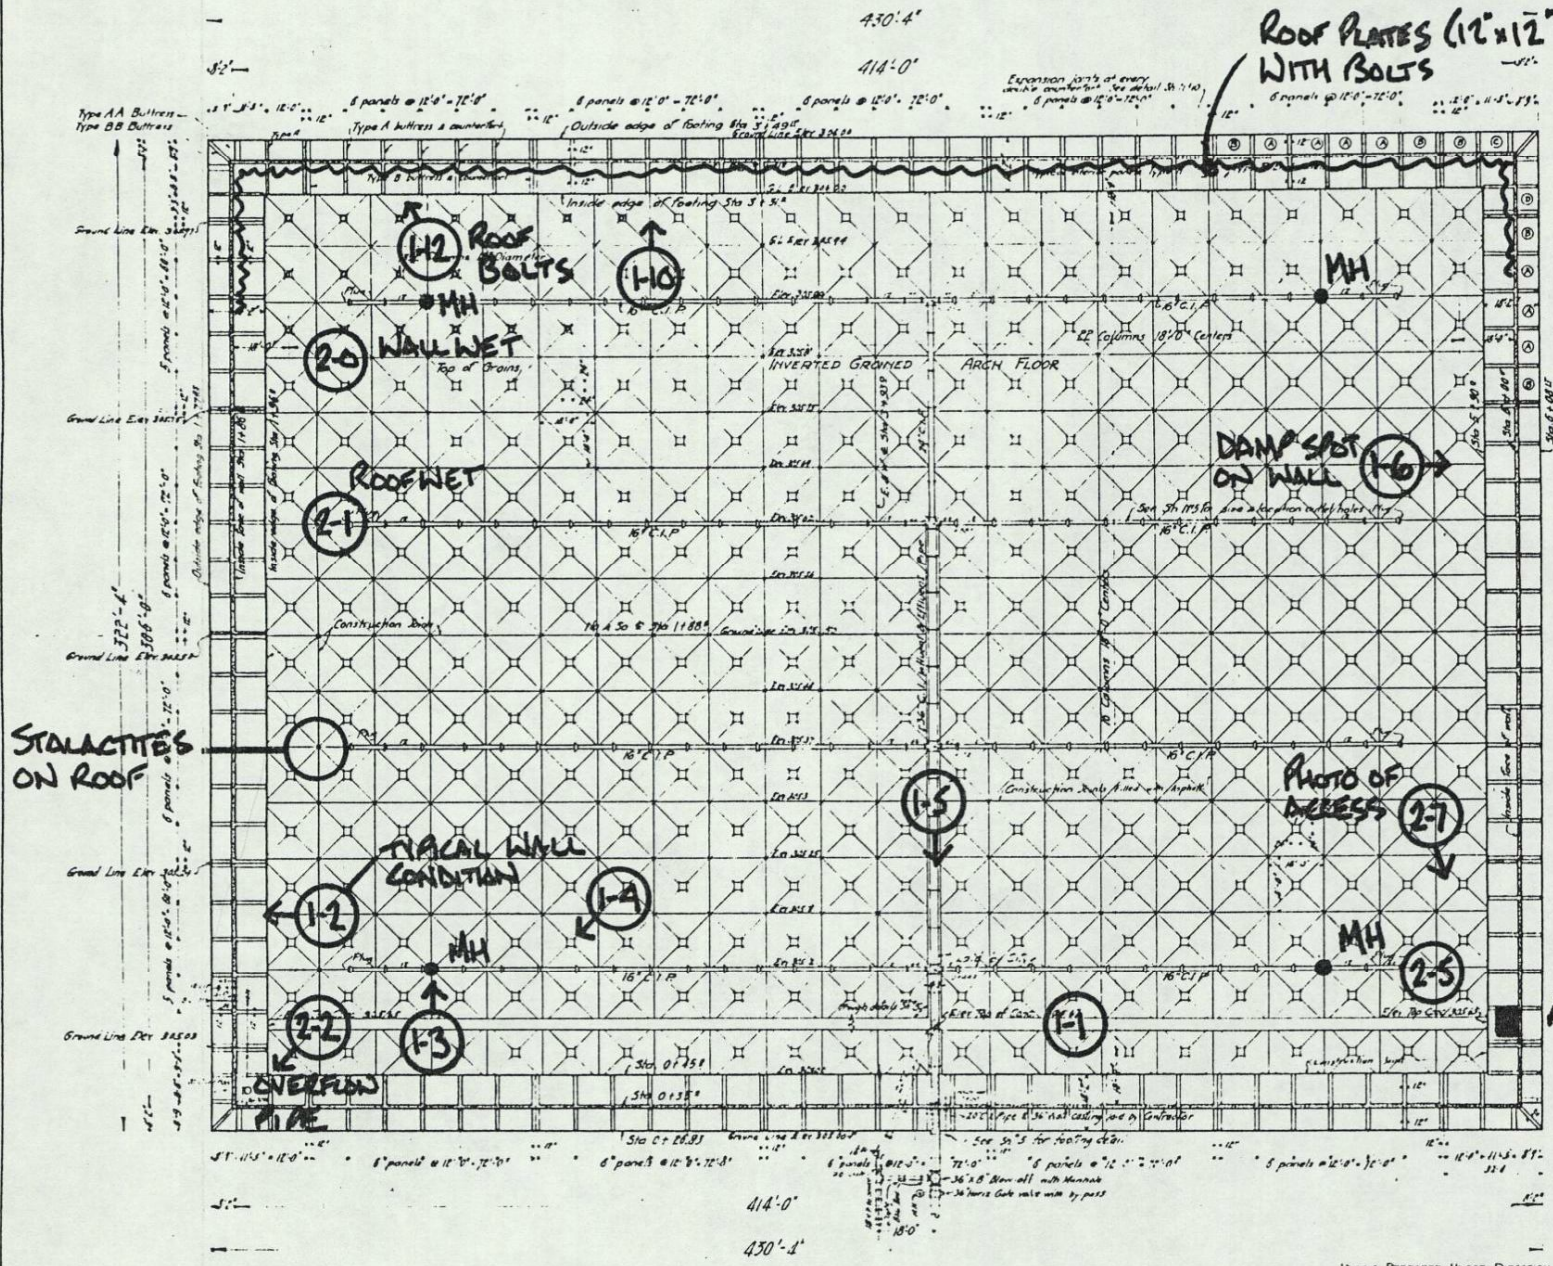
- OVERALL ROOF CONDITION EXCELLENT
- PARAPET (WALL @ ROOF IS IN VERY POOR CONDITION.
- SOME SMALL DIAGONAL CRACKS IN ROOF - APPROX. IN 5% OF BAYS.
