**CITY OF SAINT PAUL  
HERITAGE PRESERVATION COMMISSION STAFF REPORT**

FILE NAME: 1008 Portland Avenue  
DATE OF APPLICATION: September 15, 2014  
APPLICANT: Jay Duggan, Duggan Construction  
OWNER: Joan Eggenberger  
DATE OF HEARING: October 9, 2014  
HPC SITE/DISTRICT: Hill Historic District  
CATEGORY: Contributing  
CLASSIFICATION: after-the-fact building permit  
STAFF INVESTIGATION AND REPORT: Christine Boulware  
DATE: October 1, 2014

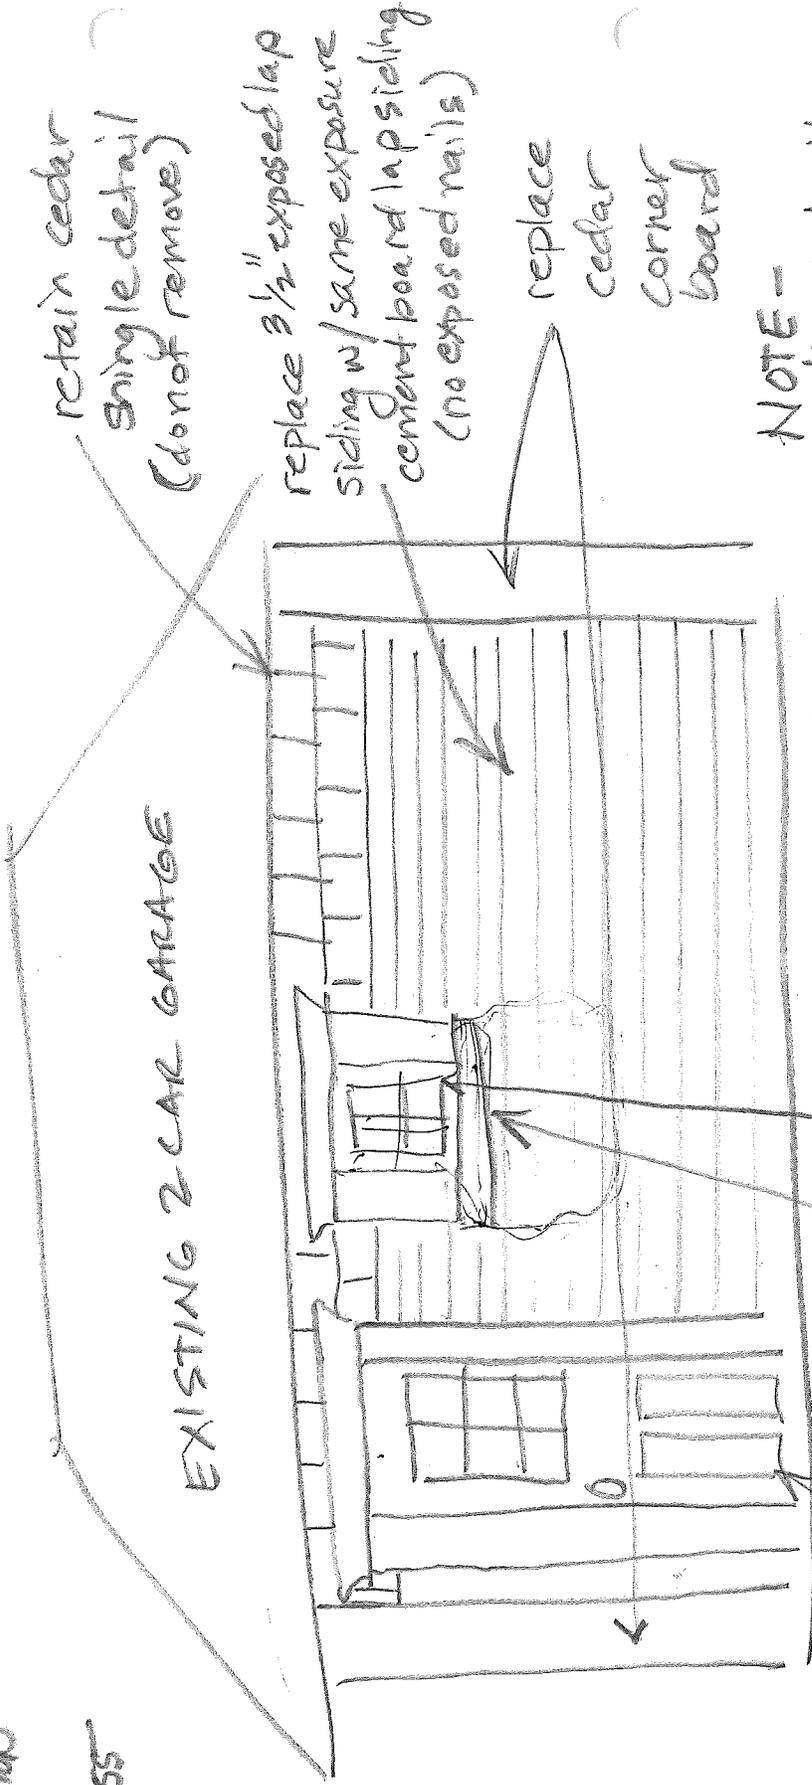
PROPOSED RESIDE @ 1008 PORTLAND AVE ST PAUL

- \* Paint all to match house in same colors as existing
- \* No soffit, fascia, roof, or new opening work.

- replace 1/2 light wood service door w/ new steel 1/2 panel 1/2 light door
- replace rotten casing legs
