**CITY OF SAINT PAUL
HERITAGE PRESERVATION COMMISSION STAFF REPORT**

FILE NAME: The Dickerman House, 1440 Summit Avenue
DATE OF APPLICATION: January 29, 2015
APPLICANT: Mike Killa, Authentic Construction Company
OWNERS: Tom and Claudia Clark
DATE OF HEARING: February 26, 2015
HPC SITE/DISTRICT: Summit Avenue West Heritage Preservation District
CATEGORY: Contributing
CLASSIFICATION: Building Permit
STAFF INVESTIGATION AND REPORT: Christine Boulware, John Beaty
DATE: February 17, 2015 update March 18, 2015

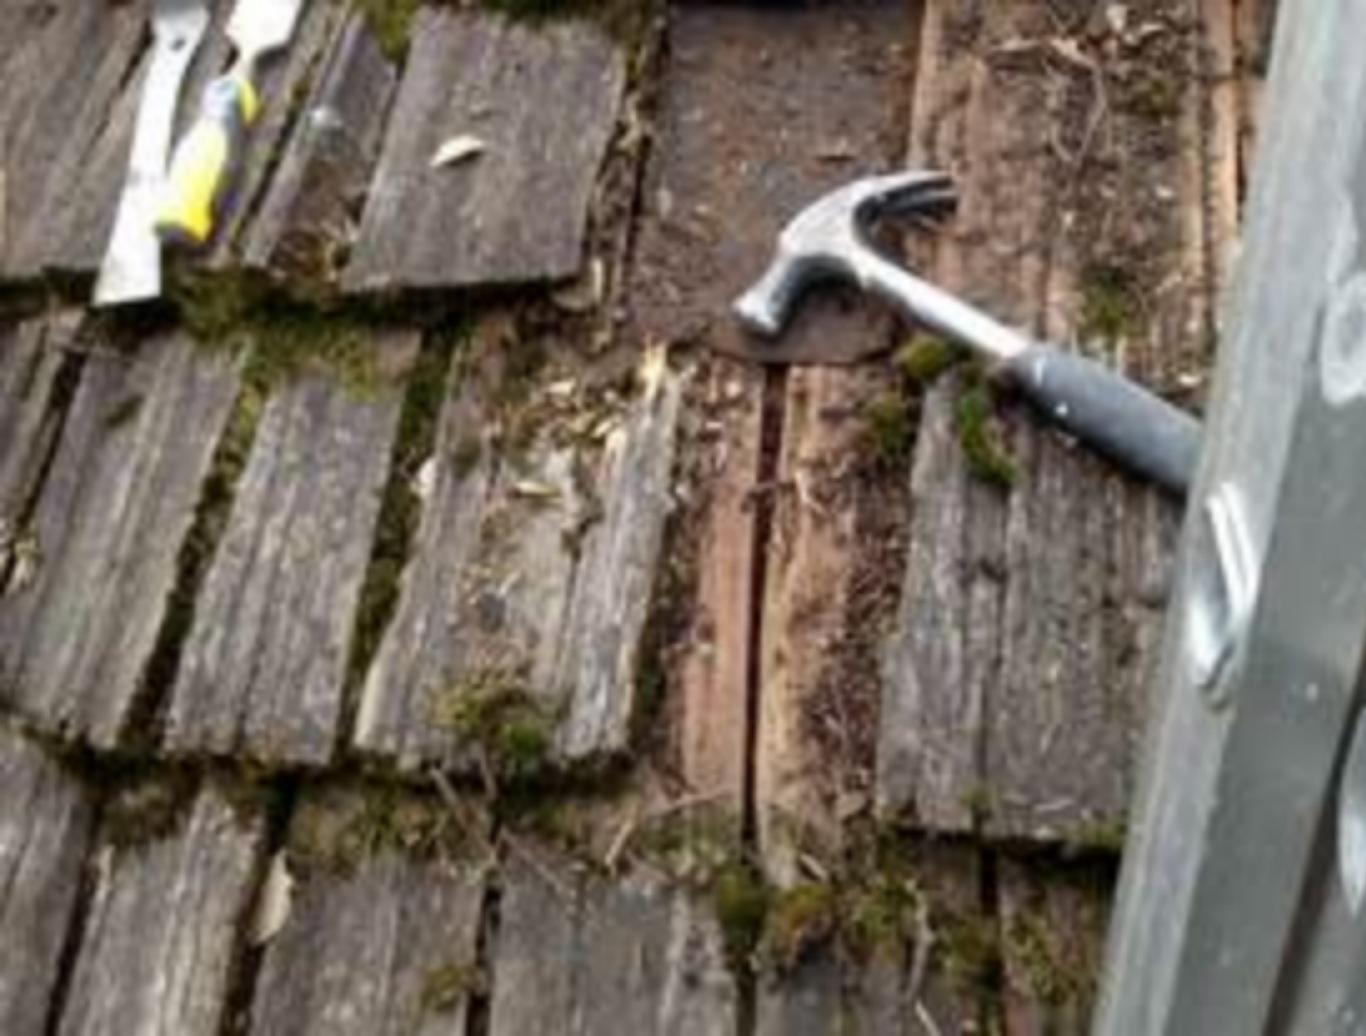
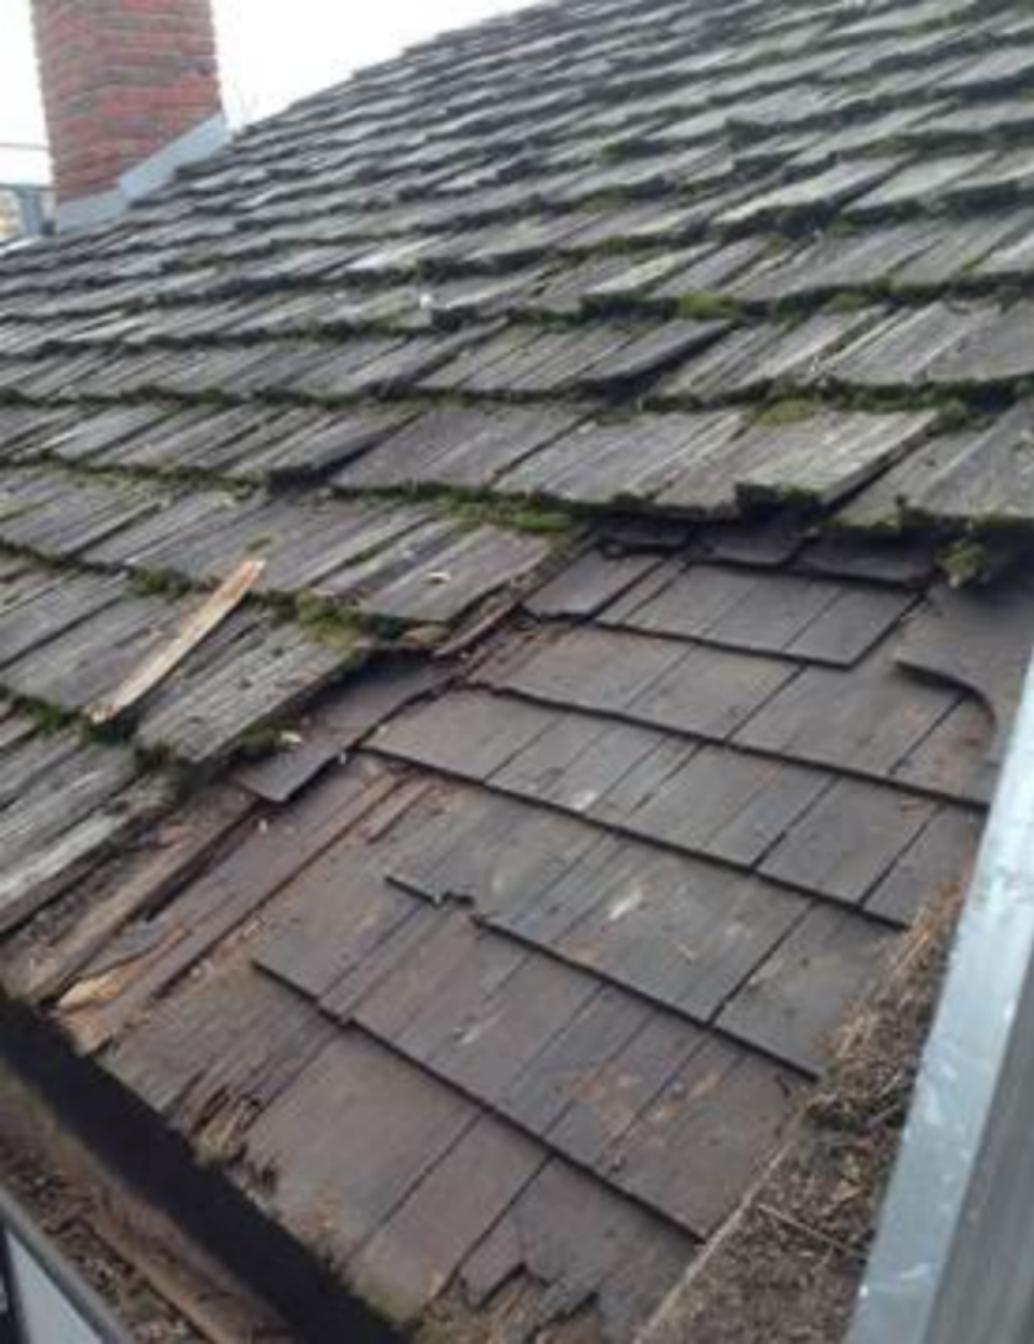
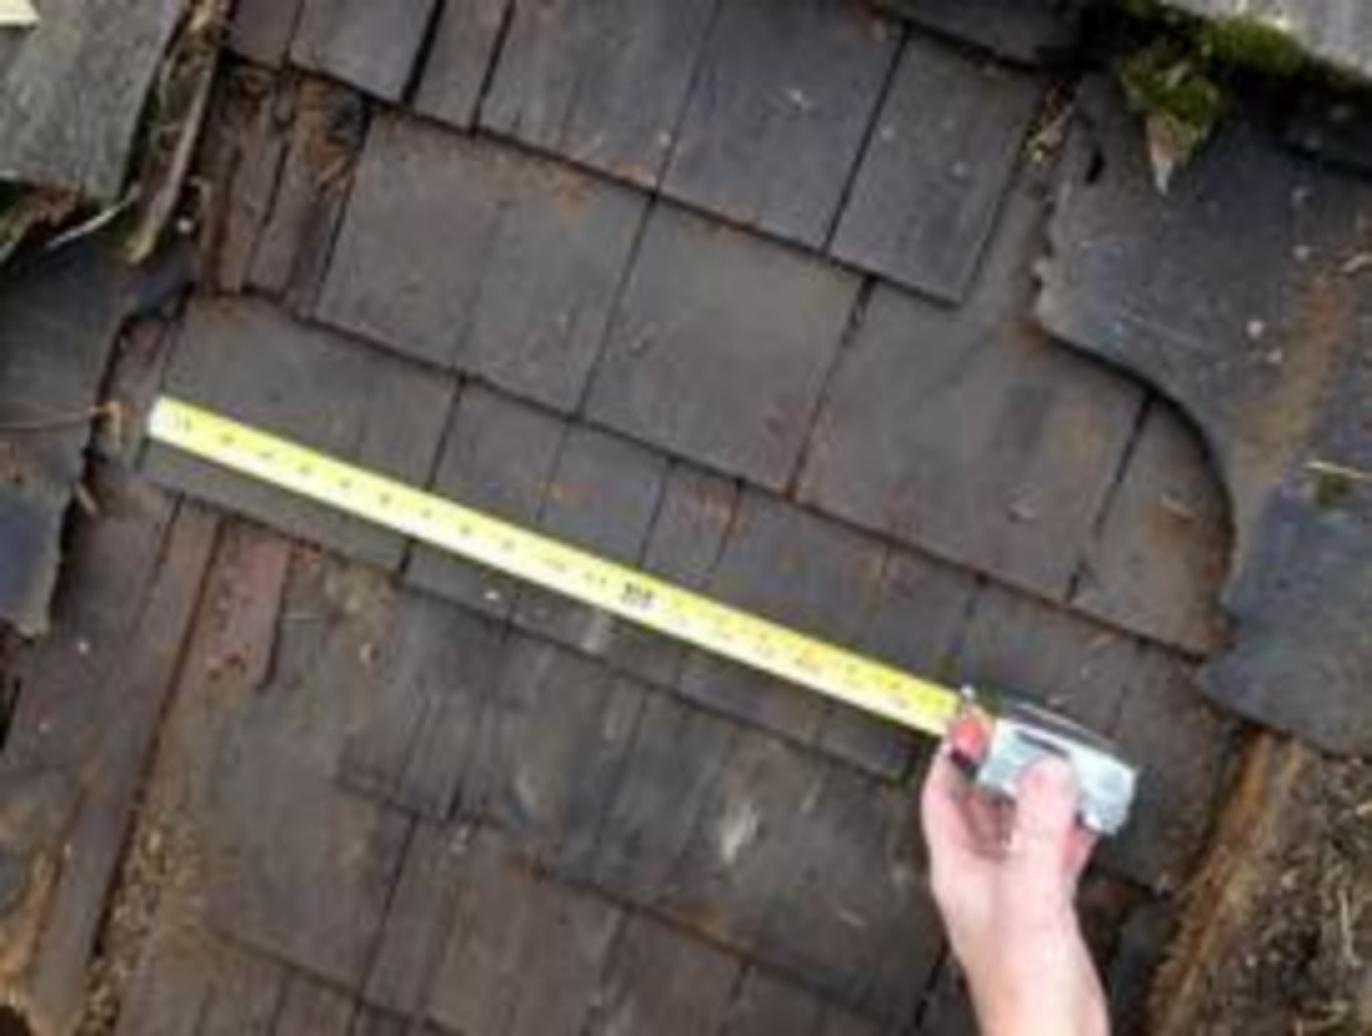
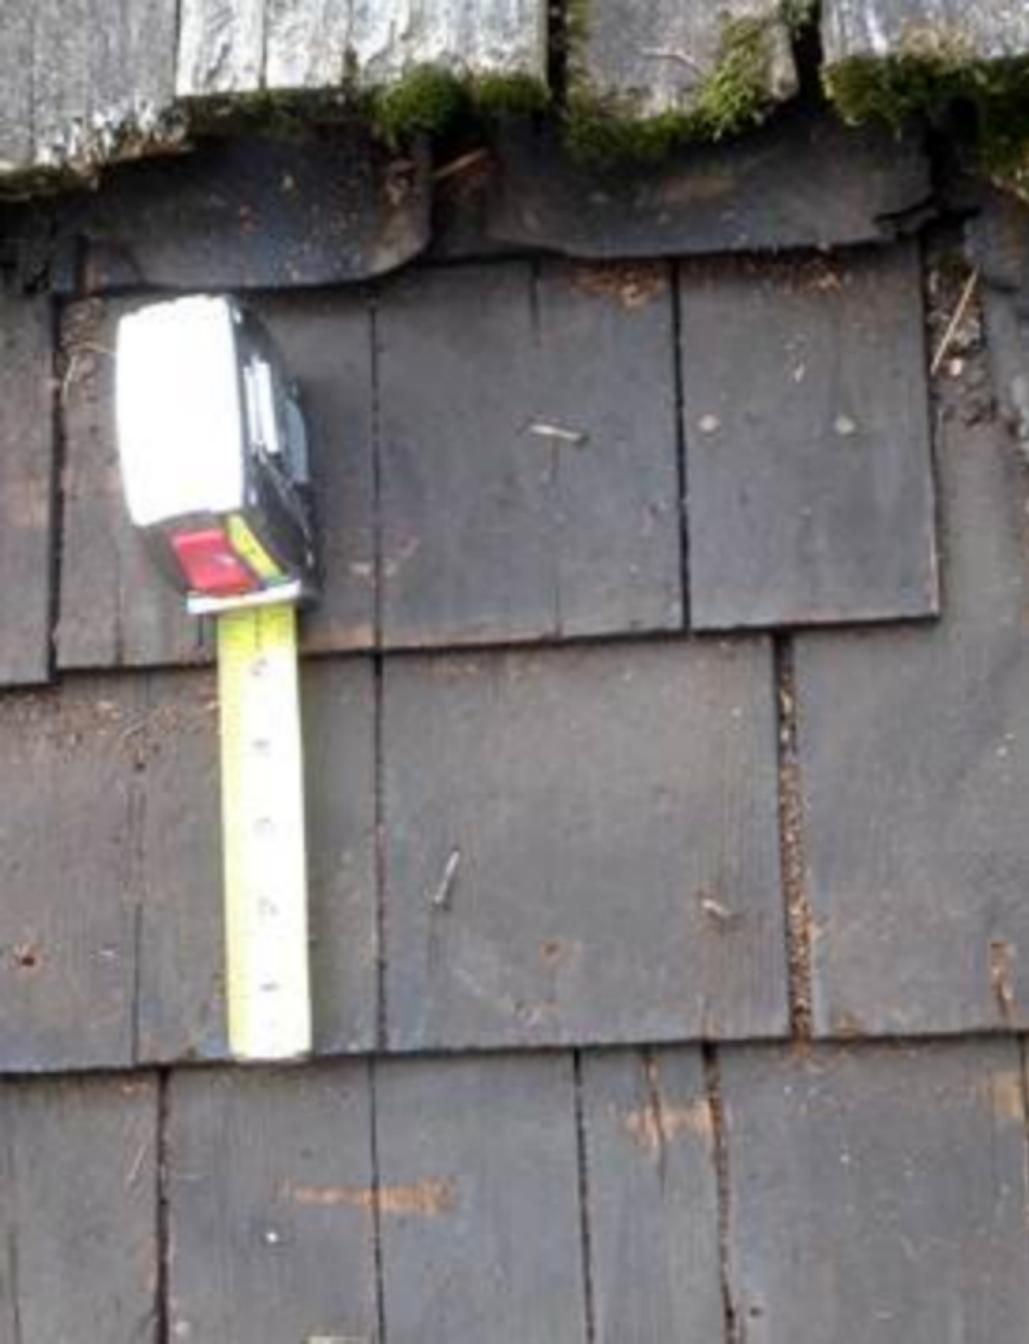
On March 18, the applicant removed a section of wood shakes from the garage to expose the historic wood shingles underneath. These shingles appear to have been dipped in creosote or stained/tinted dark brown. They are uniformly cut with square corners and smoothly finished. Photos are included in the packet and measurement details have been included in a table.

4. On March 18, the owner submitted measurements and photos of the bottom layer of wood shingles on the garage.
- 4-5. §74.36(a)(2) The replacement of the existing wood shingle/shake roof with an the CertainTeed Independence asphalt shingle ~~does not comply~~ complies with the principle, as the proposed asphalt shingles ~~do not have similar dimensions and shape to closely match the original wood shingle/shake in composition, design, color, texture and appearance.~~ The proposed asphalt shingles ~~may be have a slightly thinner profile, smaller is similar in size, and matches the (exposure), do not have the same profile/thickness, and have a different~~ The texture and appearance are not the same, but with a regular pattern and less variation in widths the product could be an appropriate replacement. (See attachments)

6. The roofing material may be an in-kind replacement of the historic wood shingles still extant. CertainTeed Independence asphalt shingles in a dark brown color would also be a suitable replacement product.
