HERITAGE PRESERVATION COMMISSION STAFF REPORT

ADDRESS: 777 6th Street E.

ZONING: RT1 **PROPOSAL:** Siding, window and rear porch work

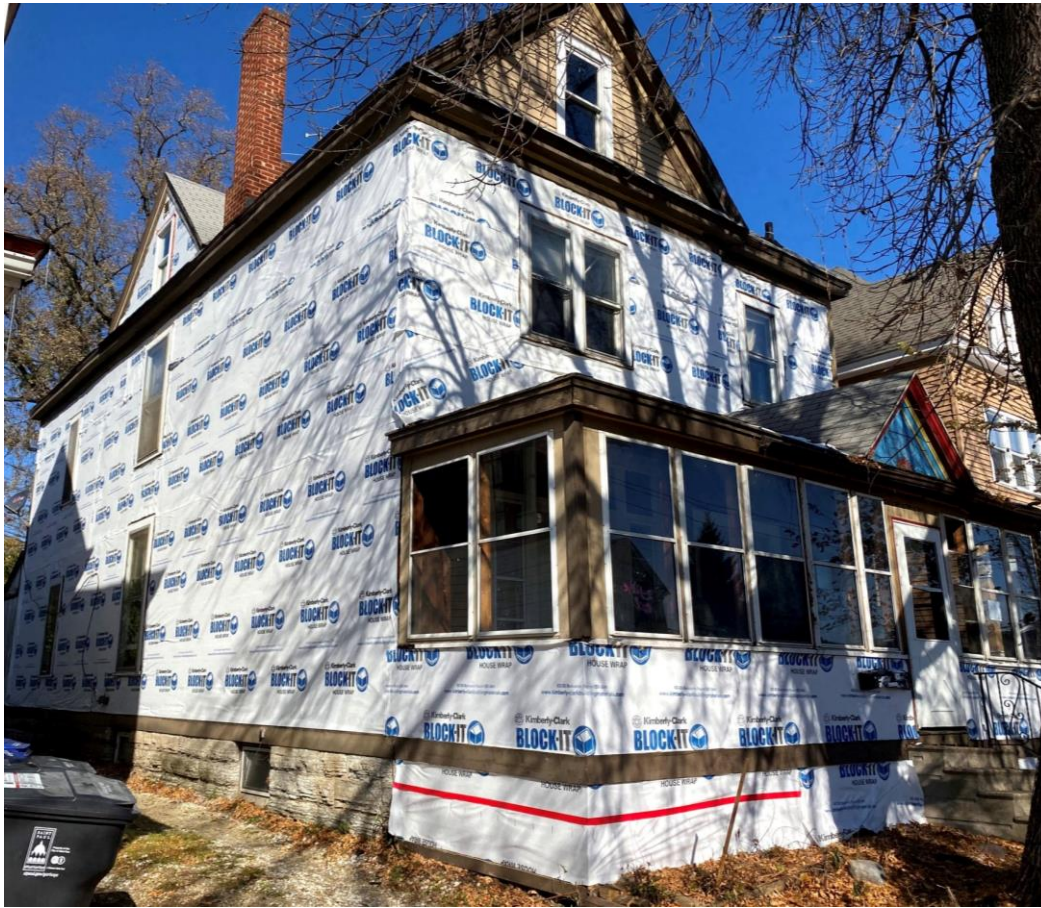
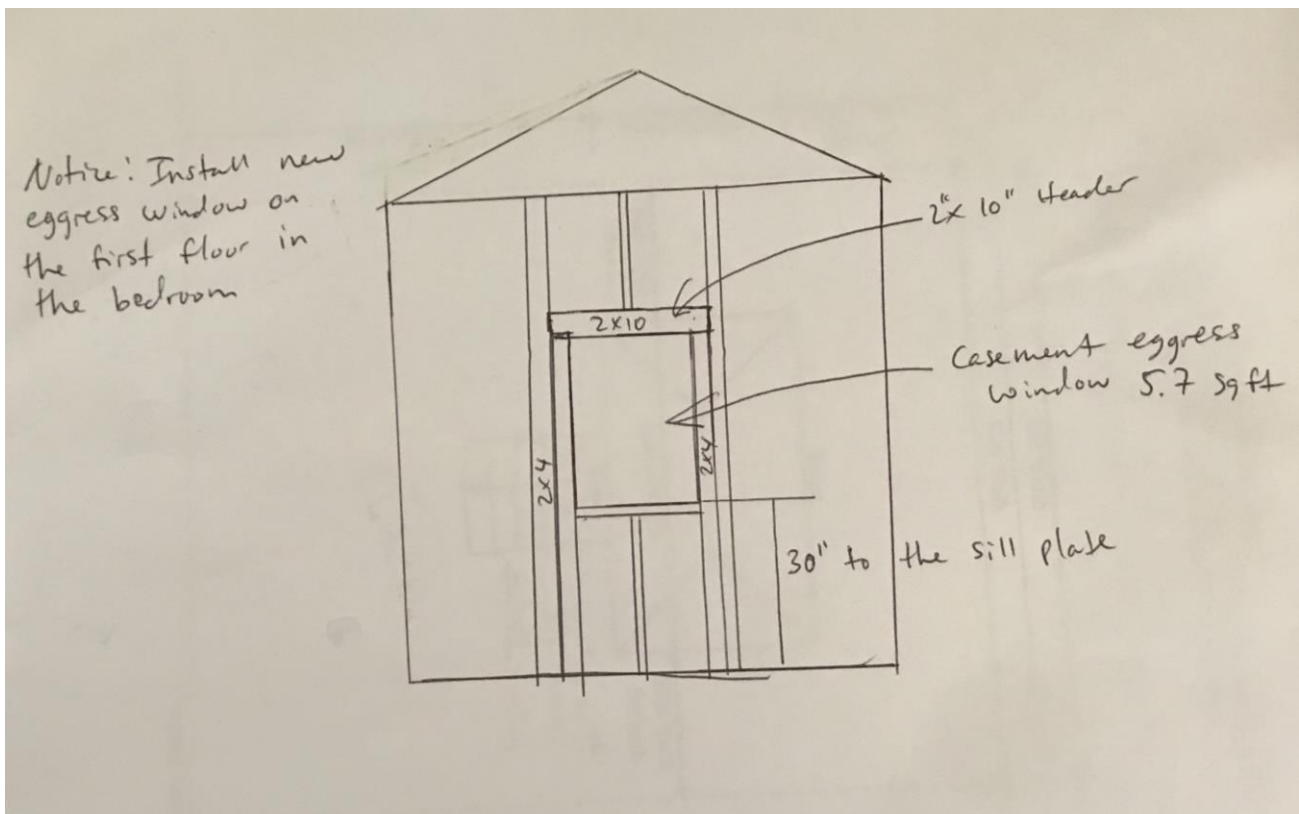
New Egress plan submitted by applicant (structural plan required for building permit)

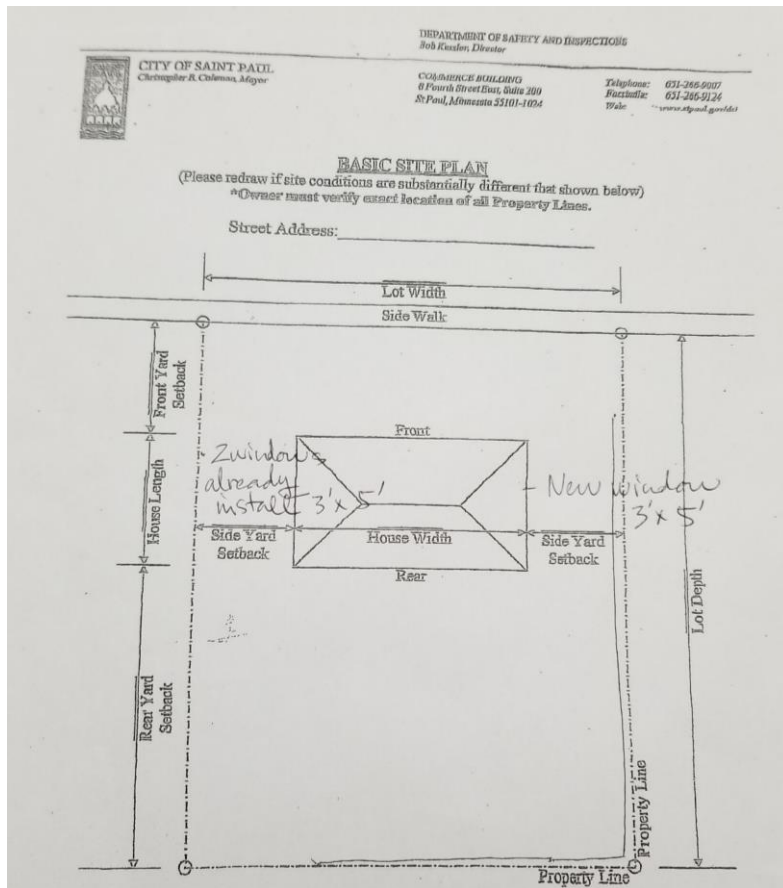
Location of replacement and new windows submitted by applicant.

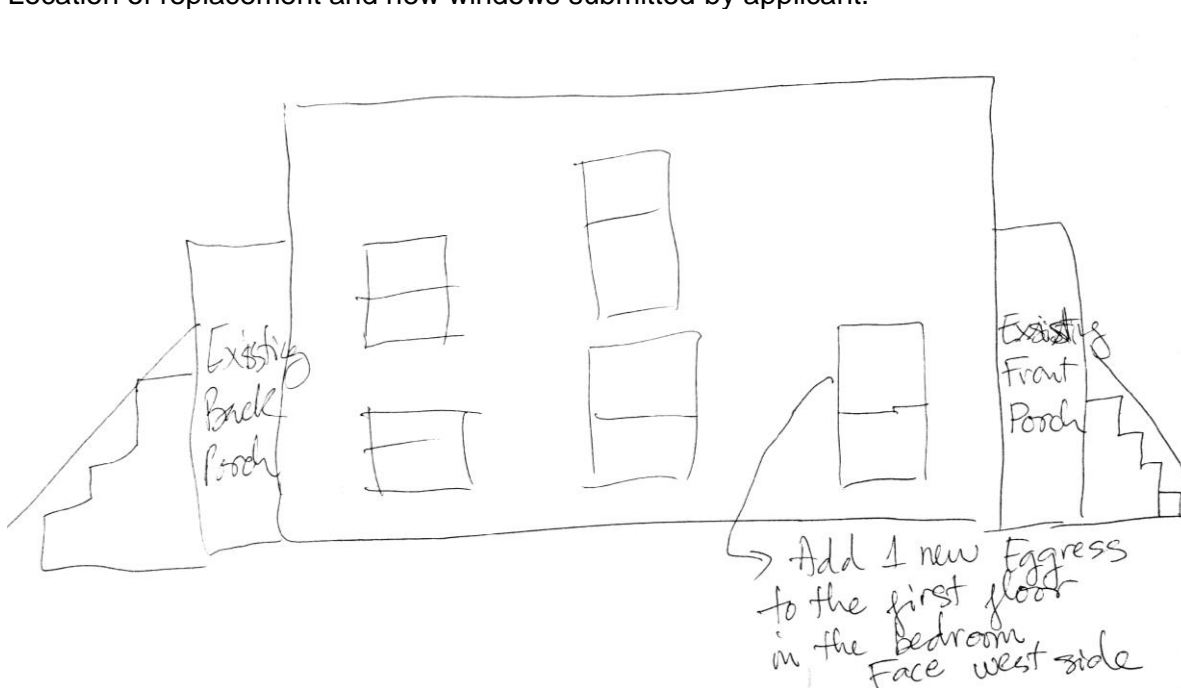
New egress window placement submitted by applicant-update from below plan

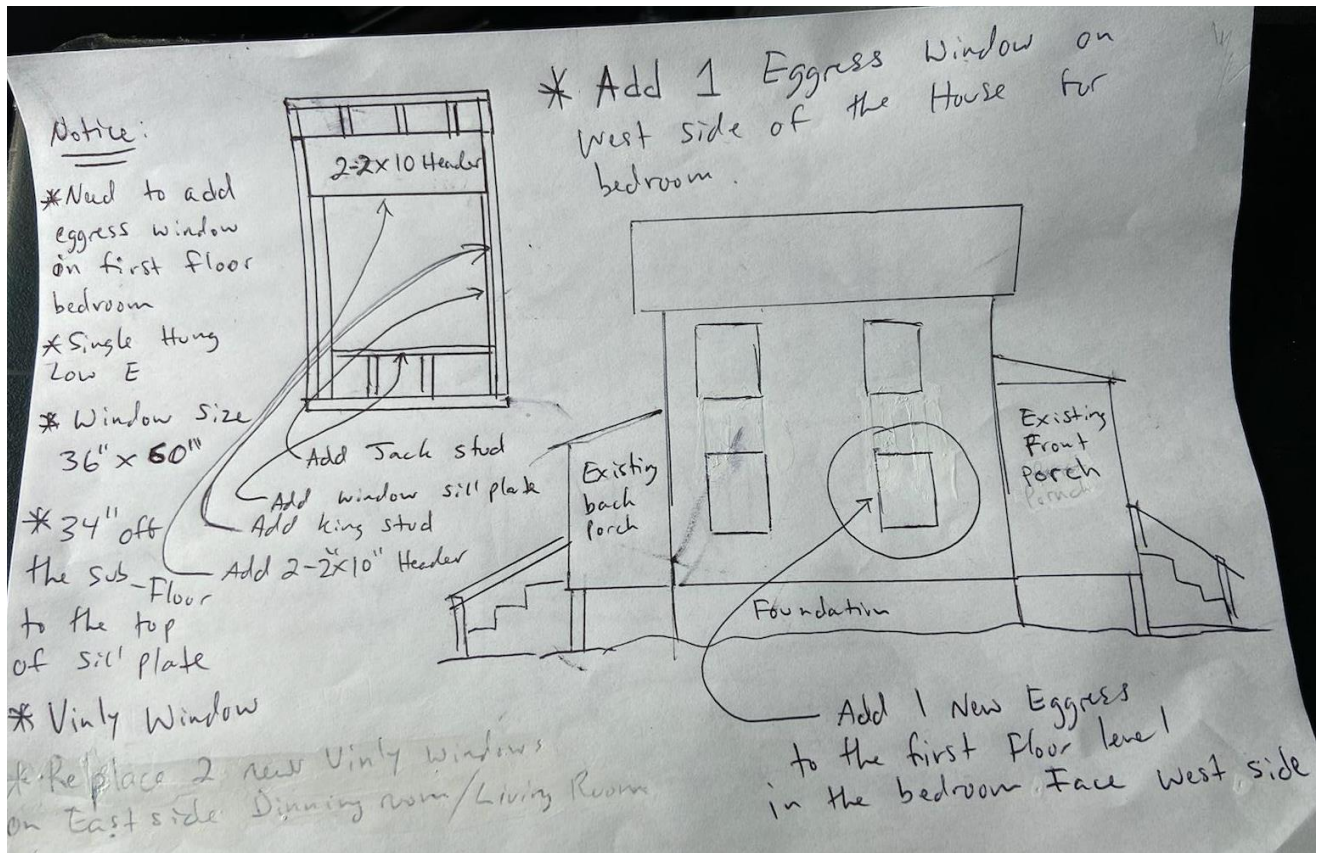
Original new egress window placement submitted by applicant

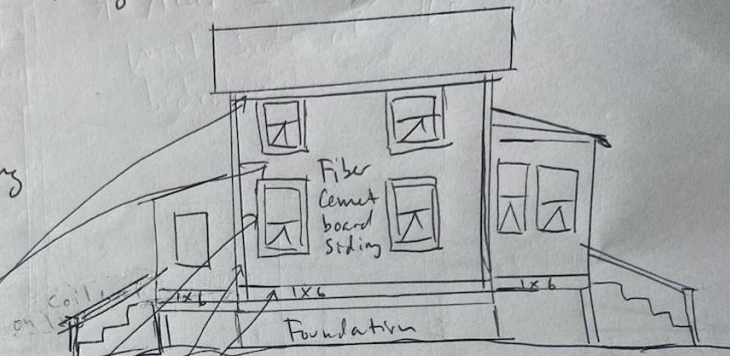
- Used Aluminum to wrap the 1x6" (white)
- Used Aluminum to wrap outside corner (white)
- Used Aluminum to wrap the 1x6" under neath the soffit
- All windows to be used Aluminum to wrap the 1x6" around the windows (white)
- the whole House to be used Fiber Cement board at 4" reveal

Siding plan as submitted by applicant

An aluminum wrap is proposed for trim. This should be cement fiberboard material that replicates the appropriate trim size/style for the structure. Again, the other seven structures along Keller Row can be used for examples.

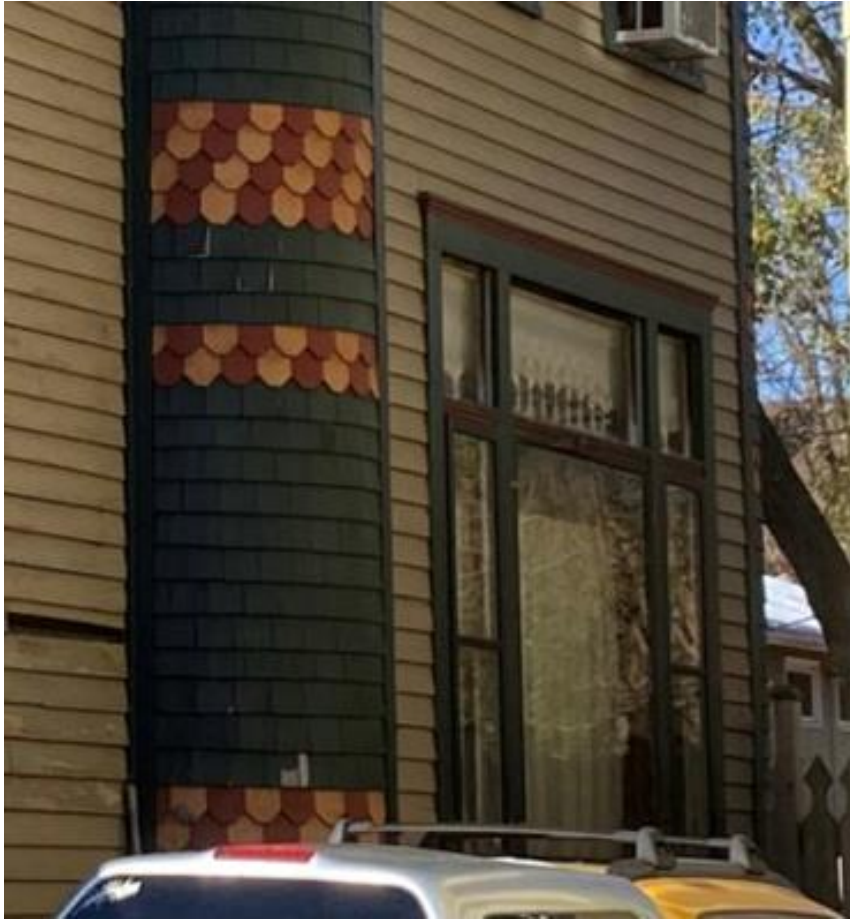
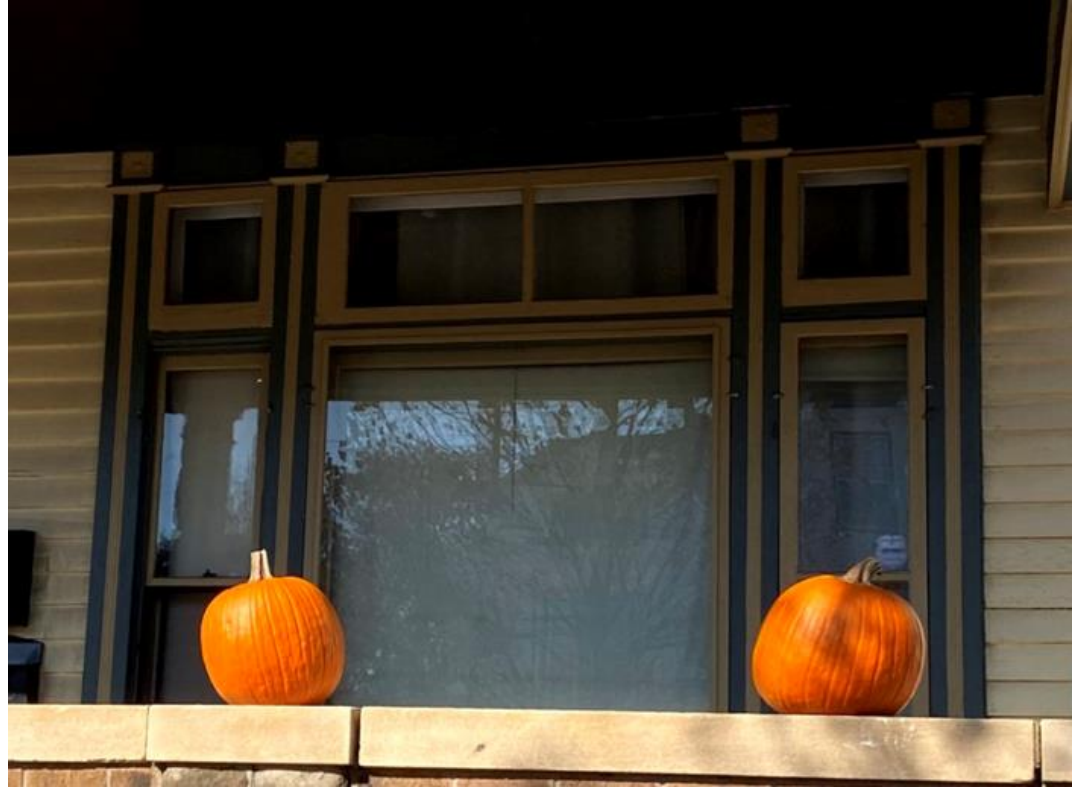
Two examples from sister buildings (771 & 767 6th St. E.)

The side window is similar had a large picture window with two thin double hung windows beside. Above were three transoms. The picture with the pumpkins shows wood storm windows which are divided.

The two windows that were altered, still exist on sister houses along the block. Those window configurations could be used for dimension and style standards in reconstructing the two window sets along the east façade.

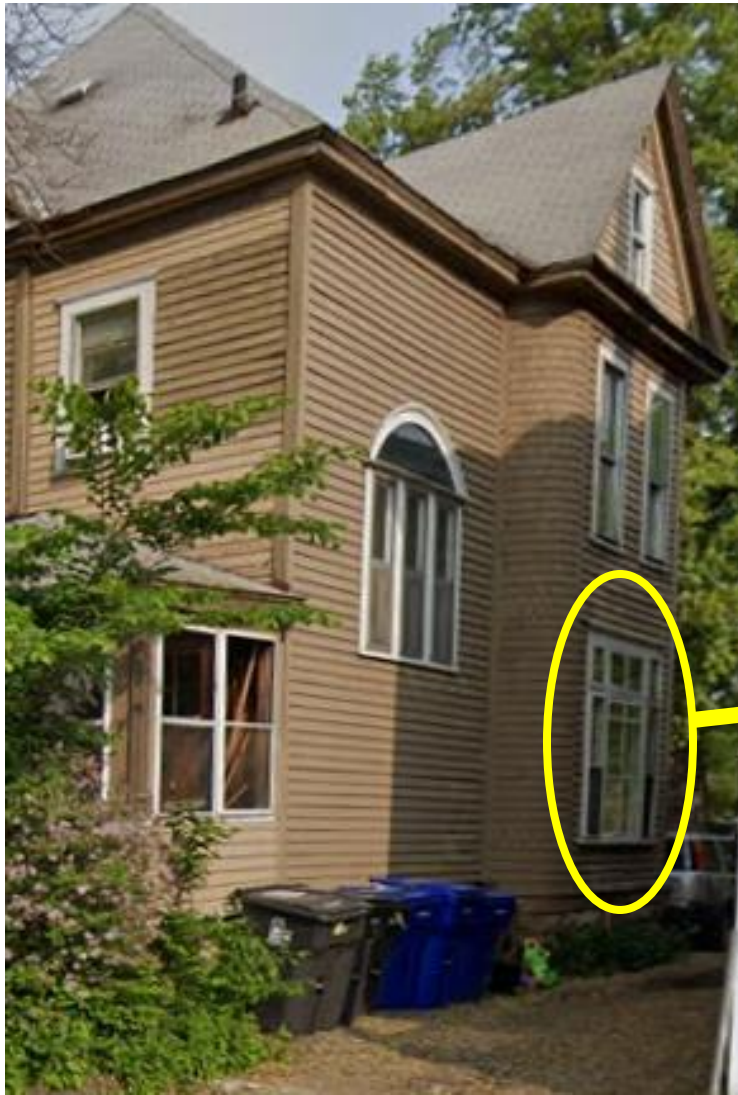
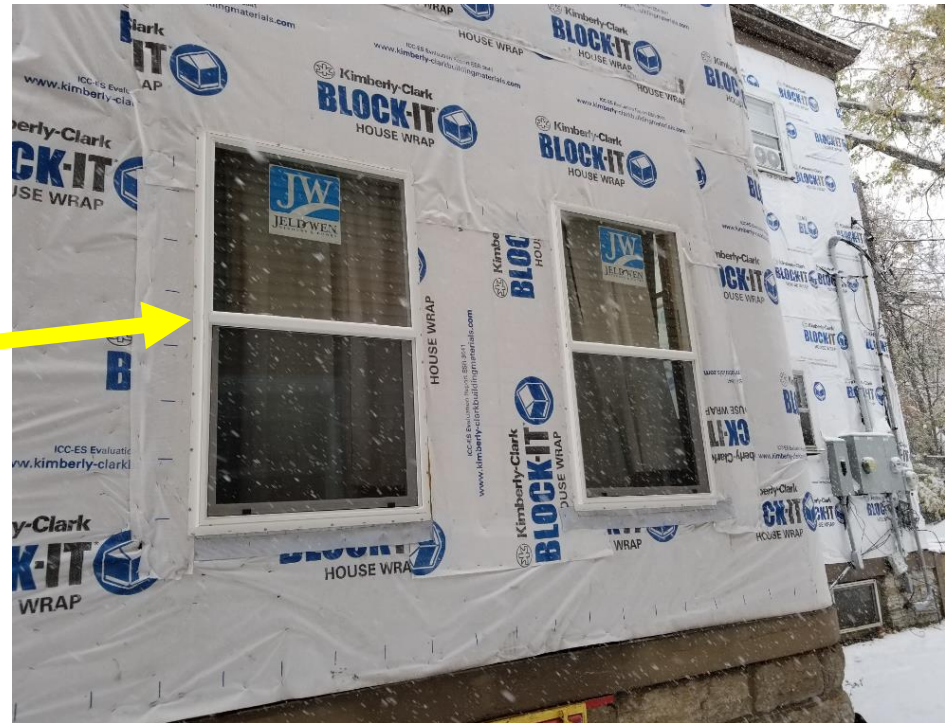
Windows: The round arch window and a multi-window on the east façade have both been altered and replaced. The applicant is proposing to reconstruct these windows back to the original configuration. Both window types exist on other Keller Row houses and are examples for reconstruction dimensions. Applicant proposes using a clad material for durability and maintenance.

777 6th Street East window alteration
