Loras Hall: HPC Pre-application Meeting

October 5, 2020 (September 18, 2020- Pre-Application)

Building Envelope Assessment

Loras Hall

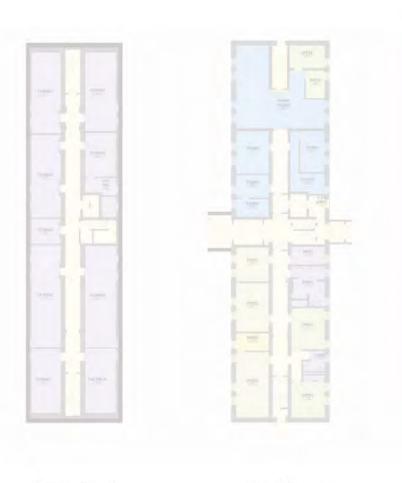
Load-bearing corridor walls result in narrow bars – limiting space for programs

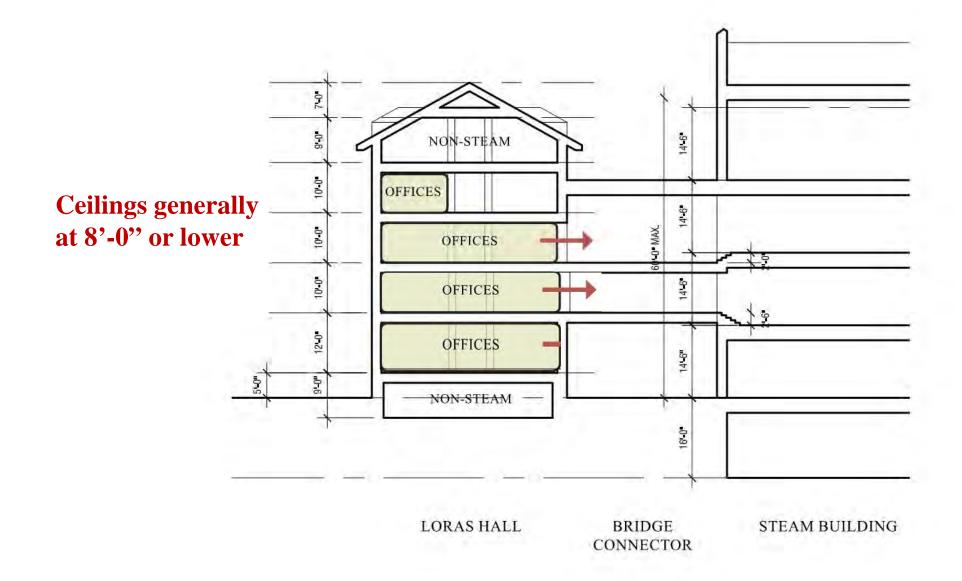
- Air Conditioning: Window units in limted locations
- Heating : Steam radiation
- Fresh Air Ventilation : Operable windows

- Brick ties in multi-wythe masonry walls deteriorating
- Wood floor framing is good condition
- Stone foundation spalling due to moisture
- Interior load bearing walls removal to enlarge space would require enlarging the interior footings
