**CITY OF SAINT PAUL
HERITAGE PRESERVATION COMMISSION STAFF REPORT**

FILE NAME: 539 Holly Avenue – Parisons House

HPC SITE/DISTRICT: Historic Hill Heritage Preservation District

DATE OF REPORT: March 17, 2017

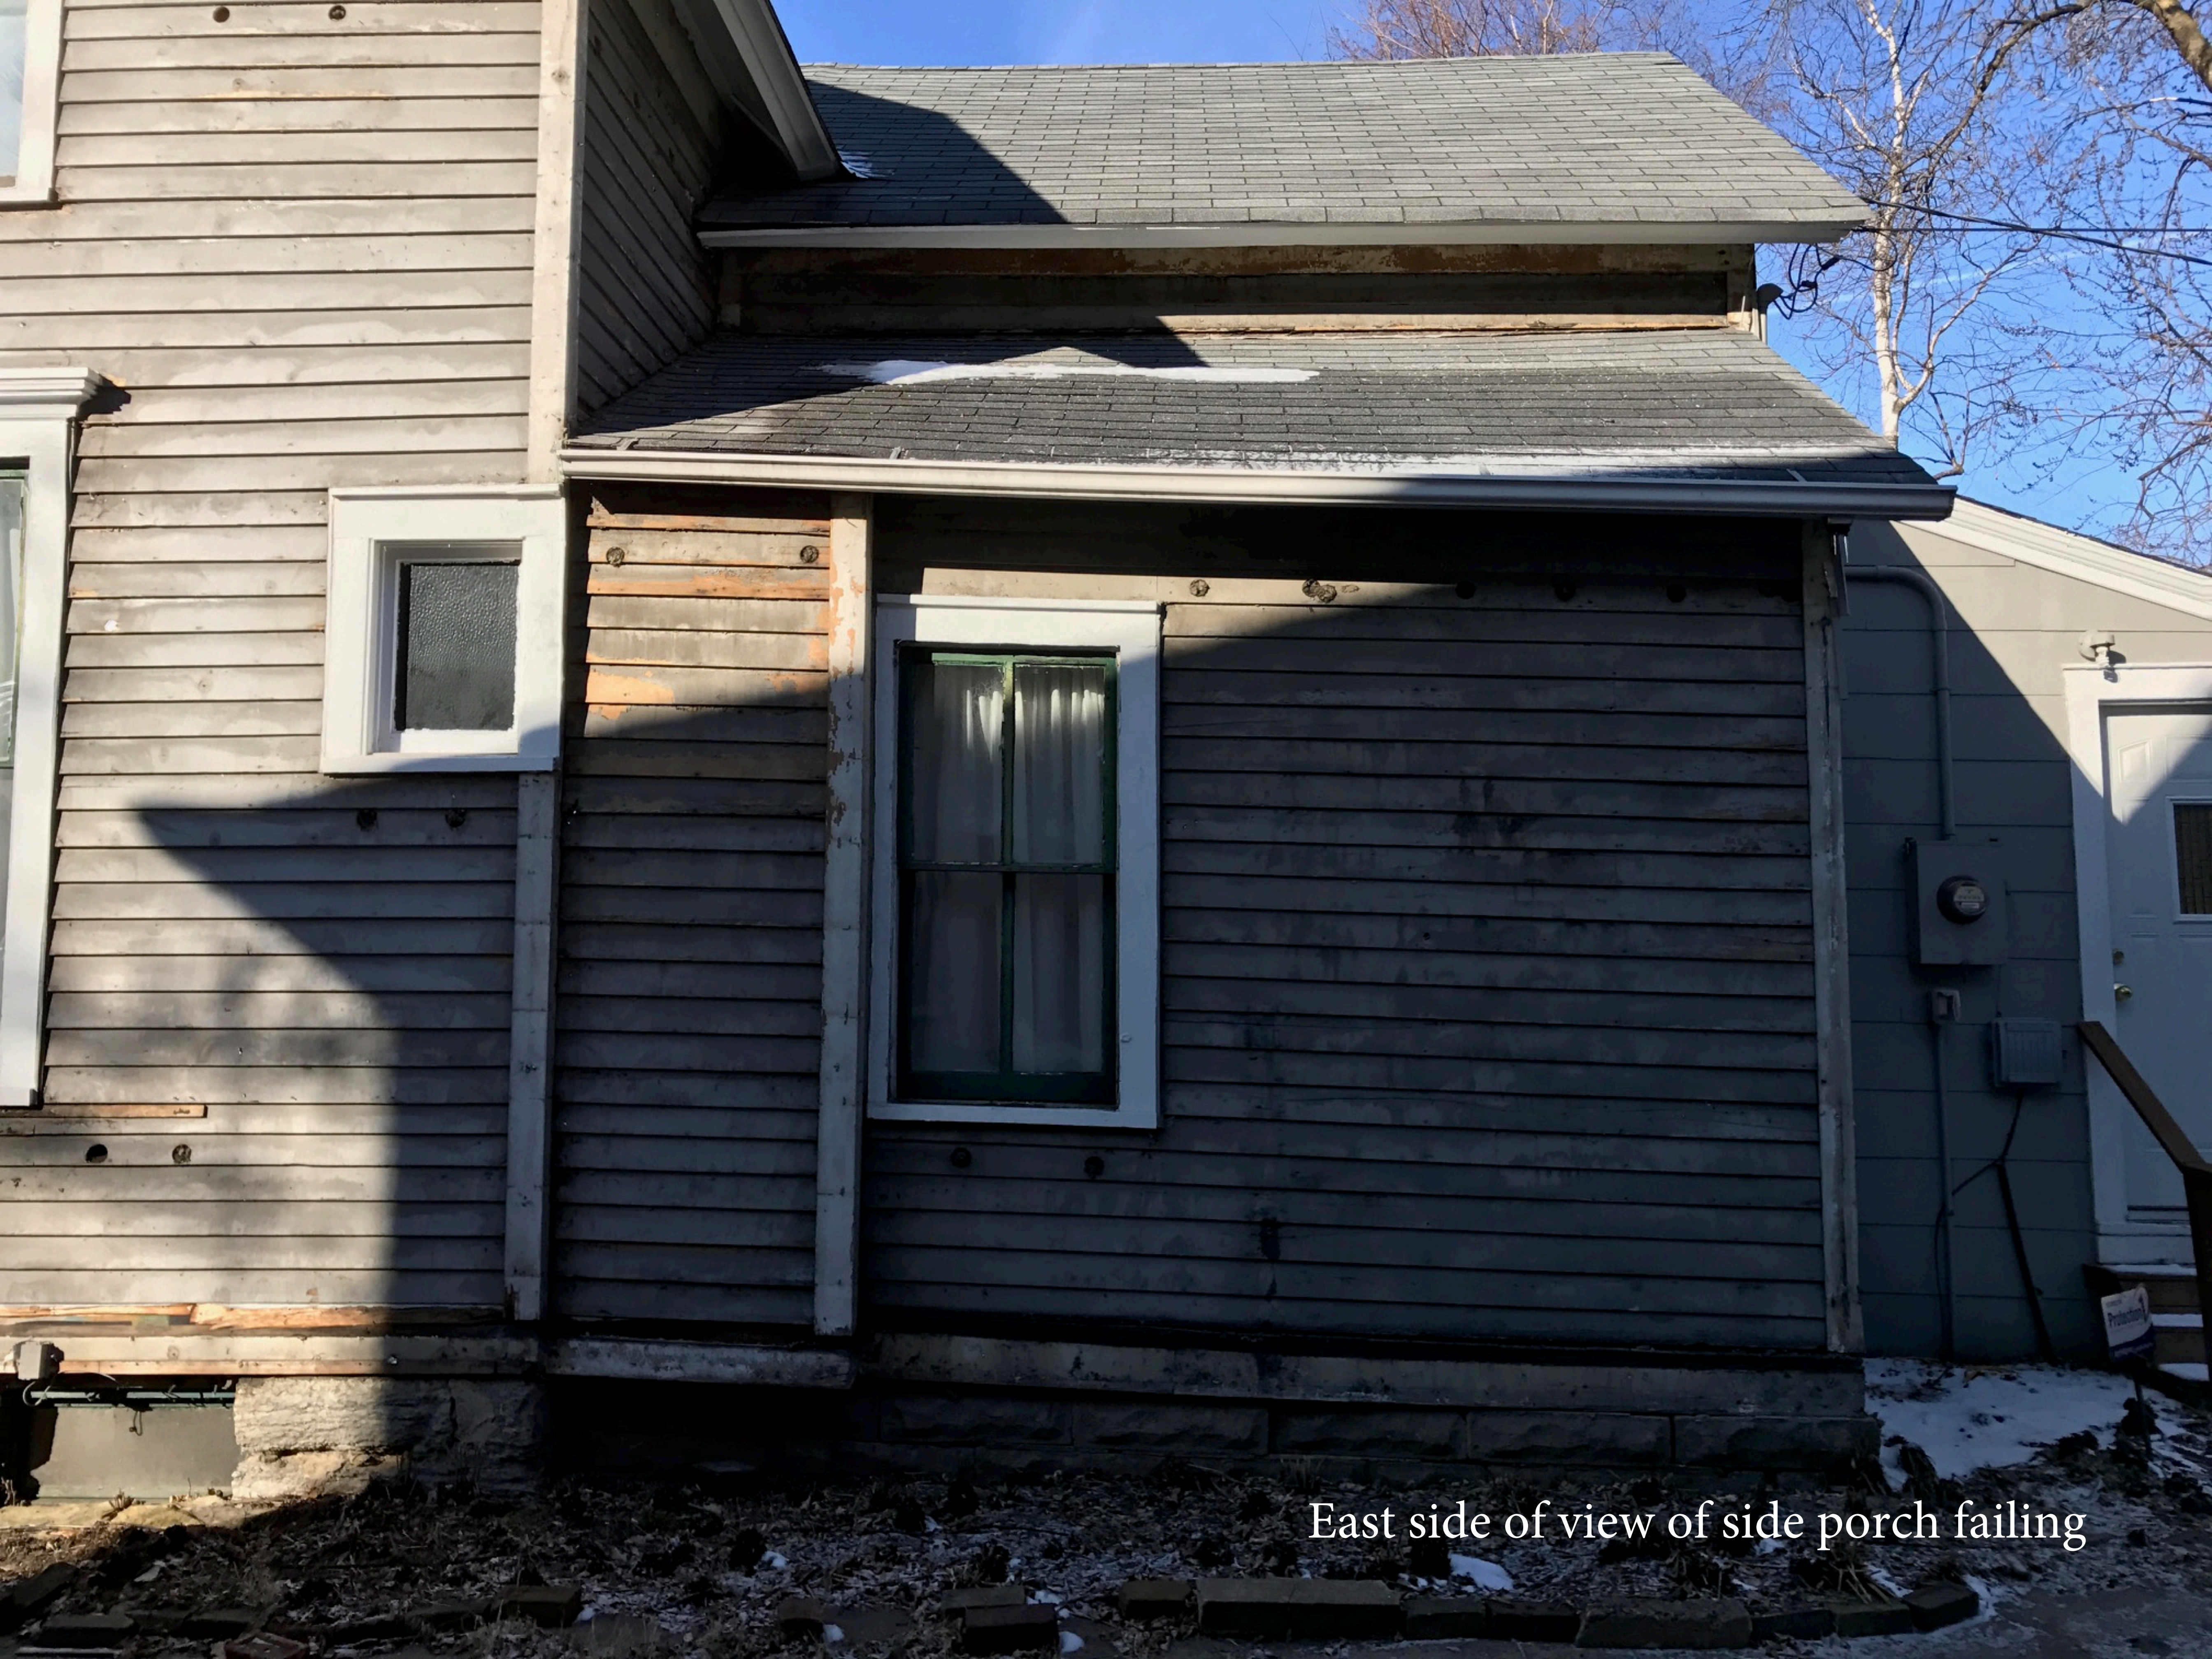
East side of view of side porch failing

Due to the poor structure and deteriorated framing of the front porch it will be demolished and rebuilt to be historically accurate open air porch with wood floor, wood railings, wood stairs, and a

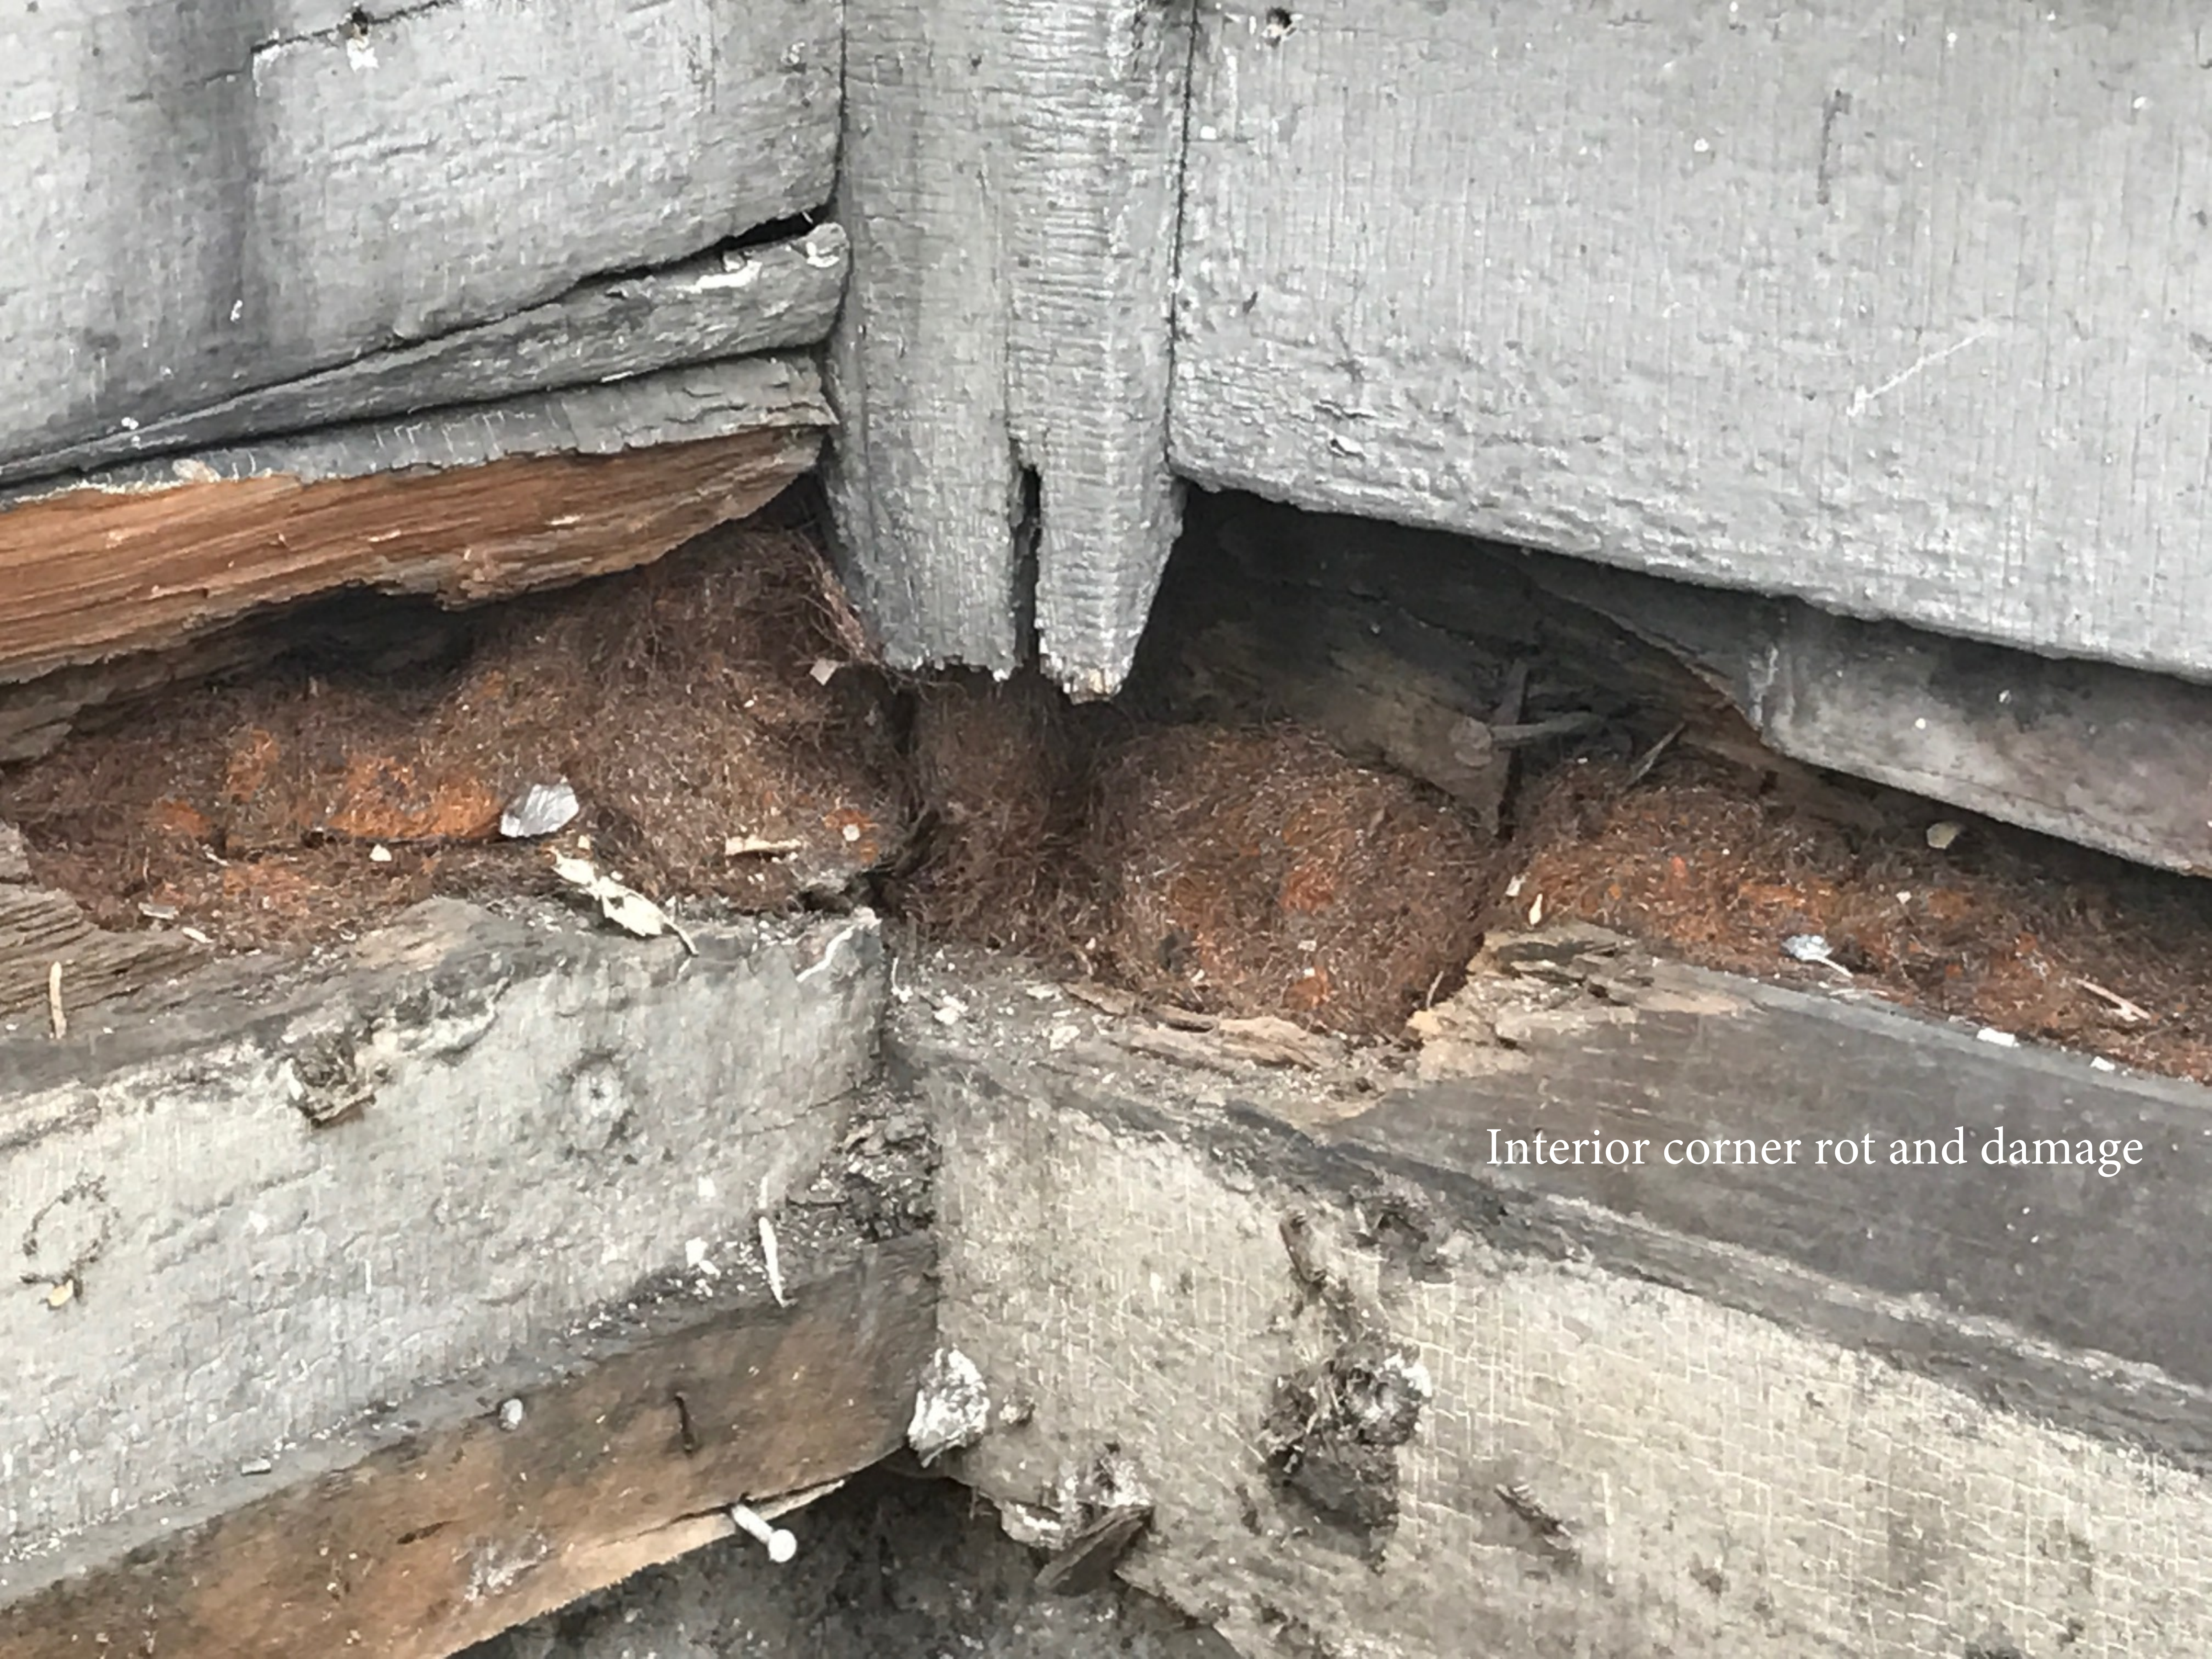
Interior corner rot and damage

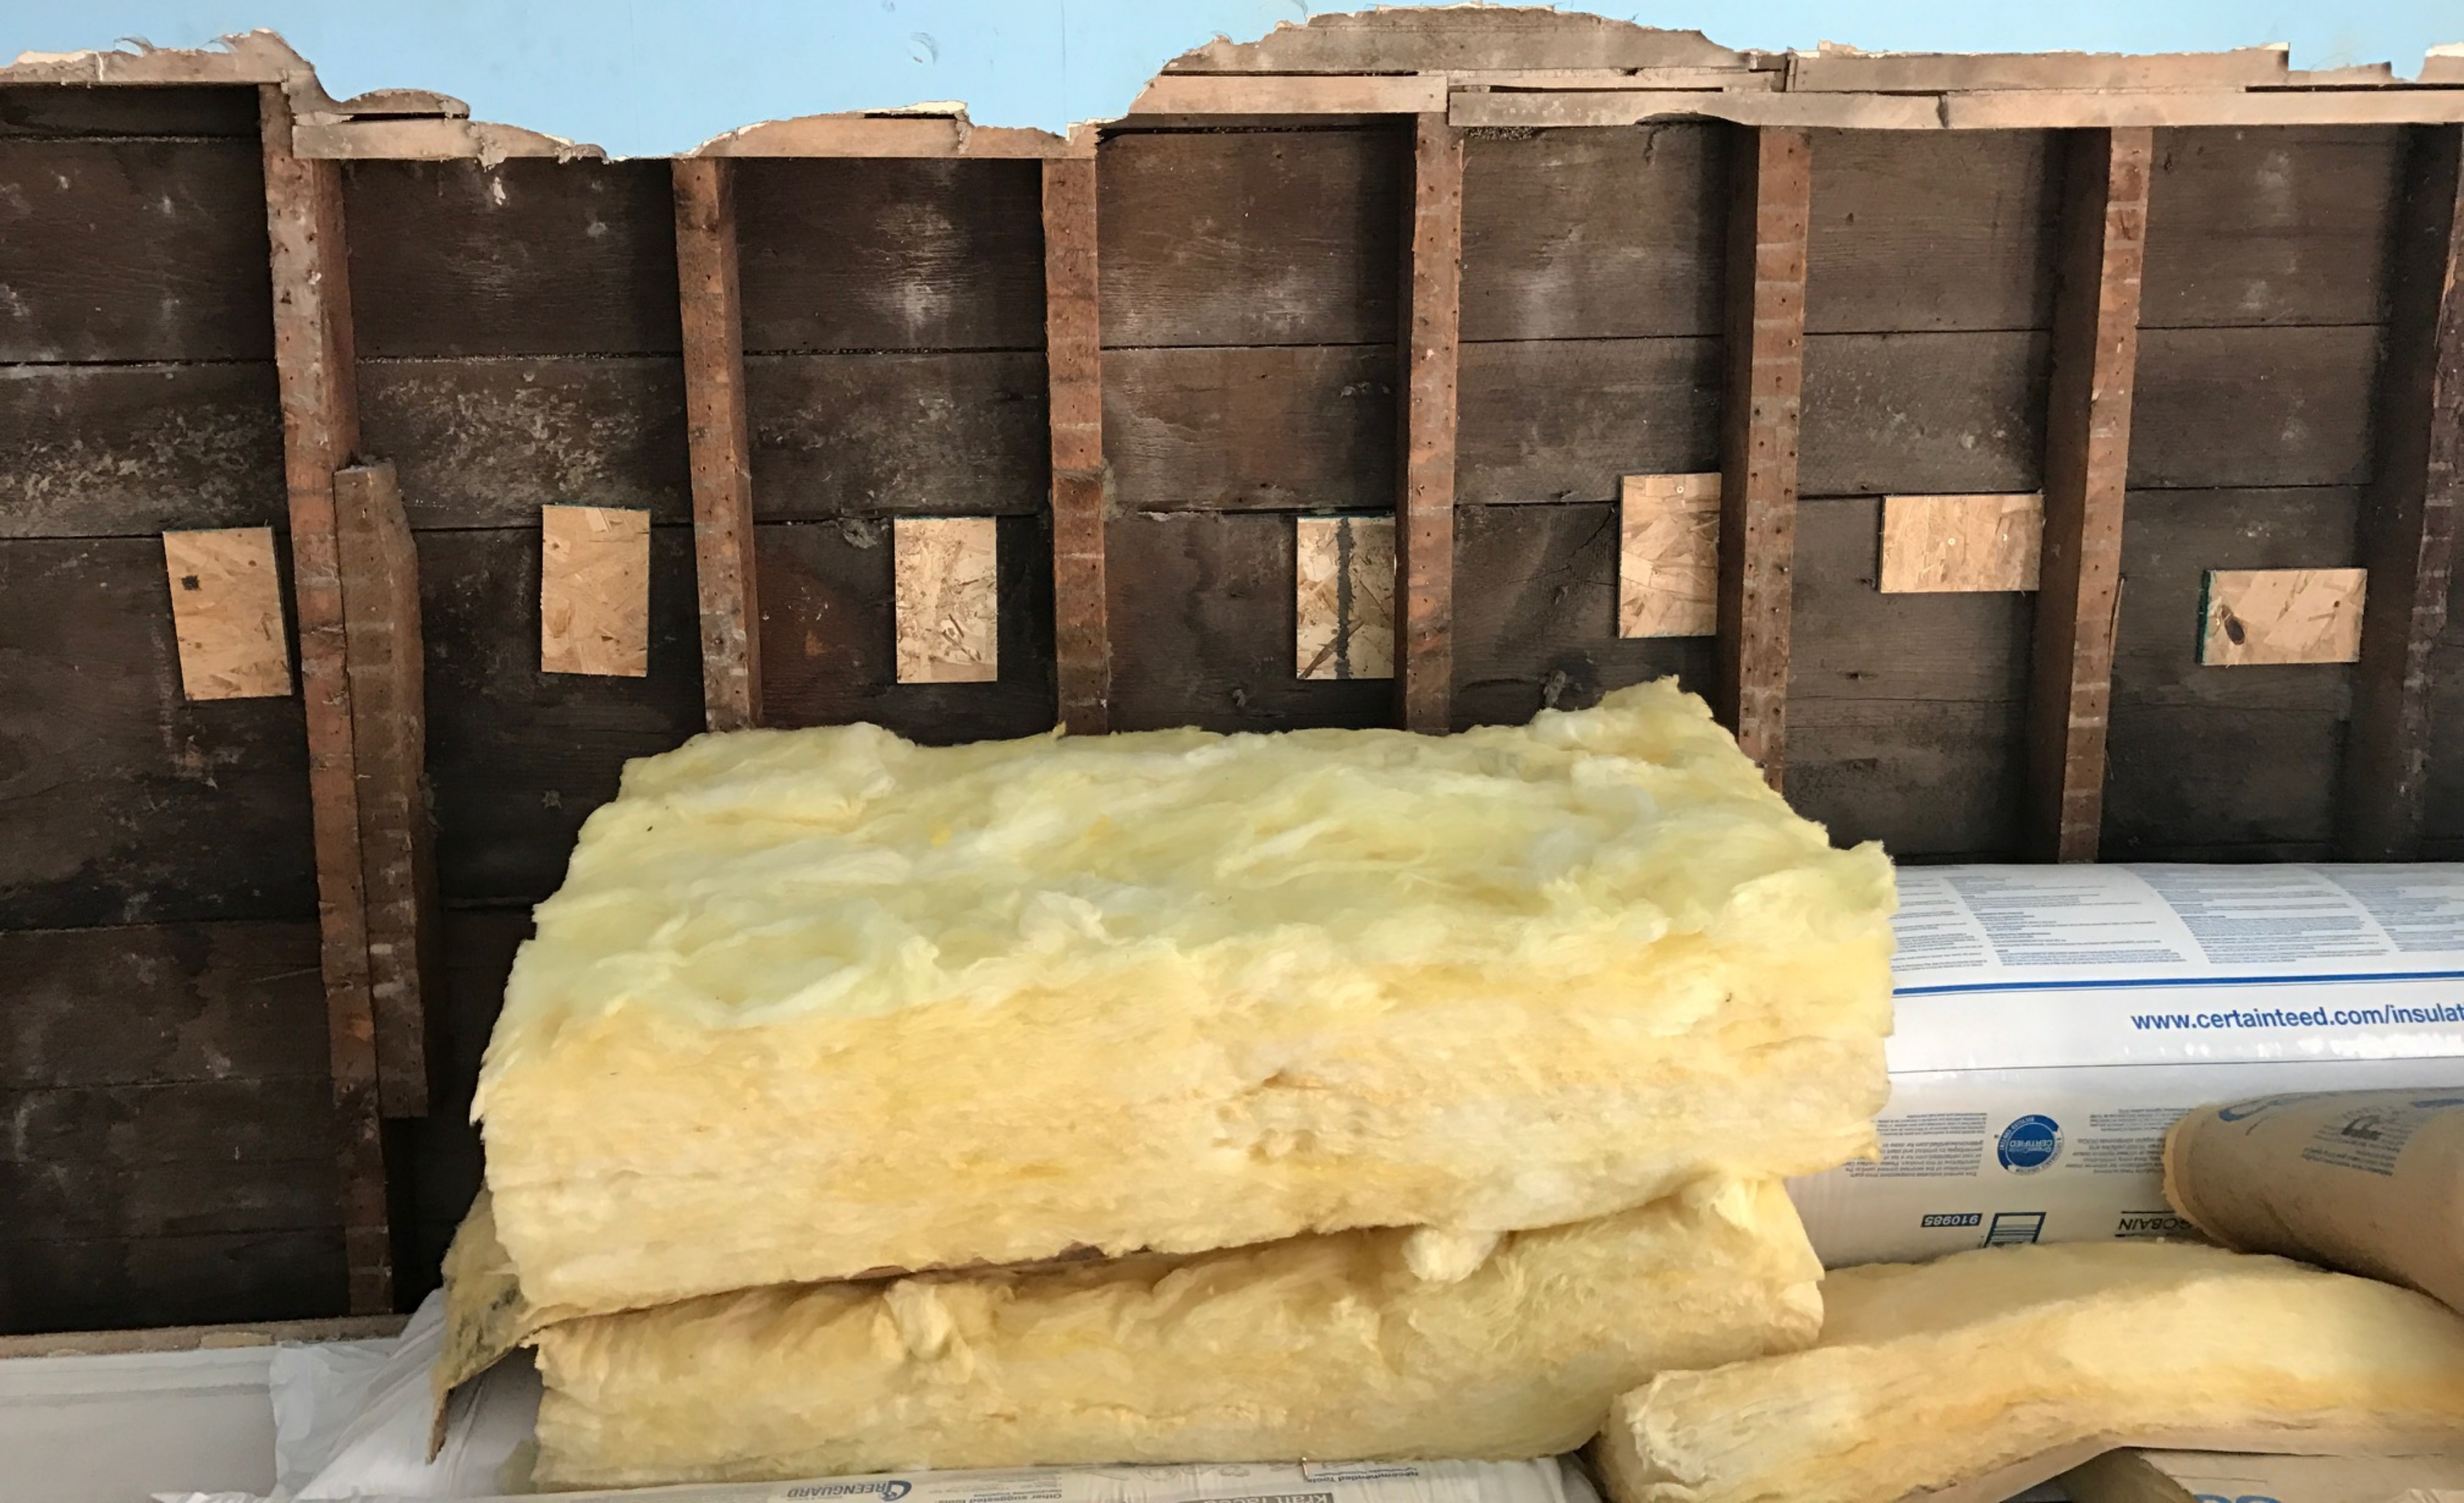
Interior water damage 2

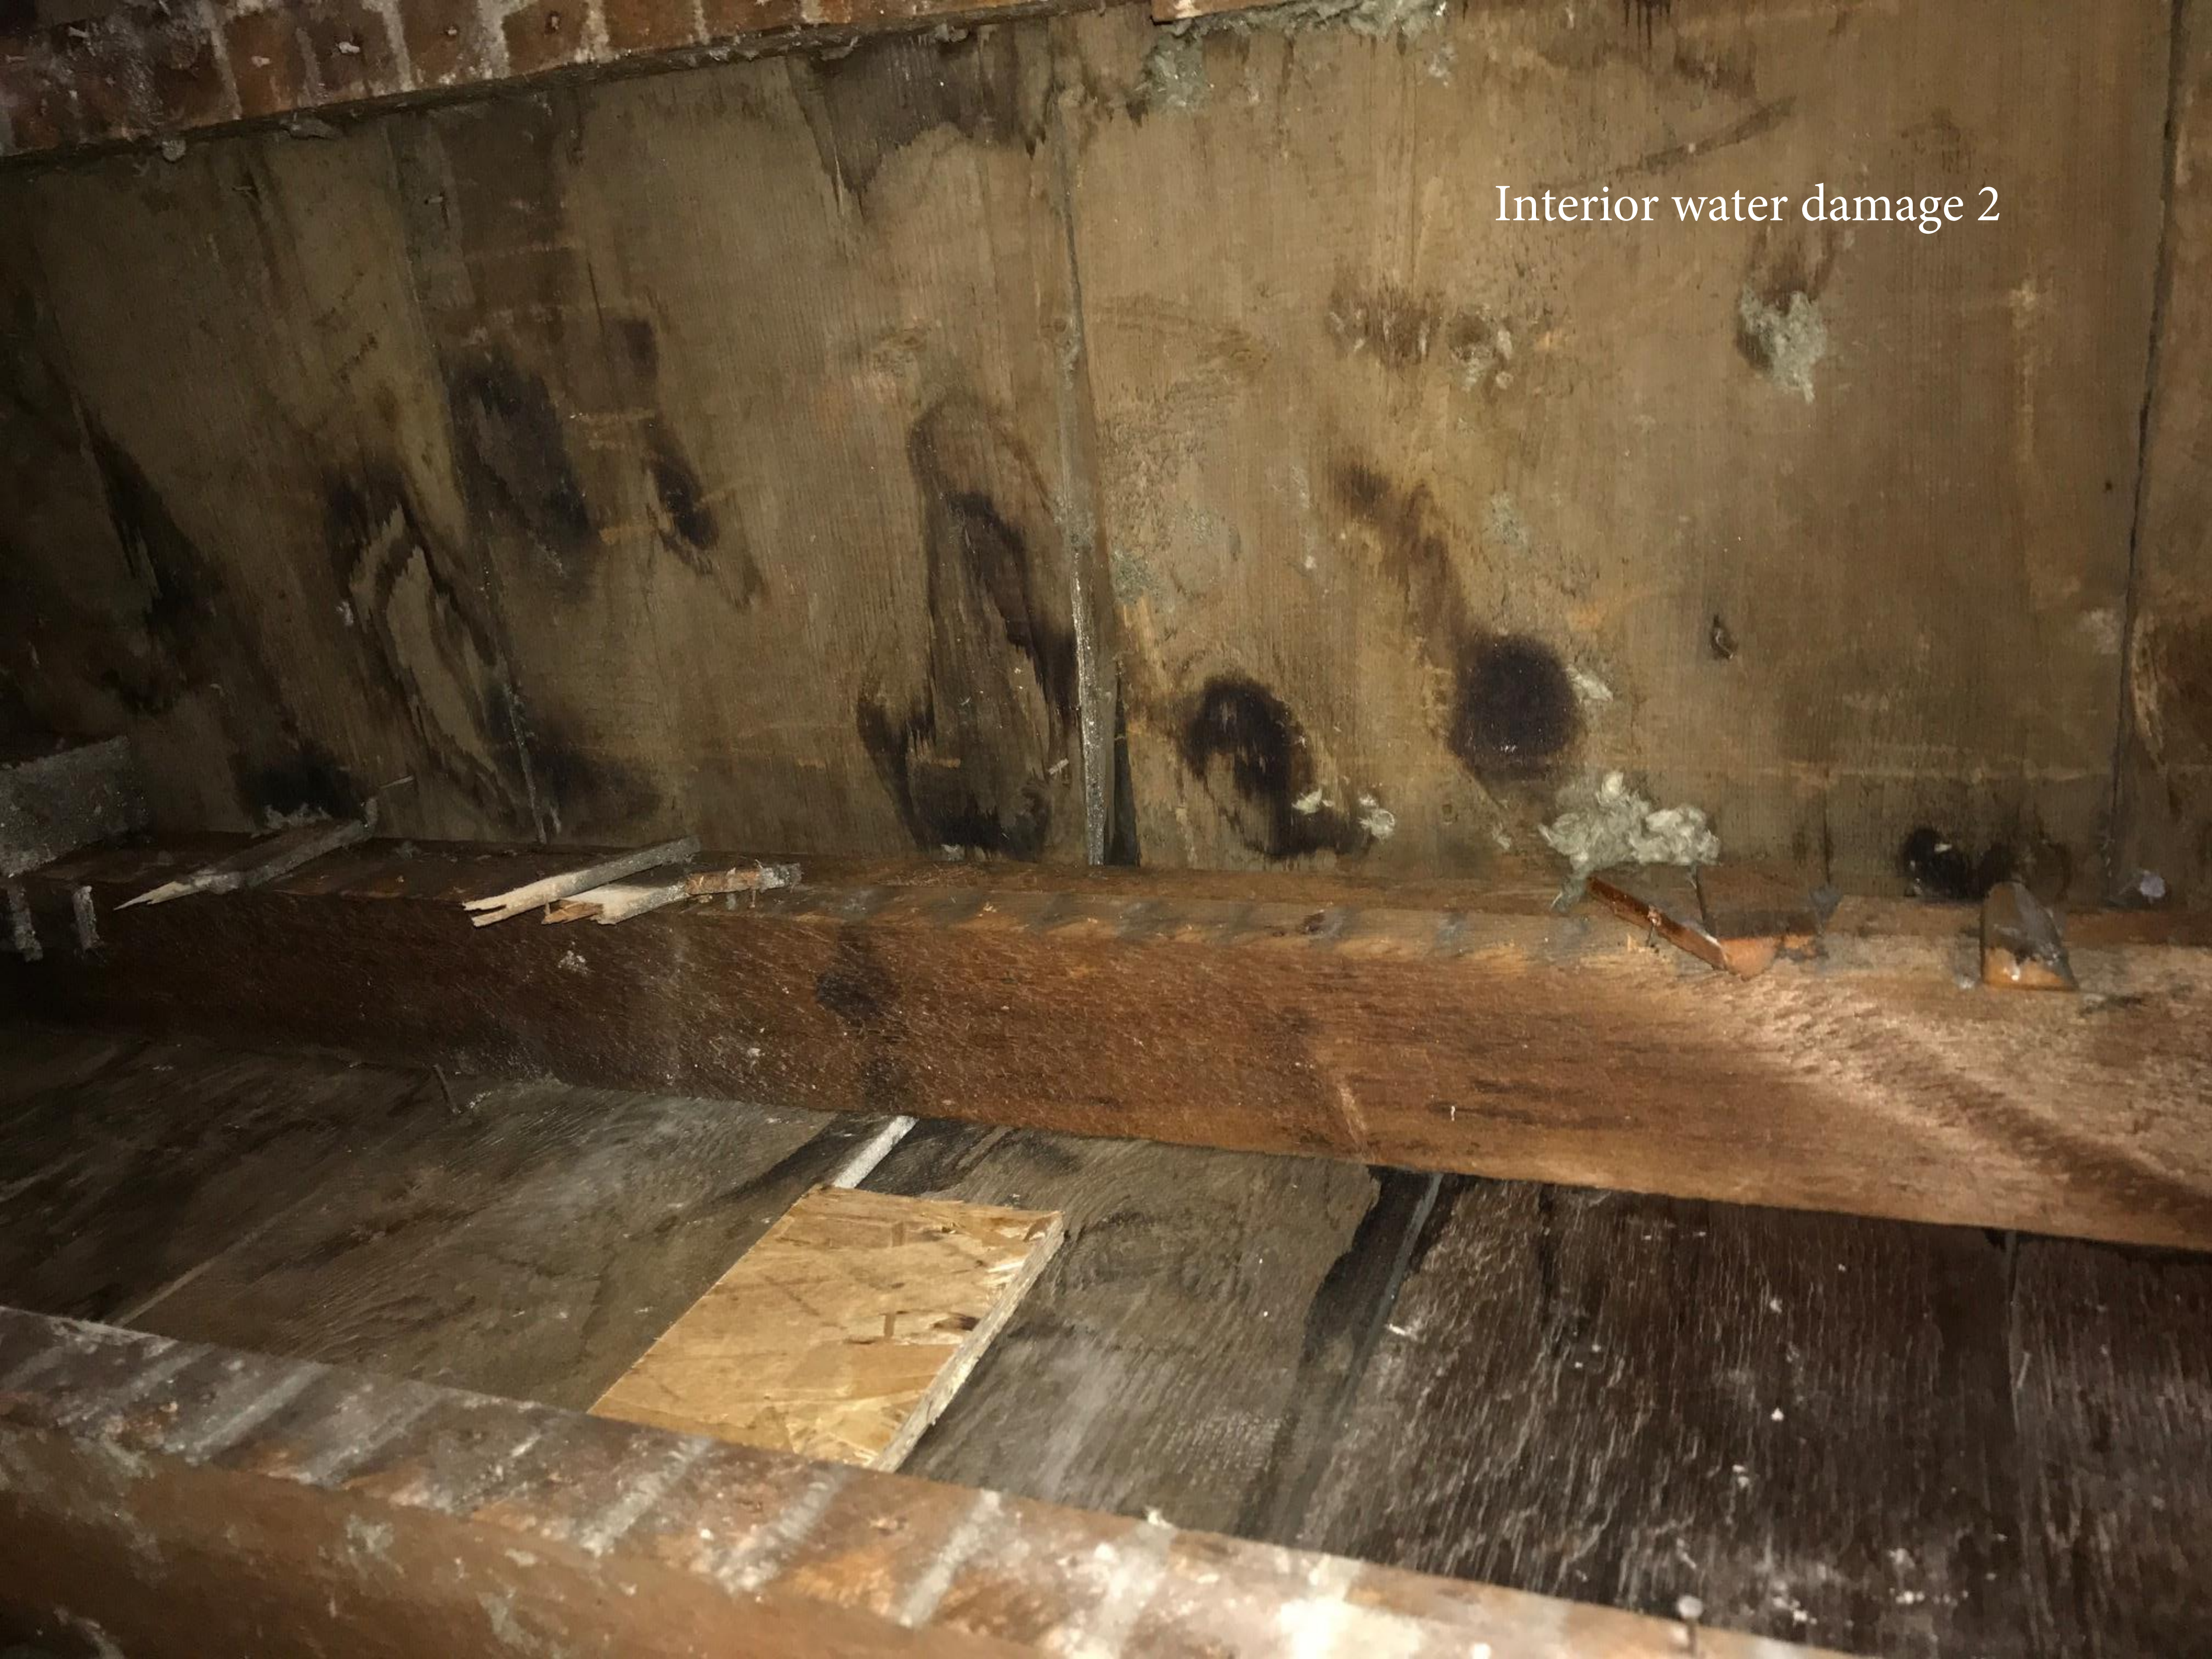
Interior water damage 3

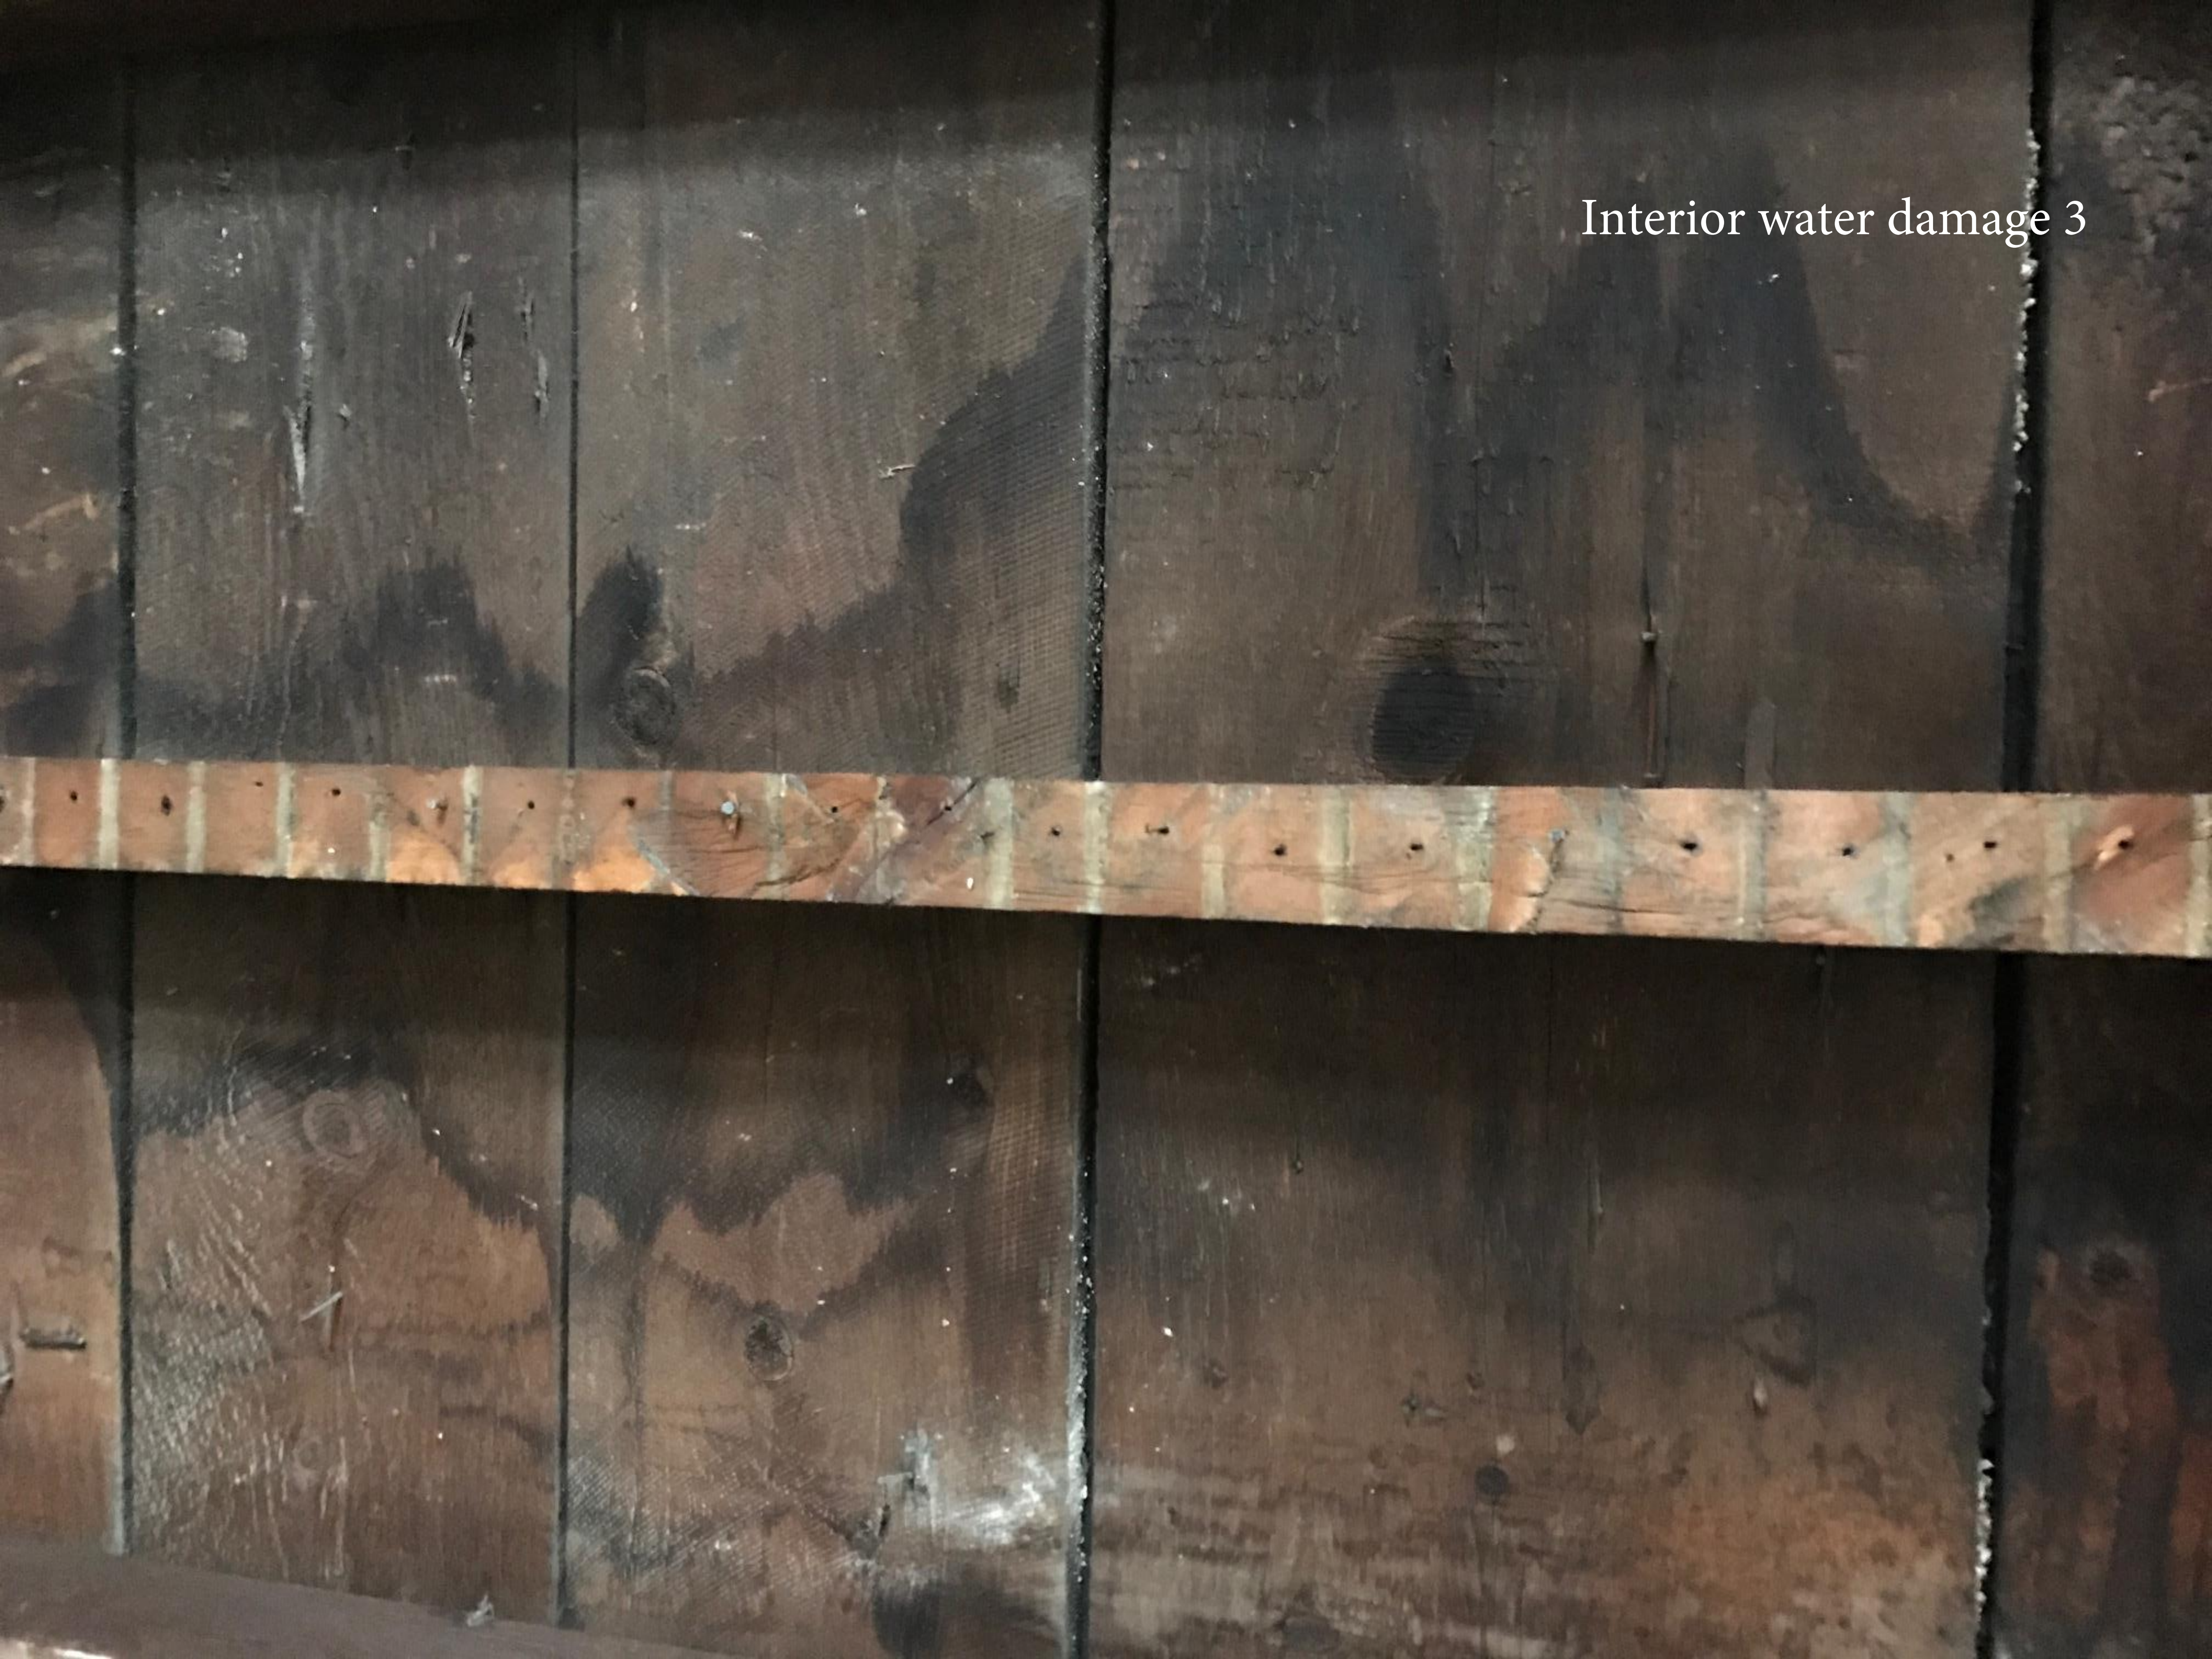
Interior water damage 4

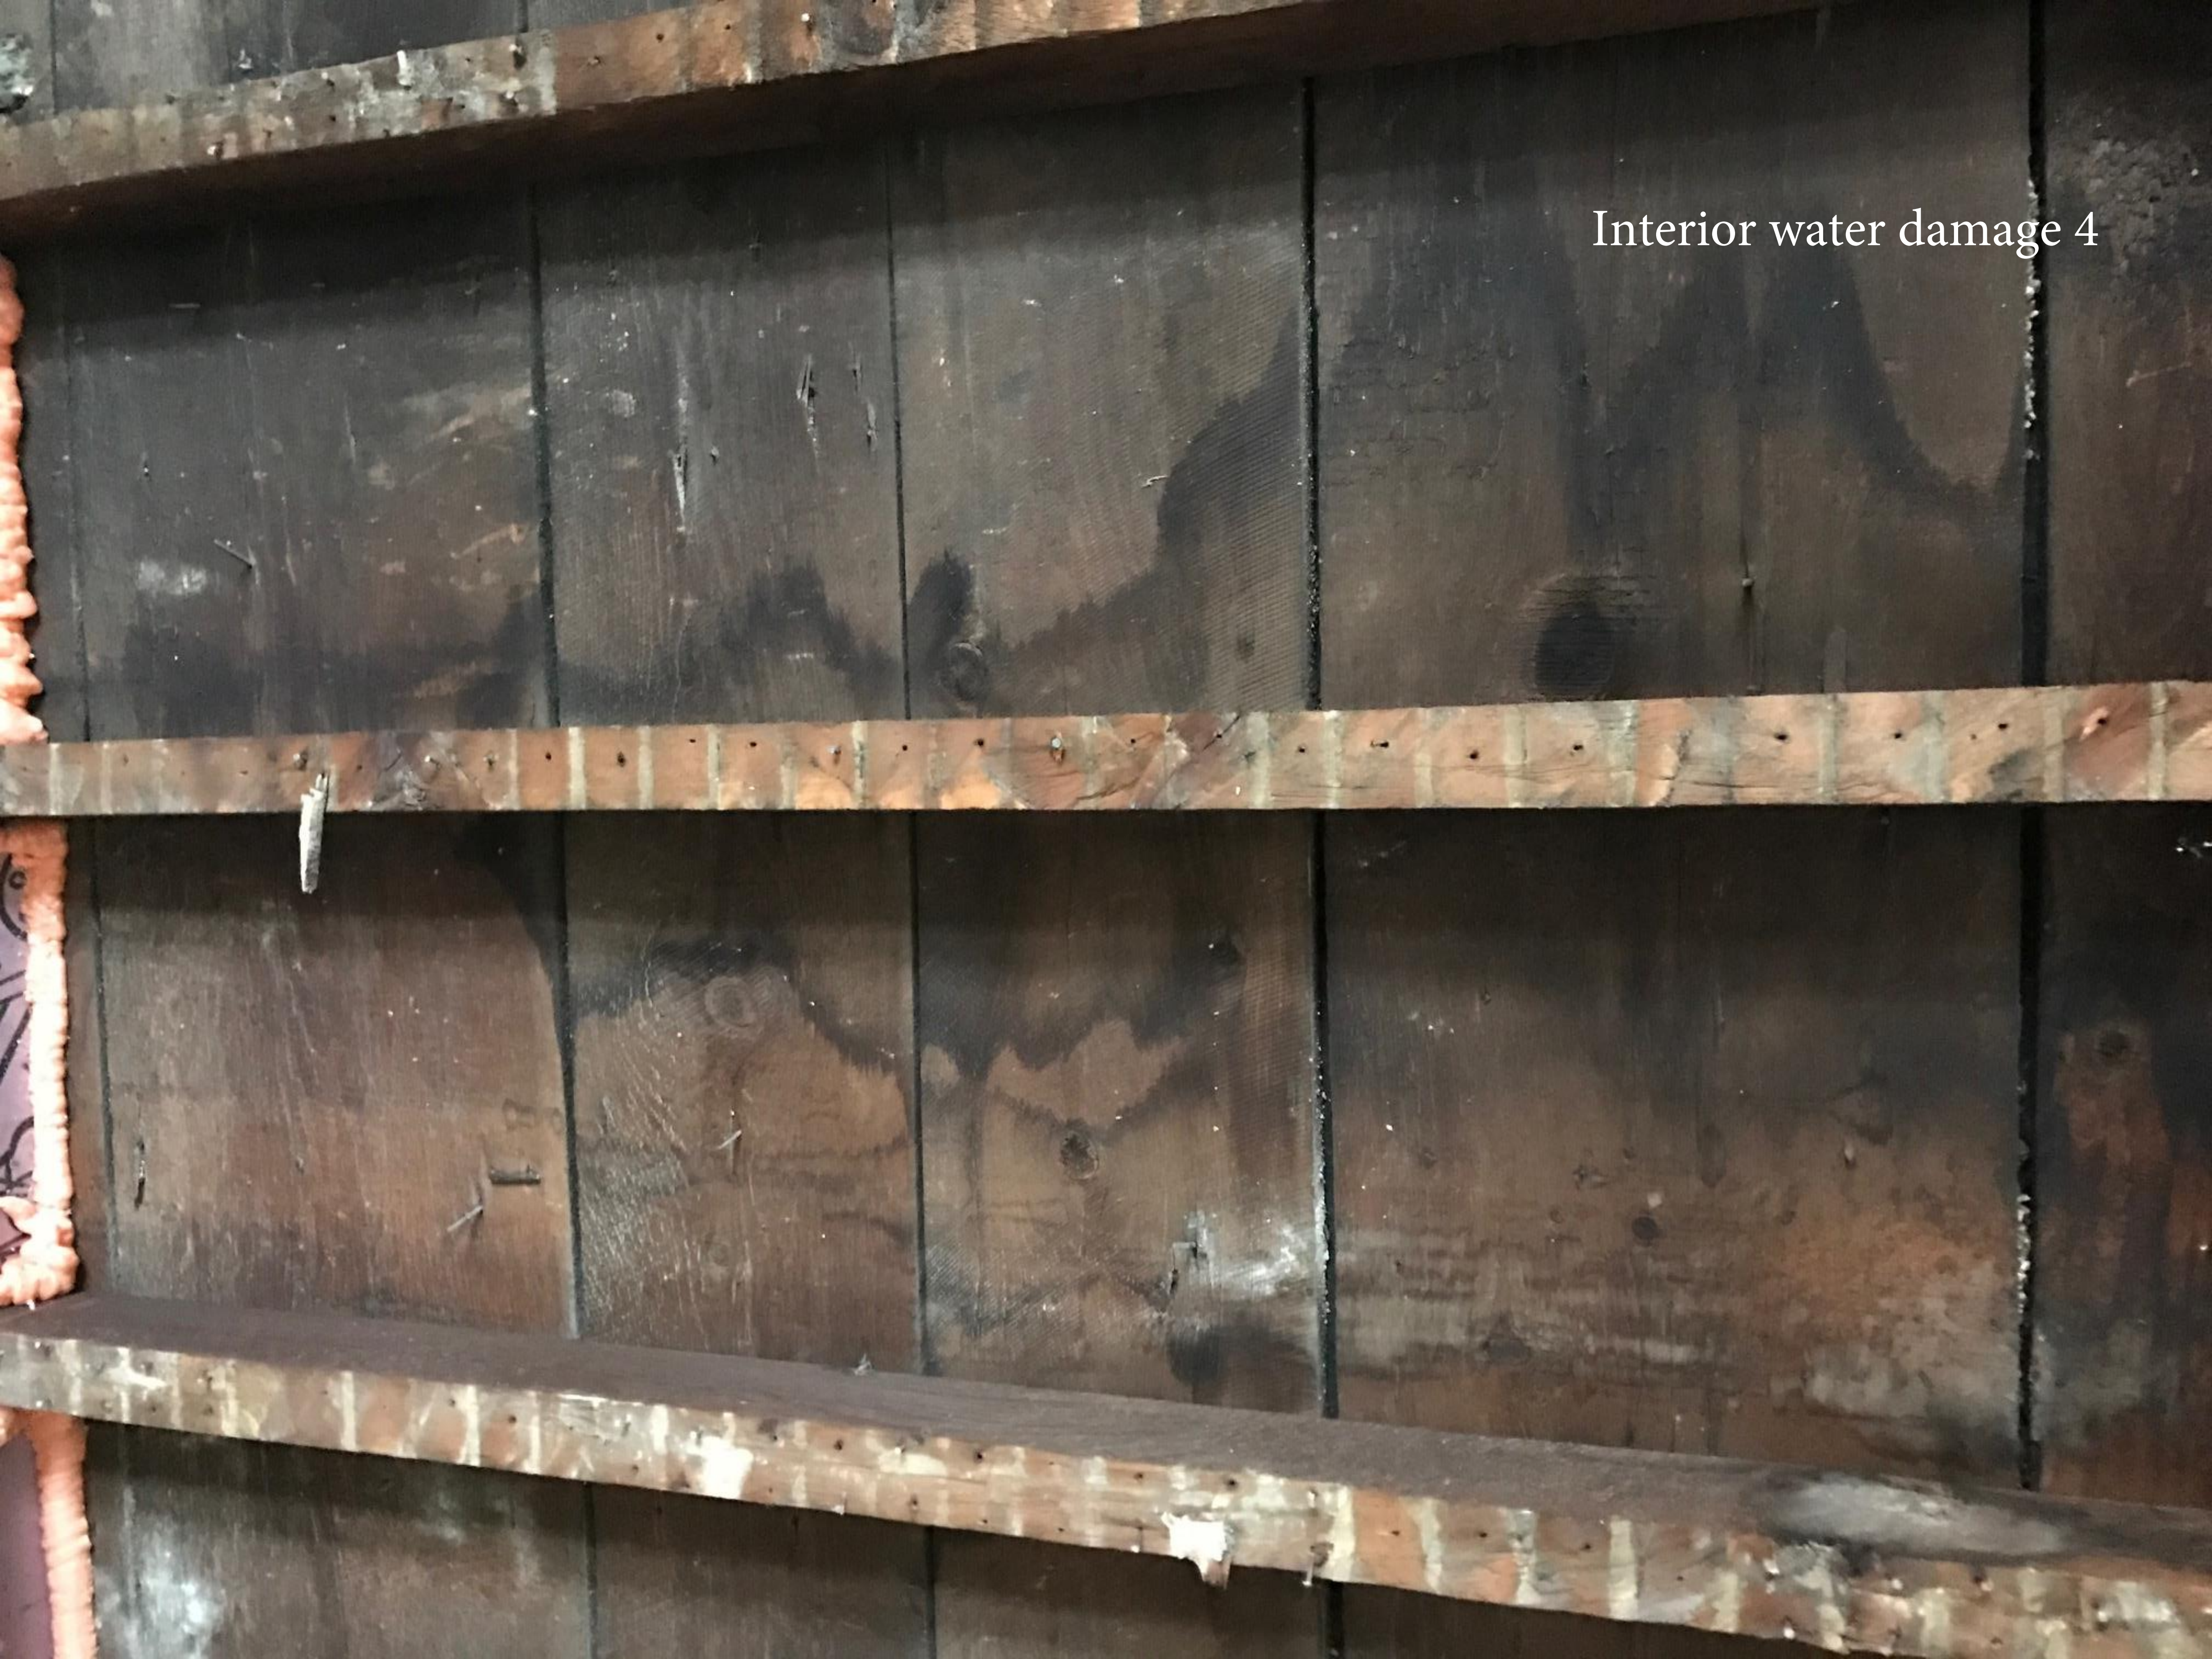
Interior water damage 5
