**CITY OF SAINT PAUL
HERITAGE PRESERVATION COMMISSION STAFF REPORT**

FILE NAME: 539 Holly Avenue – Parisons House

HPC SITE/DISTRICT: Historic Hill Heritage Preservation District

DATE OF REPORT: March 17, 2017

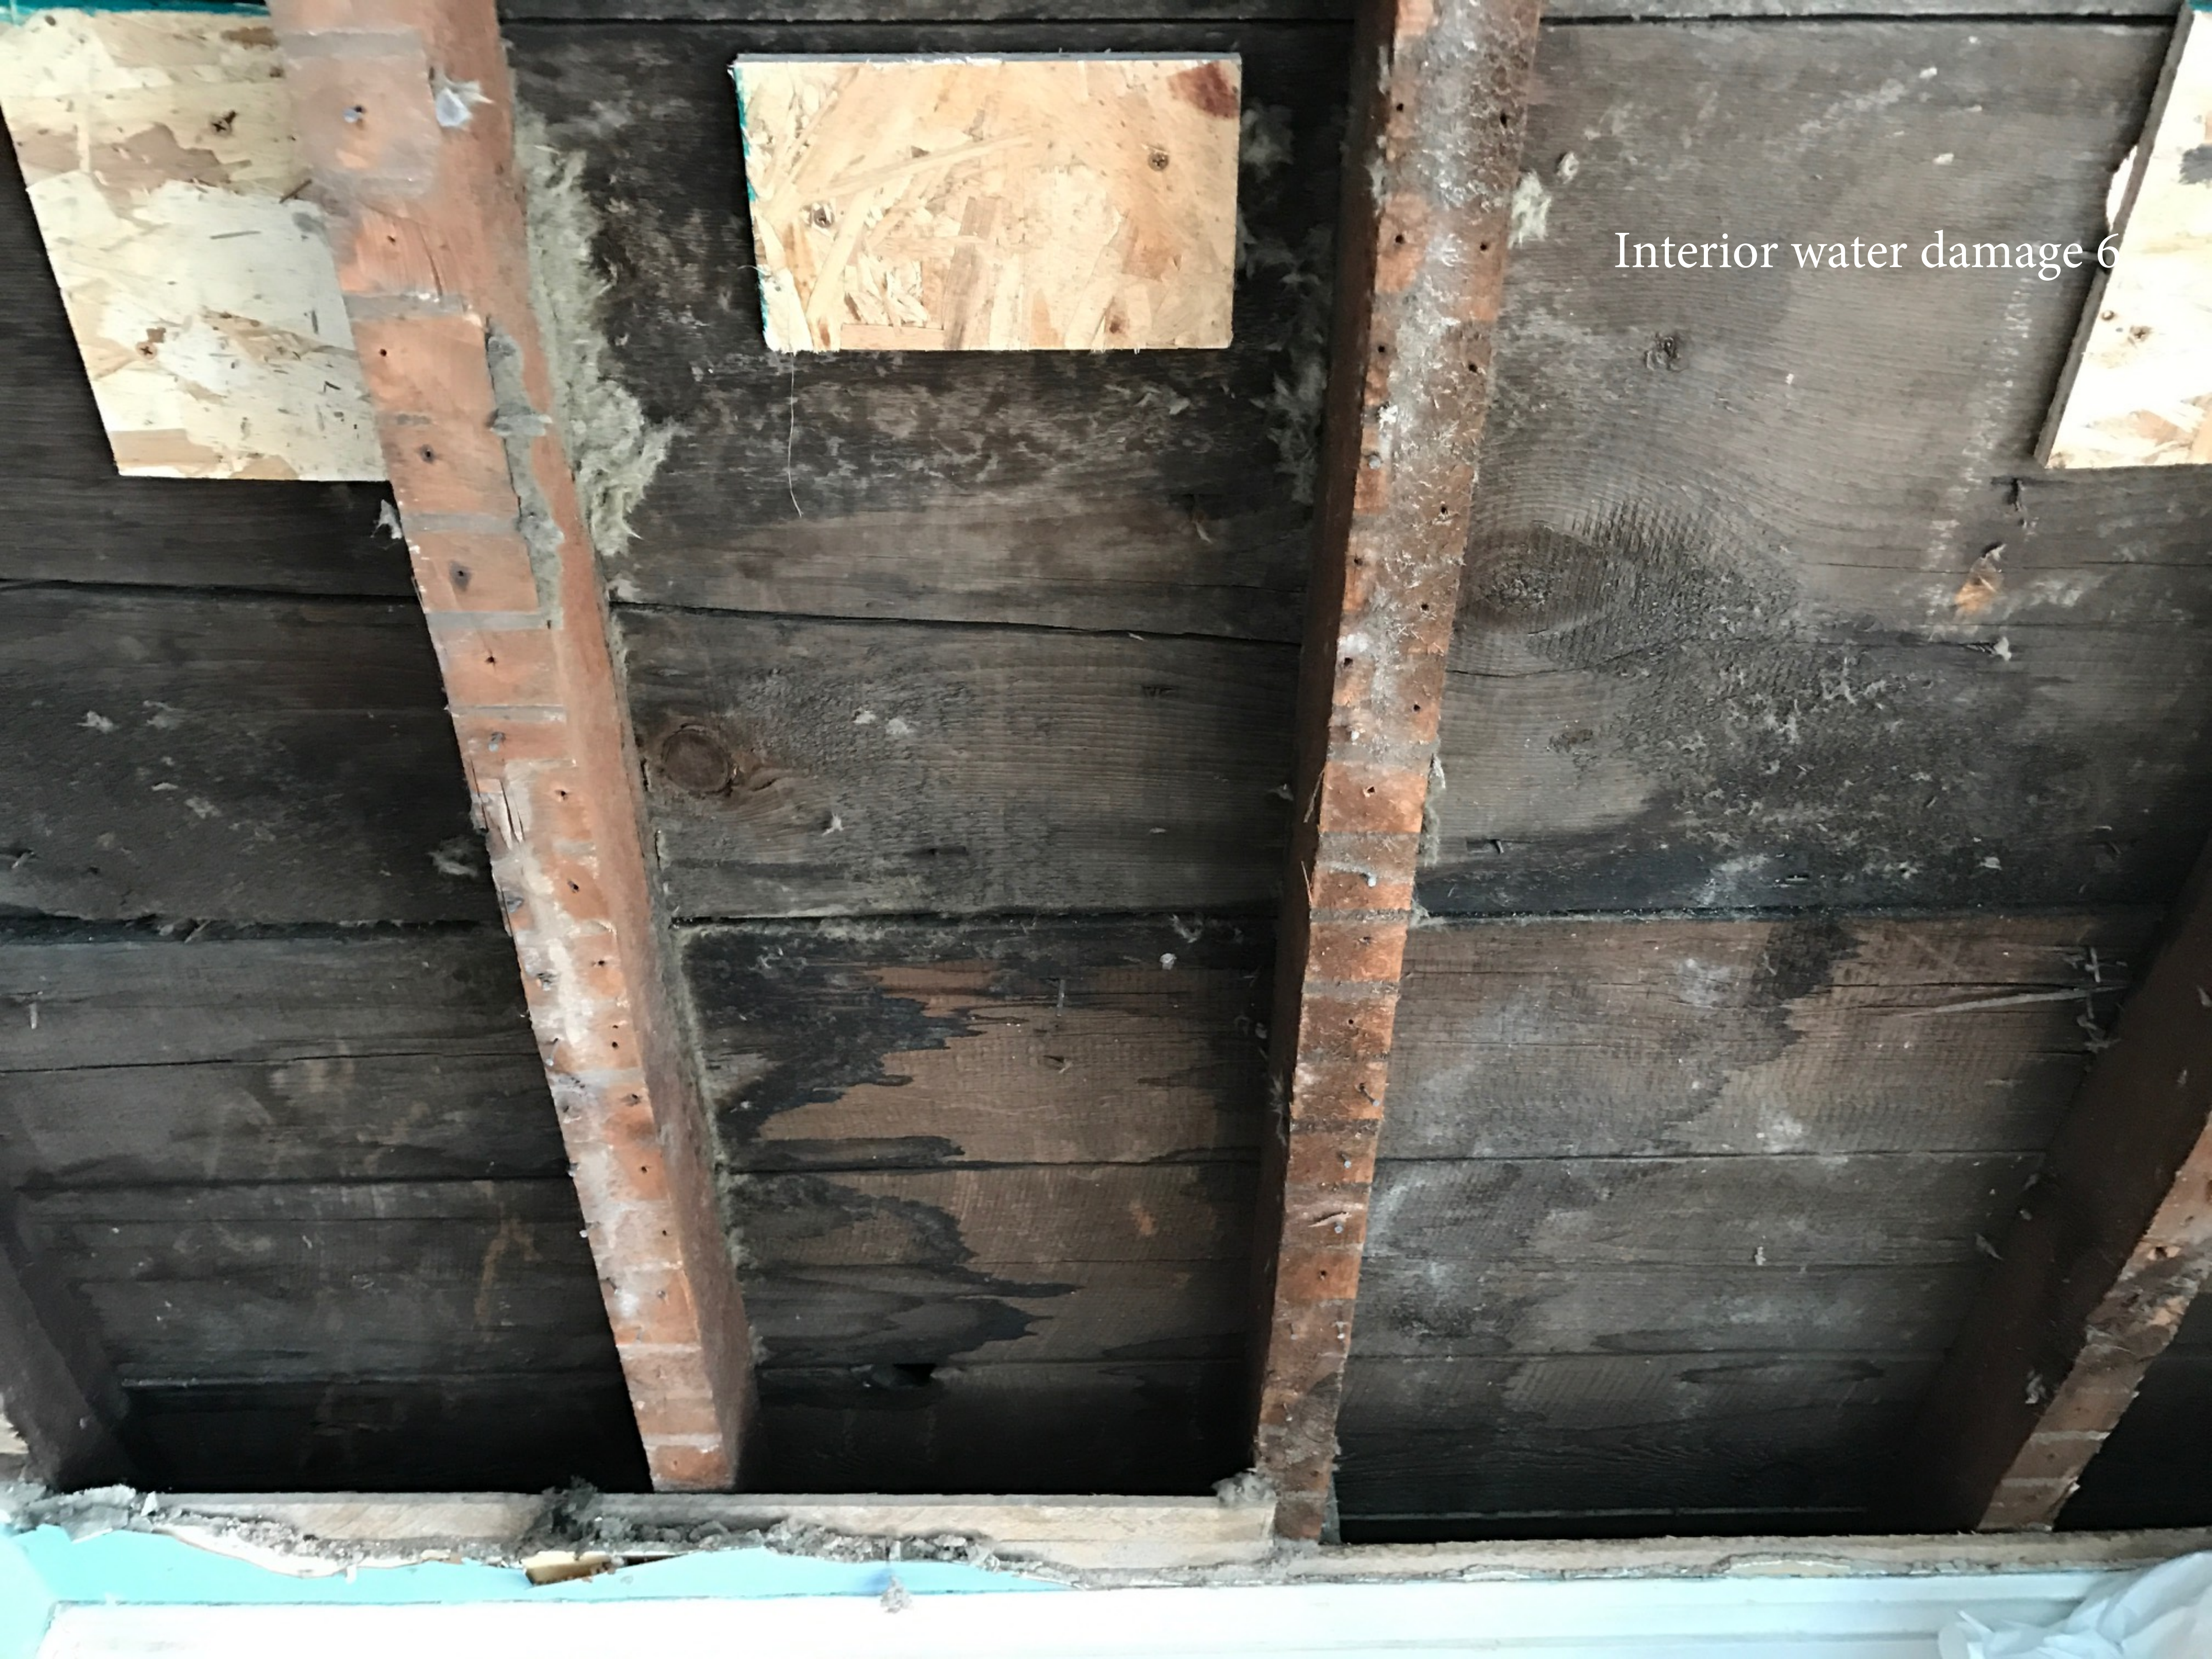
Interior water damage 6

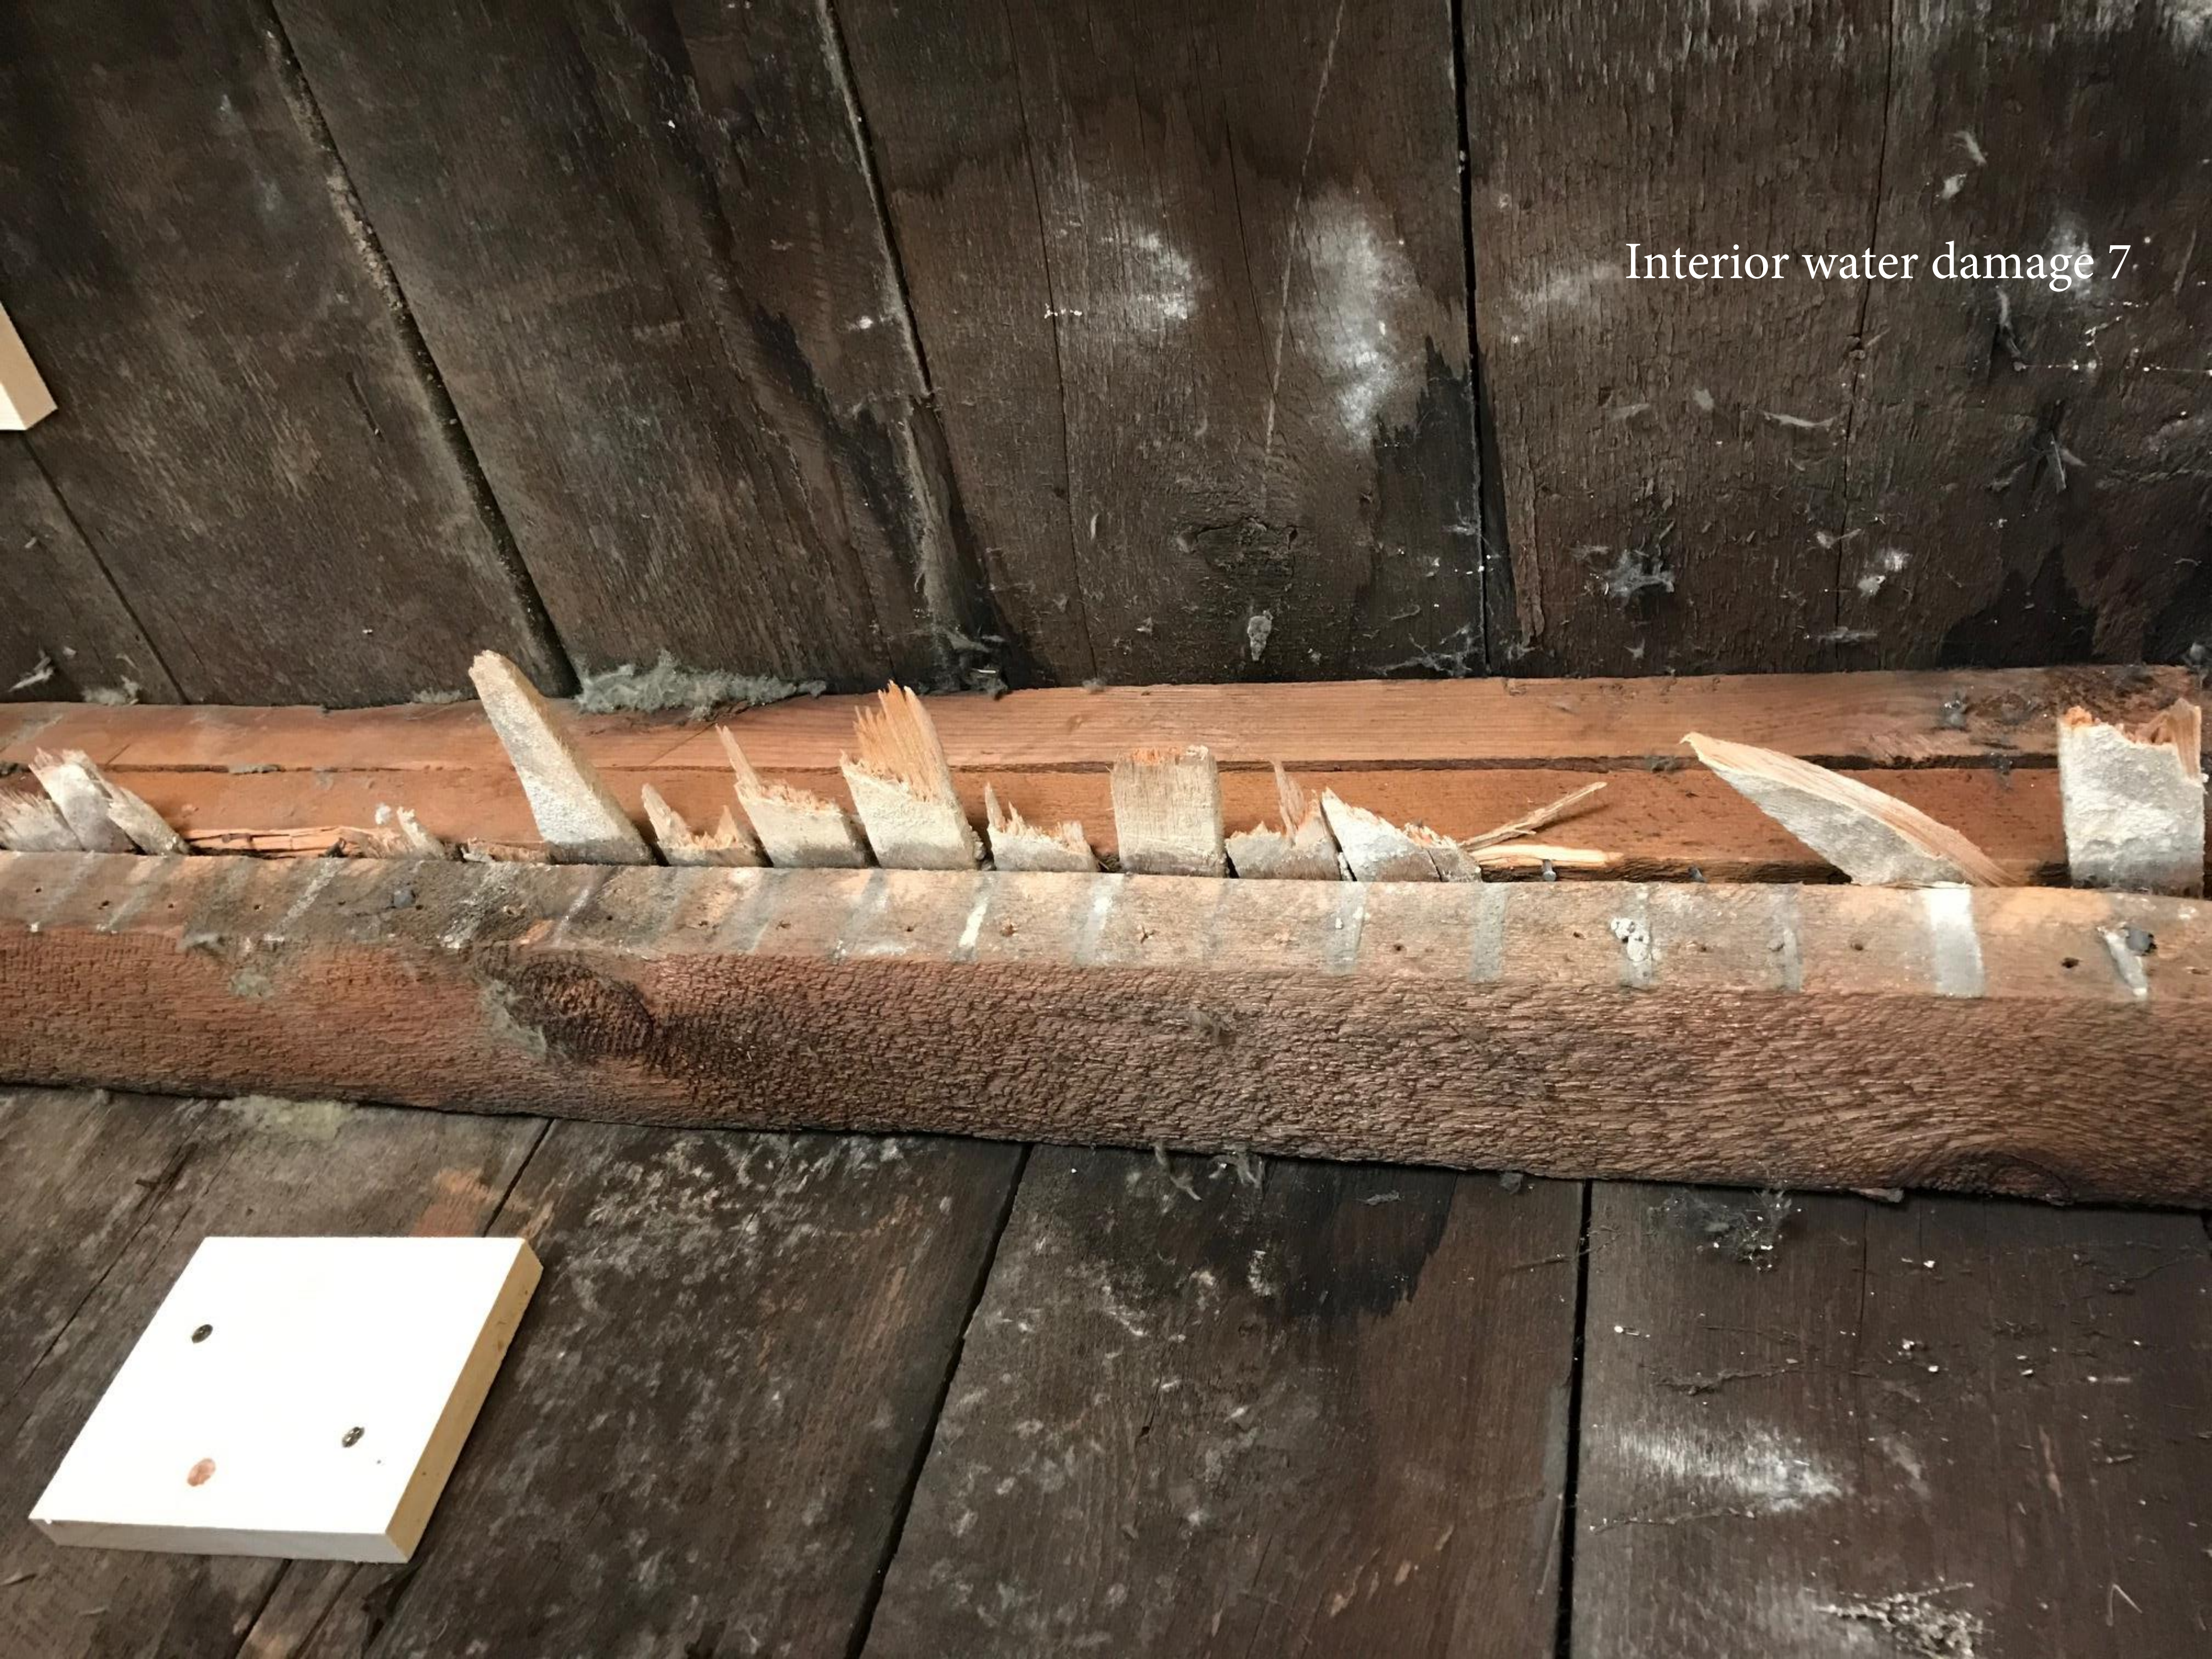
Interior water damage 7

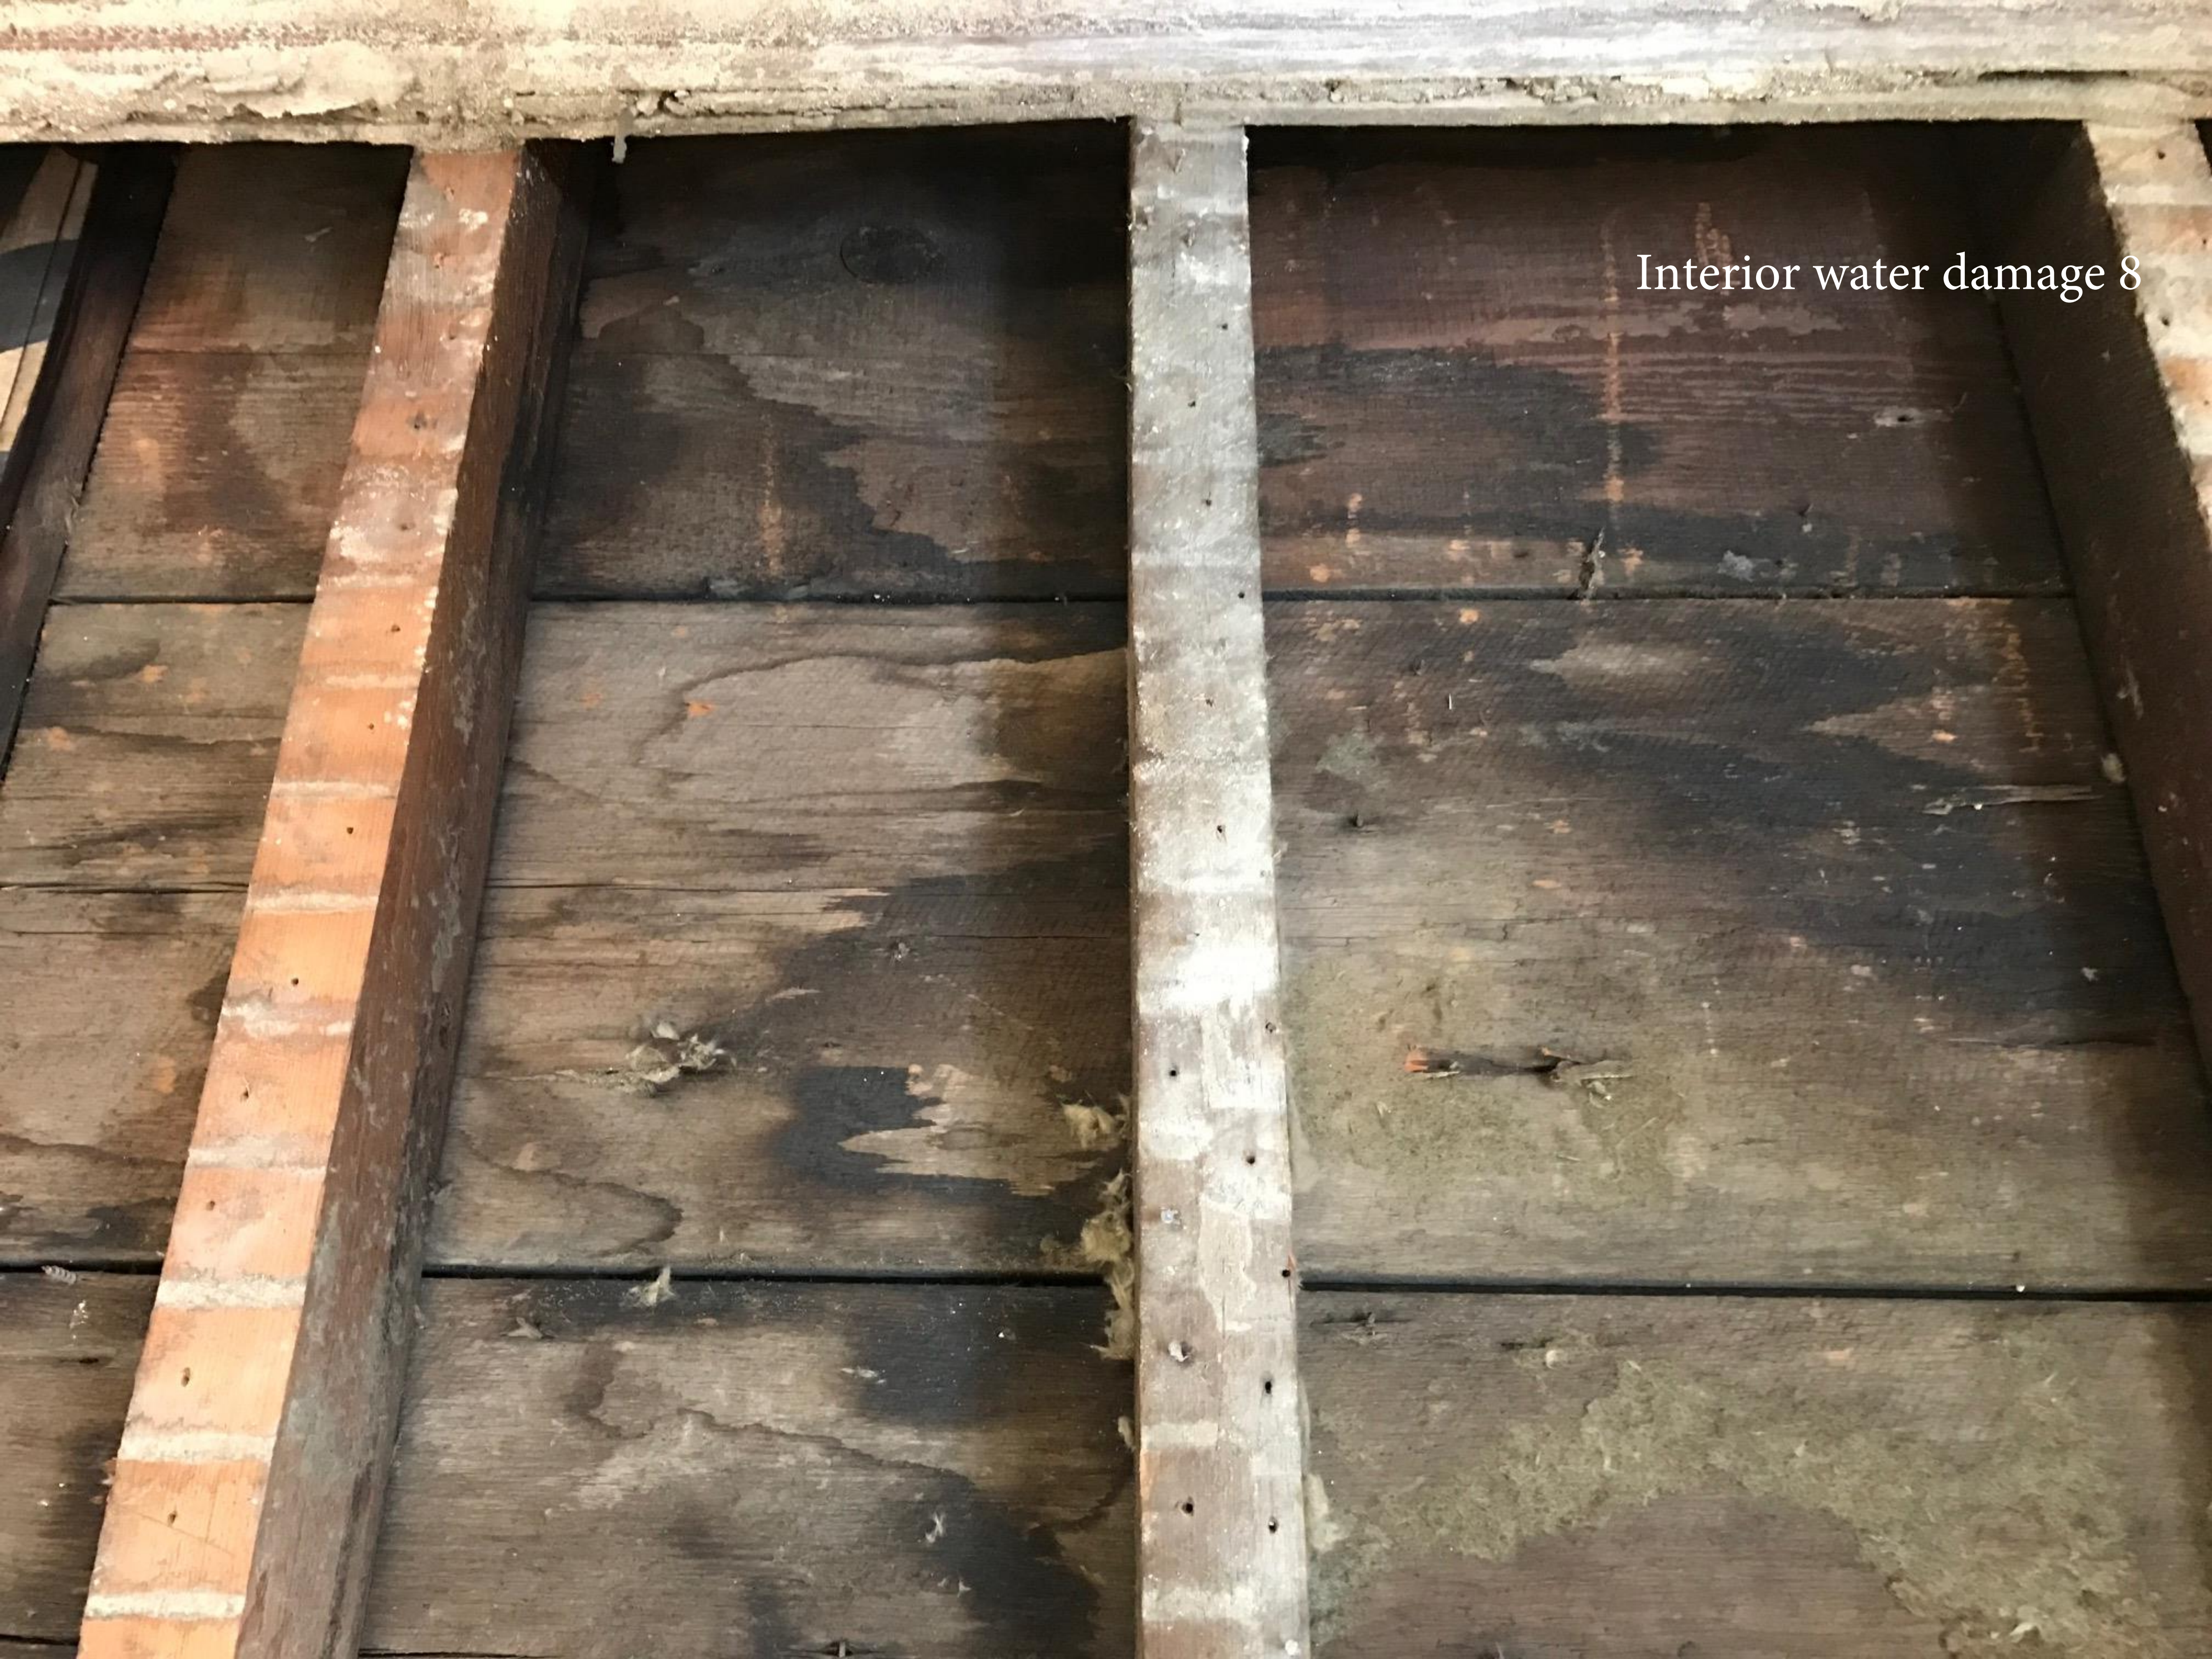
Interior water damage 8

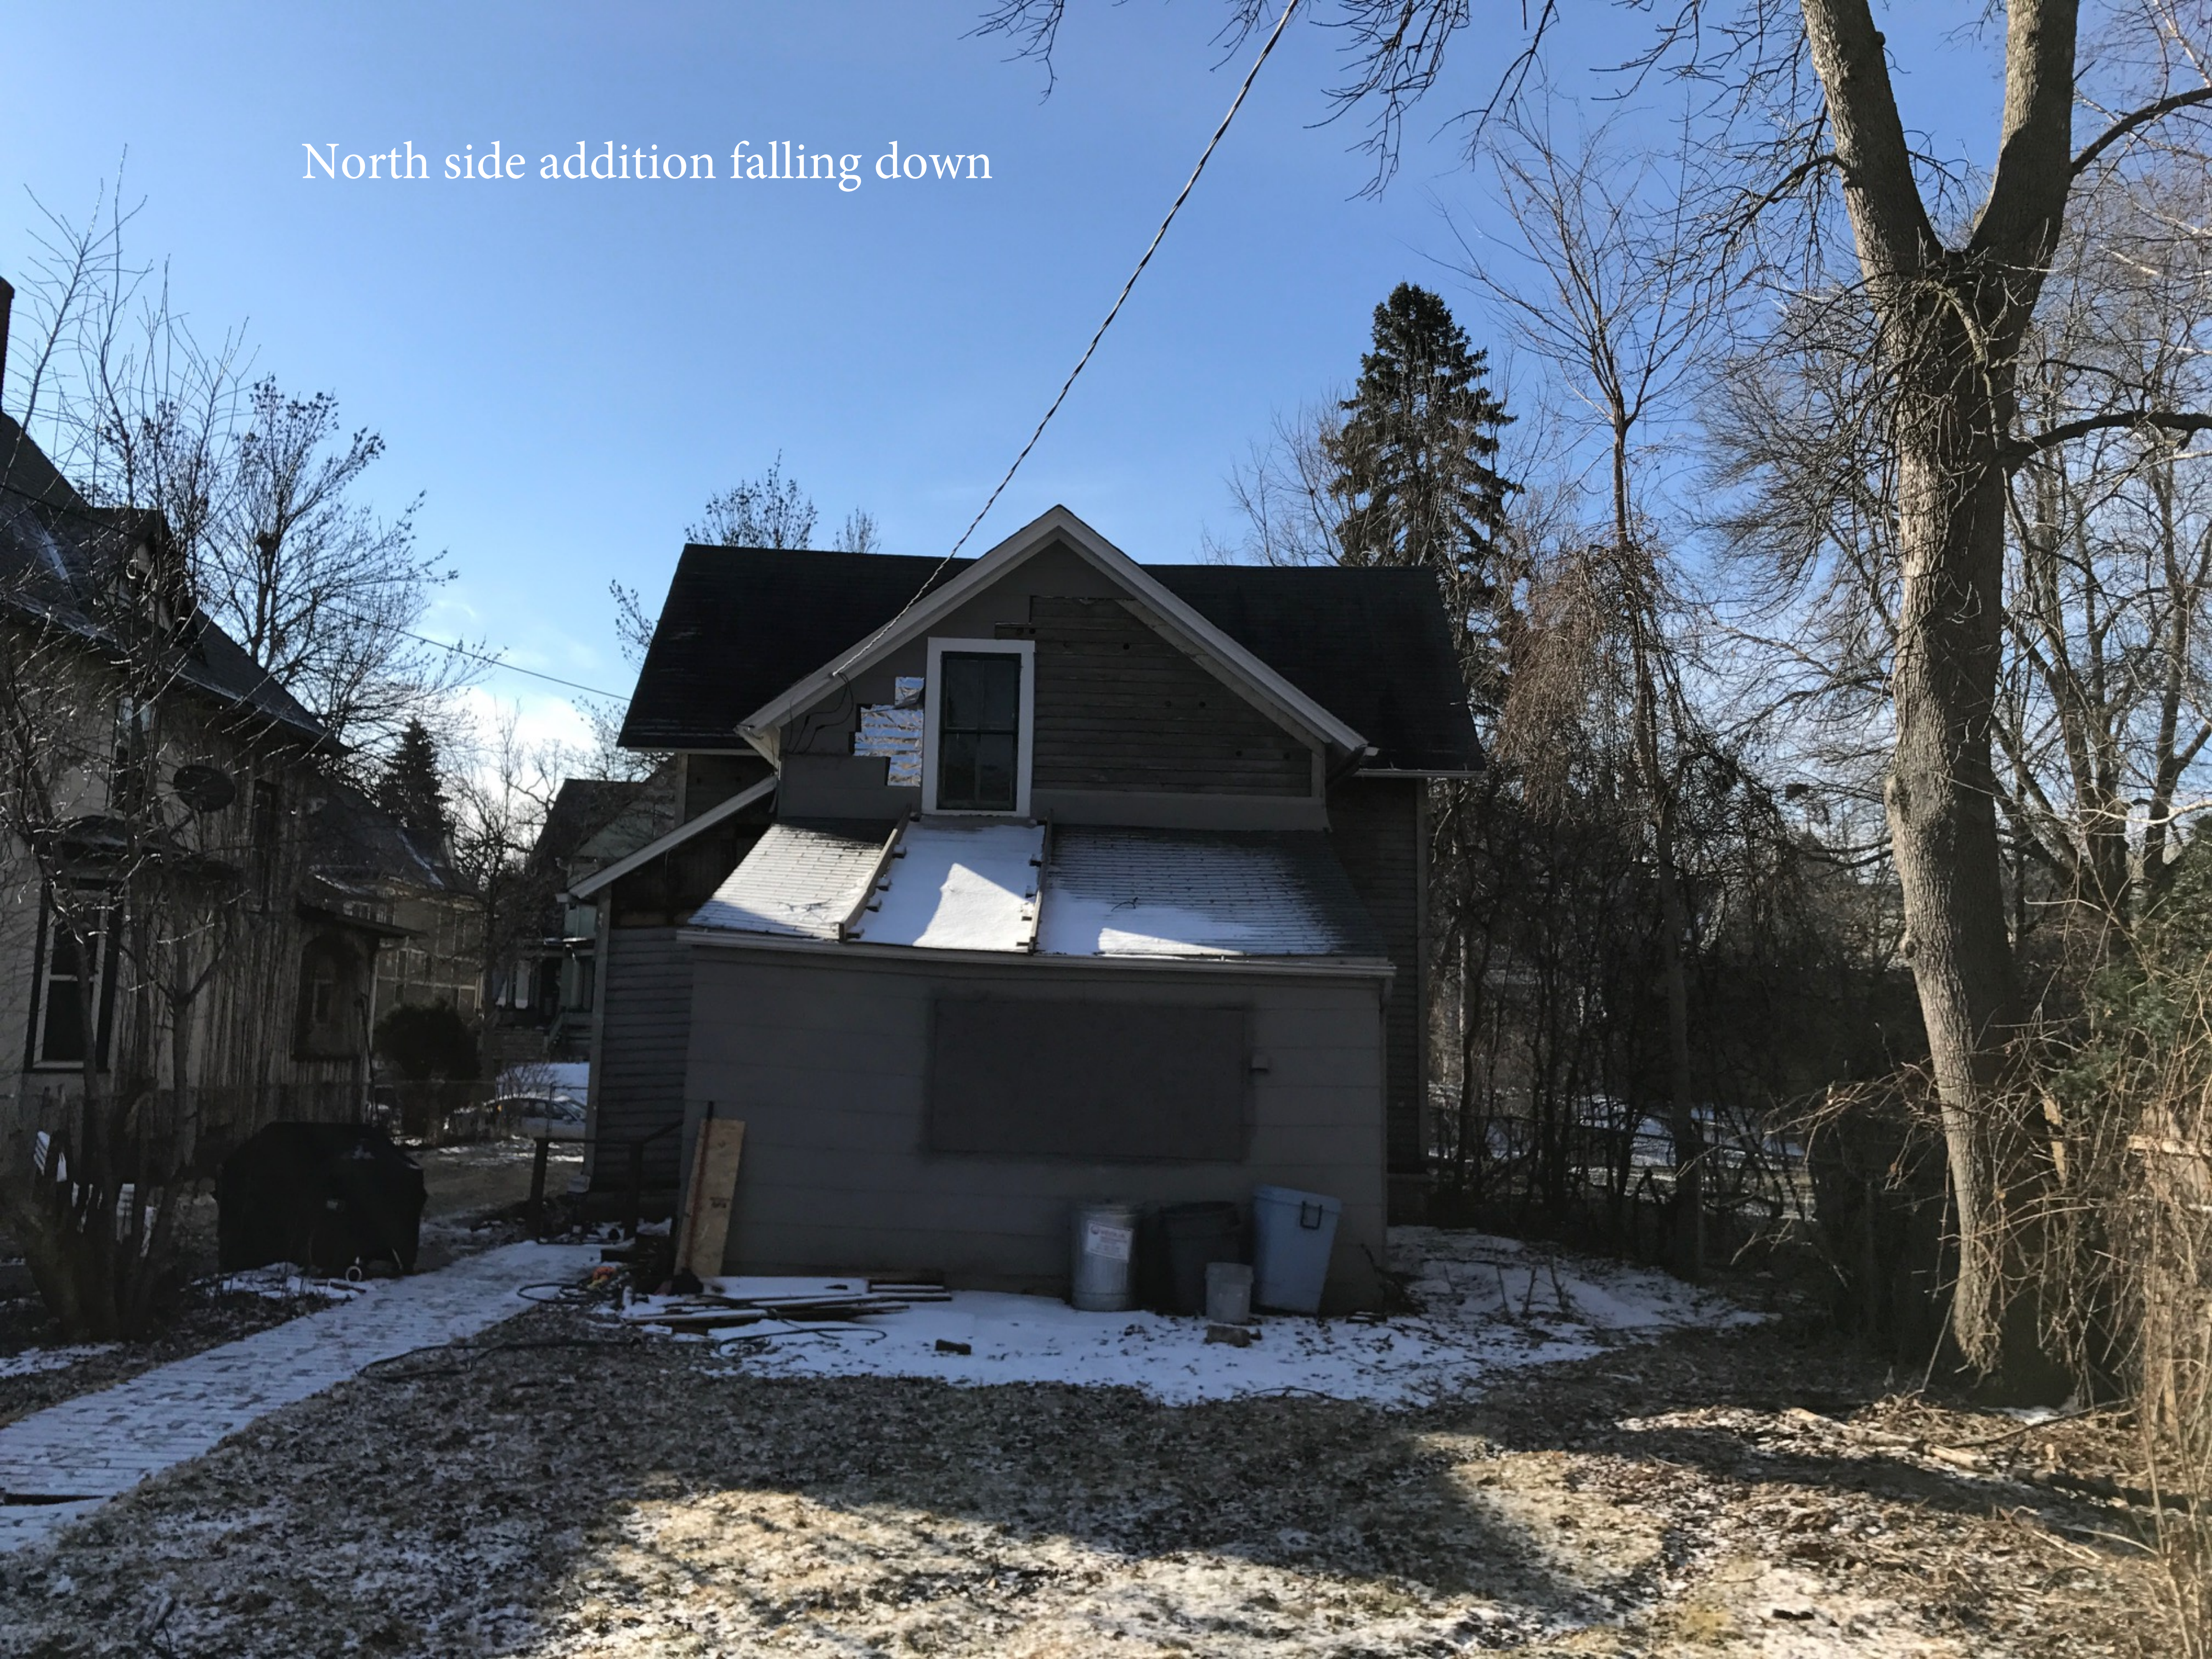
North side addition falling down

My housing project will be a complete renovation and addition. The backside of the home, a mix of different additions that are structurally falling down will be demolished. In their place a single addition will be constructed to match the front of the home with slight changes to show it is not original. This addition will have exposed split-face concrete block on the foundation, James Hardie fiber cement siding, and fully custom all wood Jeld-Wen historical replica double hung windows that will match existing windows. The windows will have custom wood storm windows to match the historical period installed as well. The existing half of the home current siding and windows will be removed due to the poor current condition as explained above.

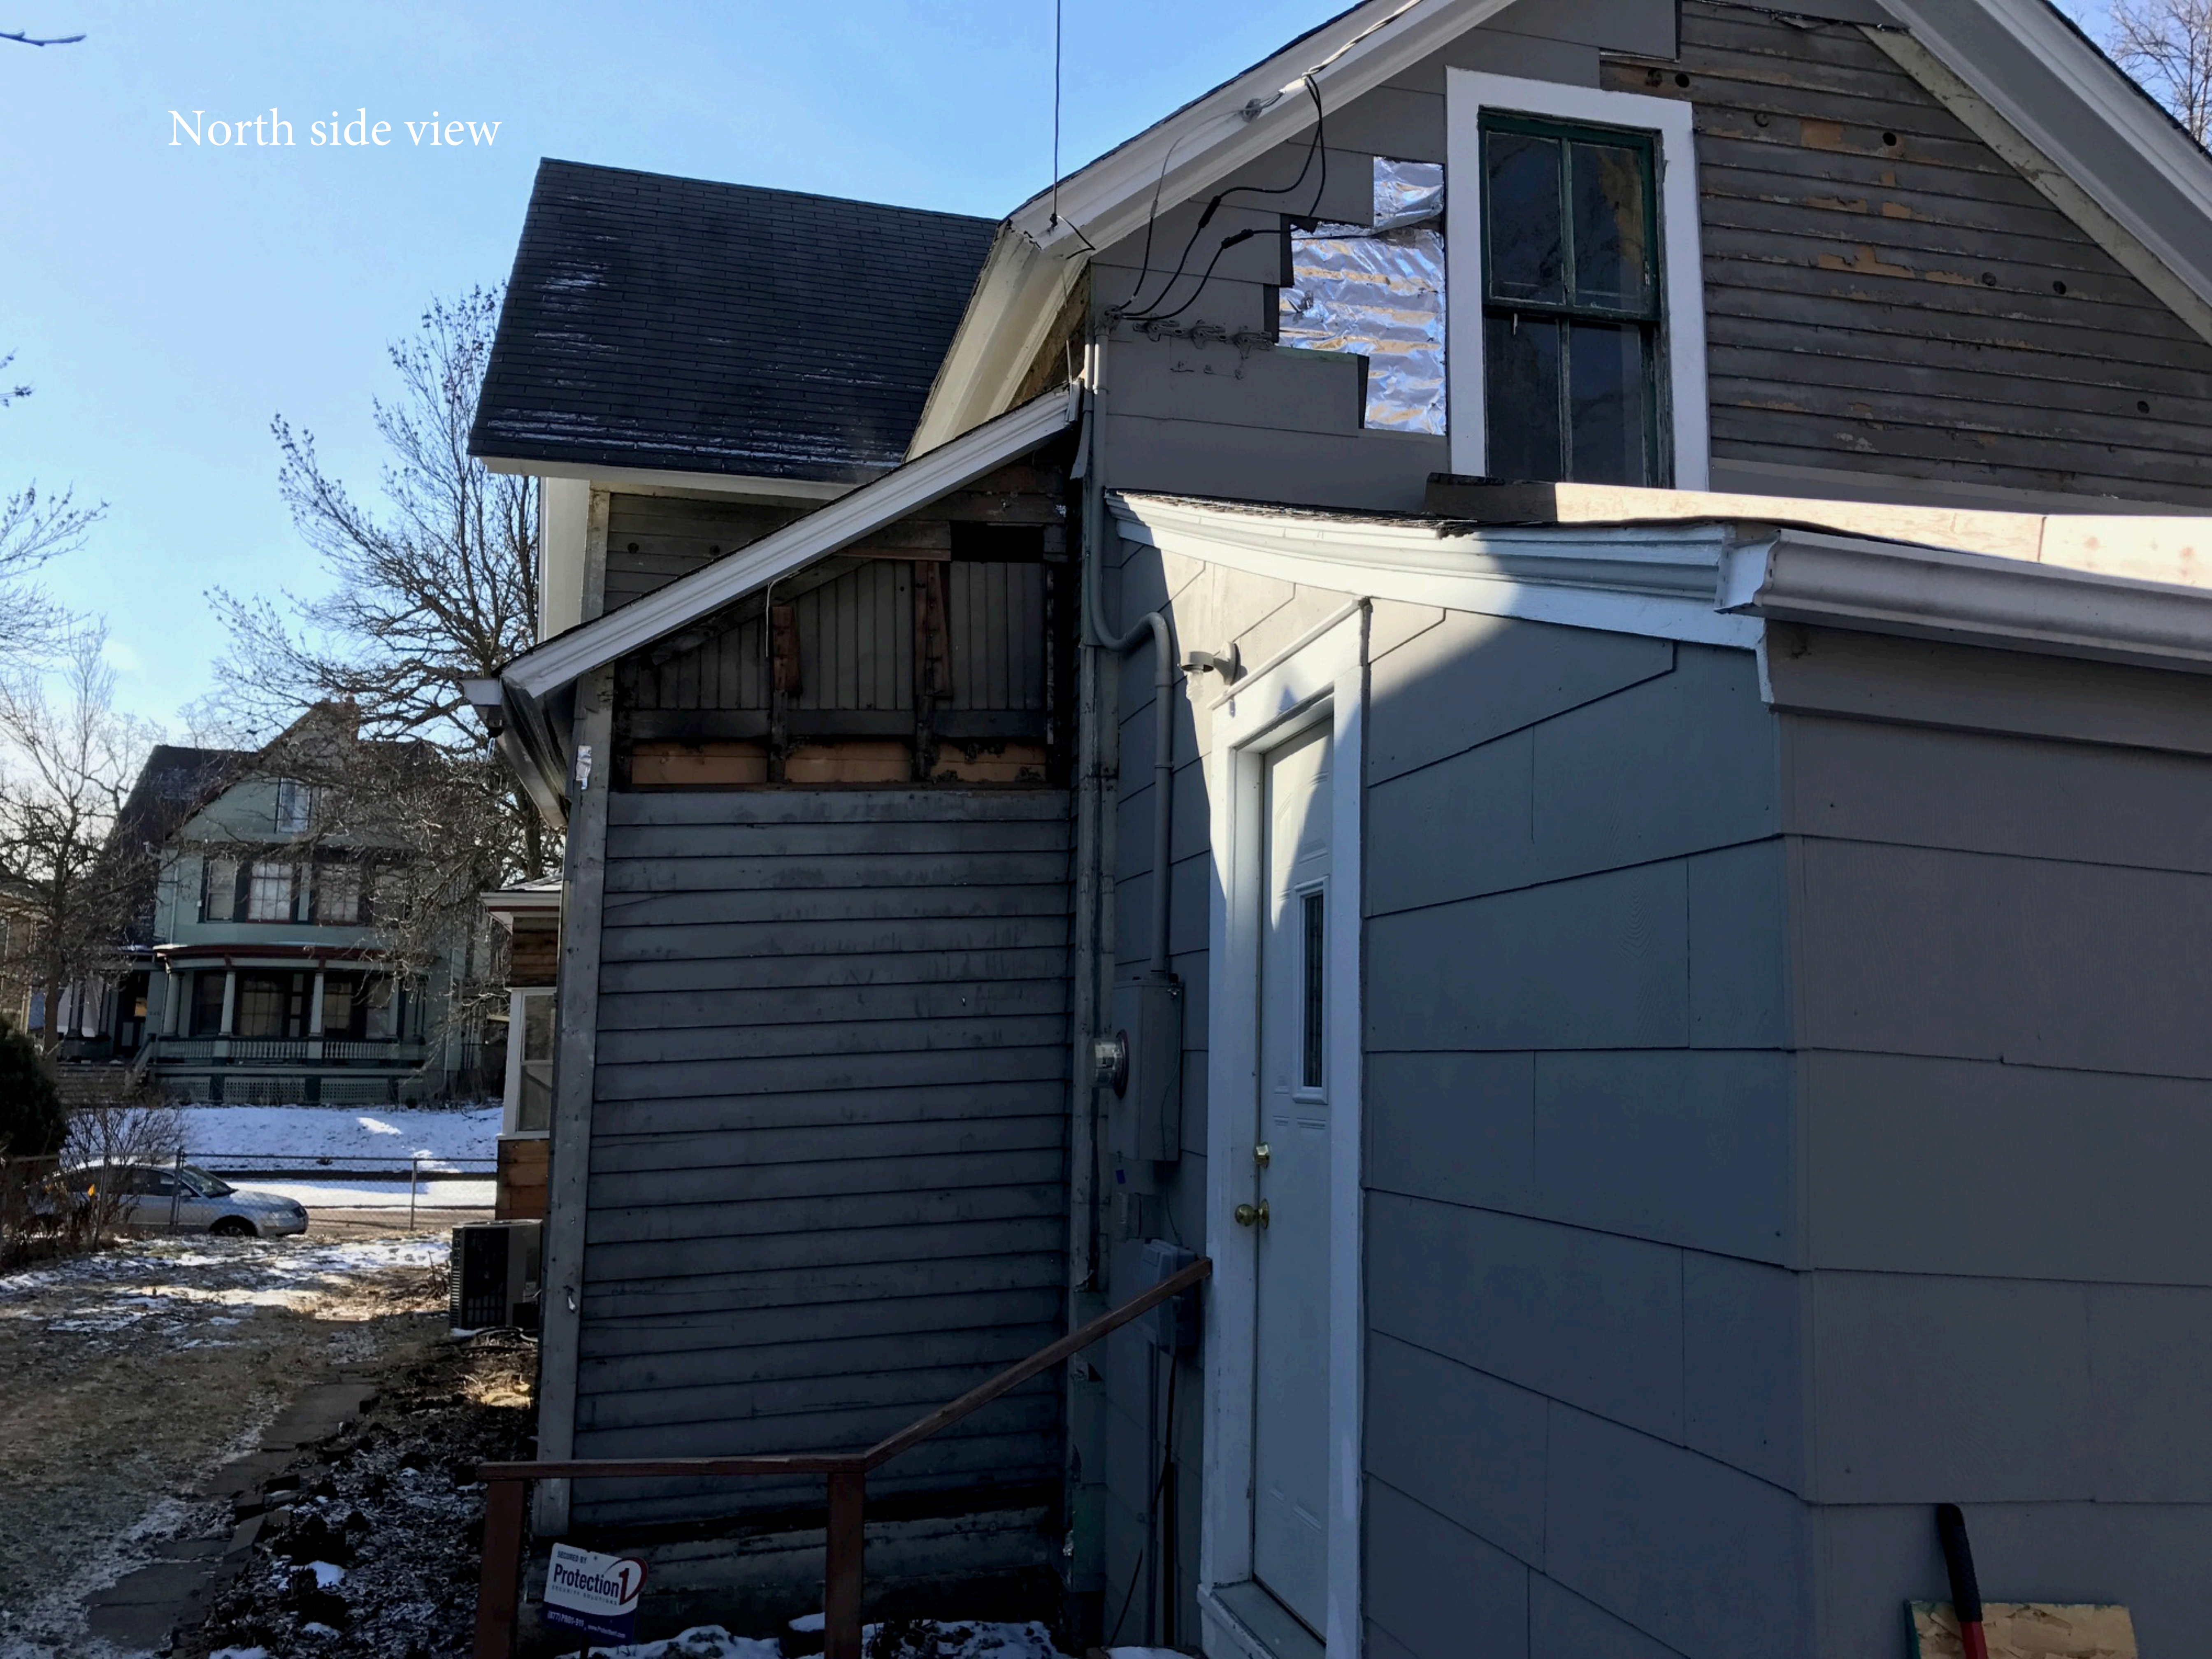
Porch framing

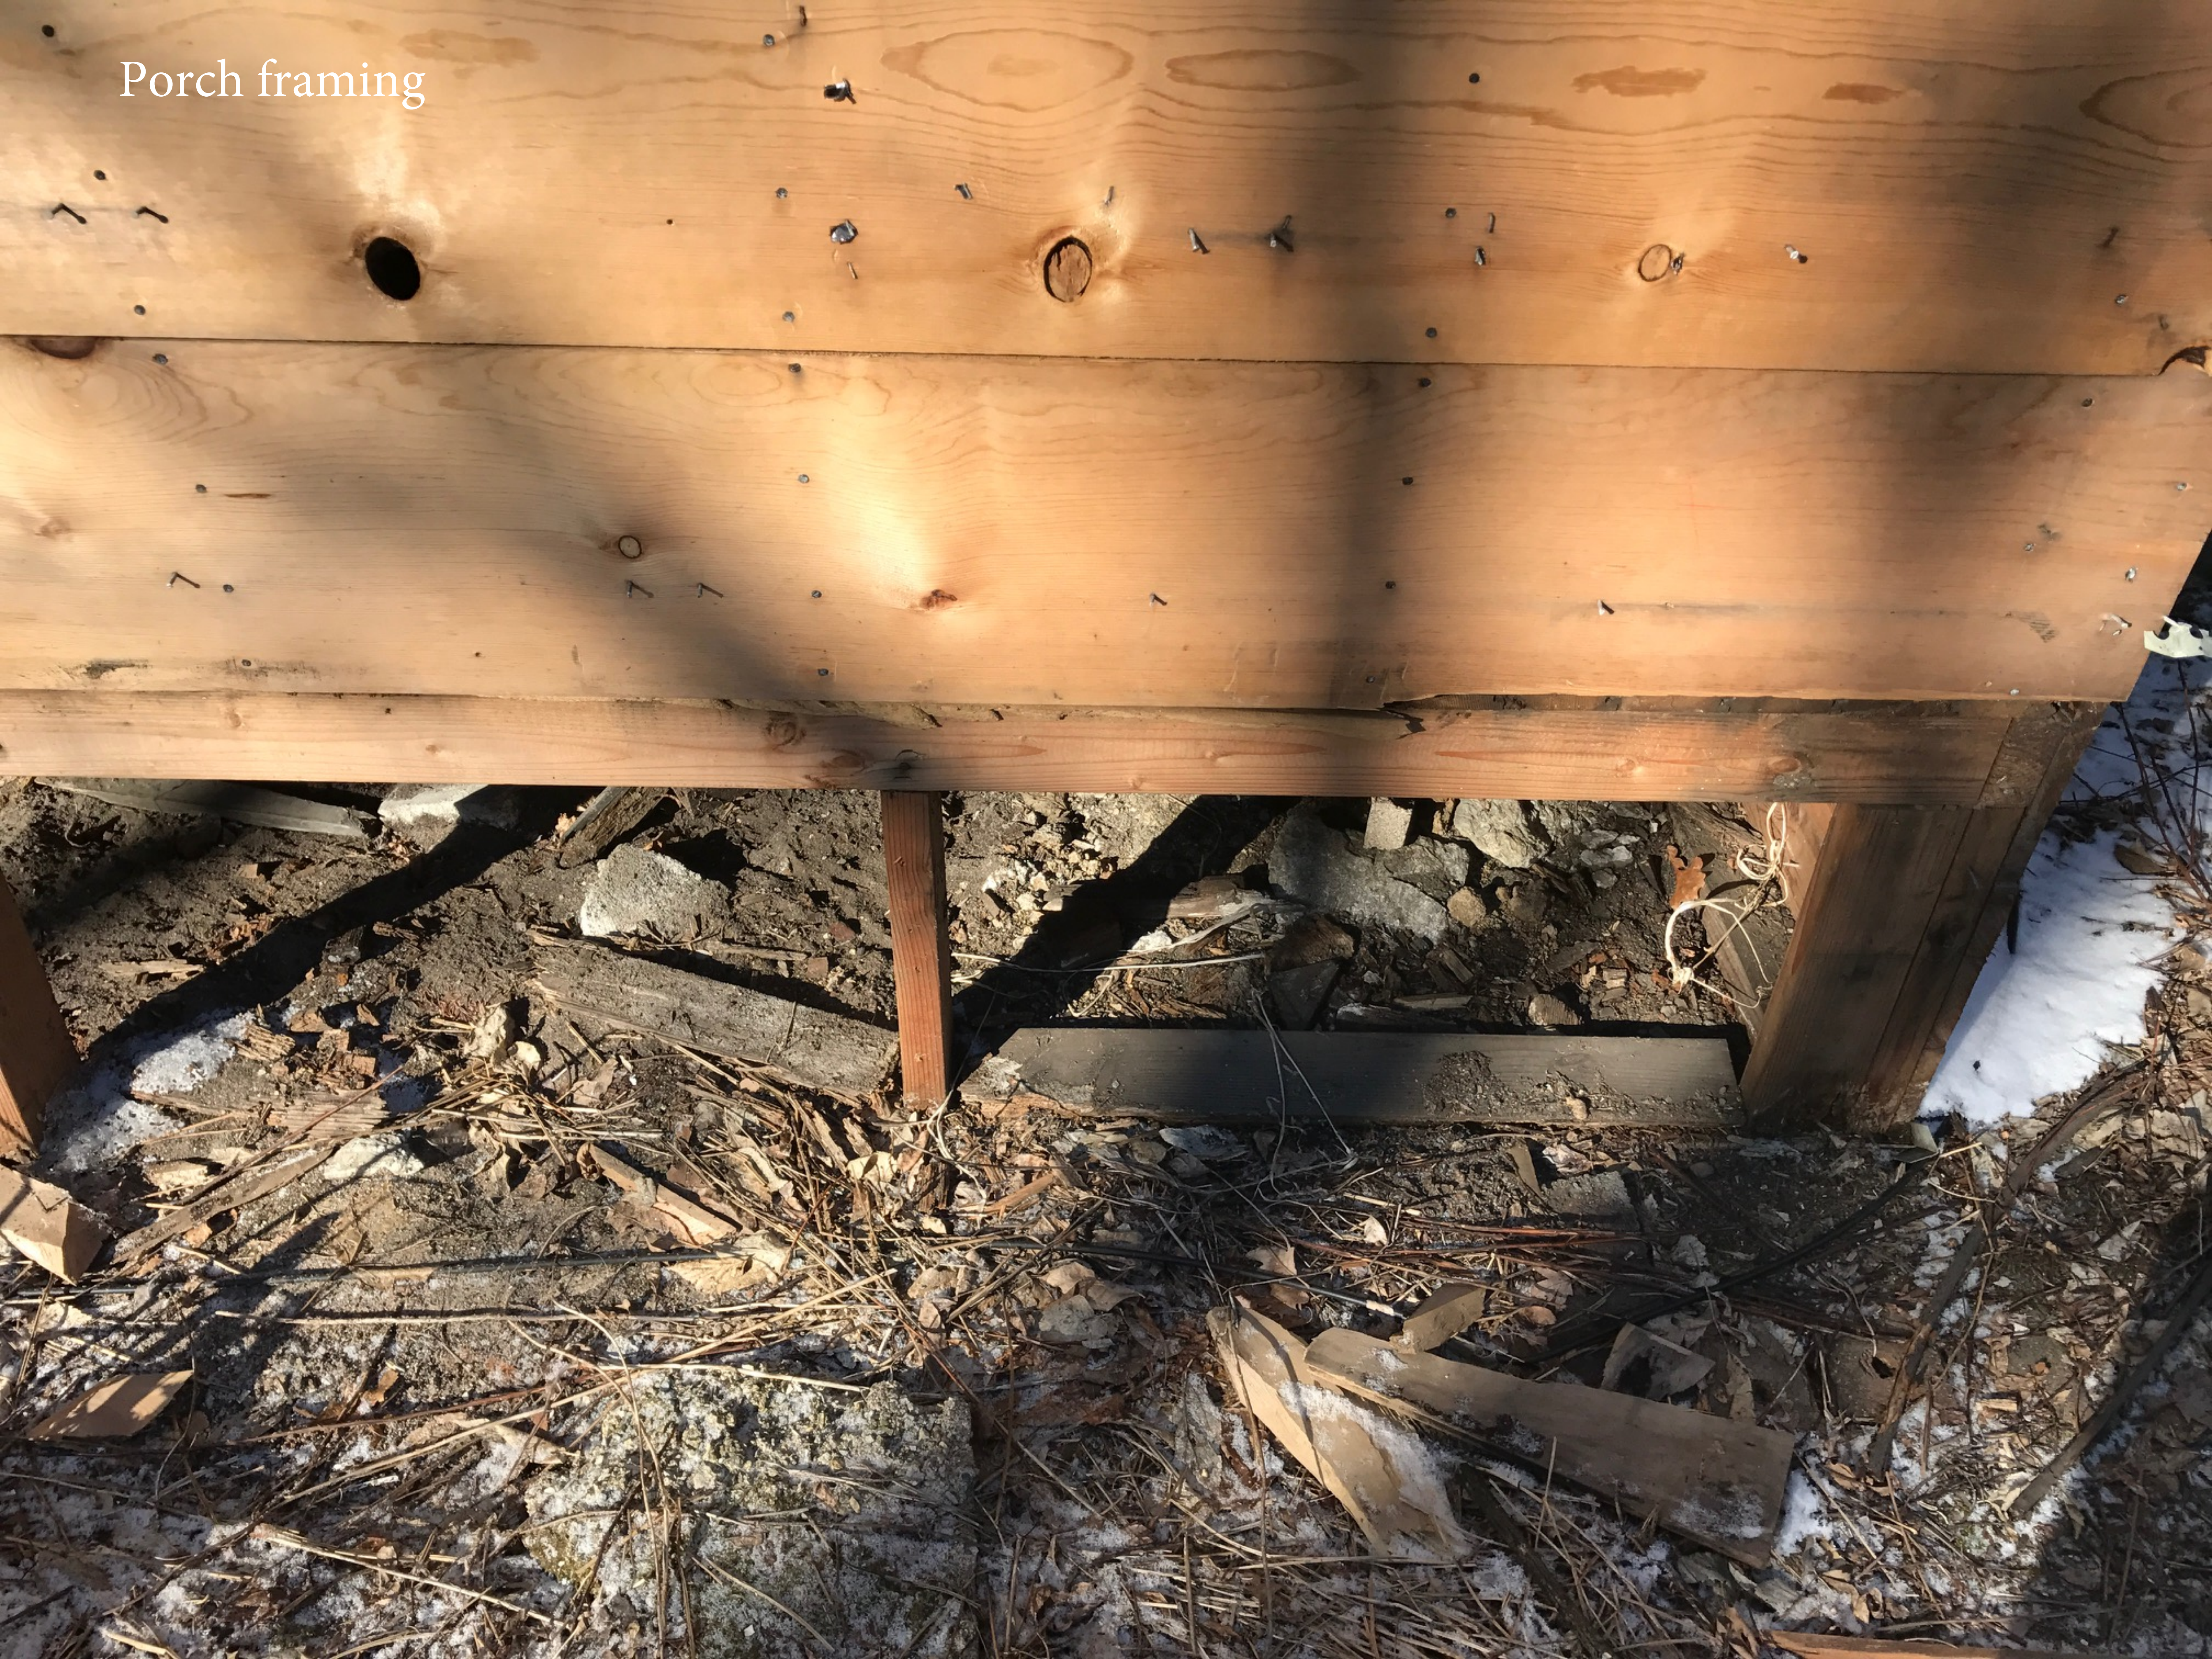
Porch framing
