**CITY OF SAINT PAUL
HERITAGE PRESERVATION COMMISSION STAFF REPORT**

FILE NAME: 539 Holly Avenue – Parisons House

HPC SITE/DISTRICT: Historic Hill Heritage Preservation District

DATE OF REPORT: March 17, 2017

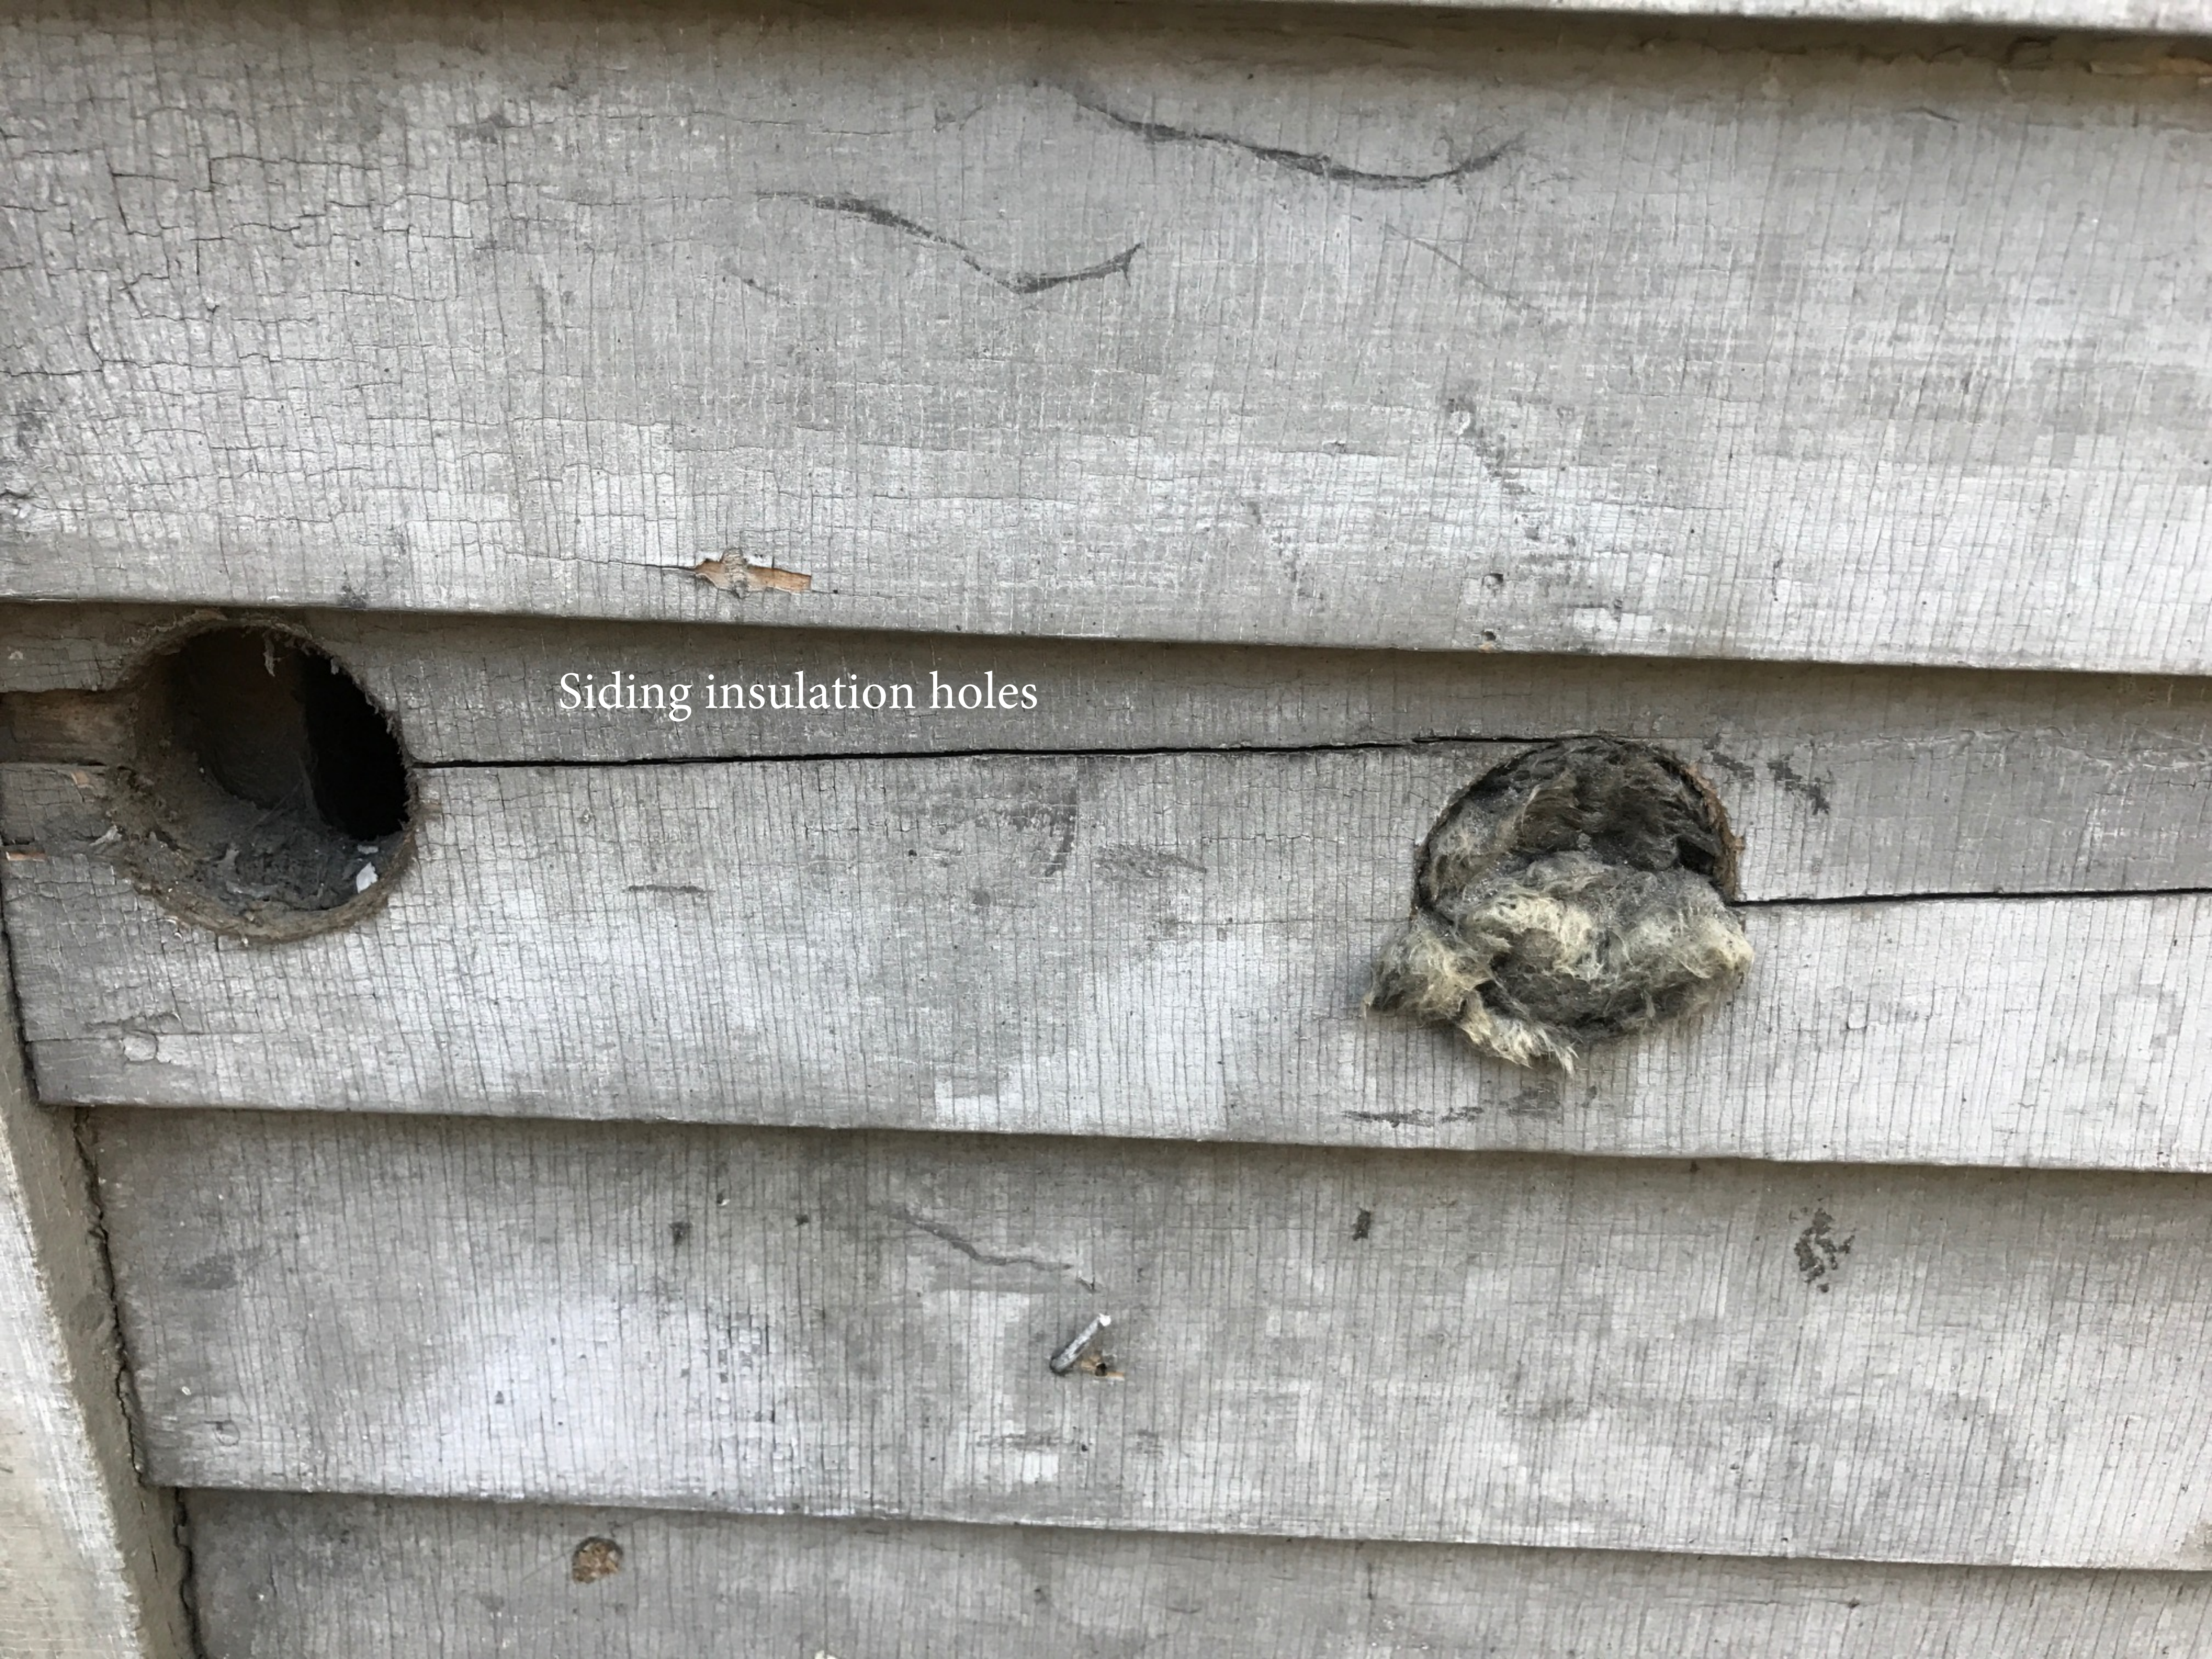
3. The existing Cedar siding now contains countless nail holes from the removed asbestos siding and a number of holes drilled through the siding to blow loose insulation into the walls at some point, see photo 7. The nail holes are a source of moisture penetration and the insulation drill holes are unsightly and will require a number of boards to be replaced, see the elevation drawings. These nail holes will continue to be a source of moisture penetration through the future and if not properly dealt with could lead to very serious damage.

Siding insulation holes

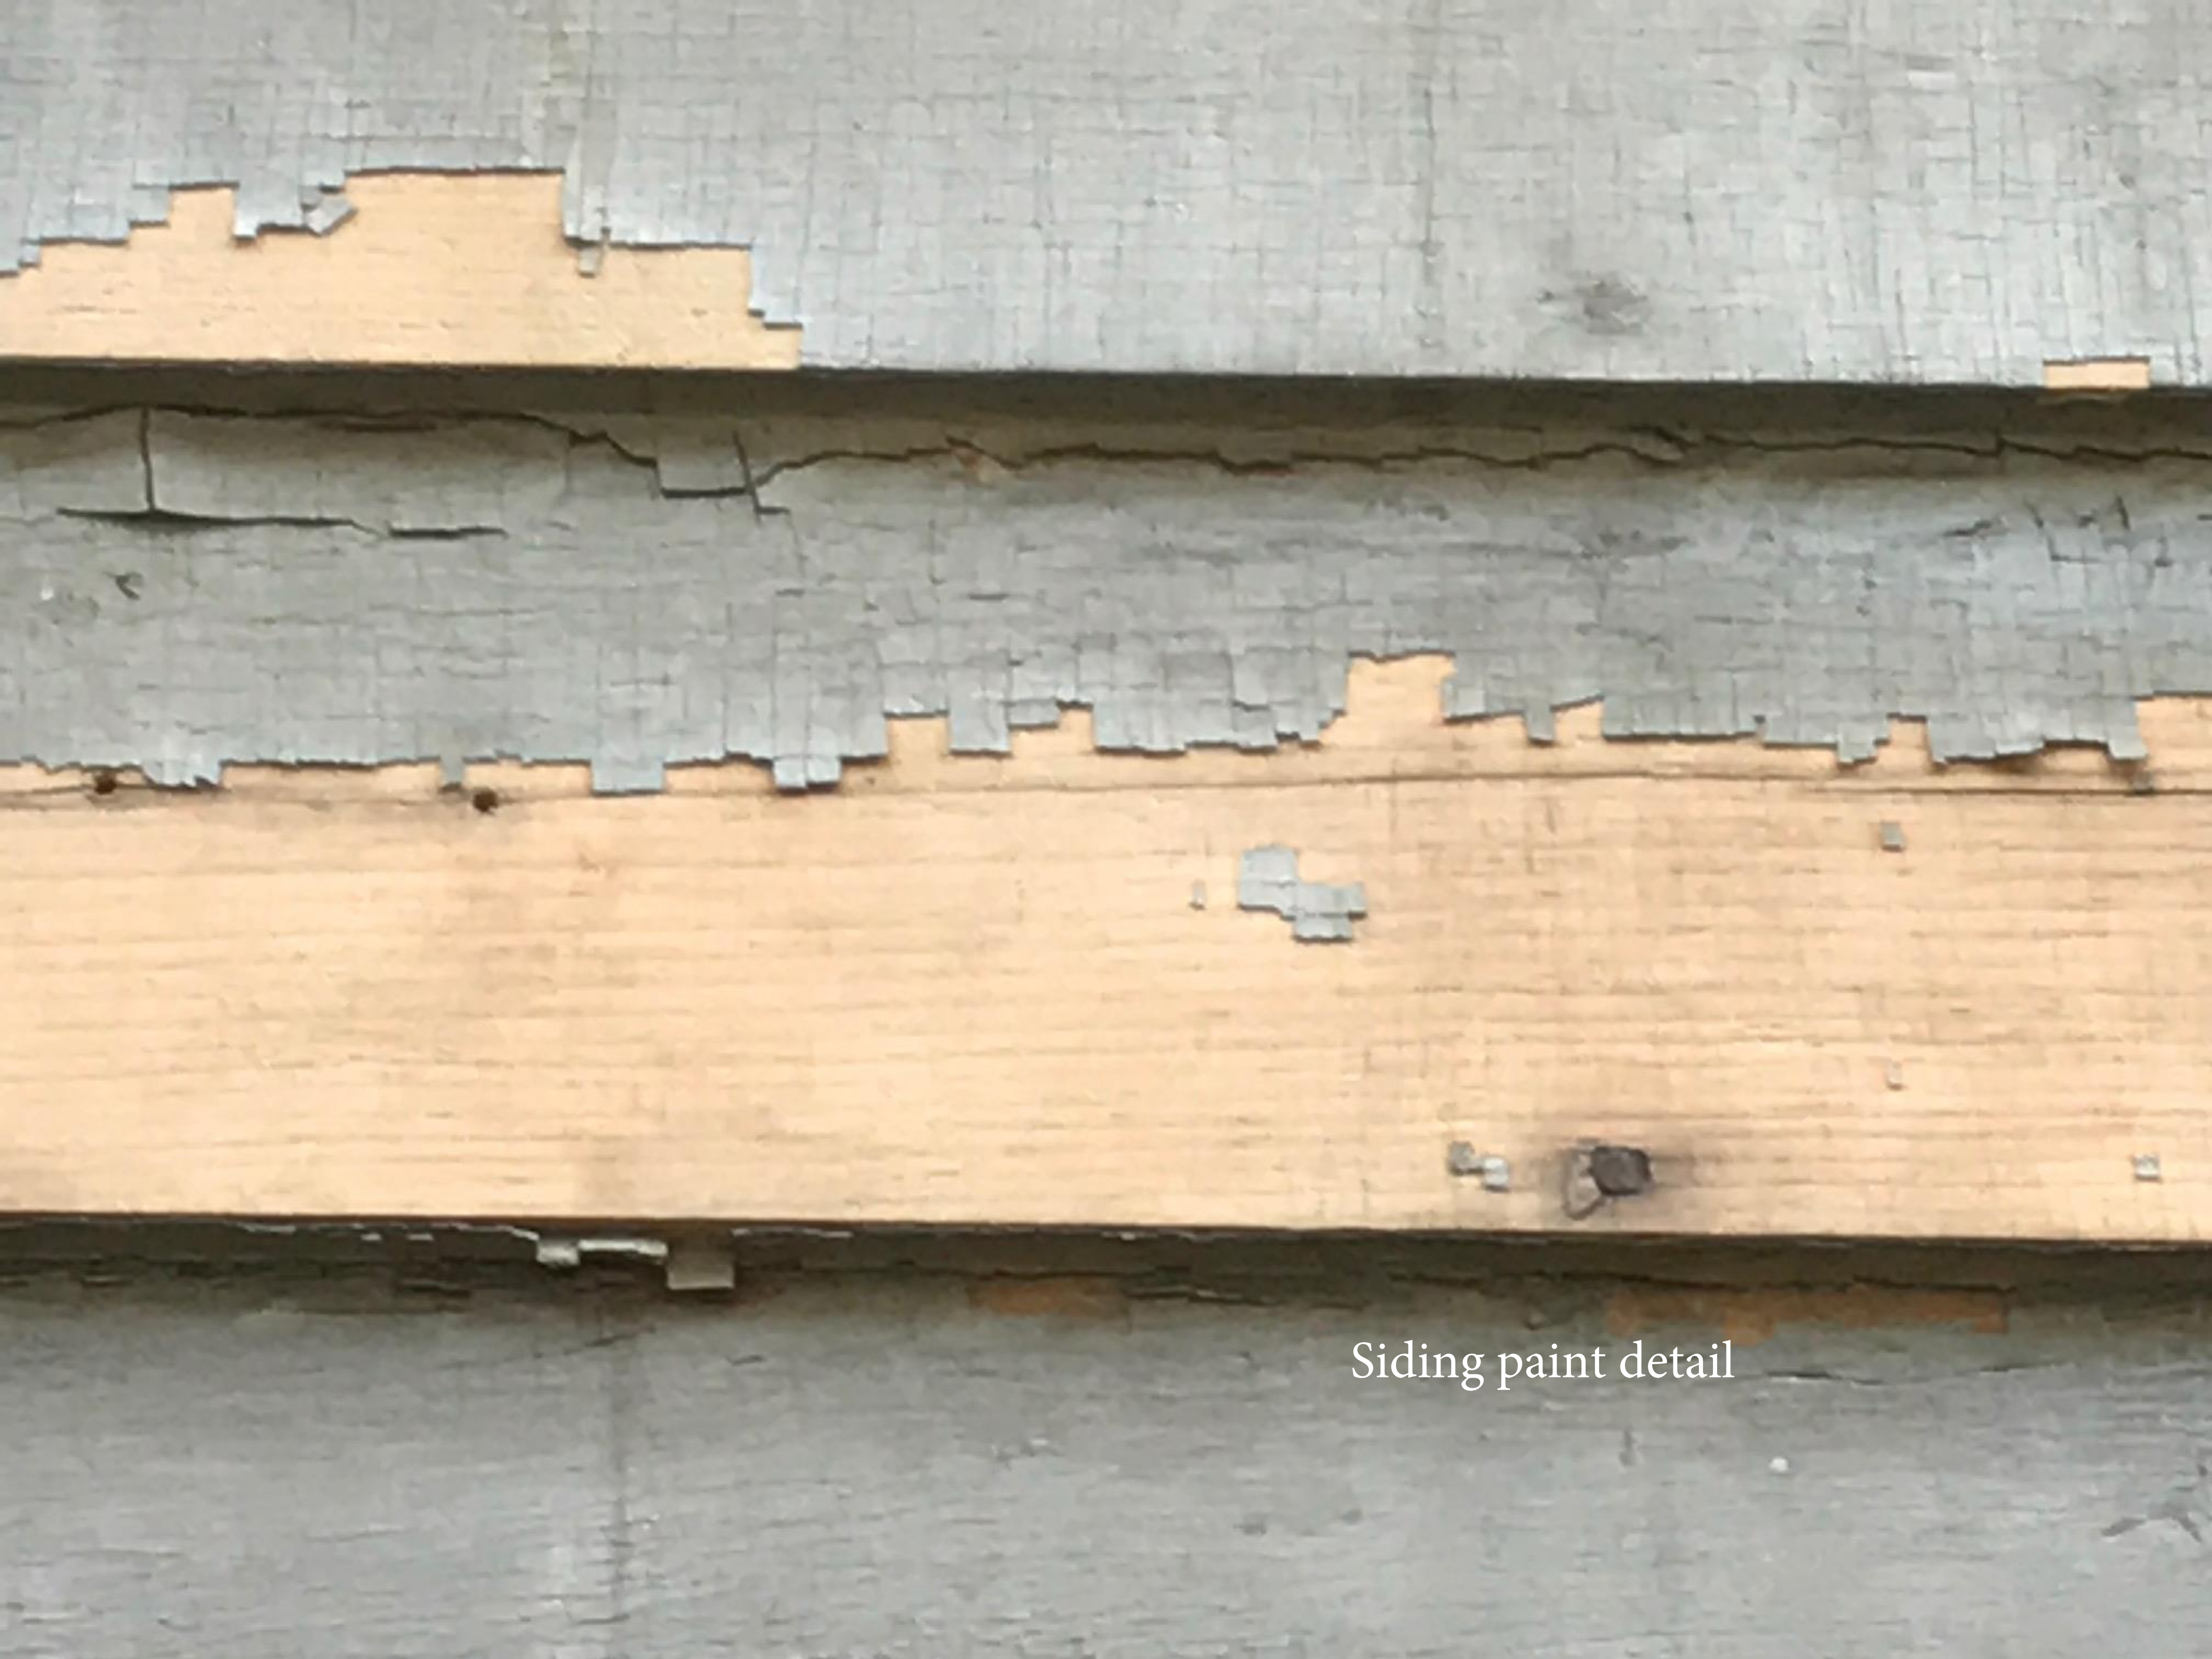
4. The Cedar siding which was uncovered has a single layer of paint on the surface, with no stain or varnish underneath this single layer of paint, see photo 3. We do not believe that one coat of paint applied roughly in 1885 could somehow last until the late 1930's when the asbestos siding would most likely have been installed. That is roughly 50 years for a single layer of paint to last, something that would be extremely unlikely. Usually with old paint surfaces on wood you will

Siding paint detail

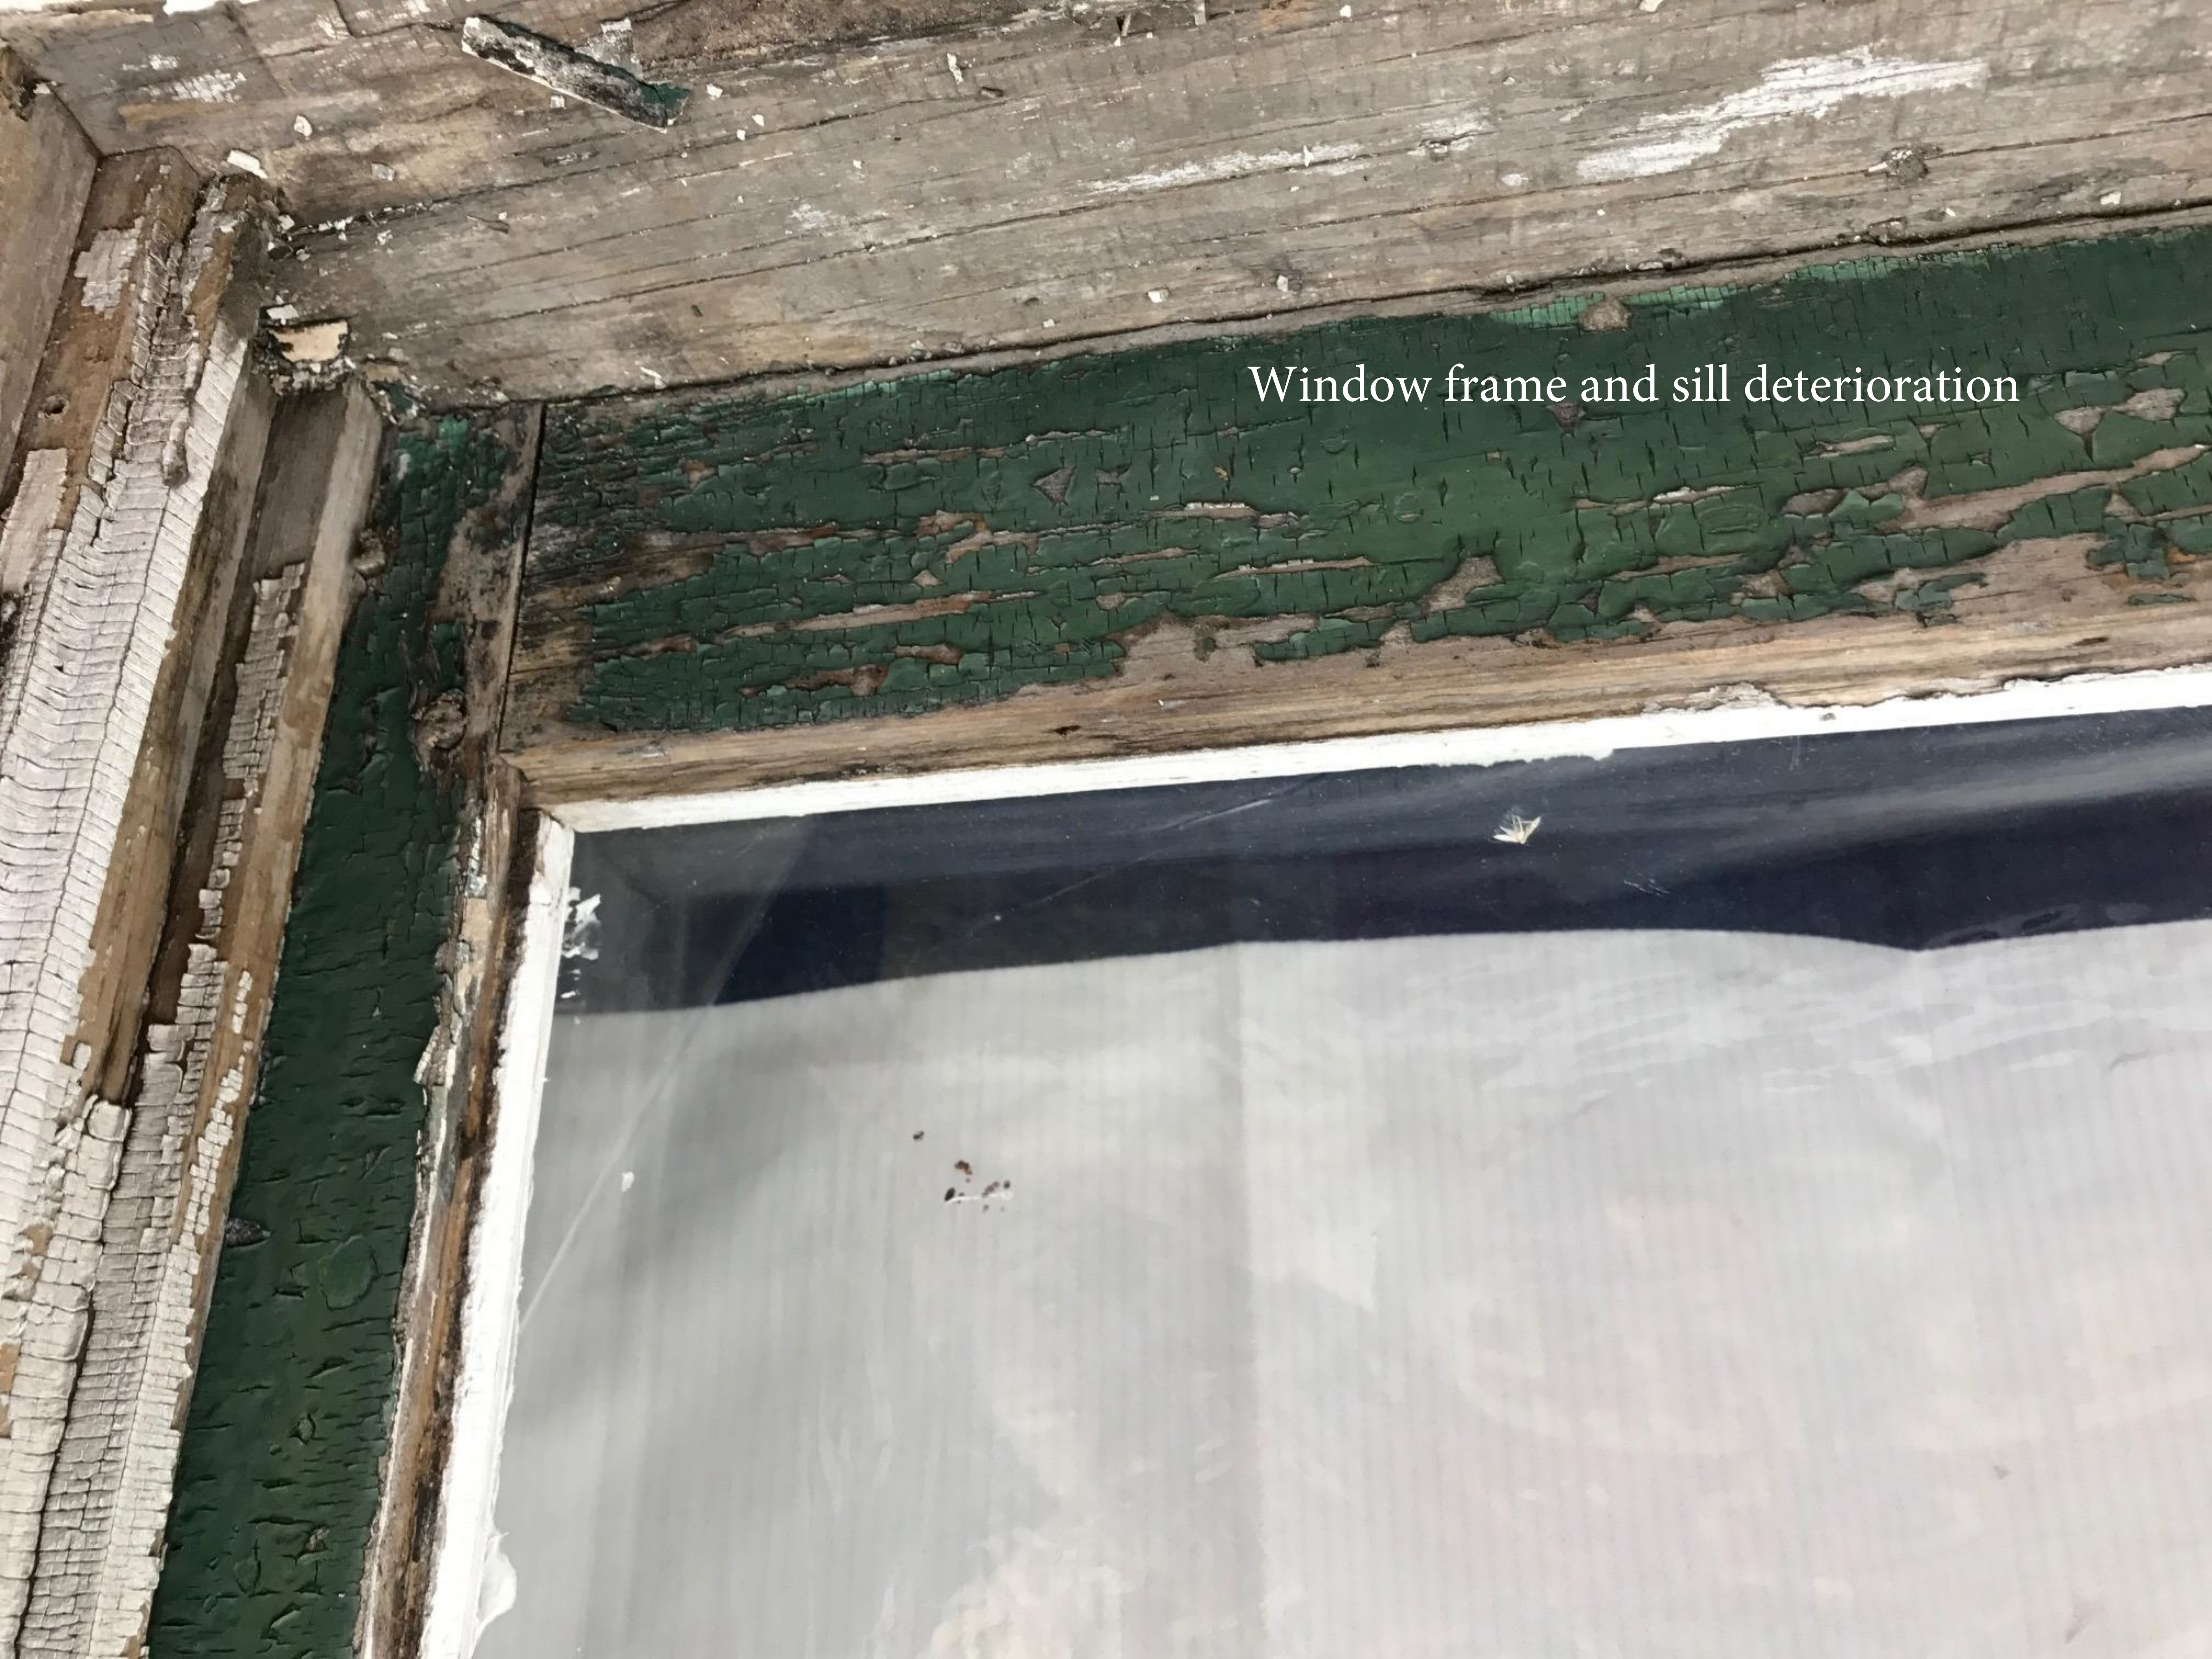
Window frame and sill deterioration

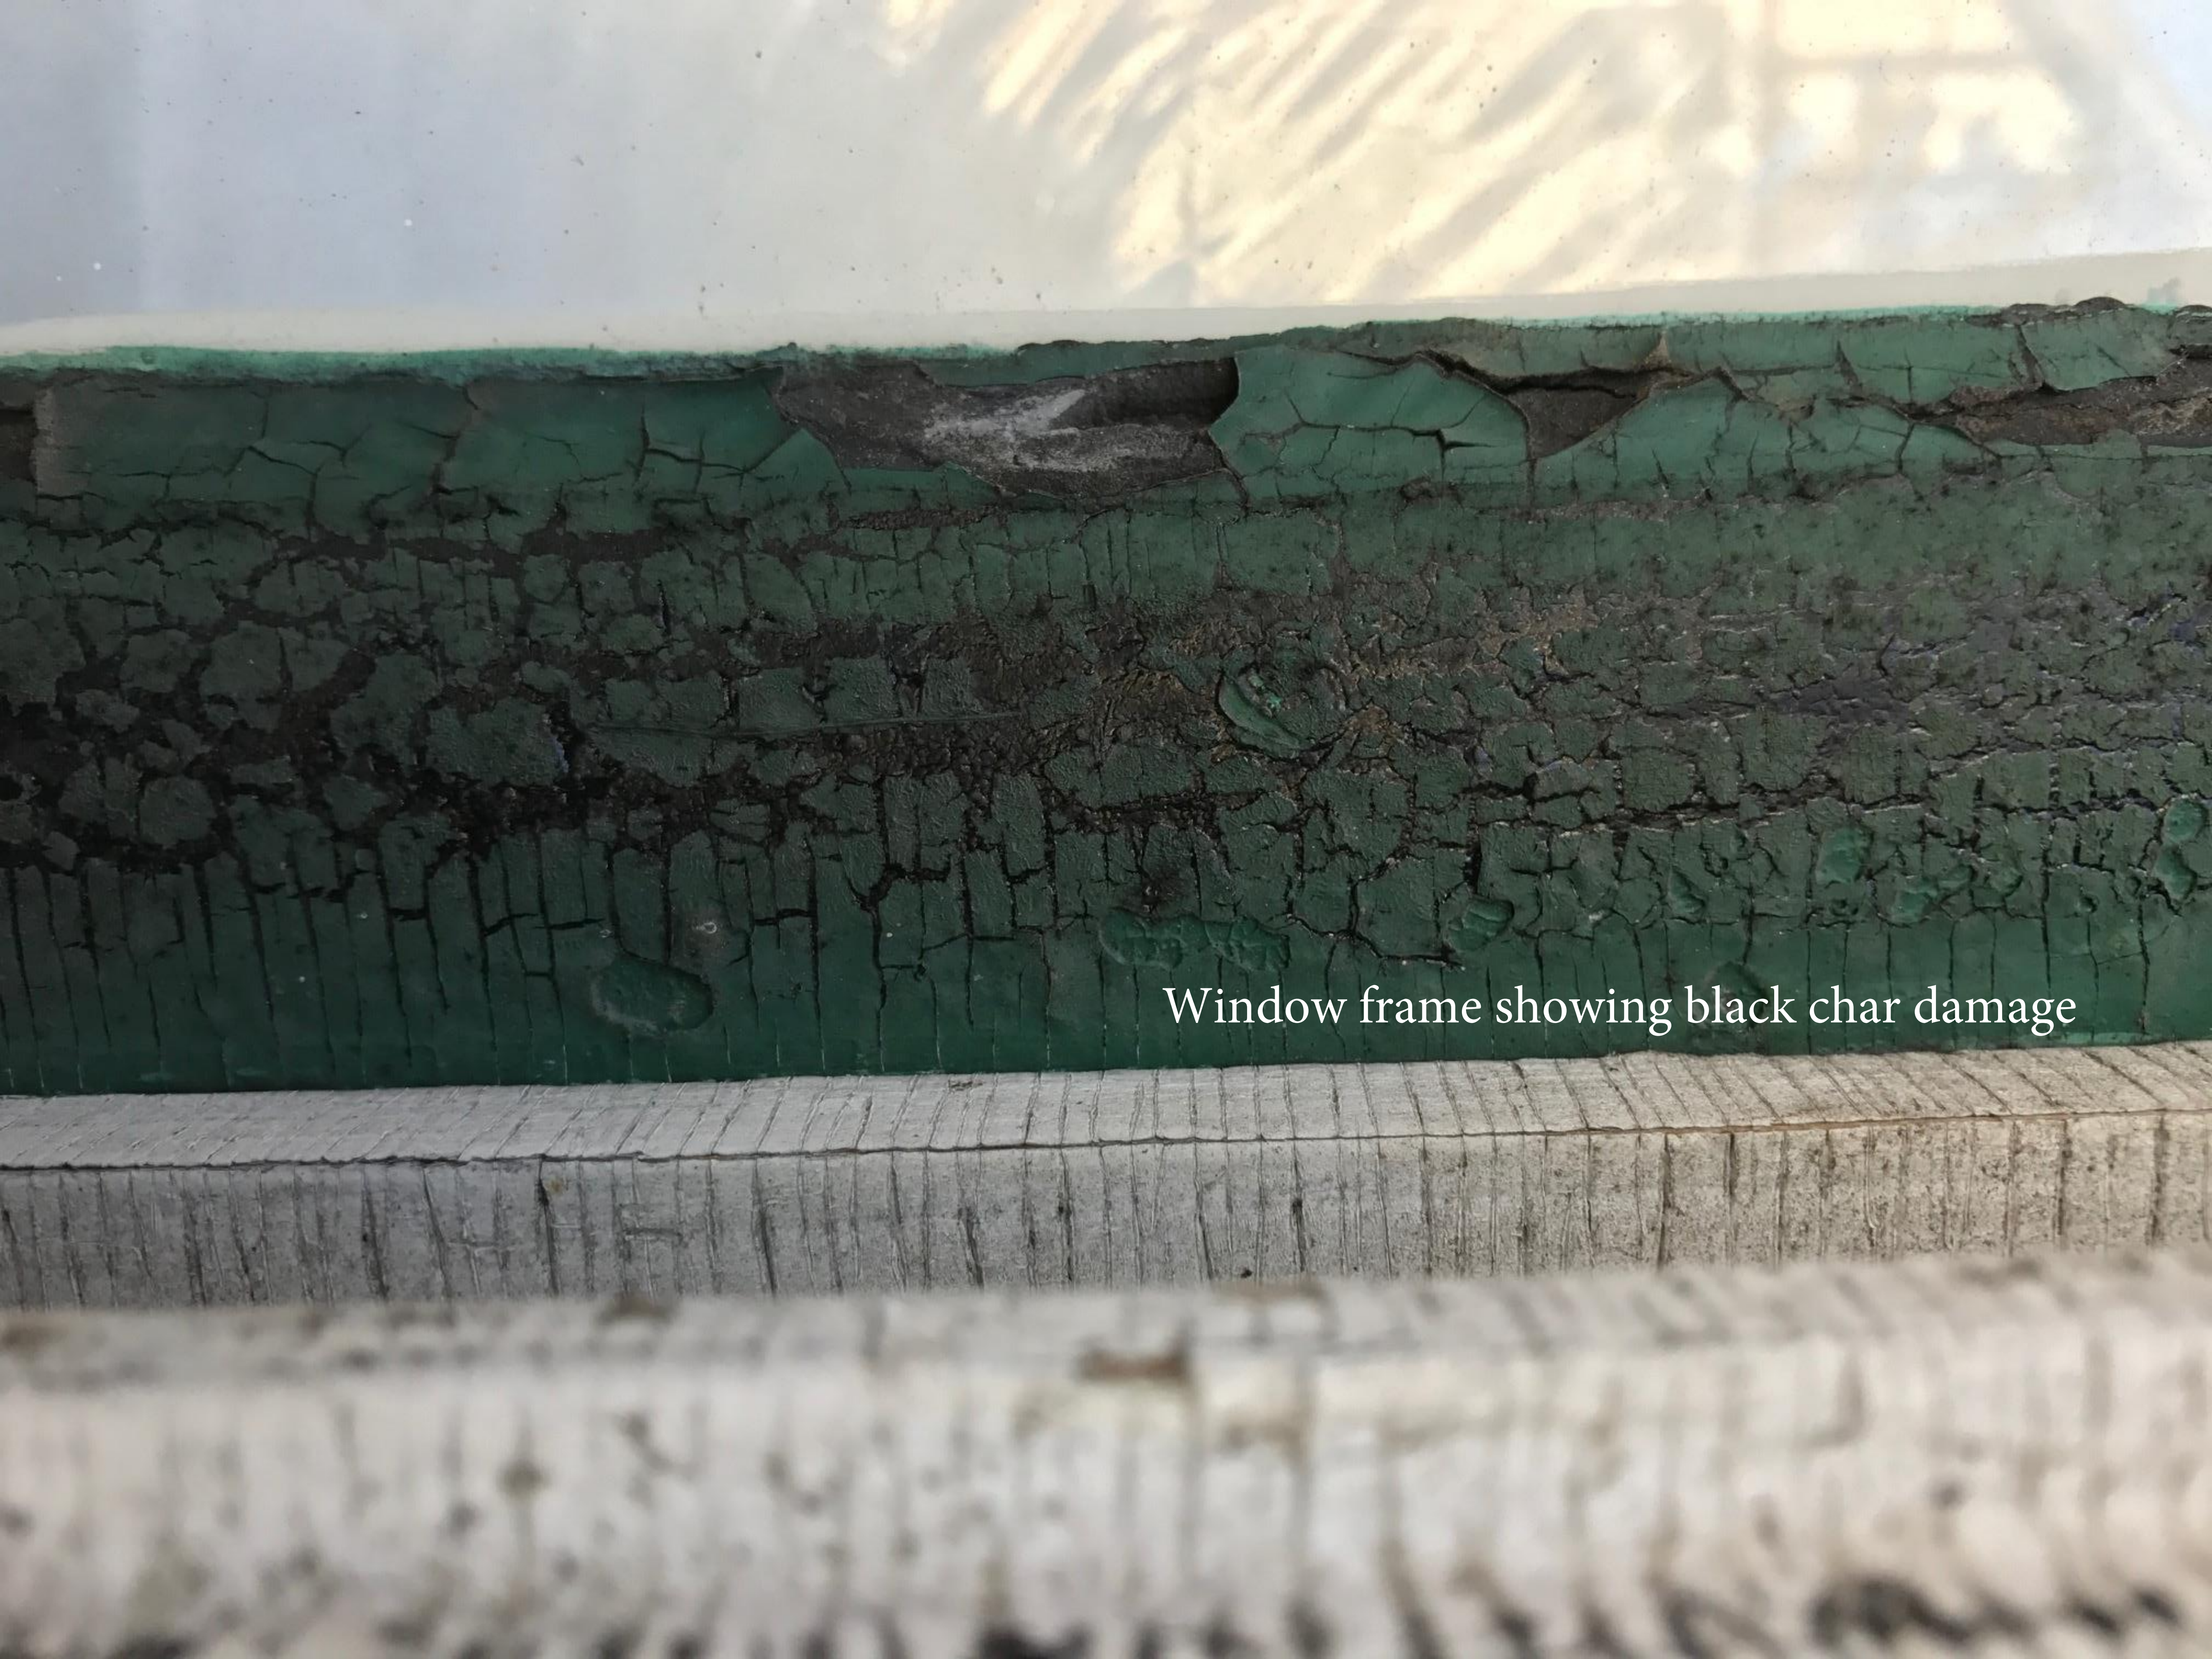
Window frame showing black char damage

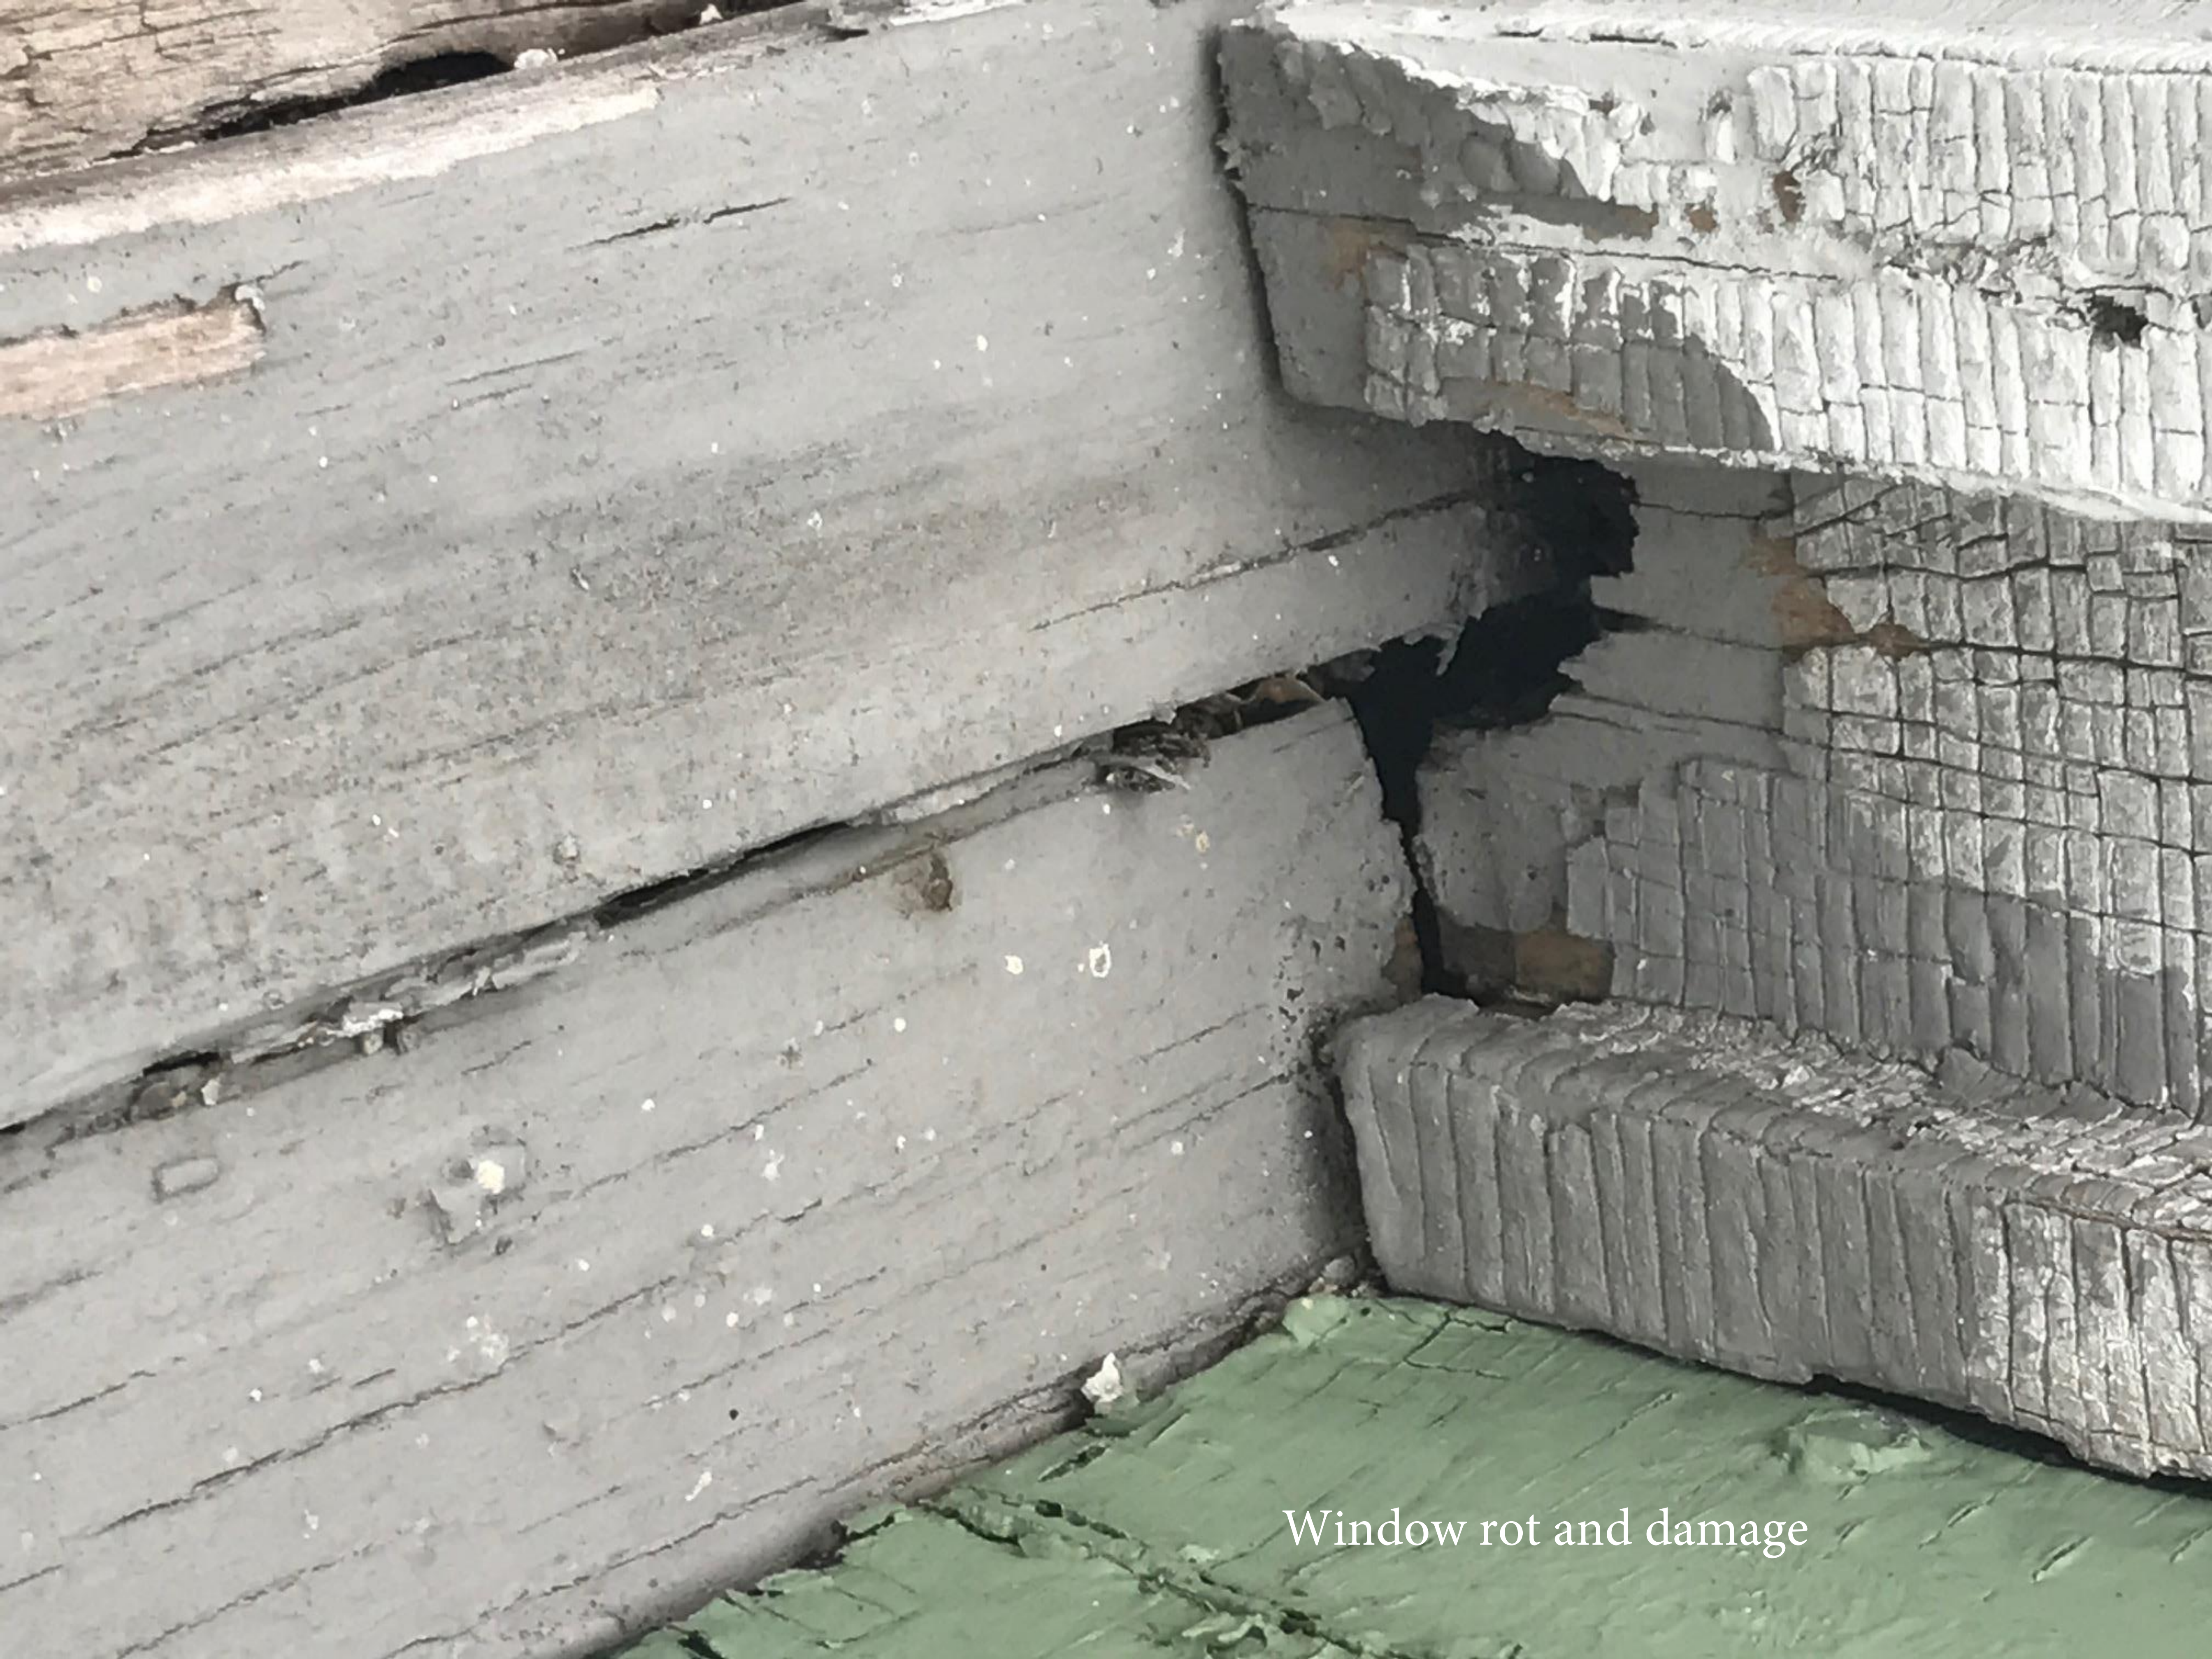
5. From close inspection of the interior and exterior surface of the existing windows they are in very rough shape from years of minimal to no maintenance performed by previous homeowners, see photos 9 and 10. To repair these windows, it will be very time intensive and costly. The window framing of the house is keeping the windows intact, by trying to repair them the risk of further damage is very high. By replacing these windows with historical replica wood exterior windows and custom wood storm windows the home will have the exact same historical look while being more energy efficient and "green". This will also allow the home to look seamless from the original to the new rear addition.

Window rot and damage
