HERITAGE PRESERVATION COMMISSION STAFF REPORT

ADDRESS: 777 6th Street E.

ZONING: RT1 **PROPOSAL:** Renovation work-after the fact

Revocation of Fire Certificate of Occupancy and Order to Vacate

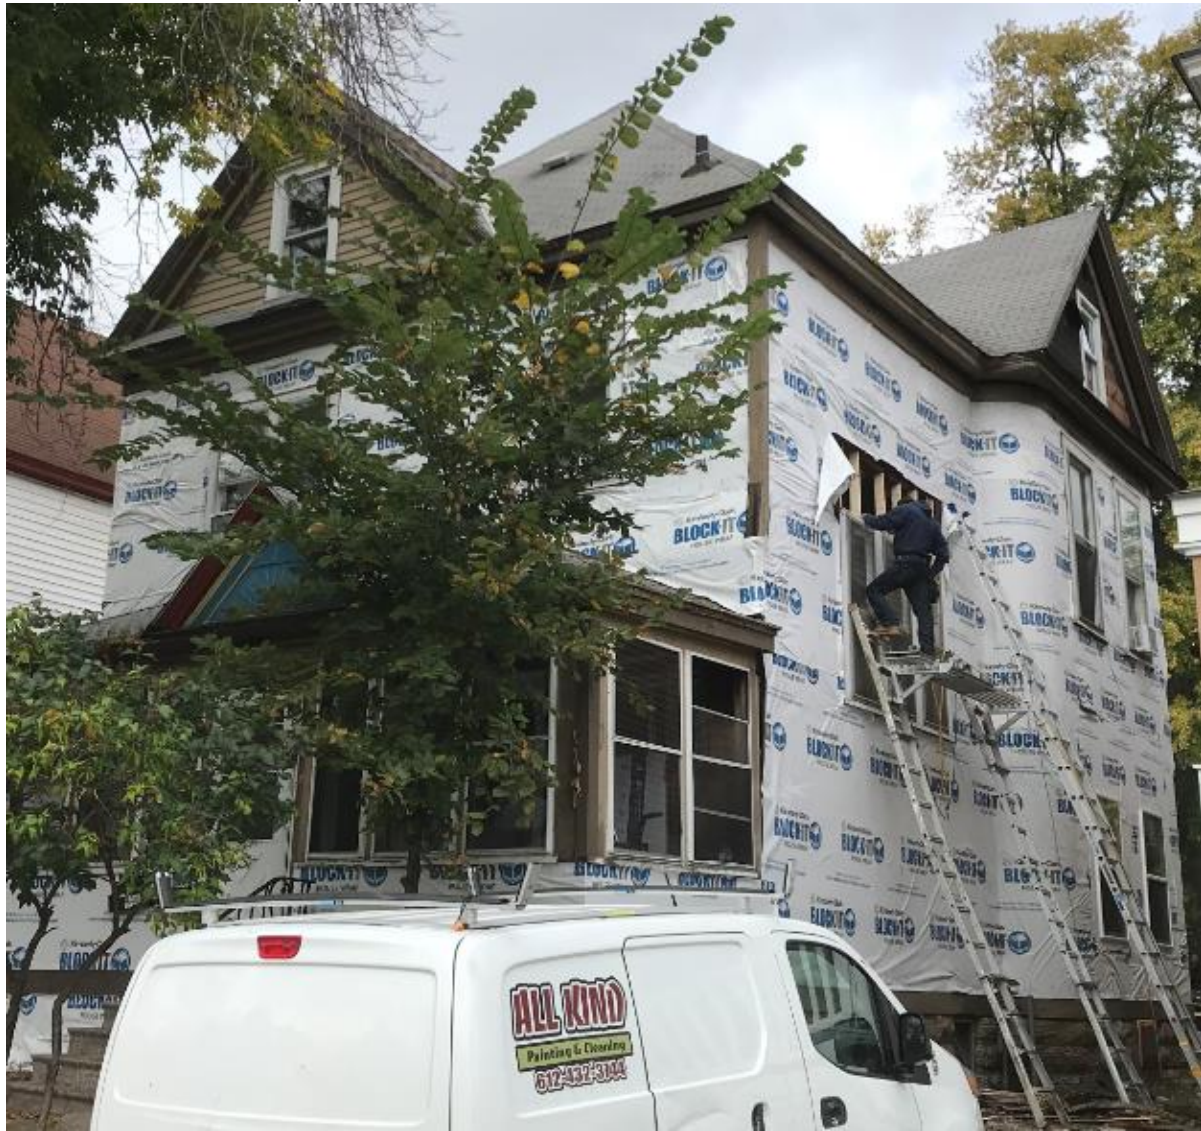
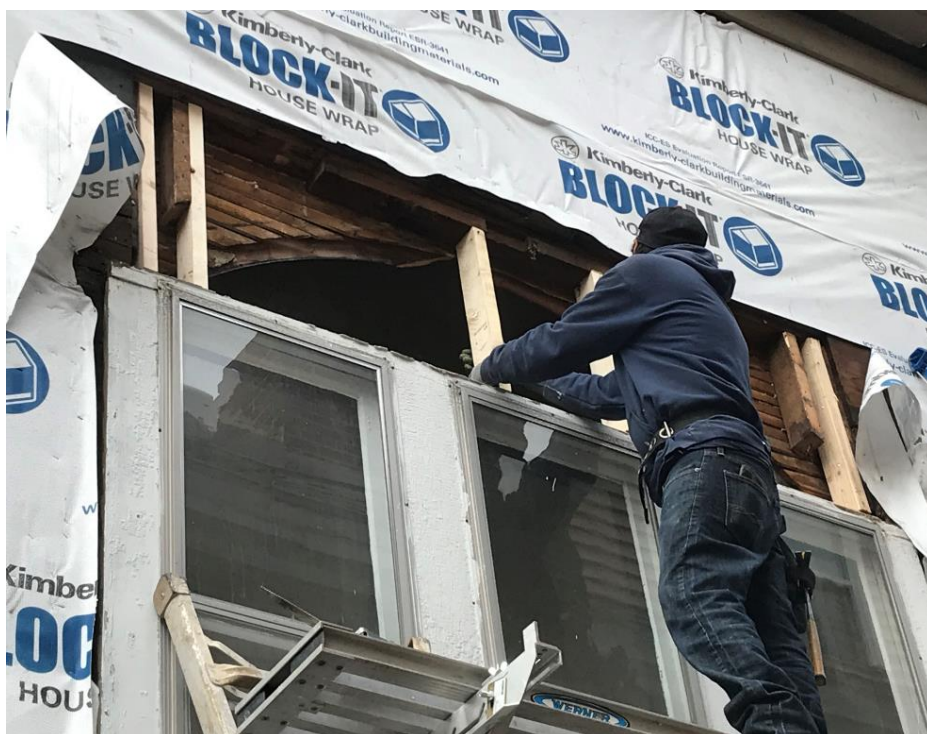
777 6th Street East work photos

In late September, staff began to get calls and emails from concerned neighbors. The siding replacement work had begun without approval. A DSI inspector also found window replacement work occurring during a visit to the property.

Siding on three sides has been removed from the structure and construction wrap installed. The applicant is proposing to install vinyl siding.

Window replacement was found to be occurring during a site visit by the inspector. The applicant has asked for window replacement but has not submitted detailed information or documentation about which windows need to be replaced or what the condition/materials of the existing windows.

Wood siding to match the original siding should be installed on the property and not vinyl. Windows should be repaired .
