INDIAN MOUNDS REGIONAL PARK MASTER PLAN

City of Saint Paul Department of Parks and Recreation Design Section

Existing Conditions East

Existing Conditions West

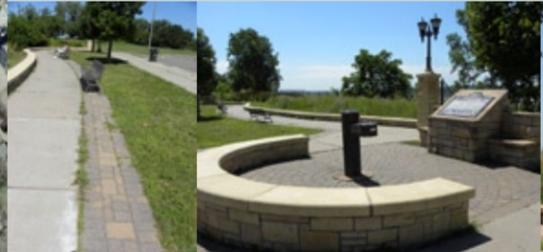
4 CARVERS CAVE OVERLOOK

- Renovated in 1996
- Planting beds between parking lot and walk removed
- Graffiti on monument
- Weeds growing through cracks
- Native planting area in poor condition

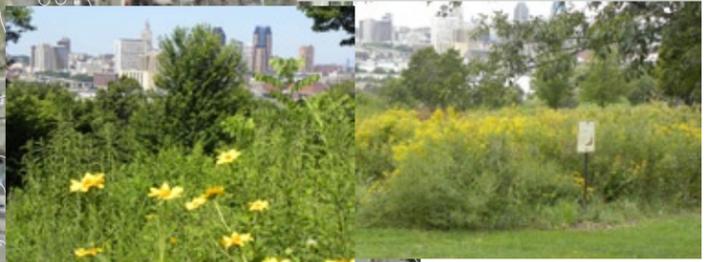
6 PRAIRIE PLANTING

- Moderate quality
- Many small trees and invasive weeds
- Mostly forbs, with Kentucky Bluegrass the predominate grass

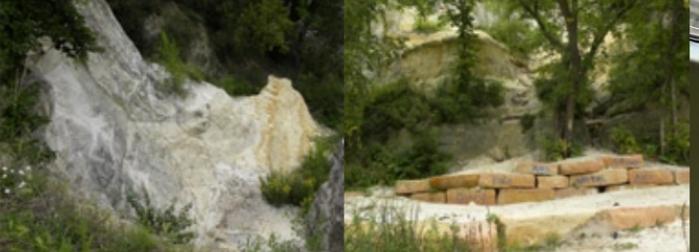
2 SAND CASTLE AREA

- Dangerous foot trails from Carver's Cave Overlook
- High erosion from foot traffic
- Sand piles at bottom of bluff
- Graffiti, hang out spot

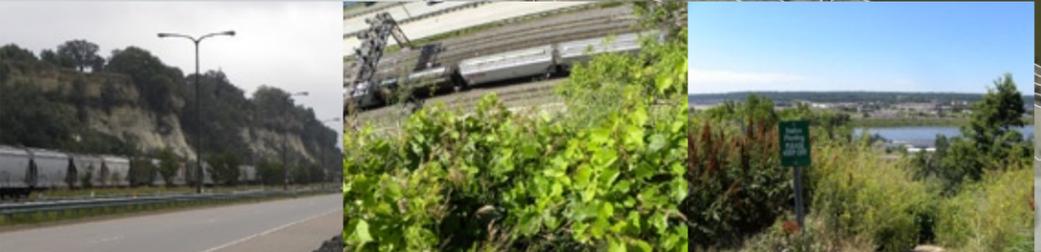
3 BLUFF

- 125' sheer drop in some areas
- Vegetation hard to maintain due to location
- Unobstructed views of natural sandstone bluffs

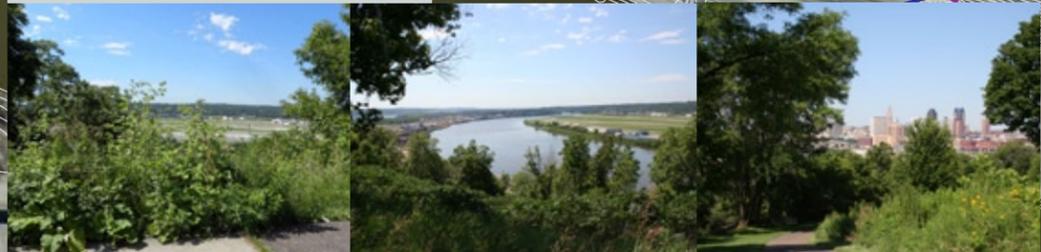
5 VIEWS

- Some views overgrown
- Excellent view down Mounds boulevard framed by trees
- A main use of the park is the viewshed

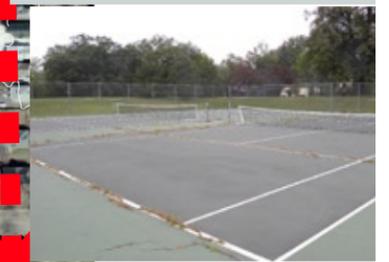
7 TENNIS COURTS

- Restored in 2005
- In fair condition

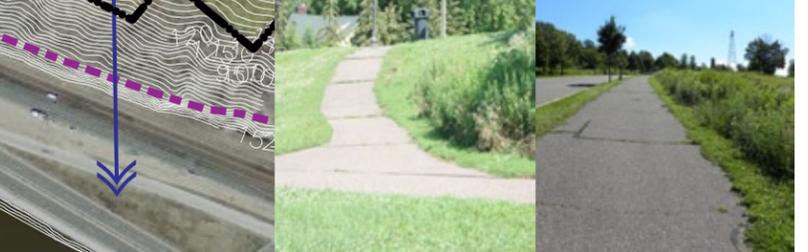
TRAILS

- Installed in 1996
- Many cracks
- Overgrown edges

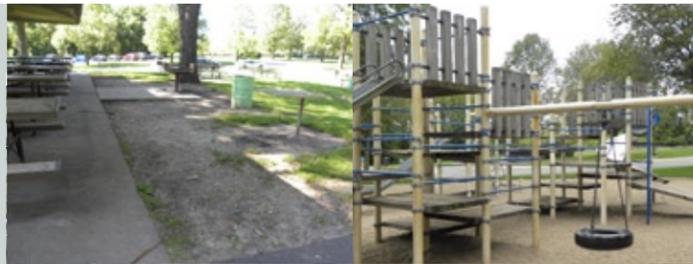
1 PICNIC AREA

- Worn area about 10' out around picnic shelters
- Some grills missing, in poor condition
- Play area installed in 1988
- Play area not ADA compliant
- 25 + Picnic tables
- Restroom installed in 2001

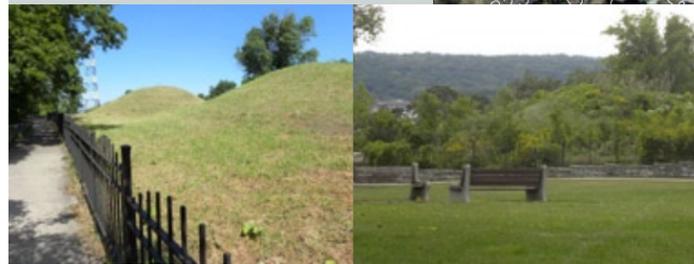
2 INDIAN MOUNDS

- Vegetation varies from brome to a mix of native plantings
- Fencing in good condition
- Signage may need updating

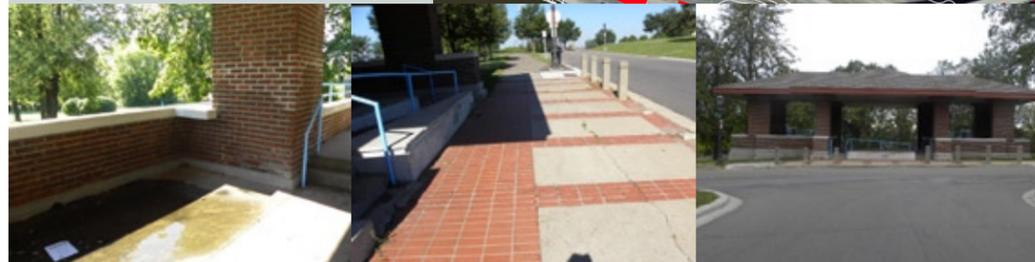
3 PAVILION

- Roof replaced in 2003
- Structure in need of repairs
- Blue handrailing out of place
- Ramp in poorly placed location
- Pavilion not used/programmed

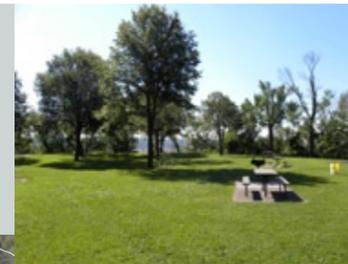
5 SOUTH PICNIC AREA

- Stormwater overflow
- Area can be wet
- 19 picnic tables
- Views overgrown
- Some dead trees

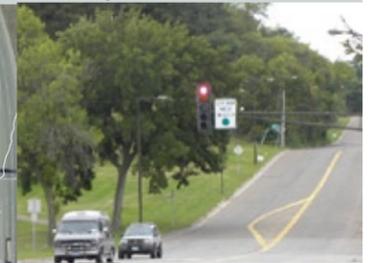
7 EASTERN ENTRANCE

- No signage denoting a park on the eastern portion of the park

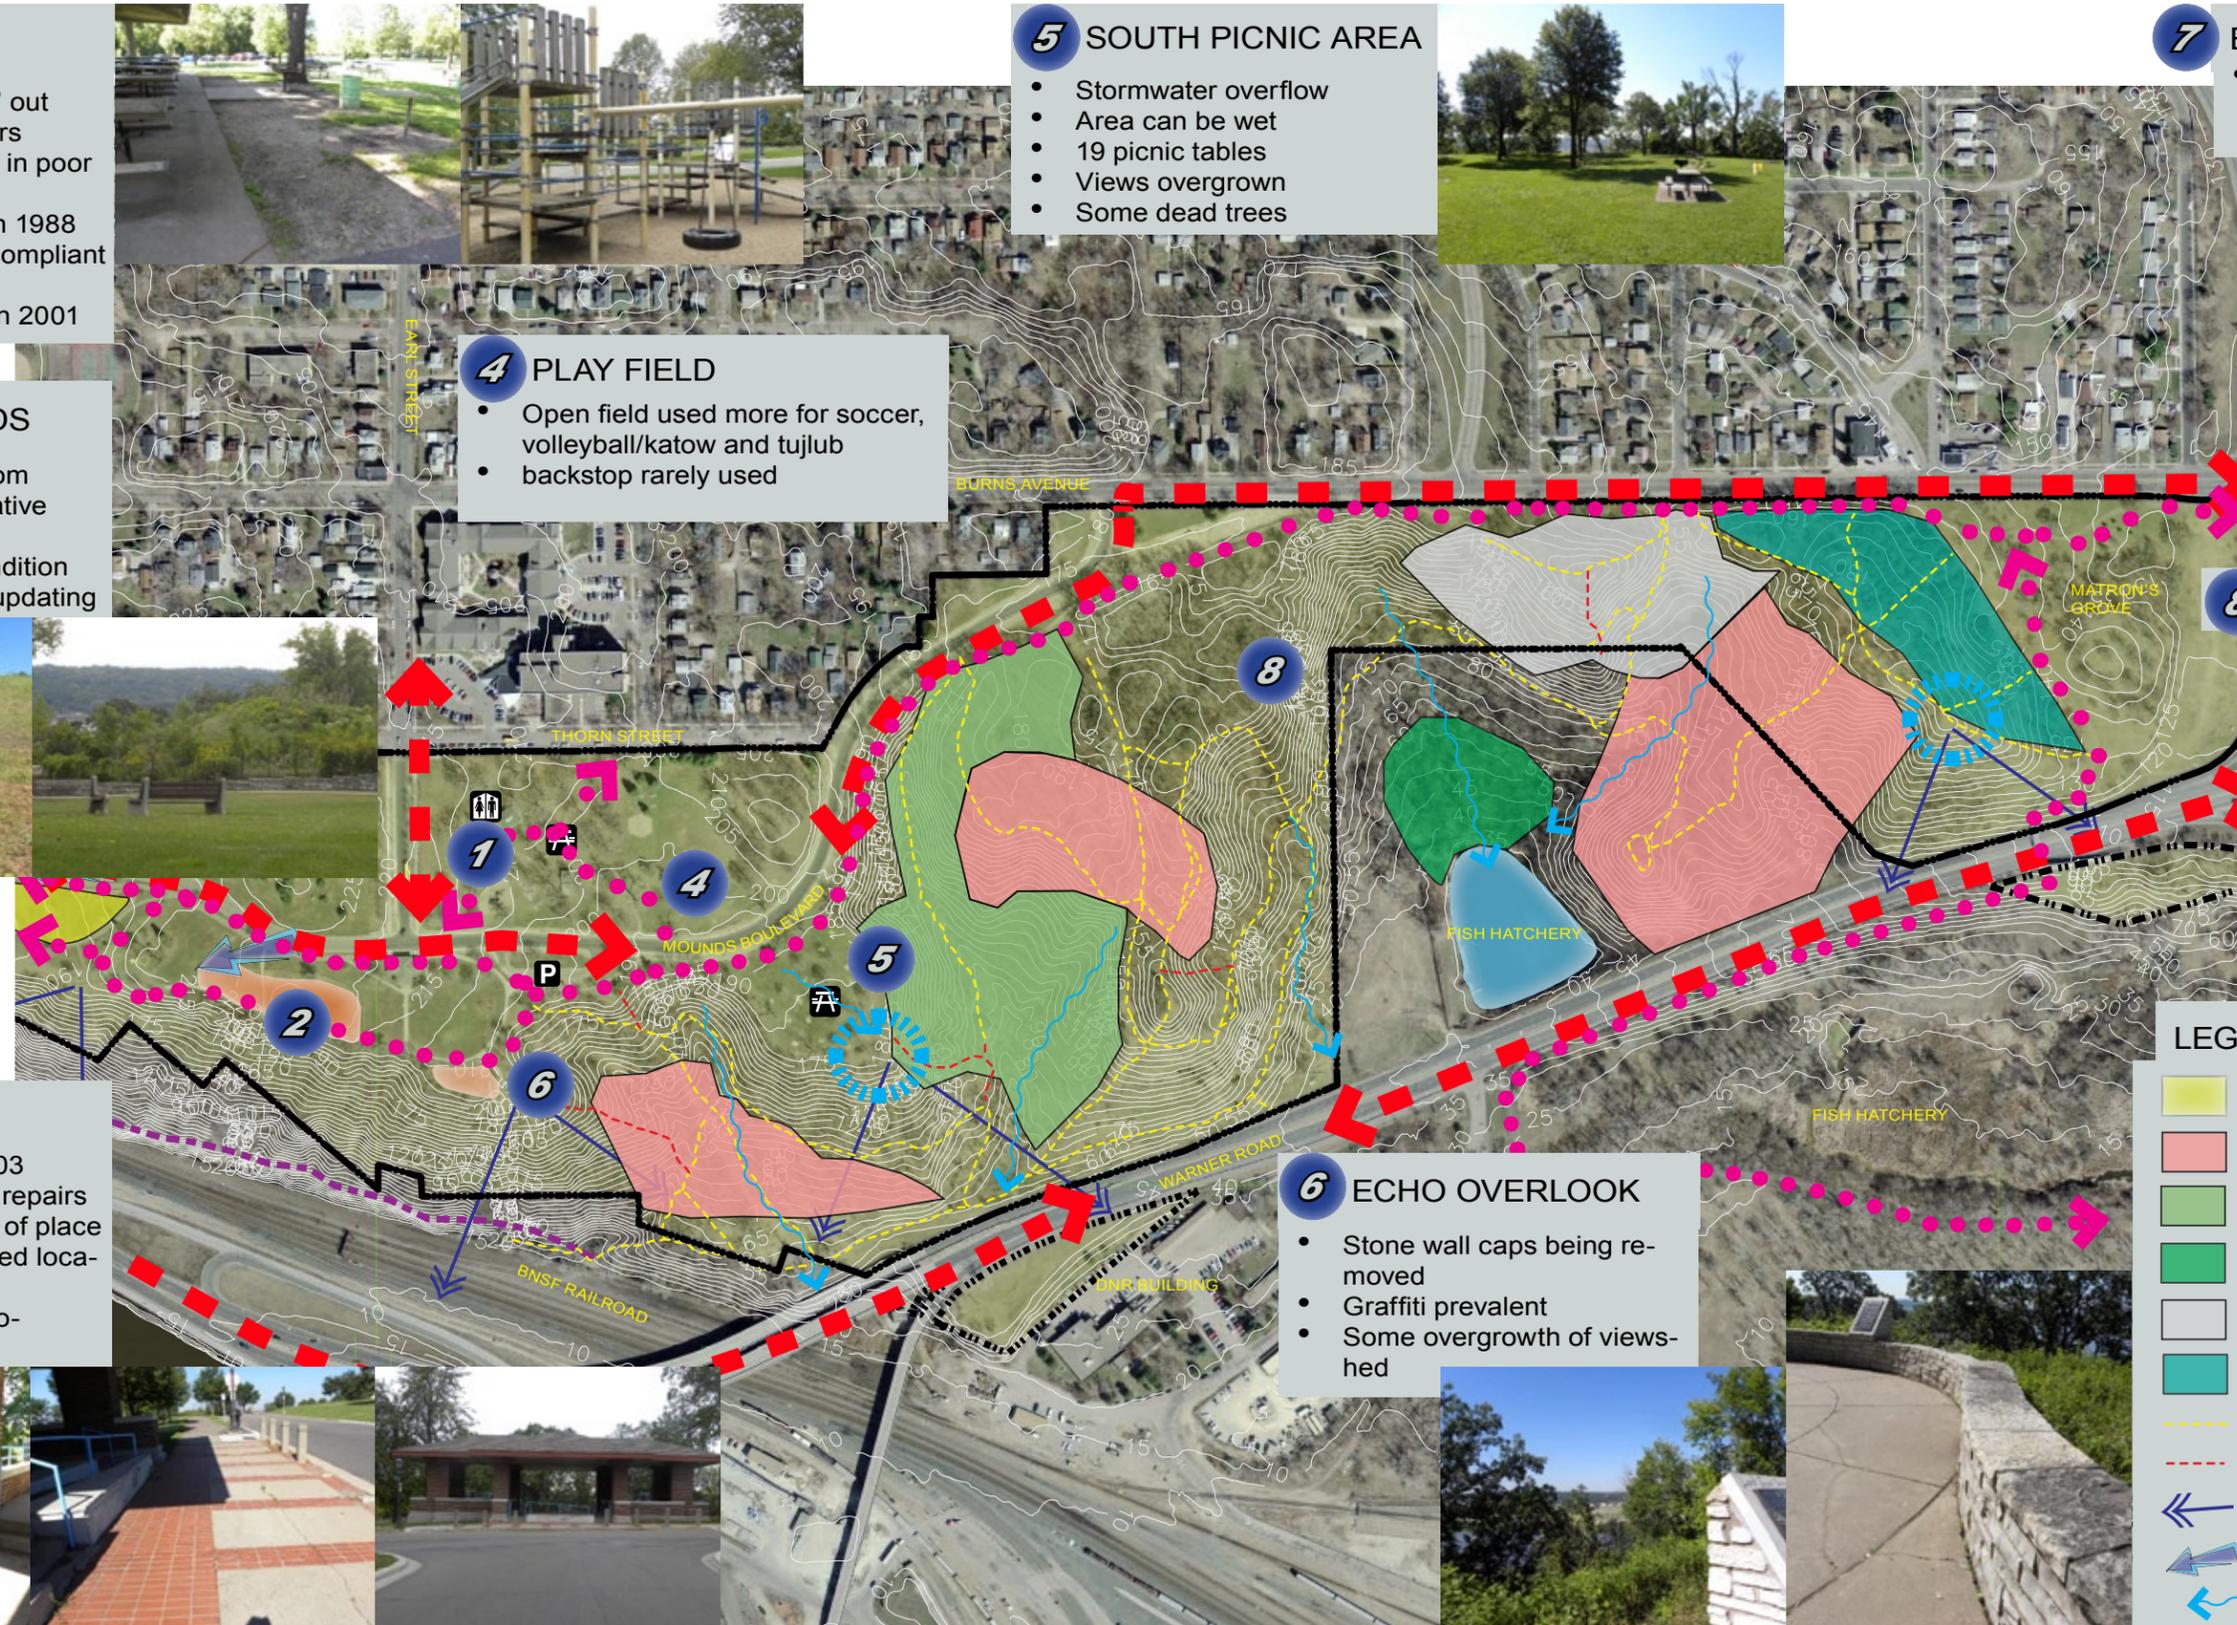
8 MUNICIPAL FOREST

- Colored areas show native vegetation
- Other vegetation mainly disturbed deciduous forest
- Steep slopes hard to manage
- Extensive invasive species removal since 2008
- Many foot trails, no actively managed trails
- No interpretive signage
