**CITY OF SAINT PAUL
HERITAGE PRESERVATION COMMISSION STAFF REPORT**

FILE NAME: 295 Summit Avenue, Unit 3 (Carriage House)
DATE OF APPLICATION: May 2 and July 17, 2013
APPLICANT: Mark Saliterman
OWNER: Mark Saliterman
DATE OF PUBLIC HEARING: August 8, 2013
HPC SITE/DISTRICT: Hill Historic District
CATEGORY: Pivotal
CLASSIFICATION: Demolition Permit
STAFF INVESTIGATION AND REPORT: Amy Spong
DATE: August 1, 2013

RE: Professional Structural Engineering
Structural Observations of Alley Structure at 295 Summit Ave
Saint Paul, Minnesota
VAA Comm. No. 130250

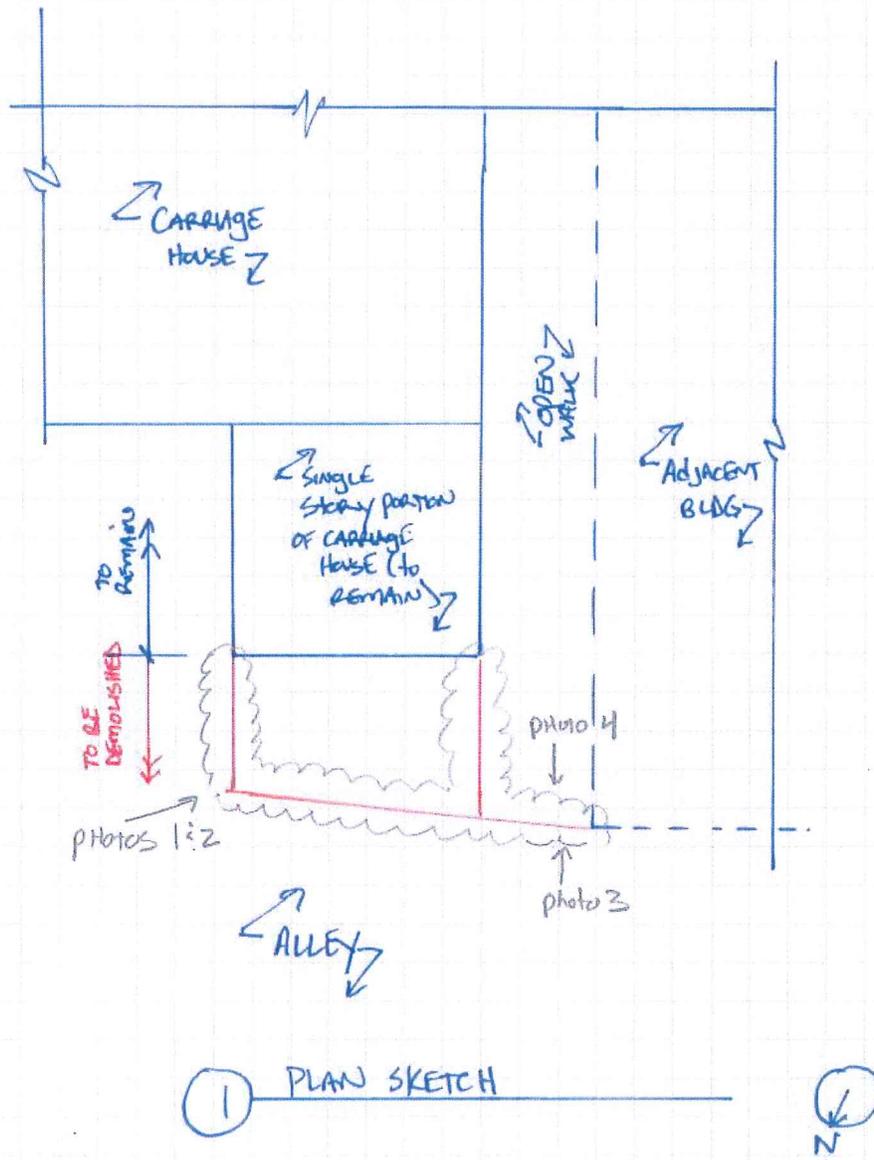
Figure 1 – Plan Sketch of the Area Being Observed

Although the primary residence was constructed in the late 1880's, it is unknown to VAA the exact date of construction for this small addition to the carriage house. It appears to have been purposed for delivery/storage of feed or some other 'back of house' function. It does not appear to currently have a function to the primary residence. The observations made are limited to the structure/walls drawn in red (clouded) in **Figure 1**.

- 1. The likely cause of the deterioration and partial collapse of the wall/structure is due to loss of foundation integrity in combination with environment effects over the life of the wall.
- 2. The integrity of the wall/structure has been compromised in these areas. It is not practical to repair the wall/structure due to the severity of deterioration and it may be a safety hazard in its current state. In my professional opinion, the walls/structure should be demolished immediately. This is limited to the walls/structure drawn in red (clouded) in **Figure 1**.

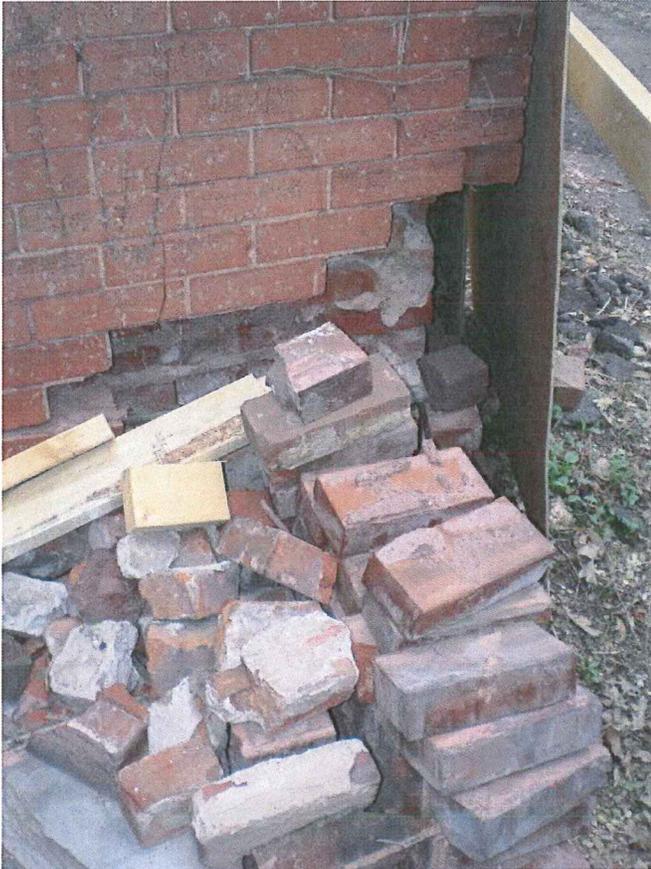
Photo 1 - Deterioration at NE Corner

- 3. There was deterioration of mortar joints and partial collapse of the wall at the bottom third of the NE corner of the walls in question. (**See Photos 1 and 2**) This appears to be due to loss of foundation support at the corner.
- 4. There was also excessive deterioration of mortar joints and substantial collapse of the full height of the wall at the NW end where it abuts the adjacent building. (**See Photo 3**). This appears to be due to a settlement of the foundation where it abuts the adjacent building (a common location of poorly backfilled soils), the location of a drainage system at the base of the wall (**See Photo 4**), seasonal temperature differentials and freeze-thaw cycles over the life of the wall.
