# Report

## Lilydale Regional Park Natural Resources Management Plan

City of St. Paul, Division of Parks and Recreation

May 2009

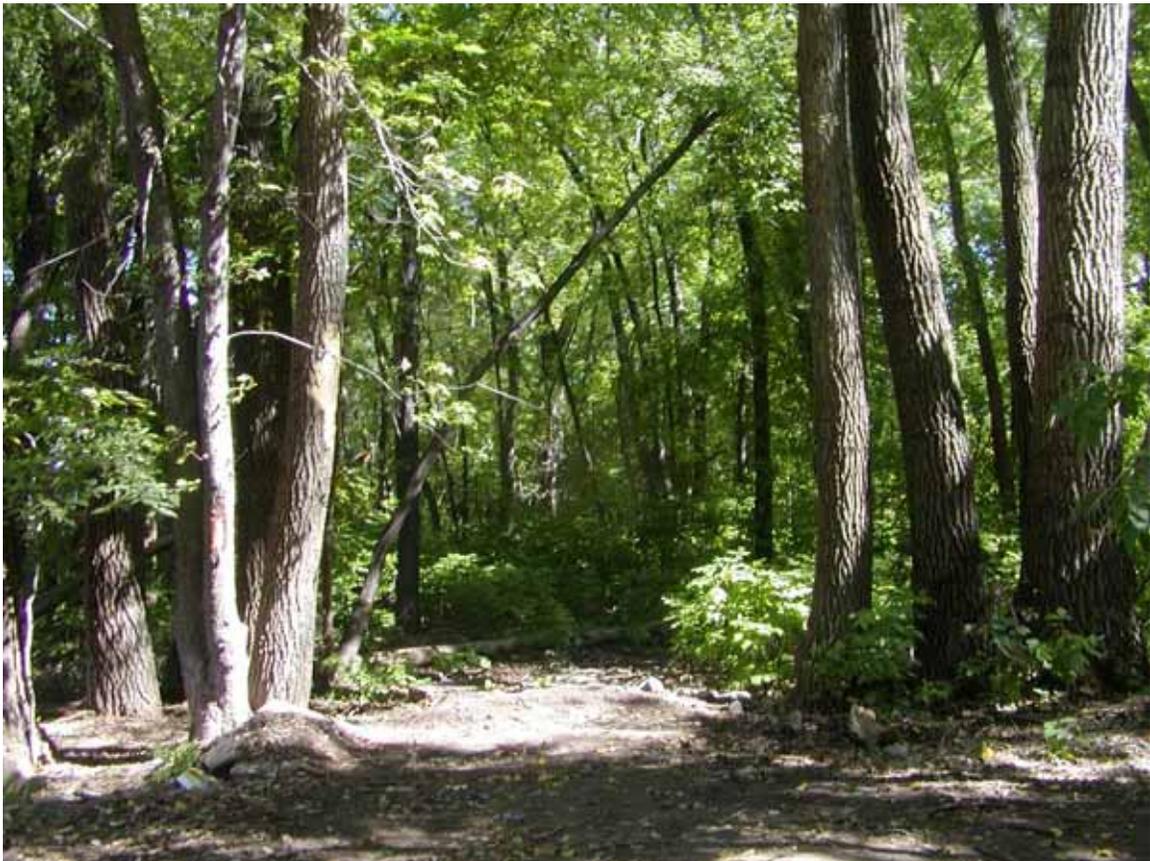
*Floodplain forest northwest of where the rail line goes over Water Street. Notice the few large cottonwood in the foreground and the dense growth of younger trees in the background.*

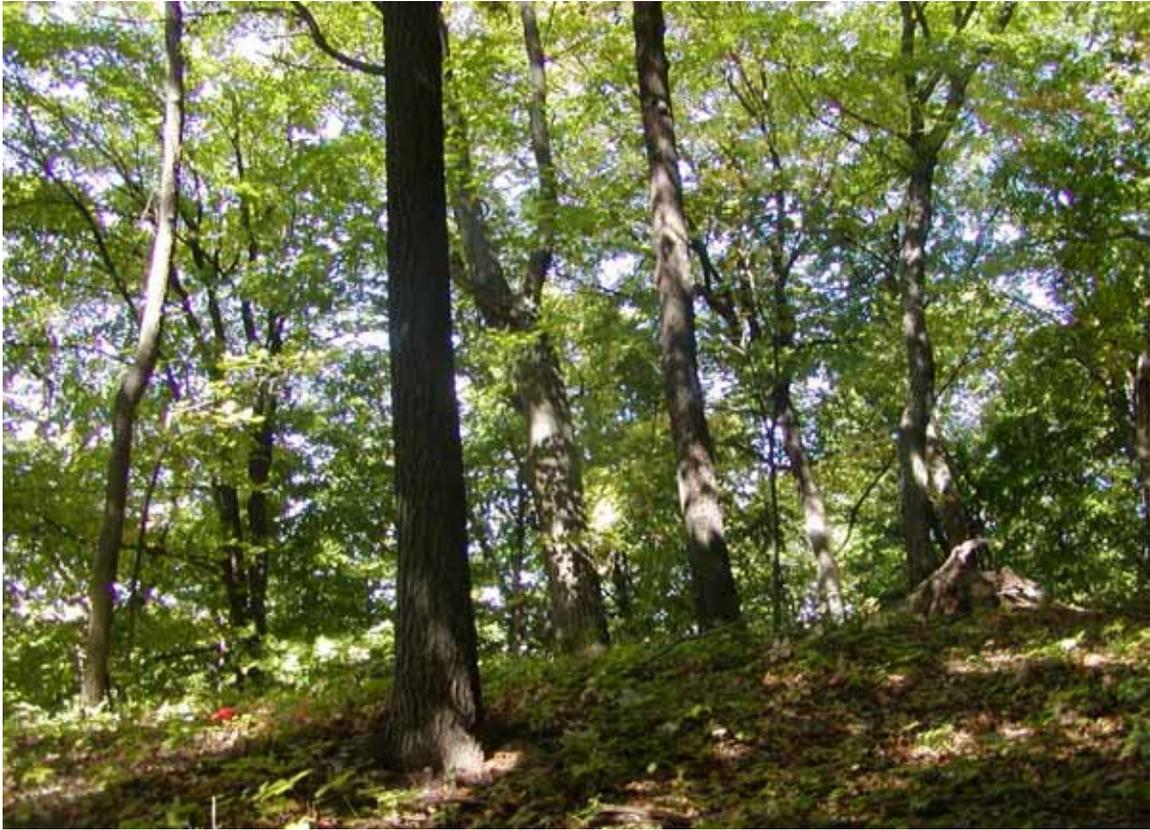
*This segment of maple-basswood forest occurs on the bluff overlooking Pickerel Lake. Notice the different age classes for trees – an indicator of better quality areas.*

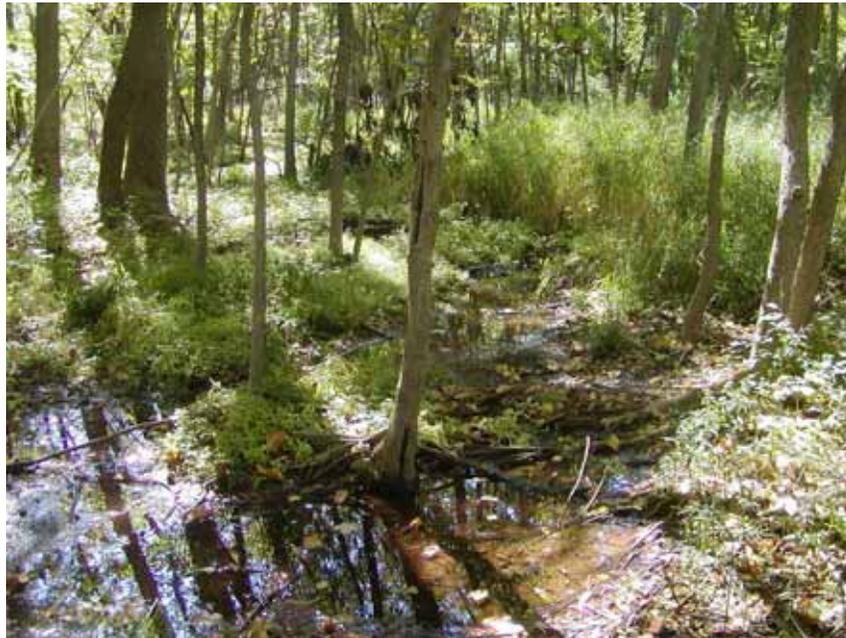
*This photo shows the better quality portion of the mixed hardwood swamp, dominated by black ash trees.*

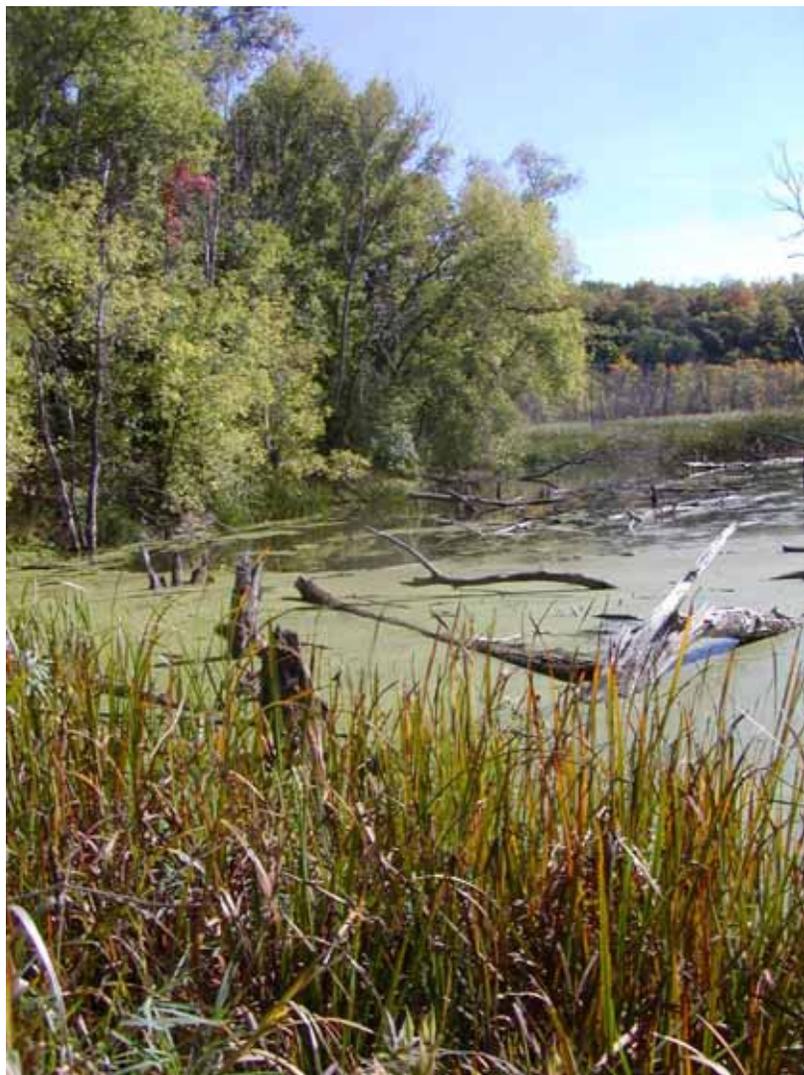
*A mixed emergent marsh area at Lilydale Regional Park dominated by bur-reed (*Sparganium eurycarpum*) shown in the foreground.*

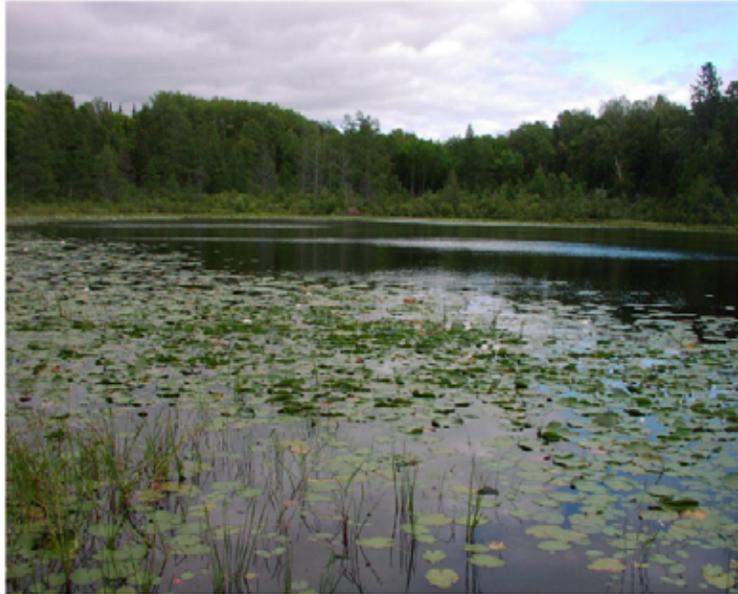
*minimally impacted shallow lake*

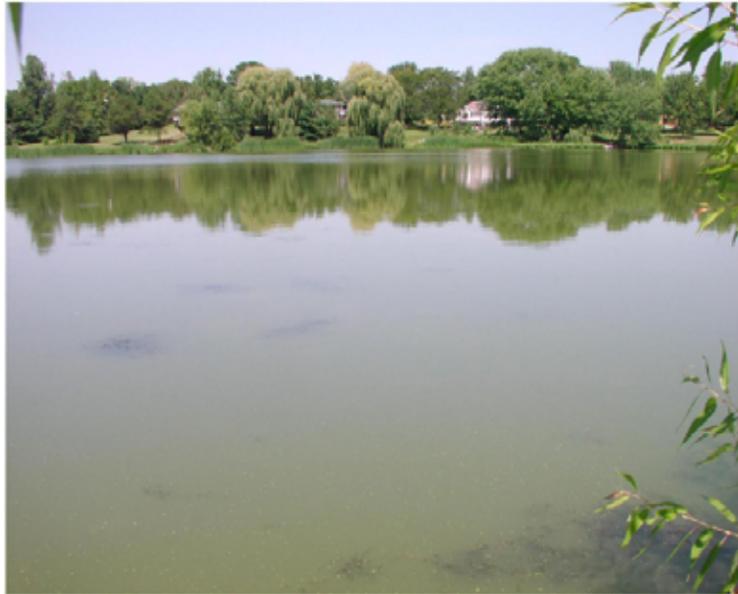
*turbid shallow lake*

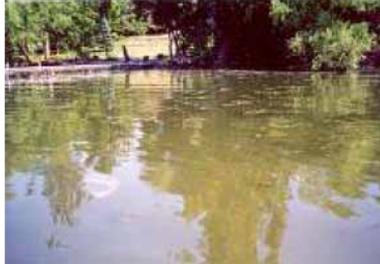
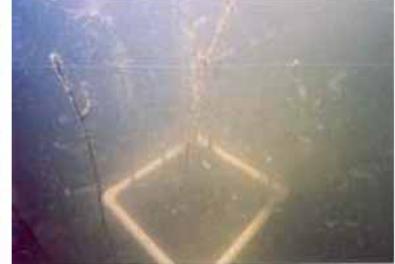
Stem density: 0 - 160 stems/m<sup>2</sup>  
Biomass: 0 - 50 g-dry wt/m<sup>2</sup>  
Estimated TP loading: <1.7 lbs/ac

*MnDNR rake sample density equivalent for light growth conditions: 1, 2, or 3.*

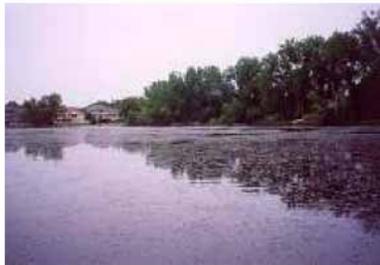
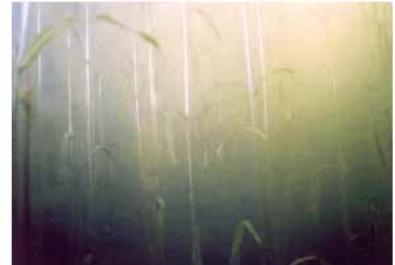
Stem density: 100 - 280 stems/m<sup>2</sup>  
Biomass: 50 - 85 g-dry wt/m<sup>2</sup>  
Estimated TP loading: 2.2 - 3.8 lbs/ac

*MnDNR rake sample density equivalent for moderate growth conditions: 2, 3 or sometimes, 4.*

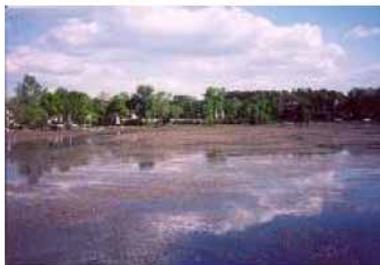
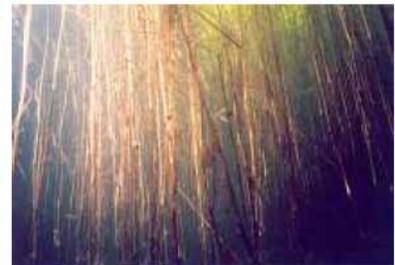
Stem density: 400+ stems/m<sup>2</sup>  
Biomass: >300 g-dry wt/m<sup>2</sup>  
Estimated TP loading: >6.7 lbs/ac

*MnDNR rake sample density has a scale from 1 to 4. For certain growth conditions where plants top out at the surface, the scale has been extended: 4.5 is equivalent to a near solid surface canopy and a 5 is equivalent to a solid surface canopy. Heavy growth conditions have rake densities of a 4 (early to mid-season with the potential to reach the surface), 4.5, or 5.*

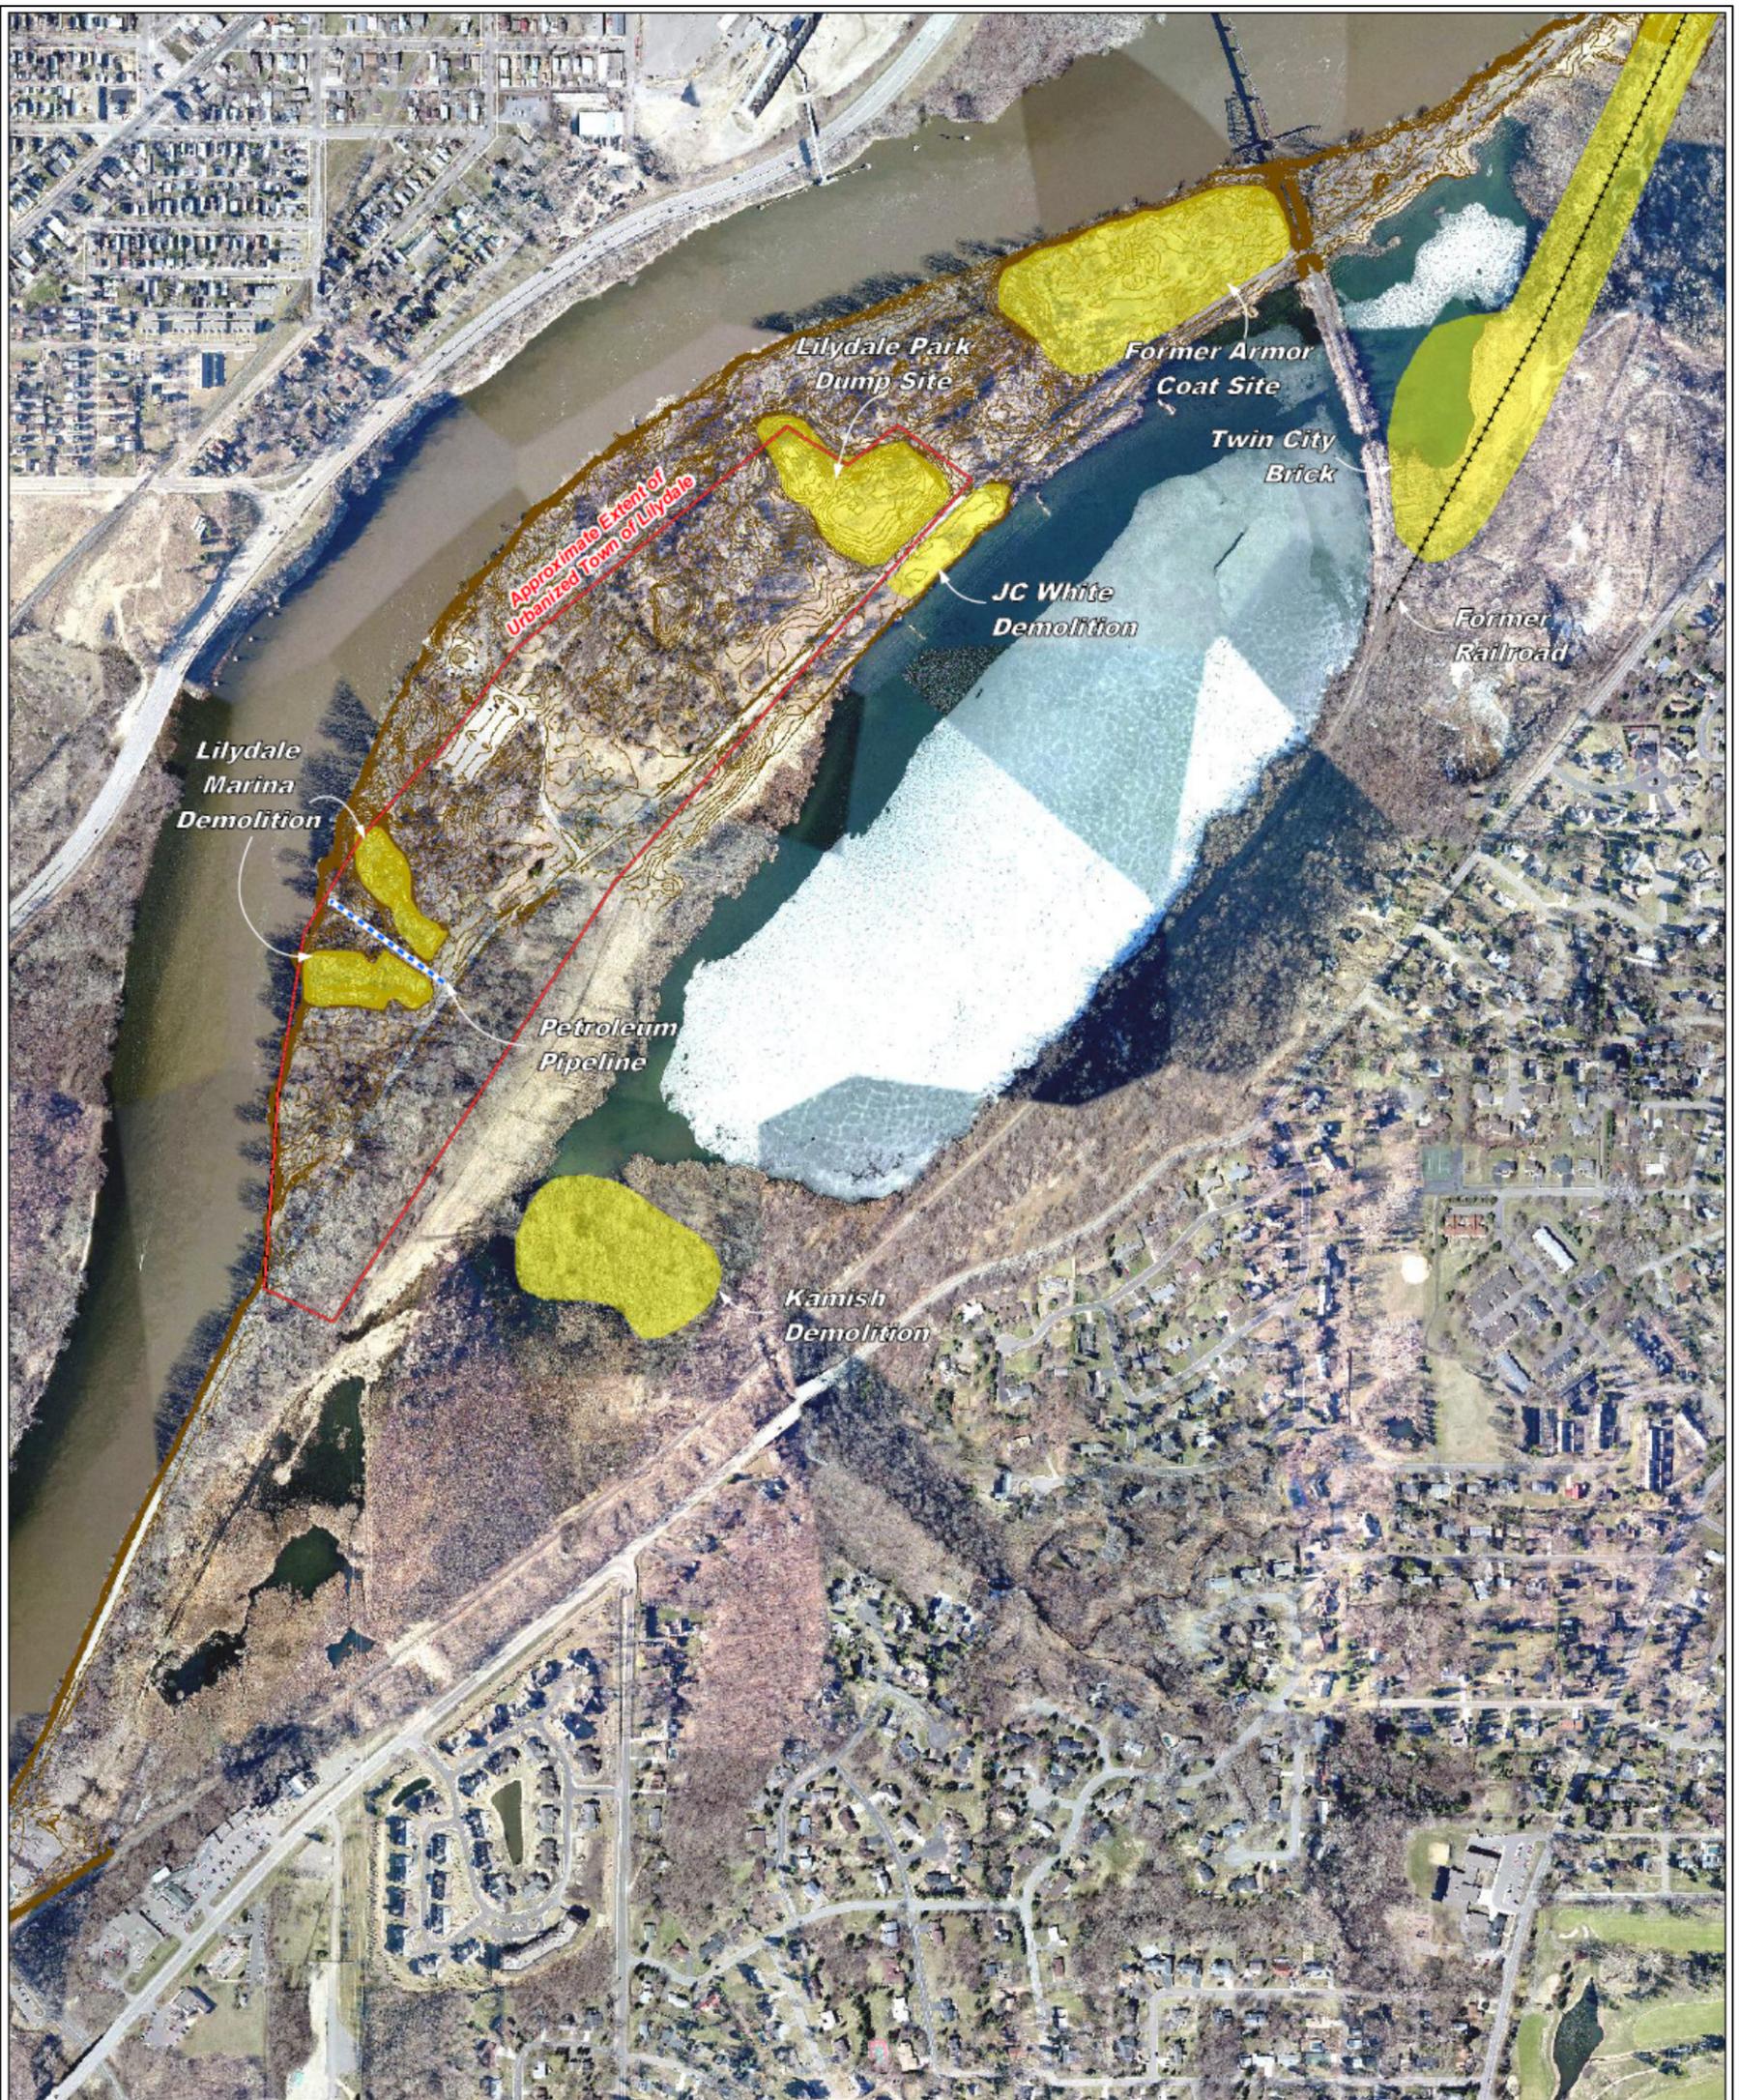
2008 Dakota County Aerial

The Kamish Demolition site can be clearly seen in the oblique aerial photograph provided by the City. Comparing the size of the fill area apparent in this photo with the other aerial photographs, it is likely that the photo provided by the City was taken between 1970 and 1974. The top of the landfill appears smooth and even at this time. What appears to be a job trailer can be seen parked along the north side of the landfill and the photo gives every appearance that the site was being operated as a commercial demolition landfill at the time.

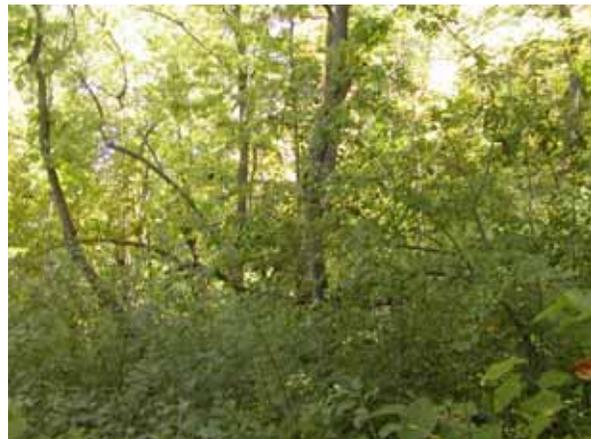
*European buckthorn occurs in relatively thick patches in some areas and should be managed to improve the quality of the hardwood forests on the bluff at LRP*

When cutting invasive deciduous trees and shrubs, it is important to treat cut stumps within 1 hour of cutting with an appropriate herbicide to minimize the chances for resprouting. For instance, a 25-50% solution of a glyphosate or picloram (Roundup or Garlon) herbicide applied to the outer edge of the flat cut surface works well. Treating cut stumps by using a spray bottle allows for treating only the edge of the stump with minimal risk of damaging any adjacent desirable plants. Treating the stumps with a herbicide is important because it minimizes resprouting. Stump resprouts create the arduous task of (re)cutting many stems where one previously existed. Resprouting can also increase the amount of shade at the ground level compared to before cutting, further hindering the improvement of the ground layer. When applying herbicides following the manufacturer's safety recommendations is critical, including the use of appropriate protective equipment such as chemical resistant gloves and eye protection.

We recommend that invasive species cutting occur between late fall and spring and that cut stems be allowed to fall in place. This method tends to limit deer movement in the forest and thereby reduces herbivory of native grasses and flowers. This gives any seeded/restored native plants a chance to establish before being subjected to pressure by deer. It has been our experience that even in areas of thick buckthorn, the cut and dropped stems of even large buckthorn will decay two to four years time. As mentioned previously, this approach also prevents the significant expense of labor to pile and burn cut material.

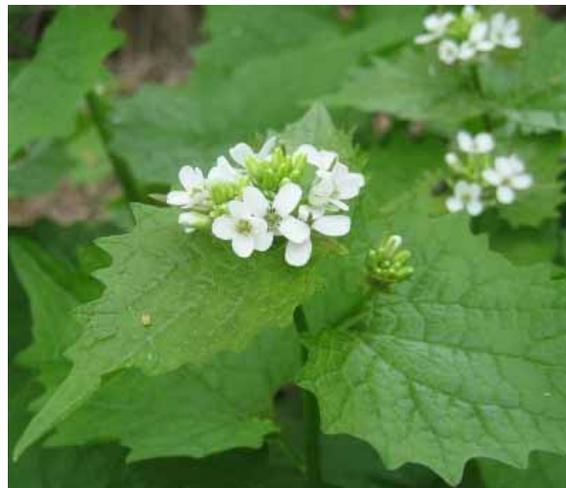
*Garlic mustard is an aggressive nonnative plant that can dominate forest ground layers and displace native species.*

The nonnative garlic mustard is highly invasive in woodland and forest settings, and is common in some areas along the bluff. Management of this biennial weed should be viewed as a long-term activity which has been approached up to this point by restorationists primarily through repeated, well-timed herbicide applications. This is a labor intensive process usually conducted in fall and early spring using a low concentration (1-3%) of a broadleaf or non-specific contact herbicide such as glyphosate (Roundup). Fall and early spring work well because most native plants of value are dormant during this period and herbicide application as described above will not impact them.

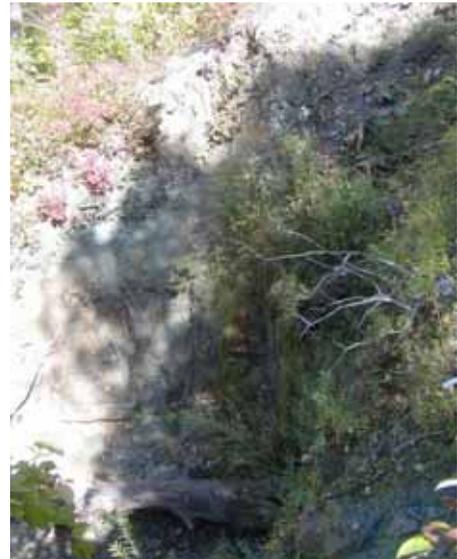
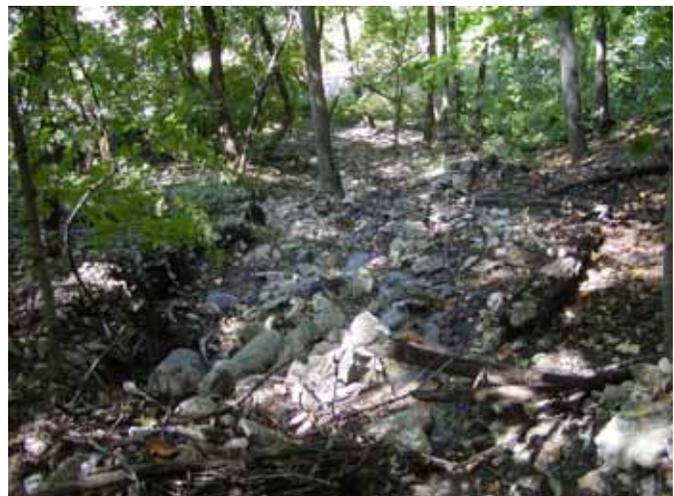
*Ravine erosion is severe in select locations along the bluff overlooking Pickerel Lake*

*This photo (right) shows the lower portion of one of the eroding ravines with substantial deposition of sediment and cobbles, burying the base of the trees in the upper middle portion of the picture. This sedimentation is also threatening the railroad grade (slightly visible through the trees at the top of the photo).*

To better understand the extent of ravine erosion on this bluff and former clay pits, a more detailed field review should be conducted that specifically inventories the location and severity of erosion features, as well as identify significant contributions, if any, by stormwater sources or individual site drainage from roof tops and yards located near the top of the bluff or adjacent to clay pits.

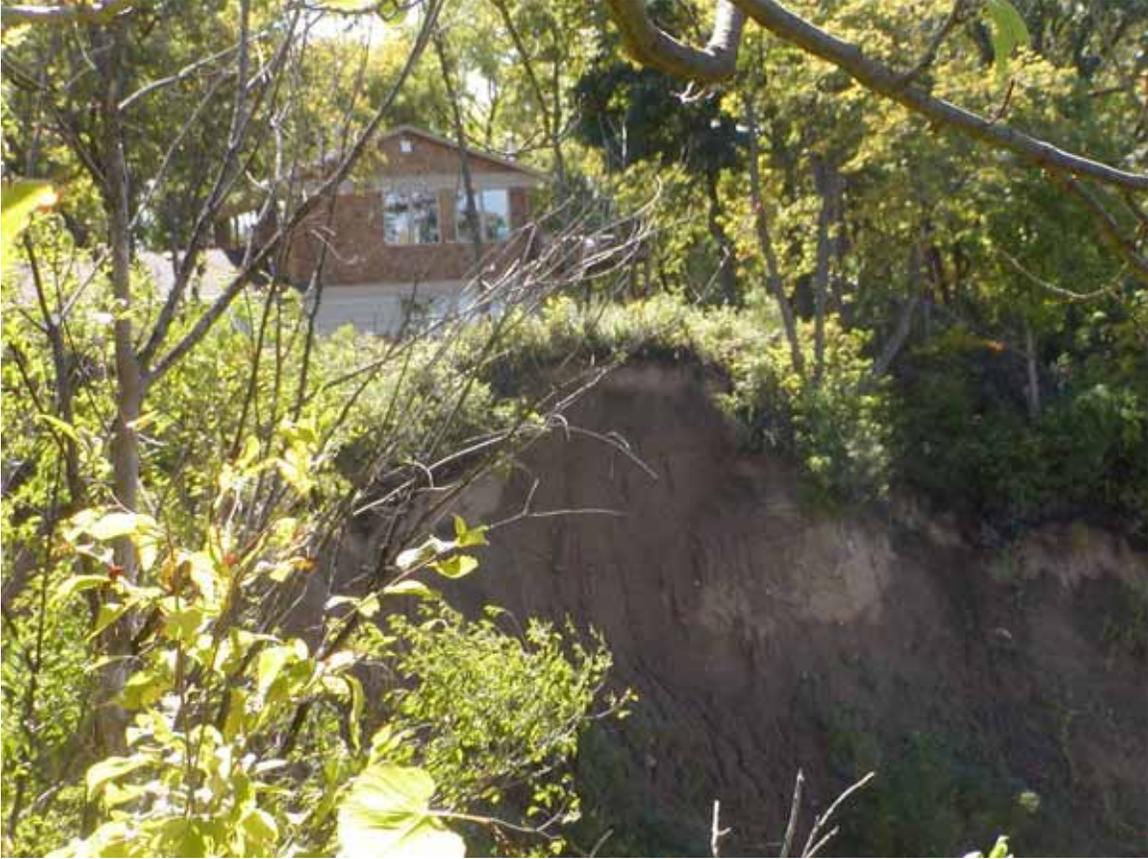
*The sheer face of this former clay pit wall occurs in close proximity to a residential home.*

Similarly, erosion along the walls of former clay pits should be evaluated and prioritized for stabilization. In particular, there is one sheer slope that is close to a residential home.

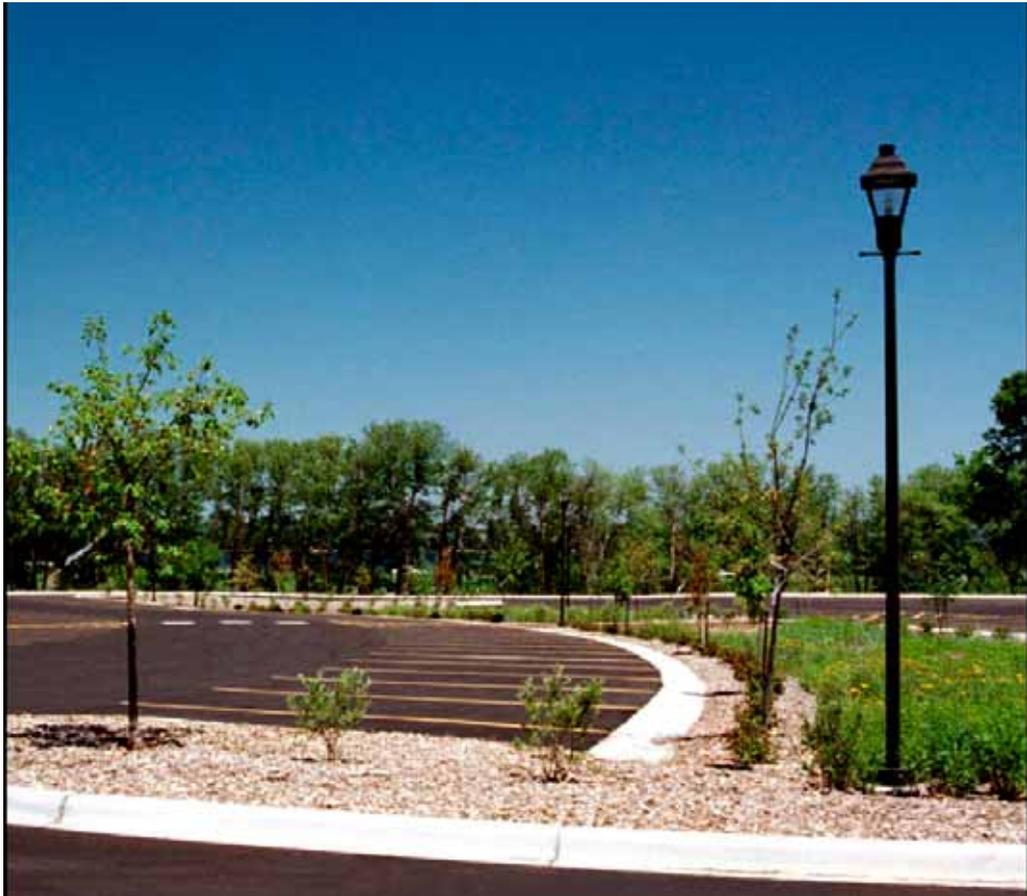
*Rain gardens, such as this one at the University of Minnesota Landscape Arboretum offer opportunities to capture and treat stormwater runoff before it reaches surface waters such as lakes and rivers.*

One way to accomplish this is to use rainwater gardens, porous asphalt, pervious pavement systems or other infiltration features in suitable locations to catch and hold runoff, then let it seep into the ground, just like in a natural system. Once in the ground, the water is filtered through the soil and sub-soil system before it reaches either groundwater or the lake. If rainwater gardens are used, the gardens can be planted with aesthetically pleasing grasses and flowering plants that add beauty to otherwise intensively used areas. It is important that the soils at the location of each infiltration feature be tested prior to design to confirm suitability. If soils are too tight to allow adequate infiltration, native soils can be replaced with engineered soils and an under-drain to provide filtration treatment of stormwater.

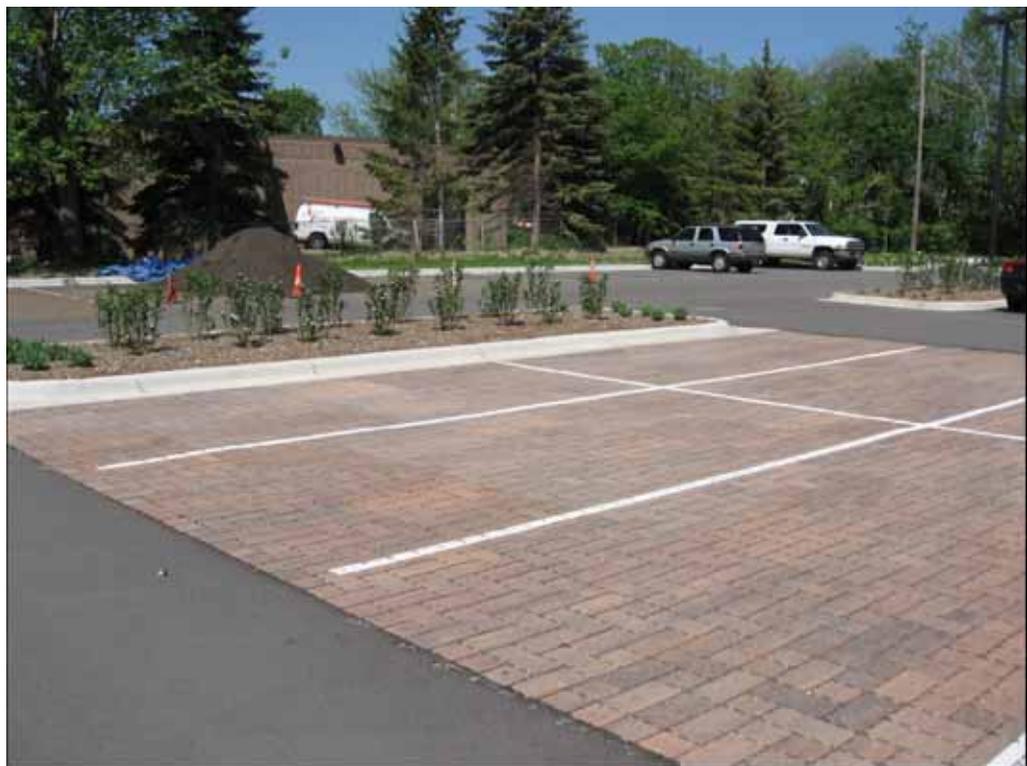
*Infiltration features also serve as important opportunities to capture and treat runoff. In this case, permeable pavers also contribute to the aesthetic appeal (Bonestroo headquarters parking lot).*

Infiltration features are best designed to treat runoff resulting from small frequent storm events. For example, capture and infiltration of just ½" of runoff depth from a parking lot will be sufficient to reduce average annual runoff volume and phosphorus loading by about 65% from the watershed area served. On average, though, a few events each year will generate more runoff than this, and overflow options need to be installed to safely convey large flows from infrequent, large runoff events to the eventual receiving waters.
