SAINT PAUL
MINNESOTA

2020 STORMWATER QUALITY AND QUANTITY MONITORING PROGRAM

CITY OF ST. PAUL

MARCH 30, 2020

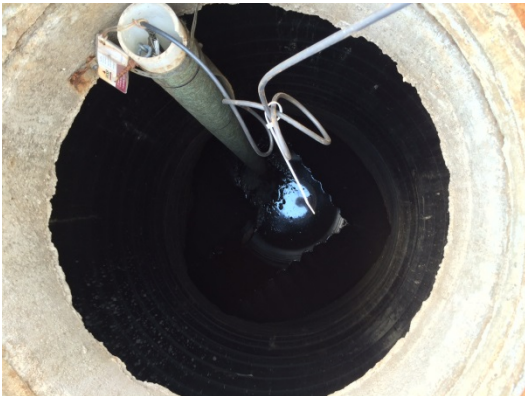
Enclosures for the infiltration gallery level loggers were installed at Beacon Bluff, St. Albans Street, and Hampden Park. These consisted of three-inch-diameter PVC pipes with four rows of half-inch-diameter holes drilled along the pipe achieving approximately twenty holes per foot. The enclosures were then wrapped with a highly permeable geotextile fabric and secured with zip ties to protect the instrument from fine sediment accumulation. Enclosures were secured to the system floor and to the access riser wall (**Photo 2-1**). Groundwater and rain garden locations were monitored from permanent monitoring wells (**Photo 2-2**).

Photo 2-1:
Infiltration Gallery Level Monitoring
Enclosure

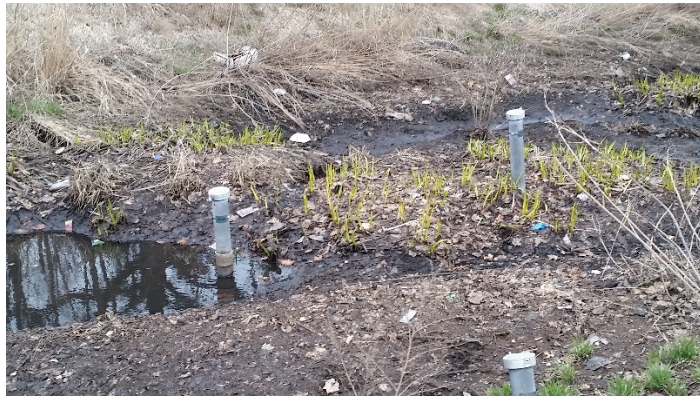
Photo 2-2:
Beacon Bluff Rain Garden and In-Rock Wells

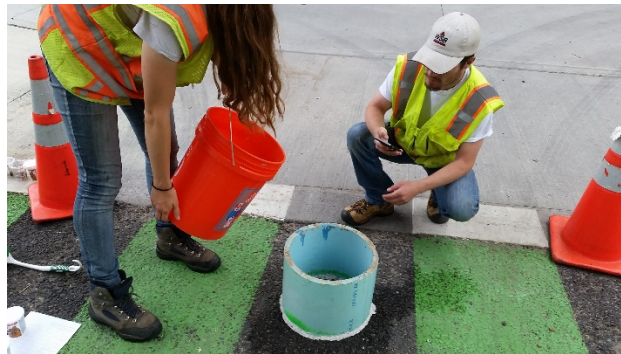
Infiltration tests were conducted according to the modified ASTM C1701 methods for measuring infiltration rates (**Photo 2-7**). Five locations at Victoria Street, 18 locations at Jackson Street, and nine locations at Hamline Midway Library were evaluated to develop an average infiltration rate measurement for each site. Tests were taken at locations that remained consistent year to year and included a combination of high and low traffic areas. At each test location, a pre-wet test was conducted, followed by two infiltration tests. The two infiltration tests were averaged to generate the infiltration rate for each location. If after 15 minutes of monitoring during a pre-wet test no infiltration was observed, the test was concluded, and no subsequent tests were completed.

Photo 2-7: Permeable Pavement Infiltration Test

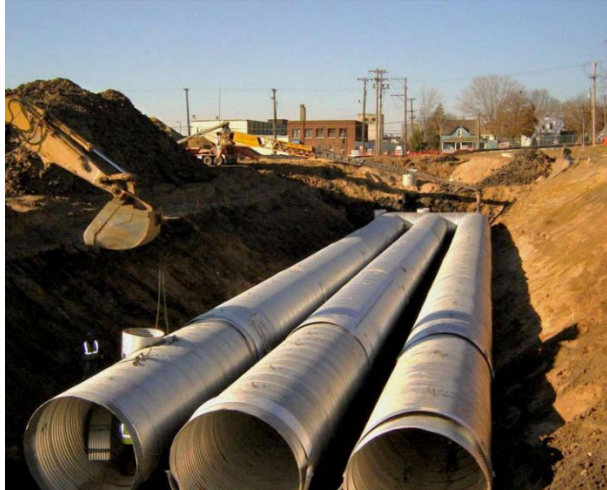
The system is comprised of three connected stormwater treatment structures, which include a stormwater pond west of the Duchess Street cul-de-sac (west pond), an infiltration basin east of the cul-de-sac (rain garden) (**Photo 4-1**), and an underground infiltration chamber (**Photo 4-2**) constructed directly beneath the rain garden. The underground chamber consists of three, parallel, 215-foot-long, ten-foot-diameter perforated metal pipes for infiltration.

Photo 4-1: Underground Infiltration Chamber (Facing West)

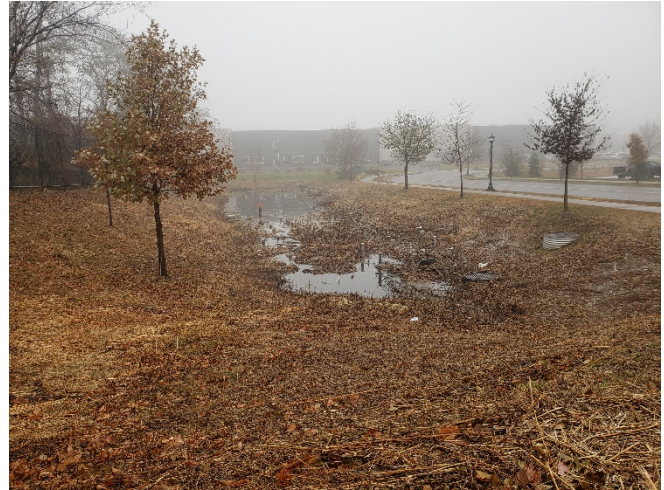
Photo 4-2: Rain Garden Located above Infiltration Chambers (Facing East)

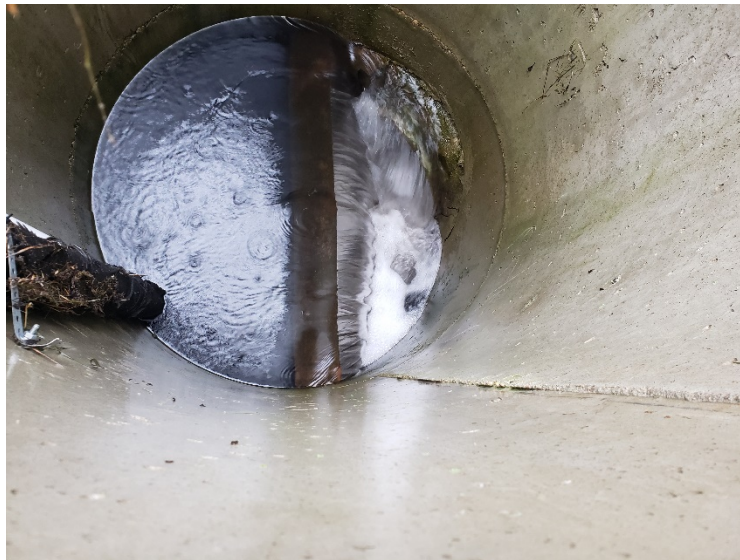
Photo 4-3: Water being conveyed back to the storm sewer from the underground chamber in the outlet control structure.

Overflow in the outlet control structure to the storm sewer, (**Photo 4-3**), occurred during eight treatment events. The 2020 rain garden infiltration rate and infiltration rate trends are provided on **Charts A.3** and **A.5** of **Appendix A**, respectively. The 2020 average infiltration rate for the BMP Pipe was 0.12 inches per hour (in/hr), which is less than the Minnesota Stormwater Manual (MSWM) recommended infiltration rate for SP (poorly graded sand) soils of 0.80 in/hr. This is the same as the rates observed in 2019 (0.12 in/hr) and 2018 (0.12 in/hr) (**Table 4-2**). Sediment accumulation has been observed ranging from 0.5 ft to 1.5 ft of depth, across the basin. The 141.5-acre drainage area discharging directly to the pond conveys a significant amount of sediment and debris, which has accumulated primarily around the diversion inlet pipe. Dredge maintenance was completed on the rain garden over the Spring of 2019.

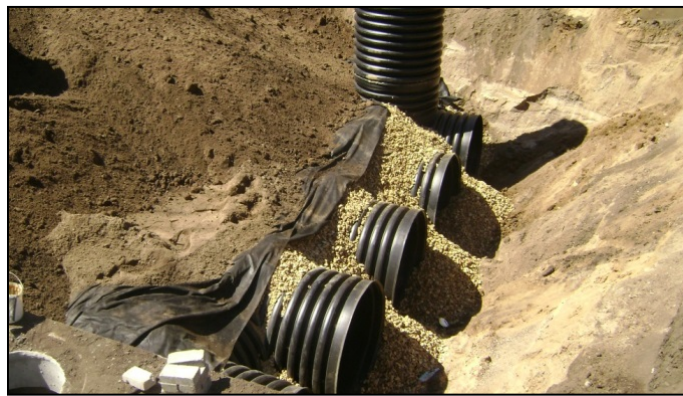
A manhole structure positioned along the main storm sewer under Aurora Avenue diverts stormwater into the underground infiltration system (**Photo 5-1**) via a 30-inch elliptical pipe. The system is also connected to the University Avenue storm sewer system. Any runoff that does not get treated by infiltration trenches and tree planters along University Avenue is directed to this system (**Photo 5-1**). When the system reaches its storage capacity, water flows west through the existing storm sewer system. The system includes a pretreatment structure comprised of a grit chamber and baffled weir to provide settling for sediment and skimming. Rainfall monitoring for the site is conducted on the roof of Fire Station 18, located across the street from the BMP. The BMP system details are provided in **Table 5-1**.

Photo 5-1: St. Albans 48" Perforated HDPE Installation

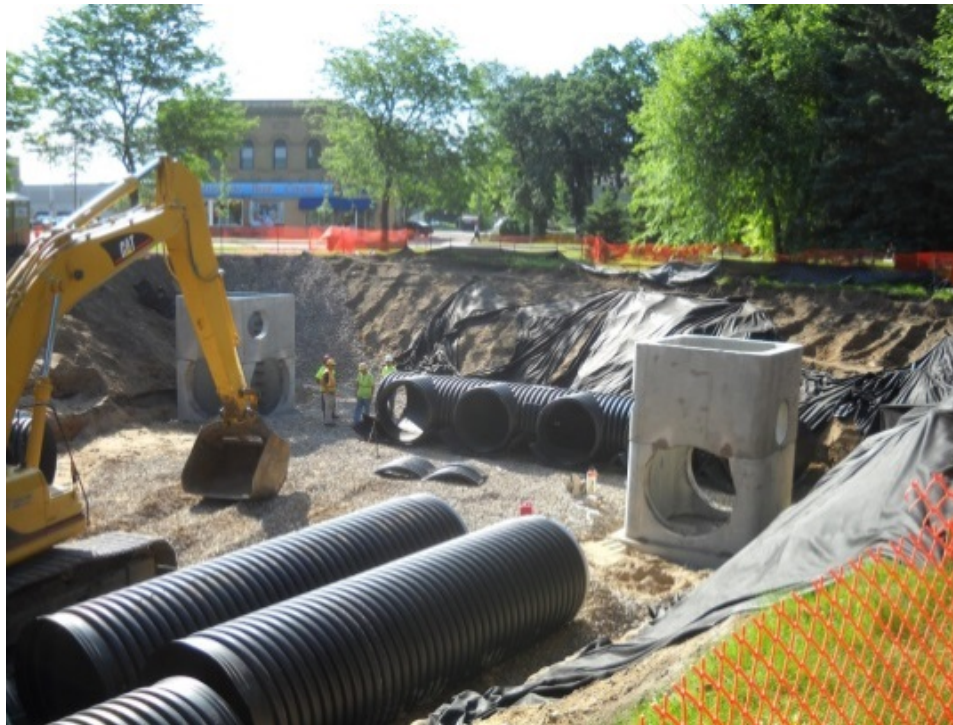
The Hampden Park infiltration gallery, shown in **Figure 6-1**, was constructed in 2014. The system consists of eight parallel perforated pipes that are 5 ft in diameter, and range in length from 40 to 100 ft. Runoff is routed to the system via a 24-inch RCP from the storm sewer line near Hampden and Raymond Avenues. Prior to entering the infiltration gallery, stormwater passes through a Vortechs pre-treatment chamber for particle settling. The infiltration gallery receives flow from a second inlet location along Hampden Avenue, farther to the north. When the system reaches full capacity, stormwater is routed back to the storm sewer via a 24-inch pipe from the southeast side of the system. Rainfall monitoring is conducted on top of the Hampden Park Co-Op across the street from the park. Monitoring has been conducted at the site since 2014. The BMP system details are provided in **Table 6-1** below.

Photo 6-1: Hampden Park BMP Construction

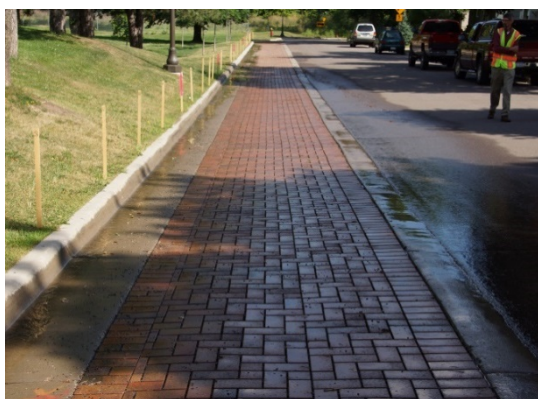
The Victoria Street pervious surface consists of a parking area completed with permeable concrete pavers designed to receive stormwater runoff from Victoria Street and the properties adjacent to it. The pavers themselves are non-permeable and they are separated with aggregate fill (**Photo 11-1** and **11-2**). The spaces between the pavers allow stormwater runoff to infiltrate into the parking surface instead of running off and being collected by the storm sewer system. The pavers were installed in 2011 and infiltration rates have been monitored annually since 2012. The site and the infiltration test locations are provided on **Figure 11-1**.

Photo 11-1: Victoria Street Pavers

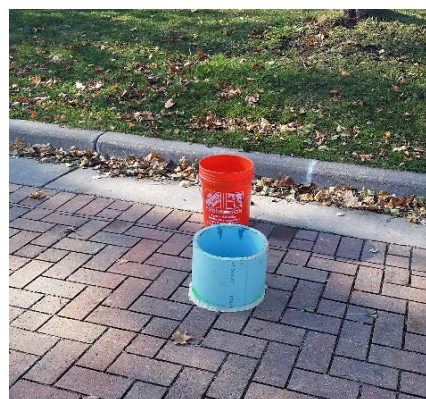
Photo 11-2: Victoria Street Infiltration Testing

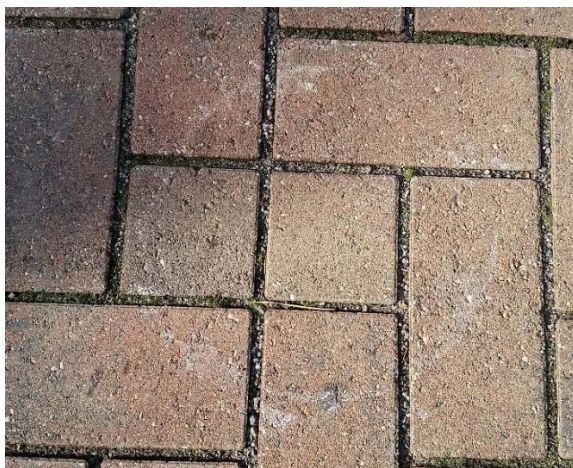
**Photo 11-3: Location D Pre-Test**

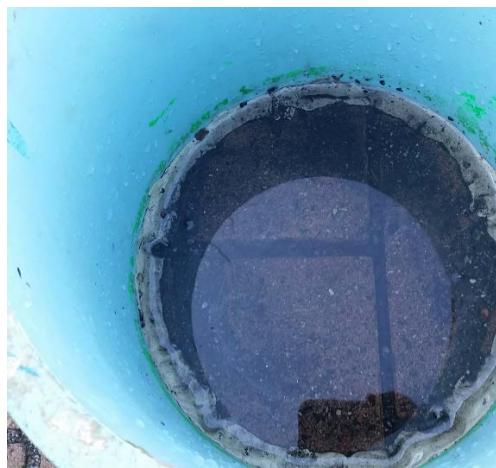
- In 2020 (5.84 in/hr) compared to 2019 (6.51 in/hr) and 2018 (10.21 in/hr).
- The 2020 (5.84 in/hr) infiltration rates were, on average, less than 4 percent of 2012 (185.04 in/hr) infiltration rates.
- Infiltration rates have been decreasing the last 2 years and 2020 (5.84 in/hr) infiltration rates were, on average, 57 percent of 2018 (10.21 in/hr) infiltration rates.
- Infiltration rates at Locations A, B, and D were greater in 2020, compared to 2019, while infiltration rates at Locations E and C were less in 2020 than 2019.

**Photo 11-4: Location D Infiltration Test**

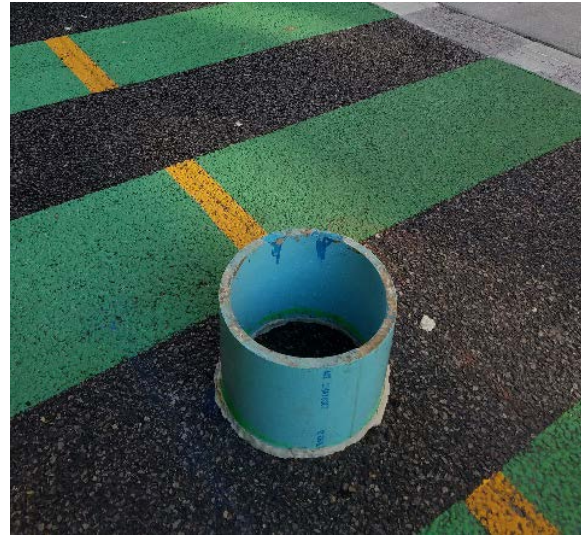
Photo 11-6: Jackson Street Infiltration Test

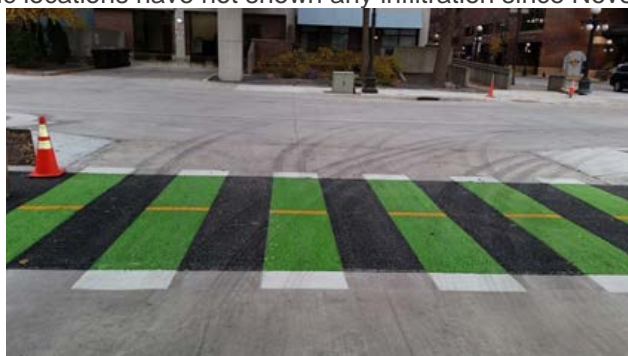
- High traffic areas had an average infiltration rate of 0.0 in/hr in 2020 testing events.
 - No infiltration was observed at all five high traffic monitoring locations in July and October 2020.

- High traffic locations have not shown any infiltration since November 2017.

**Photo 11-7: Test Locations JS-1 and JS-2 (high traffic)**

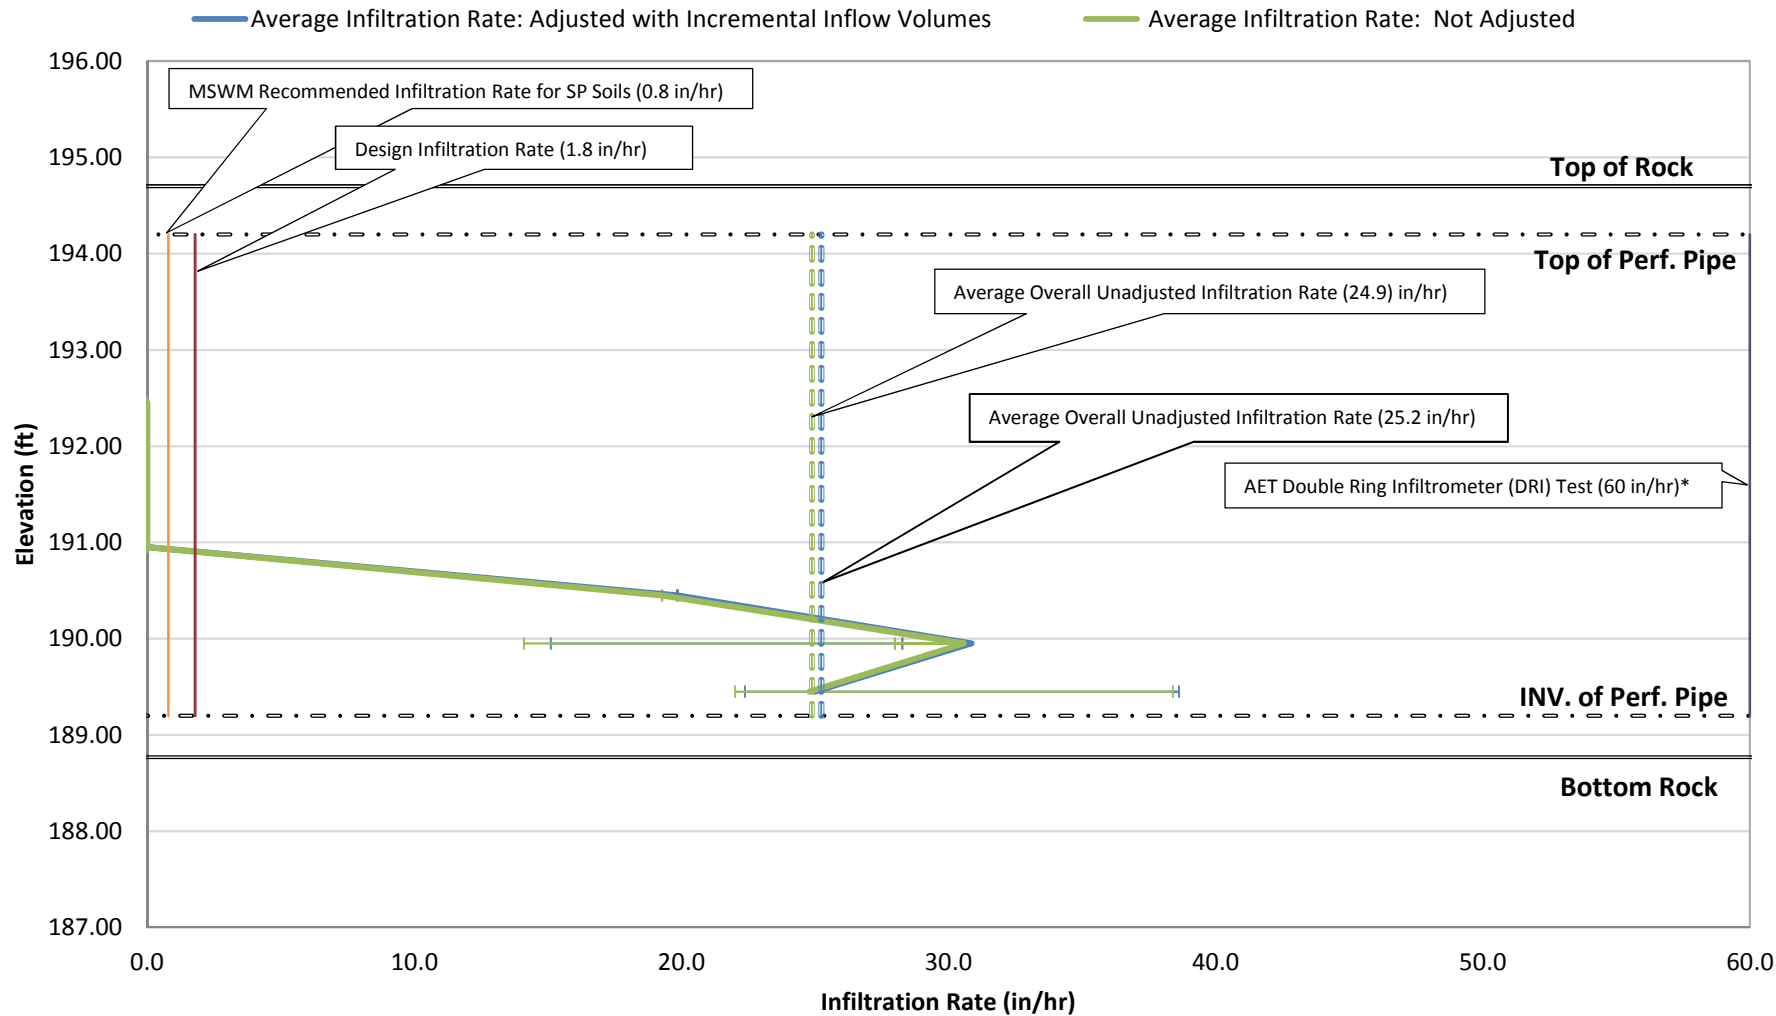
Hampden Park - Infiltration Rate Graph
 (Observed 0.5 Foot Height Increments)

Note: Pipe Invert is 189.2'
 Error Bars Represent 25th and 75th Percentiles
 * The DRI testing was completed on top of a 5 ft layer of fine filter aggregate that was constructed above the native soils, per the design.

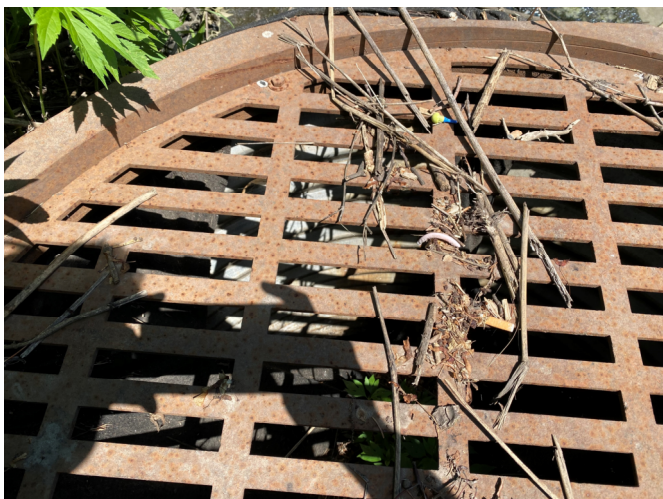
Damage to rain garden overflow at
Beacon Bluff – 6/12/20
