## CORRIDORTREES

## Evaluating Impacts

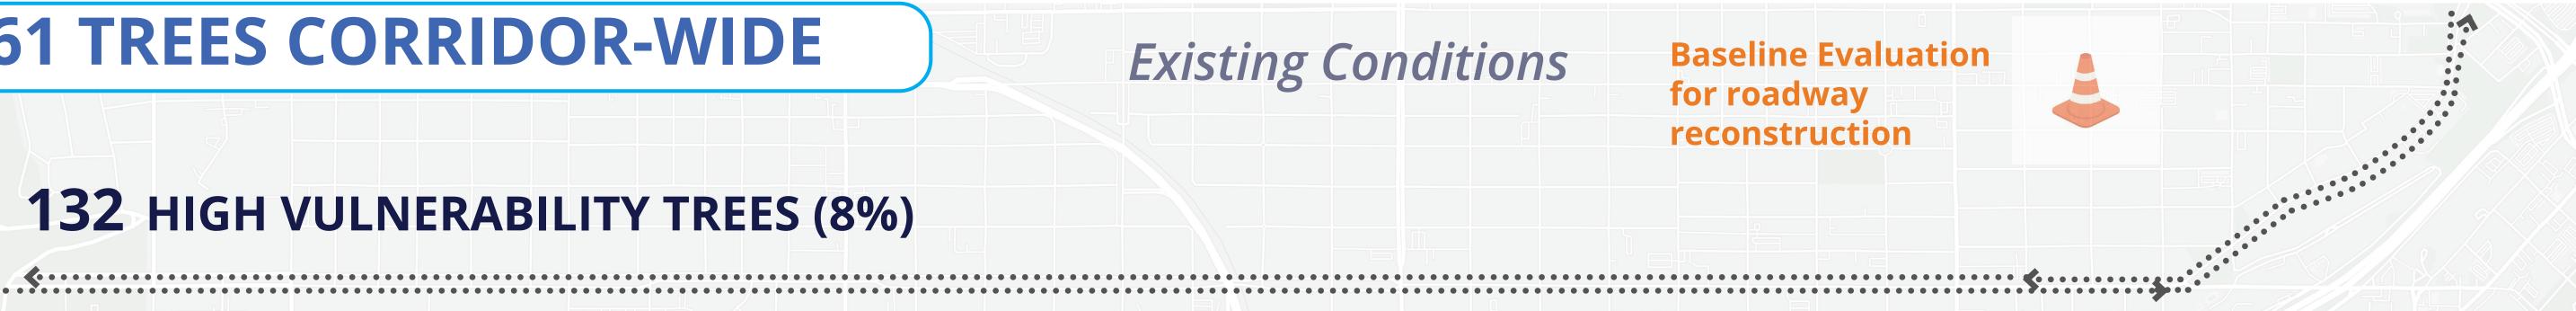
**Baseline Evaluation** for roadway reconstruction

## 1,561 TREES CORRIDOR-WIDE

**Existing Conditions**
