2022 STORMWATER QUALITY AND QUANTITY MONITORING PROGRAM

CITY OF ST. PAUL

MARCH 31, 2022

WSB PROJECT NO. 020260

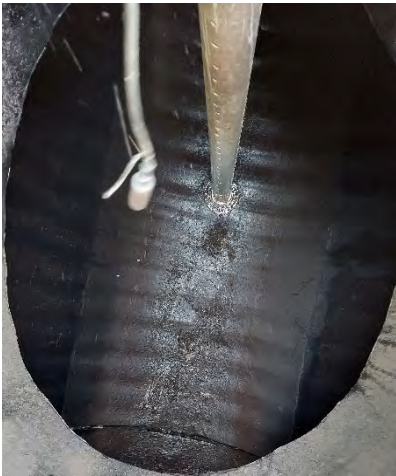
Photo 2-1:
Infiltration Gallery Level Monitoring Enclosure

Enclosures for the infiltration gallery level loggers were installed at Beacon Bluff, St. Albans Street, and Hampden Park. These consisted of three-inch-diameter PVC pipes with four rows of half-inch-diameter holes drilled along the pipe achieving approximately twenty holes per foot. The enclosures were then wrapped with a highly permeable geotextile fabric and secured with zip ties to protect the instrument from fine sediment accumulation. Enclosures were secured to the system floor and to the access riser wall (**Photo 2-1**). Groundwater and rain garden locations were monitored from permanent monitoring wells (**Photo 2-2**).

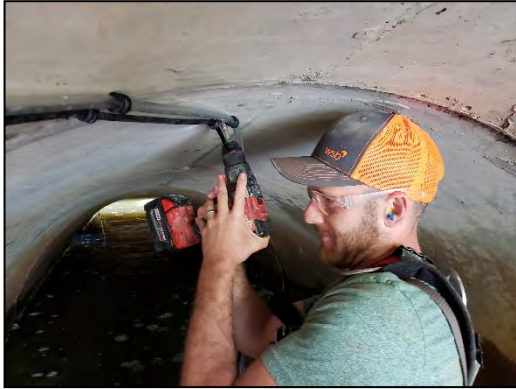
Photo 2-3: Flow Monitoring Module Install Process

Teledyne ISCO 2150 area velocity flow modules and sensors were used to monitor runoff volumes. These devices measure water level and flow velocity. Combining this information with a known conduit shape, the flow rate, and flow volume through the conduit were calculated. Each of the monitored systems received stormwater runoff from a diversion structure located along the storm sewer system. The 2150 flow sensors were positioned at the upstream and downstream pipes in these structures to measure the total volume draining to each BMP and the total volume that bypassed each BMP. **Photos 2-3** and **2-4** show the flow meters installation in Battle Creek and Victoria Street, respectively.

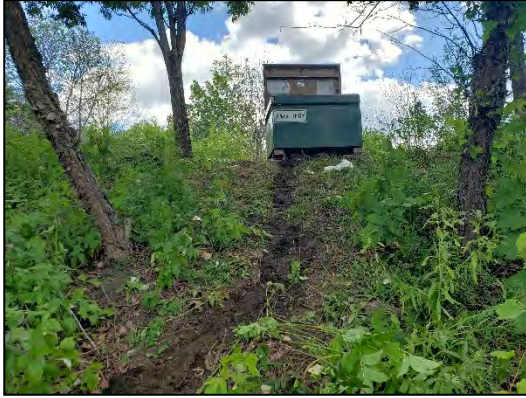
Photo 2-5:
Job Box Housing ISCO 6712 Sampler

ISCO 6712 automatic samplers were installed at all water quality locations. (**Photos 2-5** and **2-6**).

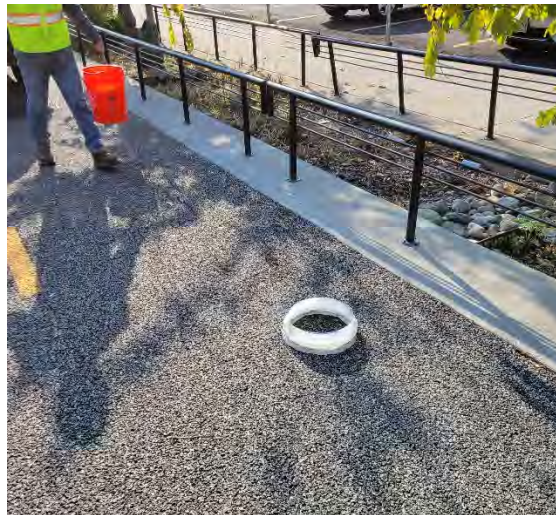
Photo 2-7: Permeable Pavement Infiltration Test

Infiltration tests were conducted according to the modified ASTM C1701 methods for measuring infiltration rates (**Photo 2-7**). Five locations at Victoria Street, 18 locations at Jackson Street, and nine locations at Hamline Midway Library were evaluated to develop an average infiltration rate measurement for each site. Tests were taken at locations that remained consistent year to year and included a combination of high and low traffic areas. At each test location, a pre-wet test was conducted, followed by two infiltration tests. The two infiltration tests were averaged to generate the infiltration rate for each location. If after 15 minutes of monitoring during a pre-wet test no infiltration was observed, the test was concluded, and no subsequent tests were completed.

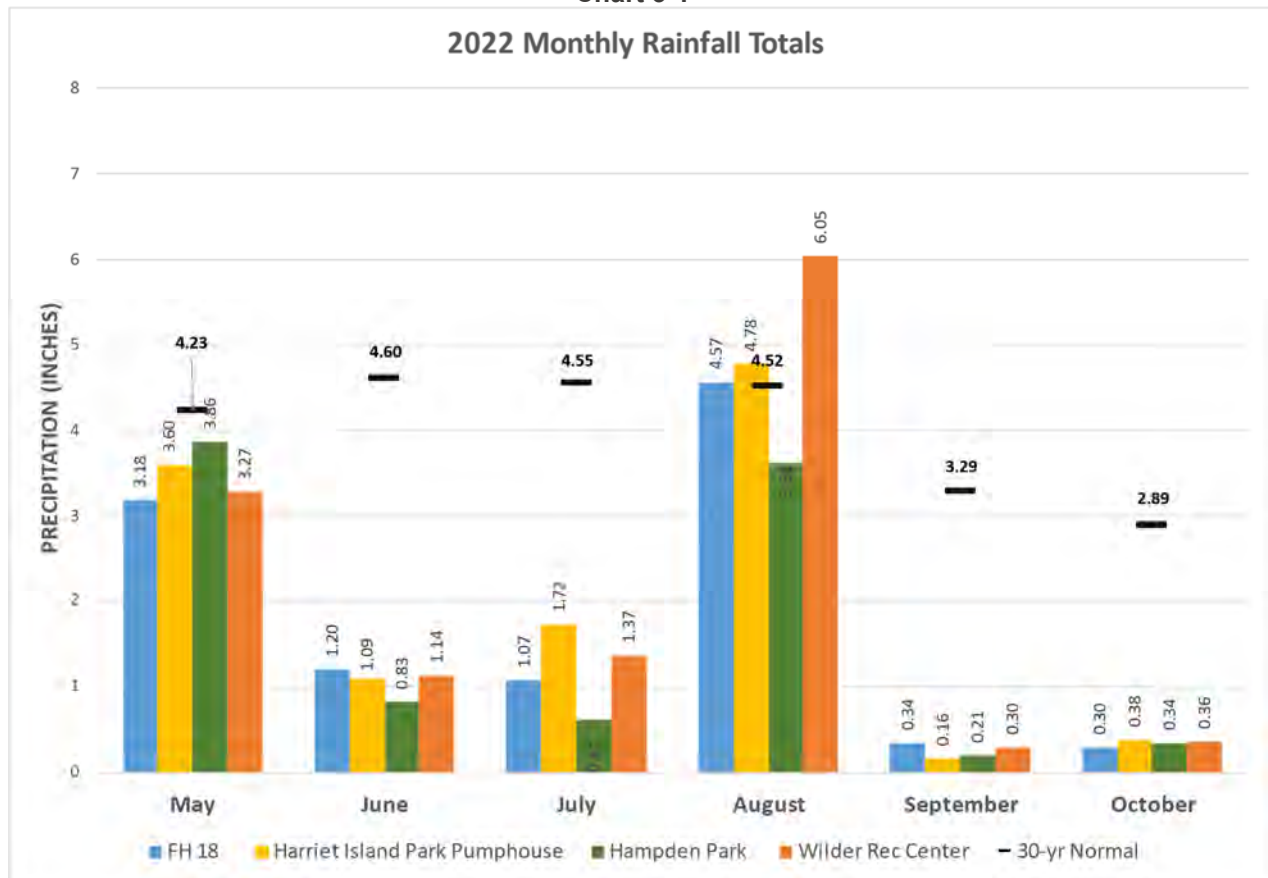
Chart 3-1

May through October rainfall ranged from 12.49 inches at the Wilder Recreation Center to 9.46 inches at Hampden Park Co-op. The City-wide seasonal total average was 11.09 inches which is 12.99 inches less than the 30-year normal. The greatest variability between stations was observed during the month of August with 2.44 inches more rainfall recorded at the Wilder Recreation Center than the Hampden Park Co-op. The month of June saw the greatest departure from the 30-year normal (-3.53 inches).

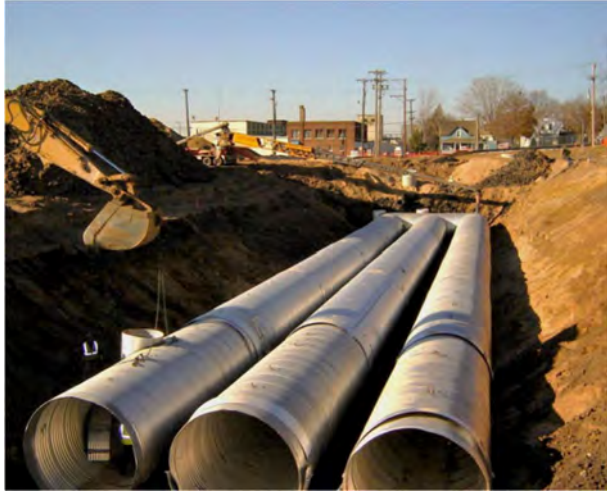
Photo 4-1: Underground Infiltration Chamber (Facing West)

The system is comprised of three connected stormwater treatment structures, which include a stormwater pond west of the Duchess Street cul-de-sac (west pond), an infiltration basin east of the cul-de-sac (rain garden) (**Photo 4-1**), and an underground infiltration chamber (**Photo 4-2**) constructed directly beneath the rain garden. The underground chamber consists of three, parallel, 215-foot-long, ten-foot-diameter perforated metal pipes for infiltration.

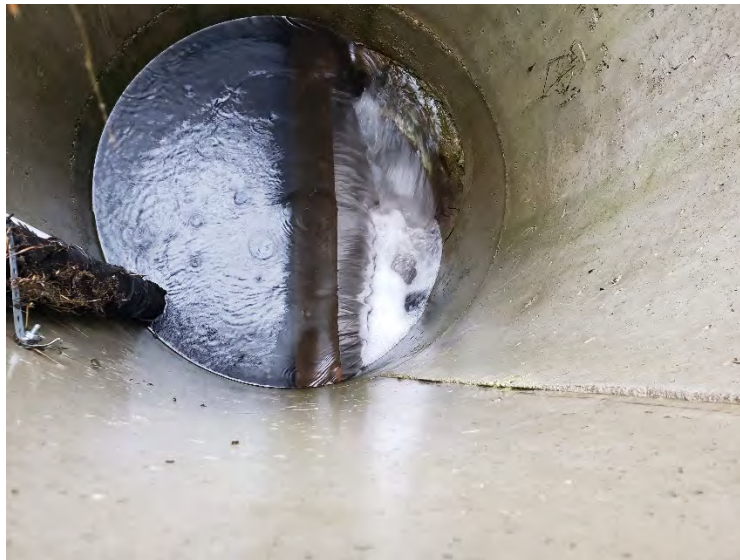
Photo 4-3: Water being conveyed back to the storm sewer from the underground chamber in the outlet control structure.

Overflow in the outlet control structure to the storm sewer, (**Photo 4-3**), occurred during six treatment events. The 2022 underground chamber infiltration rate and infiltration rate trends are provided on **Charts A.3** and **A.4** of **Appendix A**, respectively. The 2022 average infiltration rate for the BMP Pipe was 0.06 inches per hour (in/hr). This is a decrease from the rates observed in 2021 (0.09 in/hr) and 2020 (0.12 in/hr) (**Table 4-2**). Sediment accumulation has been observed ranging from 0.7 ft, across the basin. The 141.5-acre drainage area discharging directly to the pond conveys a significant amount of sediment and debris, which has accumulated primarily around the diversion inlet pipe. Dredge maintenance was completed on the rain garden over the Spring of 2019.

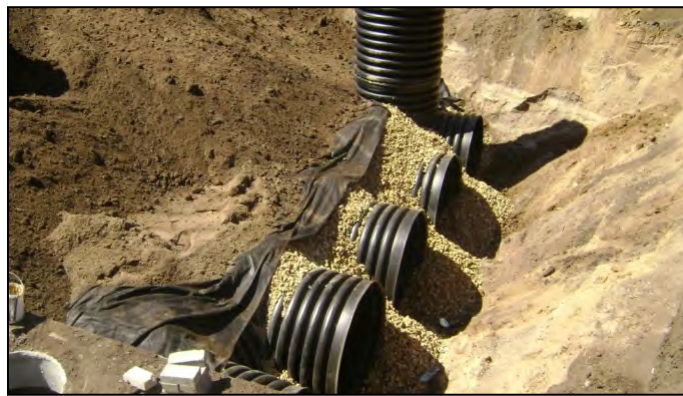
Photo 5-1: St. Albans 48" Perforated HDPE Installation

A manhole structure positioned along the main storm sewer under Aurora Avenue diverts stormwater into the underground infiltration system (**Photo 5-1**) via a 30-inch elliptical pipe. The system is also connected to the University Avenue storm sewer system. Any runoff that does not get treated by infiltration trenches and tree planters along University Avenue is directed to this system (**Photo 5-1**). When the system reaches its storage capacity, water flows west through the existing storm sewer system. The system includes a pretreatment structure comprised of a grit chamber and baffled weir to provide settling for sediment and skimming. Rainfall monitoring for the site is conducted on the roof of Fire Station 18, located across the street from the BMP. The BMP system details are provided in **Table 5-1**.

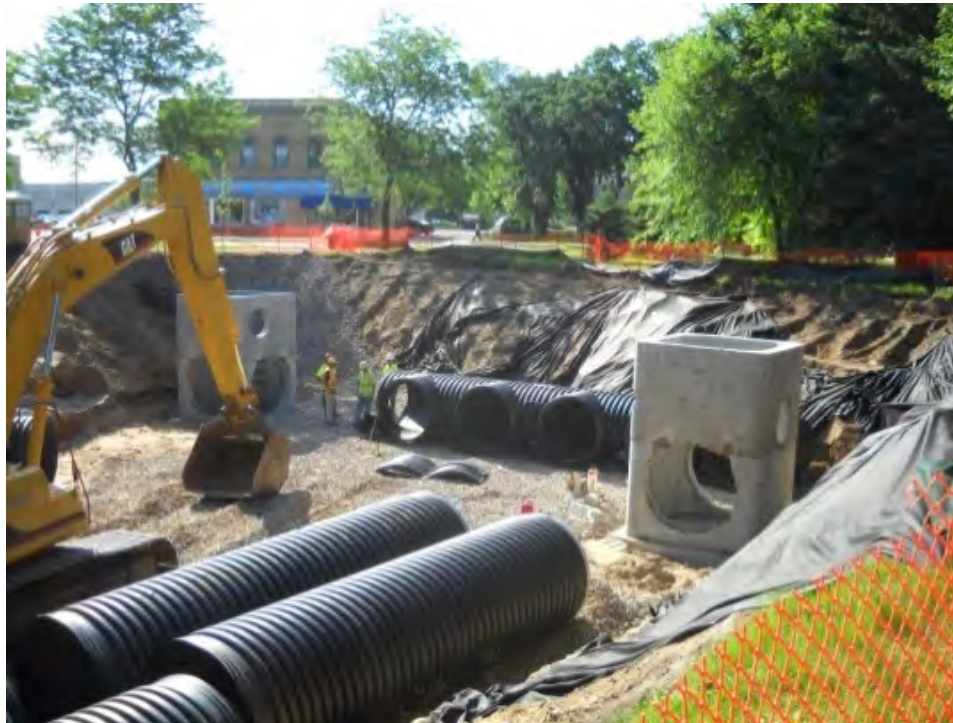
Photo 6-1: Hampden Park BMP Construction

The Hampden Park infiltration gallery, shown in **Figure 6-1**, was constructed in 2014. The system consists of eight parallel perforated pipes that are 5 ft in diameter, and range in length from 40 to 100 ft. Runoff is routed to the system via a 24-inch RCP from the storm sewer line near Hampden and Raymond Avenues. Prior to entering the infiltration gallery, stormwater passes through a Vortechs pre-treatment chamber for particle settling. The infiltration gallery receives flow from a second inlet location along Hampden Avenue, farther to the north. When the system reaches full capacity, stormwater is routed back to the storm sewer via a 24-inch pipe from the southeast side of the system. Rainfall monitoring is conducted on top of the Hampden Park Co-Op across the street from the park. Monitoring has been conducted at the site since 2014. The BMP system details are provided in **Table 6-1** below.

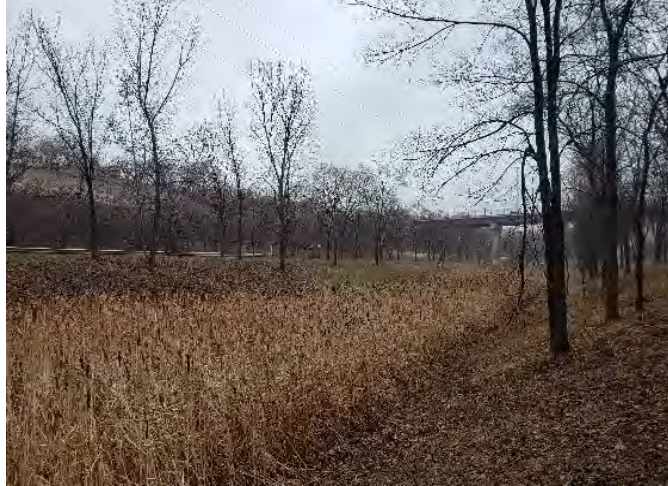
Photo 8.1-1: West Shepard Pond

The Shepard Road Ponds monitoring location is the median of Shepard Road, just under the Smith Avenue Bridge. Monitoring here provides water quality and quantity data of water flowing from the east and west along Shepard Road. Monitoring at this site was initiated in 2022.

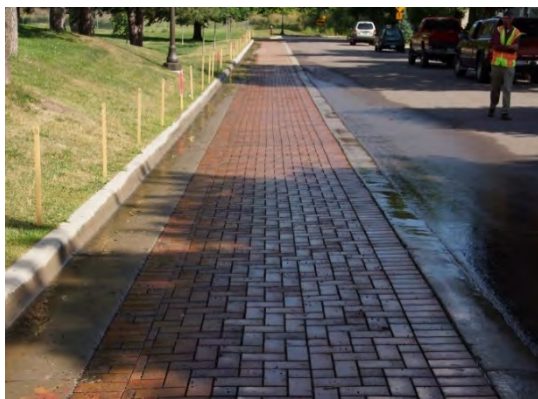
Photo 11-1: Victoria Street Pavers

The Victoria Street pervious surface consists of a parking area completed with permeable concrete pavers designed to receive stormwater runoff from Victoria Street and the properties adjacent to it. The pavers themselves are non-permeable and they are separated with aggregate fill (**Photo 11-1** and **11-2**). The spaces between the pavers allow stormwater runoff to infiltrate into the parking surface instead of running off and being collected by the storm sewer system. The pavers were installed in 2011 and infiltration rates have been monitored annually since 2012. The site and the infiltration test locations are provided on **Figure 11-1**.

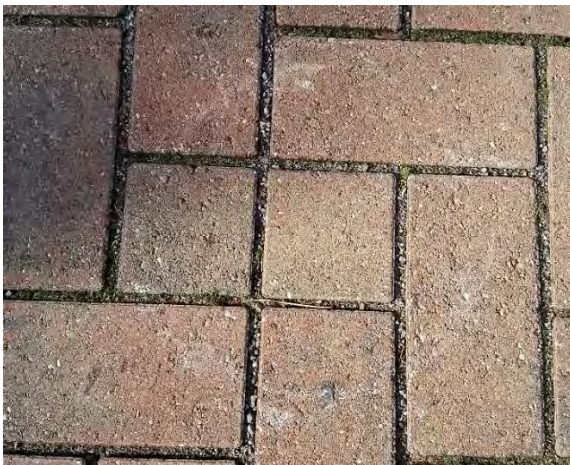
Photo 11-3: Location D Pre-Test

- In 2022 (8.04 in/hr) compared to 2021 (9.91 in/hr) and 2020 (5.84 in/hr).
- The 2022 infiltration rates were, on average, less than 5 percent of 2012 (185.04 in/hr) infiltration rates.
- Infiltration rates have been between 5 and 10 in/hr for the last six years.
- Location C had no infiltration in 2021 but infiltrated at 9.5 in/hr in 2022.

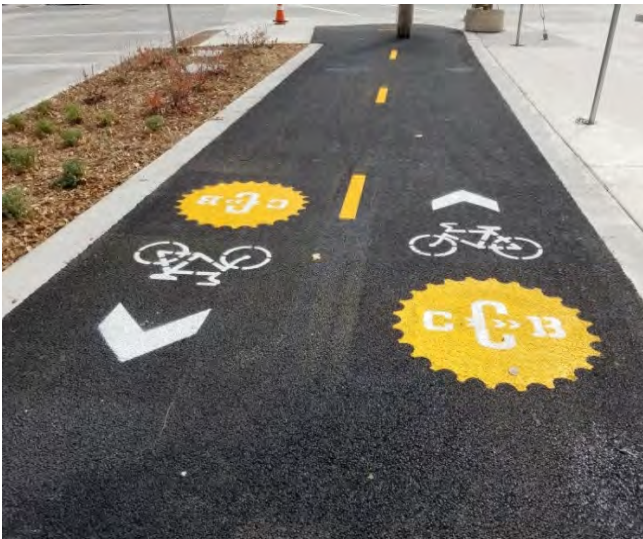
Photo 11-5: Capital City Bikeway (CCB) – Jackson Street/Kellogg Avenue

The Jackson Street BMP (**Photo 11-5** and **11-6**) is a designated bike path constructed of pervious asphalt. It is a section of the Capital City Bikeway (CCB), a system of off-street bicycle trails in downtown Saint Paul. The BMP is eight blocks long, stretching from Kellogg Street to 11th Street, and

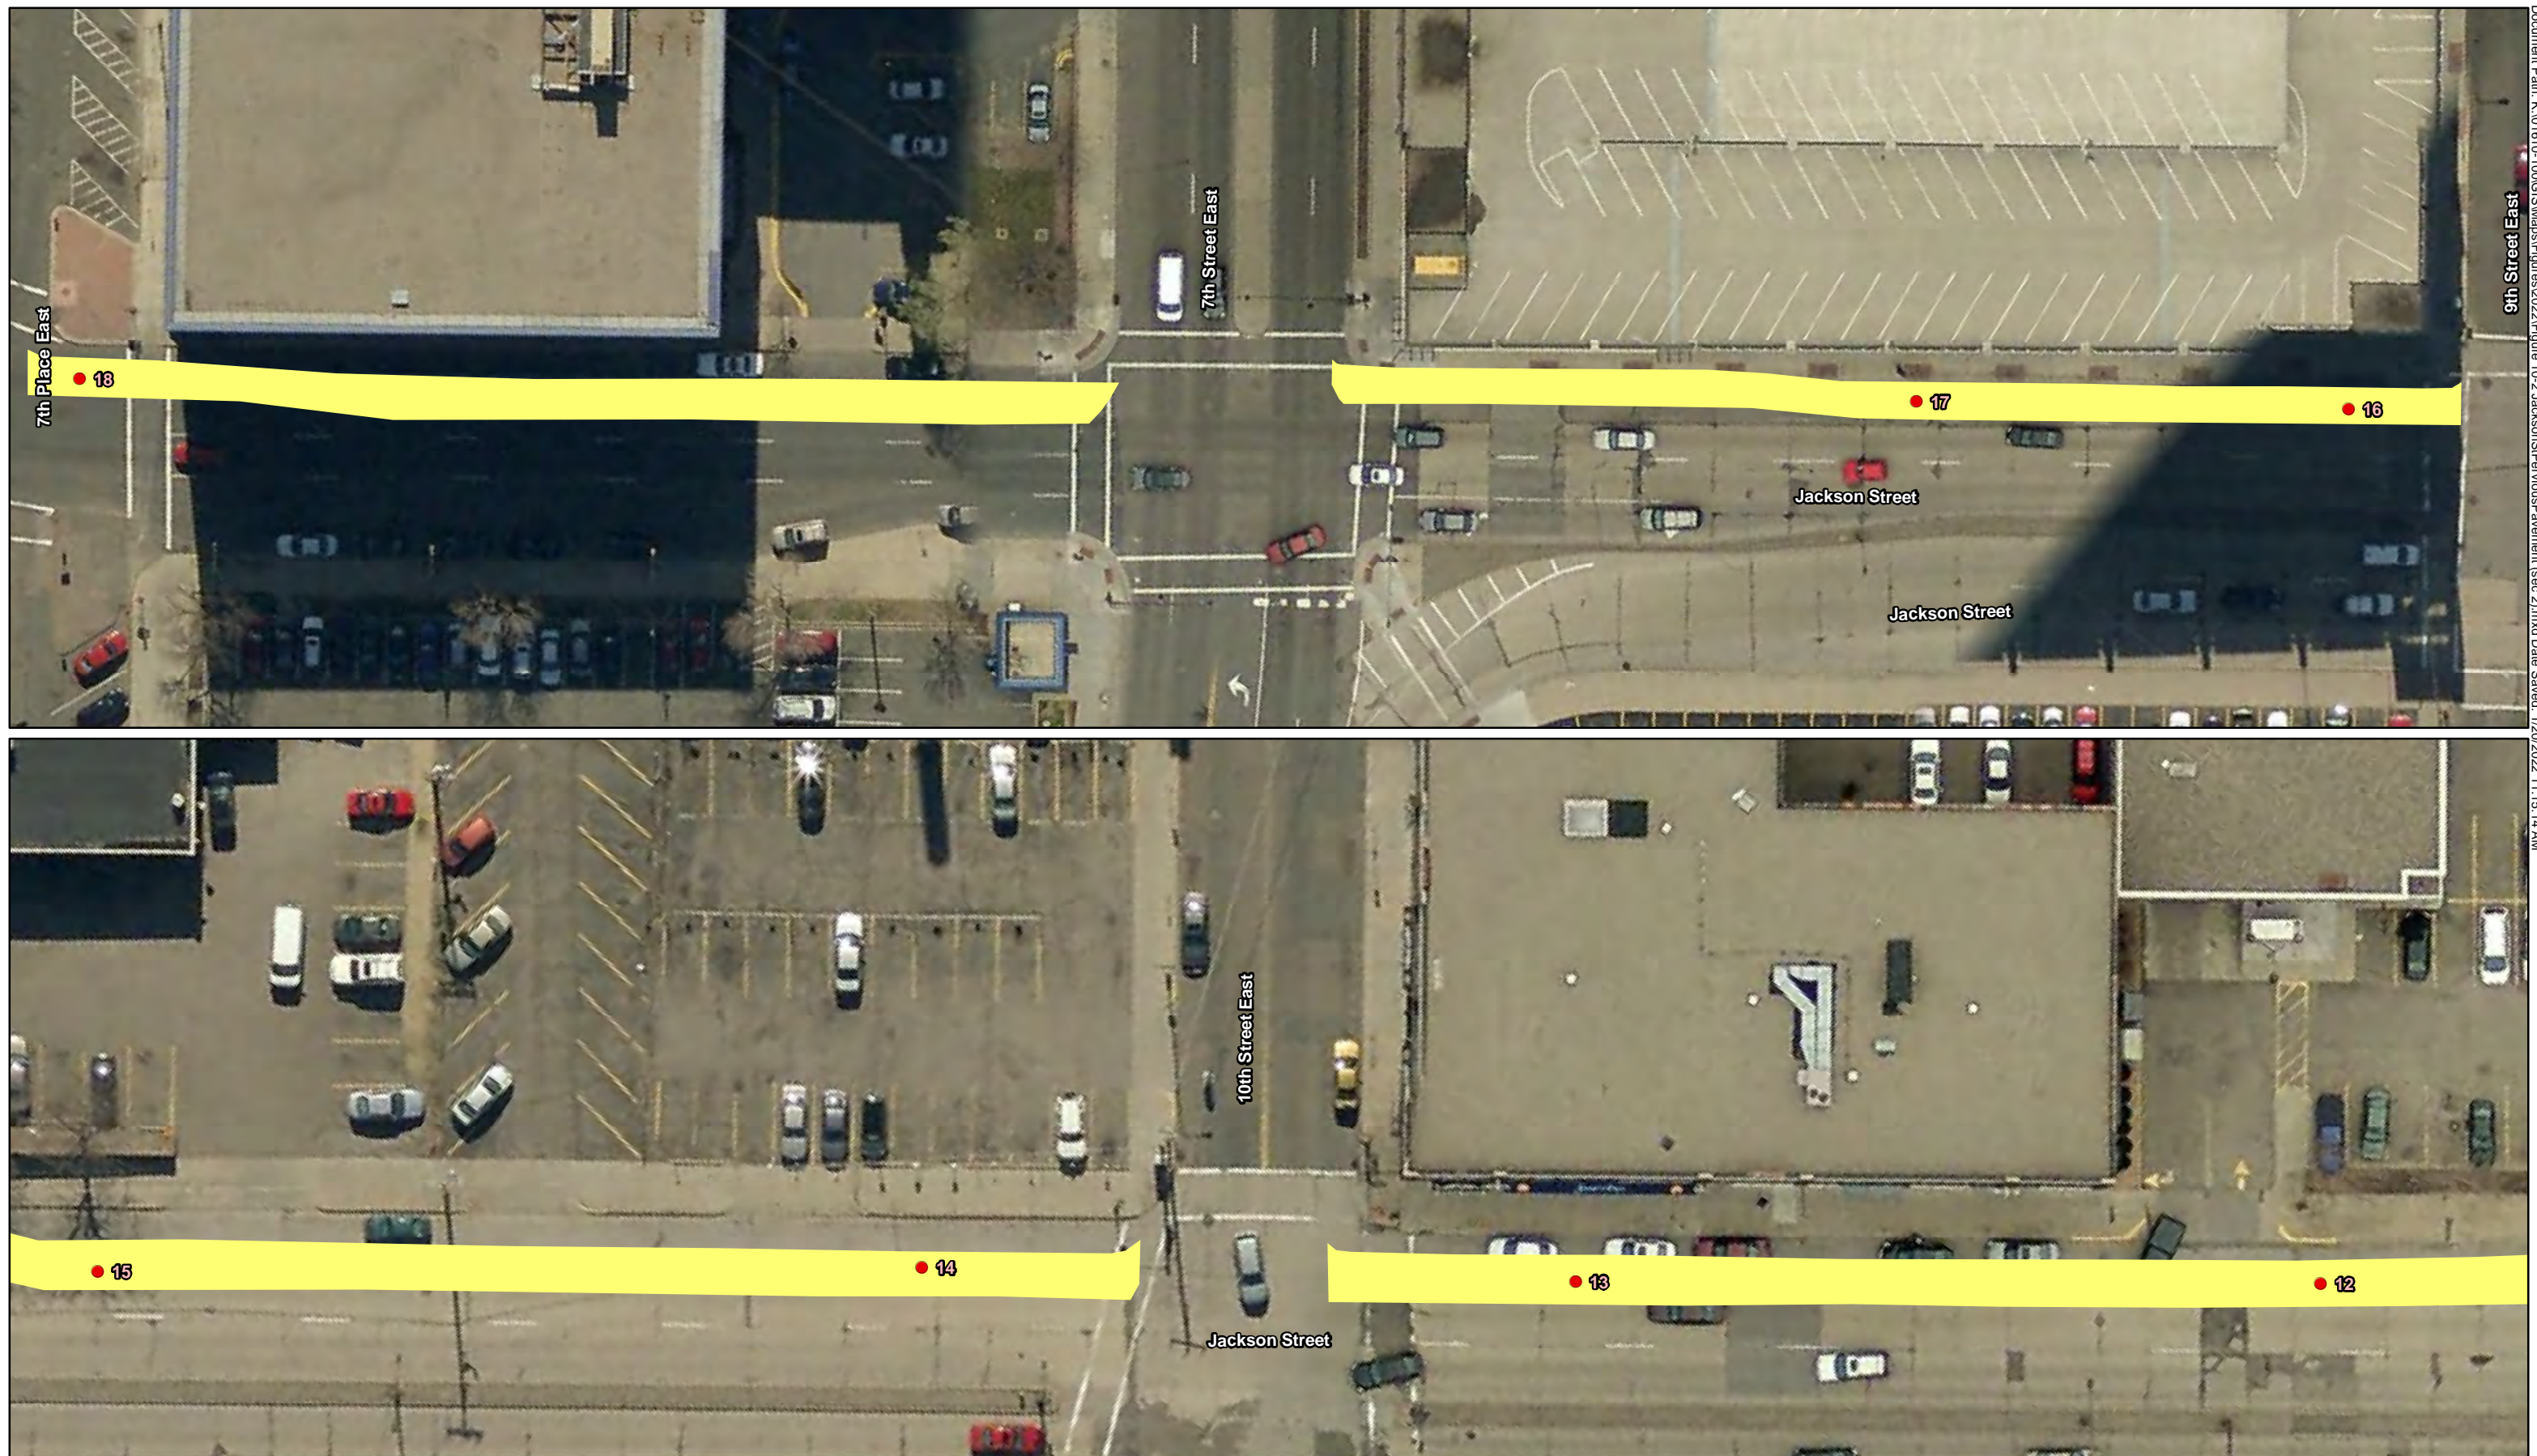
Figure 10-2 Jackson Street (pg 2 of 2)

JS-12 - JS-18 Pervious Test Locations

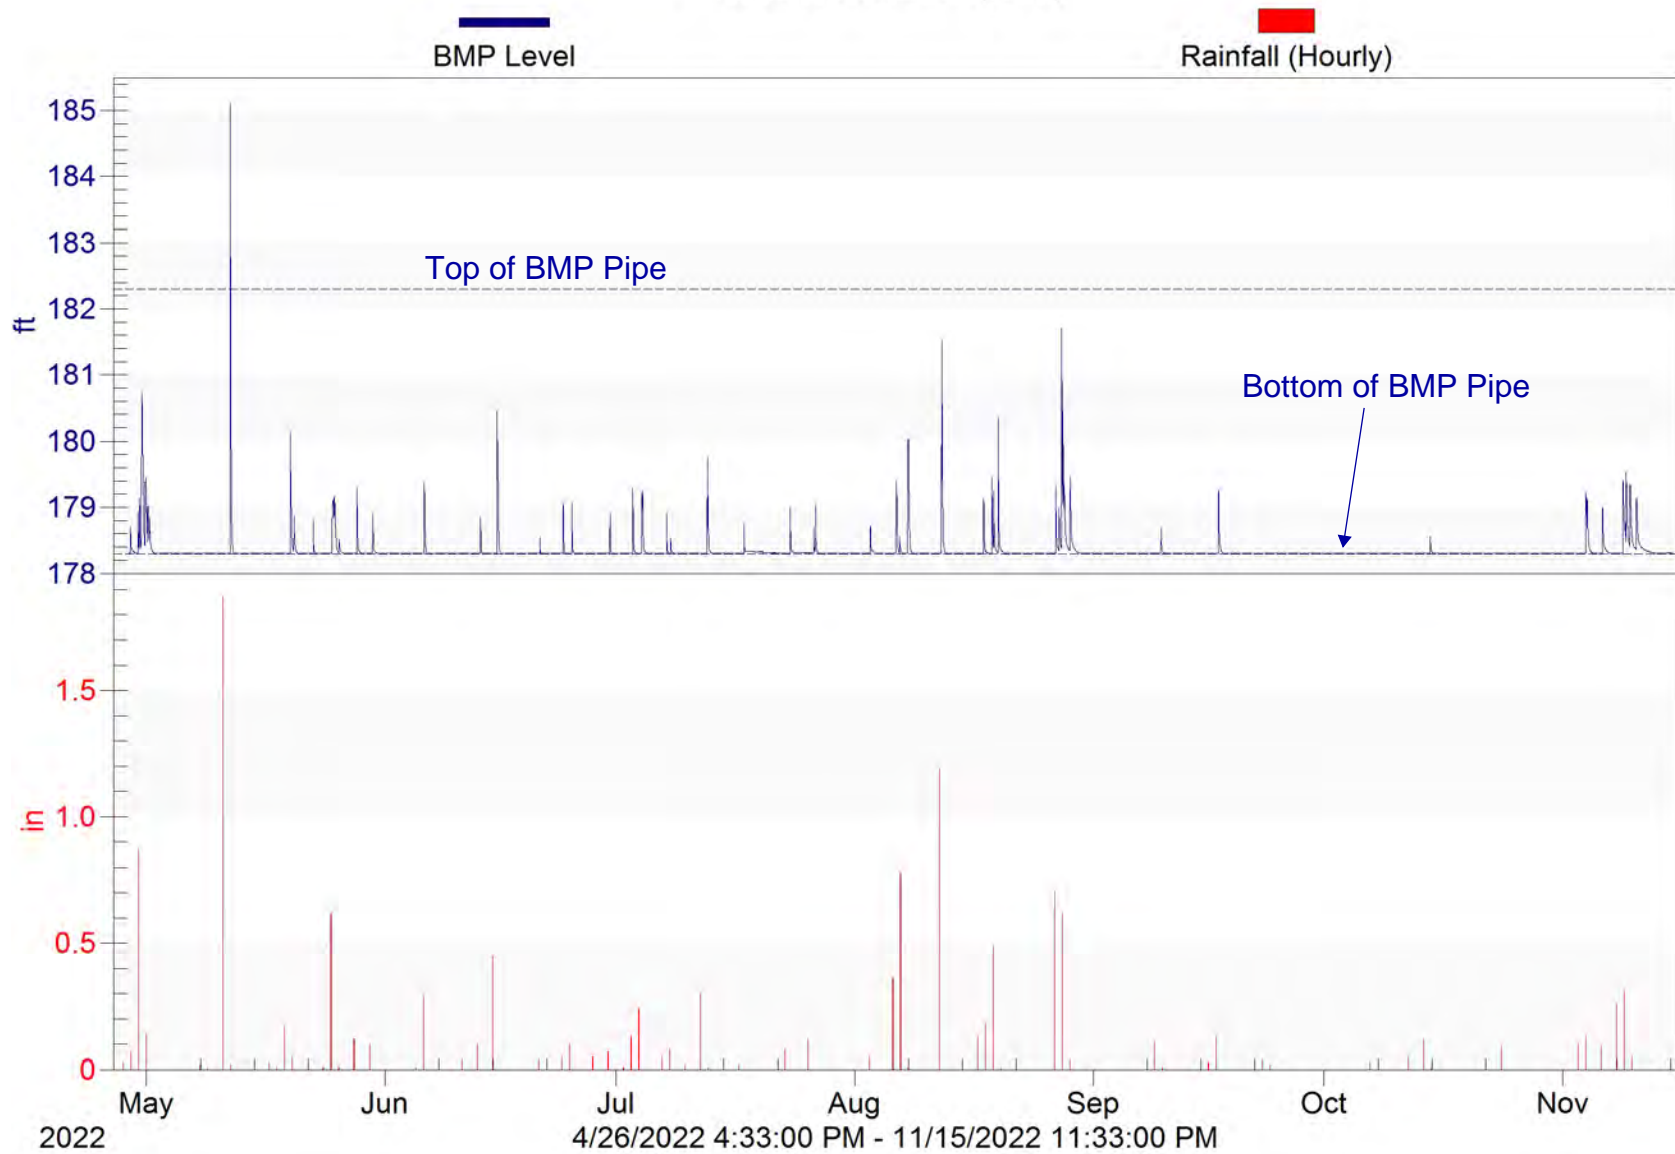
Chart A.5 St. Albans
Water Level and Rainfall (SPCD)

BMP water level was monitored in the access manhole at the northwest corner of the system. The 2022 water elevations and daily rainfall is provided on **Chart A.5** of **Appendix A**. Water level monitoring indicated that the infiltration gallery reached 100% capacity 1 time in 2022. The infiltration gallery drew down to empty in less than a 24 hour period after the conclusion of each rain event.

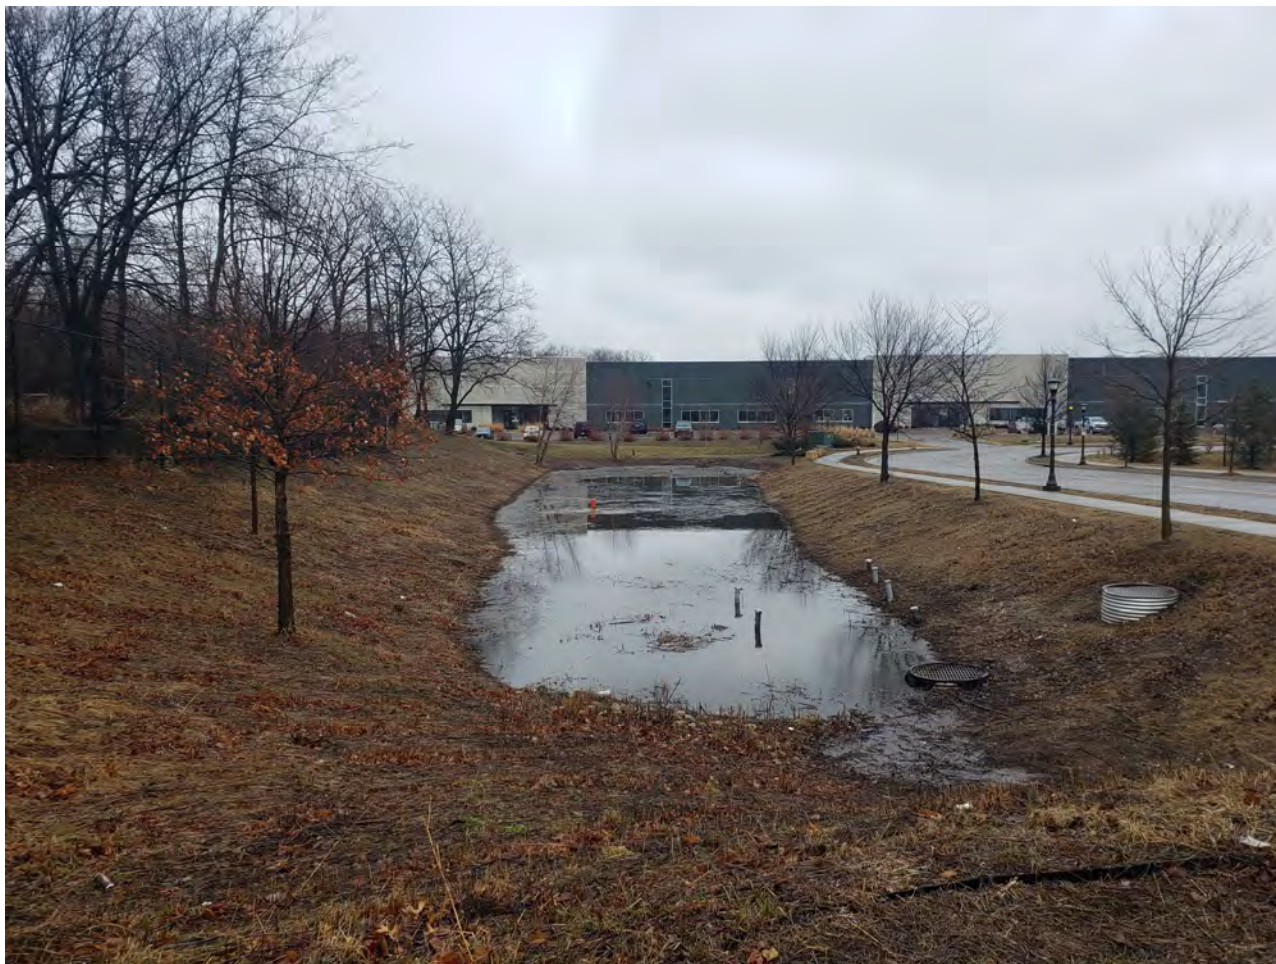
Beacon Bluff SAFL Baffle and Rain Garden - 5/13/22

Visual inspections of the pretreatment structure, rain garden, and underground system were completed during site visits to determine performance and maintenance needs. As shown in **Table 4-5**, sediment depths in the pretreatment device were approximately 0.5 ft to 2.3 ft throughout the 2022 season. Floatables and trash were observed in the pretreatment structure during all visits and within the rain garden.

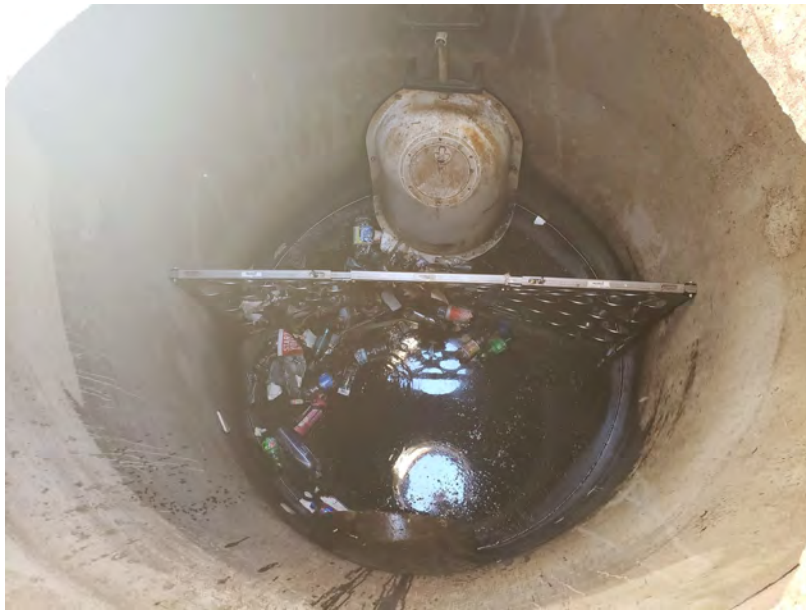
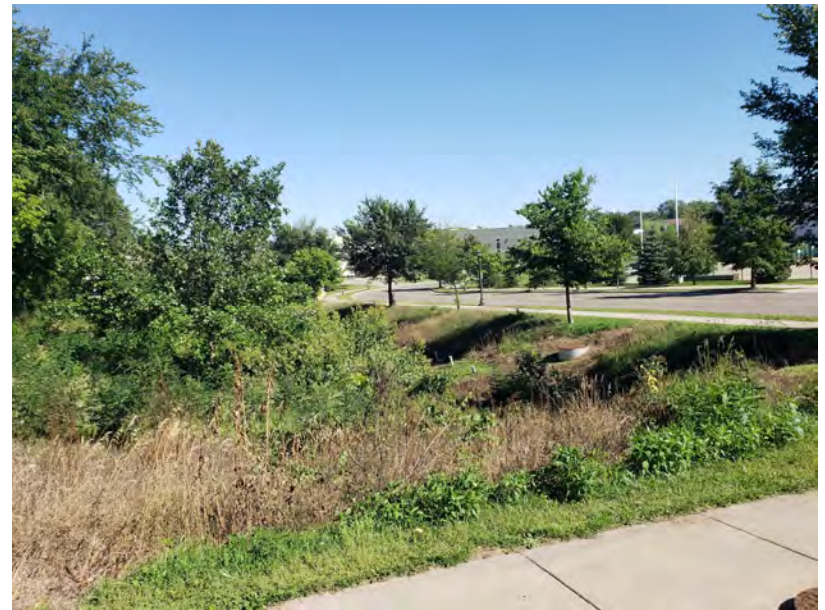
Sensor Damage at Beacon Bluff – 8/18/22

Water level was monitored by a logger placed directly in the BMP Pipe. Water level in the rain garden was not measured in 2022 due to piezometer damage following a dredge in the Spring of 2019. An additional logger was installed within the outlet control structure of the system to confirm when flow was being conveyed back to the storm sewer from the underground chamber. Groundwater elevation was also measured in two locations at the site. Water level elevations within the system and groundwater, and daily rainfall totals are presented on **Chart A.1** and **A.2** of **Appendix A**.

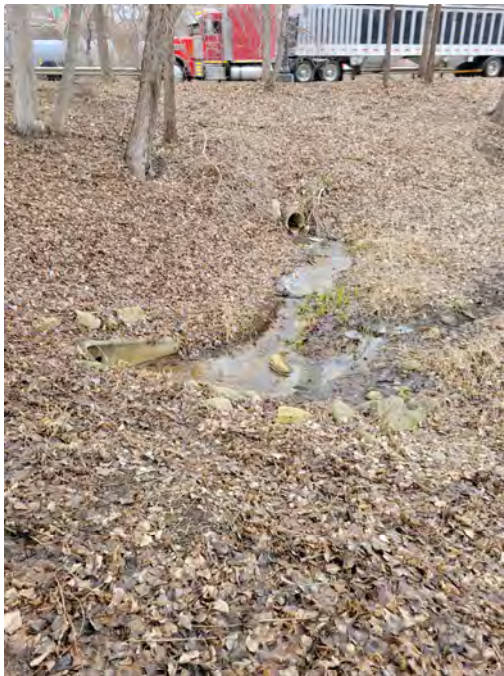
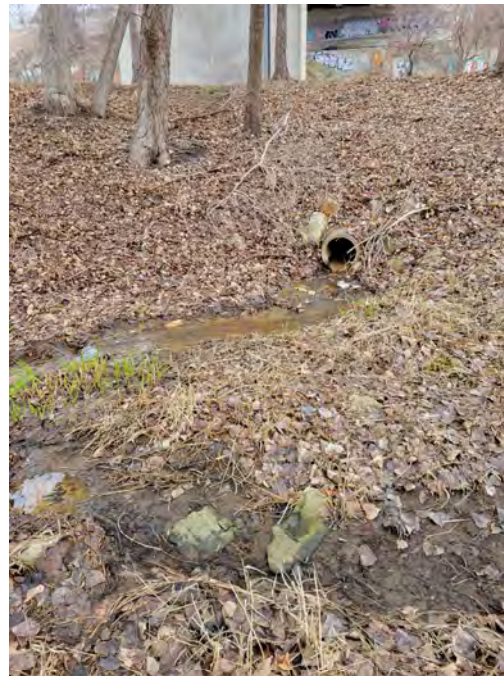
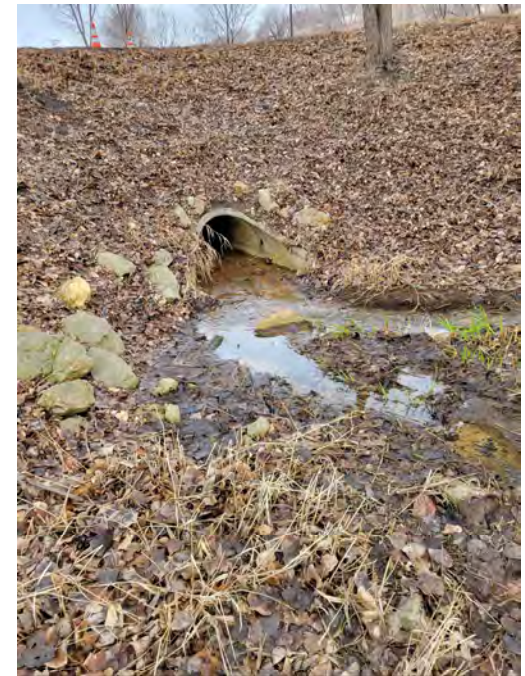
Baseflow at East Shepard Pond 4/13/22
