SAINT PAUL
MINNESOTA

2024 STORMWATER QUALITY AND QUANTITY MONITORING PROGRAM

April 23, 2025

WSB PROJECT NO. 022099

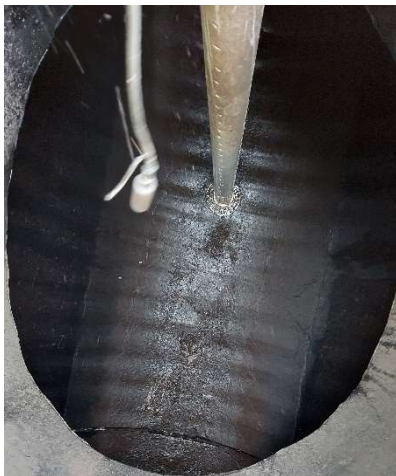
Photo 2-1:
Infiltration Gallery Level Monitoring Enclosure

Enclosures for the infiltration gallery level loggers were installed at Beacon Bluff, St. Albans Street, and Hampden Park. These consisted of three-inch-diameter PVC pipes with four rows of half inch-diameter holes drilled along the pipe, achieving approximately twenty holes per foot. The enclosures were wrapped with a highly permeable geotextile fabric and secured with zip ties to protect the instrument from fine sediment accumulation. Enclosures were secured to the system floor and to the access riser wall (**Photo 2-1**). Groundwater and rain garden locations were monitored from permanent monitoring wells (**Photo 2-2**).

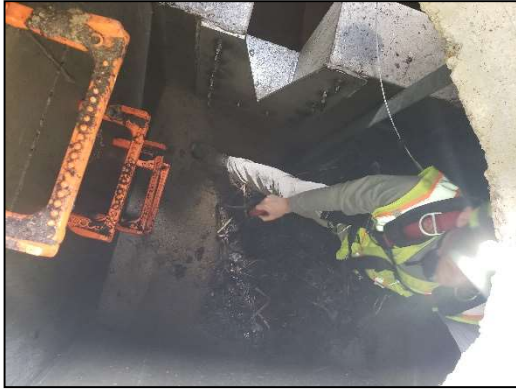
Photo 2-3: Flow Monitoring Module Install Process

Teledyne ISCO 2150 area velocity flow modules and sensors were used to monitor runoff volumes. These devices measure water level and flow velocity. Combining this information with a known conduit shape, the flow rate, and flow volume through the conduit were calculated. Each of the monitored systems received stormwater runoff from a diversion structure located along the storm sewer system. The 2150 flow sensors were positioned at the upstream and downstream pipes in these structures to measure the total volume draining to each BMP and the total volume that bypassed each BMP. **Photos 2-3** and **2-4** show the flow meters installation in West Shepard Pond and Victoria Street, respectively.

The flow modules were configured at each site to log data at one-minute intervals once the water level in the upstream pipe was greater than one-inch above the pipe invert to increase the resolution of the flow data.

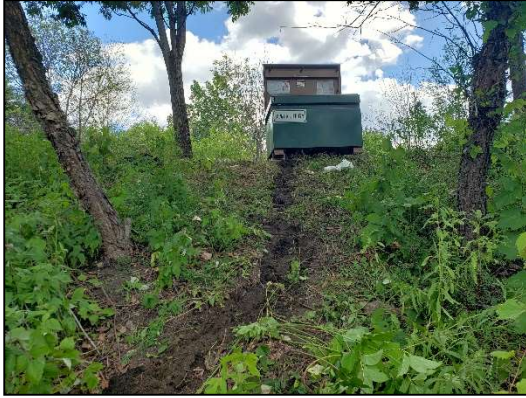
Photo 2-5:
Job Box Housing ISCO 6712 Sampler

ISCO 6712 automatic samplers were installed at all water quality locations. (**Photos 2-5** and **2-6**).

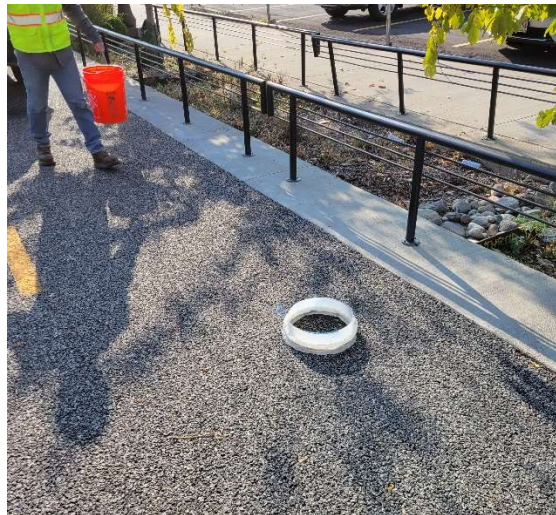
Photo 2-7: Permeable Pavement Infiltration Test

Infiltration tests were conducted according to the modified ASTM C1701 methods for measuring infiltration rates (**Photo 2-7**). Eighteen locations at Jackson Street were evaluated to develop an average infiltration rate measurement for each site. Tests were taken at locations that remained consistent year to year and included a combination of high and low traffic areas. At each test location, a pre-wet test was conducted, followed by two infiltration tests. The two infiltration tests were averaged to generate the infiltration rate for each location. If after 15 minutes of monitoring during a pre-wet test no infiltration was observed, the test was concluded, and no subsequent tests were completed.

The infiltration rate of the permeable surfaces was measured at Jackson Street pervious pavement sites following the protocols outlined in ASTM method C1701 (**Appendix G**). The following section provides a summary of those methods.

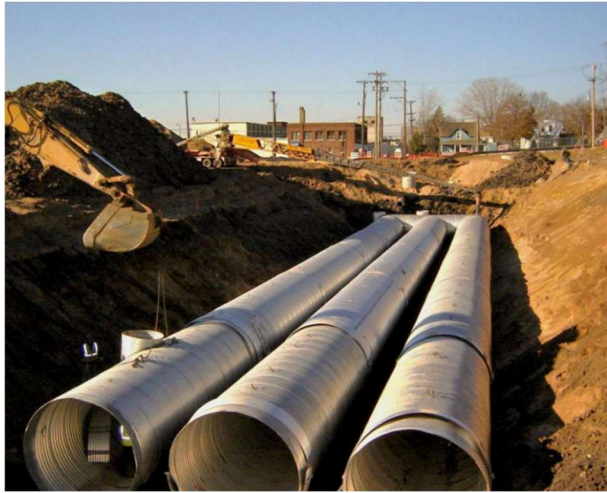
Photo 4-1: Underground Infiltration Chamber (Facing West)

The system is comprised of three connected stormwater treatment structures, which include a stormwater pond west of the Duchess Street cul-de-sac (west pond), an infiltration basin east of the cul-de-sac (rain garden) (**Photo 4-1**), and an underground infiltration chamber (**Photo 4-2**) constructed directly beneath the rain garden. The underground chamber consists of three parallel, 215-foot-long, ten-foot-diameter perforated metal pipes for infiltration.

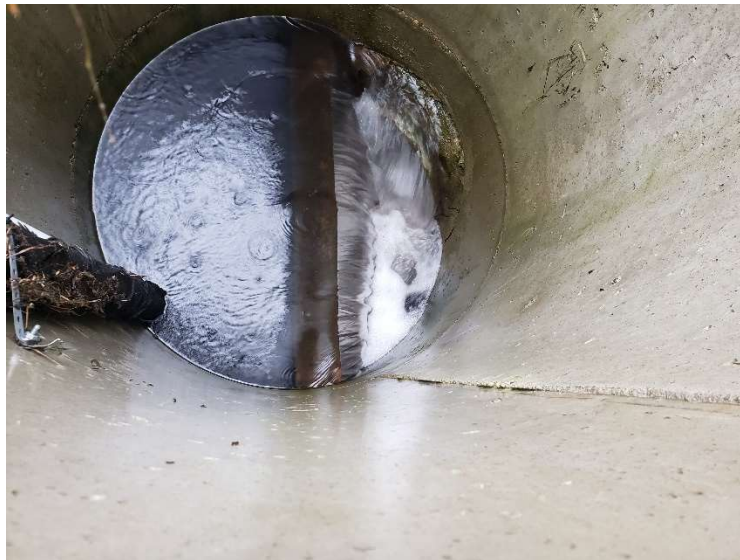
Photo 4-3: Water being conveyed back to the storm sewer from the underground chamber in the outlet control structure.

Overflow in the outlet control structure to the storm sewer, (**Photo 4-3**), occurred during eight treatment events. The 2024 underground chamber infiltration rate and infiltration rate trends are provided on **Charts A.3** and **A.4** of **Appendix A**, respectively. The 2024 average infiltration rate for the BMP Pipe was 0.06 inches per hour (in/hr). This is a decrease from the rates observed in 2023 (0.11 in/hr) and equal to the rates from 2022 (0.06 in/hr) (**Table 4-2**). Sediment accumulation has been observed ranging from 0.7 ft, across the basin. The 141.5-acre drainage area discharging directly to the pond conveys a significant amount of sediment and debris, which has accumulated primarily around the diversion inlet pipe. Dredge maintenance was completed on the rain garden over the Spring of 2019.

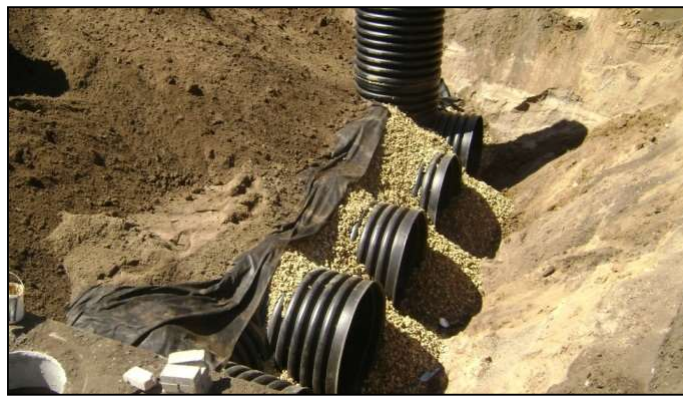
Photo 5-1: St. Albans 48" Perforated HDPE Installation

A manhole structure positioned along the main storm sewer under Aurora Avenue diverts stormwater into the underground infiltration system (**Photo 5-1**) via a 30-inch elliptical pipe. The system is also connected to the University Avenue storm sewer system. Any runoff that does not get treated by infiltration trenches and tree planters along University Avenue is directed to this system (**Photo 5-1**). When the system reaches its storage capacity, water flows west through the existing storm sewer system. The system includes a pretreatment structure comprised of a grit chamber and baffled weir to provide settling for sediment and skimming. Rainfall monitoring for the site is conducted on the roof of Fire Station 18, located across the street from the BMP. The BMP system details are provided in **Table 5-1**.

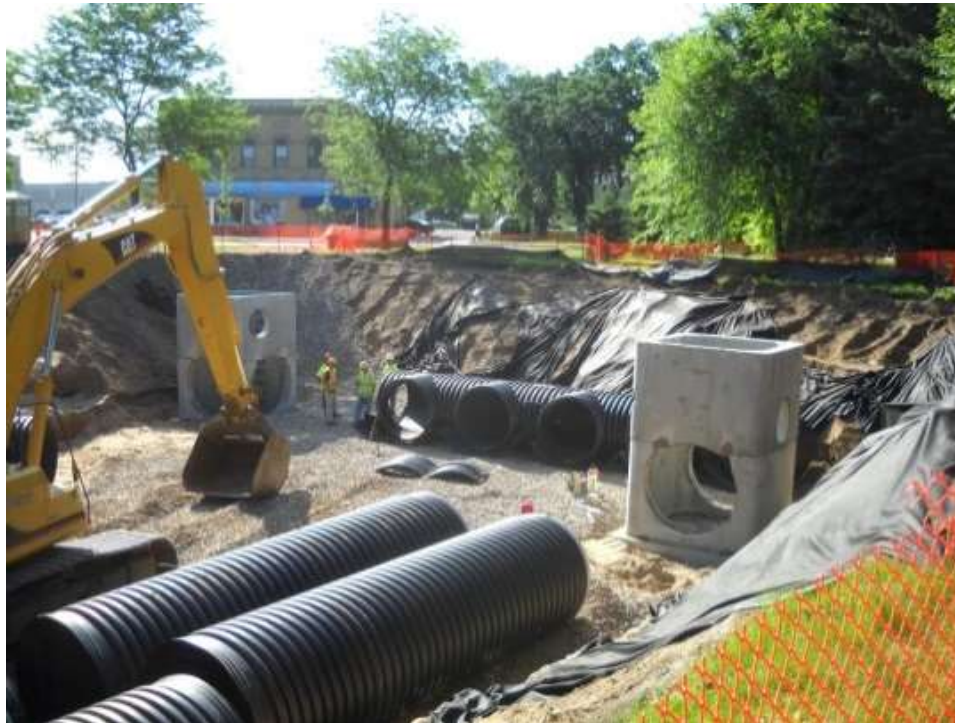
Photo 6-1: Hampden Park BMP Construction

The Hampden Park infiltration gallery, shown in **Figure 6-1**, was constructed in 2014. The system consists of eight parallel perforated pipes that are 5 ft in diameter, and range in length from 40 to 100 ft. Runoff is routed to the system via a 24-inch RCP from the storm sewer line near Hampden and Raymond Avenues. Prior to entering the infiltration gallery, stormwater passes through a Vortechs pre-treatment chamber for particle settling. The infiltration gallery receives flow from a second inlet location along Hampden Avenue, farther to the north. When the system reaches full capacity, stormwater is routed back to the storm sewer via a 24-inch pipe from the southeast side of the system. Rainfall monitoring is conducted on top of the Hampden Park Co-Op across the street from the park. Monitoring has been conducted at the site since 2014. The BMP system details are provided in **Table 6-1** below.

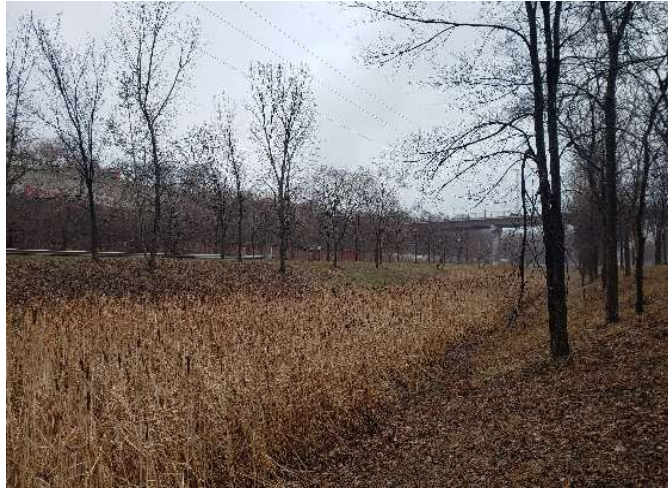
Photo 8-1: West Shepard Pond

The Shepard Road Pond monitoring location is the median of Shepard Road, just under the Smith Avenue Bridge. Monitoring here provides water quality and quantity data of water flowing from the east and west along Shepard Road. Monitoring at this site was initiated in 2023.

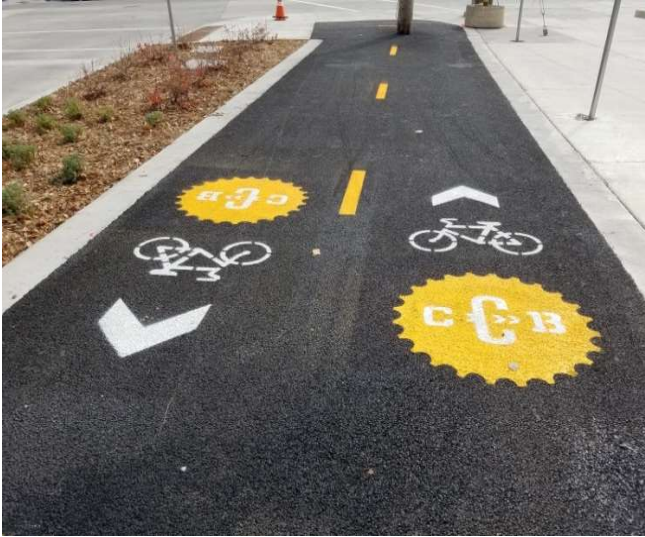
Photo 11-5: Capital City Bikeway (CCB) –
Jackson Street/Kellogg Avenue

The Jackson Street BMP (**Photo 11-5** and **11-6**) is a designated bike path constructed of pervious asphalt. It is a section of the Capital City Bikeway (CCB), a system of off-street bicycle trails in downtown Saint Paul. The BMP is eight blocks long, stretching from Kellogg Street to 11th Street, and consists of 2,750 square yards of pervious asphalt. Stormwater runoff filters through the asphalt and underlying media and is then conveyed to the storm sewer system via drain tile.

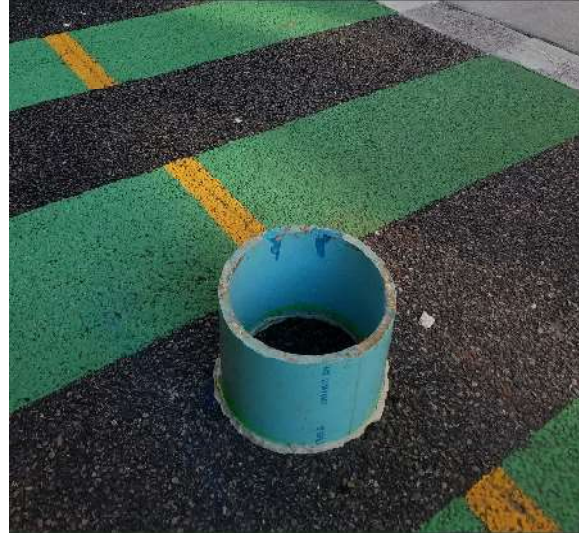
Photo 11-6: Jackson Street Infiltration Test

- The overall site infiltration rate was 38.9 inches per hour (in/hr) in October 2024.
 - 16 of 18 locations showed no infiltration rate in 2024.
 - Of the remaining three locations where infiltration occurred, infiltrations rates ranged from 38.5 in/hr to 661.1 in/hr.
- Low traffic areas had an average infiltration rate of 140 in/hr in 2024.
- Medium traffic areas had an average infiltration rate of 0.0 in/hr in 2024.
 - Locations JS-7 through JS-11 are within the first constructed section of the pervious pavement near the Jackson Street and Kellogg Boulevard intersection. These locations have not shown any infiltration since October 2018.
- High traffic areas had an infiltration rate of 0.0 in/hr in 2024.
 - High traffic locations have not shown any infiltration since November 2017.

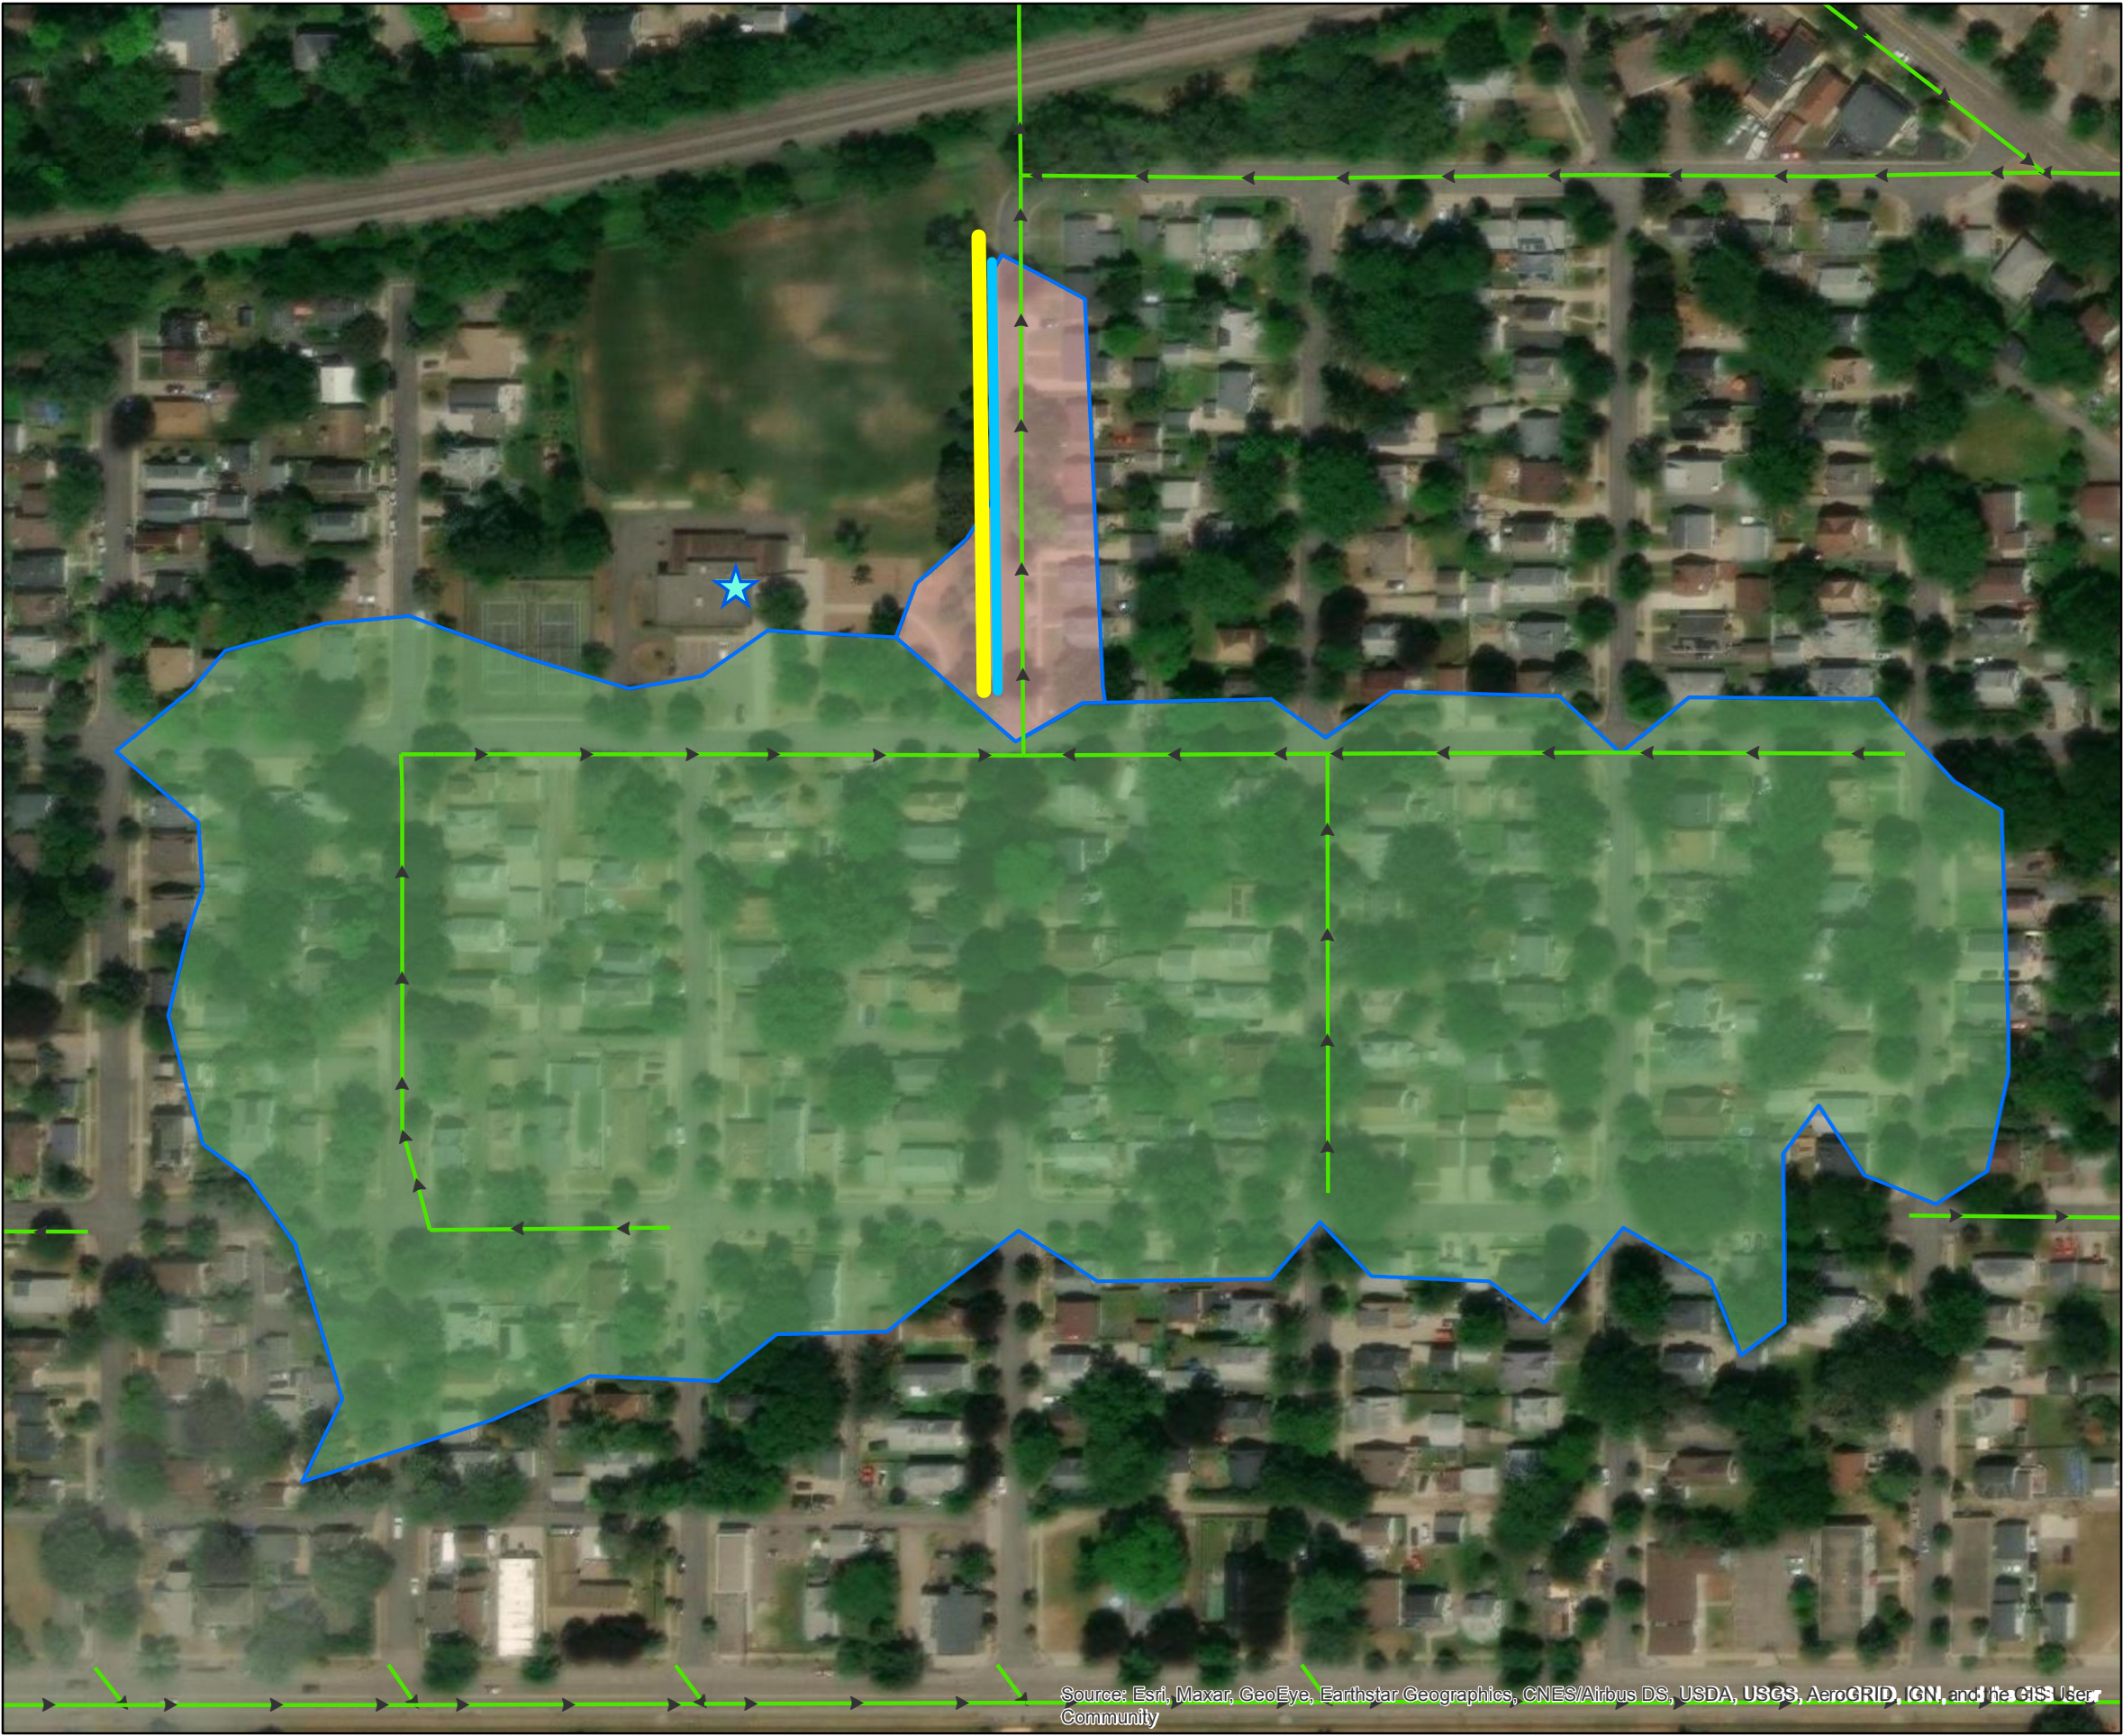
Figure 10-2 Jackson Street (pg 1of2)
JS-1 - JS-11 Pervious Test Locations
2024 Water Quantity and Quality Monitoring Program
City of Saint Paul, MN

The site was tested for infiltration in August 2023. The infiltration test results from the 18 locations are summarized in **Chart 11-1** and **Chart D.2** in **Appendix D**, which includes all infiltration test results completed to-date. **Table 11-3** is color coded to identify the site traffic characterizations described above. The infiltration tests results are also summarized in **Table 11-3**, which presents an average infiltration rate based on the monitoring location traffic characterization. The infiltration test locations are depicted in **Figure 11-2**.

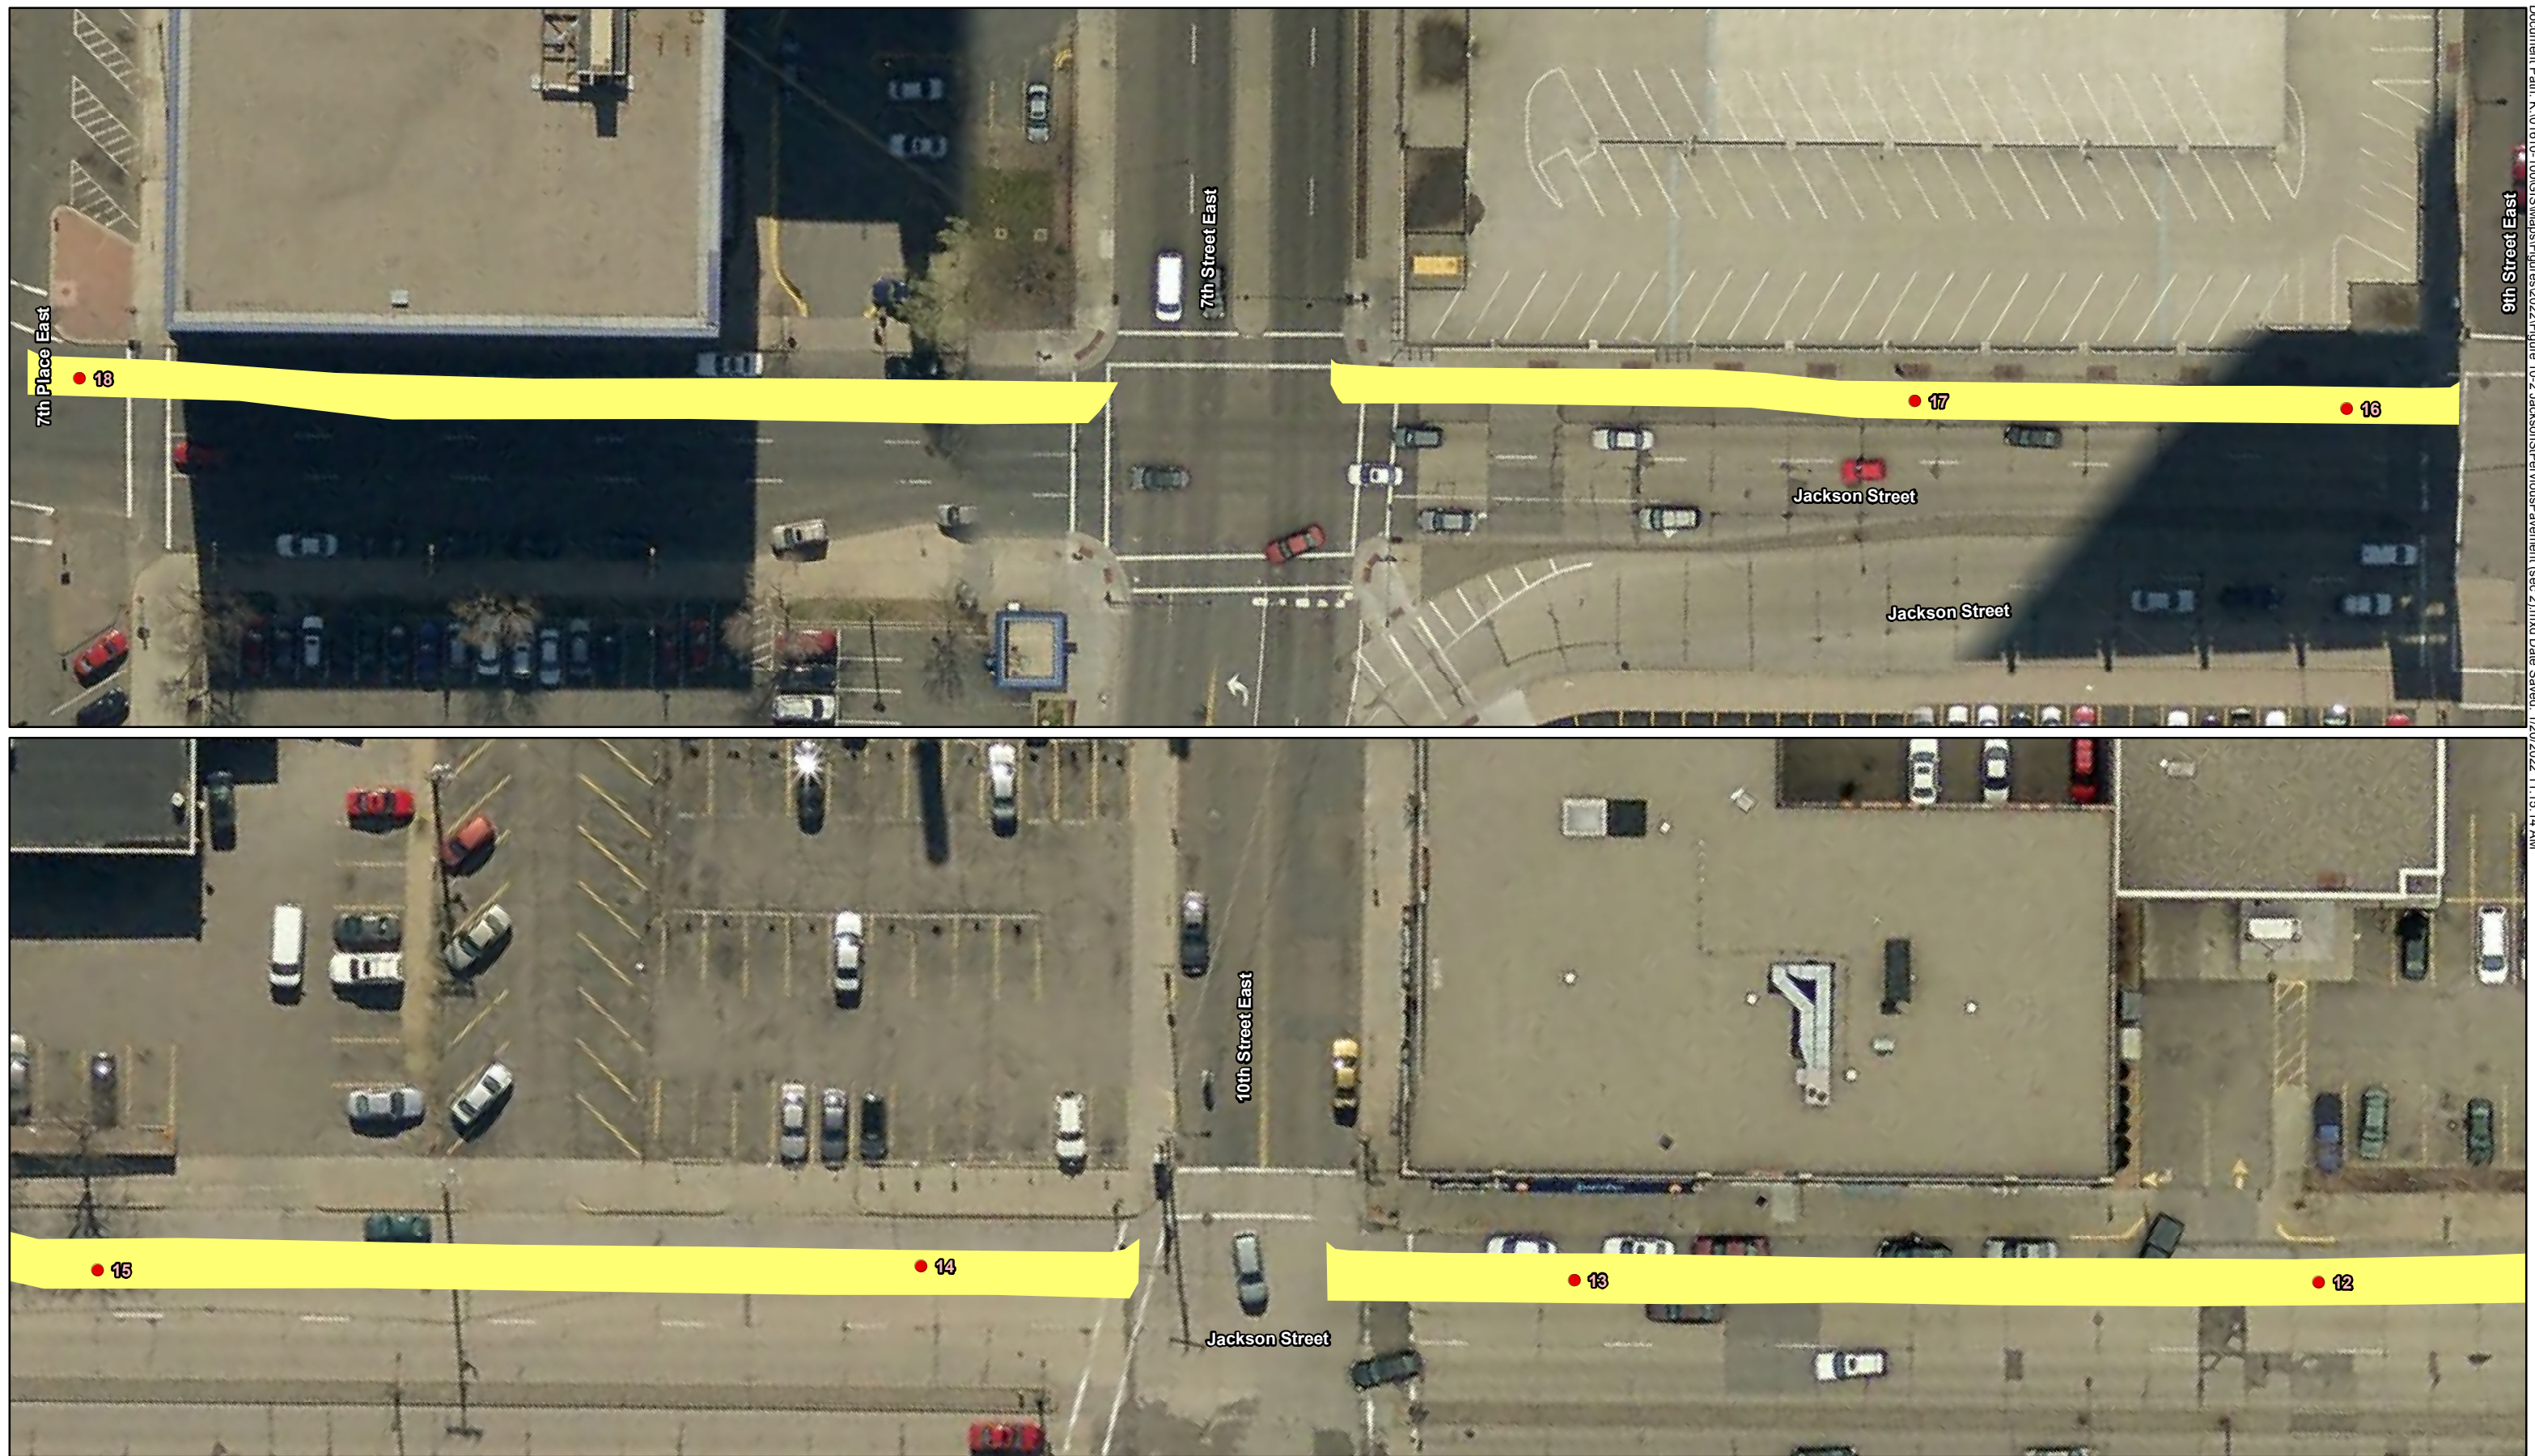
Figure 10-2 Jackson Street (pg 2of2)

JS-12 - JS-18 Pervious Test Locations

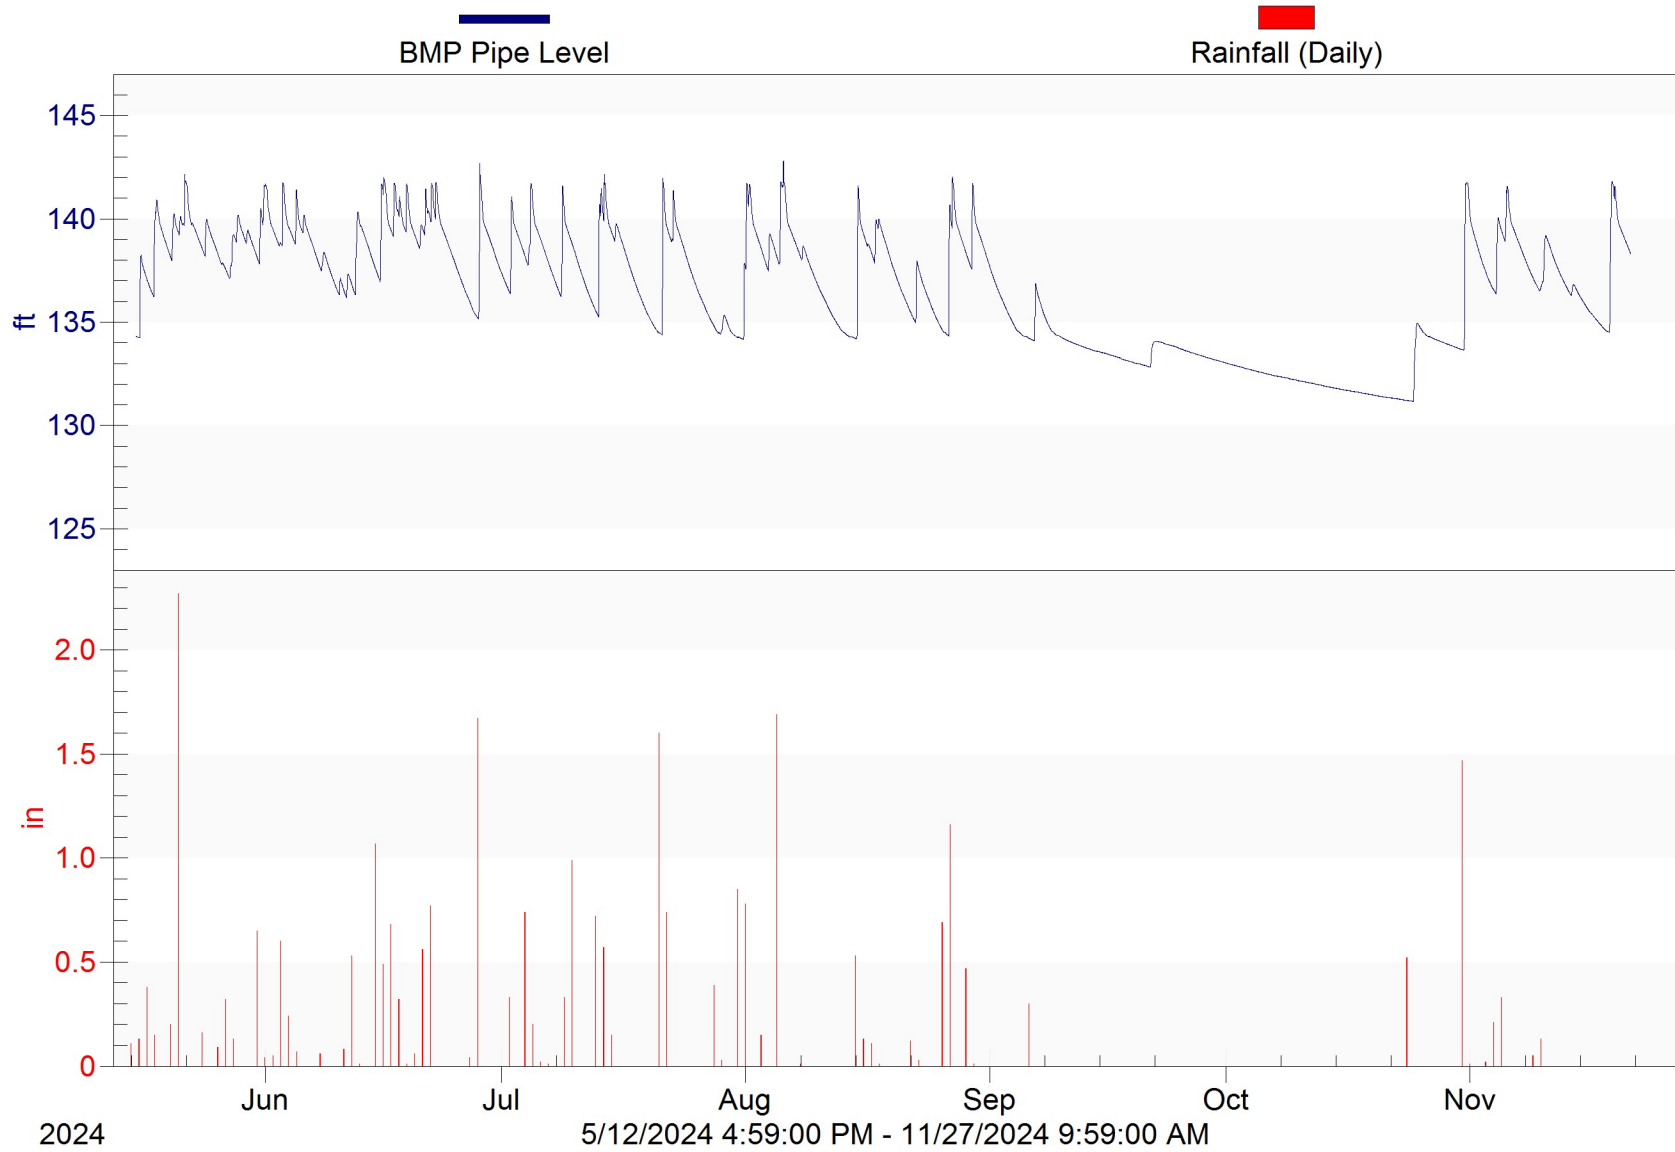
Chart A.1 Beacon Bluff

Water level was monitored by a logger placed directly in the BMP Pipe. The water level in the rain garden was not measured in 2024 due to piezometer damage following a dredge in the Spring of 2019. An additional logger was installed within the outlet control structure of the system to confirm when flow was being conveyed back to the storm sewer from the underground chamber. Groundwater elevation was also measured in two locations at the site. Water level elevations within the system and groundwater, and daily rainfall totals are presented on **Chart A.1** and **A.2** of **Appendix A**.

Water Level and Rainfall (SPCD)

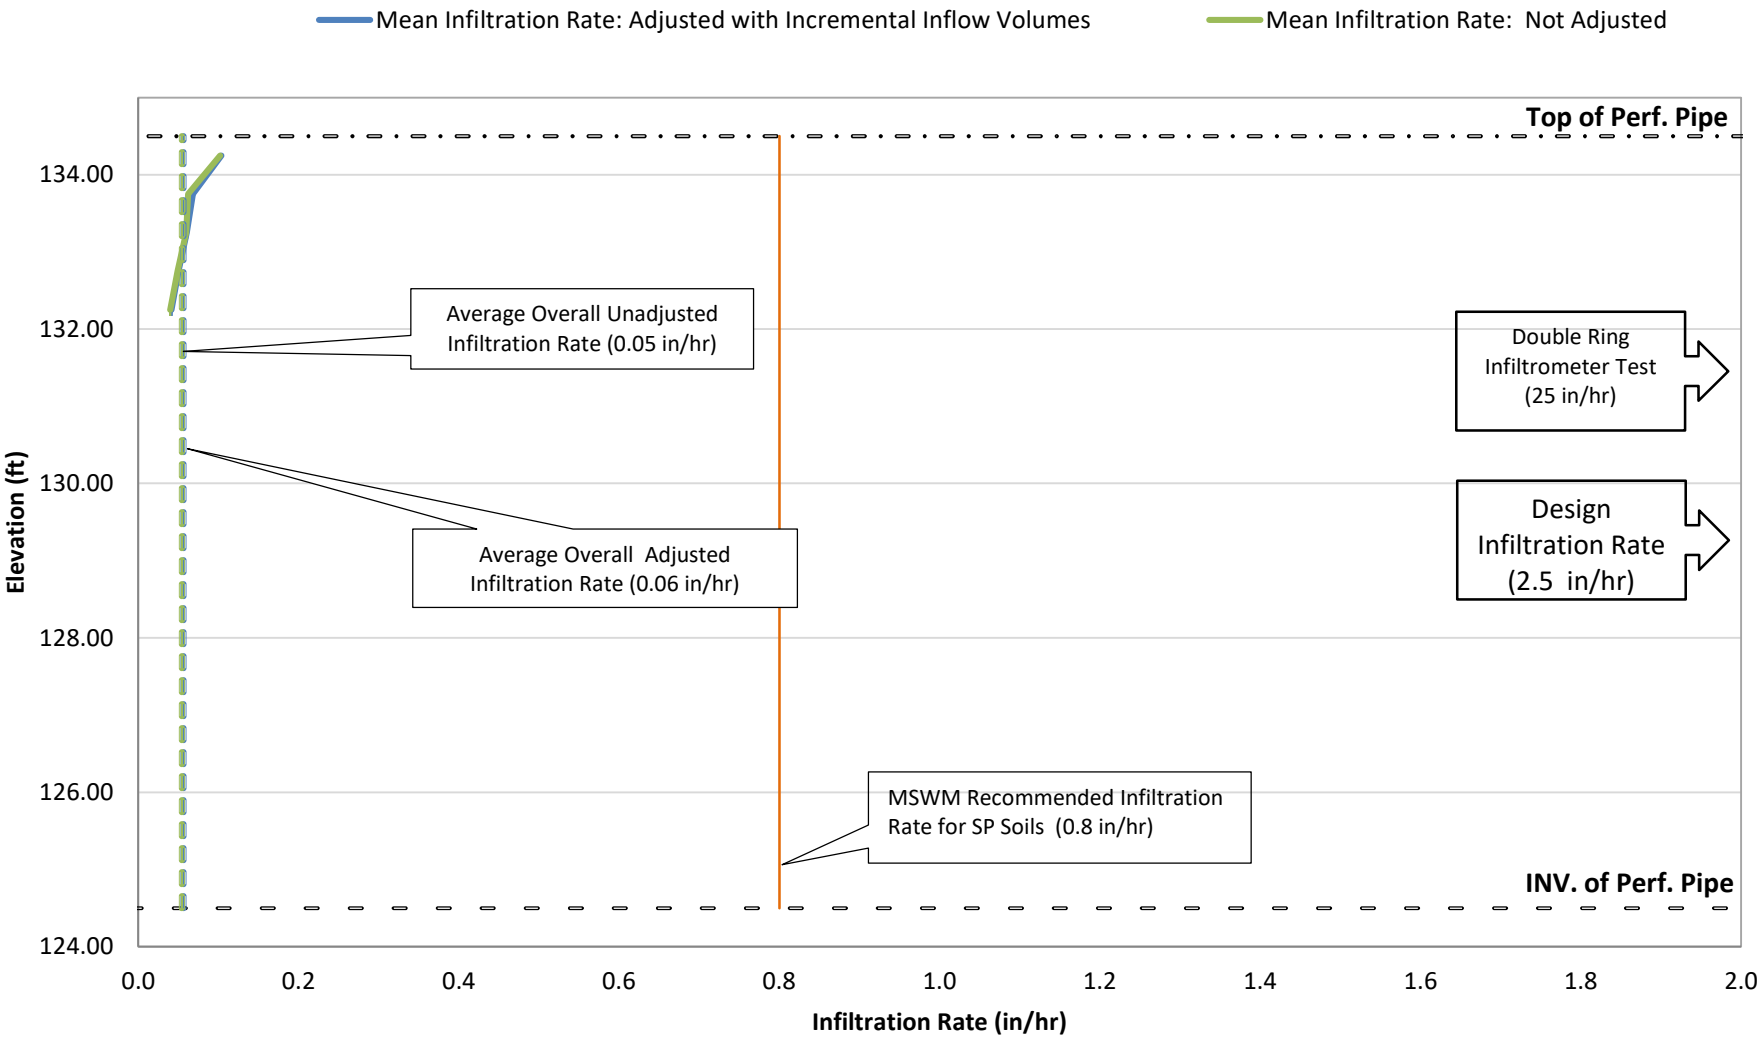
Beacon Bluff Underground System - Infiltration Rate Graph (BMP Pipe)

(Observed at 0.5 Foot Height Intervals)

Note: Pipe Invert is 124.5'
Pipe perforated around circumference of pipe

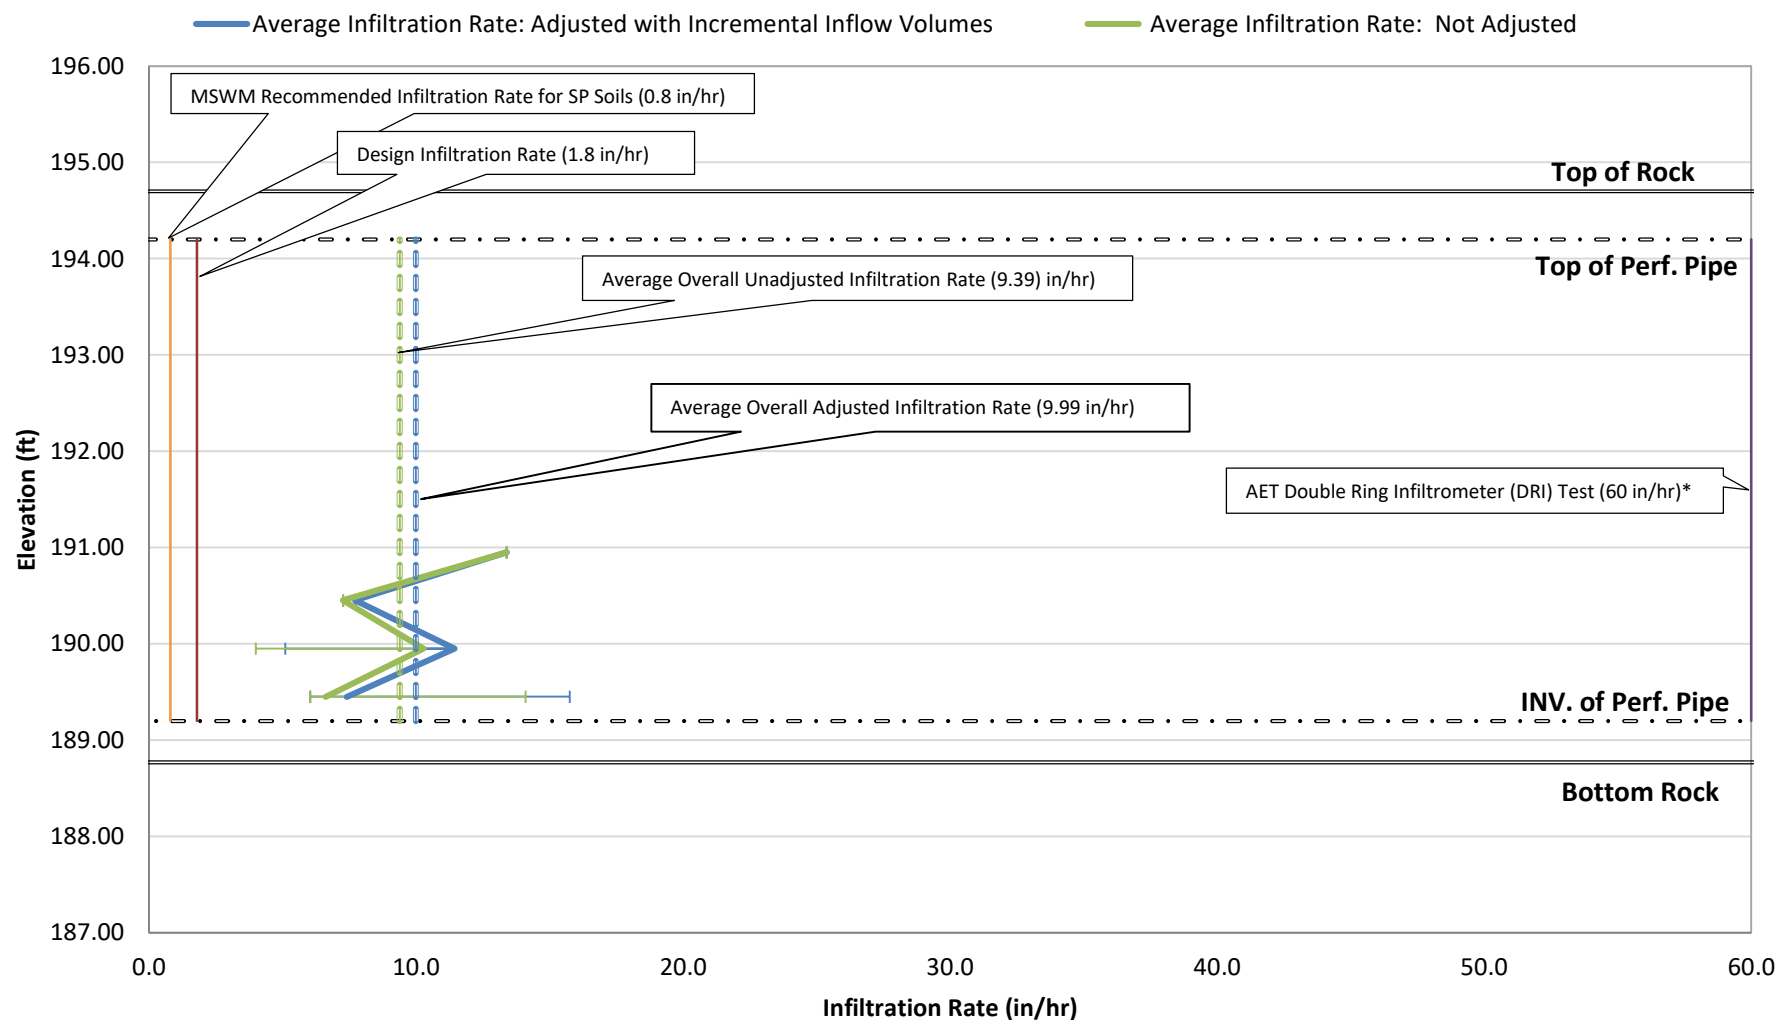
Hampden Park - Infiltration Rate Graph (Observed 0.5 Foot Height Increments)

Note: Pipe Invert is 189.2'

Error Bars Represent 25th and 75th Percentiles

The 2024 infiltration rates are presented on **Chart A.10** of **Appendix A** and are adjusted for incremental volume flow. The adjusted average infiltration rate for the BMP was 9.99 in/hr, which is above the design infiltration rate of 1.8 in/hr. Infiltration rates at the base of site during construction were calculated to be, on average, 60 in/hr using a Double Ring Infiltrometer (DRI). Infiltration rate trends are depicted on **Chart A.11**. Water level data shows that all 2024 events were infiltrated within 8 hours of a treatment event.
