**CITY OF ST. PAUL**  
**MERRIAM PARK**  
DAC Meeting 10.27.2025

# MERRIAM PARK

## Project Charter

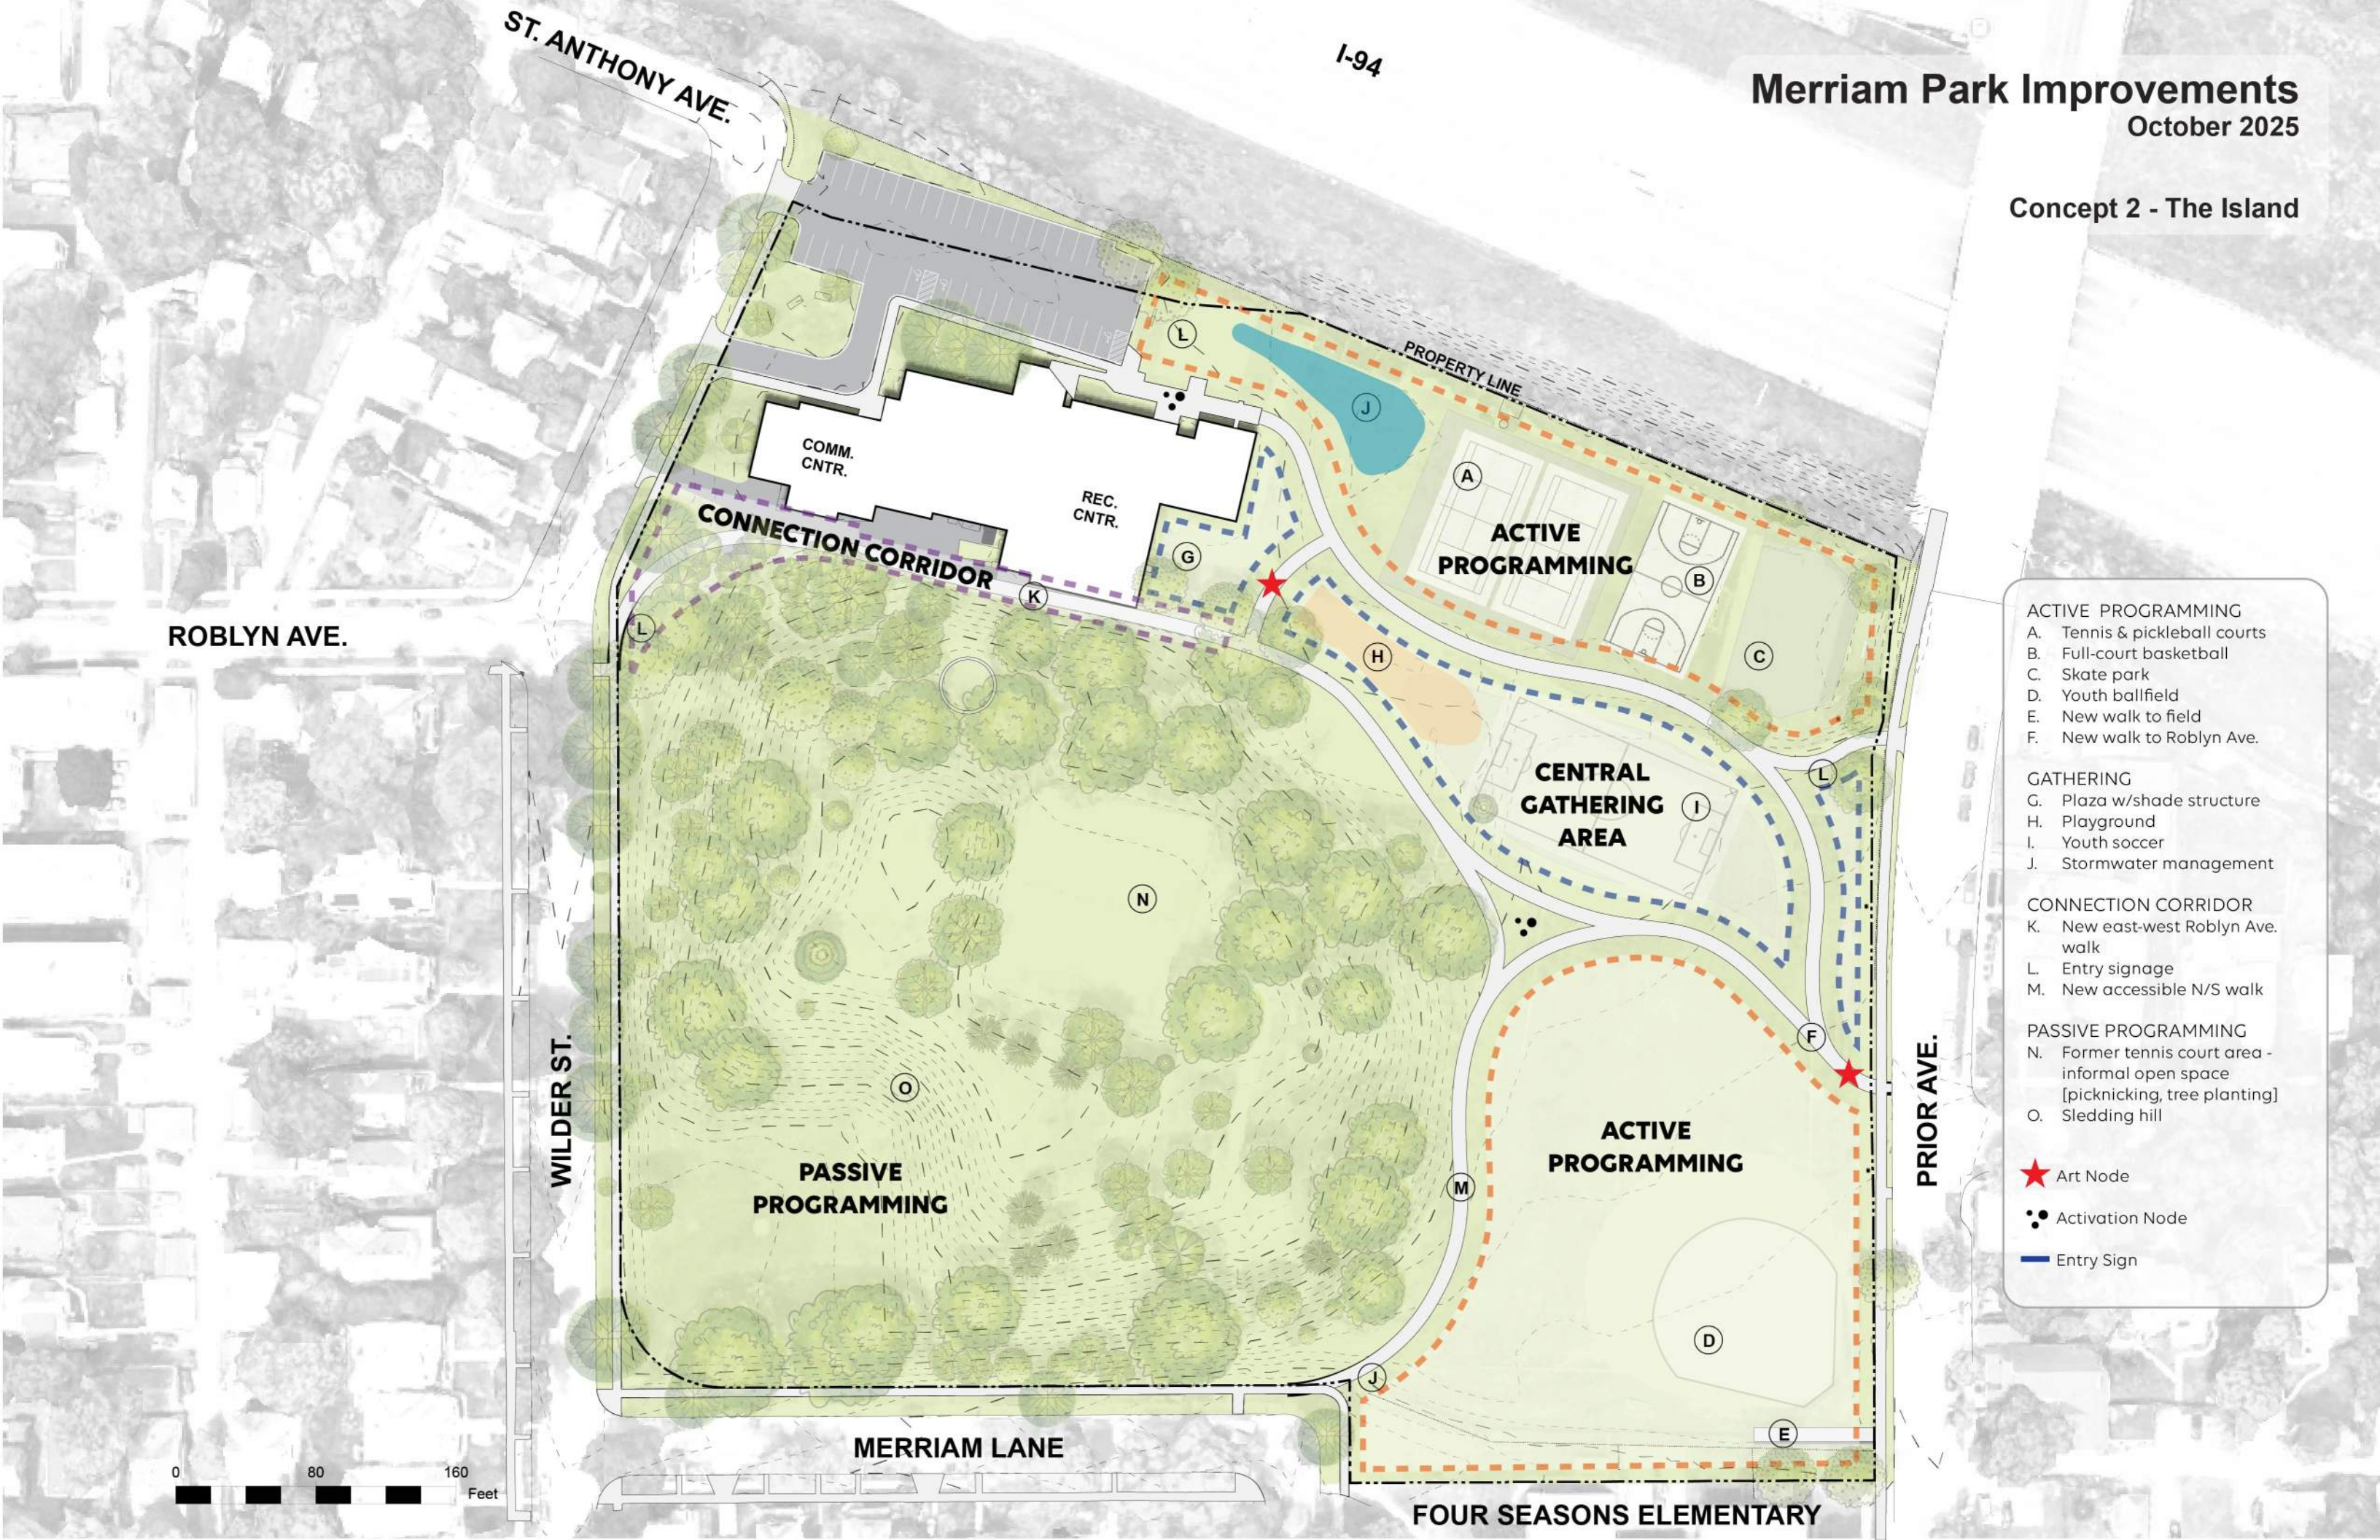
Concept 2 - The Island

- ACTIVE PROGRAMMING**
- A. Tennis & pickleball courts
  - B. Full-court basketball
  - C. Skate park
  - D. Youth ballfield
  - E. New walk to field
  - F. New walk to Roblyn Ave.
- GATHERING**
- G. Plaza w/shade structure
  - H. Playground
  - I. Youth soccer
  - J. Stormwater management
- CONNECTION CORRIDOR**
- K. New east-west Roblyn Ave. walk
  - L. Entry signage
  - M. New accessible N/S walk
- PASSIVE PROGRAMMING**
- N. Former tennis court area - informal open space [picknicking, tree planting]
  - O. Sledding hill
- ★ Art Node
- Activation Node
- Entry Sign
