Lilydale Regional Park “North Knob” Stabilization Meeting

February 1, 2018

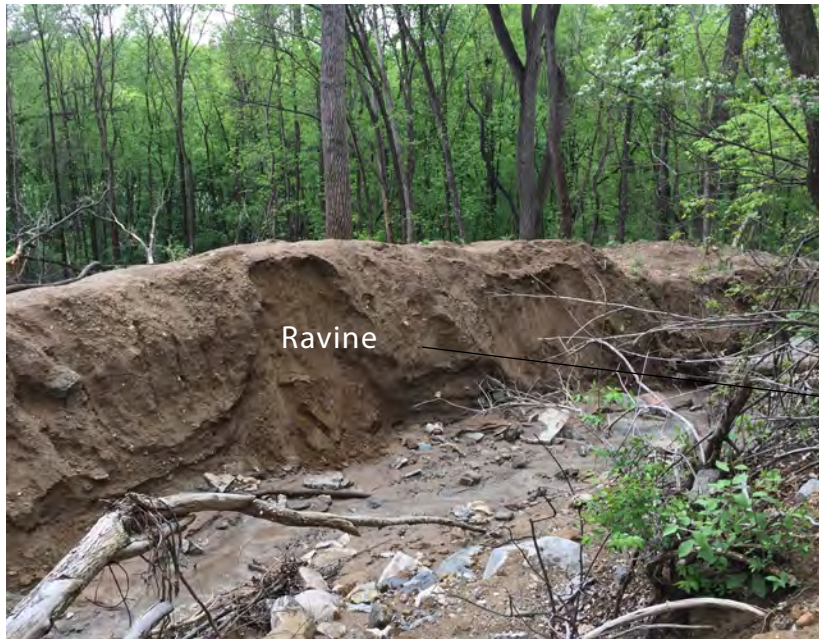
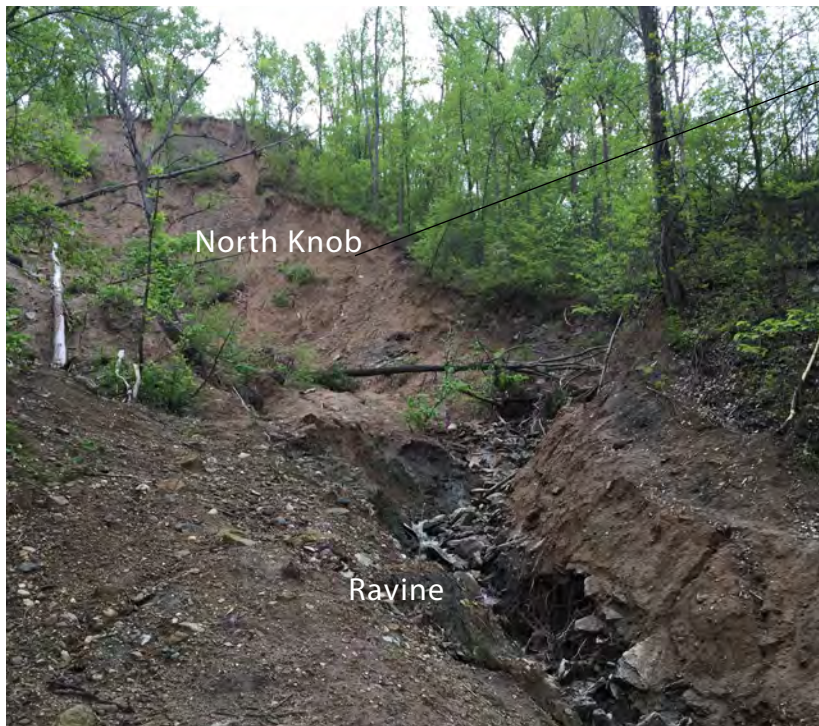
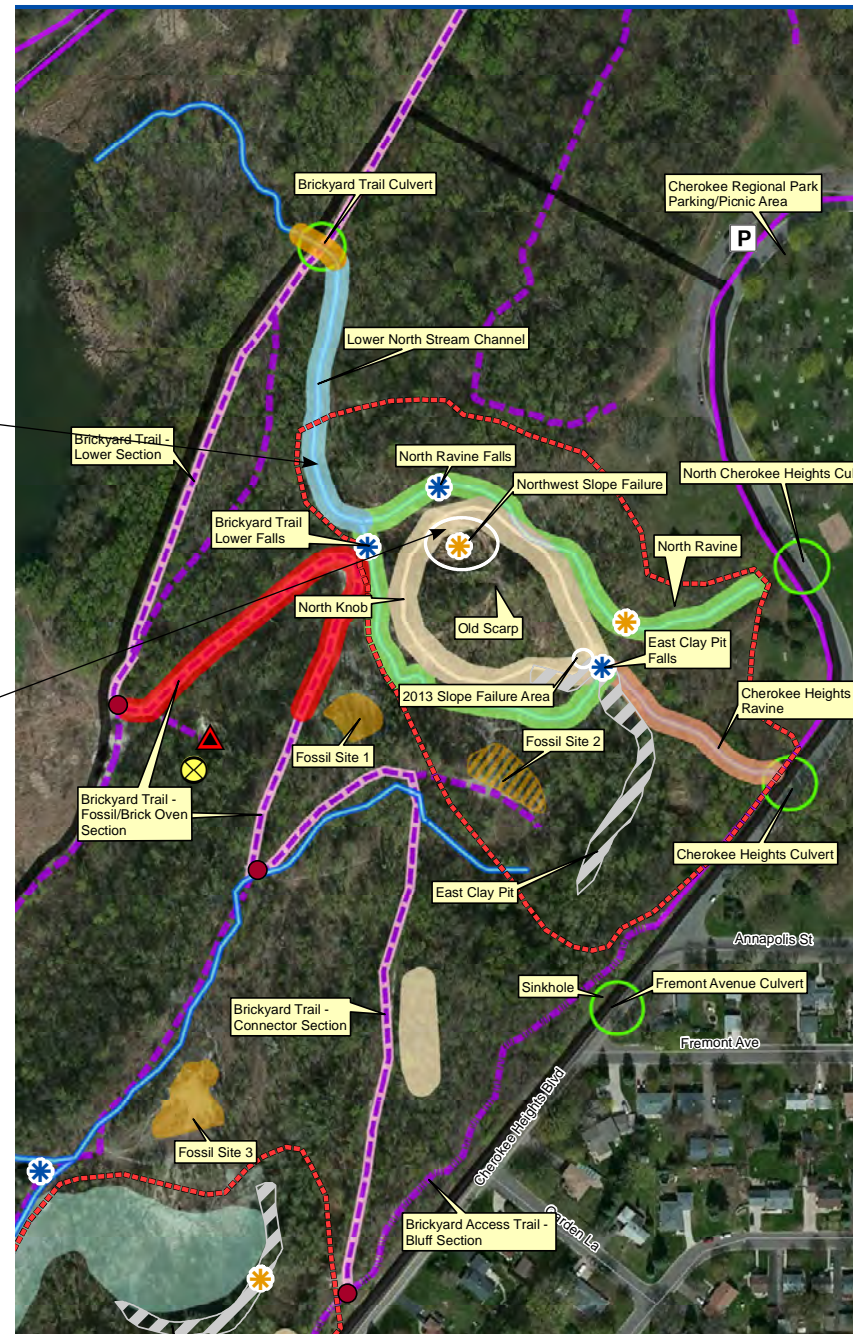
Pre-construction condition (March 2015)

4' gully across path-
culvert 100% blocked and
washout around

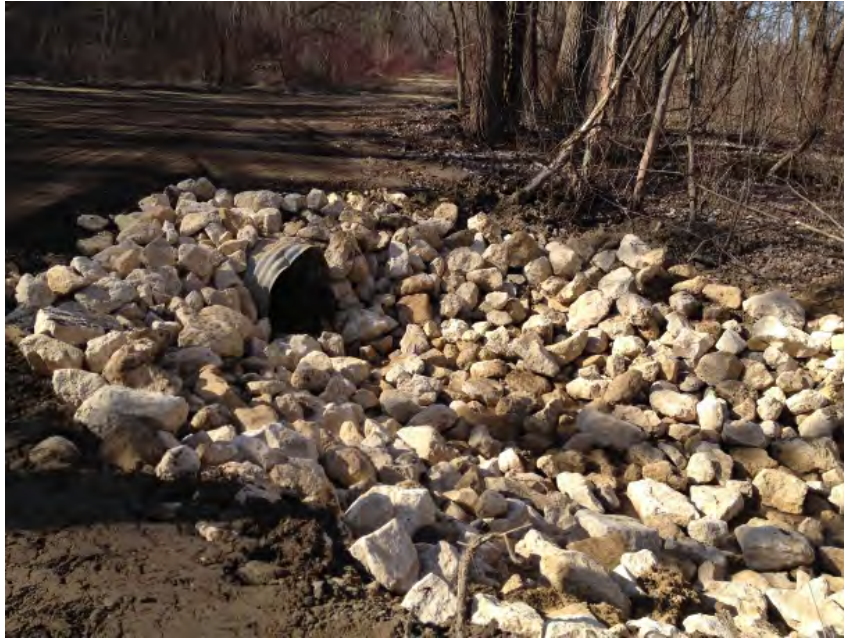
Culvert Repair (April 2015)

Culvert removed, ravine channel regraded and culvert replaced.

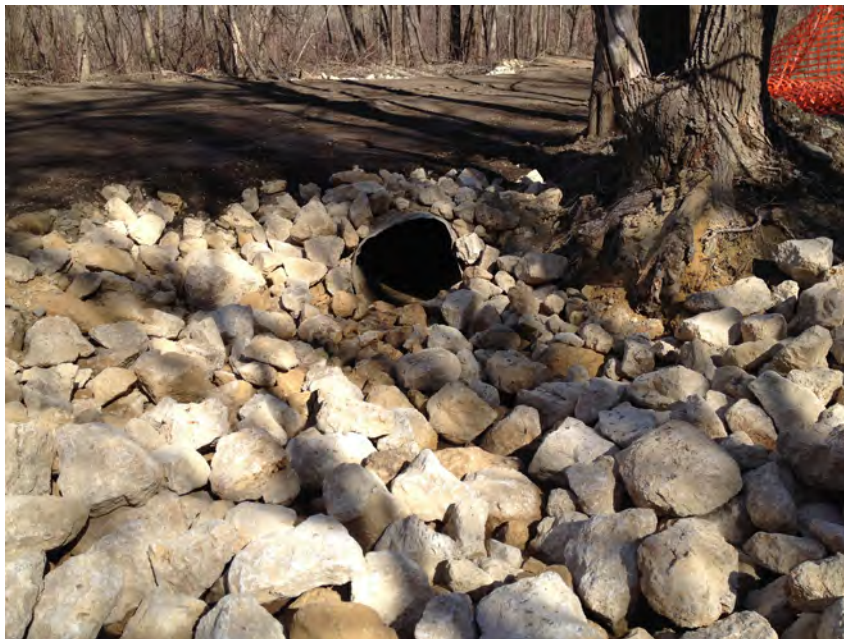
Post Rain Event (May 8, 2015)

75% blockage after rain event. Upstream channel diverted during rain event and resulted in erosion west of culvert.

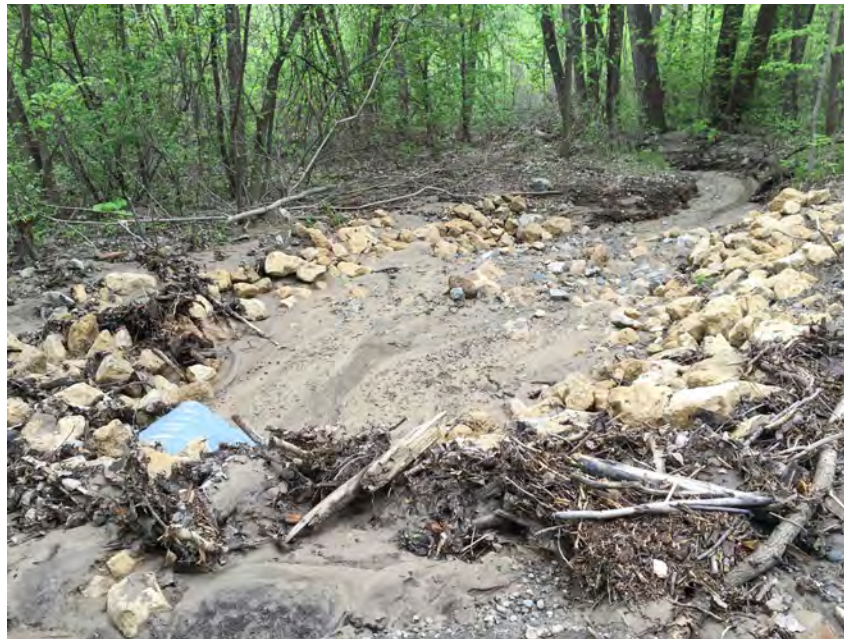
Post Rain Event (May 28, 2015)

100% blockage after
additional rain events.

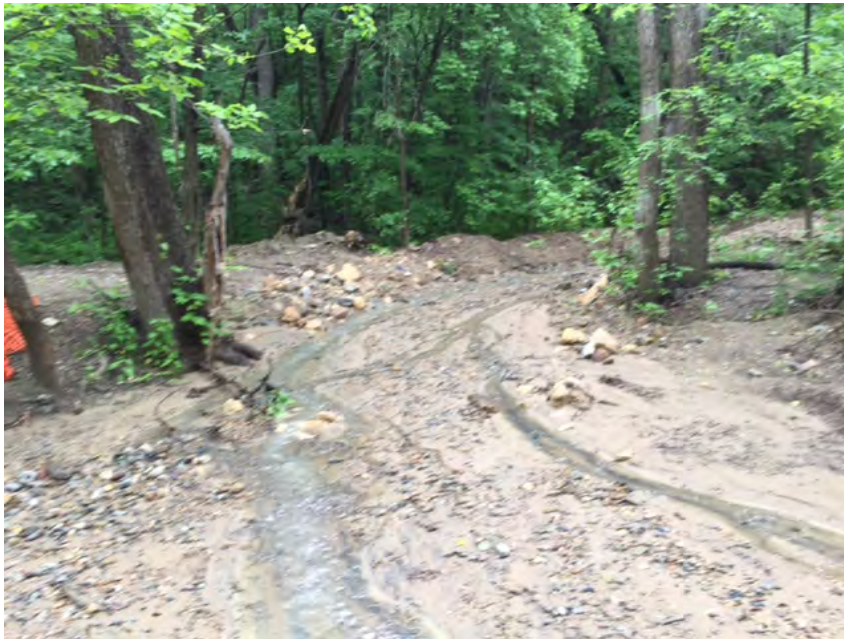
Sediment carried to Mississippi River via Pickerel Lake

***Sediment from North Knob area
will continue to be deposited into
Pickerel Lake and Mississippi River
until North Knob stabilized.***

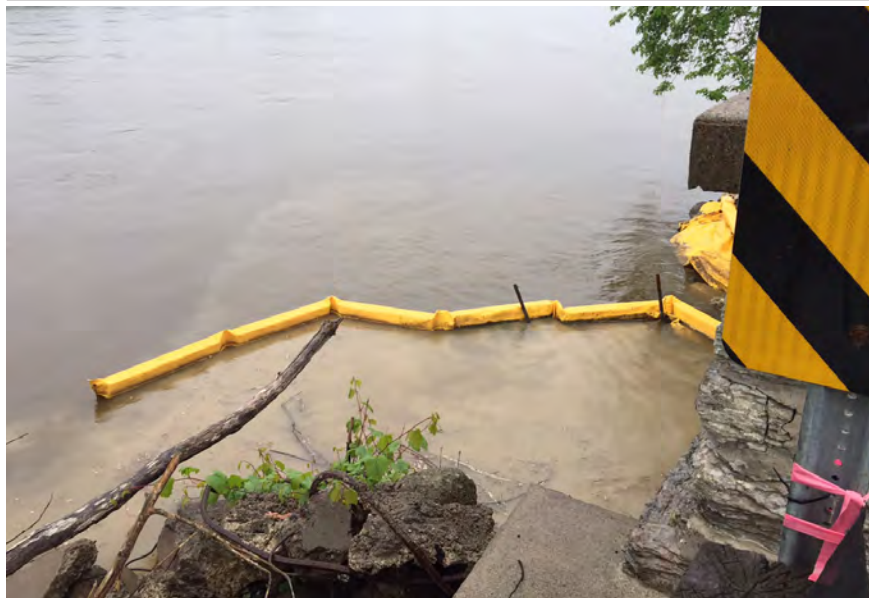
Sediment caught by floating silt curtain

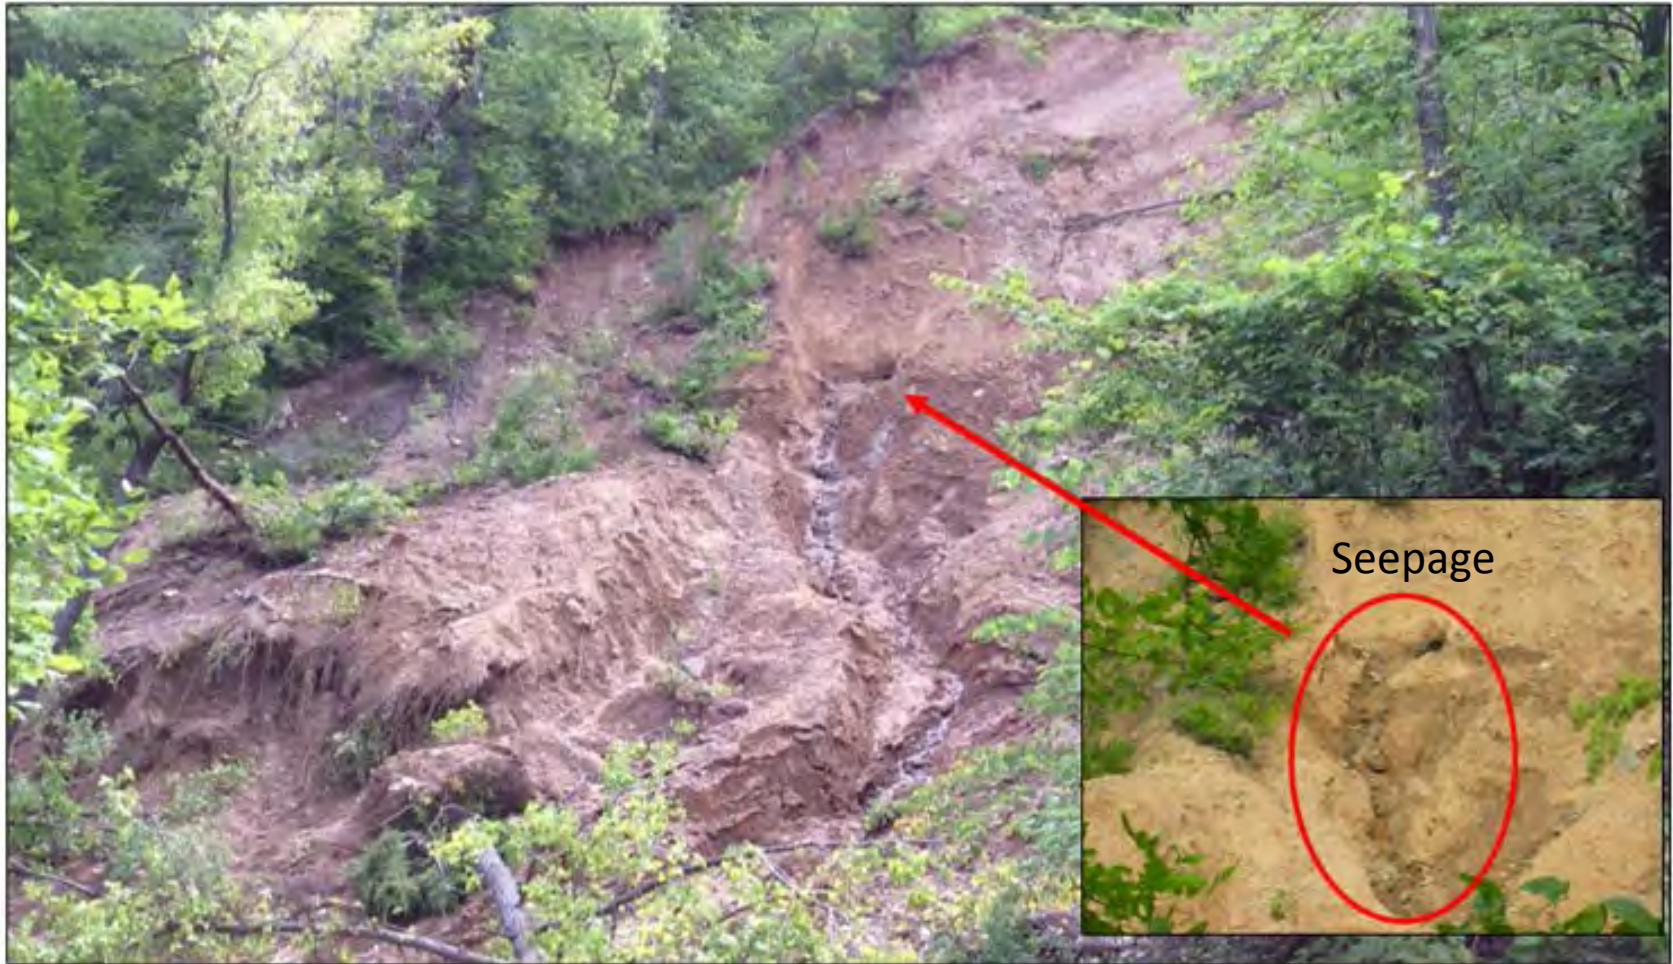
Slope Failure Area & Lower North Stream Channel

Large June 2014 slope failure from below with inset showing seepage (July 2014 site visit)

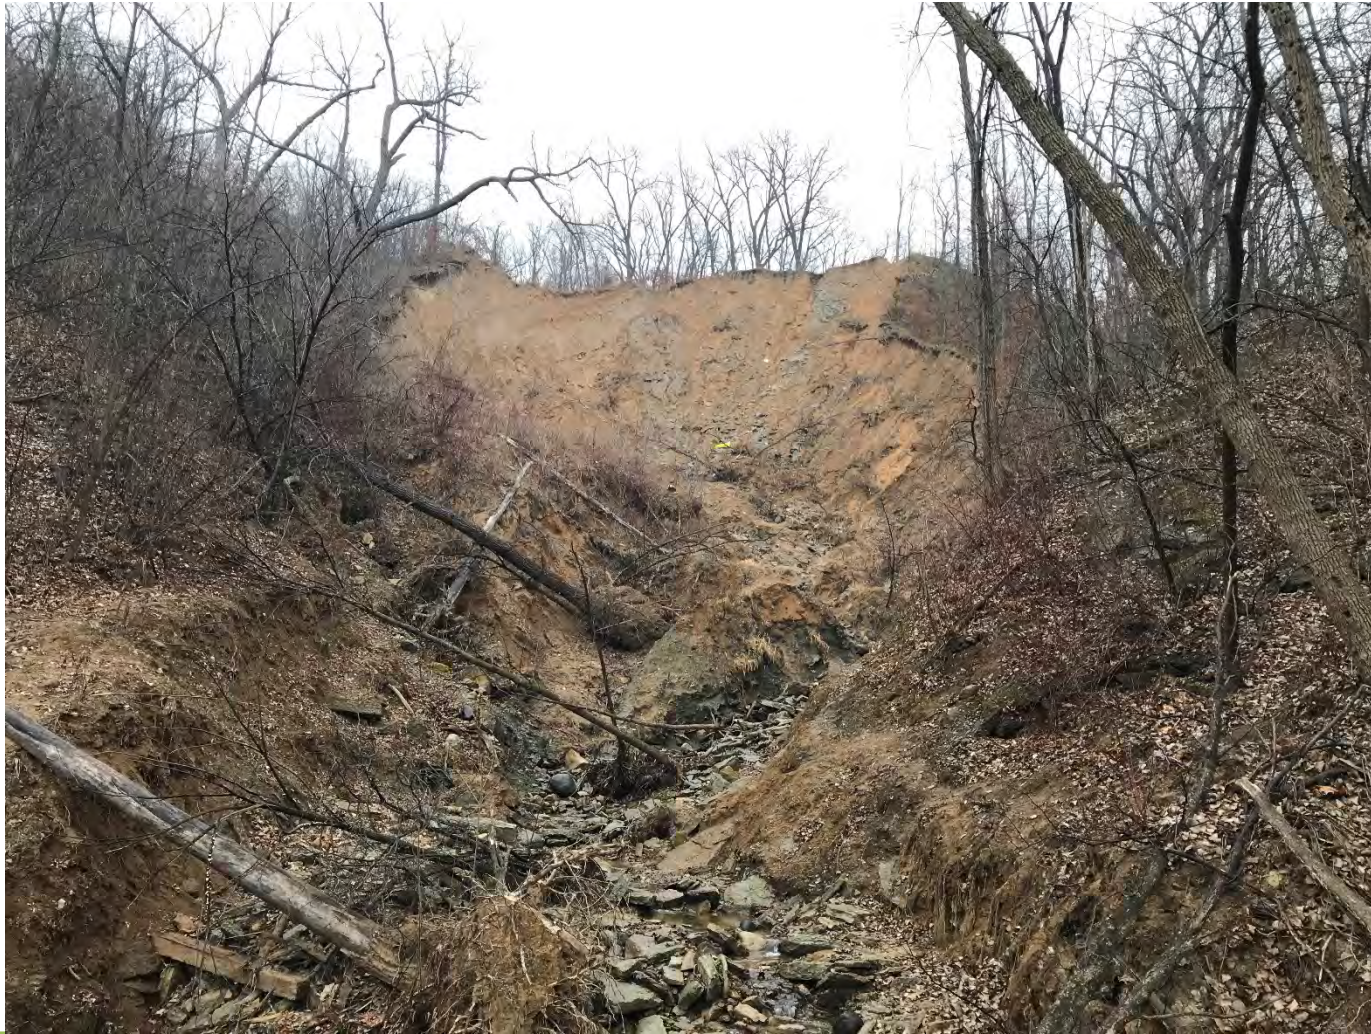
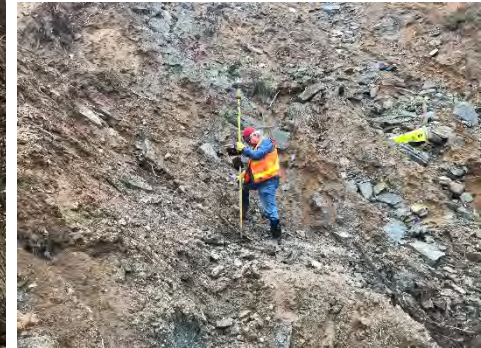
Slope Failure Area & Lower Stream Channel

Large slide, looking up through eroded stream channel (December 4 2017 site visit)

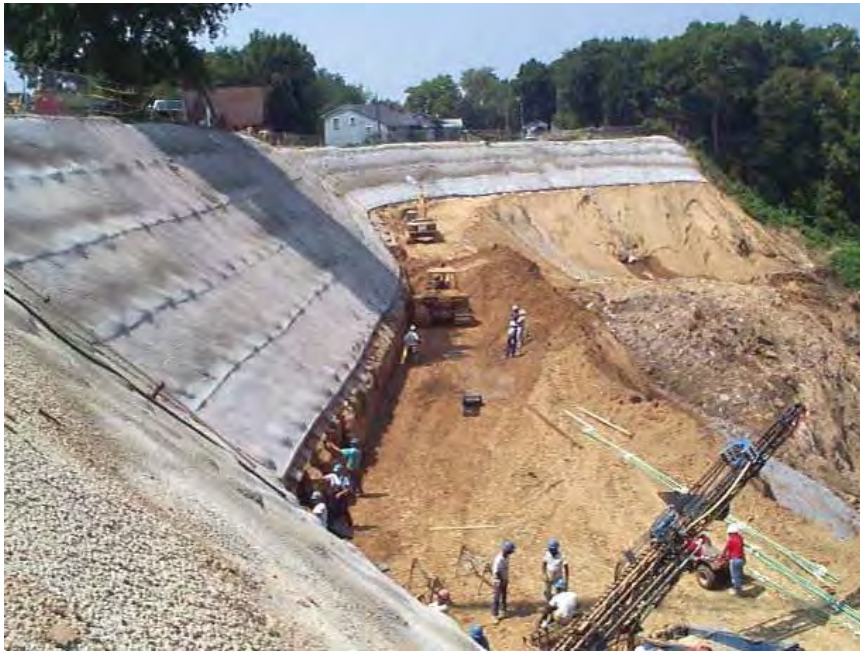
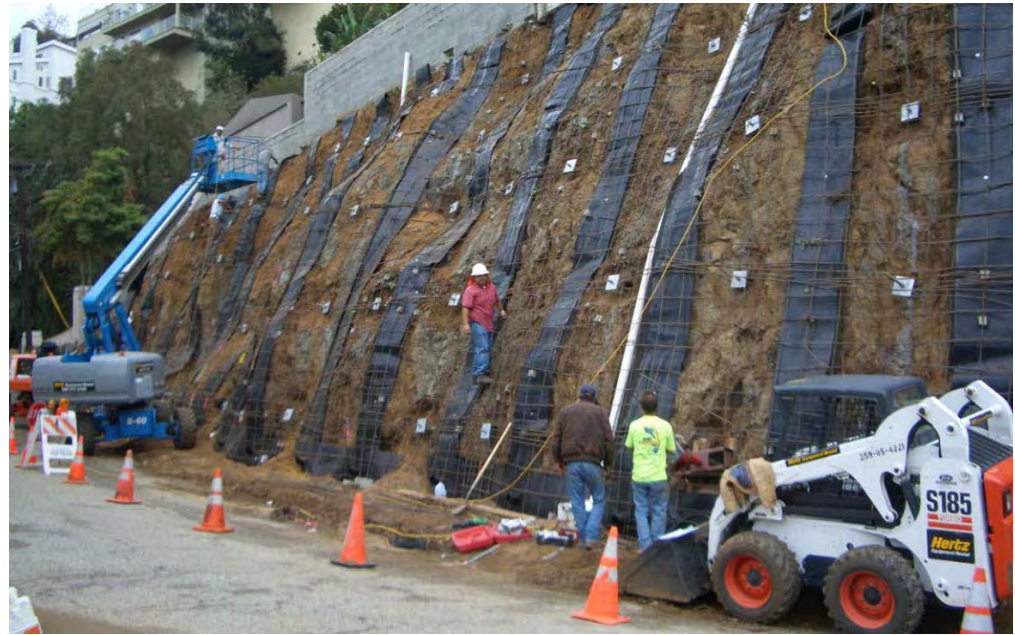
Conceptual Slope Stabilization Options

1. Mechanical Stabilization – soil nails

- Unnatural aesthetics
- High cost

Soil Nails

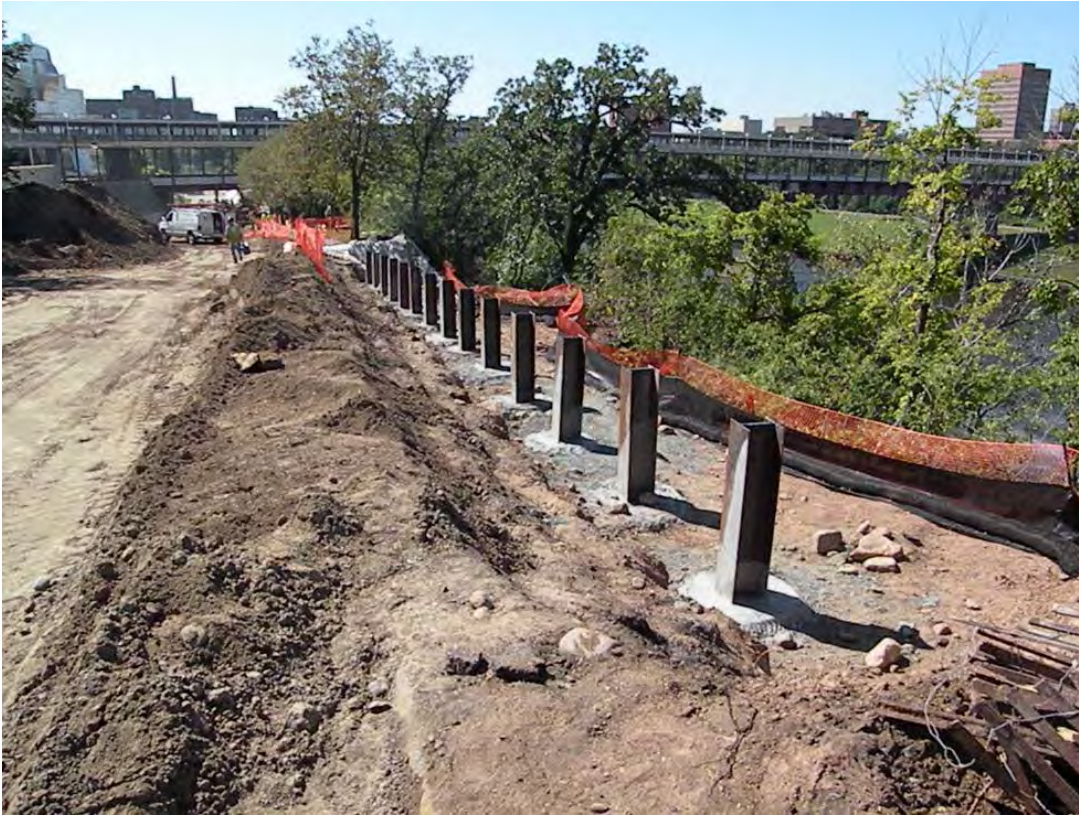
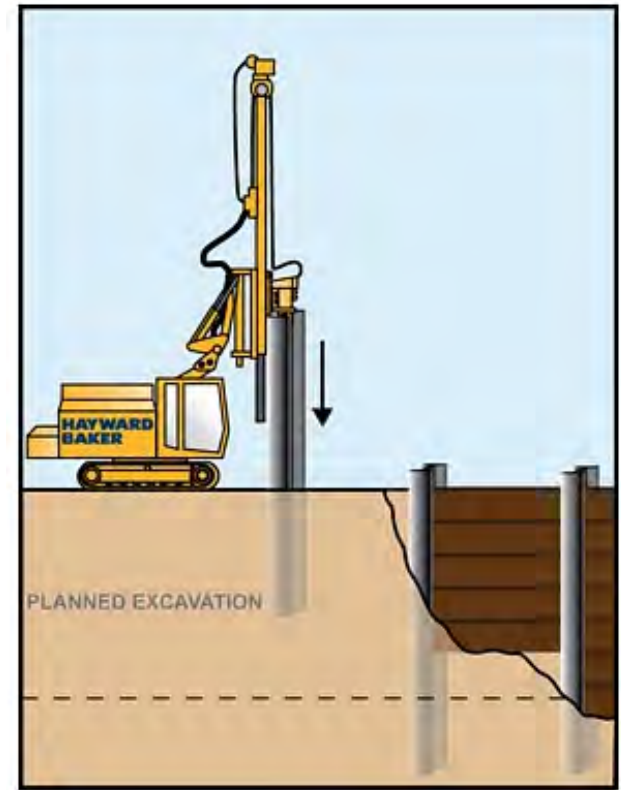
Conceptual Slope Stabilization Options

2. Mechanical Stabilization – piles

- Constructability issues
- High cost

Piles

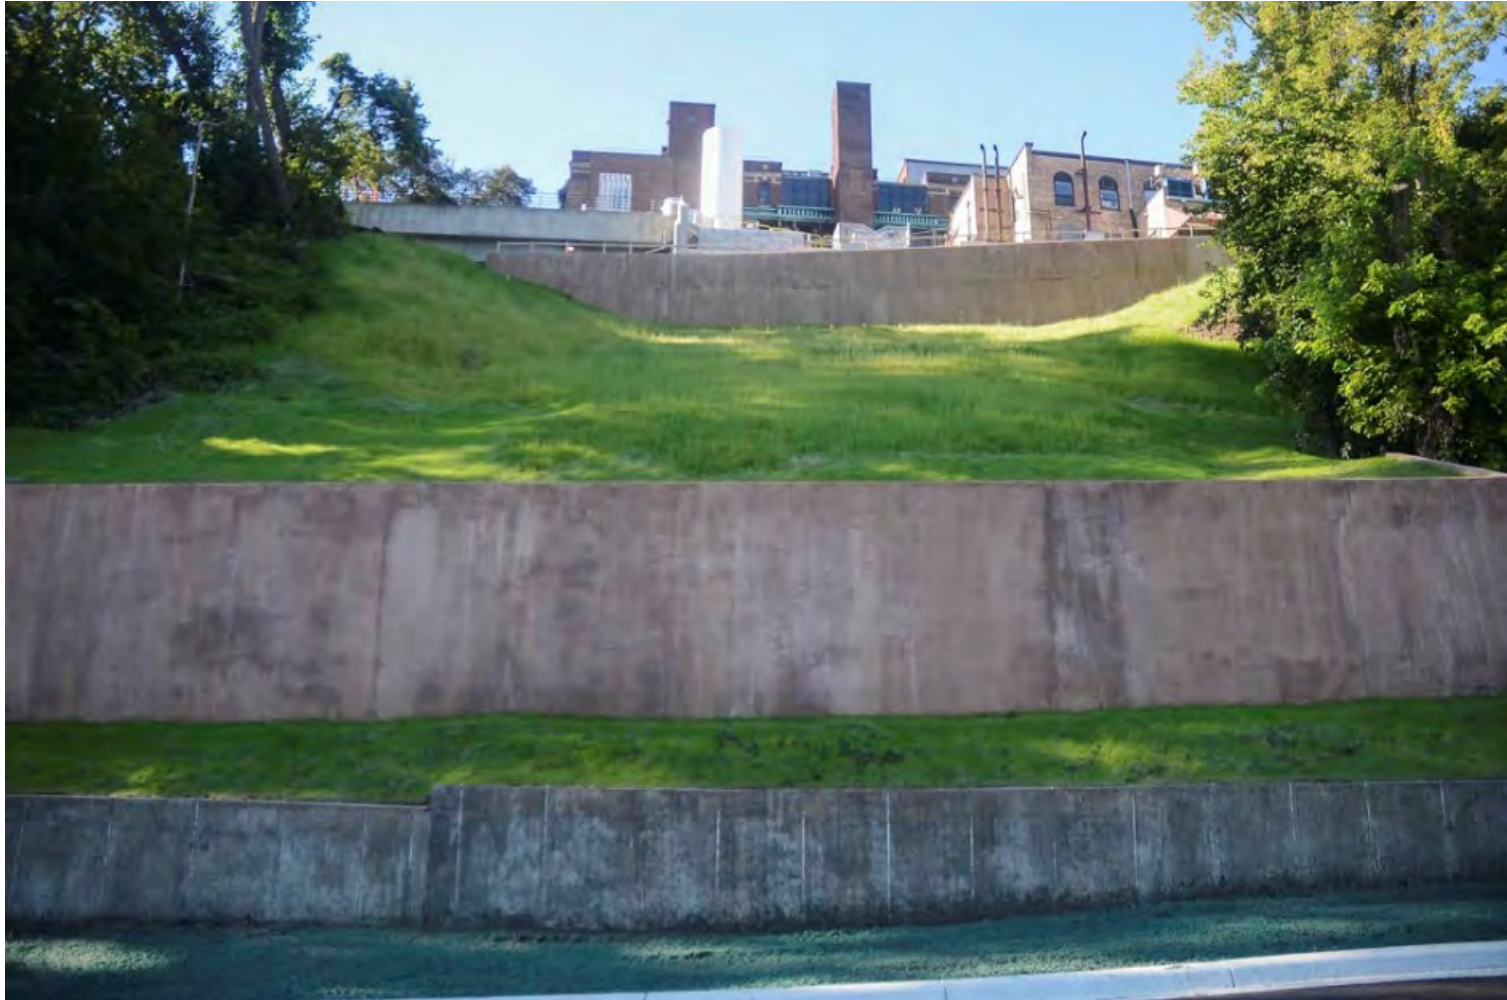
Conceptual Slope Stabilization Options

Walls, Graded Slope, Soils Nails

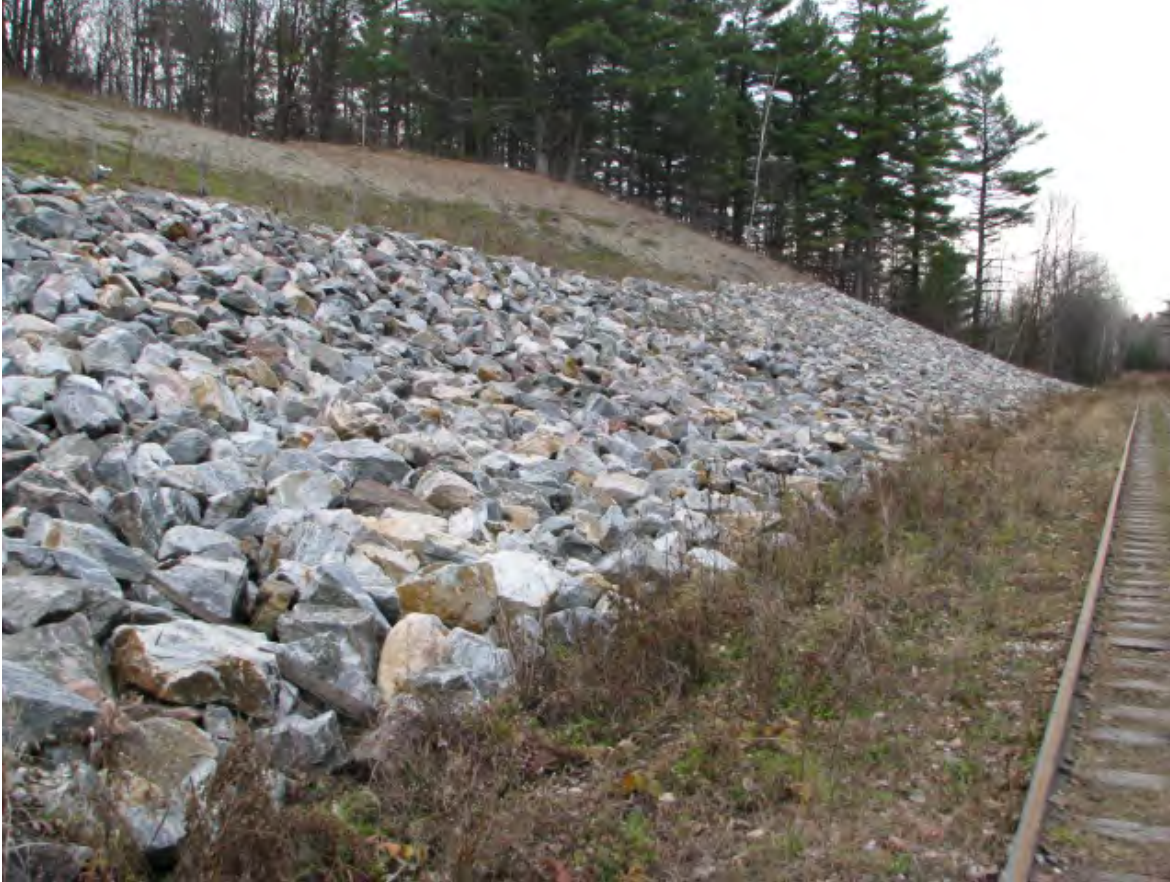
Conceptual Slope Stabilization Options

Graded Slope, Toe Protection

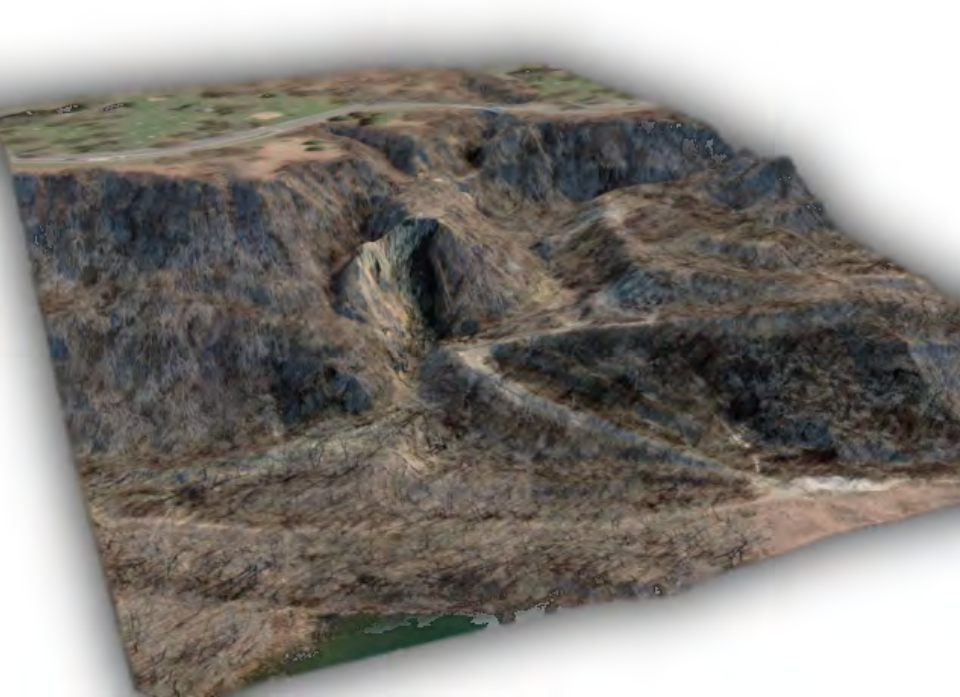
Existing

Restoration - 3D Simulation
