<b>Date</b>	October 29, 2012 ( <i>Updated August 18, 2013</i> )
<b>To</b>	Brian Tourtelotte (City of St. Paul) Bob Fossum (Capitol Region Watershed District)
<b>From</b>	Meghan Jacobson, PhD, and Cecilio Olivier, PE
<b>Regarding</b>	Swede Hollow Water Quality Monitoring Data Analysis

# Swede Hollow Water Resource Improvements: Water Source Options

SWEDE HOLLOW PARK  
DAYLIGHTED STREAM ANALYSIS  
AND FEASIBILITY STUDY

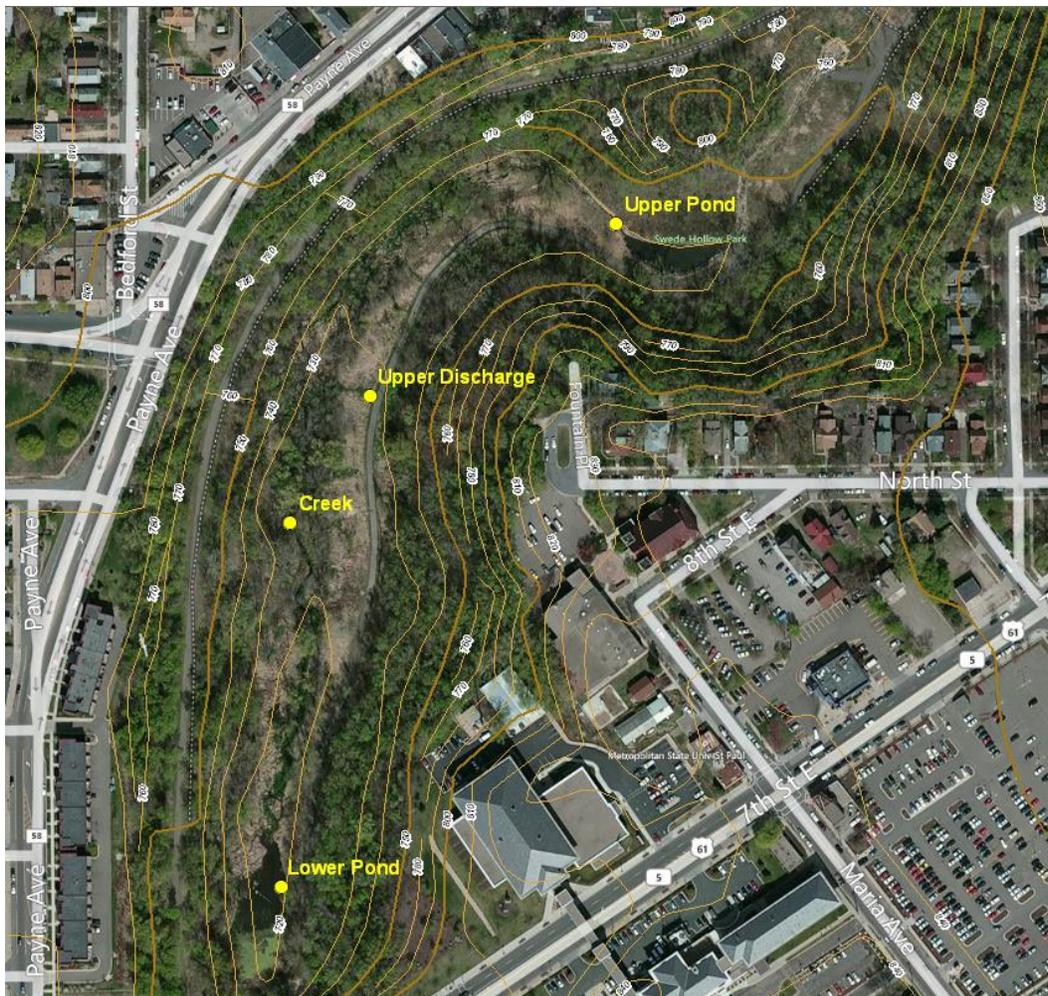
Figure 1. Water quality monitoring sites in the Swede Hollow study area, 2012

Water quality samples were collected from four sites on August 10 and from three sites on September 4, 2012 (Figure 1):

- Upper Pond:<sup>1</sup> Outlet of the Upper Pond

- Upper Discharge: Outlet of a pipe under the walking path at the base of the east hillside (groundwater seepage discharge)
- Creek: Within the Creek near a gravel path leading off the paved walking path
- Lower Pond

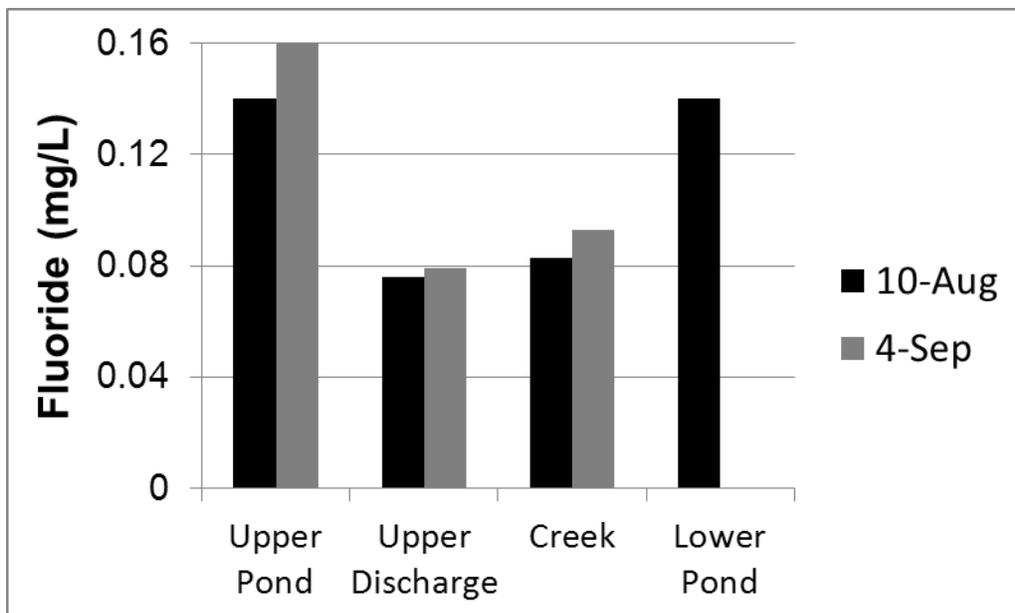
Figure 2. Bar graphs of fluoride concentrations in the Swede Hollow study area, 2012

Fluoride was measured as a potential indicator of municipal wastewater in the Creek. Fluoride is naturally found in the environment from igneous rock weathering. The overall median concentration of fluoride in Minnesota aquifers was 0.30 mg/L (range 0.27 – 0.45 mg/L; Minnesota Pollution Control Agency May 1999 Environmental Outcomes Division Factsheet: *Chloride and Fluoride in Minnesota’s Ground Water*). None of the fluoride concentrations measured as part of this study was greater than natural background concentrations typically found in Minnesota groundwater (Table 1). Additional fluoride is added to the water supply system during water treatment to prevent tooth decay. Average concentrations of fluoride in Saint Paul drinking water are 1.08 mg/L (range 1.0 – 1.1 mg/L), with a federal drinking water quality standard of 4.0 mg/L (Saint Paul Regional Water Services *Water Quality Report 2012*).

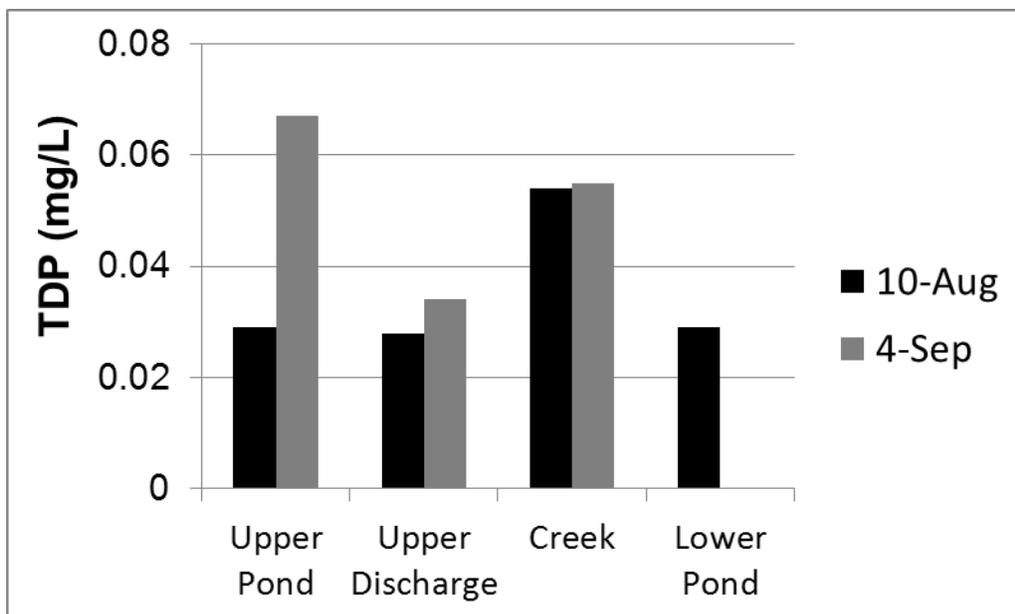
Figure 3. Bar graphs of total dissolved phosphorus (TDP) concentrations in the Swede Hollow study area, 2012

Total dissolved phosphorus (TDP) and total phosphorus (TP) were measured as potential nutrient sources for the observed algal blooms in the creek. TP includes both dissolved and particulate (phosphorus incorporated into living tissue or adsorbed to sediments) forms. TDP typically comprises a greater fraction of the TP in municipal wastewater, due to leaching of dissolved nutrients from human waste, than the TP in surface waters, where P is found in plant or algae tissues or bound to sediment. Typical TP concentrations in Minnesota wastewater are 5.86 mg/L (range 1.17 mg/L – 25.05 mg/L; MPCA report wq-qqtp9-06a Appendix A: *Phosphorus Removal by Minnesota Municipal Wastewater Treatment Facilities*), compared to 0.07 mg/L in Minnesota groundwater (Minnesota Pollution Control Agency, May 1999, Environmental Outcomes Division Factsheet: *Phosphorus in Minnesota's Ground Water*). TDP comprised nearly all of the TP found in the groundwater seepage discharge and creek sites, however at concentrations much lower than typical raw municipal wastewater and similar to typical groundwater. The TP concentrations in the Upper Discharge and Creek were similar to the overall median concentration of TP in Minnesota wells (0.07 mg/L). TP concentrations were higher in the Pond sites with smaller fractions of TDP indicating that more TP may be found in algal tissues. However, the TP concentration in the lower pond (0.065 mg/L) was near the Minnesota shallow lake water quality standard of 0.06 mg/L, indicating that the overall water quality of the Lower Pond was within the expected range for its size and depth. Moreover, the pond surface was covered in duck weed, a small floating aquatic plant, which can be mistaken for an algal bloom.

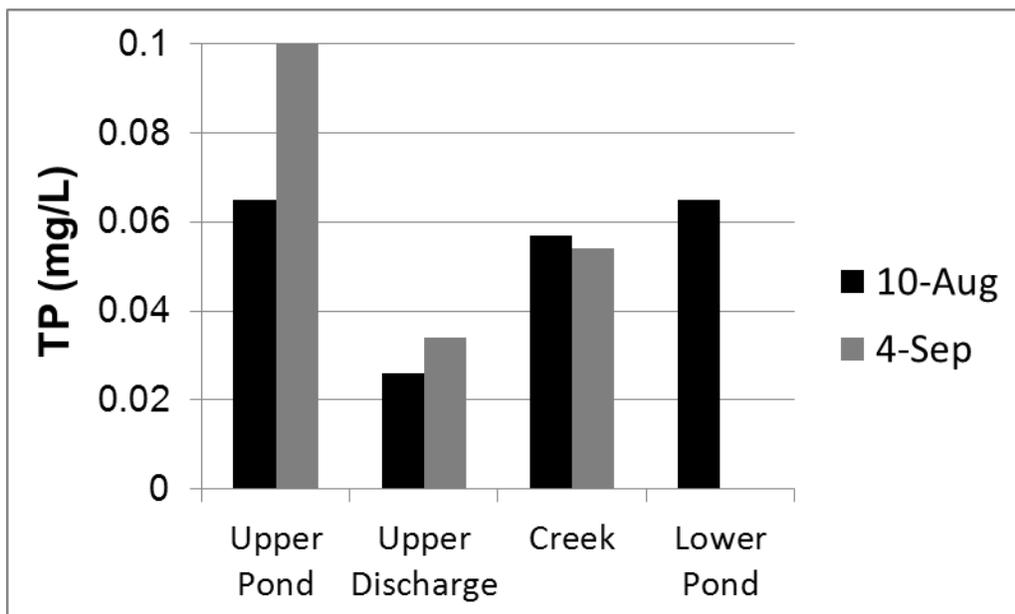
Figure 4. Bar graphs of total phosphorus (TP) concentrations in the Swede Hollow study area, 2012

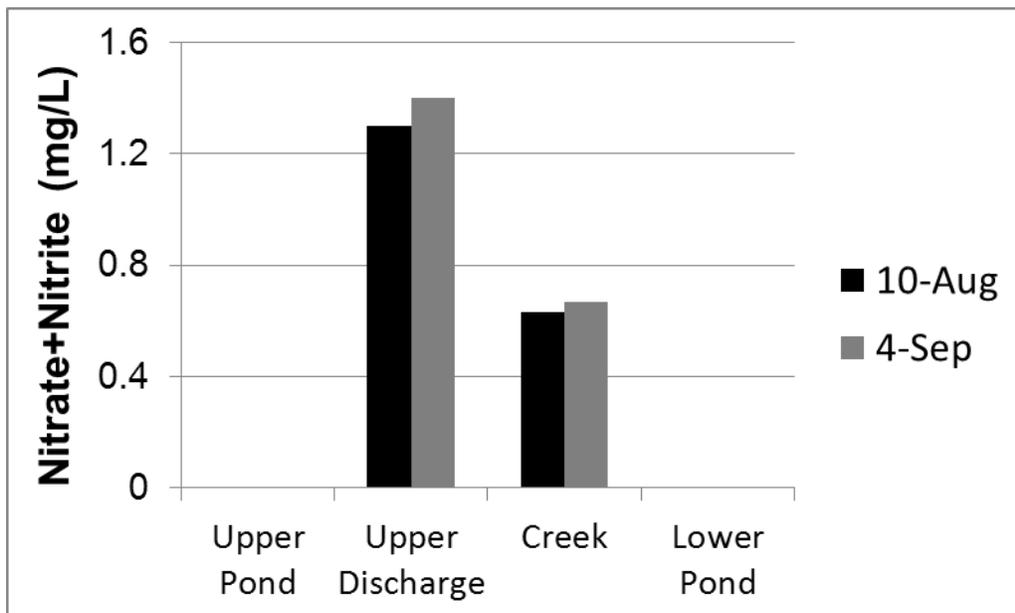
Figure 5. Bar graphs of nitrate and nitrite concentrations in the Swede Hollow study area, 2012

Nitrate and nitrite were measured as other potential nutrient sources for the observed algal blooms in the creek. Nitrate and nitrite are dissolved forms of nitrogen that can be taken up directly by plants and algae for growth. Nitrate and nitrite concentrations were highest in the groundwater seepage Discharge and Creek site. Nitrate and nitrite concentrations were below detection limit at both Pond sites suggesting that these forms of nitrogen were being taken up quickly from surface waters for algal growth.

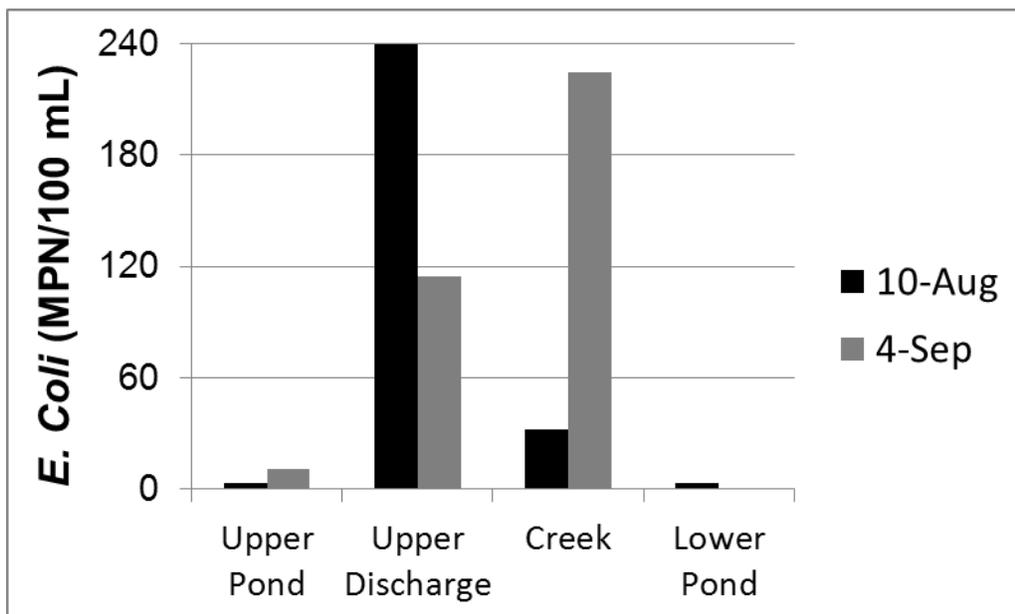
Figure 6. Bar graphs of *Escherichia coli* (*E. coli*) concentrations in the Swede Hollow study area, 2012

*E. coli* was measured as another potential indicator of municipal wastewater in the creek. High *E. coli* concentrations in surface waters are typically associated with sources of human or animal waste. The *E. coli* levels in the Upper Discharge and Creek sites were higher than either pond

site, and exceeded the State surface water quality standard (126 organisms/ 100 mL) on a single occasion in August for the Upper Discharge site and on a single occasion in September for the Creek site (Table 1). However, a minimum of 5 samples in the same month should be taken to determine an accurate geometric mean *E. coli* level.<sup>2</sup>

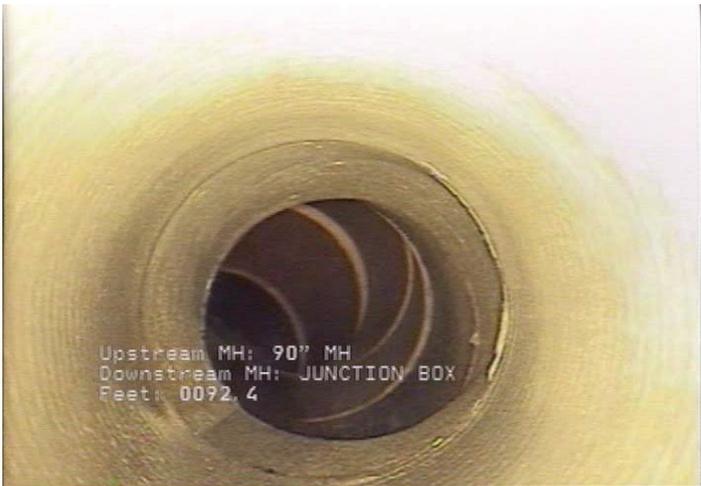
MGO - General Observation @ 60.0 ft.  
LOOKING UP LINE THAT GOES UP HILL

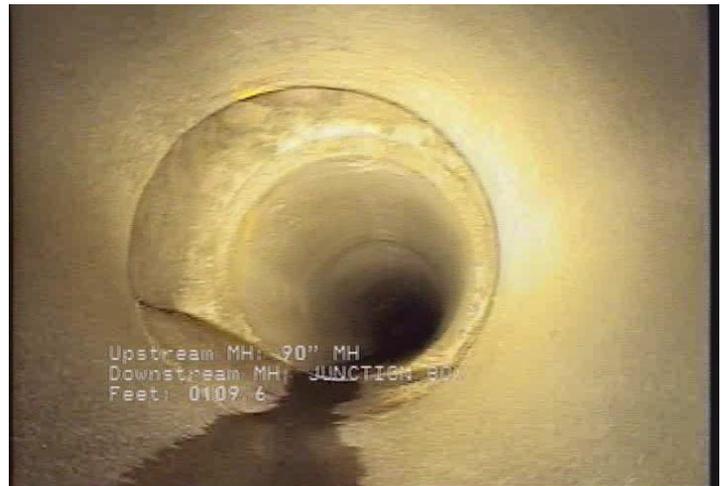
MGO - General Observation @ 98.0 ft.  
LOOKING UP 36"

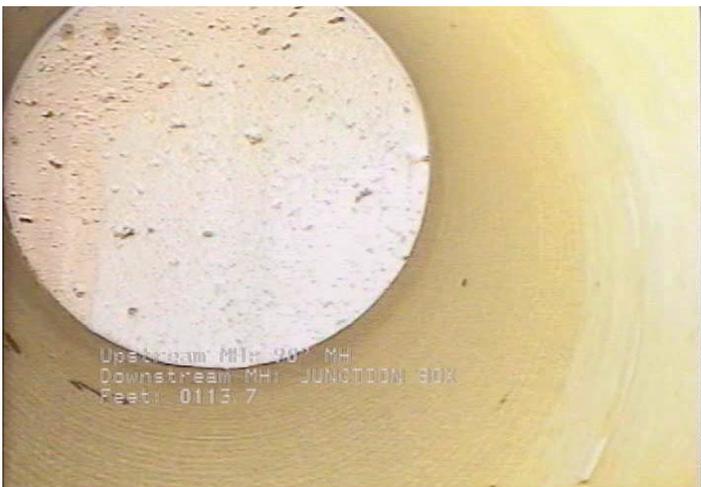
MGO - General Observation @ 103.0 ft.  
LOOKING UP DROP INLET

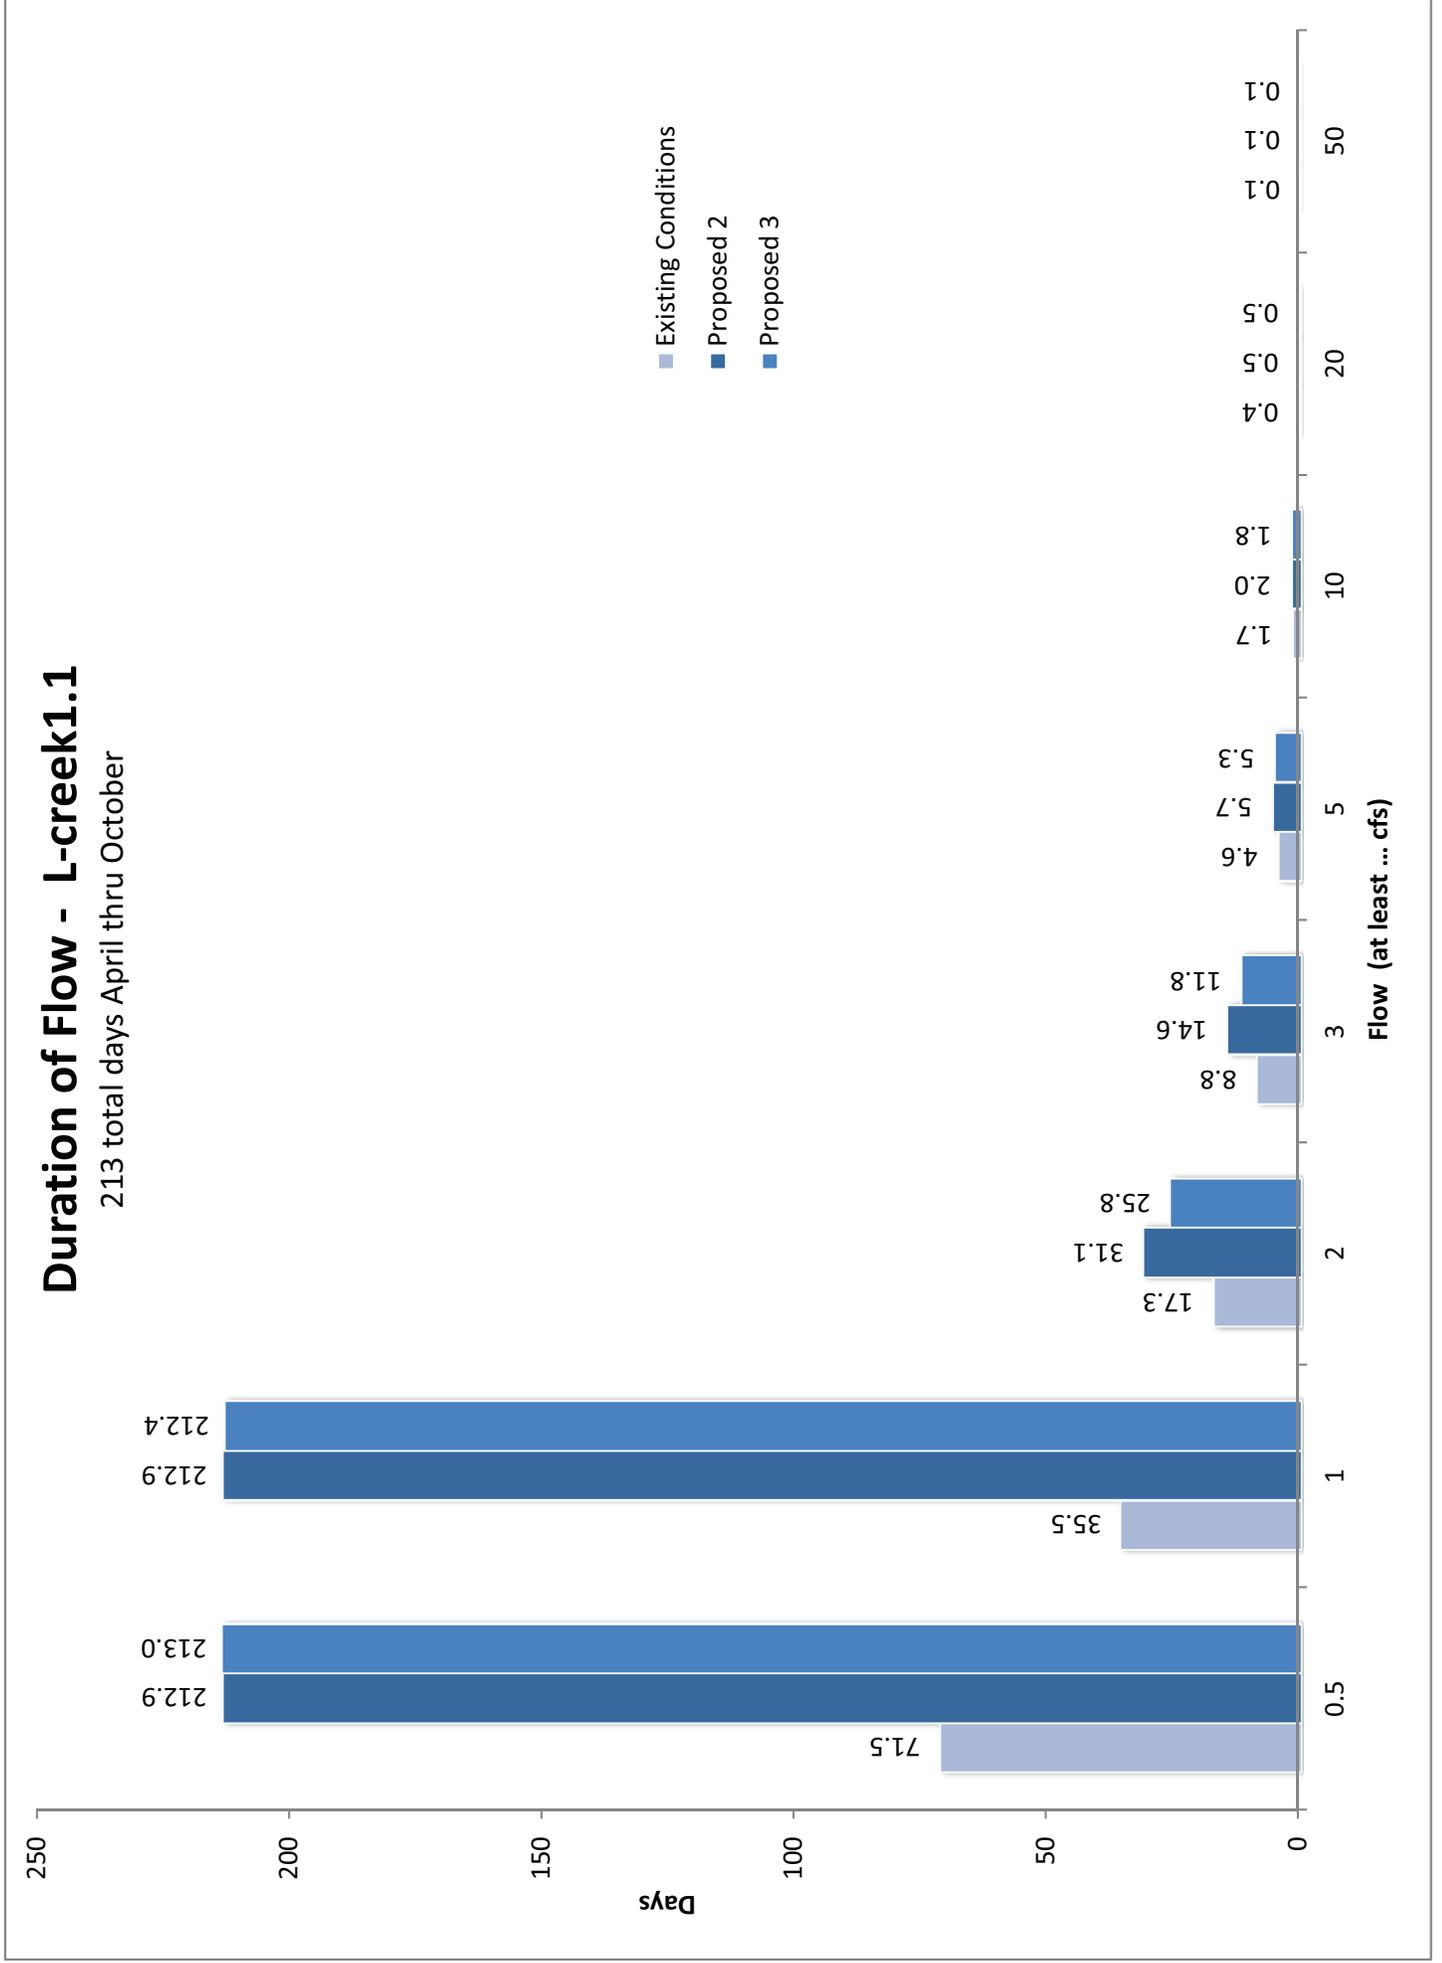
Figure 12. Duration of Flow for L-creek1.1

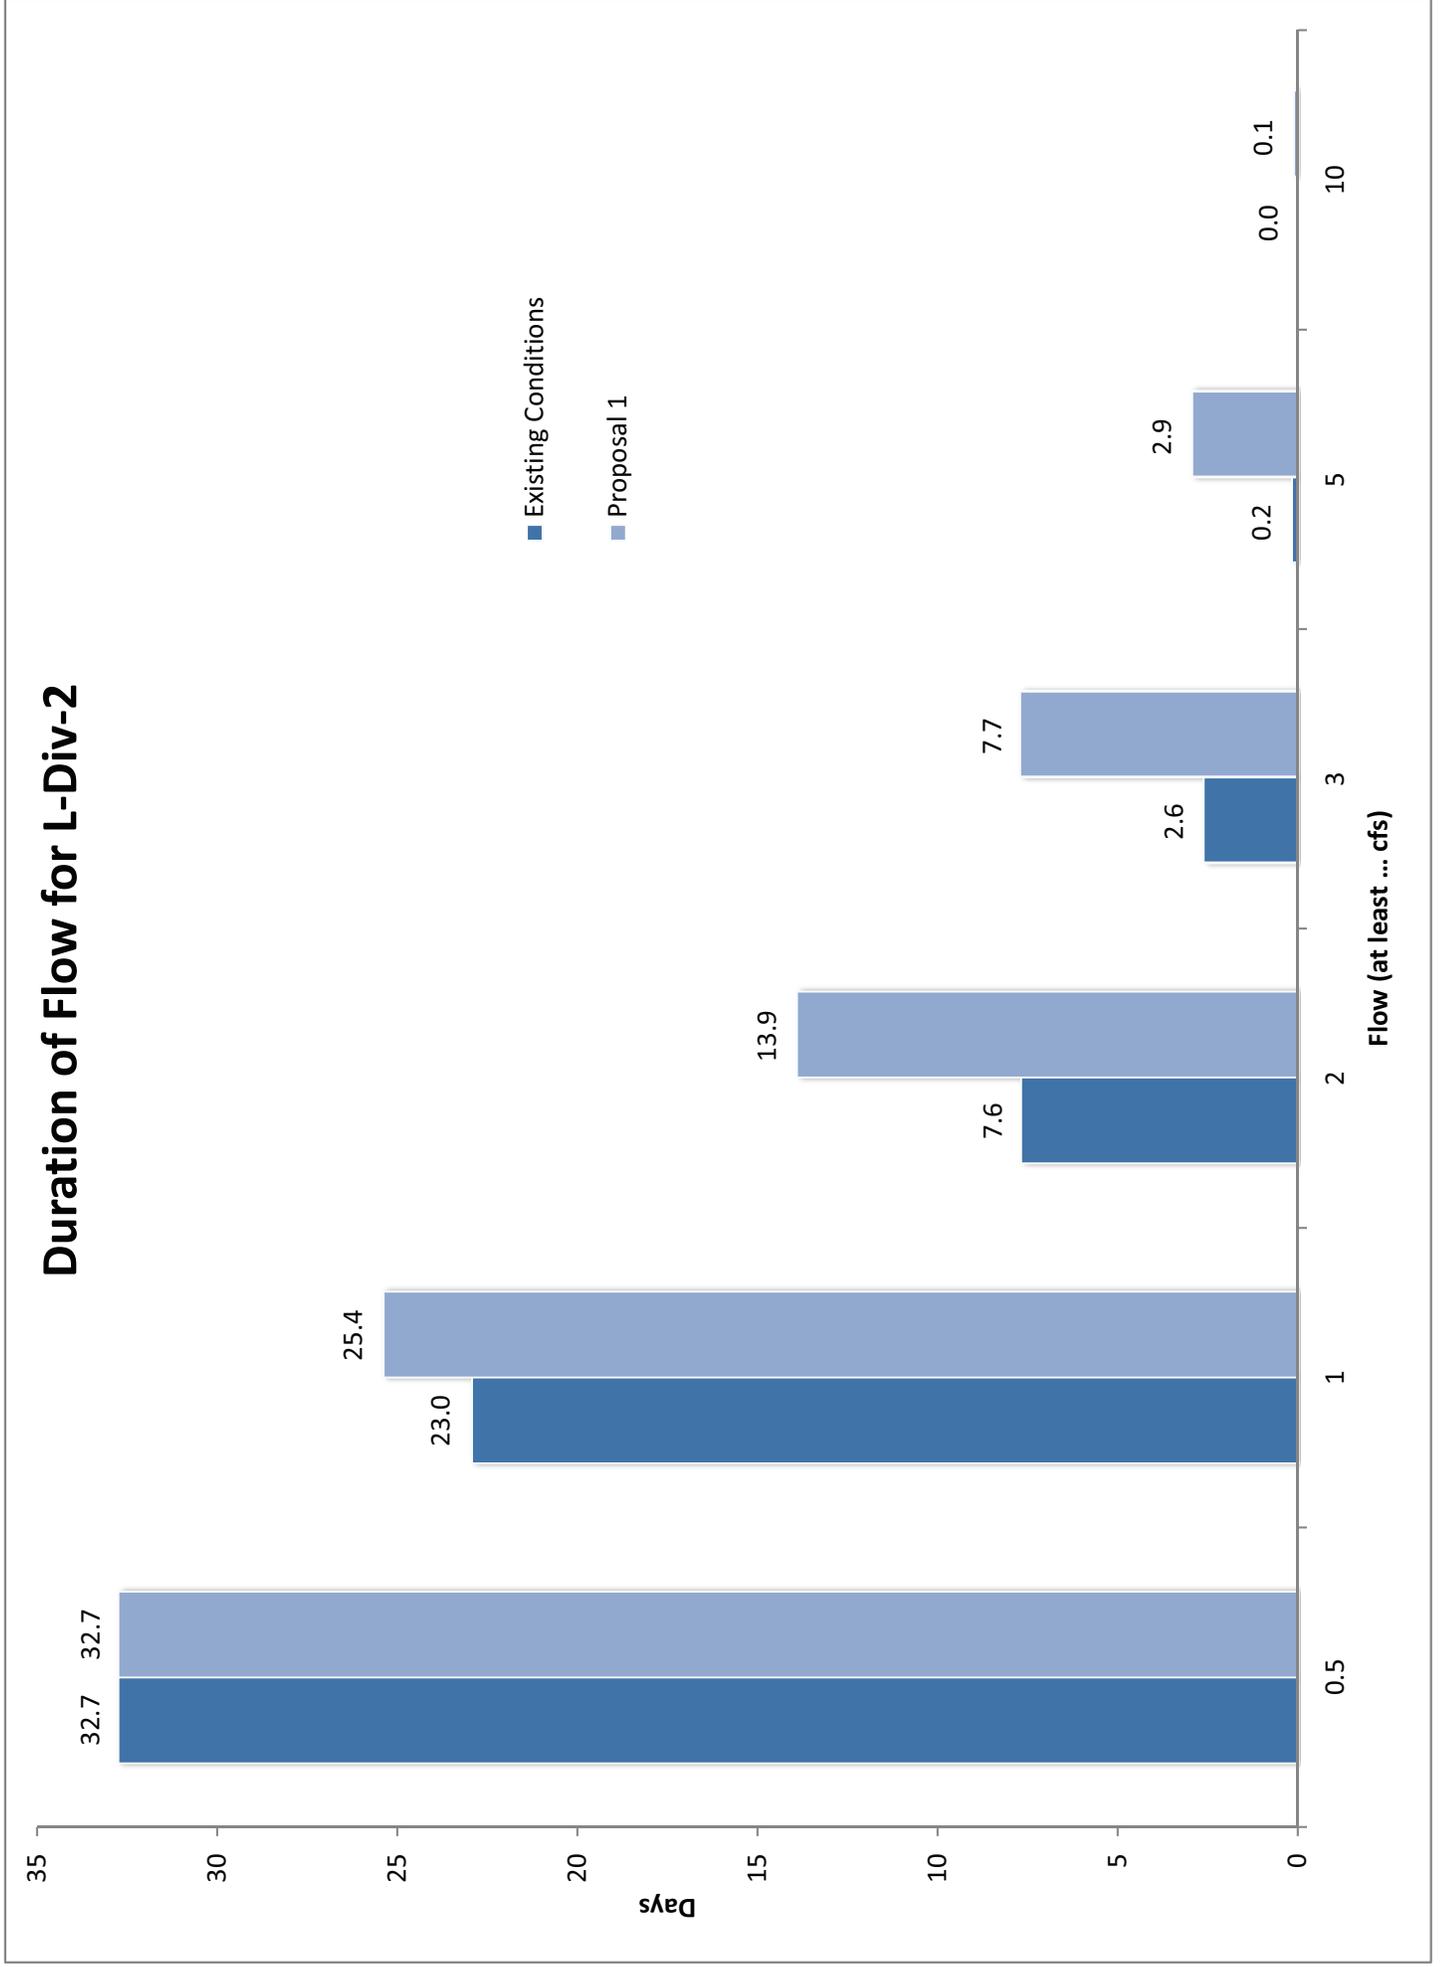
Figure 13. Duration of Flow for L-Div-2

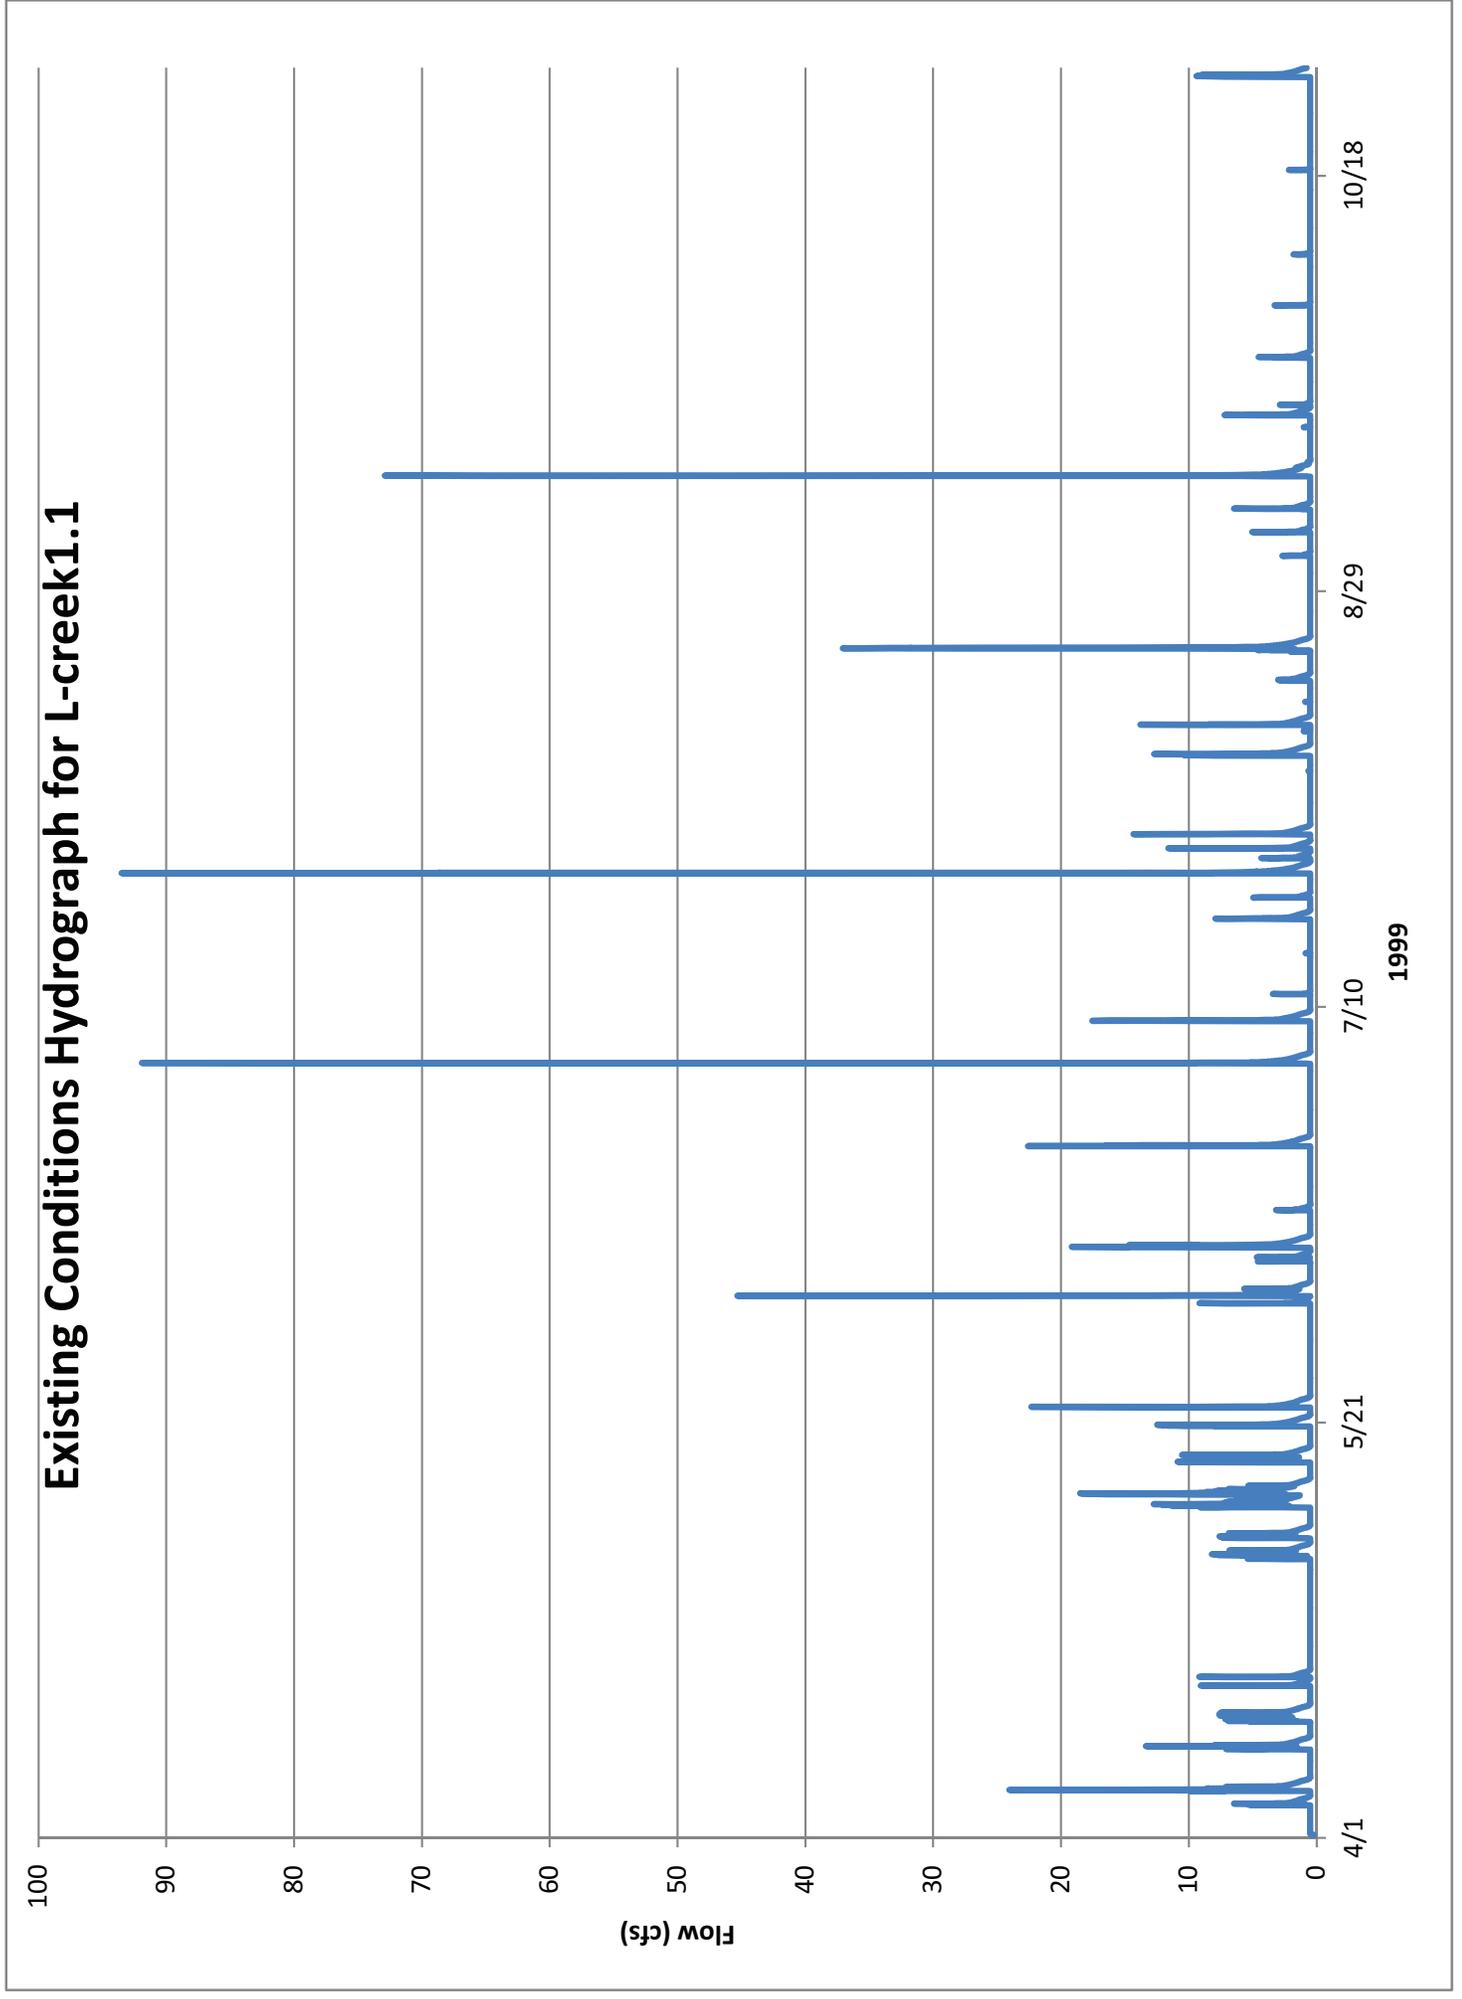
Figure 14. Existing Conditions Hydrograph for L-creek1.1

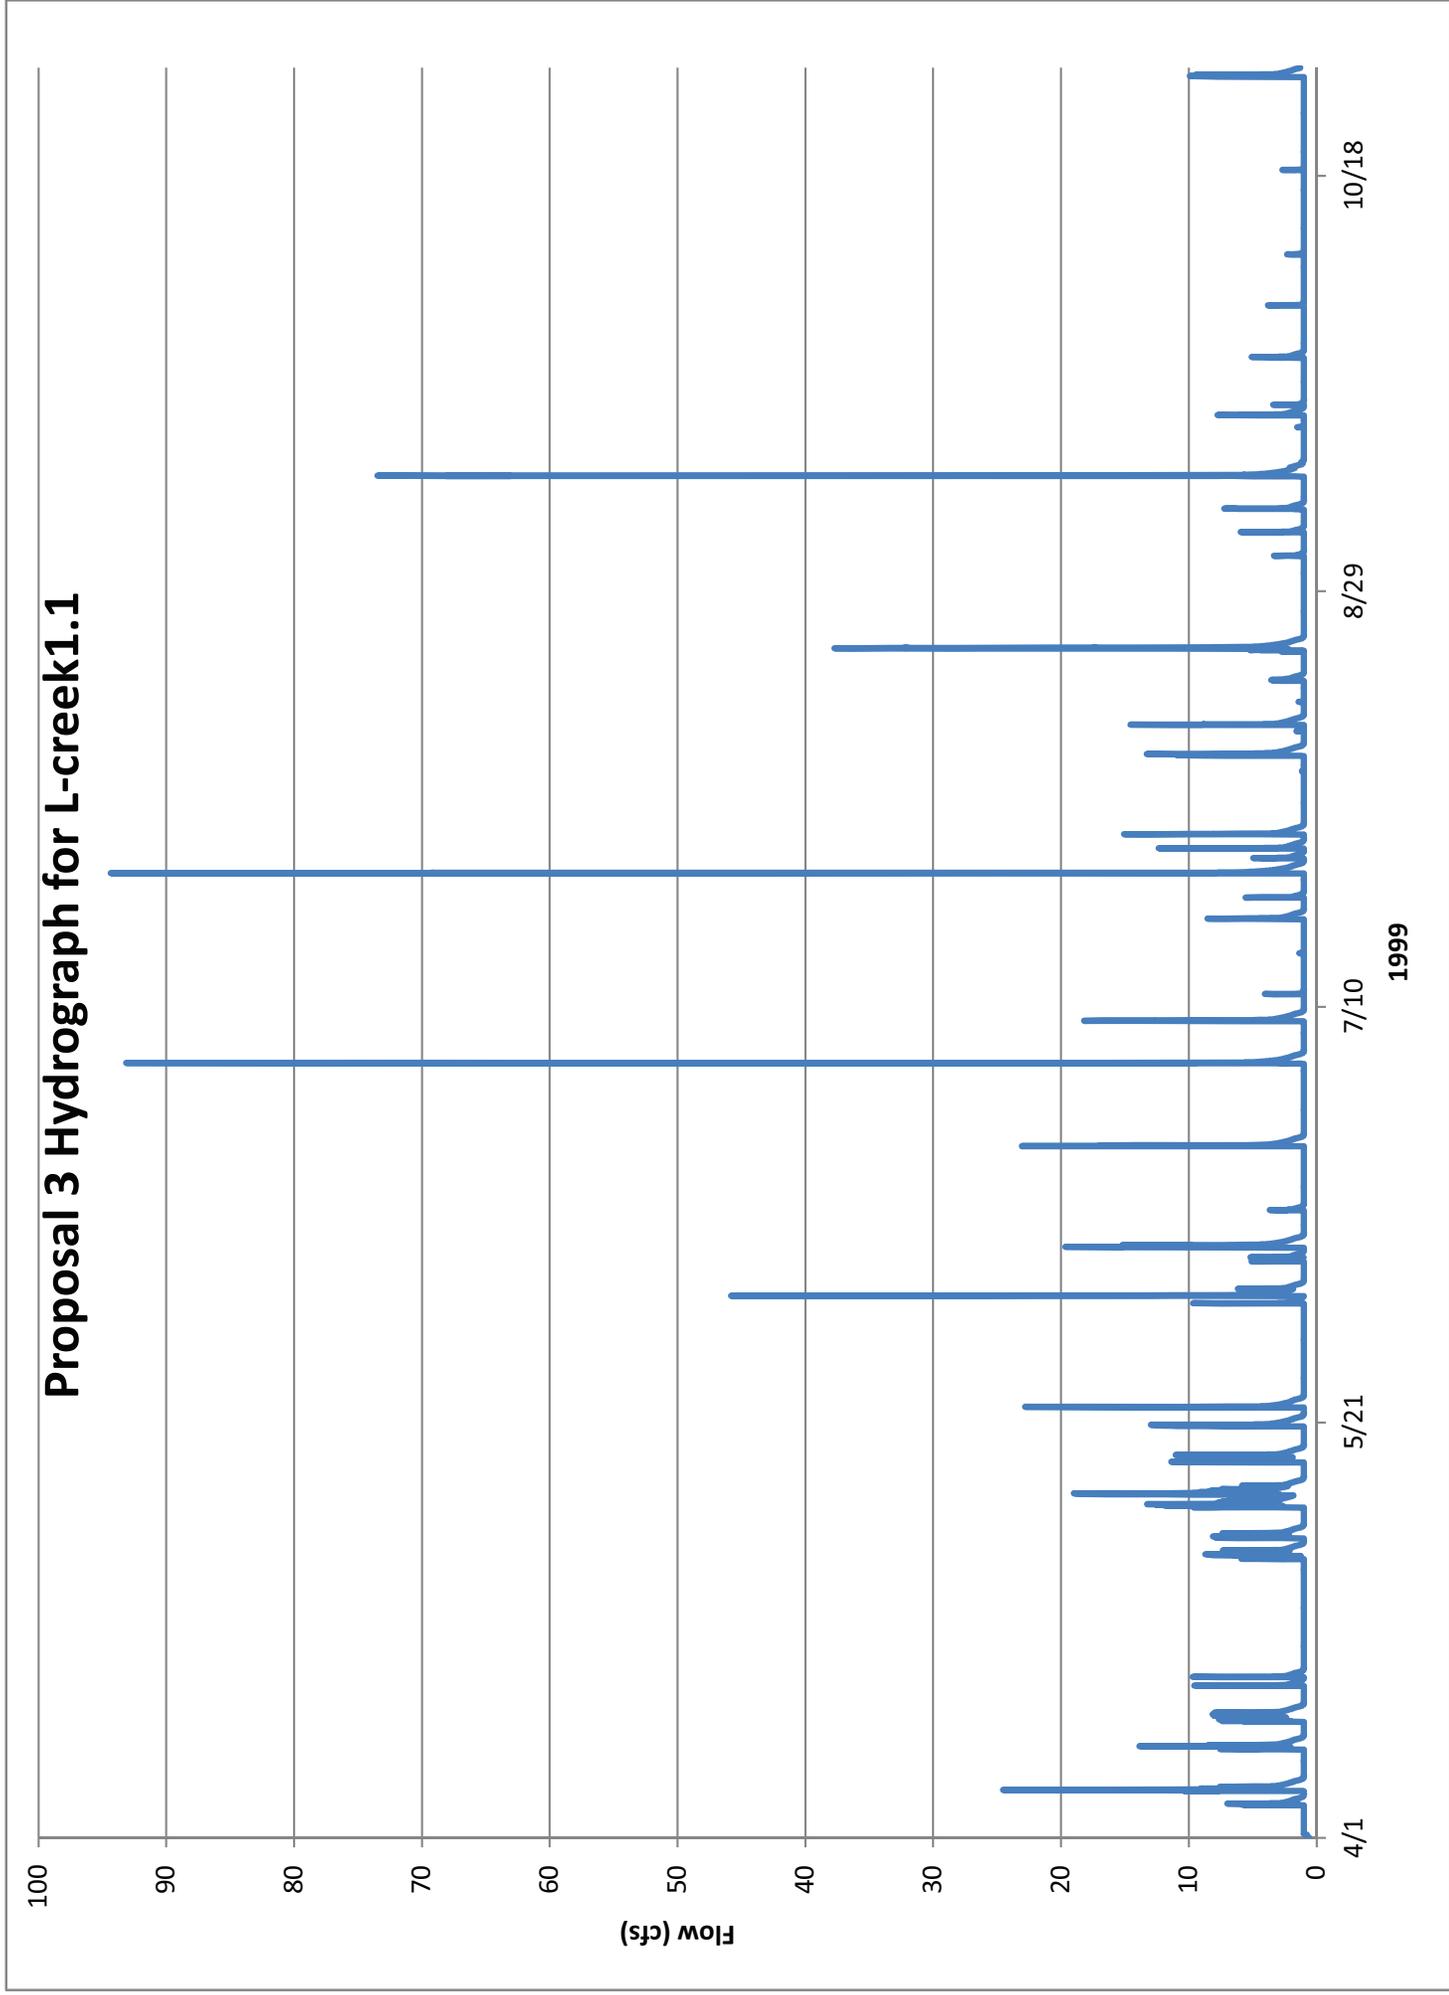
Figure 15. Proposal 3 Hydrograph for L-creek1.1

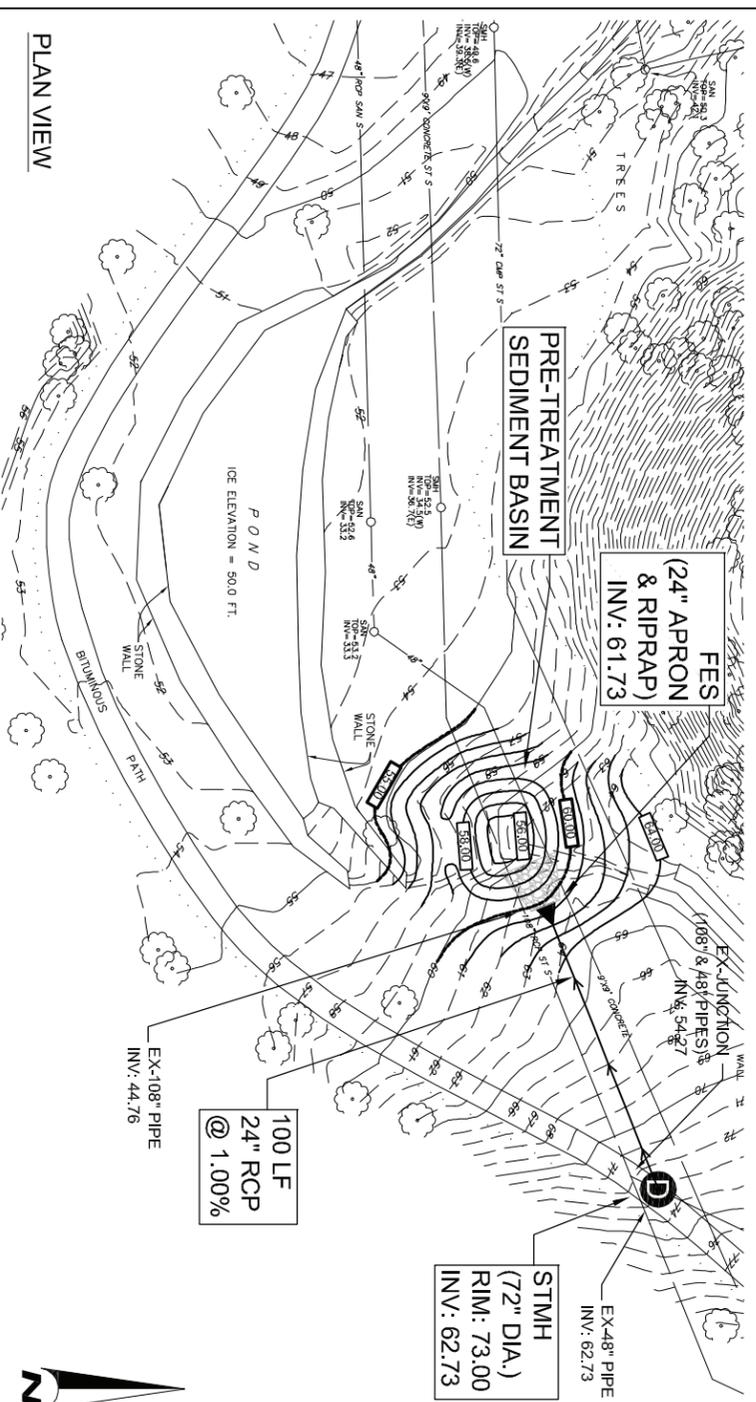
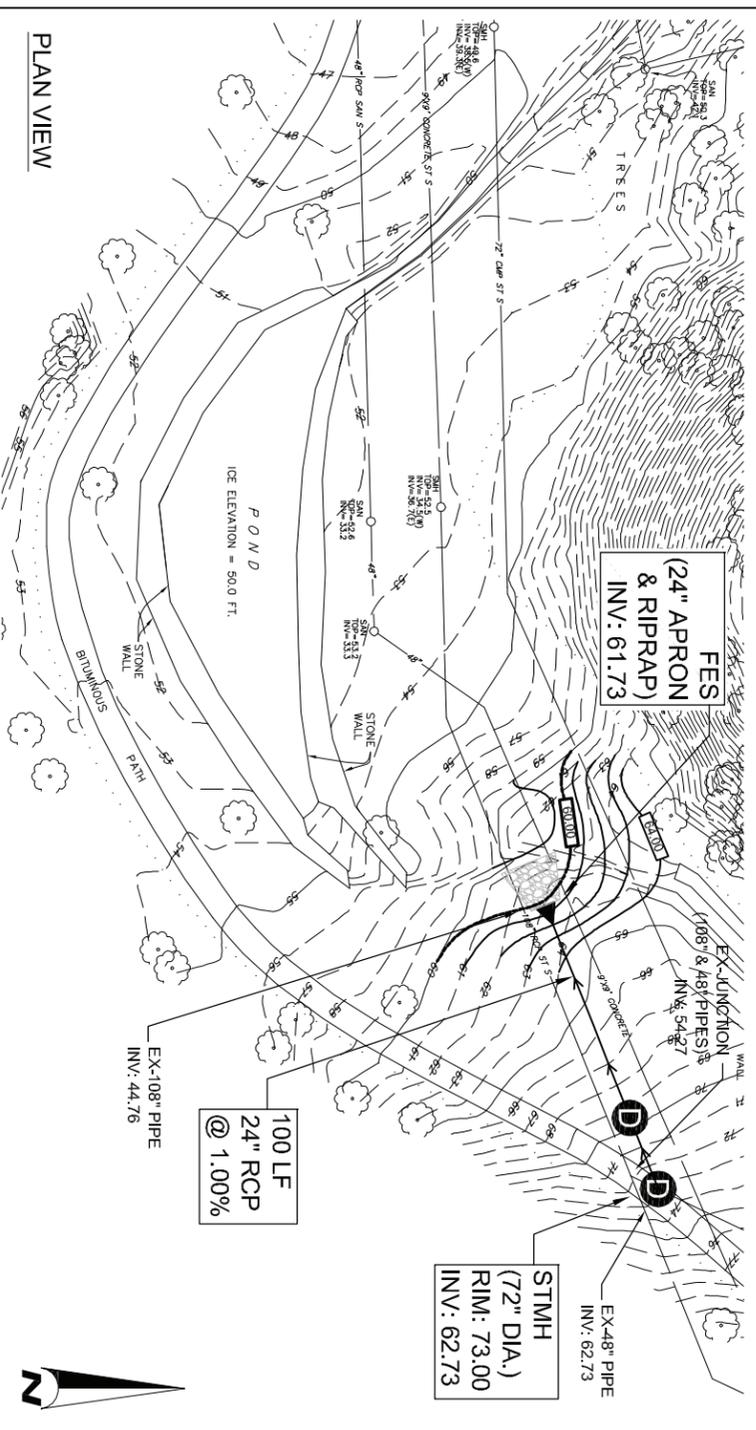
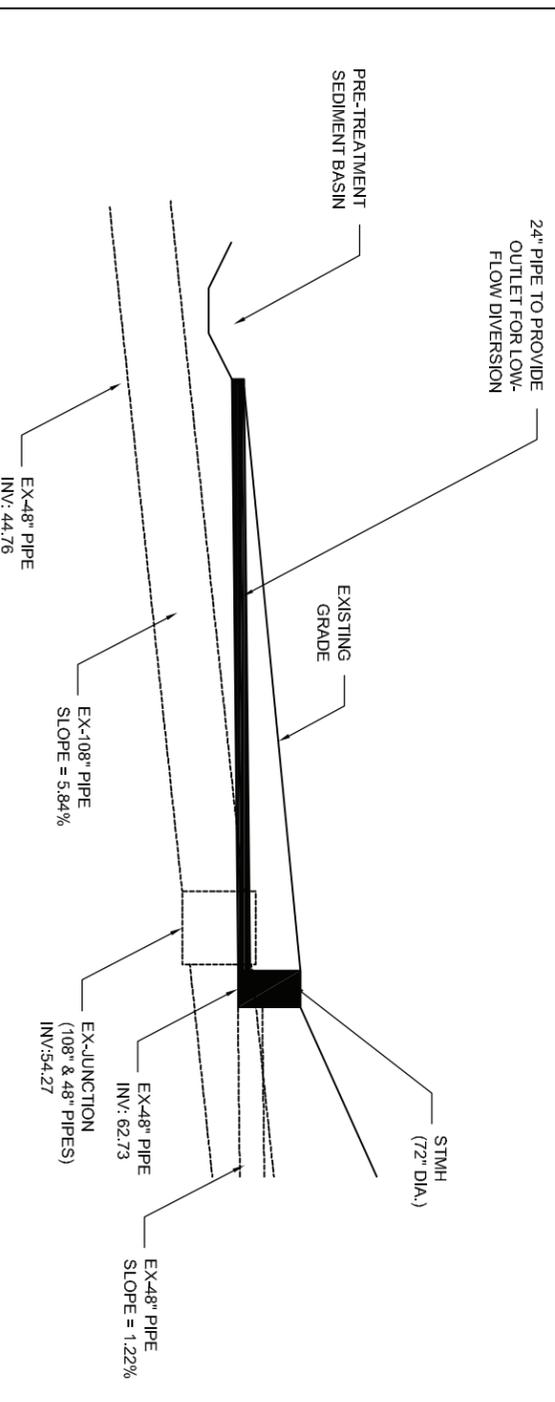
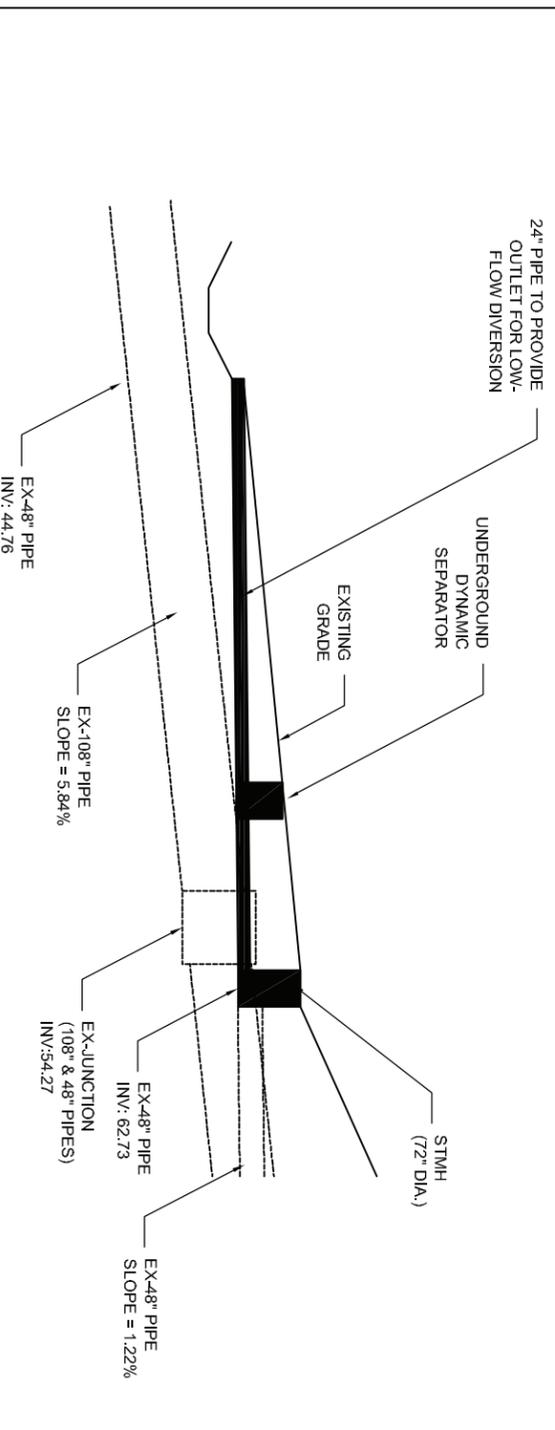
OPTIONS 4A AND 4B  
FIGURE 16

1  
F-16  
NO SCALE  
OPTION 4A - 48" PIPE LOW-FLOW DIVERSION & EXISTING MIDDLE, IN-CREEK POND IMPROVEMENTS

2  
F-16  
NO SCALE  
OPTION 4B - 48" PIPE LOW-FLOW DIVERSION & UNDERGROUND DYNAMIC SEPARATOR

4A	48" pipe low-flow diversion & existing middle, in-creek pond improvements	●	●*	●	⊗	●	●	○	Water not accessible until "Middle Pond".	\$153,000	\$20,000	
4B	48" pipe low-flow diversion & underground dynamic separator	●	●*	●	●	●	●	●	* Significant uncertainty regarding the availability of continuous flows exceeding 0.5 cfs	\$214,000	\$35,500	
5	Groundwater harvesting & discharge into the second half of the lower channel	○	●	○	●	○	○	○	Water only accessible below "Middle Pond", midway into the lower channel	\$51,000	\$20,000	
6A	Water recirculation – from the middle pond to the upper outlet pond	○	●	●	○	○	○	○	Circulation not provided below "Middle Pond". Water aeration is considered a moderate benefit	\$104,000	\$45,000	
6B	Water recirculation – from the lower pond to the upper outlet pond	●	●	●	●	●	○	○	Water aeration is considered a moderate benefit	\$208,000	\$55,000
