<b>Date</b>	October 29, 2012 ( <i>Updated August 18, 2013</i> )
<b>To</b>	Brian Tourtelotte (City of St. Paul) Bob Fossum (Capitol Region Watershed District)
<b>From</b>	Meghan Jacobson, PhD, and Cecilio Olivier, PE
<b>Regarding</b>	Swede Hollow Water Quality Monitoring Data Analysis

# Swede Hollow Water Resource Improvements: Water Source Options

SWEDE HOLLOW PARK  
DAYLIGHTED STREAM ANALYSIS  
AND FEASIBILITY STUDY

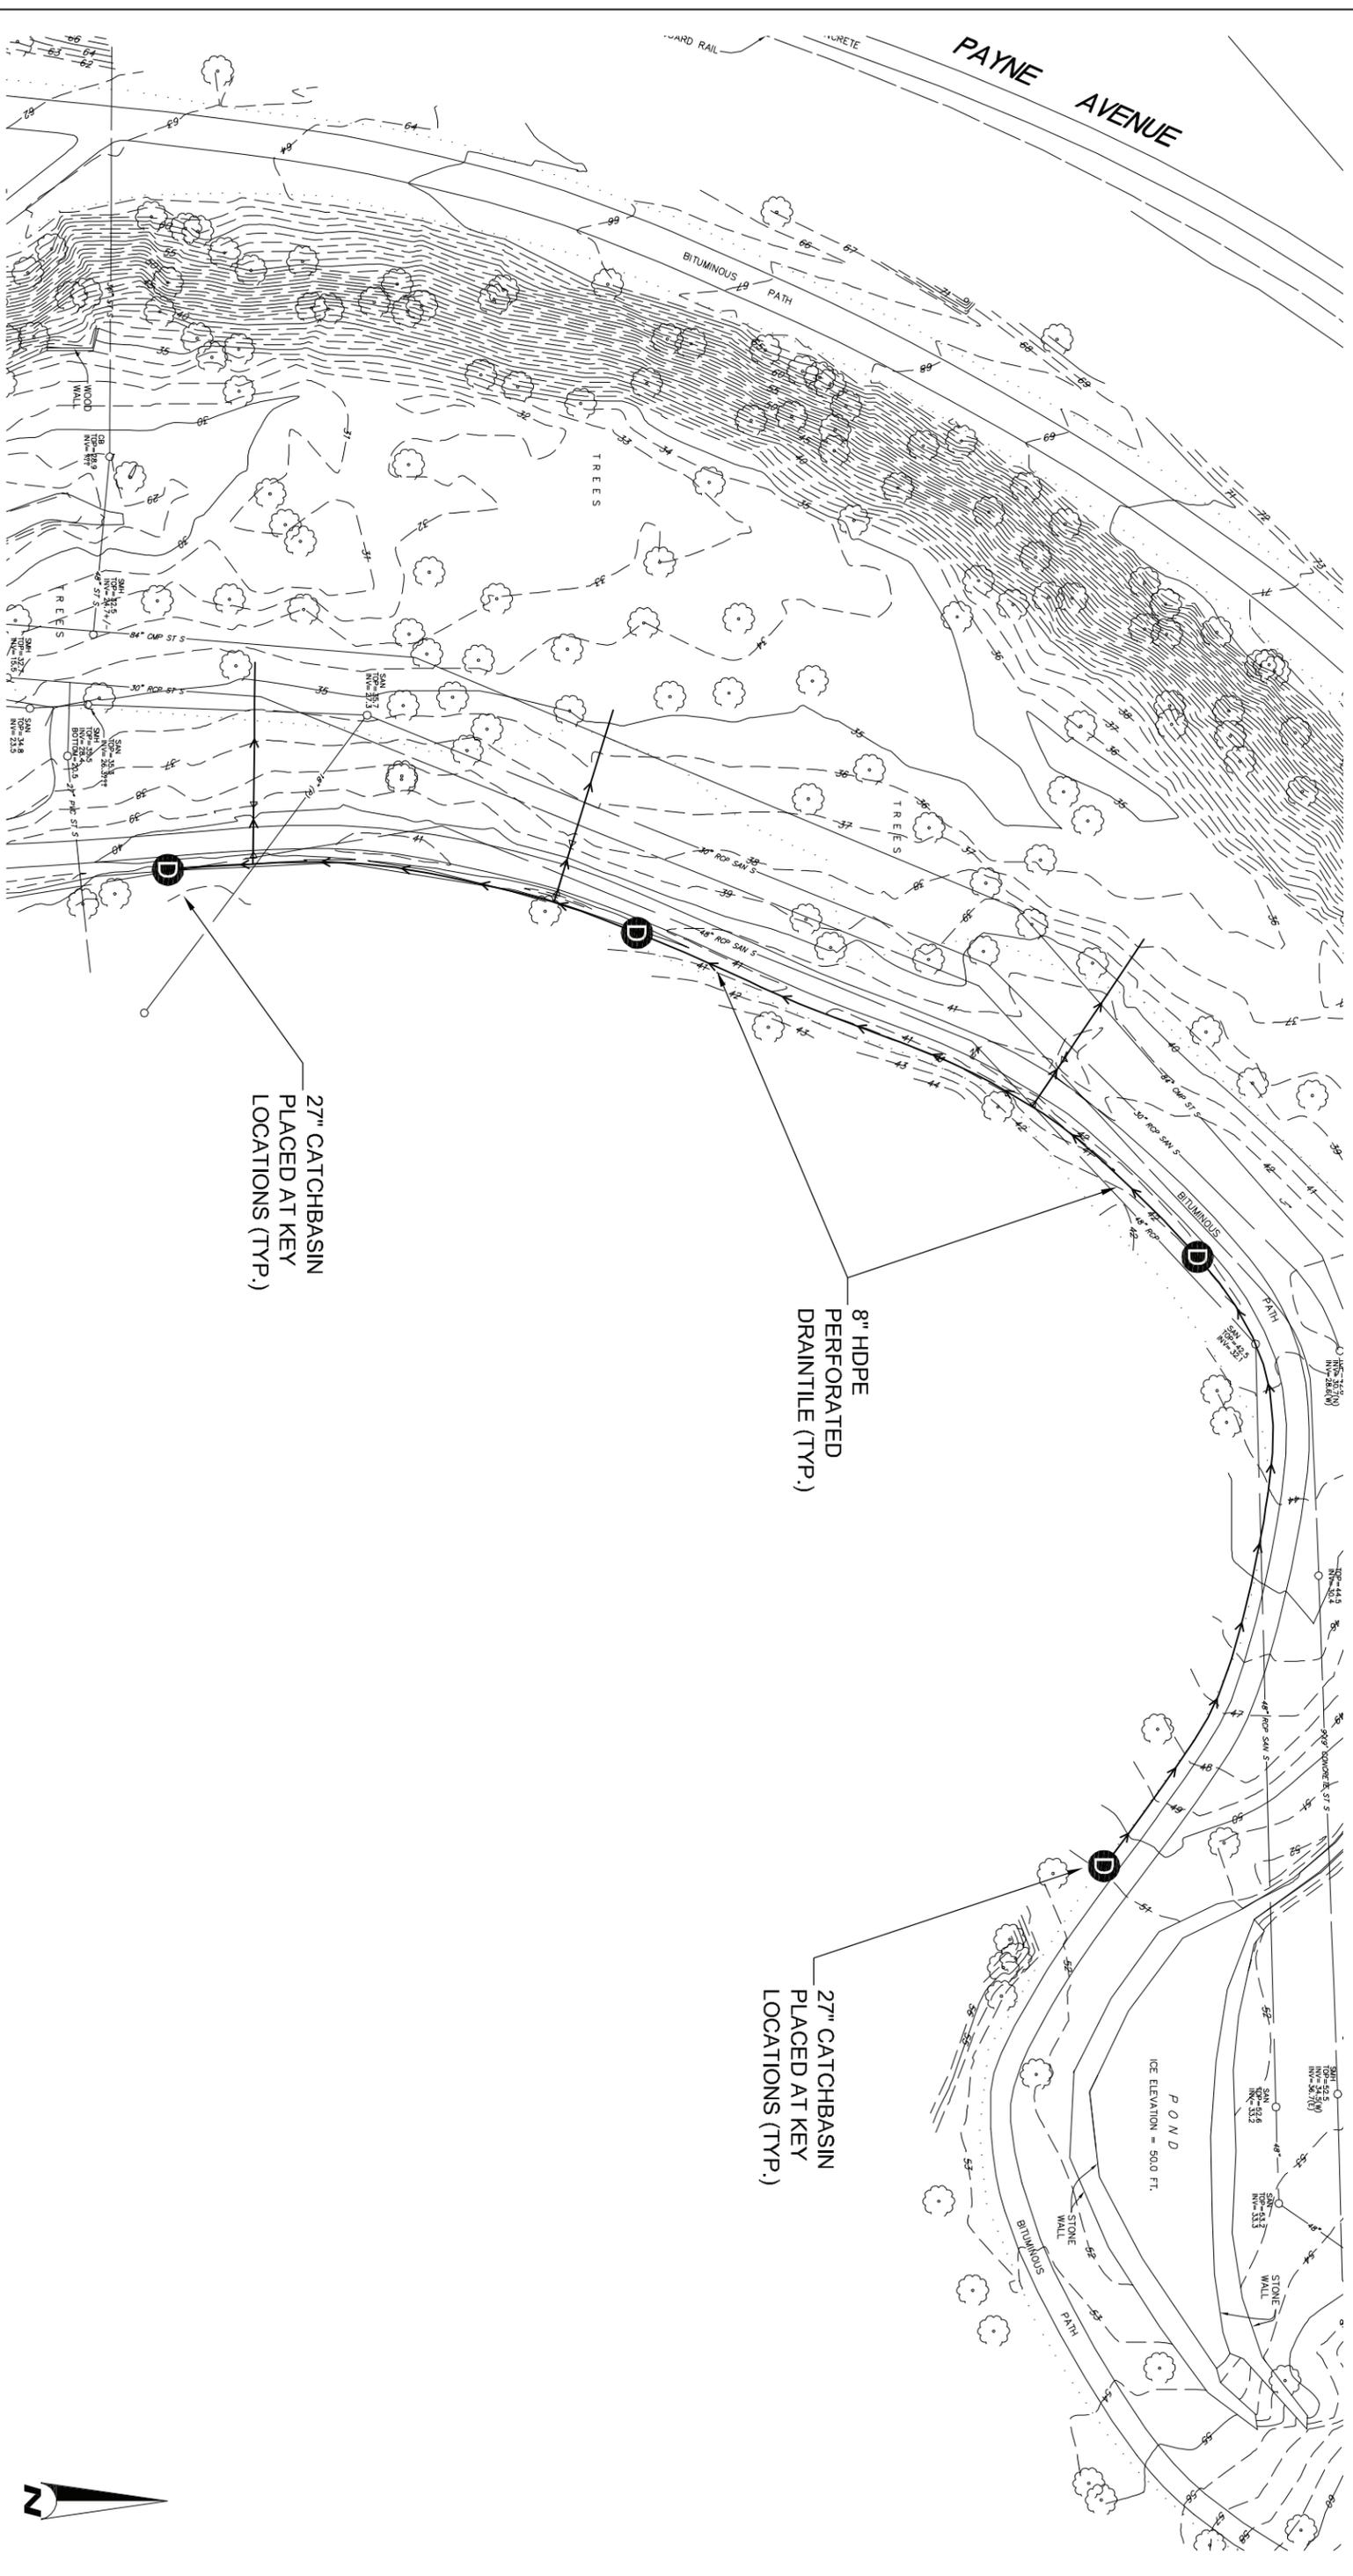
OPTION 5  
 FIGURE 17

1 OPTION 5 - GROUNDWATER HARVESTING & DISCHARGE INTO THE SECOND HALF OF THE LOWER CHANNEL  
 F-17 NO SCALE

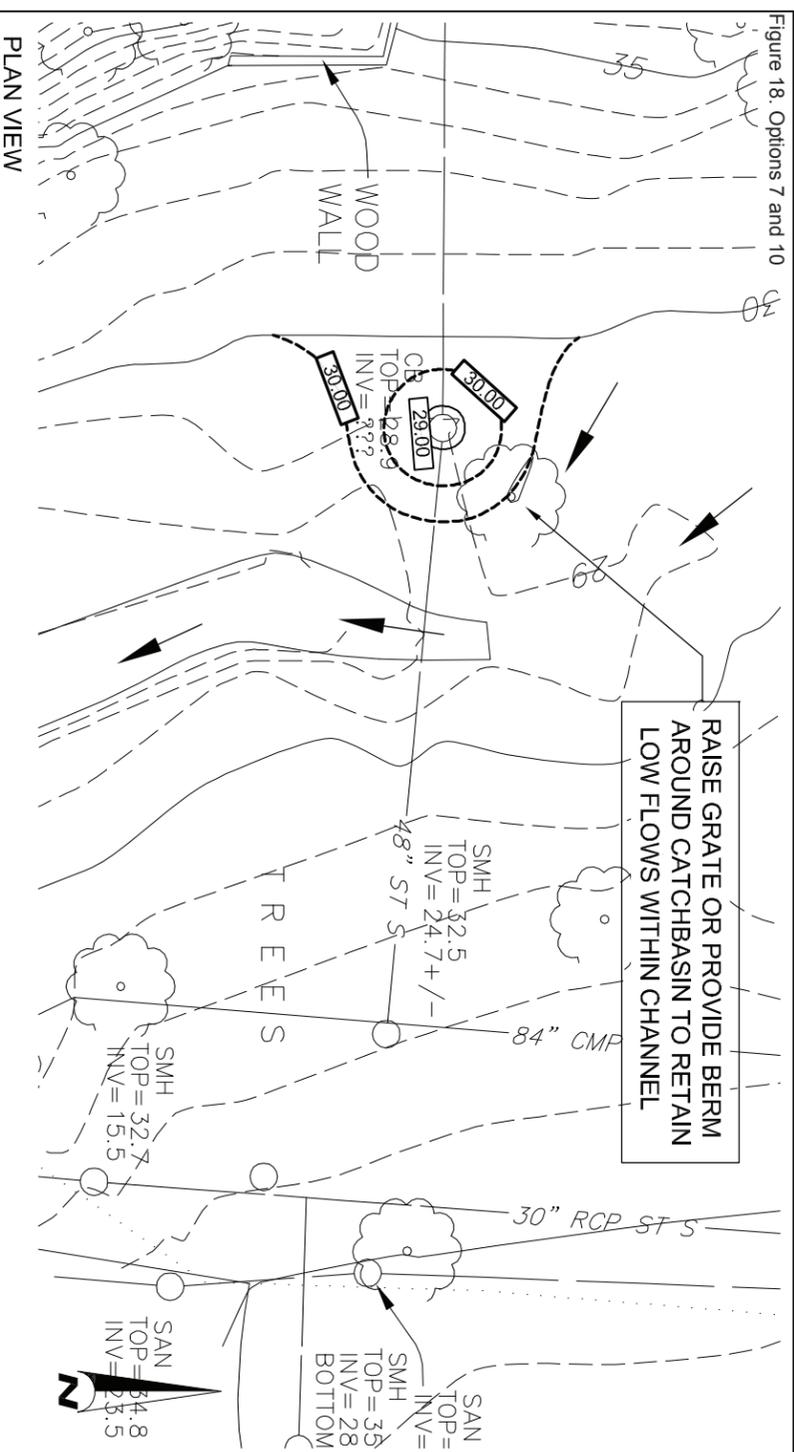
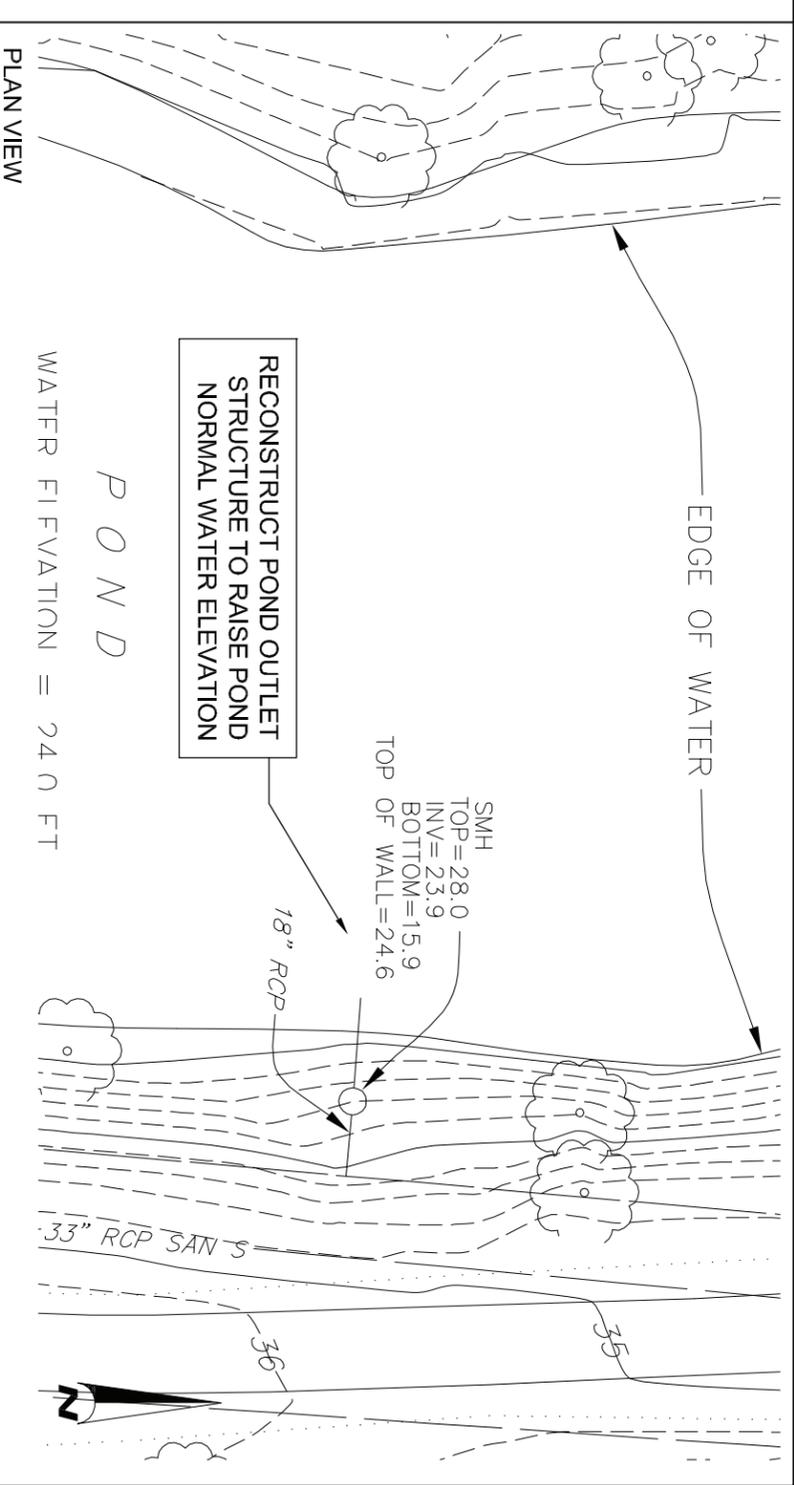
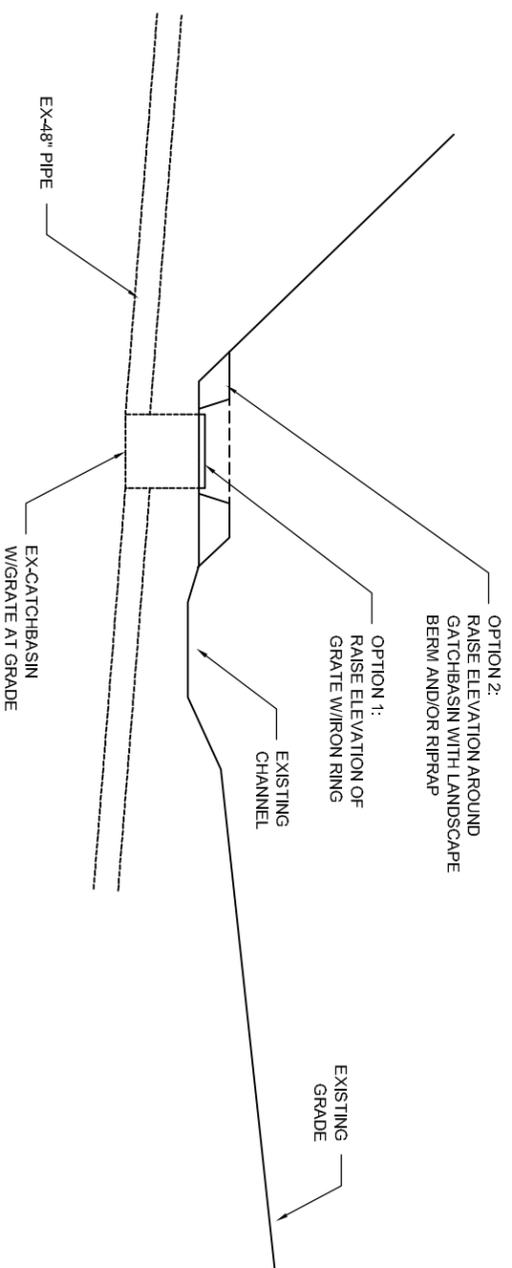
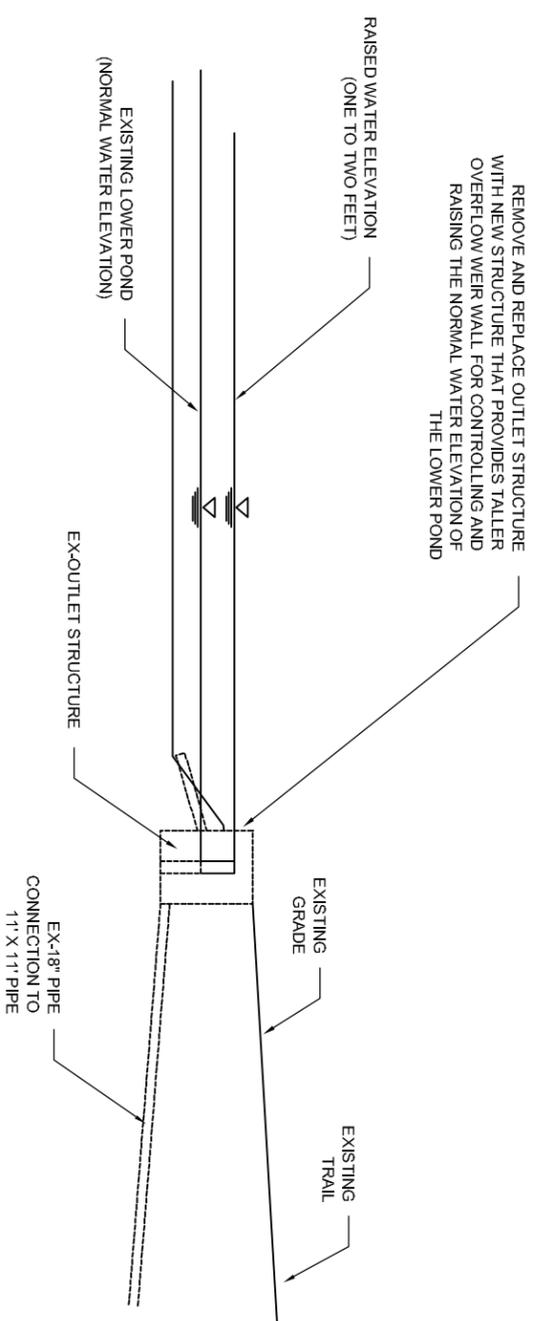
STATE PROJECT NO. \_\_\_\_\_  
 CITY PROJECT NO. \_\_\_\_\_  
 OPTIONS 7 AND 10  
 FIGURE 18

1 OPTION 7 - MODIFYING EXISTING GRATE AT THE DOWNSTREAM END OF THE LOWER CHANNEL  
F-18 NO SCALE

2 OPTION 10 - RECONSTRUCT LOWER POND OUTLET STRUCTURE & RAISE OUTLET ELEVATION  
F-18 NO SCALE

OTHER CORRIDOR IMPROVEMENTS		RECREATION & ECOLOGY				STORMWATER MANAGEMENT†			OTHER KEY PROS OR CONS		COST	
		Riparian health	Duration of flow	Lower pond aesthetics	Corridor aesthetics	Volume	Rate	Water quality			Construction	20-yr. O&M & inspection
7	Modifying existing grate at the downstream end of the lower channel	○	○	●	●	●	○	○	Not an additional water source option, but does prevent flows from bypassing the lower pond	\$15,500	\$5,000	
8	Channel improvements – upper reach	●	○	○	●	○	○	○		\$58,000	\$15,000	
9	Channel improvements – lower reach	●	○	○	●	○	○	○		\$122,500	\$18,500	
10	Reconstruct lower pond outlet structure & raise outlet elevation	○	○	●	○	●	○	●		\$30,000	\$9,000
