Memorandum

SUBJECT: Incidental Wetland Request for Kasota Avenue

& MN-280 Property Development

St. Paul, Minnesota Sambatek #21625

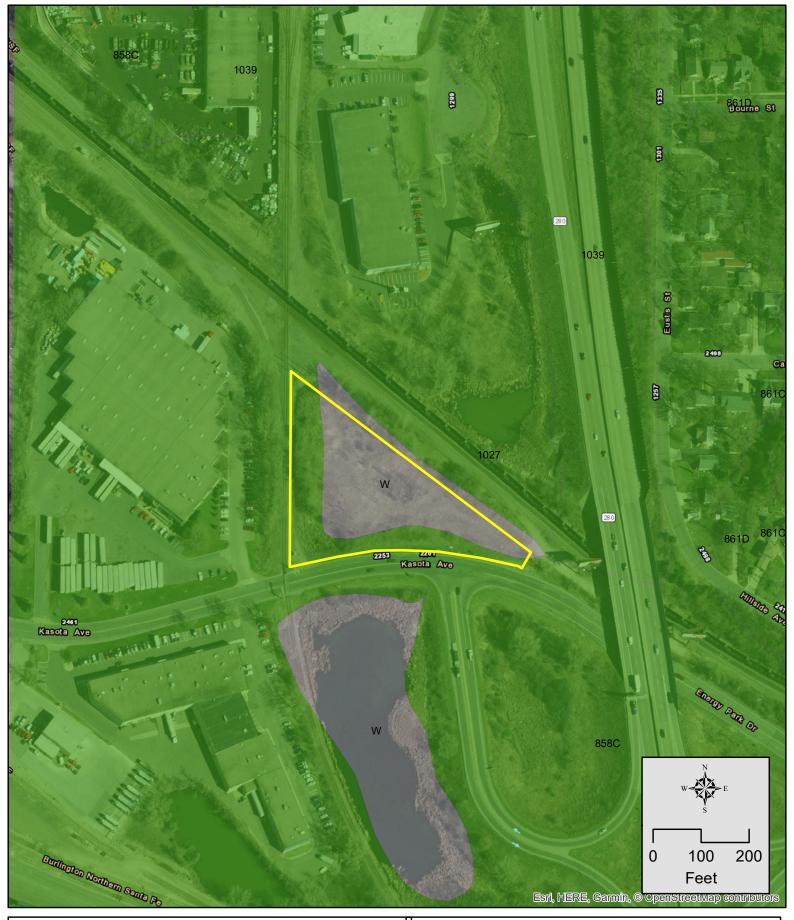
The Ramsey County Soil Survey was examined to identify areas of mapped hydric soils within the project boundaries. Hydric soil is an indicator of potential wetland conditions. Two soil types are identified within the project area, which include: **Udorthents, wet subtratum, 0-6% slopes (1027)**

and **Urban land-Chetek complex, 3 to 15 percent slopes (858C)**. Most of the project area is classified as water. Neither soil map unit is classified as a hydric soil.

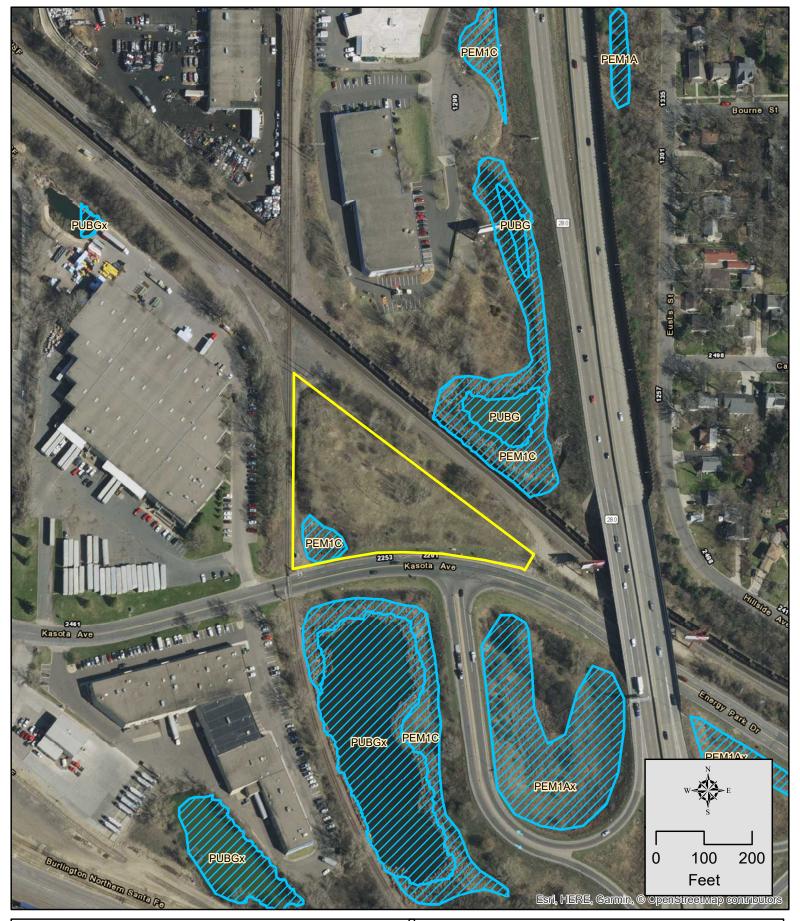
National Wetland Inventory

Digital NWI data were obtained from the Minnesota Geospatial Commons website (http://gisdata.mn.gov), overlain on aerial photography and depicted on maps used during the office and fieldwork activities. NWI maps are utilized as an off-site tool in identifying areas of potential wetlands. The most current mapping, 2011 update, was used for this portion of the investigation. One NWI Mapped wetland is identified within the project area: **PEM1C**, which is located in the southwest corner of the project area.

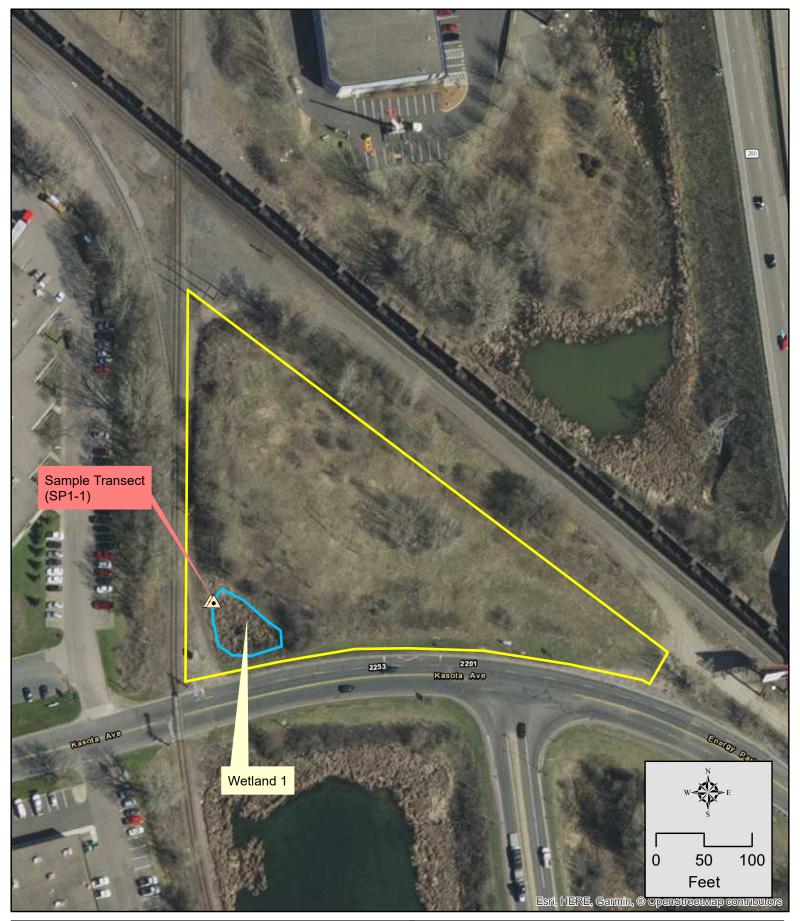
Delineated Wetlands Map

Sambatek visited the site on July 25, 2019 to examine it for areas exhibiting wetland conditions. The Subject Property is relatively flat and was fully vegetated at the time of the site visit. One area in the southwest corner of the Subject Property exhibited wetland conditions and was delineated as Wetland 1. The banks of Wetland 1 are very steep and rip rap was observed on the south side of the wetland. Based on the steep banks and rip rap it appears that Wetland 1 may have been created to treat stormwater on the site.

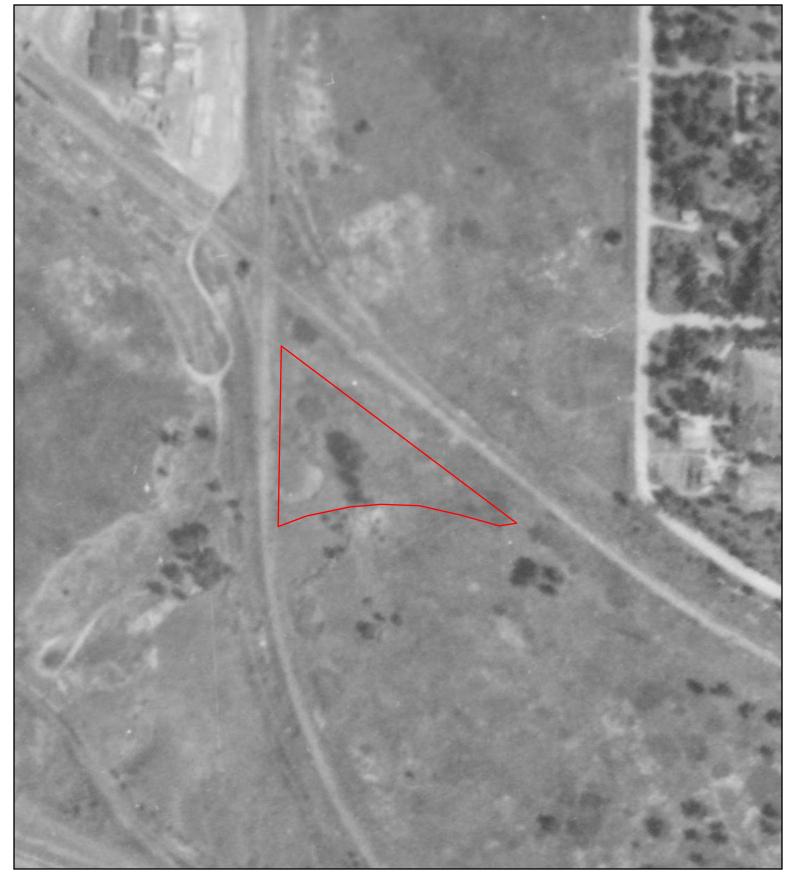
1937 – The Subject Property appears to be bordered by two railroad tracks to the north and the west. There are several trees located in the center of the Subject Property. No wetland indicators are located on the Subject Property or within the limits of Wetland 1.

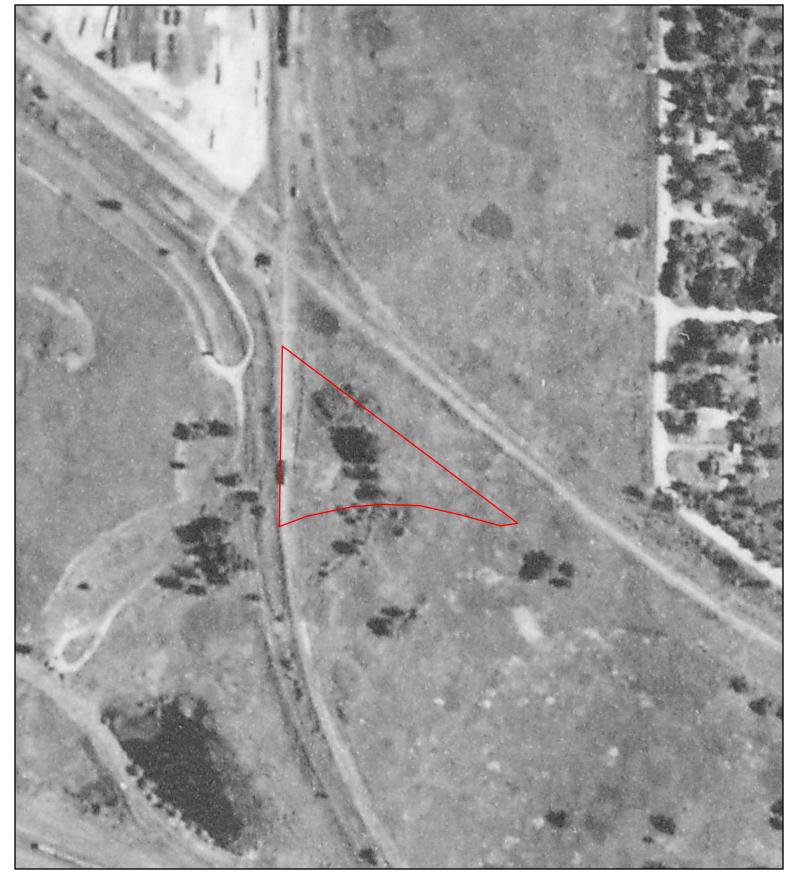
1940 – Subject Property contains few trees with slightly increased canopy cover in the middle of the site. No wetland signatures are observed in the 1940 aerial photograph.

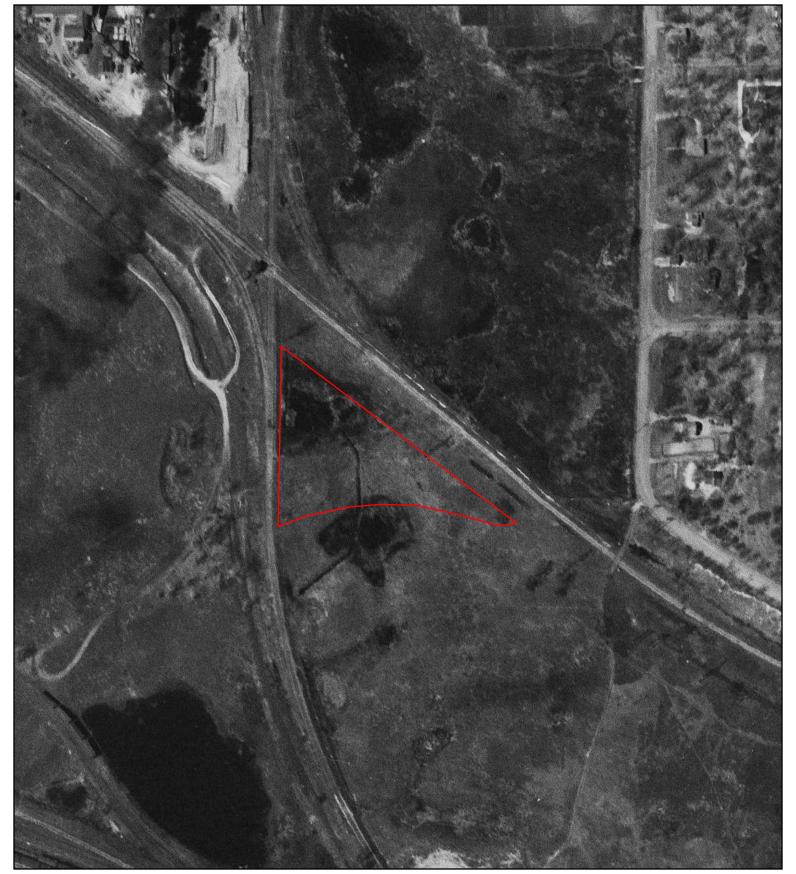
1947 – The railroad to the north of the Subject Property appears to have been slightly improved. The trees that were observed in the 1940 aerial photograph appear to have been cleared from the Subject Property. There appears to be a wetland located within the northwest corner of the Subject Property. Through the center of the Subject Property is a north/south oriented ditch that connects the wetland in the northwest corner of the Subject Property to the south property boundary. None of the wetland boundaries extend into the boundaries of Wetland 1.

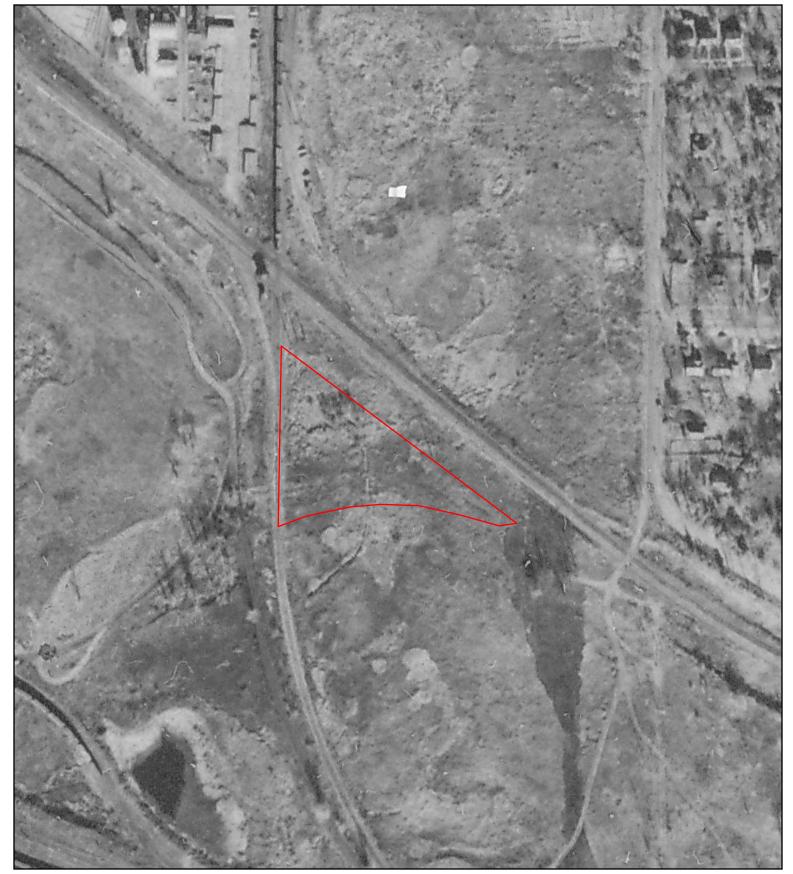
- 1953 No significant changes have occurred on the site. The wetland signatures observed along the north property boundaries in the 1947 aerial photograph are still evident. No wetland signatures are observed within the boundaries of Wetland 1.

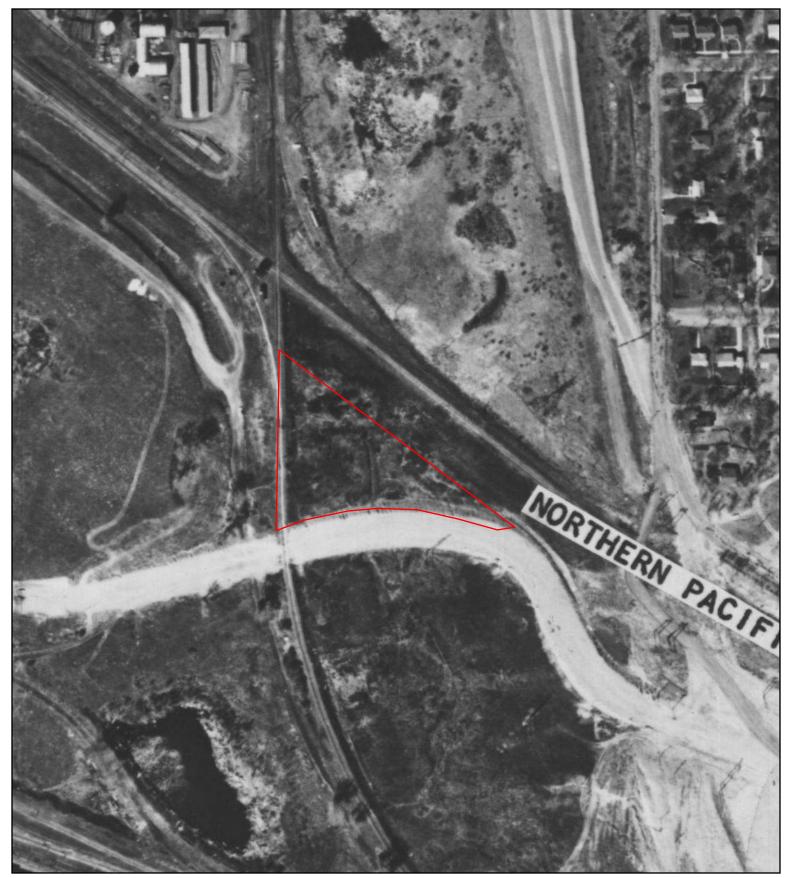
- 1958 Grading for Kasota Avenue has begun to the south of the Subject Property. The north/south ditch is still apparent through the center of the property. The wetland in the northwest corner is not obvious. No wetland signatures are observed within the area of Wetland 1 in the 1958 aerial photograph.

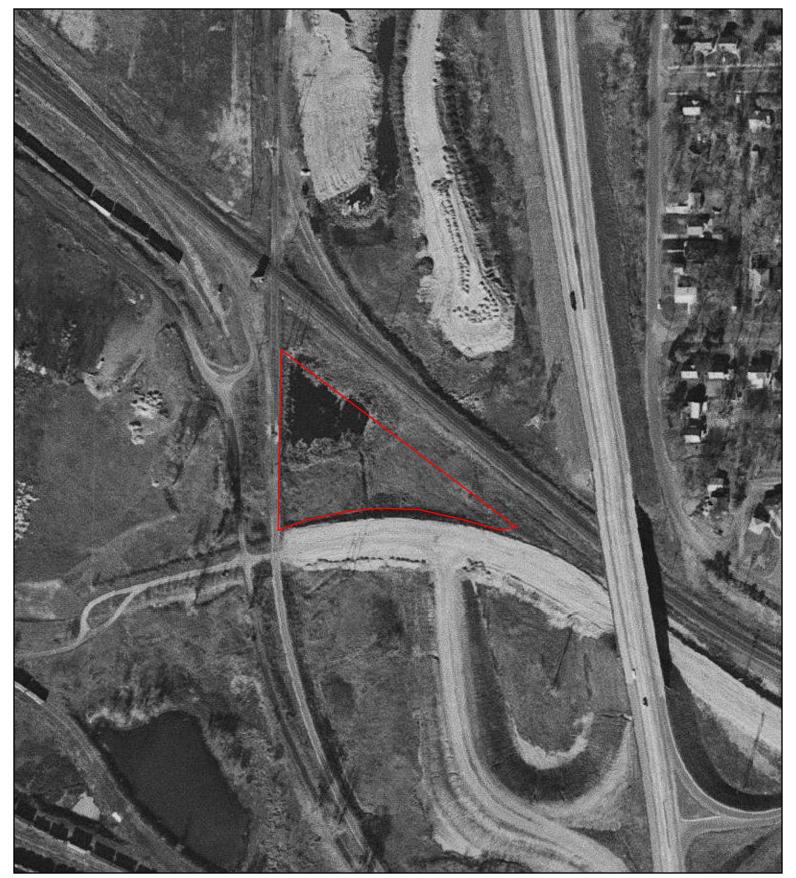
- 1966 Kastoa Avenue appears to be realigned in order to accommodate on off ramp for MN-280. MN-280 has been constructed to the east of the Subject Property. The wetland signature located in the northwest corner of the property and the drainage ditch observed in the previous aerial photographs are more evident in the 1966 aerial photograph. No wetland signatures are observed within the boundaries of Wetland 1.

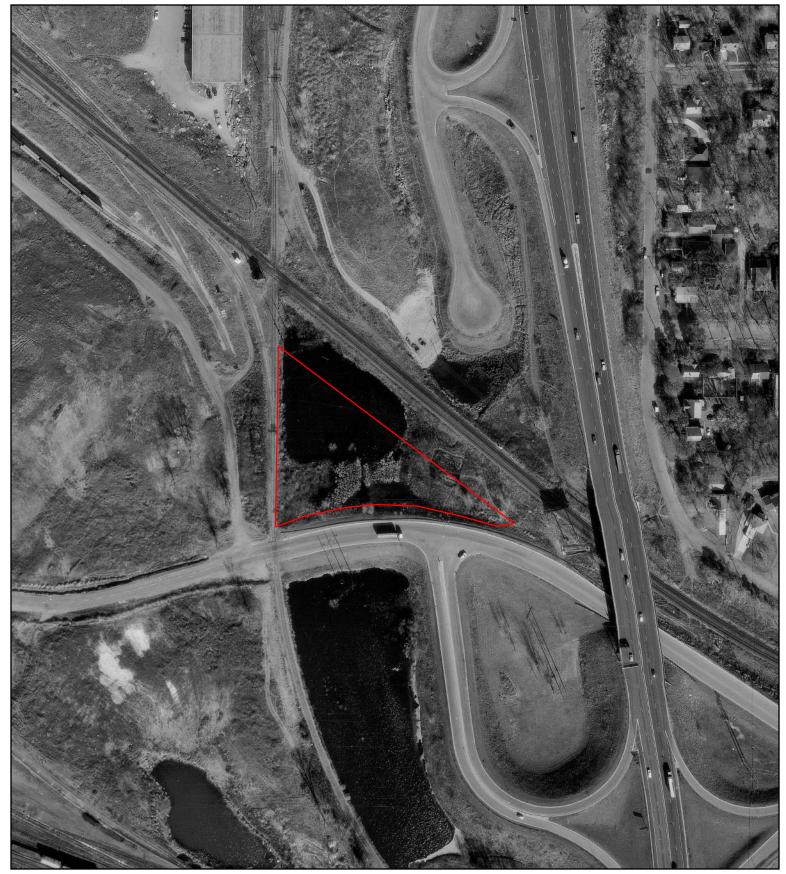
- 1974 Construction of Kasota Avenue has been completed. The northern portion of the Subject Property appears to be flooded. A wetland is apparent approximately midway along the southern property boundary. No wetland signatures are observed in within the boundaries of Wetland 1.

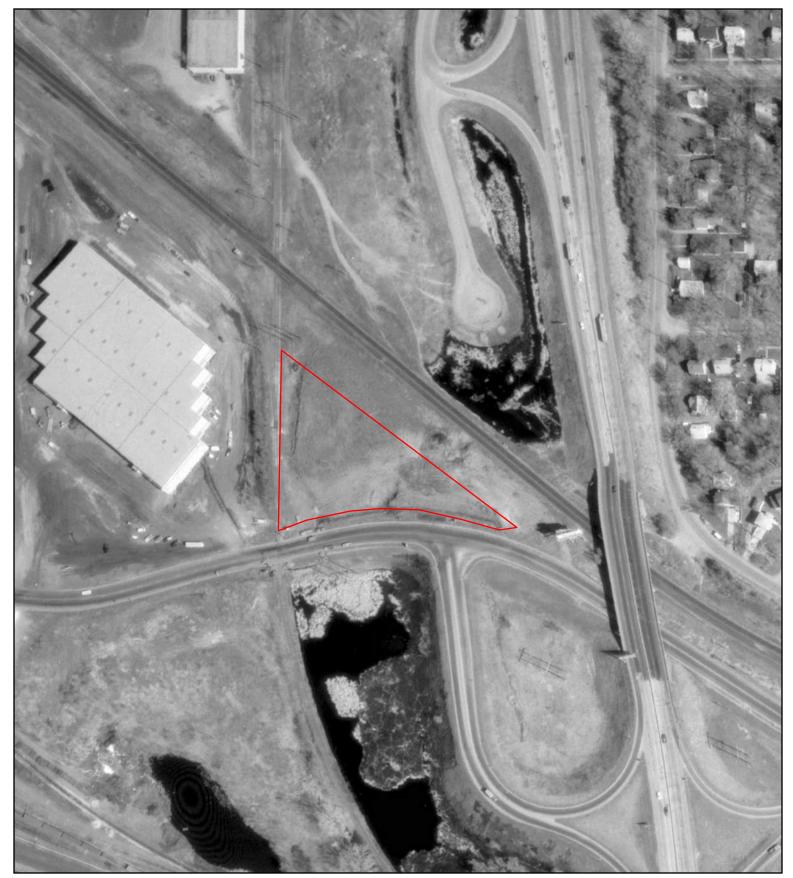
- 1980— It appears that the Subject Property has been mass graded since the 1974 aerial photograph. Not wetland signatures are observed on the Subject Property in the 1980 aerial photograph.

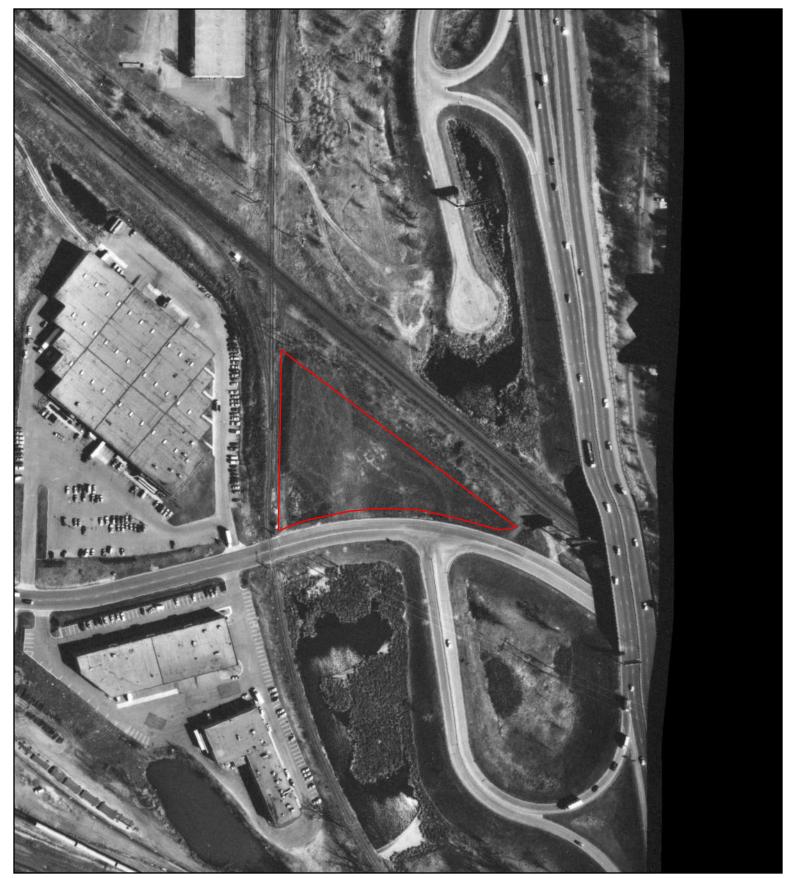
- 1988 –A stormwater pond appears to have been constructed on the Subject Property. The stormwater pond is located within the boundaries of Wetland 1.
- 1991 No significant changes have occurred on the Subject Property since the 1988 aerial photograph.

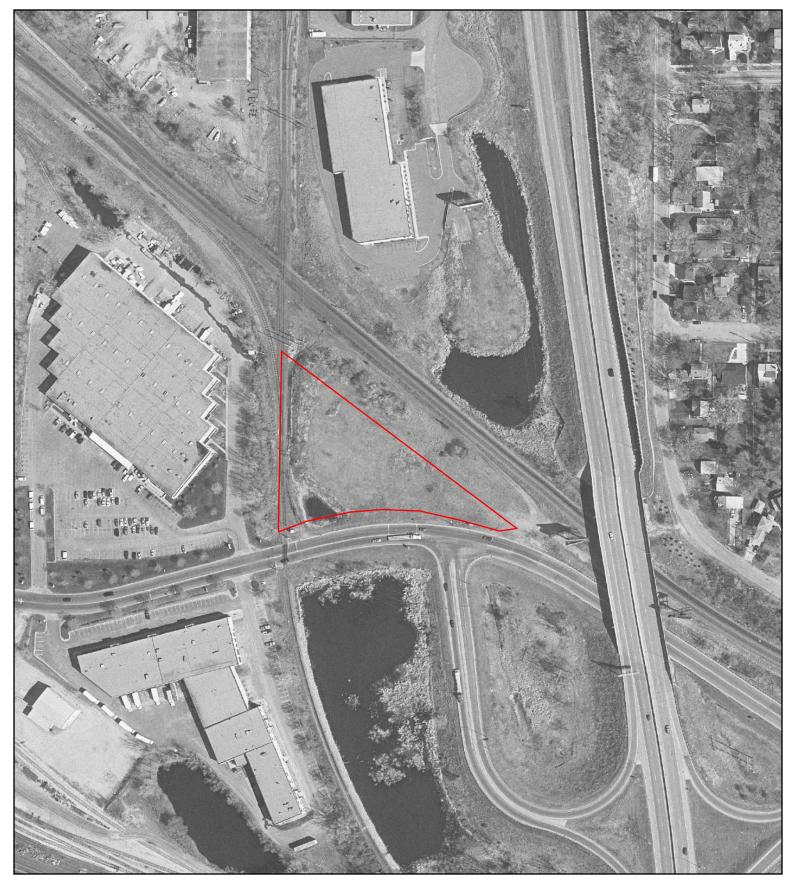
- 1994 No significant changes have occurred on the Subject Property since the 1991 aerial photograph.
- 2000 No significant changes have occurred on the Subject Property since the 1994 aerial photograph. Wetland 1 is more evident in 2000 due to ponded water.

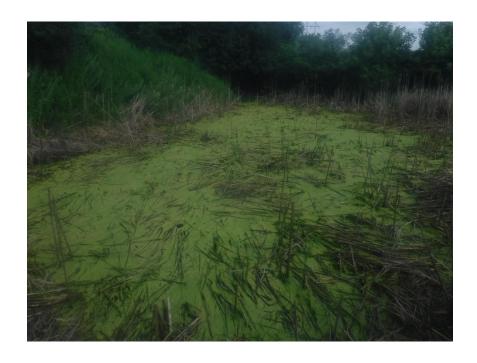
Photo No. 1

South boundary of Wetland 1

Facing Northwest looking across Wetland

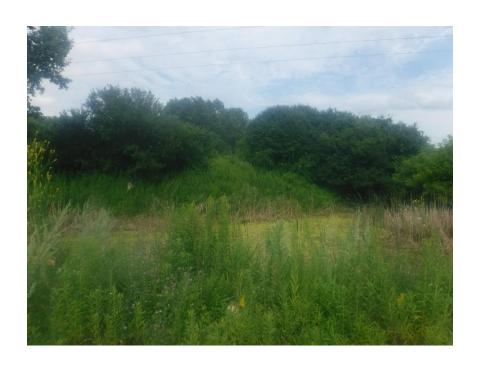
Photo No. 2

Southwest boundary of Wetland 1

Facing north across wetland boundary

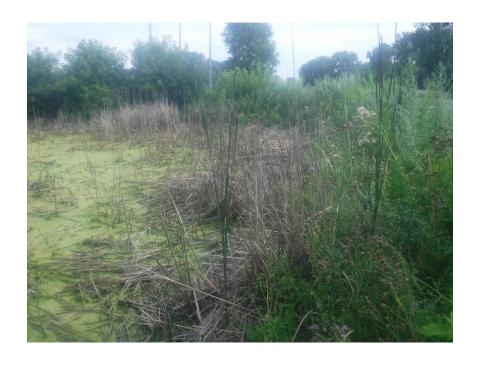
Photo No. 3

Boundary of Wetland Boundary

Abrupt boundary of Wetland 1

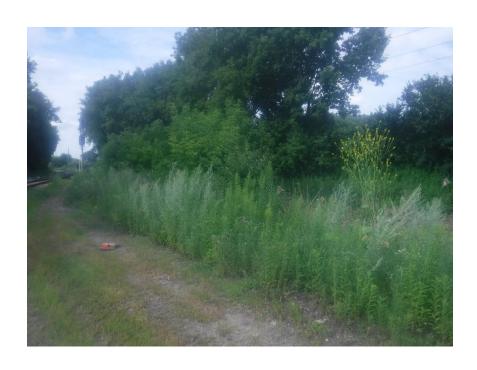
Photo No. 4

Southwest corner of Subject Property

Upland surrounding Wetland 1
