**SUBJECT:** Fire Station No. 10 at 754 Randolph Avenue in Saint Paul  
Proposed Designation as a Saint Paul Heritage Preservation Site  
Discuss Consistency with the Comprehensive Plan and Recommendation to the  
Saint Paul Heritage Preservation Commission

# Engine House #10 754 Randolph Avenue

754 Randolph Avenue  
St. Paul, Minnesota  
SHPO Inv. # RA-SPC-3110

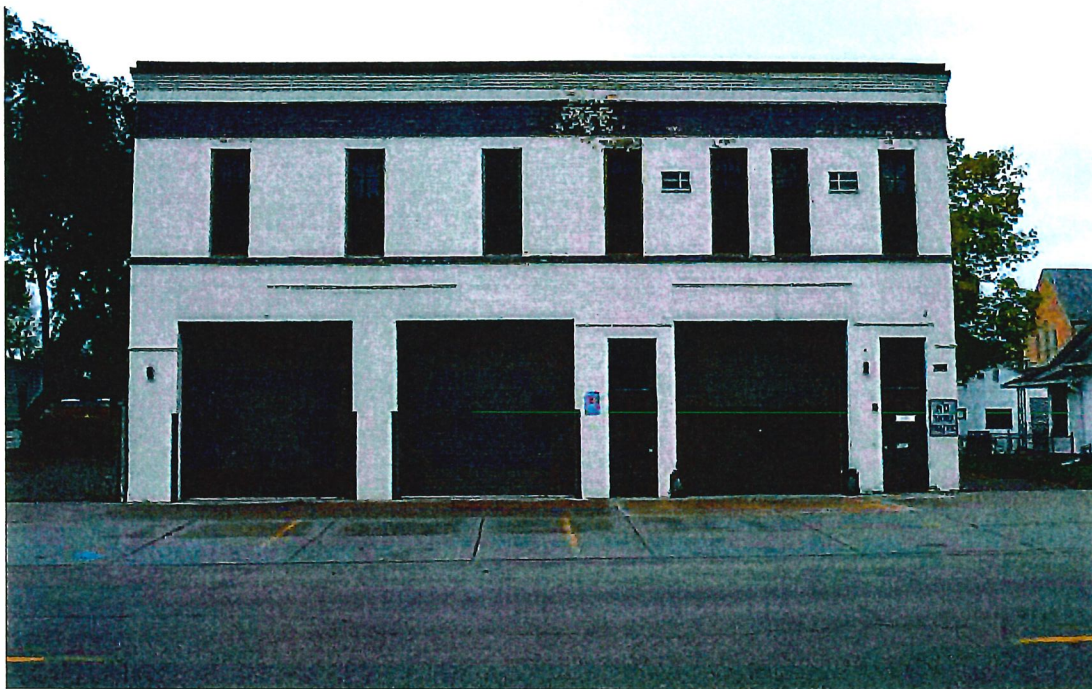
Photograph 1. North façade of Engine House No. 10, taken from Randolph Avenue.

The material integrity and workmanship of the building is fair. The exterior brick corbelling is intact, but the windows and doors have been replaced. It is important to note that the fenestration and brick detailing on the primary façade facing Randolph Avenue are vital to the building's character and identity as part of its community in the city of St. Paul. Although the materials of the doors and windows have not been retained, the feeling of this façade has been retained due to the presence of the large doors. Although the building has been decommissioned as a fire station, the city of St. Paul currently owns the building, and no significant changes have been made since it ceased operations as a fire station in 2010. Therefore, the association is intact.

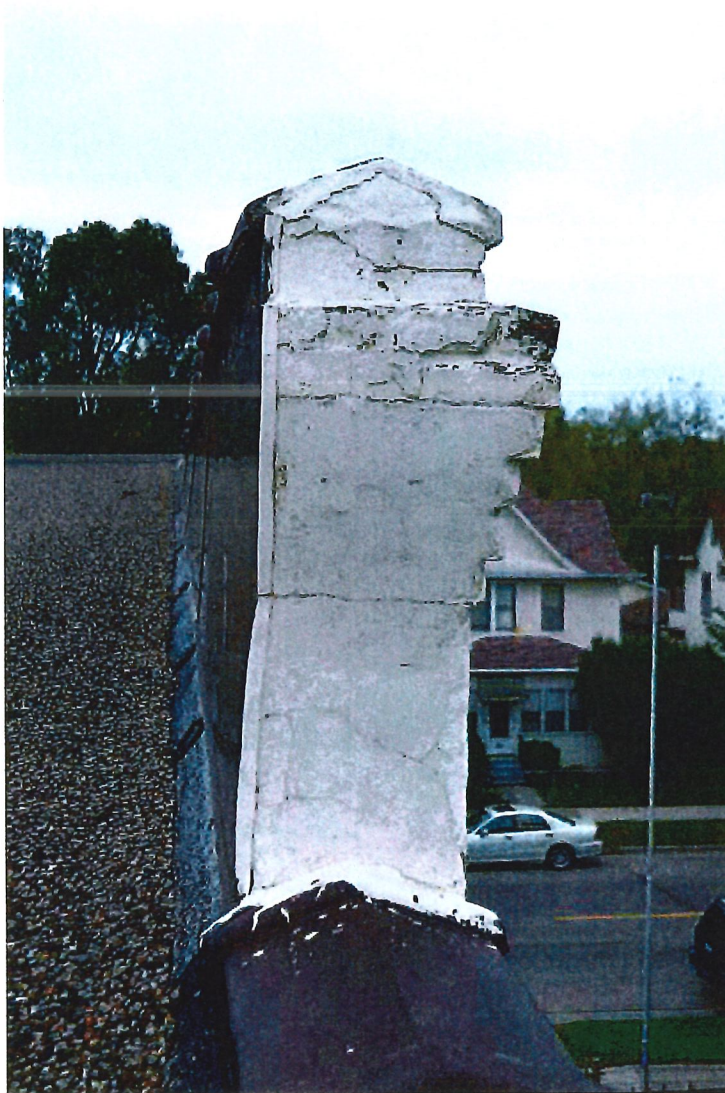
Photograph 5. Parapet of original portion of building. Photograph shows the addition of a parapet cap to match the detailing of the 1911 addition.

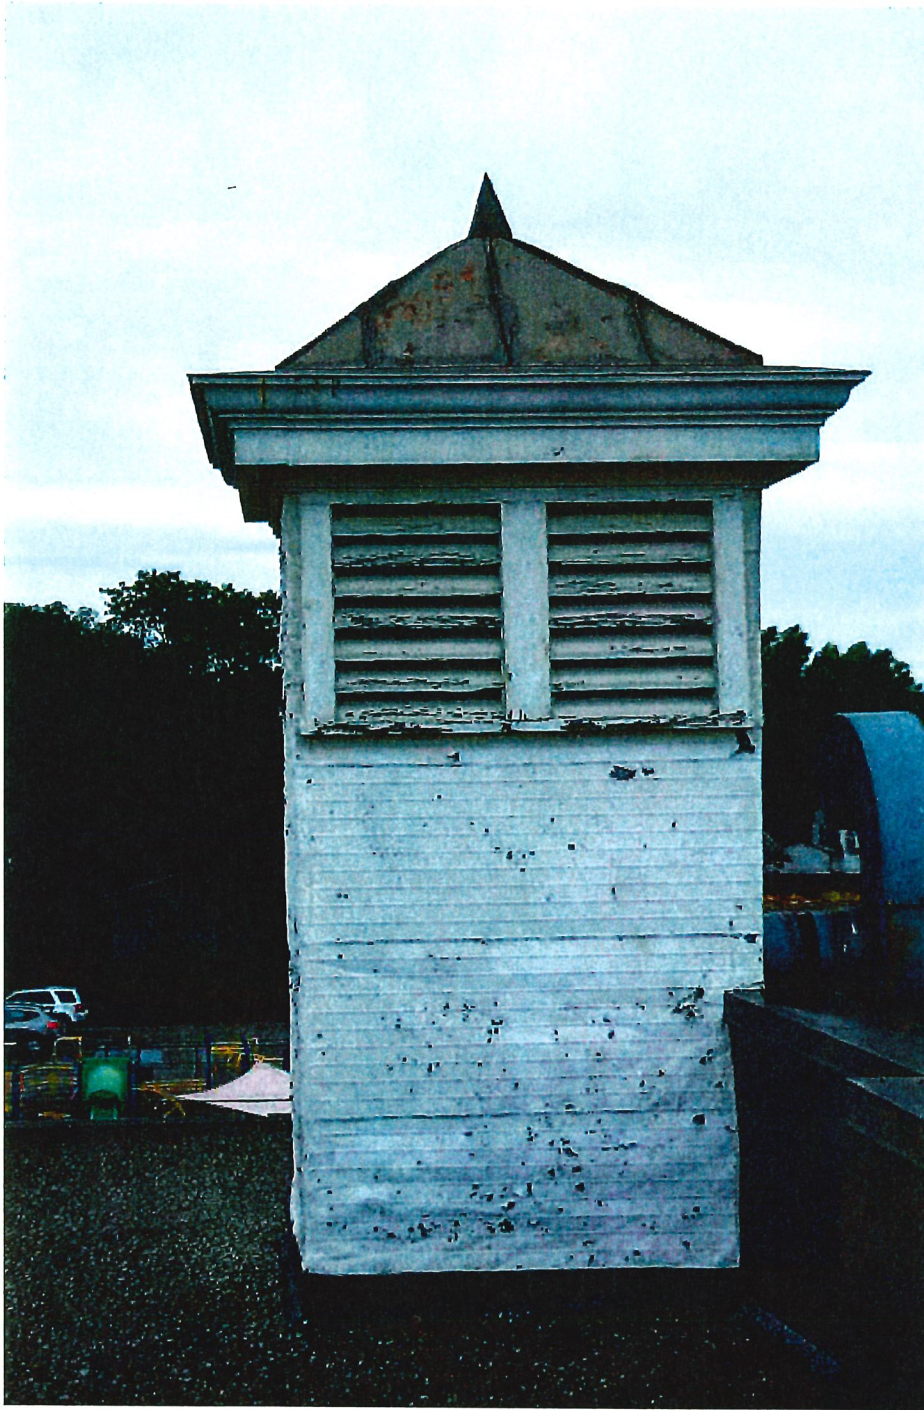
Photograph 6. View of hose tower from roof, camera facing north.

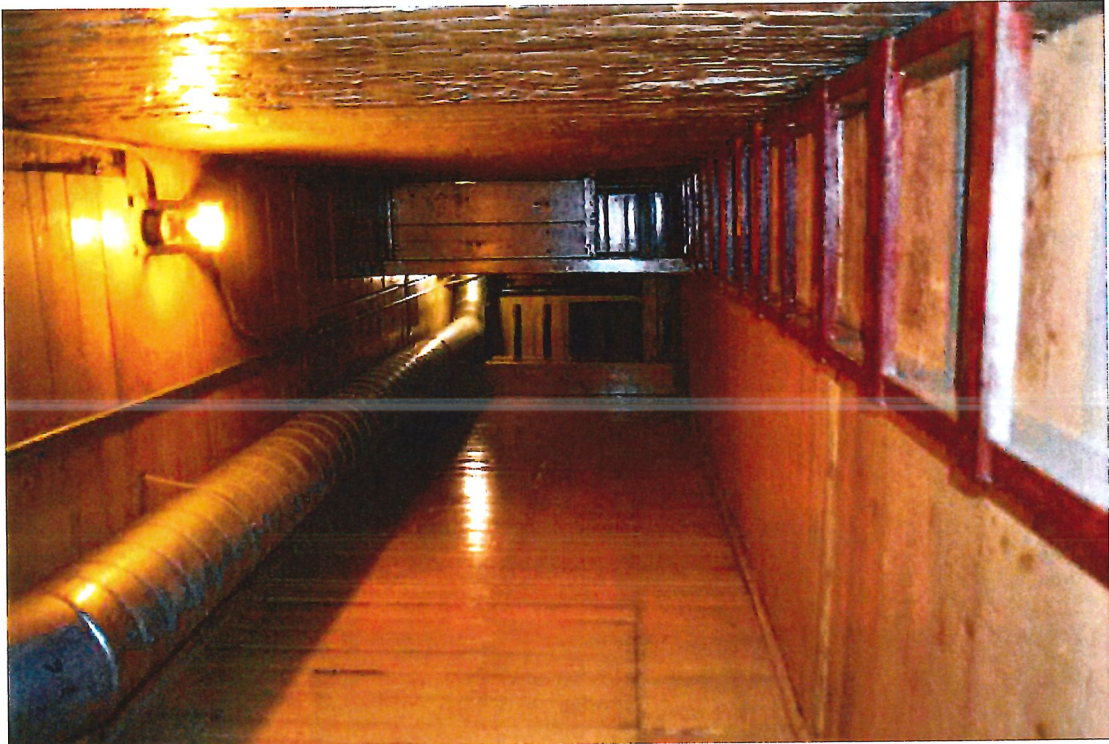
Photograph 12. Interior of hose tower, looking up from main level.

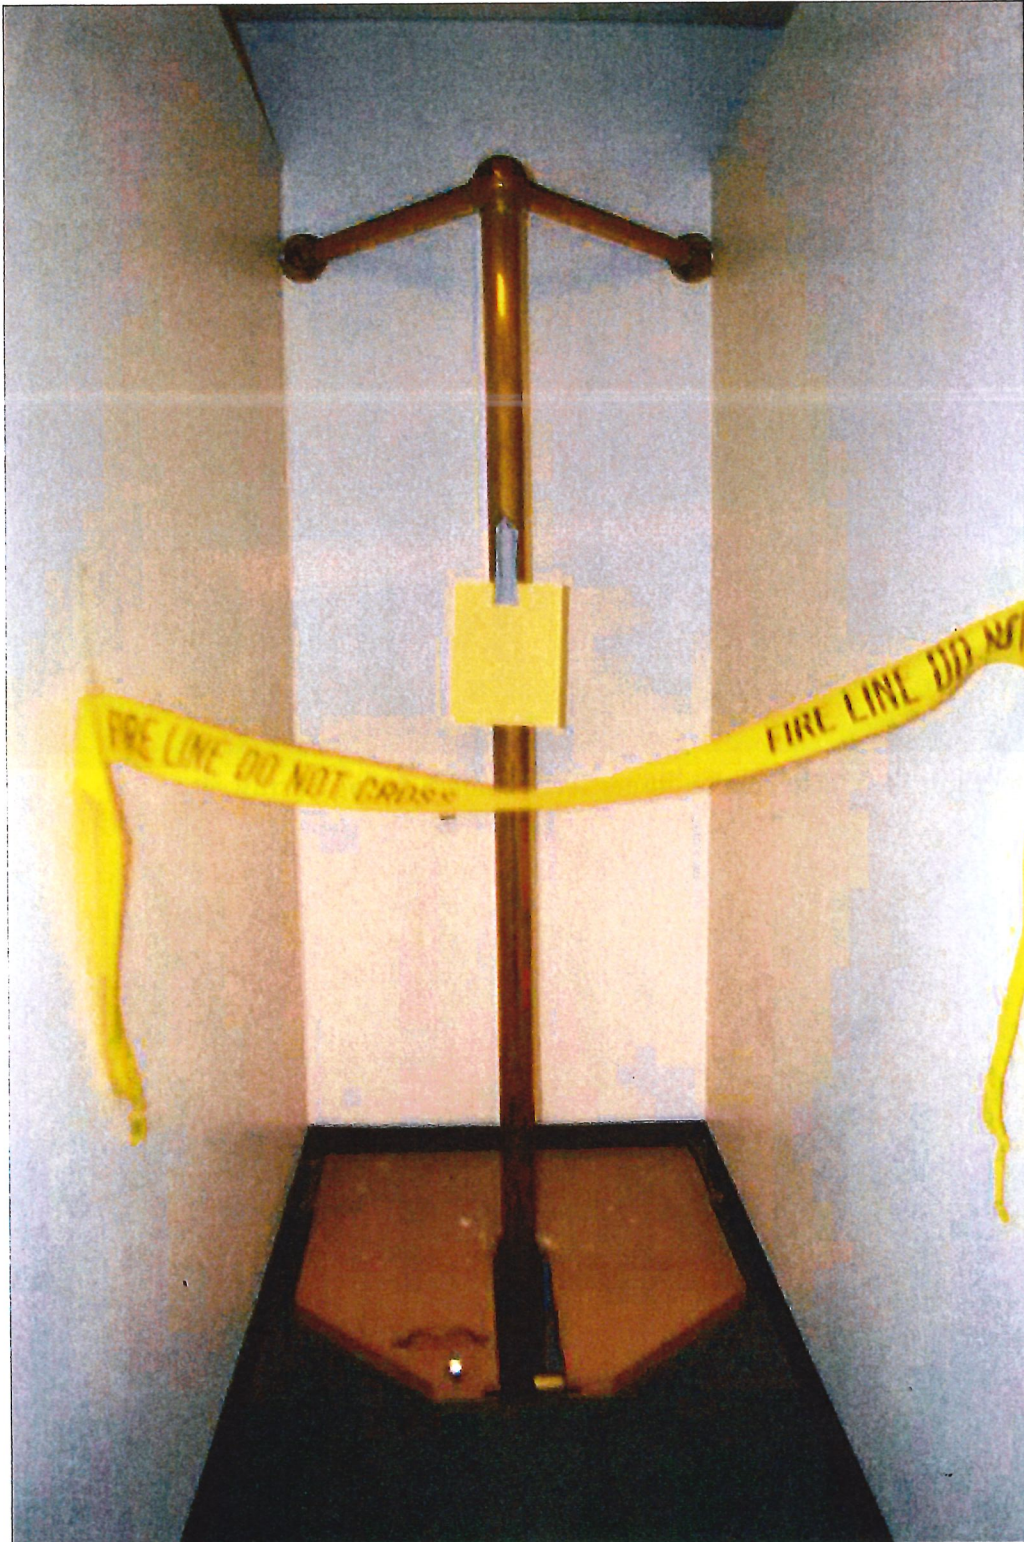
Photograph 15. Fire pole, photograph facing east, taken from upper level.
