**SUBJECT:** Proposed designation of St. Andrew's Church as a Saint Paul Heritage Preservation Site

**St. Paul Heritage Preservation Commission  
Individual Property Designation Form**

**St. Andrew's Church**  
**Part 4**  
**Preservation Program and Design Review Guidelines**

# Proposed Church of Saint Andrew Local Heritage Preservation Site Boundaries

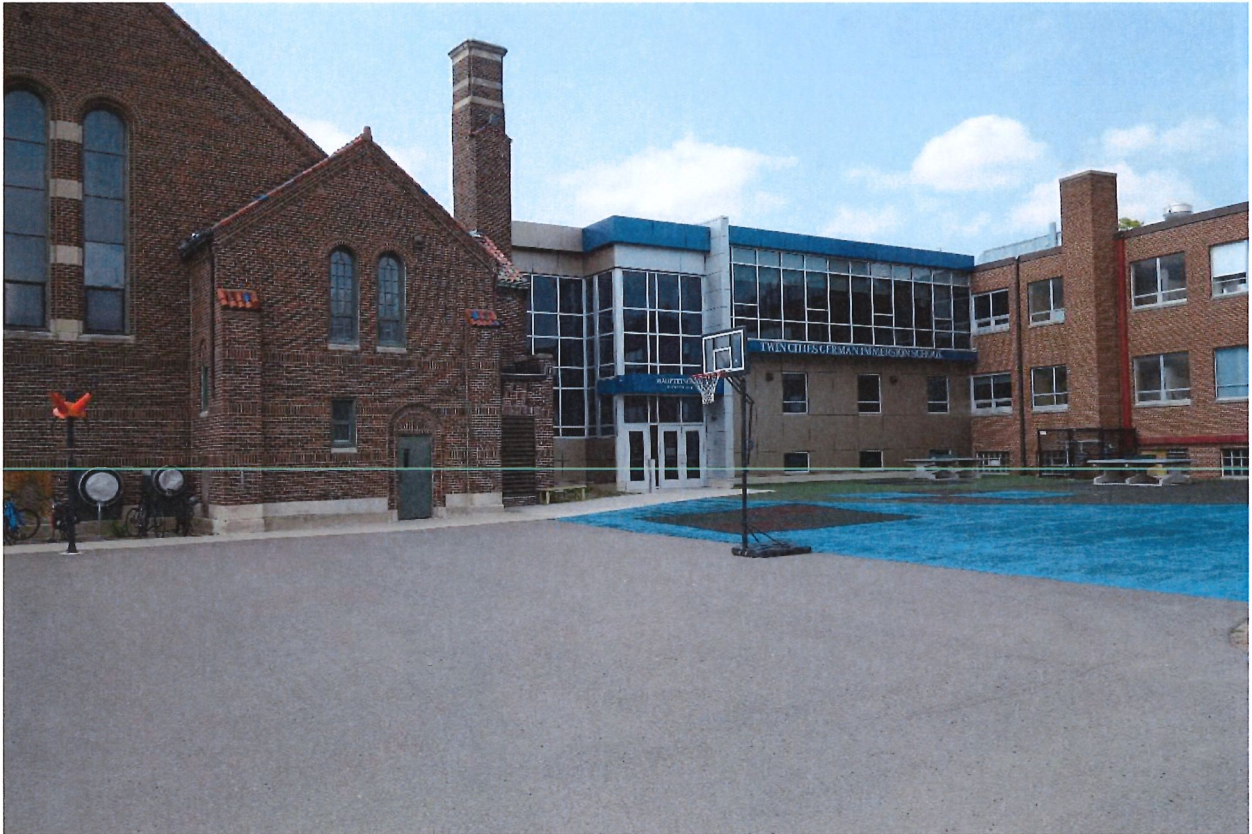
Figure 10. St. Andrew's Church at the left, the school building at the right, and the addition that connects the buildings in the center. Photo Rolf Anderson

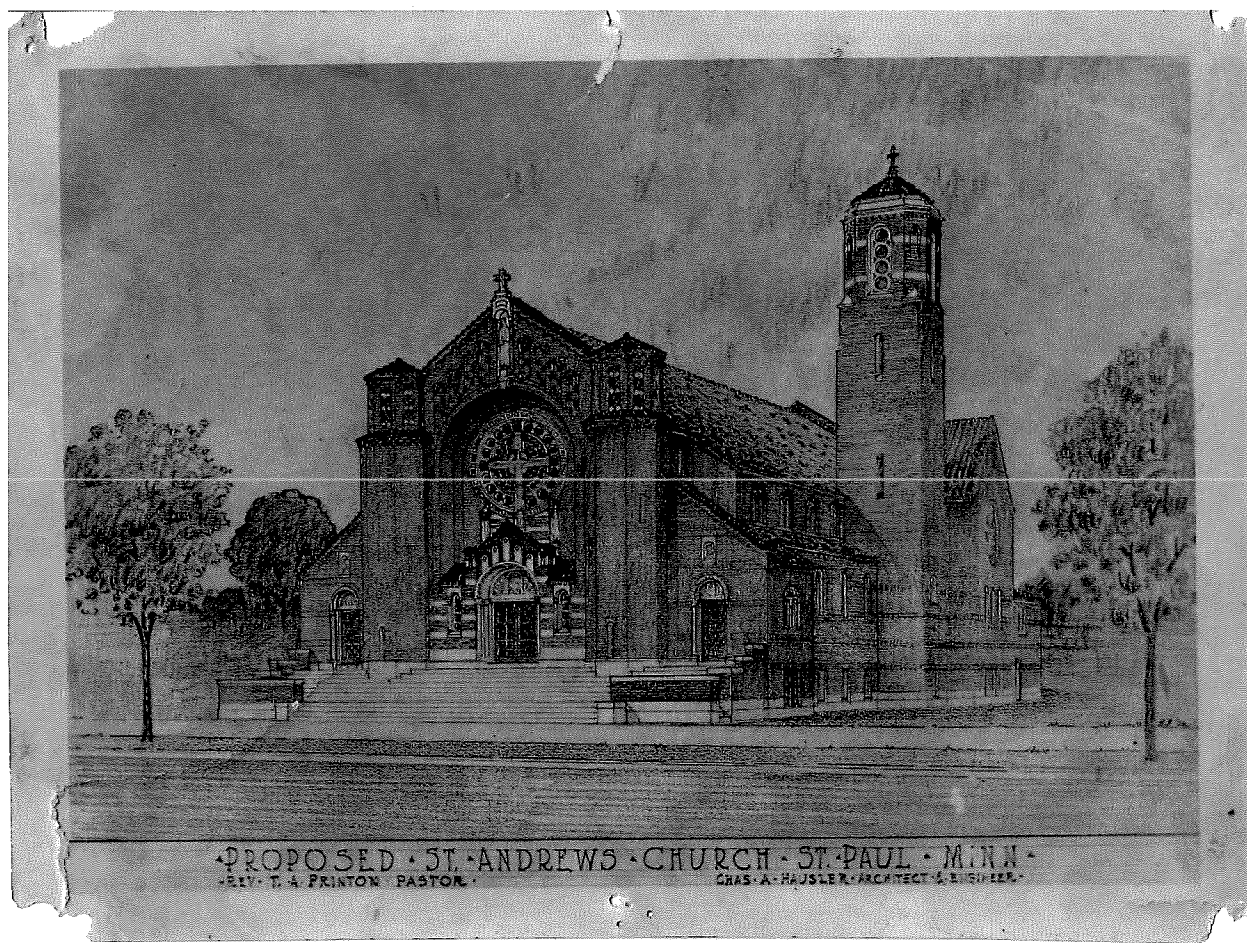
Figure 12. Architect's rendering of St. Andrew's Church. Image courtesy Jennie Hausler

St. Andrew's is an example of the Romanesque Revival Style, which is a revival of the Romanesque style that first developed in Europe in the 9<sup>th</sup> through the 12<sup>th</sup> centuries. Design features found in St. Andrew's that reflect this style include the use of semi-circular arches for all openings, and the use of arches, or a series of arches, even when there are no openings, in order to enrich the wall surface. The round arch motif is also repeated at a smaller scale in arcaded corbel tables. The towers with pyramidal roofs, the entrance portico set within a high recessed arch, and the tri-part window arrangement on the east and west elevations also reflect the style. The polychromatic use of stone and brick is also an element of the style.

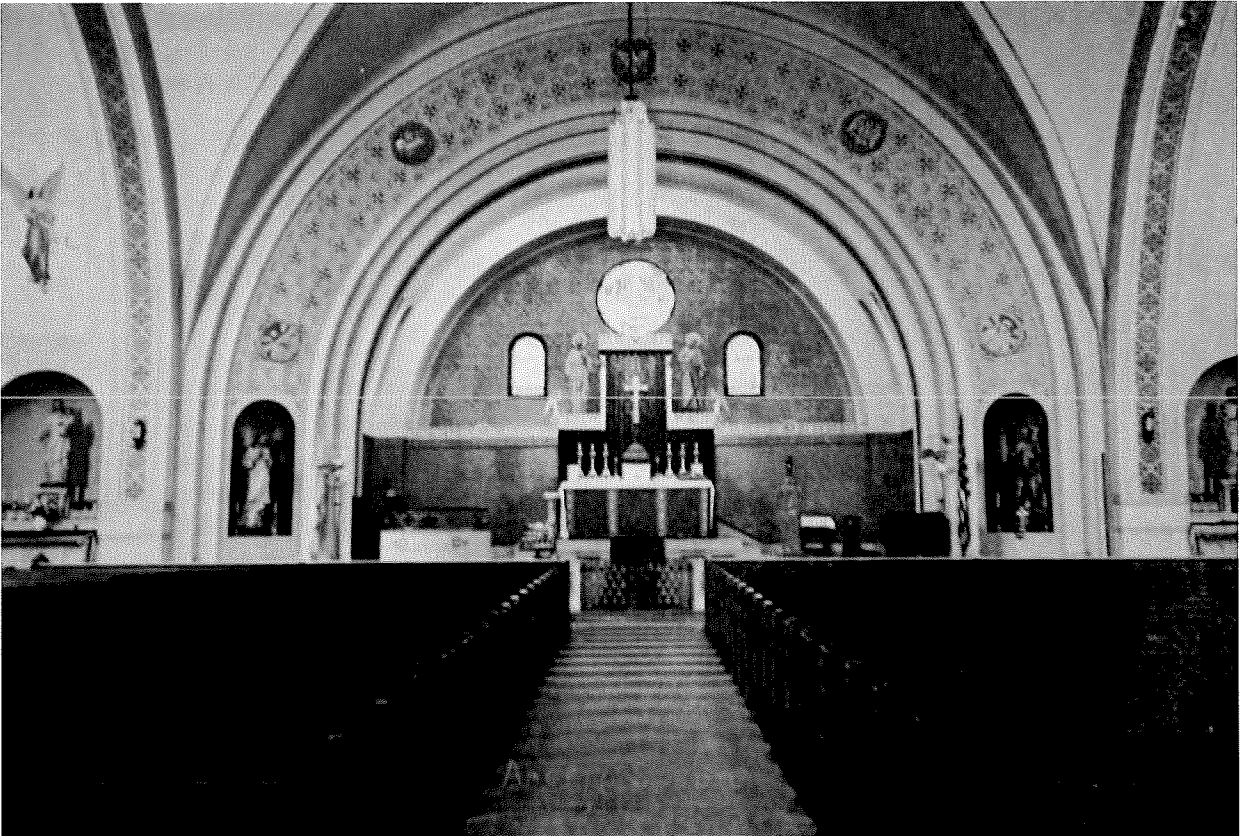
Figure 14. Historic interior view ca. 1930. Image St. Andrew's Archives

In 1968, as a result of the Second Vatican Council, the interior of the church was modernized and simplified. St. Andrew's was one of the first churches in the Archdiocese to be updated. As part of the changes, the three stained-glass windows in the chancel were closed off, although one of the openings was later reopened.
