Water Quality & Quantity MONITORING PROGRAM Monitoring Report

WSB Project No. 1610-10

**2014 STORMWATER QUANTITY AND QUALITY
MONITORING PROGRAM**

**FOR THE CITY OF
SAINT PAUL, MINNESOTA**

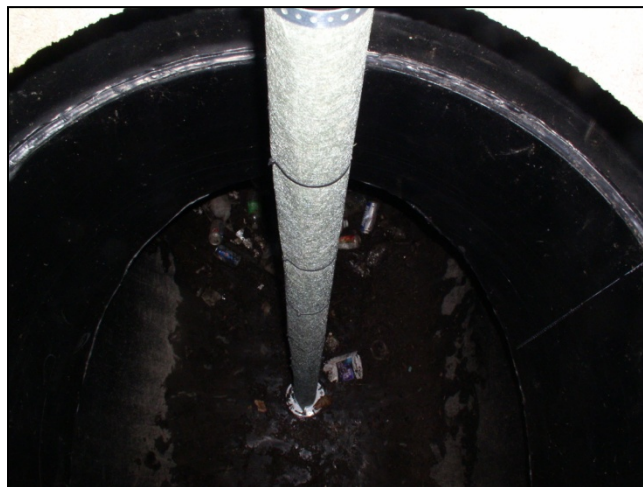
Enclosures for the level loggers were installed at Hillcrest Knoll Park, St. Albans Street, and Arundel Street. These consisted of three-inch-diameter PVC pipes with four rows of half-inch-diameter holes drilled along the pipe achieving approximately twenty holes per foot. The enclosures were then wrapped with a highly permeable geotextile fabric and secured with zip ties to protect the instrument from fine sediment accumulation. Enclosures were secured to the system floor and to the access riser wall (**Photo 2-1**).

Photo 2-1: Level Logger Enclosure

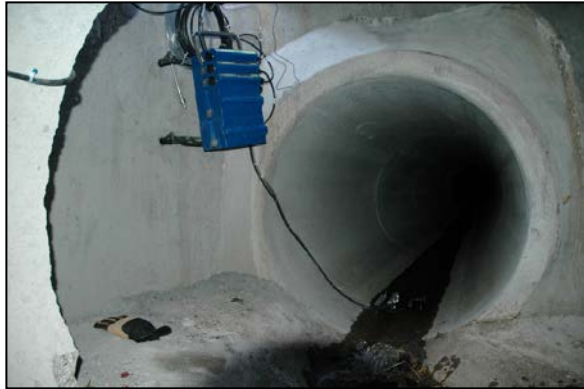
Teledyne ISCO 2150 area velocity flow modules and sensors were used to monitor runoff volumes. These devices measure water level and flow velocity. Combining this information with a known conduit shape, the flow rate and flow volume through the conduit were calculated. Each of the monitored systems received stormwater runoff from a diversion structure located along the storm sewer system. The 2150 flow sensors were positioned at the upstream and downstream pipes in these structures to measure the total volume draining to each BMP and the total volume

Photo 2-2: Flow module in Beacon Bluff diversion structure (looking upstream)

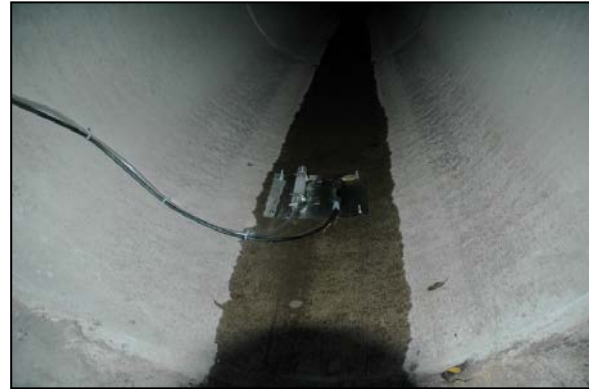
Photo 2-3: Flow sensor in upstream pipe in Beacon Bluff diversion structure

The flow modules were configured at each site to log data at one minute intervals once the water level in the upstream pipe was greater than one-inch above the pipe invert to increase the resolution of the flow data.

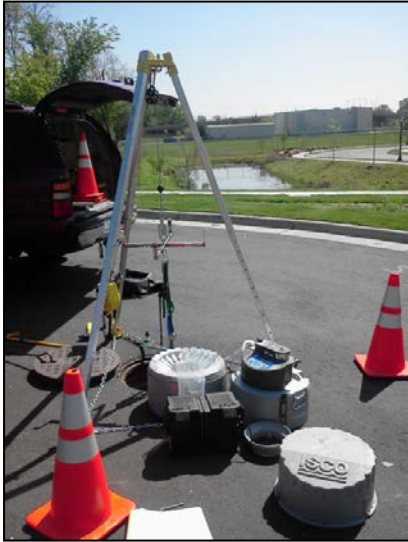
ISCO 6712 automatic samplers were installed in the diversion structures at Beacon Bluff, Hillcrest Knoll, and St. Albans Street (**Photos 2-4** and **2-5**). Dale Street water quality was monitored by grab samples collected from upstream and downstream of the system.

Photo 2-4 : ISCO 6712 sample at Beacon Bluff

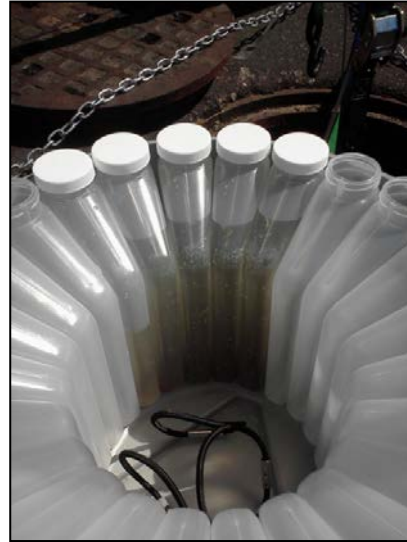
Photo 2-5 : ISCO 6712 sampling carousel (24 – 1,000 mL sample bottles)

The automatic samplers were configured to collect 200 mL samples at constant volume intervals. The flow pacing intervals were initially estimated for each site to provide a minimum of six samples during a quarter-inch storm but less than 120 samples for the three-inch storm. Flow pacing was refined during the monitoring period to achieve this objective.

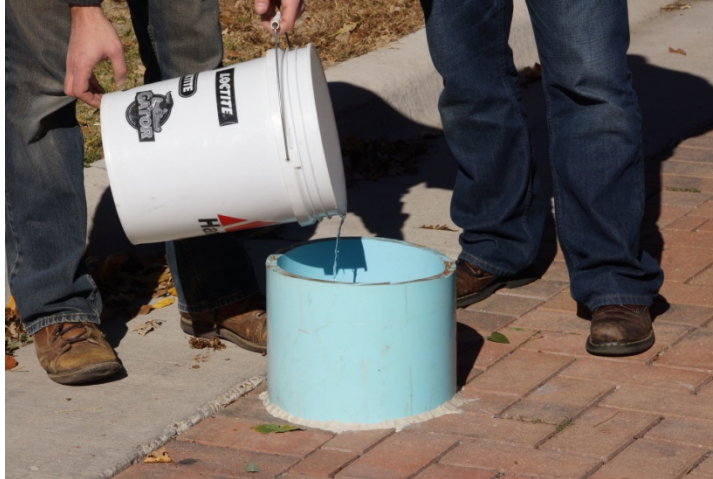
Photo 2-6: Permeable Pavement Infiltration Test

Infiltration tests were conducted according to the modified ASTM C1701 methods for measuring infiltration rates. Five to nine tests were conducted at random locations over each of the permeable surfaces to develop an average infiltration rate measurement. Tests were taken at locations that remained consistent year to year and included a combination of high and low traffic areas. At each test location a pre-wet test was conducted, followed by two infiltration tests. The two infiltration tests were averaged to generate the infiltration rate for each location. If after twenty five minutes of monitoring during a pre-wet test no infiltration was observed, the test was aborted and no subsequent tests were completed.

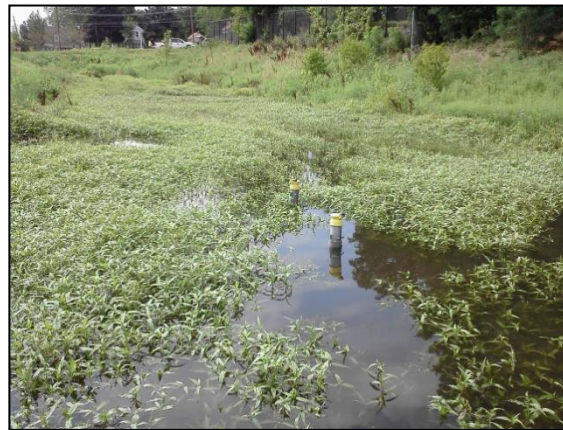
Photo 3-2: Infiltration basin located above storage chambers

The system consists of three parallel 215 foot-long, ten-foot-diameter perforated metal underground chambers constructed beneath an infiltration basin. Stormwater is routed into the infiltration basin from a diversion structure in the storm sewer along Duchess Street and from two other storm sewer outfalls. Additionally, there is a small pond to the west of the underground infiltration system which drains directly into the underground chamber. An outlet structure, which is connected directly to the underground chamber, conveys stormwater back to the storm sewer when the system is full. Rainfall monitoring for the site is conducted on the roof of Wilder Recreation Center located 0.8 miles to the west of the system.

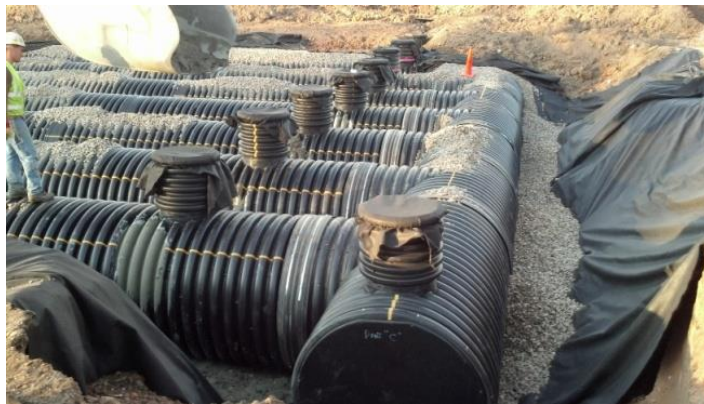
Photo 4-1: 60" Perforated HDPE pipes during system construction

The system consists of an underground pipe gallery infiltration system containing nine parallel 275-foot-long, 60-inch-diameter perforated HDPE pipes. Stormwater runoff within the 37.1 acre subwatershed is directed to the system via a diversion structure in the trunk storm sewer system along Flandrau Street. When the system has reached its storage capacity, runoff continues to flow downstream through the storm sewer. Pretreatment for this design includes a Vortechs hydrodynamic separator and an isolator row within the storage gallery. Rainfall monitoring for this site is conducted at the Hayden Heights Recreation Center which is located one half mile to the east of the system.

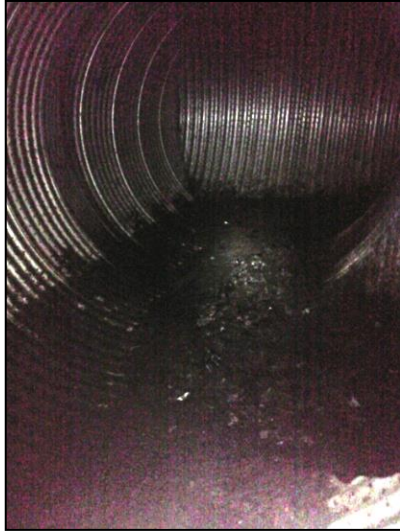
This system, shown in **Figure 6-1**, is owned and operated by the Capitol Region Watershed District (CRWD) and funded in part by the City of Saint Paul. It has been monitored by the City since 2012. CRWD also conducted monitoring of the AHUG system during the 2014 season which included BMP level, flow data and water quality. A complete summary of those results can be found in CRWD Annual Monitoring Report. Water quality results and BMP maintenance are not discussed in this report.

Photo 6-1: Underground perforated CMP storage chambers

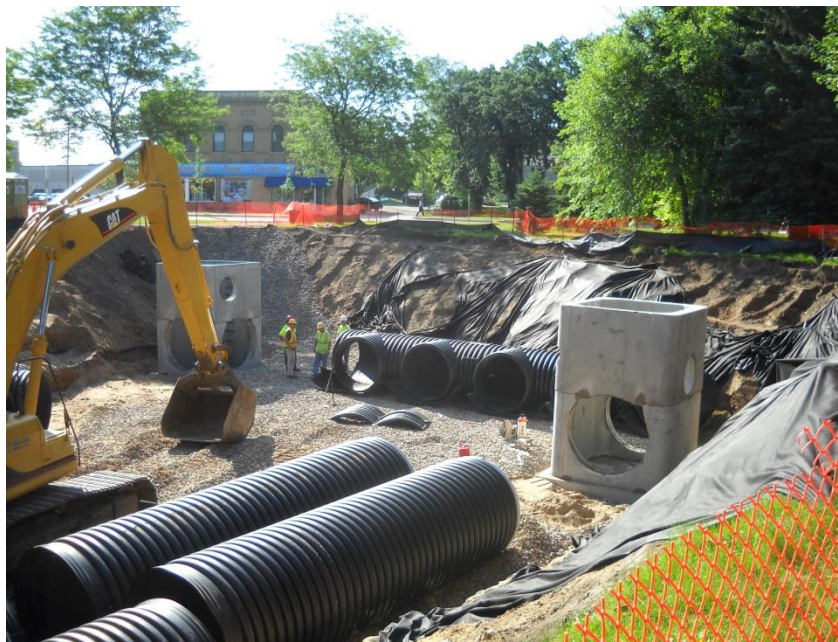
Photo 8-1: Hampden Park BMP Construction

The Hampden Park infiltration gallery, shown in **Figure 8-1**, was constructed in 2014. The system consists of eight parallel perforated pipes that are five feet in diameter and range in length from 40 to 100 feet. Runoff is routed to the pretreatment system via a 24" RCP from main storm sewer near Hampden and Raymond Avenues. From that location, stormwater enters a pretreatment structure which consists of a box culvert section and baffled weir to provide skimming and settling of runoff prior to entering the infiltration chamber. When the system reaches full capacity, stormwater is routed back to the storm sewer via a 24" pipe from the southeast side of the system. Monitoring of the system began in September 2014.

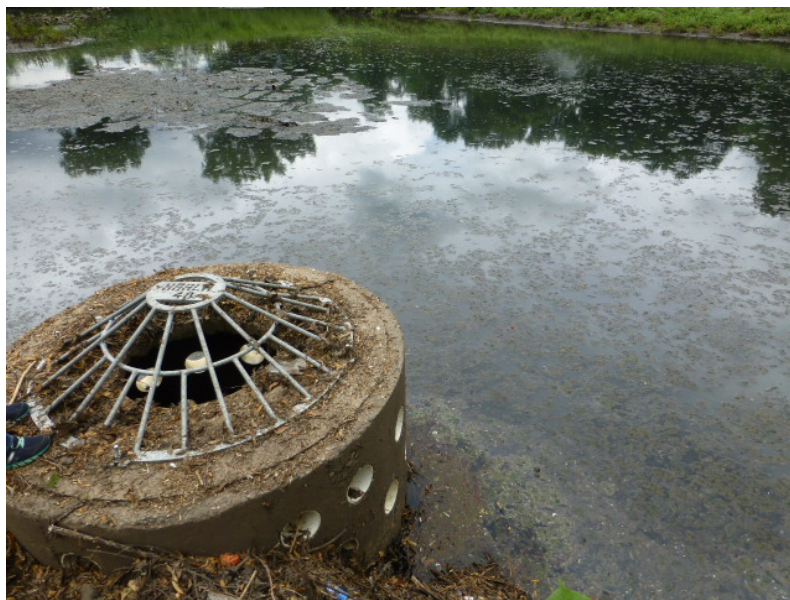
Photo 10-1: Flandrau-Hoyt Pond outlet

A level logger was installed near the pond outlet and configured to record elevations once per hour. Pond water elevations and rainfall are presented on **Chart A.20** of **Appendix A**. During the 2014 monitoring season (July – October), the maximum water elevation observed at Flandrau-Hoyt pond was 206.4 ft (Saint Paul City Datum) in comparison to the emergency overflow elevation of the pond which is 216.50 ft (Saint Paul City Datum).

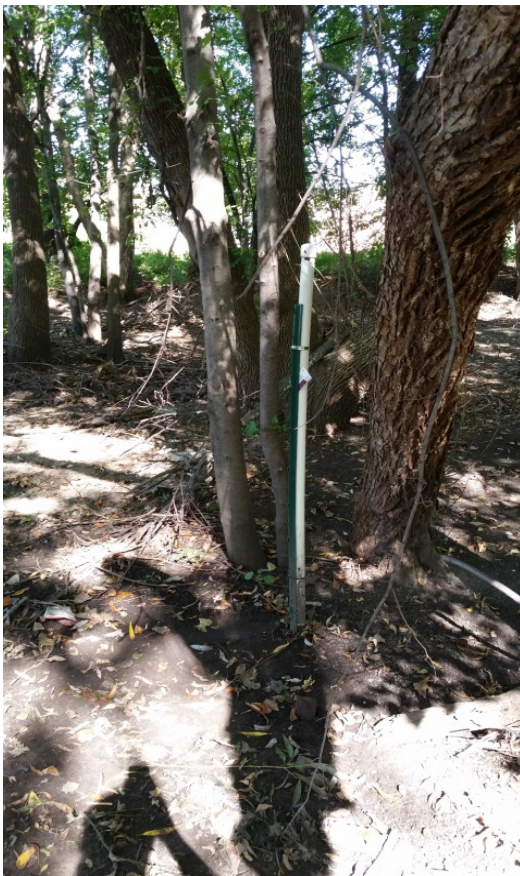
Photo 11-1: Level logger configuration

A level logger was installed near the pond outlet and configured to record elevations once per hour. Pond water elevations and rainfall are presented on **Chart A.21** of **Appendix A**. During the 2014 monitoring period, water levels reached the logger location one time following a 0.98 inch rain event on July 7, 2014.

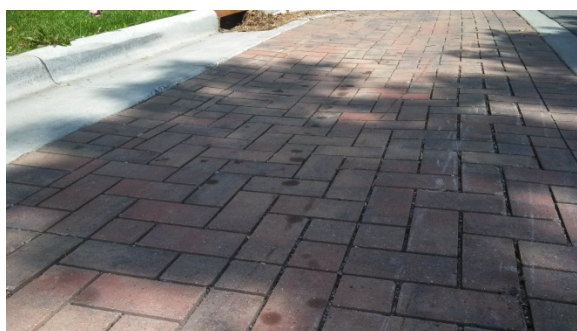
Photo 12-1: Interlocking Pavers at Victoria Street

- **Victoria Street Permeable Pavers Maintenance** – Since 2012, the average infiltration rate of the Victoria Street permeable pavers has decreased from 180.04 in/hr to 14.42 in/hr (**Section 12.1**). In one of five locations, the infiltration rate was observed to be zero. Sediment accumulation within the pavers has been observed at the site. It is recommended that the City complete maintenance of the pavers utilizing a vacuum air sweeper, and restore the aggregate fill between the pavers subsequent to vacuuming.

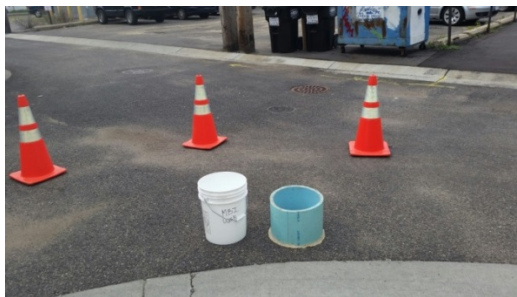
Photo 12-2: Sediment accumulation on pervious pavement

- **Hamline-Midway Library Pervious Pavement Maintenance** – Since 2013, the average infiltration rate at the Hamline-Midway Library decreased from 206.8 in/hr to 31.1 in/hr (**Section 12.2**). In 2014, seven of nine locations at Hamline-Midway Library were observed to have zero infiltration. Large amounts of sediment and debris was observed on the pavement. It is recommended that the City complete maintenance on the surface utilizing a vacuum air sweeper.

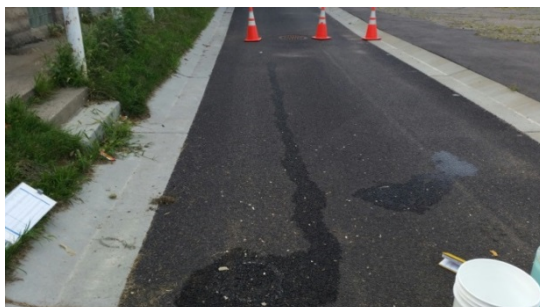
Photo 12-3: No infiltration observed

*Locations were monitored for a maximum of 25 minutes during the pre-wet test. If no infiltration was observed, no subsequent tests were completed and infiltrations rates were documented to be 0.0 in/hr.

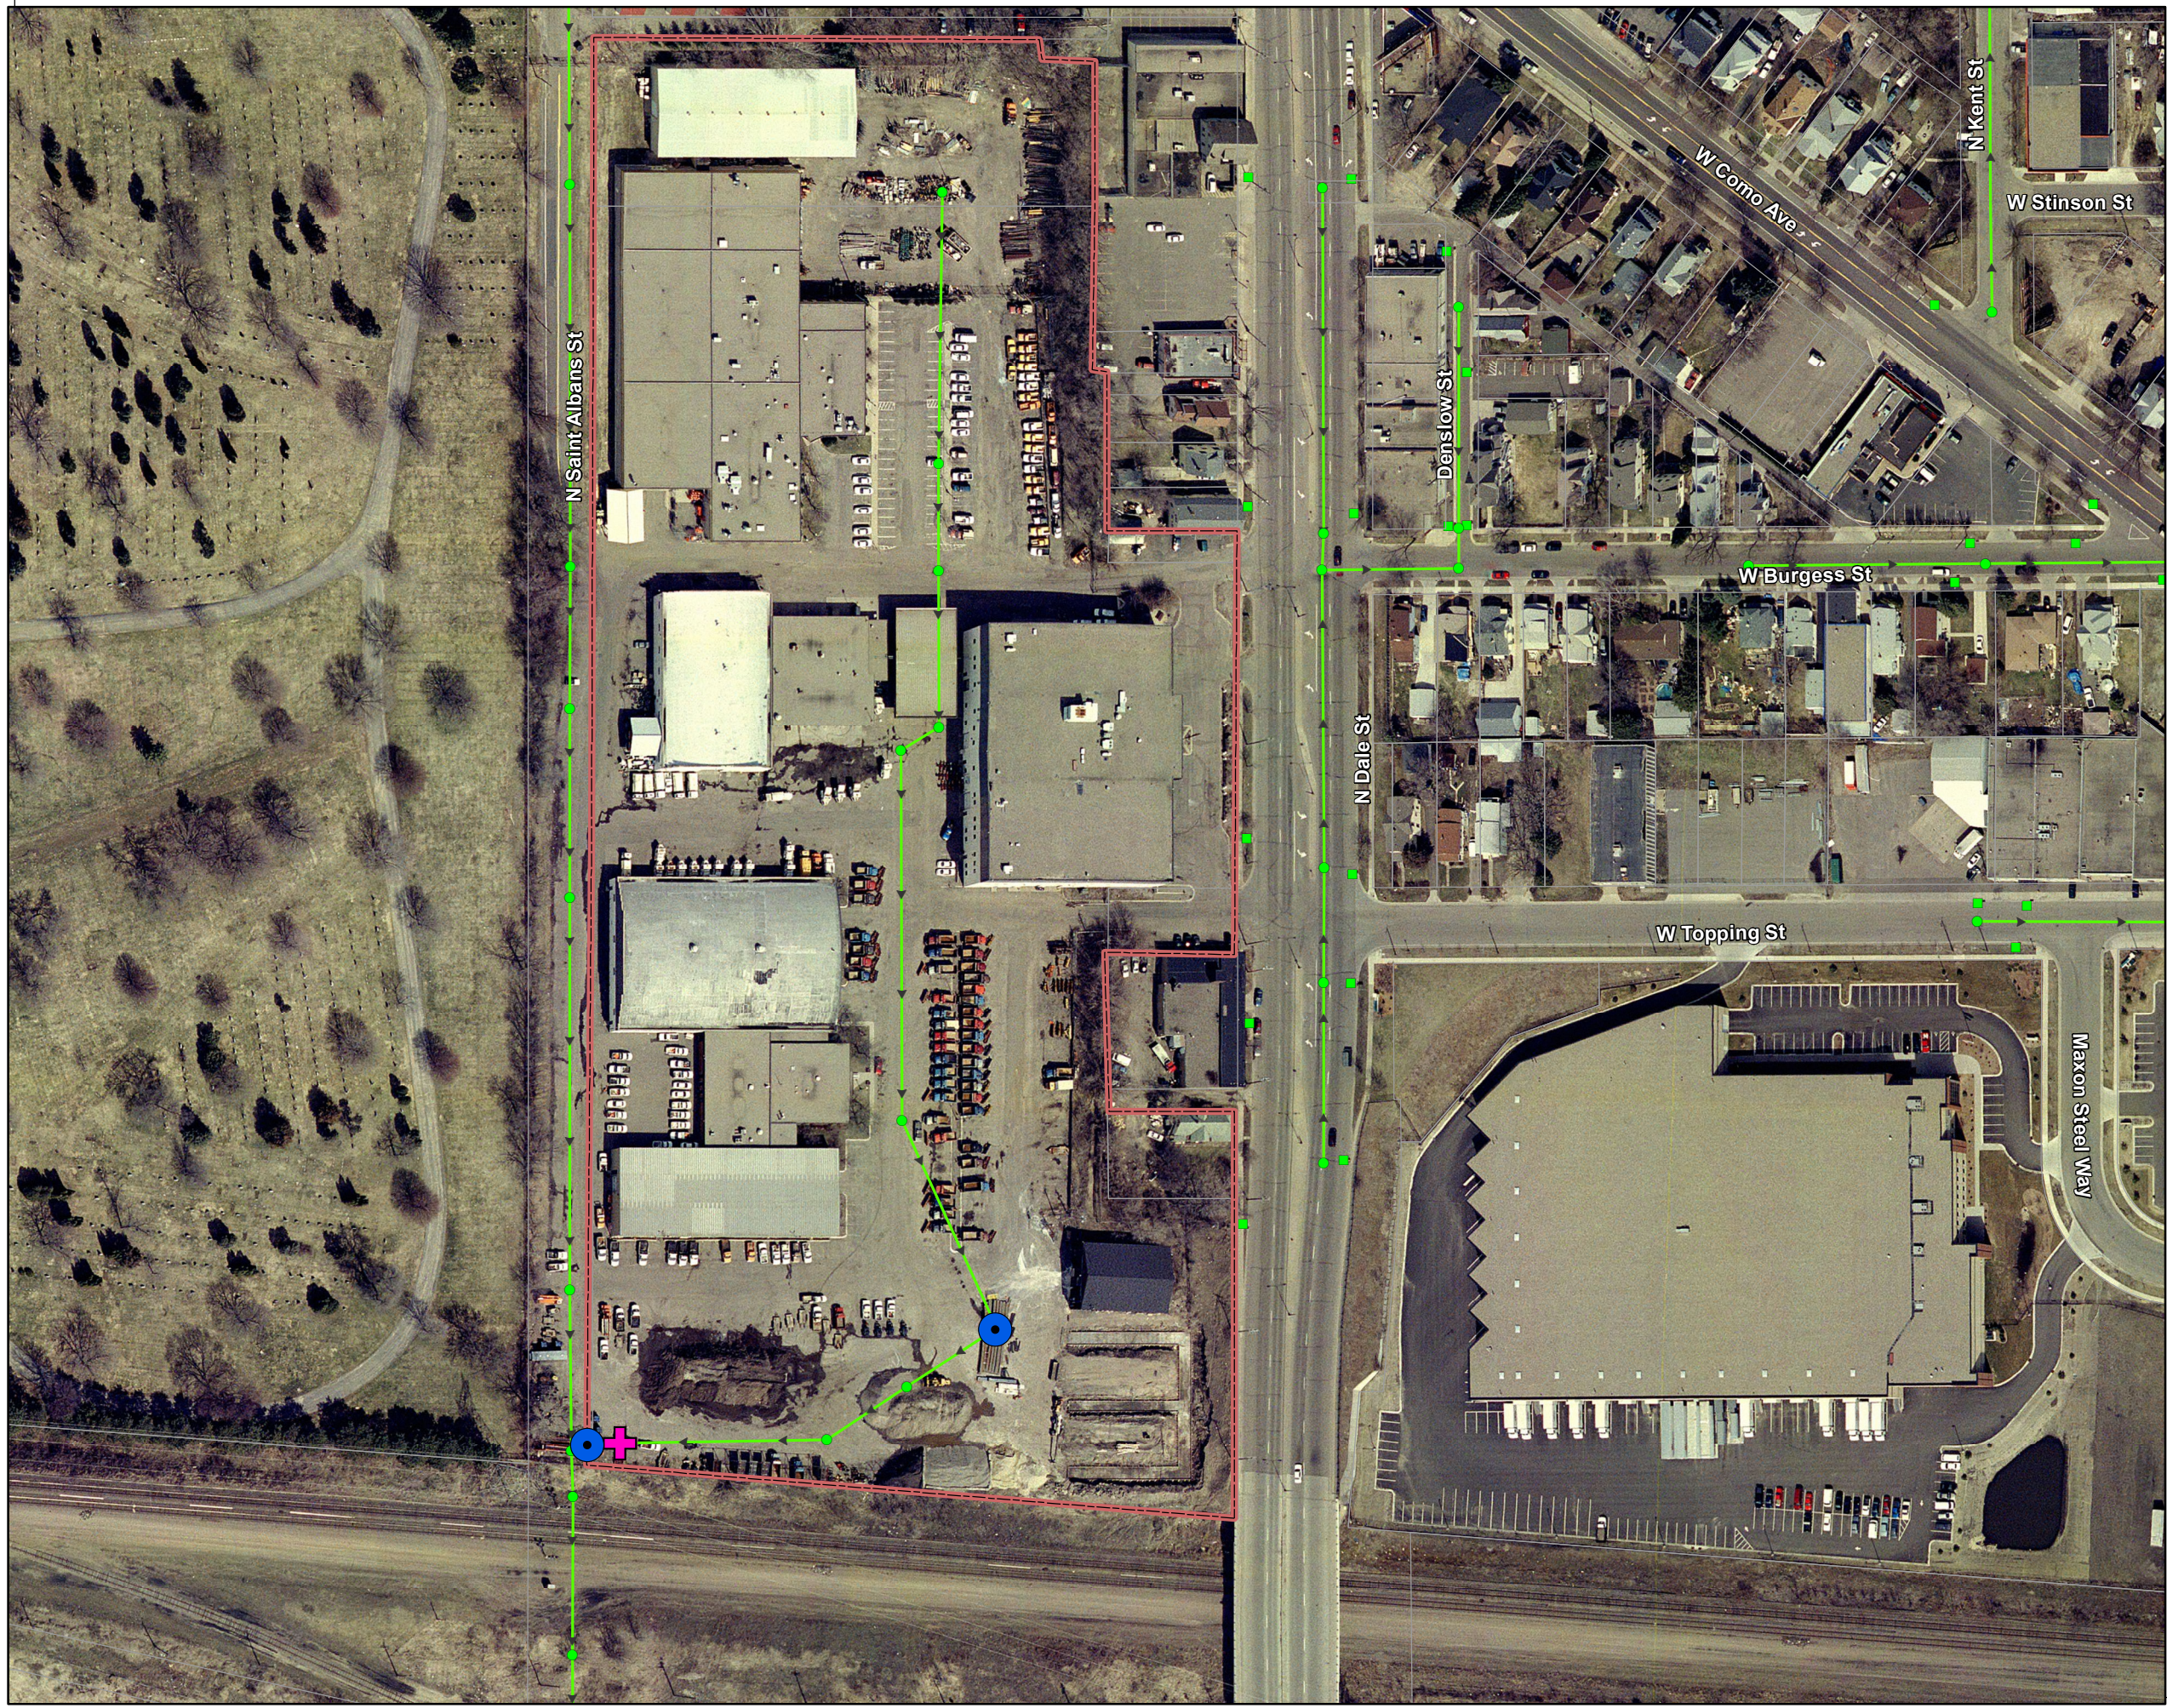
Figure 9-1
Dale Street Facility
Site Map

Vortechs system was constructed to collect sediment and debris from the Dale Street Facility, which is shown on **Figure 9-1**. Water quality monitoring has been conducted at the site since 2013.

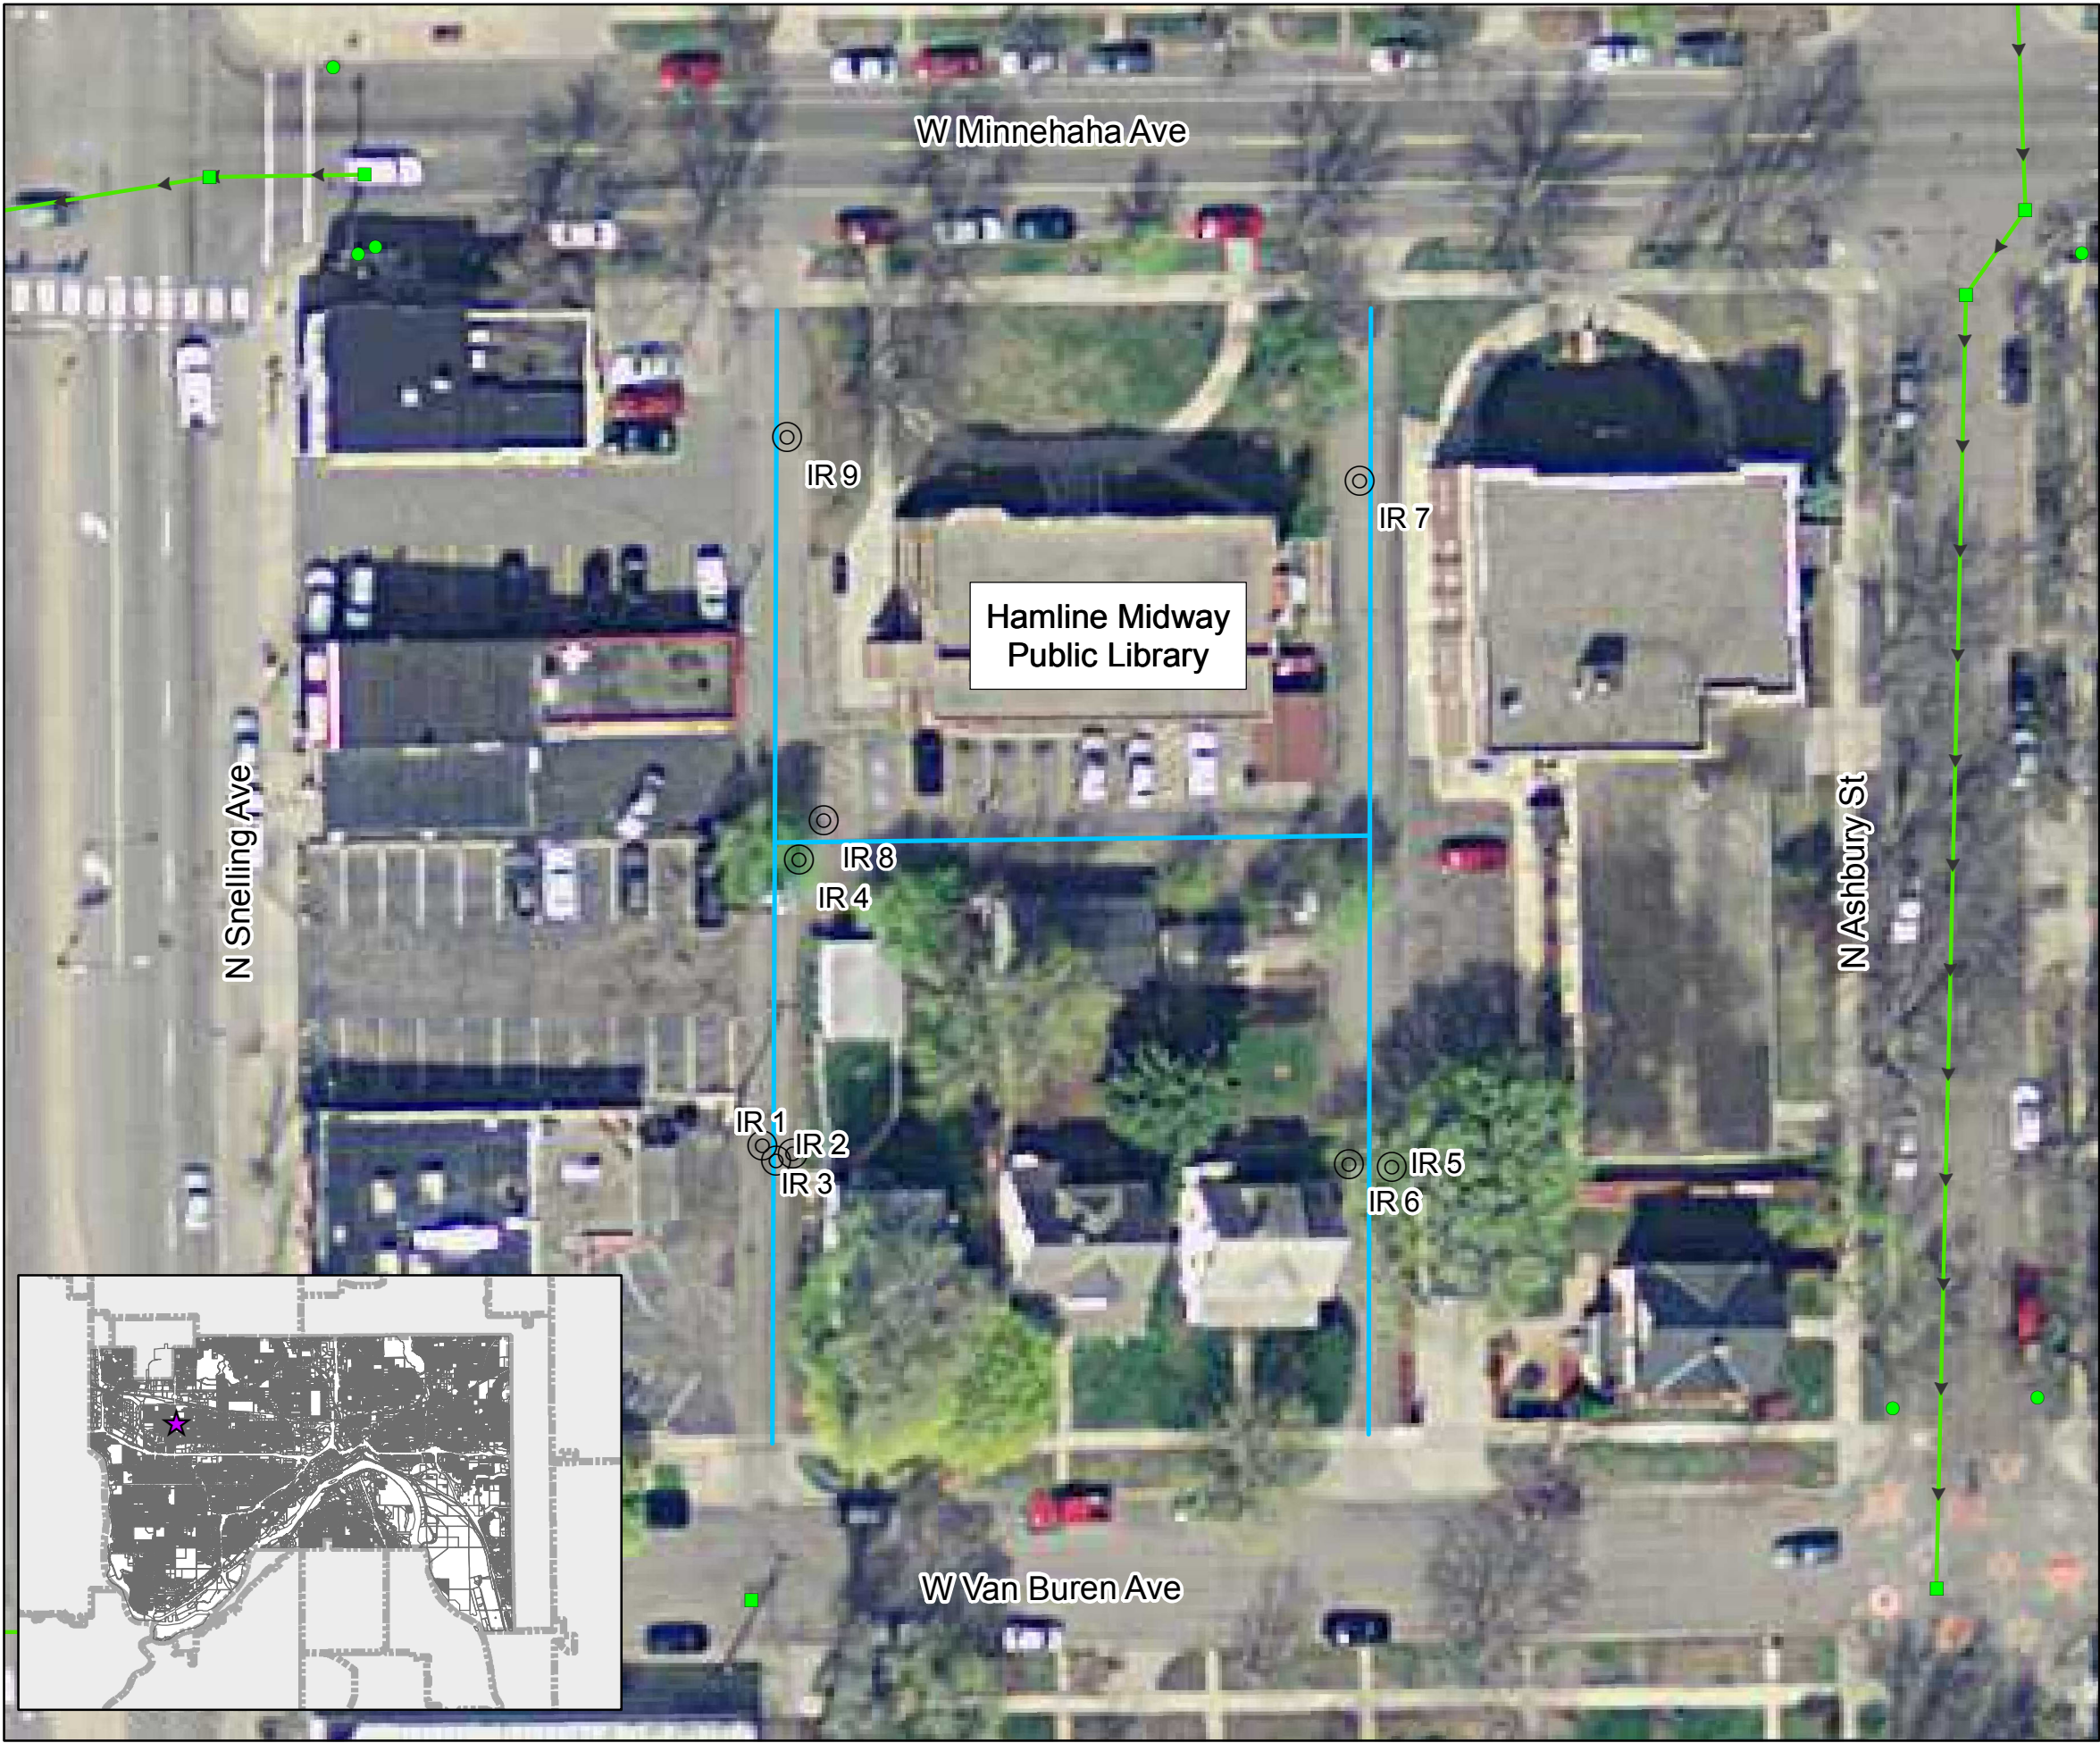
Figure 12-2

The Hamline Midway Library pervious surface consists of porous asphalt. The asphalt was installed in 2012 and infiltration rates were monitored in 2013 and 2014. As shown in **Table 12-2**, infiltration rates at nine locations on-site have decreased from 2013 to 2014. In 2014, seven of nine locations exhibited no infiltration. Overall, the site average infiltration rate in 2014 was 31.1 in/hr comparison to 206.8 in/hr in 2013. The test locations are presented in **Figure 12-2**.
