2015 Water Quality & Quantity Monitoring Program

Monitoring Report

2015 STORMWATER QUANTITY AND QUALITY MONITORING PROGRAM

FOR THE CITY OF SAINT PAUL, MINNESOTA

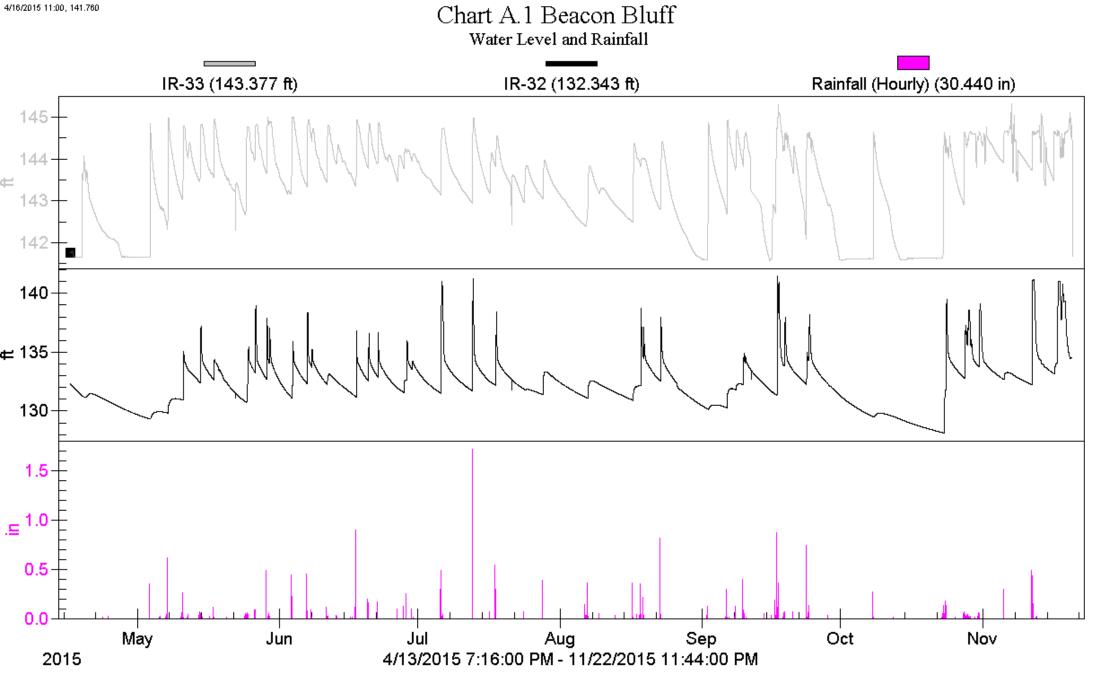
City of Saint Paul 2015 Water Quality and Quantity Report Chart A.2 WSB Job No.: 01610-100

Infiltration rates of the soil in the west infiltration basin (rain garden) and the underground system (BMP pipe) were measured by using continuous water level loggers placed in piezometers. Groundwater elevation was also measured in four locations at the site. Water level elevations, within the system and groundwater, and daily rainfall totals are presented on **Chart A.1** and **A.2** of **Appendix A**. Level monitoring in the infiltration gallery indicated a level range of 128.3-141.6 Saint Paul City Datum (SPCD) (bottom and top elevations of the infiltration gallery are 124.5 and 134.5 SPCD, respectively). This confirms that the system did not completely drain throughout the 2015 monitoring period. Monitoring in the outlet control structure weir elevation five times during the monitoring season. On July 6th, July 13th, September 17th, November 11th, and November 17th a portion of volume from the underground system was conveyed back to the main stormsewer line. Groundwater elevations at the site were a minimum of thirteen ft below the bottom of the infiltration gallery for the 2015 season.

Groundwater and Infiltration System Level Measurements Beacon Bluff St. Paul, MN

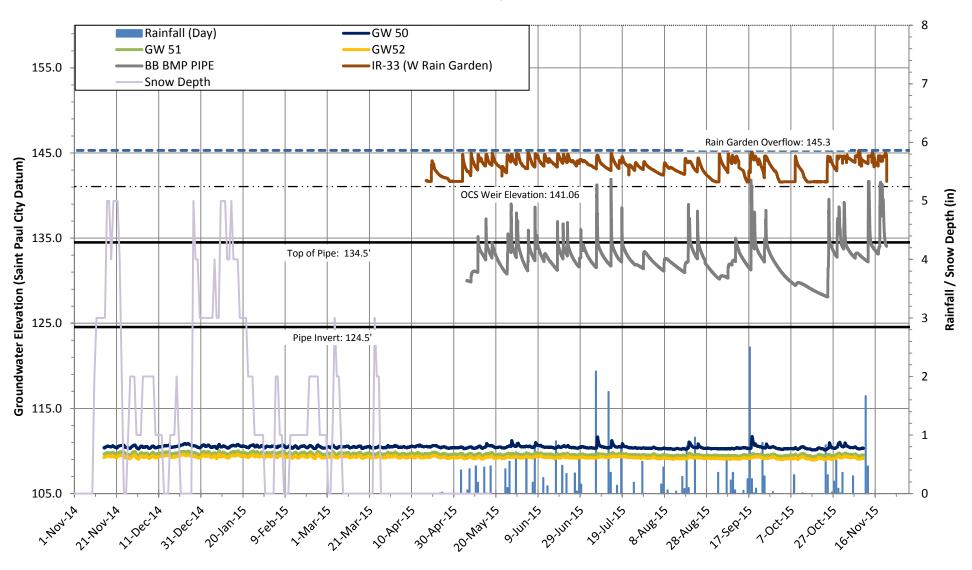
City of Saint Paul 2015 Water Quality and Quantity Monitoring Chart A.3 WSB Project No.: 01610-100

Infiltration rates are presented on **Charts A.3** and **A.4** of **Appendix A**. In 2015, average infiltration rates for the rain garden and BMP pipe were 0.29 and 0.30 inches per hour (in/hr) respectively, as shown in **Table 3-2**. These infiltration rates are below the MSWM recommended infiltration rate for SP soils of 0.8 in/hr and the design infiltration rate of 2.5 in/hr.

Beacon Bluff Raingarden Soil - Infiltration Rate Graph (IR-33) (Observed at 0.5 Foot Height Intervals)

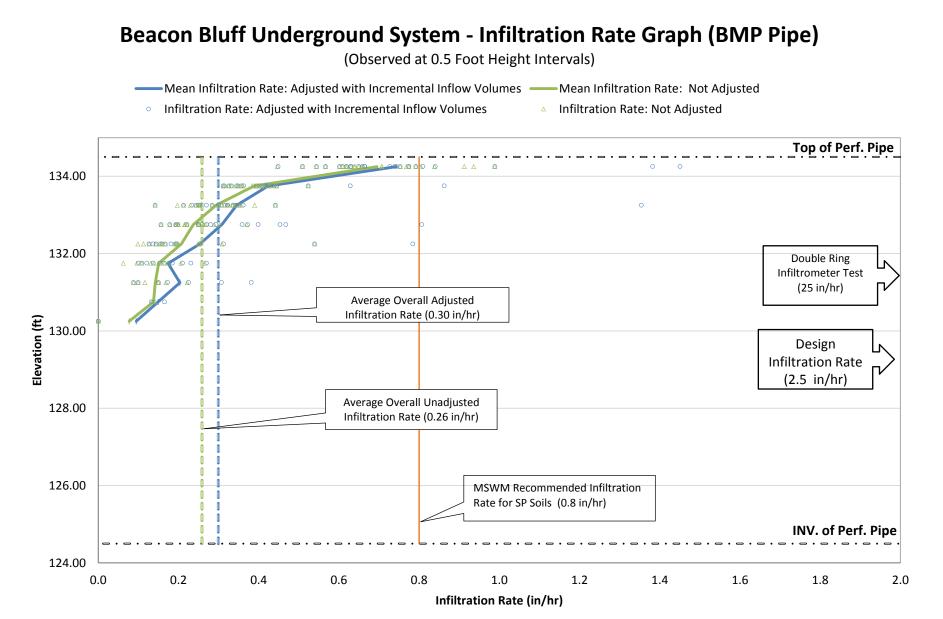
Infiltration rate trends for discrete 0.5 foot intervals for the rain garden (IR-33) and BMP pipe (IR-32) are depicted on **Charts A.5** and **A.6** respectively. Historical infiltration rates are also listed in **Table 3-2** below. Since 2012, average adjusted infiltration rates in the rain garden have decreased from 2.9 in/hr to 0.29 in/hr. Infiltration rates in the BMP pipe have also decreased from 2.6 in/hr to 0.30 in/hr. The decline in infiltration rates in both the rain garden and BMP are likely attributed to sediment accumulation. As mentioned above, standing water was observed in the infiltration gallery, and monitoring data indicated that BMP levels did not drop below five ft. A layer of 0.5 to 1.5 ft of sediment has been observed across the rain garden basin. In 2015, the rain garden was free of standing water for 24 out of 218 days monitored, primarily in early May and October.

Note: Pipe Invert is 124.5' Pipe perforated around circumference of pipe

Infiltration Rate Trends Beacon Bluff (IR-31/ Rain Garden) Adjusted with Incremental Inflow Volumes

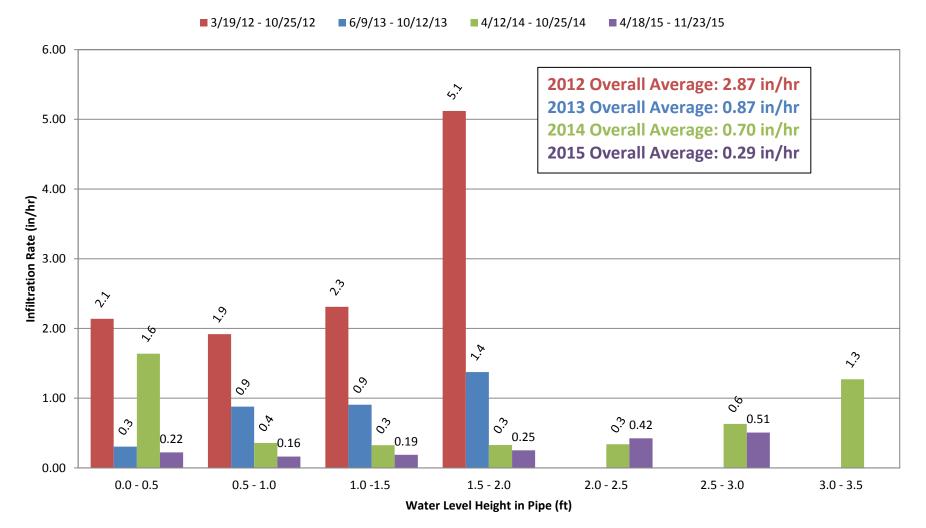
Infiltration Rate Trends Beacon Bluff (IR-32/BMP Pipe) Adjusted with Incremental Inflow Volumes

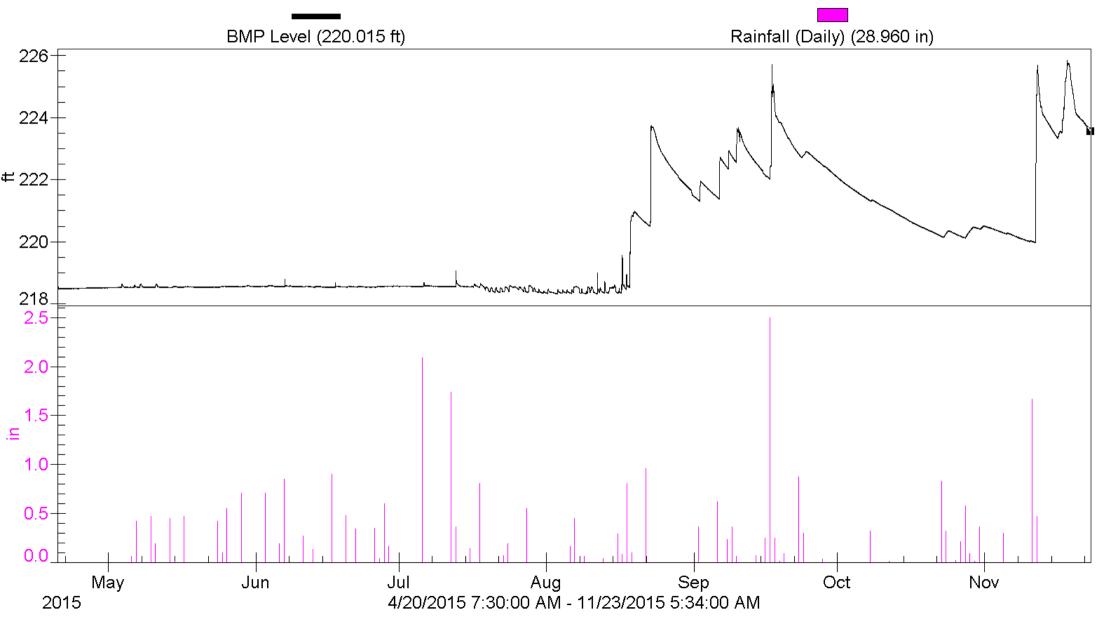
City of Saint Paul 2015 Water Quality and Quantity Report Chart A.8 WSB Job No.: 01610-100

Water elevation was monitored in the system at two locations and groundwater at one using continuous water level loggers placed in piezometers and pvc within the BMP. Water levels, within the BMP pipe and groundwater, and daily rainfall totals are presented on **Charts A.7** and **A.8** of **Appendix A**. In 2015, the float for the bypass gate valve was inadvertently stuck in the closed position, which diverted a majority of water directly downstream instead of allowing flow into the BMP pipe until August 11, 2015. Subsequent to maintenance of the float valve, levels in the infiltration gallery ranged from 218.5 to 228.8 SPCD (bottom and top pipe elevations are 218.3 and 223.55 SPCD, respectively). Following maintenance of the float, the infiltration gallery did not completely drain to empty for the remainder of the 2015 monitoring season. Groundwater levels were documented at elevations within infiltration gallery, consistent with previous years monitoring (See **Chart A.8**)

Groundwater and Infiltration System Level Measurements

Hillcrest Knoll Park

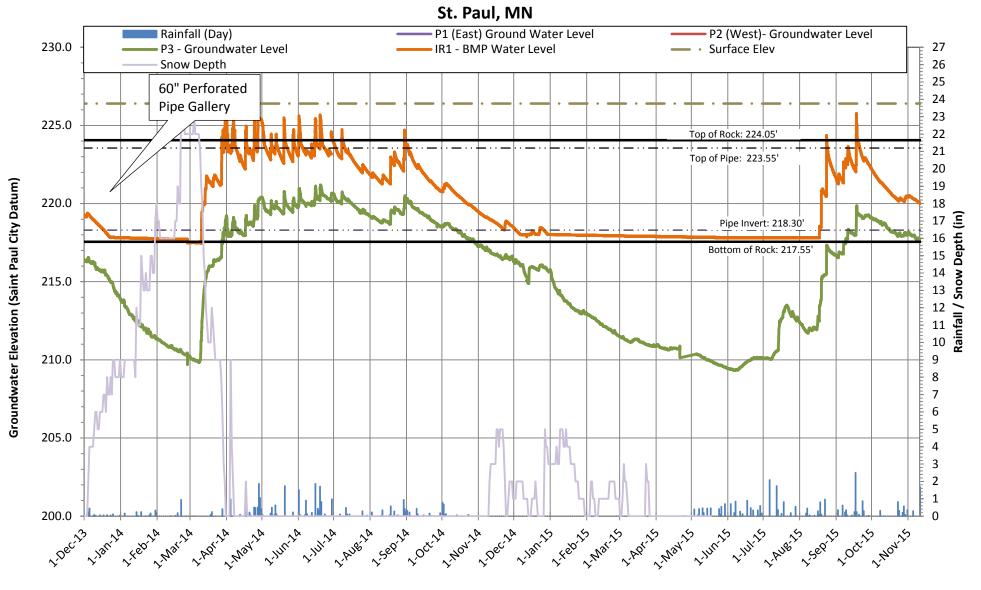
City of Saint Paul 2015 Water Quality and Quantity Report Chart A.9 WSB Job No.: 01610-100

2015 infiltration rates and infiltration rate trends are presented on **Charts A.9** and **A.10** of **Appendix A**, respectively. In 2015, the average infiltration rate for the BMP pipe was 0.92 in/hr in comparison to 0.52 in/hr in 2014 and 0.67 in/hr in 2013 (**Table 4-2**). This is above the MSWM recommended infiltration rate for SP soils of 0.8 in/hr, but below the design infiltration rate of 2 in/hr. The calculated increase in infiltration rates may be a reflection of fewer flow events in which the infiltration rates were averaged over. As shown on **Chart A.10**, incremental infiltration rates for water depths of 2 - 7 ft are similar to infiltration rates calculated in 2013 and 2014. Water level within the BMP reached a depth of 7 - 8 ft during one flow event, which may have biased the infiltration rate for that interval and the overall average for 2015.

Hillcrest Knoll Park - Infiltration Rate Graph

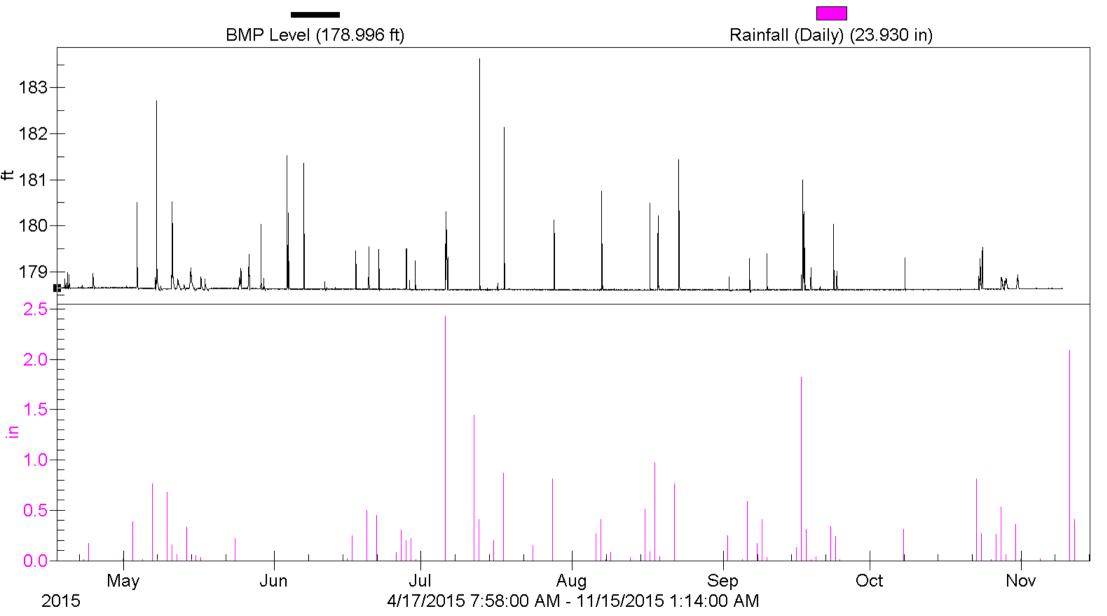
City of Saint Paul 2015 Water Quality and Quantity Report Chart A.12 WSB Job No.: 01610-100

Infiltration rates are presented on **Chart A.12** of **Appendix A**. In 2015, the average infiltration rate of the BMP pipe was 55.3 in/hr (**Table 5-2**), which is above the MSWM recommended infiltration rate for SP soils of 0.8 in/hr and the design infiltration rate of 26.0 in/hr. Infiltration rate trends for the Saint Albans Street BMP pipe are depicted on **Chart A.13**. Infiltration rates have exceeded the design rate every year since monitoring was initiated at the Site in 2012.

St. Albans Street - Infiltration Rate Graph

(Observed 0.5 Foot Height Increments)

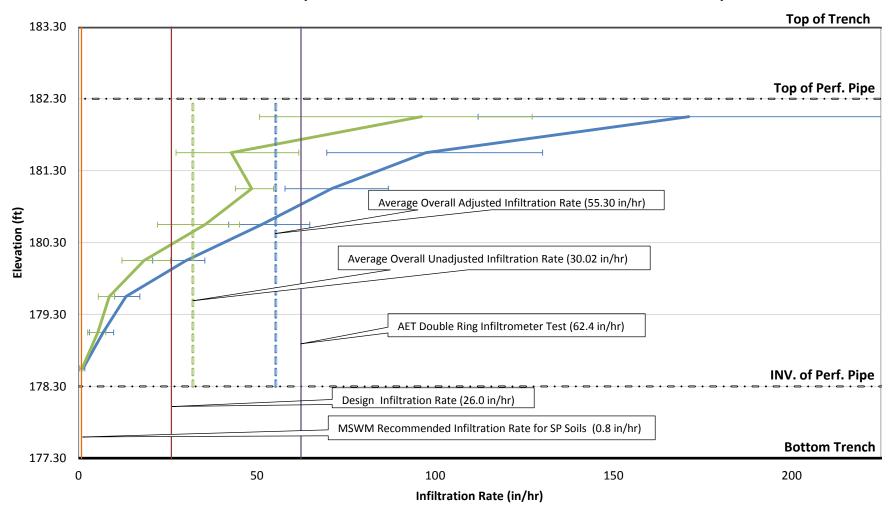
Note: Pipe Invert is 178.3' Error Bars Represent 25th and 75th Percentiles Pipe perforated w/ 2 rows of holes at Elev: 178.9' and 179.2'

Infiltration Rate Trends St. Albans Adjusted with Incremental Inflow Volumes

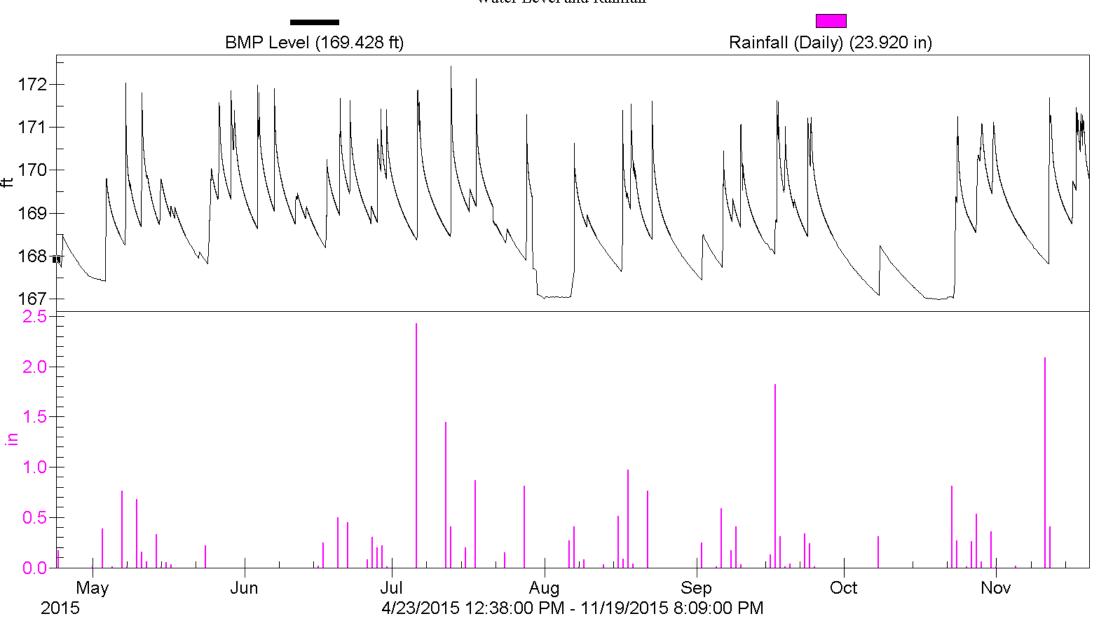
City of Saint Paul 2015 Water Quality and Quantity Chart A.17 WSB Job No : 01610-100

The same analysis method was used to evaluate infiltration rates in the Arundel Street BMP. However, since no monitored inflow data was available, inflow volume was not accounted for.

Arundel Street - Infiltration Rate Graph

(Observed at Incremental 0.5 Foot Elevations)

Mean Infiltration Rate: Not Adjusted (No Inflow Data Collected)

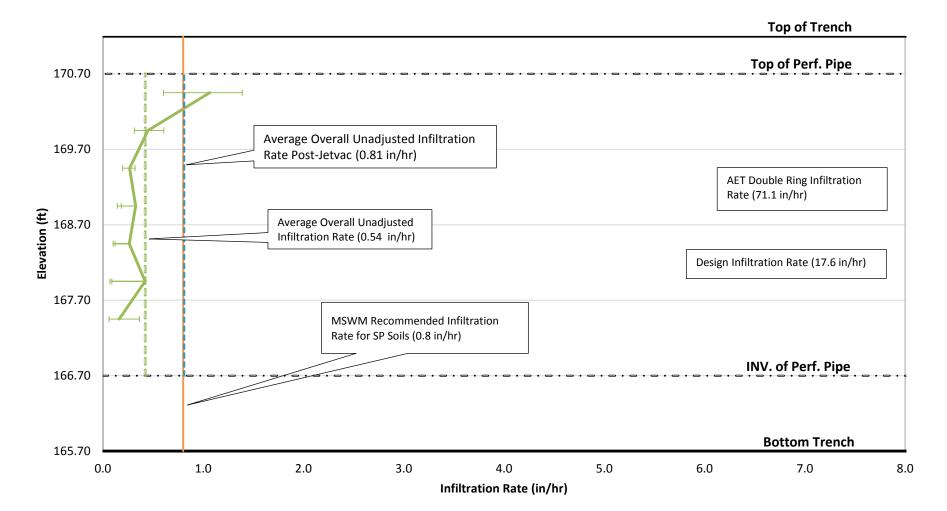
Note: Pipe Invert is 166.7' Error Bars Represent 25th and 75th Percentiles Pipe perforated w/ 2 rows of holes at Elev: 167.3' and 167.6'

Infiltration Rate Trends

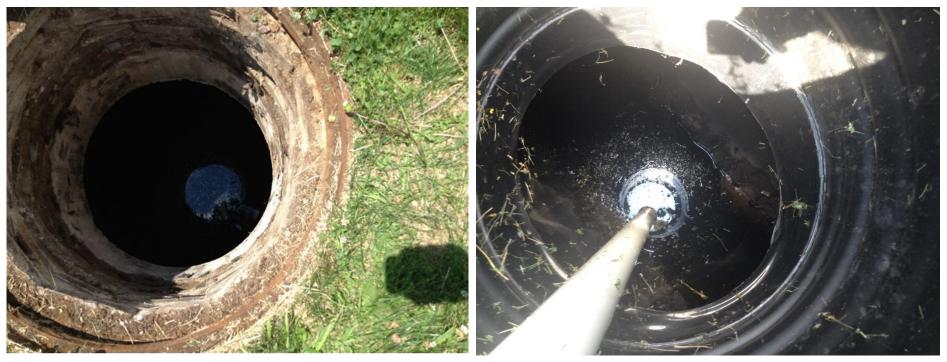
Hillcrest Knoll 6/26/15 Pretreatment and BMP Pipe

Sediment depths in the pretreatment structure and in the underground infiltration system were measured during site visits to determine performance and maintenance needs. As shown in **Table 4-5**, the sediment measured in the pretreatment device was 0.8 to 1.2 ft of soft material. Garbage was observed occasionally in the pretreatment structure, although none was observed in the infiltration gallery. Standing water was observed in the infiltration gallery during the September and November inspections.

On August 11, 2015 the float for the bypass gate valve was found to be stuck in the closed position. The float was manually forced down and water was observed flowing to the BMP. The float was found stuck again on November 10, 2015 and manually forced down during that visit. See **Appendix D** for the **Photolog.**

Pre-treatment

bmp Pipe

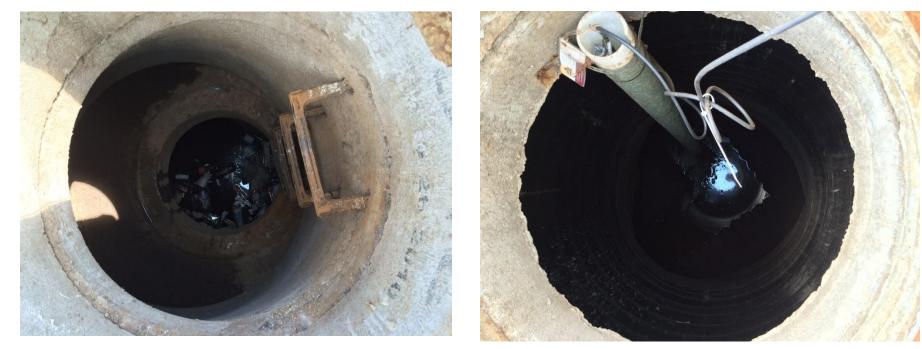
St. Albans 6/25/15

St. Alban's Pre treatment 6-25-15

St. Alban's level logger location 6-25-15
