2018 STORMWATER QUALITY AND QUANTITY MONITORING PROGRAM

CITY OF ST. PAUL

MAY 10, 2019

WSB PROJECT NO. R-001610-100

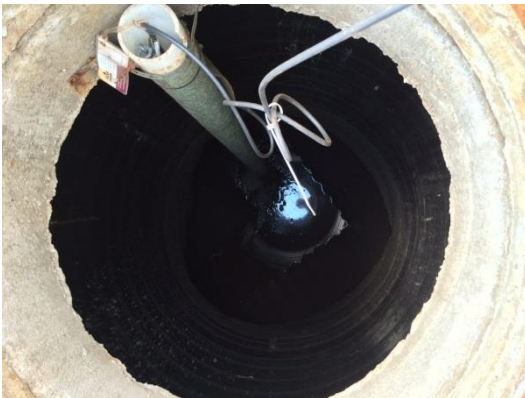
Photo 2-1: Infiltration gallery level monitoring enclosure

Enclosures for the infiltration gallery level loggers were installed at Beacon Bluff, Hillcrest Knoll Park, St. Albans Street, Hampden Park, and Arundel Street Sites. These consisted of three-inch-diameter PVC pipes with four rows of half-inch-diameter holes drilled along the pipe achieving approximately twenty holes per foot. The enclosures were then wrapped with a highly permeable geotextile fabric and secured with zip ties to protect the instrument from fine sediment accumulation. Enclosures were secured to the system floor and to the access riser wall (**Photo 2-1**). Groundwater, in-rock (IR), and rain garden locations were monitored from permanent monitoring wells (**Photo 2-2**). Sites with IR monitoring locations include Beacon Bluff and Hillcrest Knoll Park. These monitoring wells are completed to the depth of the rock base of the BMP.

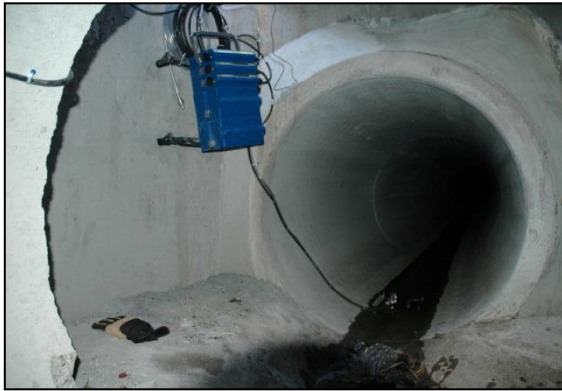
Photo 2-3: Flow monitoring module

Teledyne ISCO 2150 area velocity flow modules and sensors were used to monitor runoff volumes. These devices measure water level and flow velocity. Combining this information with a known conduit shape, the flow rate, and flow volume through the conduit were calculated. Each of the monitored systems received stormwater runoff from a diversion structure located along the storm sewer system. The 2150 flow sensors were positioned at the upstream and downstream pipes in these structures to measure the total volume draining to each BMP and the total volume that bypassed each BMP. **Photos 2-3** and **2-4** show the flow meters installed in the Beacon Bluff diversion structure.

The flow modules were configured at each site to log data at one-minute intervals once the water level in the upstream pipe was greater than one-inch above the pipe invert to increase the resolution of the flow data.

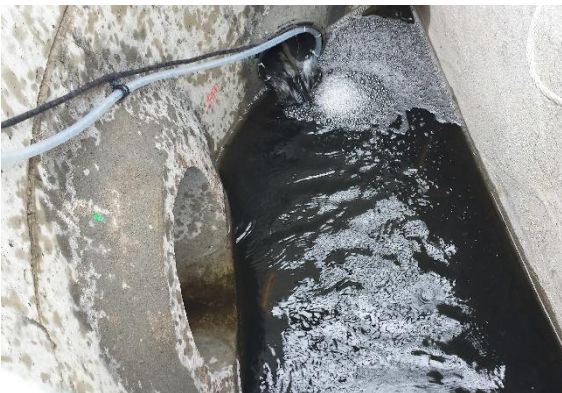
Photo 2-5: Jenks Pond 8" drain tile and outlet pipe within the outlet control structure

Water treated by the IESF ponds at the TBNS is conveyed to the outlet control structure by eight-inch drain tile beneath the sand benches. Flow sensors at the TBNS IESF Pond sites were installed within the drain tile discharge point to the outlet control structure of the ponds (**Photos 2-5 and 2-6**). Additional details regarding the TBNS IESF pond monitoring configurations are described in **Section 2.3** and **Section 10**.

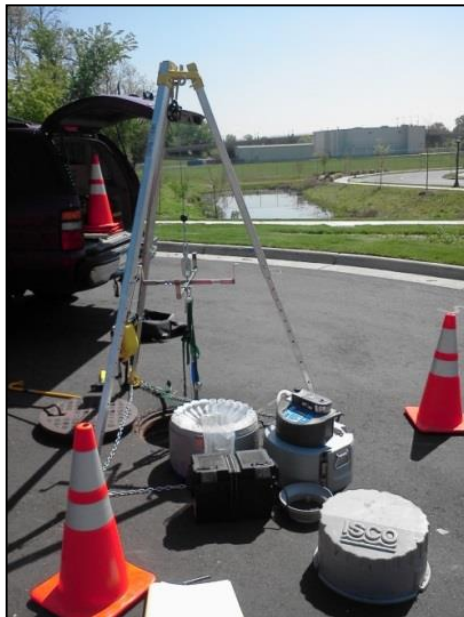
Photo 2-7: ISCO 6712 Sampler at Beacon Bluff

ISCO 6712 automatic samplers were installed in the diversion structure at Beacon Bluff and the outfall monitoring location at Robie Street (**Photos 2-7** and **2-8**).

The automatic samplers were configured to collect 200 mL samples at constant volume intervals. The flow pacing intervals were initially estimated for each site to provide a minimum of six samples during a quarter-inch storm, but less than 120 samples for the three-inch storm. Flow pacing was refined during the monitoring period to achieve this objective.

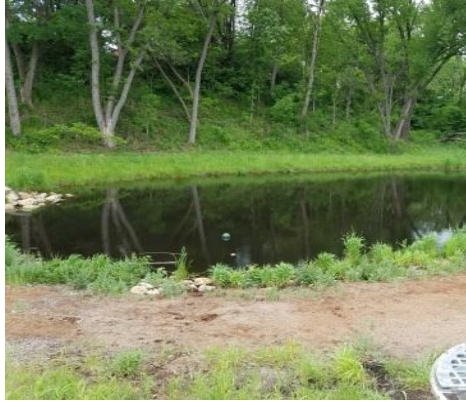
Photo 2-9: Magnolia Pond pretreatment sample float

The sampling configuration at each of the three TBNS IESF Ponds consisted of a job box containing two ISCO 6712 automated samplers, triggered by a 2150 flow meter. Tubing was routed from the first sampler through a buried conduit to a float within the pond basin (**Photo 2-9**). This location was established as the pre-treatment sample. Tubing was routed for the second sampler along with the 2150 flow meter to a position in the eight-inch drain tile outlet into the outlet control structure. This location was established as the post-treatment sample. The samplers (**Photo 2-10**) were programmed to collect simultaneous flow weighted samples based on flow pacing monitored in the outlet control structure. The flow pacing at each pond was refined during the monitoring period to best capture the entire flow profile of a treatment event, while still meeting the 48-hour hold time for the ortho-phosphate laboratory method.

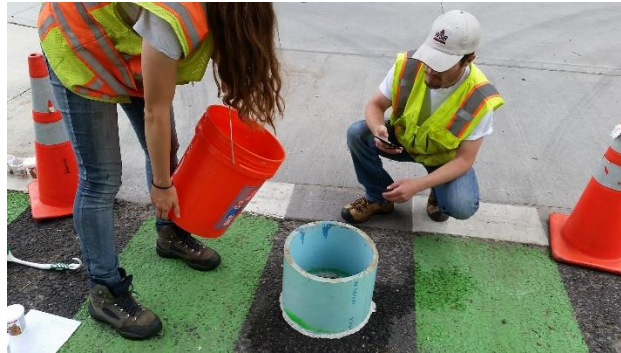
Photo 2-11: Permeable Pavement Infiltration Test

Infiltration tests were conducted according to the modified ASTM C1701 methods for measuring infiltration rates (**Photo 2-11**). Five locations at Victoria Street and 18 locations at Jackson Street were evaluated to develop an average infiltration rate measurement for the Site. Tests were taken at locations that remained consistent year to year and included a combination of high and low traffic areas. At each test location, a pre-wet test was conducted, followed by two infiltration tests. The two infiltration tests were averaged to generate the infiltration rate for each location. If after 15 minutes of monitoring during a pre-wet test no infiltration was observed, the test was concluded, and no subsequent tests were completed.

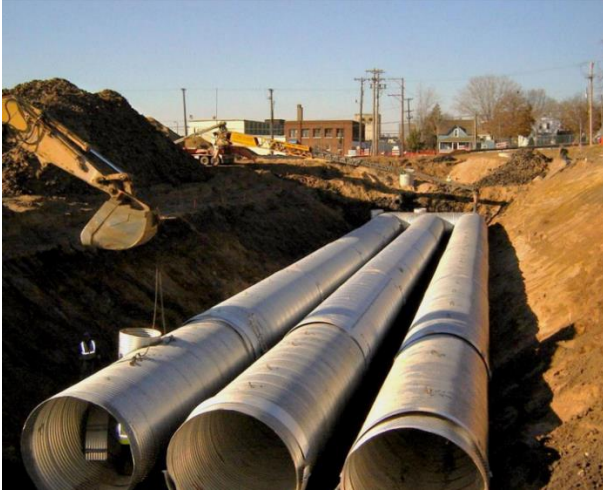
Photo 4-1: Underground infiltration chamber (Facing west)

The system is comprised of three connected stormwater treatment structures, which include a stormwater pond west of the Duchess Street cul-de-sac (west pond), an infiltration basin east of the cul-de-sac (rain garden) (**Photo 4-1**), and an underground infiltration chamber (**Photo 4-2**) constructed directly beneath the rain garden. The underground chamber consists of three, parallel, 215-foot-long, ten-foot-diameter perforated metal pipes for infiltration.

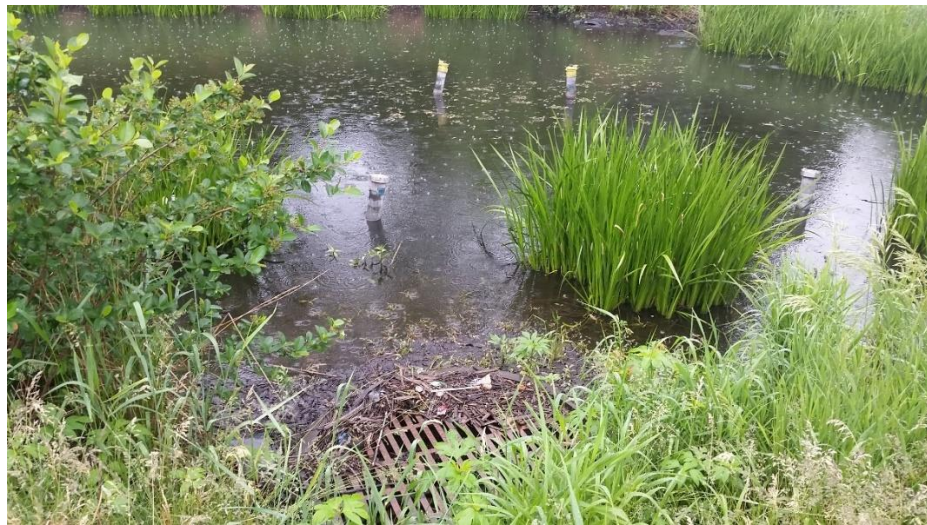
Photo 4-3: IR-31 (Rain garden) and IR-32 (underground system) monitoring piezometers (yellow caps), and open grate overflow structure to underground chamber

Water level in the rain garden (IR-31) and the underground system (IR-32) were measured using continuous water level loggers installed within piezometers. An additional logger was installed within the outlet control structure of the system to confirm when flow was being conveyed back to the storm sewer from the underground chamber. Groundwater elevation was also measured in two locations at the site. Water level elevations within the system and groundwater, and daily rainfall totals are presented on **Chart A.1** and **A.2** of **Appendix A**.

Water level in the rain garden ranged from 0.6 feet (ft) to 3.6 ft of depth in 2018. Overflow from the rain garden to the underground system, through open grate structures (**Photo 4-3**), occurred during most treatment events. The 2018 rain garden infiltration rate and infiltration rate trends are provided on **Charts A.3** and **A.5** of **Appendix A**, respectively. The 2018 average infiltration rate for the rain garden was 0.40 inches per hour (in/hr), which is less than the Minnesota Stormwater Manual (MSWM) recommended infiltration rate for SP (poorly graded sand) soils of 0.80 in/hr. This is slightly less than the rates observed in 2017 (0.50 in/hr) and 2017 (0.43 in/hr) (**Table 4-2**). Sediment accumulation has been observed ranging from 0.5 ft to 1.5 ft of depth, across the basin. The 141.5-acre drainage area discharging directly to the pond conveys a significant amount of sediment and debris, which has accumulated primarily around the diversion inlet pipe. Dredge maintenance was completed on the rain garden over the winter of 2018-2019.

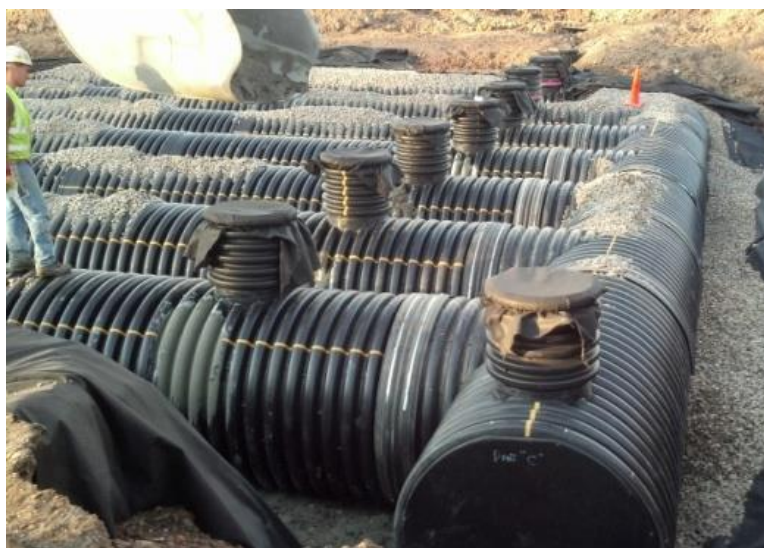
Photo 5-2: 60" Perforated HDPE pipes during system construction

The system consists of an underground pipe gallery infiltration system containing nine parallel 275-foot-long, 60-inch-diameter perforated high-density polyethylene (HDPE) pipes (**Photo 5-2**). Stormwater runoff within the 37.1 acre subwatershed is directed to the system via a diversion structure in the trunk storm sewer system along Flandrau Street. When the system has reached its storage capacity, a float forces down a gate valve that restricts flow to the BMP, and the runoff continues to flow downstream through the storm sewer. Pre-treatment for this design includes a Vortechs hydrodynamic separator and an isolator row within the storage gallery. Rainfall monitoring for this site is conducted at the Frost Lake Elementary School which is located approximately 0.4 miles west of the system. The BMP details are provided in **Table 5-1**.

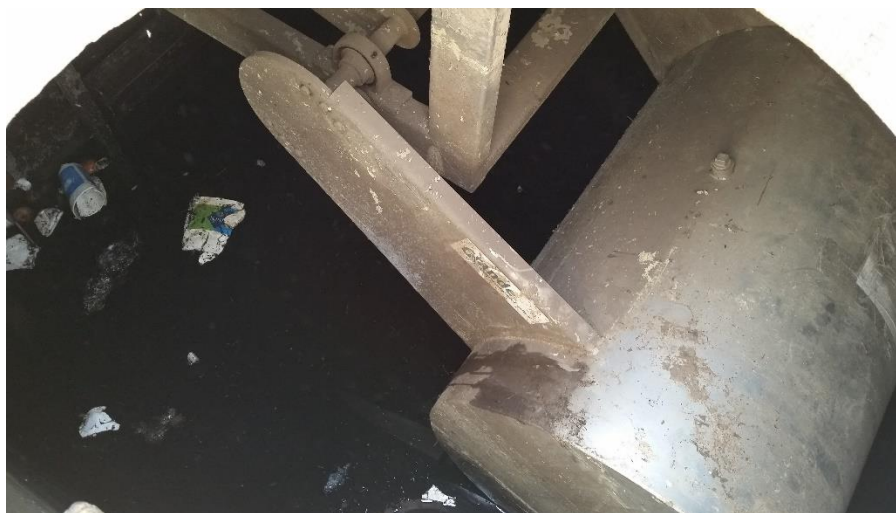
**Photo 5-3: System gate valve and float**

The float mechanism for the system gate valve was inspected regularly in 2018 (**Photo 5-3**). The float was exercised during multiple maintenance visits in 2018 to ensure that it was not stuck in the closed position, which would prevent flow from entering the infiltration system. Photos from the inspection visits are included in the photo log (**Appendix E**).

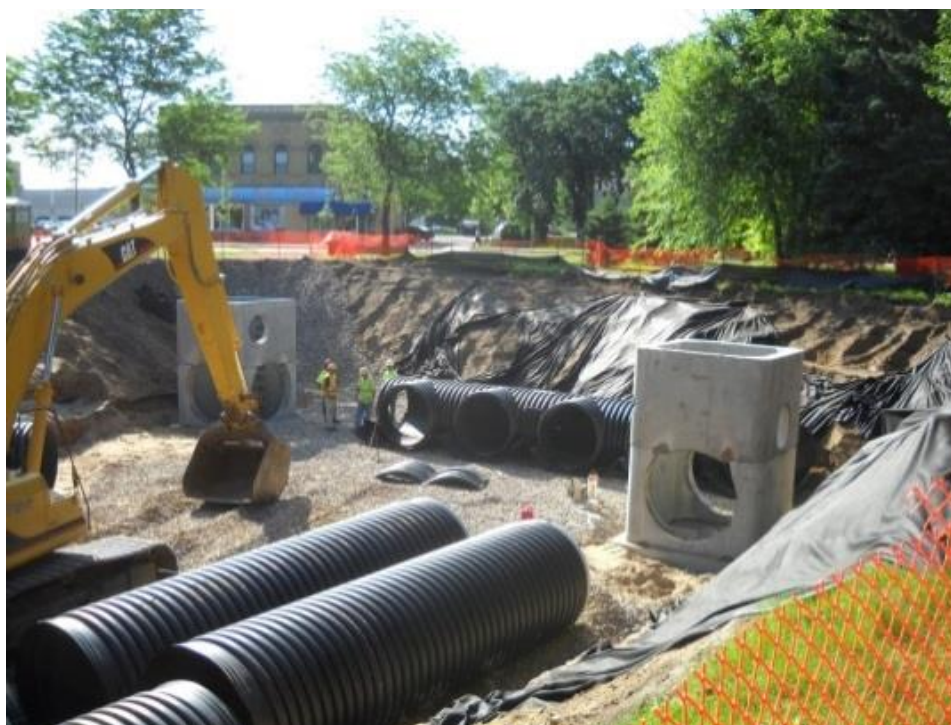
Photo 6-1: Hampden Park BMP Construction

The Hampden Park infiltration gallery, shown in **Figure 7-1**, was constructed in 2014. The system consists of eight parallel perforated pipes that are 5 ft in diameter, and range in length from 40 to 100 ft. Runoff is routed to the system via a 24-inch RCP from the storm sewer line near Hampden and Raymond Avenues. Prior to entering the infiltration gallery, stormwater passes through a Vortechs pre-treatment chamber for particle settling. The infiltration gallery receives flow from a second inlet location along Hampden Avenue, farther to the north. When the system reaches full capacity, stormwater is routed back to the storm sewer via a 24-inch pipe from the southeast side of the system. Rainfall monitoring is conducted on top of the Hampden Park Co-Op across the street from the park. Monitoring has been conducted at the site since 2014. The BMP system details are provided in **Table 7-1** below.

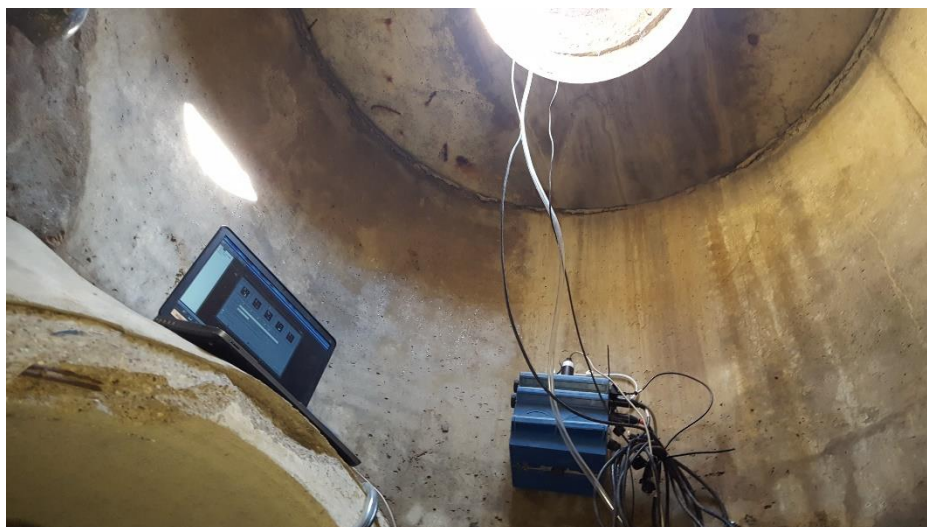
Photo 9-1: Robie Street Flow Meter Installation

The Robie Street Outfall is located on Saint Paul's West Side neighborhood within the Lower Mississippi River Watershed. The outfall consists of a 54-inch RCP pipe that receives that runoff from a 118-acre drainage area, which then outfalls to the Mississippi River. The drainage area consists of predominately residential land use and 42% impervious surface. The first year of monitoring at Robie Street was completed in 2018, which consisted of continuous flow measurements and water quality sampling.

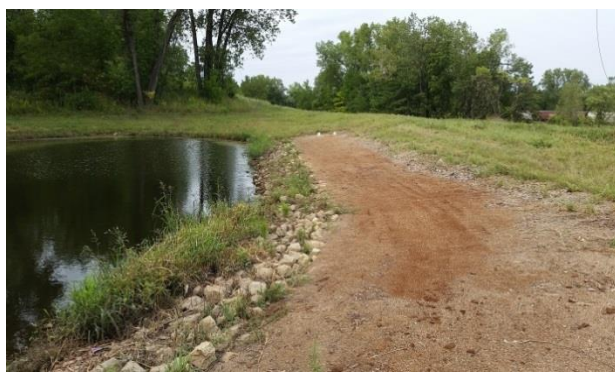
Photo 10-1: Magnolia Pond

The monitoring completed by the City includes performance monitoring of three IESF ponds at the site: Maryland Pond (**Photo 10-3**), Magnolia Pond (**Photo 10-1** and **10-4**), and Jenks Pond (**Photo 10-2**). The effectiveness of the IESF ponds was determined by collecting samples from the within the pond and the pond outlet control structure during treatment events. The samplers were programmed to collect simultaneous flow weighted samples based on flow pacing monitored in the outlet control structure. Additional information regarding equipment and monitoring procedures for the TBNS monitoring effort is described in **Section 2.3**.

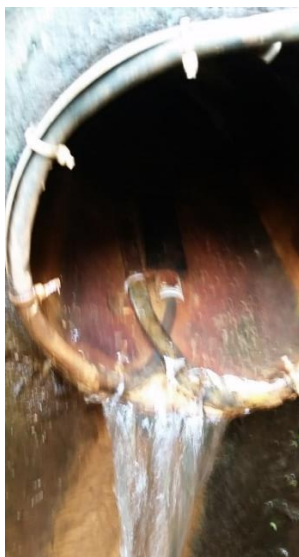
**Photo 10-5: Iron Precipitate
at drain tile outlet to OCS**

The increase in iron is suspected to be related to continuous flow through the IESF media. Additionally, iron precipitate was also observed accumulating at the drain tile outlet at Maryland (**Photo 10-5**). Based on the analytical and flow data, and observed precipitate, it is suspected that continuous flow may be creating anaerobic conditions, which have contributed to the export of iron from the media beds. Total rainfall in September was 2.2 times greater than the 30-year normal and October rainfall also exceeded the 30-year normal. The above normal rainfall may have contributed to higher water levels within the basins which allowed for continued saturation of the media beds at Magnolia and Jenks. Continuous flow at Maryland has been observed every monitoring year to date.

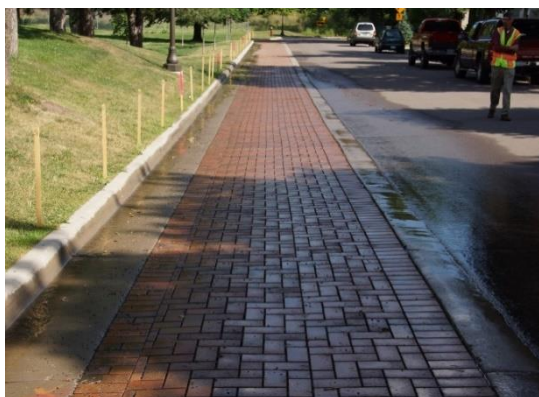
Photo 13-1: Victoria Street pavers

The Victoria Street pervious surface consists of a parking area completed with permeable concrete pavers designed to receive stormwater runoff from Victoria Street and the properties adjacent to it. The pavers themselves are non-permeable and they are separated with aggregate fill (**Photo 13-1** and **13-2**). The spaces between the pavers allow stormwater runoff to infiltrate into the parking surface instead of running off and being collected by the storm sewer system. The pavers were installed in 2011 and infiltration rates have been monitored annually since 2012. The site and the infiltration test locations are provided on **Figure 13-1**.

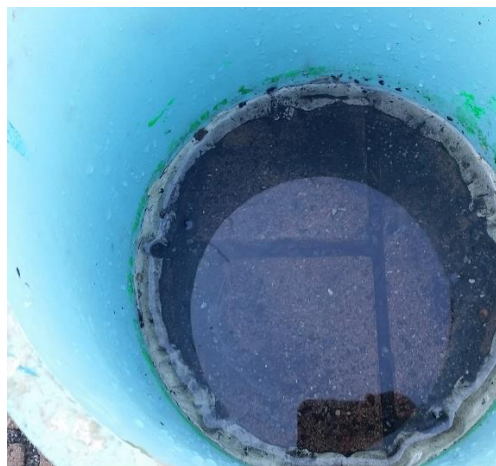
Photo 13-4: Location D Infiltration Test

- The overall site infiltration rate was similar in 2018 (1.11 in/hr) compared to 2017 (1.19 in/hr).
- The 2018 infiltration rates were, on average, less than one percent of 2012 infiltration rates.
- No infiltration was observed at Location D, which is consistent with testing completed from 2015 through 2017 (**Photo 13-3 and 13-4**).
- Infiltration rates at Locations E and A were greater in 2018, compared to 2017, while infiltration rates at Locations B and C were less in 2018 than 2017.

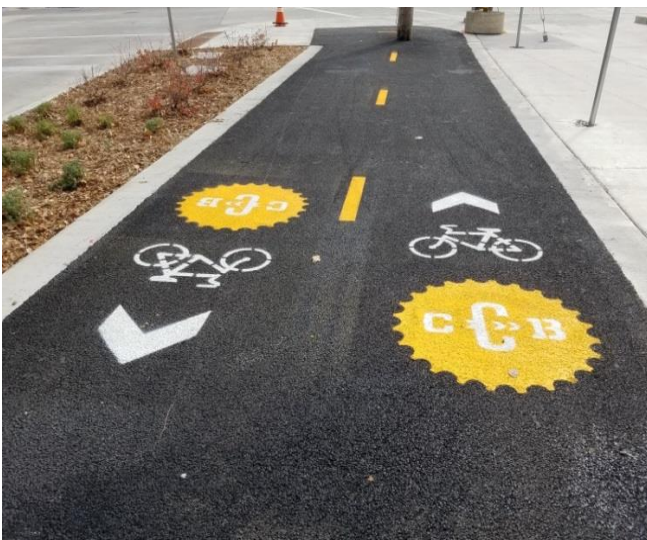
Photo 13-5: Capital City Bikeway (CCB) – Jackson Street/Kellogg Avenue

The Jackson Street BMP (**Photo 13-5** and **13-6**) is a designated bike path constructed of pervious asphalt. It is a section of the Capital City Bikeway (CCB), a system of off-street bicycle trails in downtown Saint Paul. The BMP is eight blocks long, stretching from Kellogg Street to 11th Street, and consists of 2,750 square yards of pervious asphalt. Stormwater runoff filters through the asphalt and underlying media and is then conveyed to the storm sewer system via drain tile.

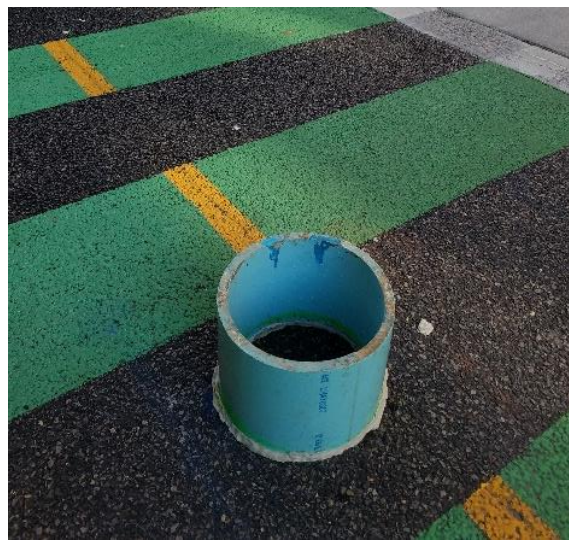
Photo 13-6: Jackson Street Infiltration Test

The site was tested for infiltration in July 2018 and October 2018. The infiltration test results from the 18 locations are summarized in **Table 13-3** and **Chart D.2** in **Appendix D**, which includes all infiltration test results completed to-date. **Table 13-3** is color coded to identify the site traffic characterizations described above. The infiltration tests results are also summarized in **Table 13-4**, which presents an average infiltration rate based on the monitoring location traffic characterization. The infiltration test locations are depicted on **Figure 13-2**.

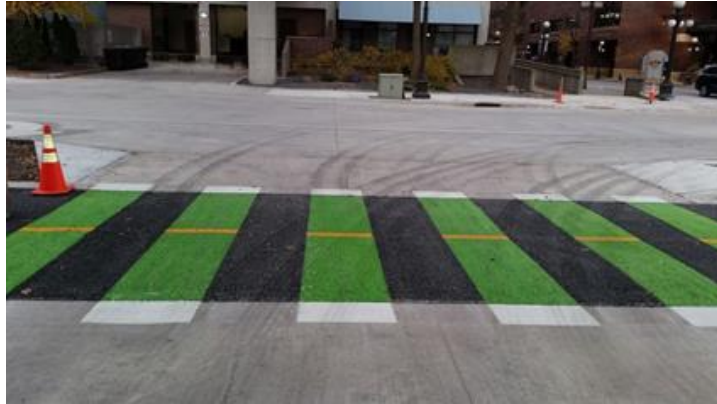
Photo 13-11: Test Locations JS-1 and JS-2 (high traffic)

- Four of the five high traffic areas were reduced to no infiltration after one year of monitoring. The remaining location was reduced to no infiltration after 1.5 years of monitoring.

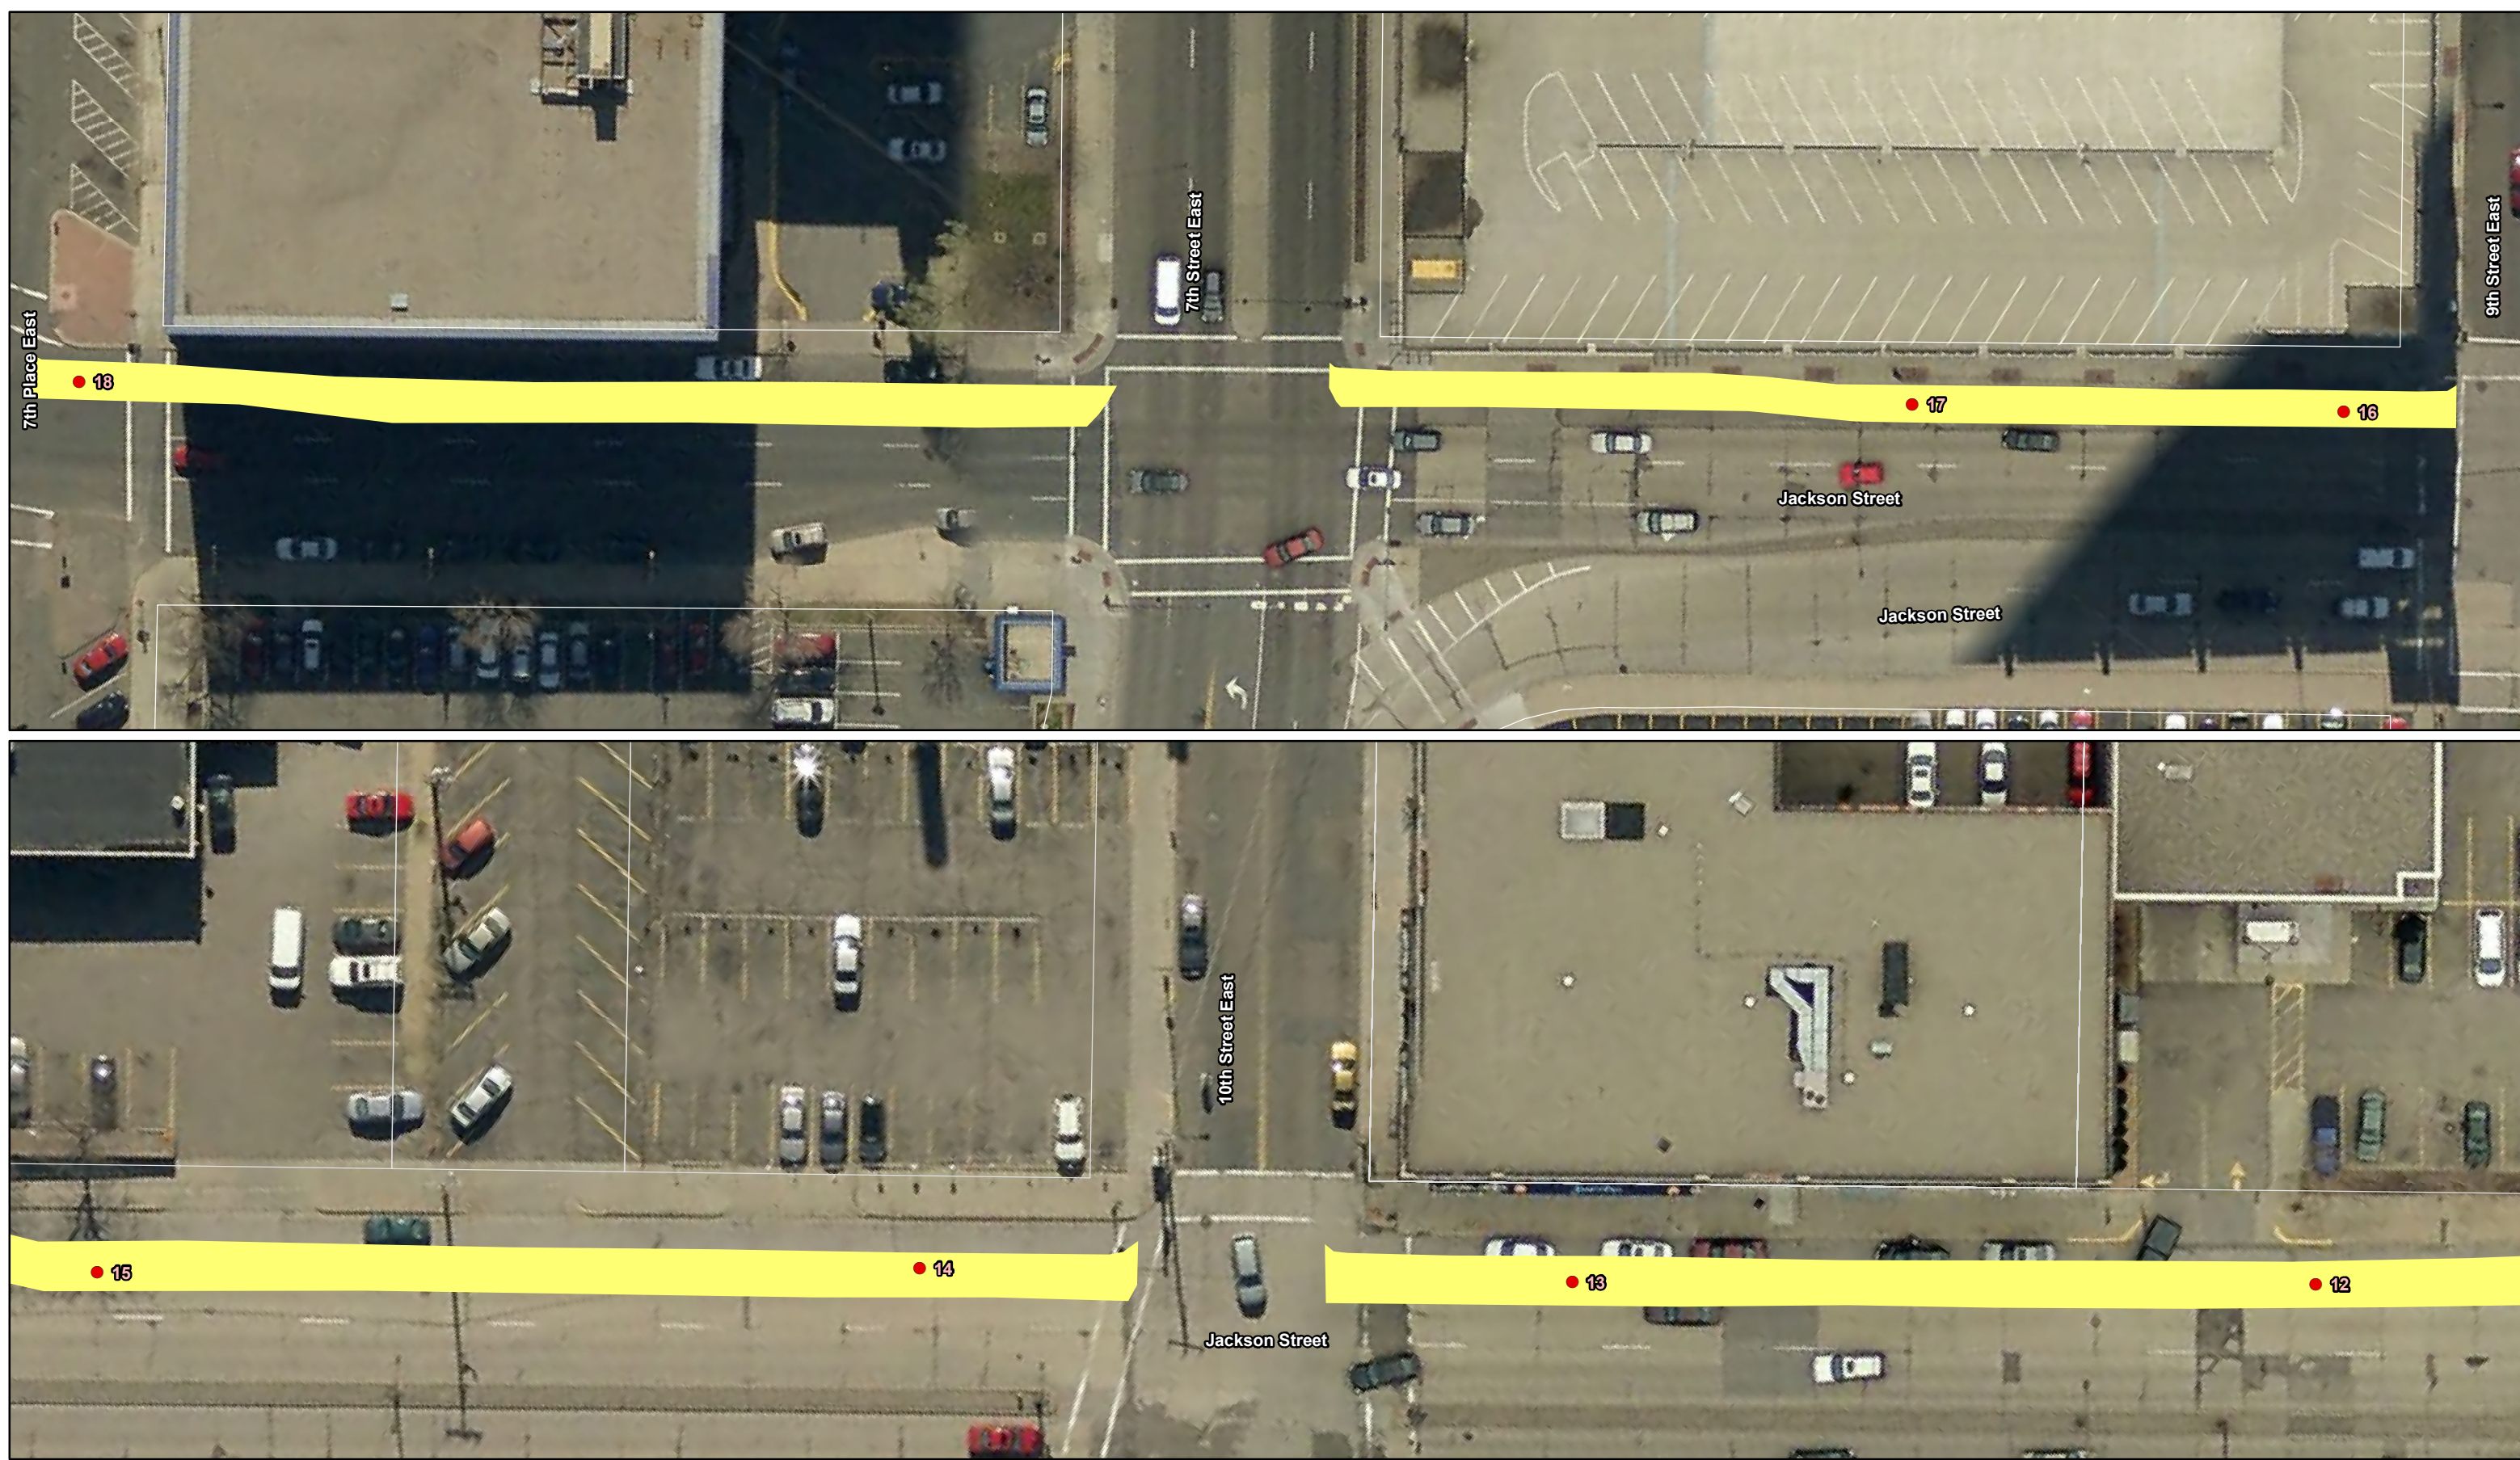
Figure 13-2 Jackson Street (pg 2 of 2)
JS-12 - JS-18 Pervious Test Locations
2018 Water Quantity and Quality Monitoring Program
City of Saint Paul, MN

Monitoring locations JS-1 through JS-11 were established in November 2016 upon completion of the four-block stretch from Kellogg Boulevard to 7th Place East. Monitoring locations JS-12 through JS-18 were established in November 2017 upon completion of the four-block stretch from 7th Place East to 11th street. The monitoring locations were carefully selected to evaluate sediment loading and asphalt compaction from varying levels of pedestrian and vehicular traffic. Each site was characterized into one of three groups, identified in **Table 13-2**, based on their location and surroundings. The site and infiltration test locations are depicted on **Figure 13-2**. Site photos are provided in **Appendix E**.
