# 2019 STORMWATER QUALITY AND QUANTITY MONITORING PROGRAM

CITY OF ST. PAUL

MARCH 9, 2020

WSB PROJECT NO. 01610-100

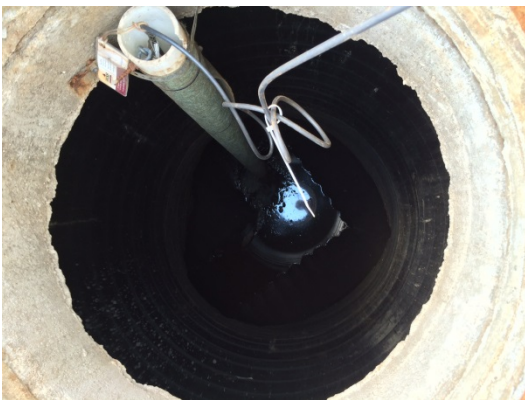
**Photo 2-1:**  
Infiltration Gallery Level Monitoring  
Enclosure

Enclosures for the infiltration gallery level loggers were installed at Beacon Bluff, St. Albans Street, and Hampden Park. These consisted of three-inch-diameter PVC pipes with four rows of half-inch-diameter holes drilled along the pipe achieving approximately twenty holes per foot. The enclosures were then wrapped with a highly permeable geotextile fabric and secured with zip ties to protect the instrument from fine sediment accumulation. Enclosures were secured to the system floor and to the access riser wall (**Photo 2-1**). Groundwater and rain garden locations were monitored from permanent monitoring wells (**Photo 2-2**).

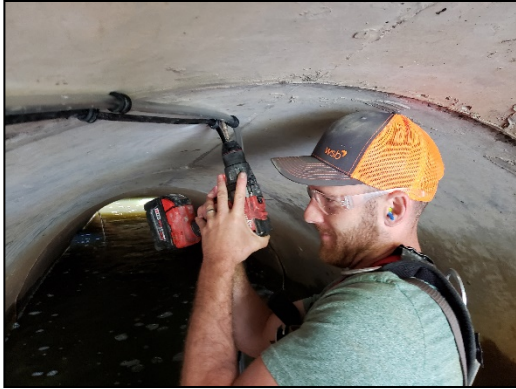
**Photo 2-3: Flow Monitoring Module Install Process**

Teladyne ISCO 2150 area velocity flow modules and sensors were used to monitor runoff volumes. These devices measure water level and flow velocity. Combining this information with a known conduit shape, the flow rate, and flow volume through the conduit were calculated. Each of the monitored systems received stormwater runoff from a diversion structure located along the storm sewer system. The 2150 flow sensors were positioned at the upstream and downstream pipes in these structures to measure the total volume draining to each BMP and the total volume that bypassed each BMP. **Photos 2-3** and **2-4** show the flow meters installation in Battle Creek and Sackett Park, respectively.

The flow modules were configured at each site to log data at one-minute intervals once the water level in the upstream pipe was greater than one-inch above the pipe invert to increase the resolution of the flow data.

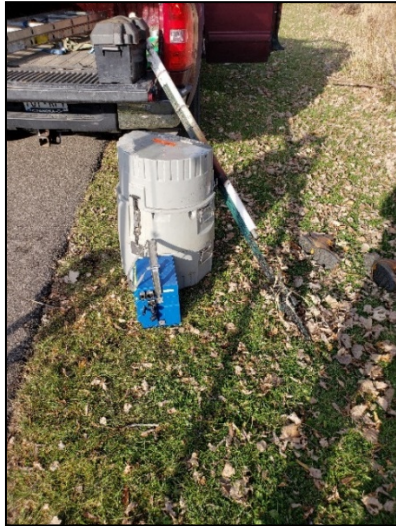
**Photo 2-7:**  
**ISCO 6712 Sampler at**  
**Battle Creek**

ISCO 6712 automatic samplers were installed at all water quality locations. (**Photos 2-7** and **2-8**).

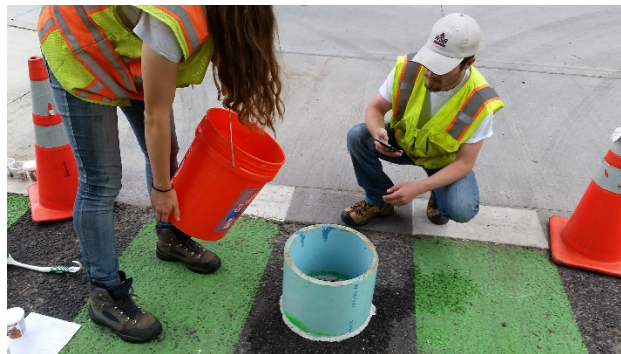
**Photo 2-11: Permeable Pavement Infiltration Test**

Infiltration tests were conducted according to the modified ASTM C1701 methods for measuring infiltration rates (**Photo 2-11**). Five locations at Victoria Street, 18 locations at Jackson Street, and nine locations at Hamline Midway Library were evaluated to develop an average infiltration rate measurement for each site. Tests were taken at locations that remained consistent year to year and included a combination of high and low traffic areas. At each test location, a pre-wet test was conducted, followed by two infiltration tests. The two infiltration tests were averaged to generate the infiltration rate for each location. If after 15 minutes of monitoring during a pre-wet test no infiltration was observed, the test was concluded, and no subsequent tests were completed.

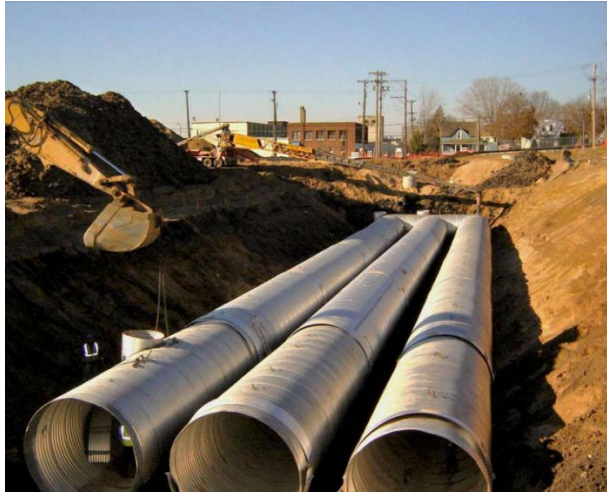
Photo 4-1: Underground Infiltration Chamber (Facing West)

The system is comprised of three connected stormwater treatment structures, which include a stormwater pond west of the Duchess Street cul-de-sac (west pond), an infiltration basin east of the cul-de-sac (rain garden) (**Photo 4-1**), and an underground infiltration chamber (**Photo 4-2**) constructed directly beneath the rain garden. The underground chamber consists of three, parallel, 215-foot-long, ten-foot-diameter perforated metal pipes for infiltration.

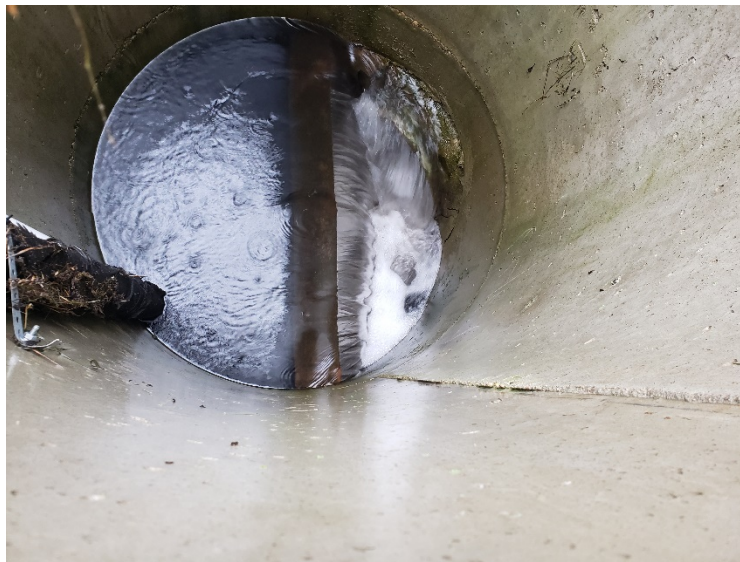
Photo 4-3: Water being conveyed back to the storm sewer from the underground chamber in the outlet control structure.

Overflow in the outlet control structure to the storm sewer, (**Photo 4-3**), occurred during fifteen treatment events. The 2019 rain garden infiltration rate and infiltration rate trends are provided on **Charts A.3 and A.5 of Appendix A**, respectively. The 2018 average infiltration rate for the rain garden was 0.40 inches per hour (in/hr), which is less than the Minnesota Stormwater Manual (MSWM) recommended infiltration rate for SP (poorly graded sand) soils of 0.80 in/hr. This is slightly less than the rates observed in 2017 (0.50 in/hr) and 2017 (0.43 in/hr) (**Table 4-2**). Sediment accumulation has been observed ranging from 0.5 ft to 1.5 ft of depth, across the basin. The 141.5-acre drainage area discharging directly to the pond conveys a significant amount of sediment and debris, which has accumulated primarily around the diversion inlet pipe. Dredge maintenance was completed on the rain garden over the winter of 2018-2019.

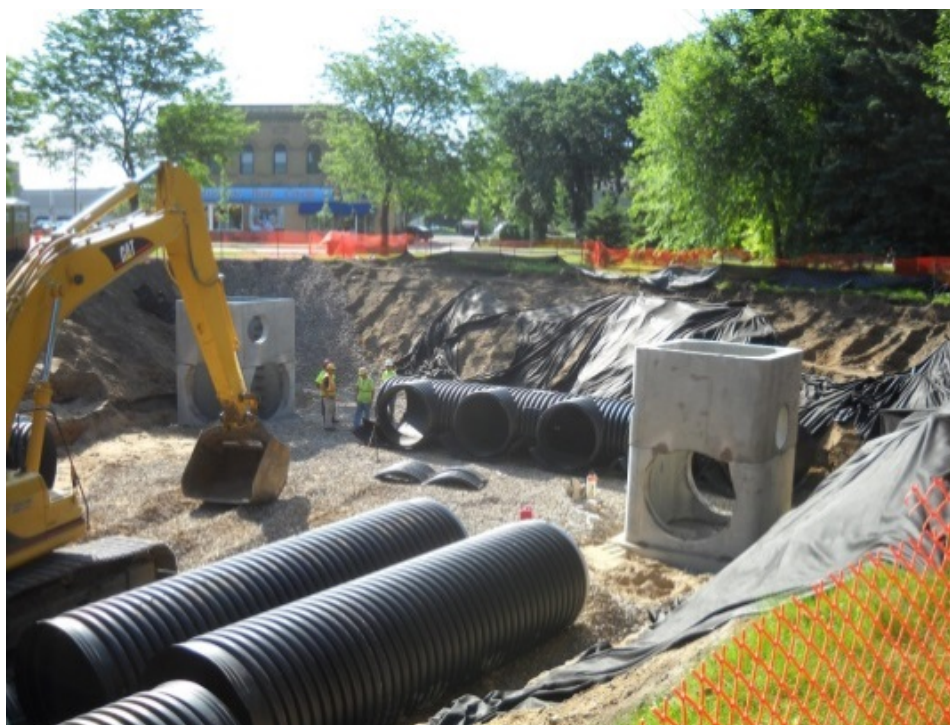
**Photo 6-1: Hampden Park BMP Construction**

The Hampden Park infiltration gallery, shown in **Figure 6-1**, was constructed in 2014. The system consists of eight parallel perforated pipes that are 5 ft in diameter, and range in length from 40 to 100 ft. Runoff is routed to the system via a 24-inch RCP from the storm sewer line near Hampden and Raymond Avenues. Prior to entering the infiltration gallery, stormwater passes through a Vortechs pre-treatment chamber for particle settling. The infiltration gallery receives flow from a second inlet location along Hampden Avenue, farther to the north. When the system reaches full capacity, stormwater is routed back to the storm sewer via a 24-inch pipe from the southeast side of the system. Rainfall monitoring is conducted on top of the Hampden Park Co-Op across the street from the park. Monitoring has been conducted at the site since 2014. The BMP system details are provided in **Table 6-1** below.

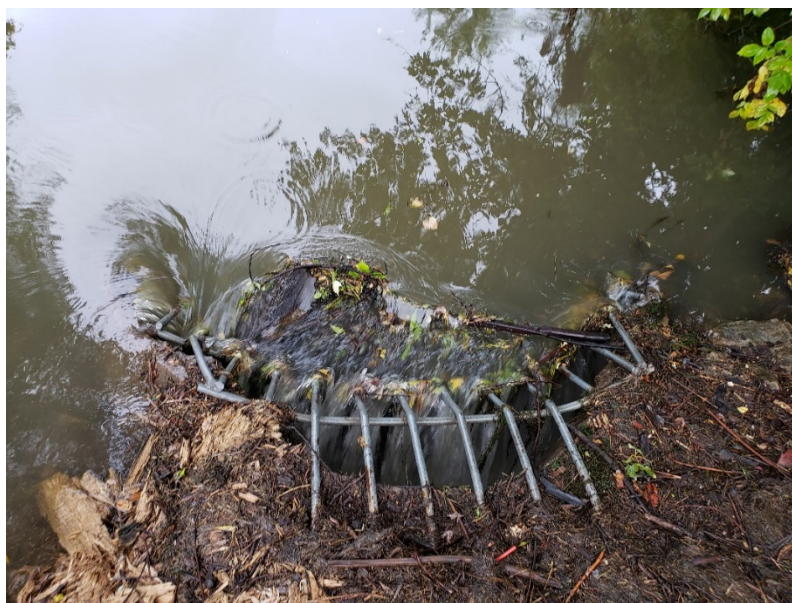
**Photo 8-1: Debris in Battle Creek 72" Arch RCP pipe**

In 2019, water levels ranged from 199.4 ft SPCD on July 15, 2019 to 206.1 ft SPCD on August 18, 2019. The maximum level occurred as a result of 1.99 inches of rain on August 18th, 2019, which increased the level by 5.50 ft. In 2019, 50 rain events ranging from 0.07 inches to 1.99 inches resulted in water level elevations that kept creek levels high and continuous flow through the pipe. The inlet grate into 72" arch pipe was often blocked with debris, possibly causing a longer time for the level to drop.

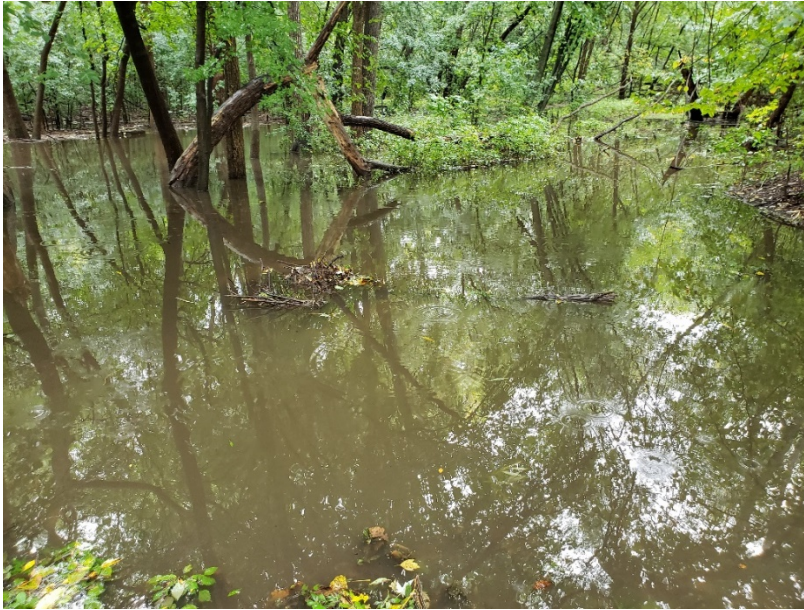
In 2019, water levels ranged from 192.5 ft SPCD on June 6, 2019 to 195.67 ft SPCD on August 18, 2019. The maximum level occurred as a result of 2.01 inches of rain on August 18th, 2019, which increased the level by 2.85 ft. In 2019, 26 rain events ranging from 0.08 inches to 2.01 inches resulted in water level elevations that exceeded the top of the outlet control structure. Following those events, the level decreased to below the top of the outlet control structure within 10 hours, but for most events the level decreased within 2 hours. Outlet control structure was often blocked with debris.

**Photo 9-2: Sackett Park Pond Outlet Control Structure Submerged – Runoff Exceeds Channel Bank, Enters Flood Plain and Flows over Ball Fields (9/18/2019)**

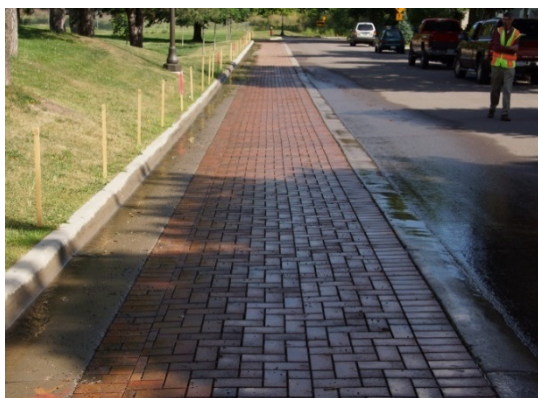
Photo 10-1: Victoria Street Pavers

The Victoria Street pervious surface consists of a parking area completed with permeable concrete pavers designed to receive stormwater runoff from Victoria Street and the properties adjacent to it. The pavers themselves are non-permeable and they are separated with aggregate fill (**Photo 10-1** and **10-2**). The spaces between the pavers allow stormwater runoff to infiltrate into the parking surface instead of running off and being collected by the storm sewer system. The pavers were installed in 2011 and infiltration rates have been monitored annually since 2012. The site and the infiltration test locations are provided on **Figure 10-1**.

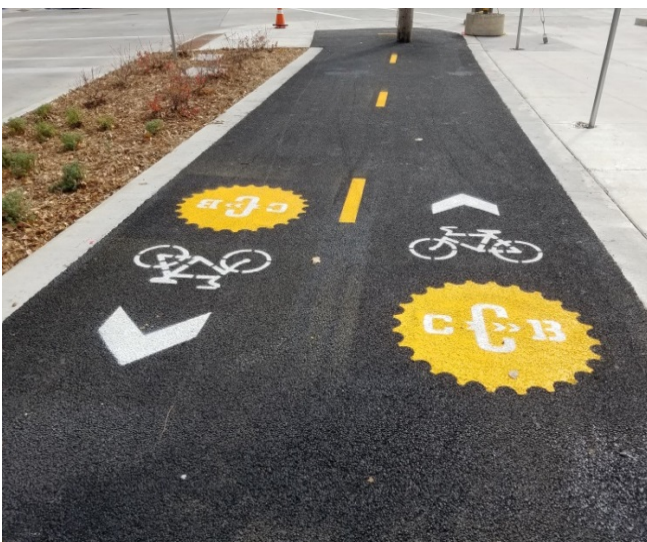
Photo 10-5: Capital City Bikeway (CCB) – Jackson Street/Kellogg Avenue

The Jackson Street BMP (**Photo 10-5** and **10-6**) is a designated bike path constructed of pervious asphalt. It is a section of the Capital City Bikeway (CCB), a system of off-street bicycle trails in downtown Saint Paul. The BMP is eight blocks long, stretching from Kellogg Street to 11<sup>th</sup> Street, and consists of 2,750 square yards of pervious asphalt. Stormwater runoff filters through the asphalt and underlying media and is then conveyed to the storm sewer system via drain tile.

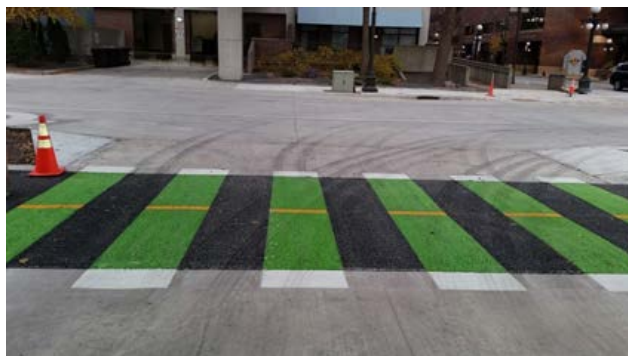
**Photo 10-7: Test Locations JS-1 and JS-2 (high traffic)**

- High traffic areas had an average infiltration rate of 0.0 in/hr in July 2019 and October 2019.
  - No infiltration was observed at all five high traffic monitoring locations in July and October 2019.

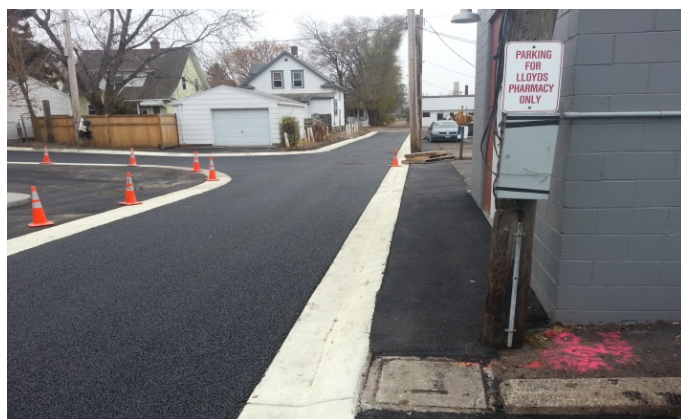
**Photo 10-8: Recently Constructed Hamline Midway Library Porous Asphalt (2012)**

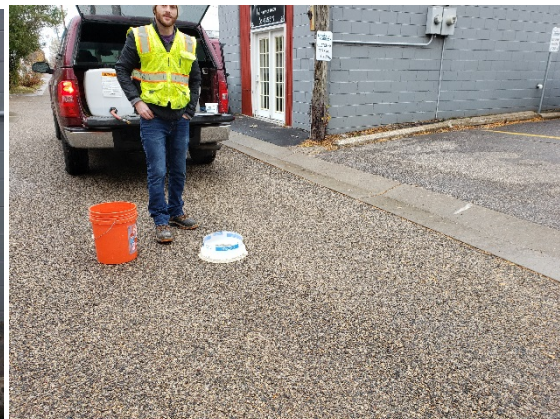
**Photo 10-9: Hamline Midway Library Asphalt (2019)**

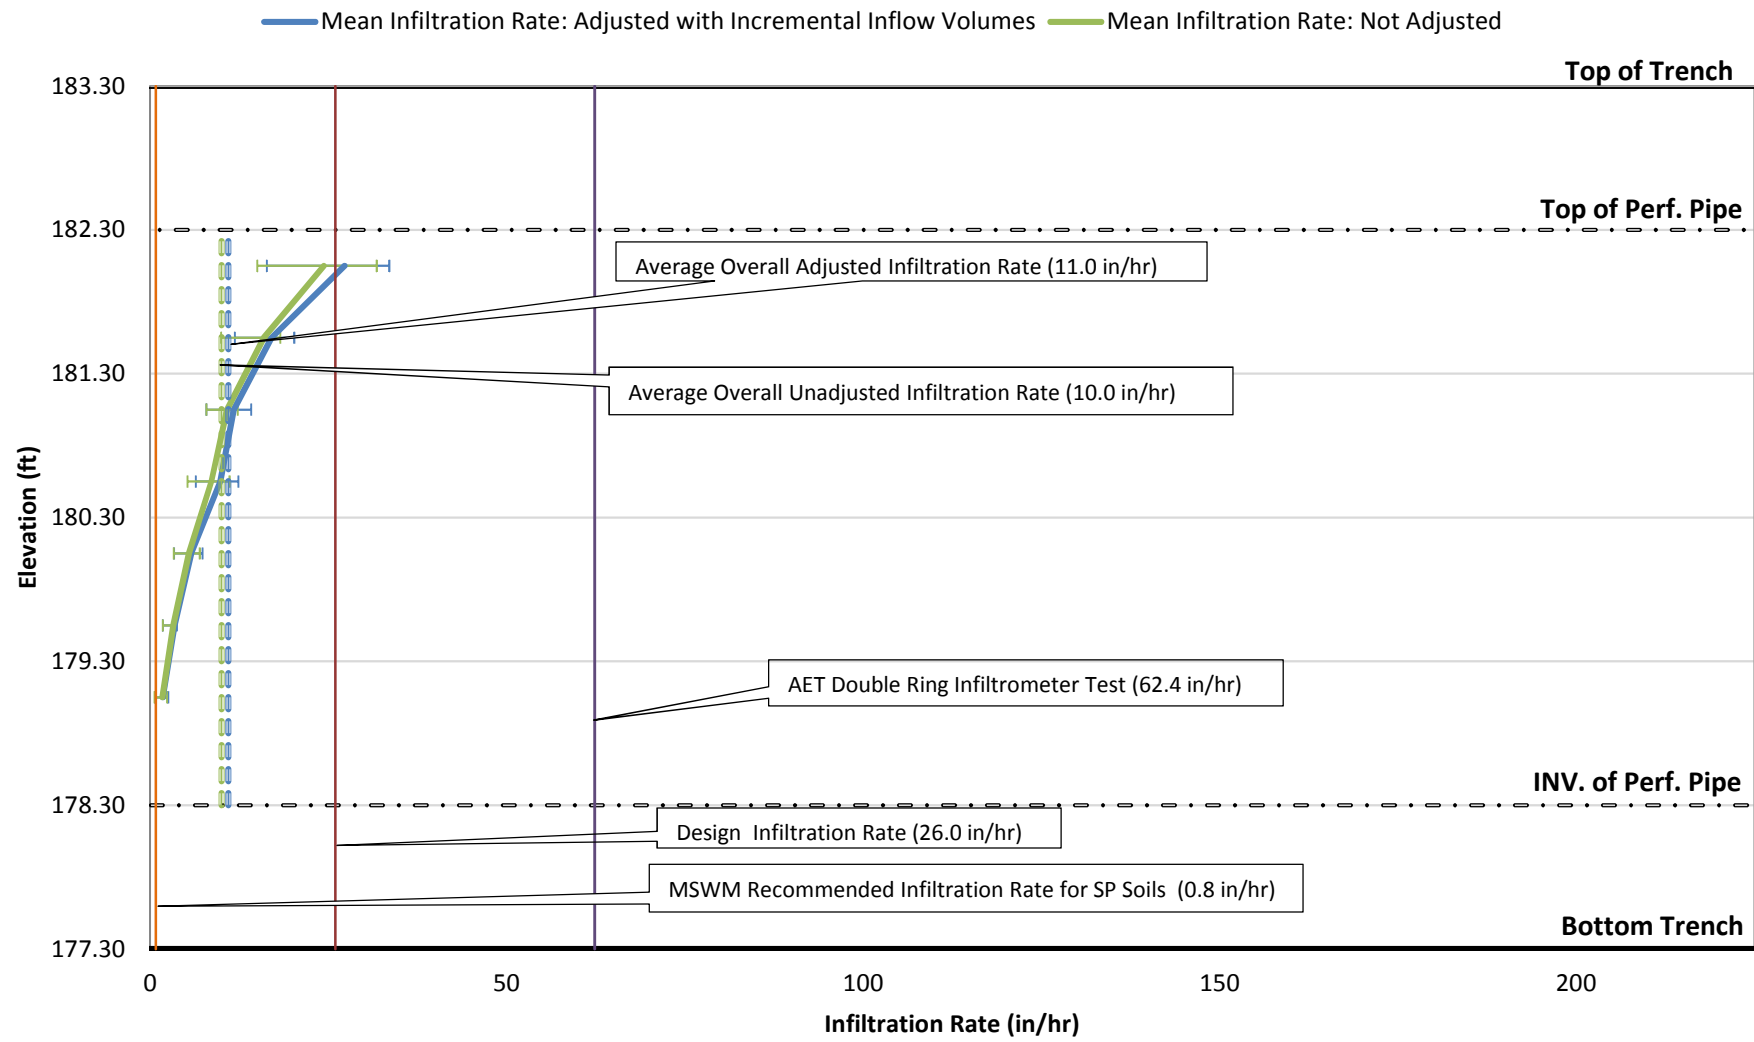
# St. Albans Street - Infiltration Rate Graph

(Observed 0.5 Foot Height Increments)

Note: Pipe Invert is 178.3'  
Error Bars Represent 25th and 75th Percentiles  
Pipe perforated w/ 2 rows of holes at Elev: 178.9' and 179.2'

Infiltration rates are presented on **Chart A.12** of **Appendix A**. In 2019, the average infiltration rate of the BMP pipe was 9.6 in/hr (**Table 5-2**), which is above the MSWM recommended infiltration rate for SP soils of 0.8 in/hr, but below the design infiltration rate of 26.0 in/hr. Infiltration rate trends for the St. Albans Street BMP pipe are depicted on **Chart A.13**.
