2025 STORMWATER QUALITY AND QUANTITY MONITORING PROGRAM

CITY OF ST. PAUL

November 2025

WSB PROJECT NO. 028315

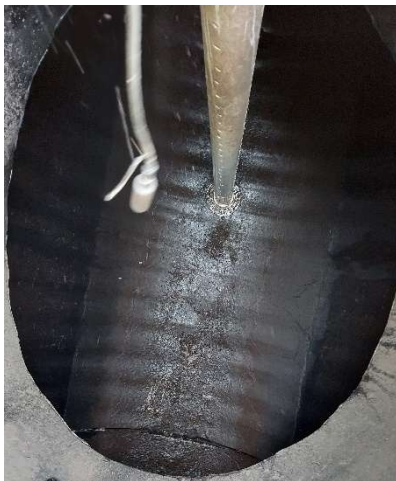
Enclosures for the infiltration gallery level loggers were installed at Beacon Bluff, St. Albans Street, and Hampden Park. These consisted of three-inch-diameter PVC pipes with four rows of half inch-diameter holes drilled along the pipe, achieving approximately twenty holes per foot. The enclosures were wrapped with a highly permeable geotextile fabric and secured with zip ties to protect the instrument from fine sediment accumulation. Enclosures were secured to the system floor and to the access riser wall (**Photo 2-1**). Groundwater and rain garden locations were monitored from permanent monitoring wells (**Photo 2-2**).

Photo 2-1:
Infiltration Gallery Level Monitoring Enclosure

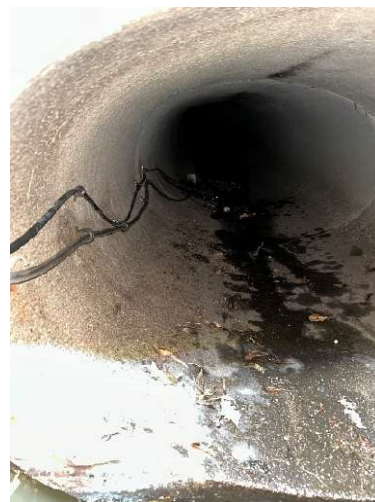
Photo 2-2:
Sensor configuration in St. Albans elliptical pipe

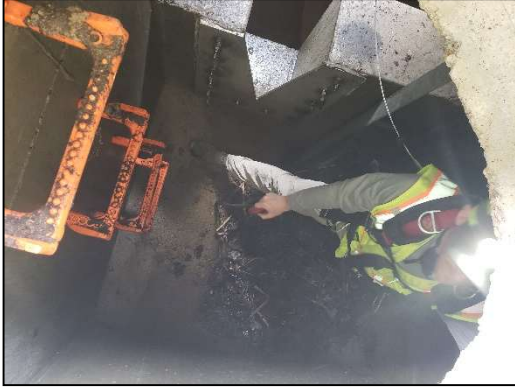
Photo 2-3: Flow Monitoring Module Install Process

Teledyne ISCO 2150 area velocity flow modules and sensors were used to monitor runoff volumes. These devices measure water level and flow velocity. Combining this information with a known conduit shape, the flow rate, and flow volume through the conduit were calculated. Each of the monitored systems received stormwater runoff from a diversion structure located along the storm sewer system. The 2150 flow sensors were positioned at the upstream and downstream pipes in these structures to measure the total volume draining to each BMP and the total volume that bypassed each BMP. **Photos 2-3** and **2-4** show the flow meters installation in West Shepard Pond and Victoria Street, respectively.

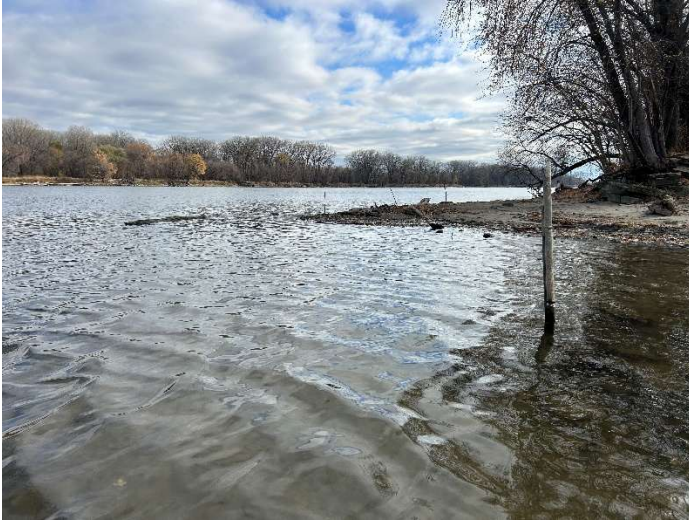
Photo 2-5:
Kaposia Landing River Logger

ISCO 6712 automatic samplers were installed at all water quality locations. (**Photos 2-5 and 2-6**).

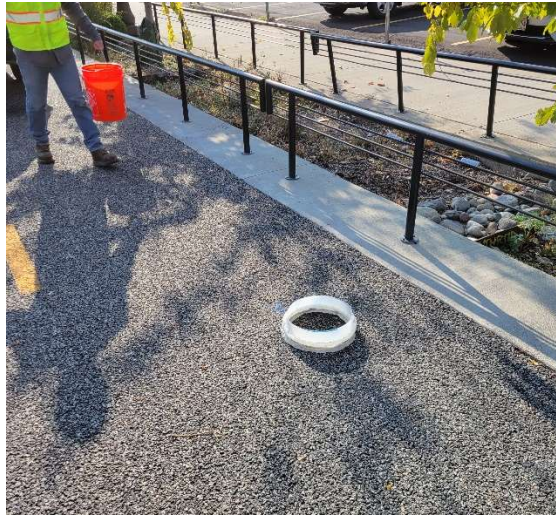
Infiltration tests were conducted according to the modified ASTM C1701 methods for measuring infiltration rates (**Photo 2-7**). Eighteen locations at Jackson Street and ten locations along Victoria Street were evaluated to develop an average infiltration rate measurement for each site. Tests were taken at locations that remained consistent year to year and included a combination of high and low traffic areas. At each test location, a pre-wet test was conducted, followed by two infiltration tests. The two infiltration tests were averaged to generate the infiltration rate for each location. If after 15 minutes of monitoring during a pre-wet test no infiltration was observed, the test was concluded, and no subsequent tests were completed.

Photo 2-7: Permeable Pavement Infiltration Test

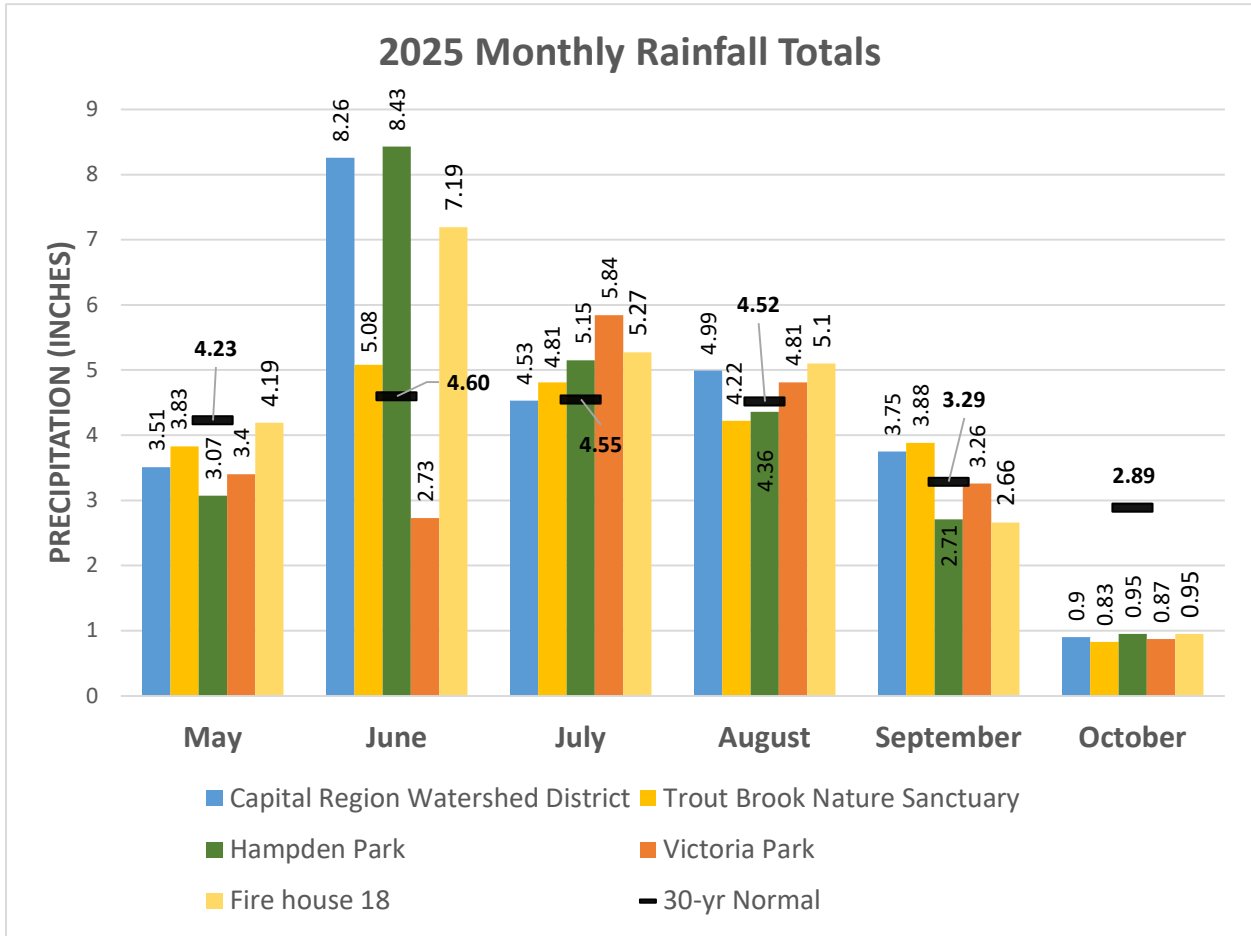
Chart 3-1

May through October rainfall ranged from 21.62 inches at Victoria Park to 27.97 inches at Capital Region Watershed District. The City-wide seasonal total average was 23.91 inches which is 0.174 inches less than the 30-year normal. The greatest variability between stations was observed during the month of June with 5.70 inches more rainfall recorded at Capital Region Watershed District than at Victoria Park. The month of October saw the greatest departure from the 30-year normal (-1.99 inches).

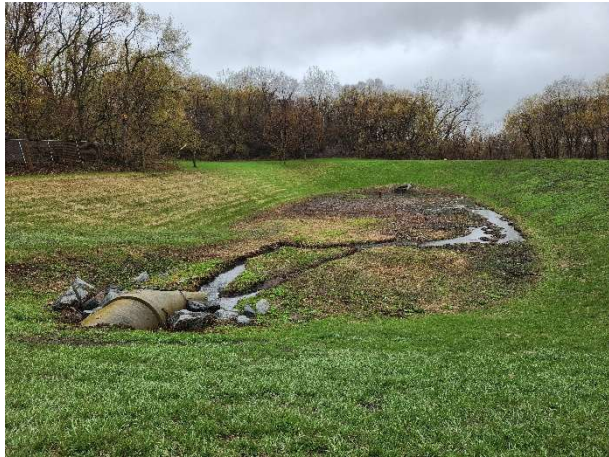
Photo 4-1: Bush Desoto in 2023 Before Reconstruction

The Bush-Desoto Pond is an infiltration basin in the southern end of the Payne-Phalen Neighborhood. The stormwater inlet is on the east side and receives water from Bush Avenue. The outlet on the west side connects excess water back to the main storm sewer line. The pond was reconstructed in 2024 to enlarge the bottom of the pond by removing the top 8 inches other changes include the removal of a 48-inch RCP on the west side of the pond for 54-inch RCP and the 54-inch RCP on the east side of the pond was replaced with a 72-inch RCP. These changes in result have added a treatment value of 85,000 credits. The pond location is provided in **Figure 4-1**. A stormwater sampler was installed at the intersection on Bush and Desoto Ave.

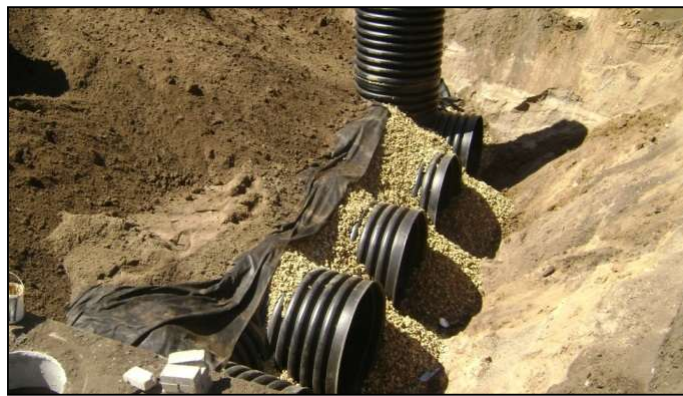
A manhole structure positioned along the main storm sewer under Aurora Avenue diverts stormwater into the underground infiltration system (**Photo 5-1**) via a 30-inch elliptical pipe. The system is also connected to the University Avenue storm sewer system. Any runoff that does not get treated by infiltration trenches and tree planters along University Avenue is directed to this system (**Photo 5-1**). When the system reaches its storage capacity, water flows west through the existing storm sewer system. The system includes a pretreatment structure comprised of a grit chamber and baffled weir to provide settling for sediment and skimming. Rainfall monitoring for the site is conducted on the roof of Fire Station 18, located across the street from the BMP. The BMP system details are provided in **Table 5-1**.

Photo 5-1: St. Albans 48” Perforated HDPE Installation

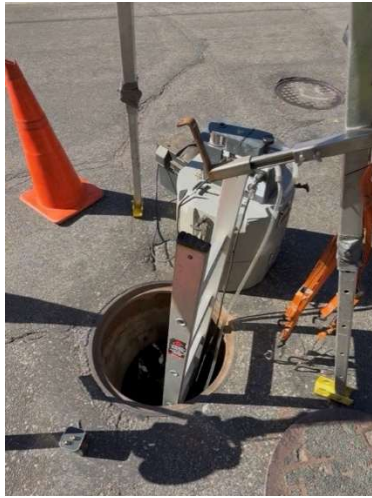
Photo 8-1: East Phalen Stormwater site monitoring

The East Phalen monitoring location is at the intersection of Clarence St. and Ivy Ave E. in Saint Paul, MN and is a part of the Upper Mississippi-Crow- Rum drainage basin, the City of St. Paul-Mississippi River watershed and the Lake Phalen sub watershed. Lake Phalen is the farthest downstream lake in the Phalen Chain of Lakes, while the direct tributary area to the lake is close to 2,000 acres, the total land area that ultimately drains through Lake Phalen is closer to 15,000 acres including the Keller Lake and Wakefield Lake sub-watersheds. Monitoring in the East Phalen region was initiated in 2025.

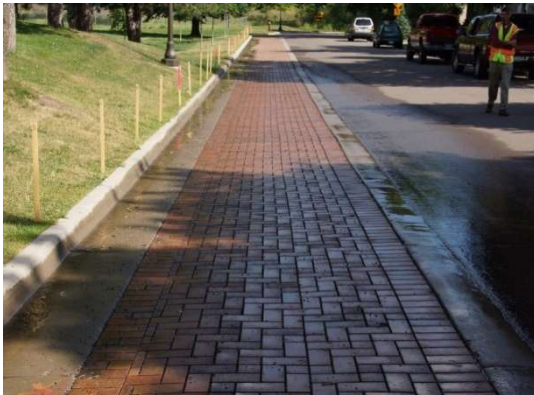
The Victoria Street pervious surface consists of a parking area completed with permeable concrete pavers designed to receive stormwater runoff from Victoria Street and the properties adjacent to it. The pavers themselves are non-permeable, and they are separated with aggregate fill (**Photo 11-1** and **11-2**). The spaces between the pavers allow stormwater runoff to infiltrate into the parking surface instead of running off and being collected by the storm sewer system. The pavers were installed in 2011, and infiltration rates have been monitored annually since 2012. The site and the infiltration test locations are provided on **Figure 11-1**. Street sweeping occurred on 4/22/2025, 9/30/2025 and 10/27/2025.

Photo 11-1: Victoria Street Pavers

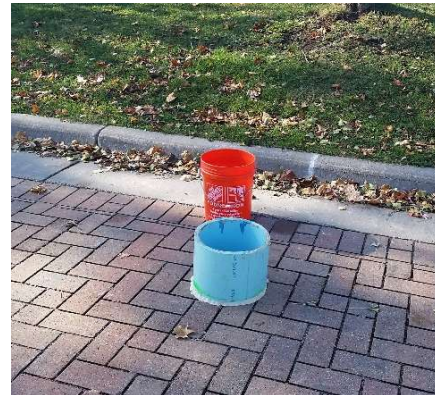
Photo 11-2: Victoria Street Infiltration Testing

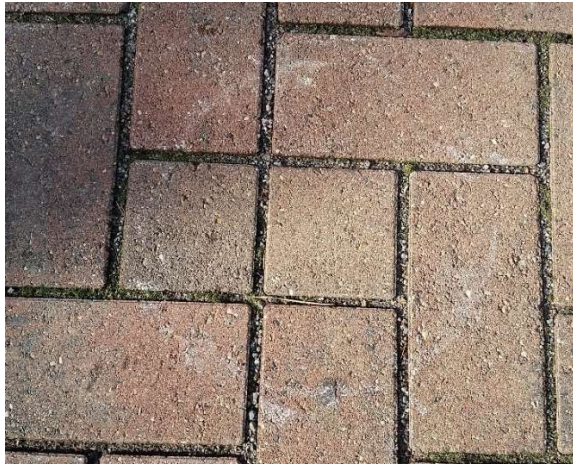
- Average infiltration rate in 2025 was 0.0 in/hr. A significant decrease from previous years such as 2023 (3.02 in/hr.), 2022 (8.04 in/hr.) and 2021 (9.91 in/hr.).
- Infiltration rates dropped to 0 in/hr. at all locations in 2025.

Photo 11-3: Location D Pre-Test

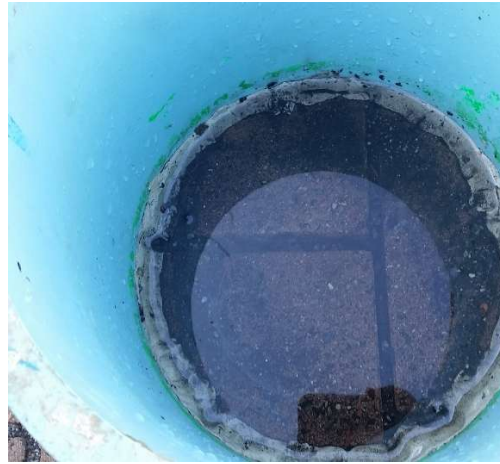
Photo 11-4: Location D Infiltration Test

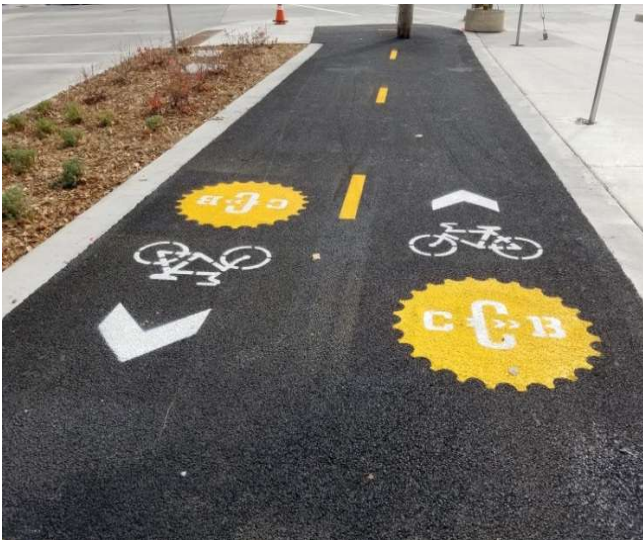
Photo 11-5: Capital City Bikeway (CCB) – Jackson Street/Kellogg Avenue

The Jackson Street BMP (**Photo 11-5** and **11-6**) is a designated bike path constructed of pervious asphalt. It is a section of the Capital City Bikeway (CCB), a system of off-street bicycle trails in downtown Saint Paul. The BMP is eight blocks long, stretching from Kellogg Street to 11th Street, and consists of 2,750 square yards of pervious asphalt. Stormwater runoff filters through the asphalt and underlying media and is then conveyed to the storm sewer system via drain tile.

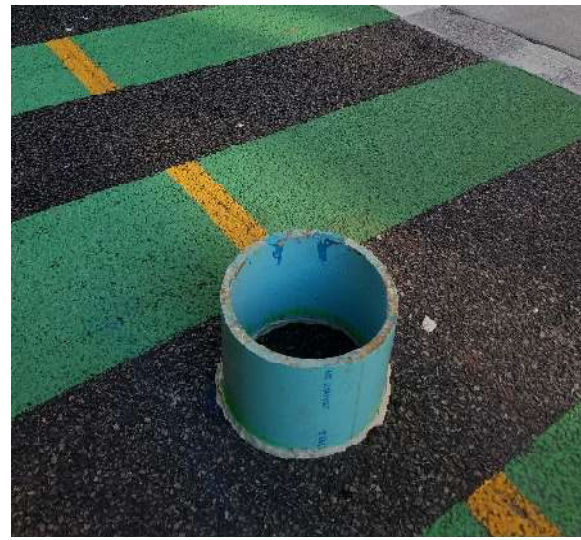
Photo 11-6: Jackson Street Infiltration Test

- The overall site infiltration rate was 39.2 inches per hour (in/hr.) in 2025
 - 16 of 18 locations showed no infiltration rate in 2025.
 - Of the two locations where infiltration occurred, infiltrations rates ranged from 679.5 in/hr. to 732.2 in/hr.
- Low traffic areas had an average infiltration rate of 140 in/hr. in 2025.
- Medium traffic areas had an average infiltration rate of 91.5 in/hr. in 2025.
 - Locations JS-7 through JS-11 are within the first constructed section of the pervious pavement near the Jackson Street and Kellogg Boulevard intersection. These locations have not shown any infiltration since October 2018.
- High traffic areas had an infiltration rate of 0.0 in/hr. in 2025.
 - High traffic locations have not shown any infiltration since November 2017.

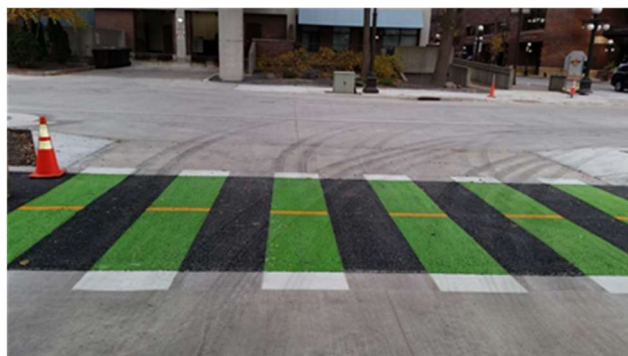
The permeable pavement systems installed in 2012 on Jackson Street and Victoria Street are no longer functioning effectively as infiltration systems. Over the past 13 years, infiltration capacity has significantly diminished, and 2025 monitoring results show infiltration at only one location on Jackson Street and none on Victoria Street.

Photo 11-7: Test Locations JS-1 and JS-2 (high traffic)

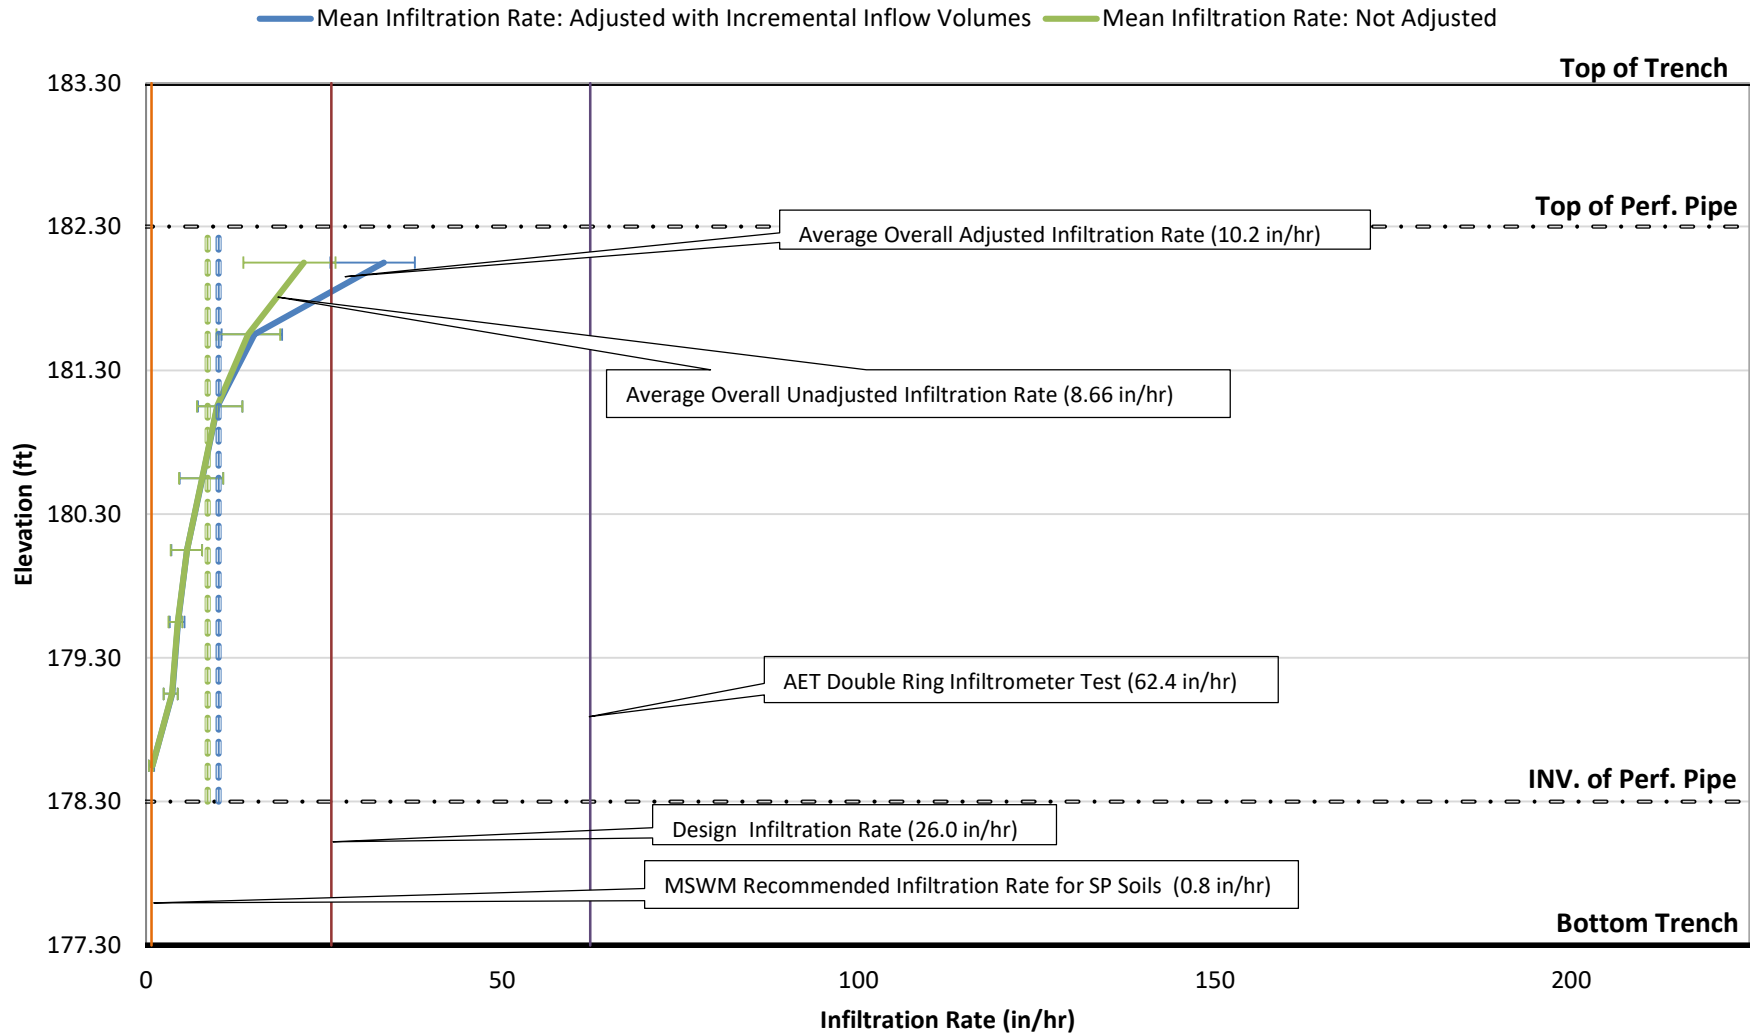
Infiltration rates are presented in **Chart A.6** of **Appendix A**. In 2025, the average infiltration rate of the BMP pipe was 10.2 in/hr. (**Table 5-2**), which is below the design infiltration rate of 26.0 in/hr. Infiltration rate trends for the St. Albans Street BMP pipe are depicted on **Chart A.7**.

St. Albans Street - Infiltration Rate Graph

(Observed 0.5 Foot Height Increments)

Note: Pipe Invert is 178.3'
 Error Bars Represent 25th and 75th Percentiles
 Pipe perforated w/ 2 rows of holes at Elev: 178.9' and 179.2'

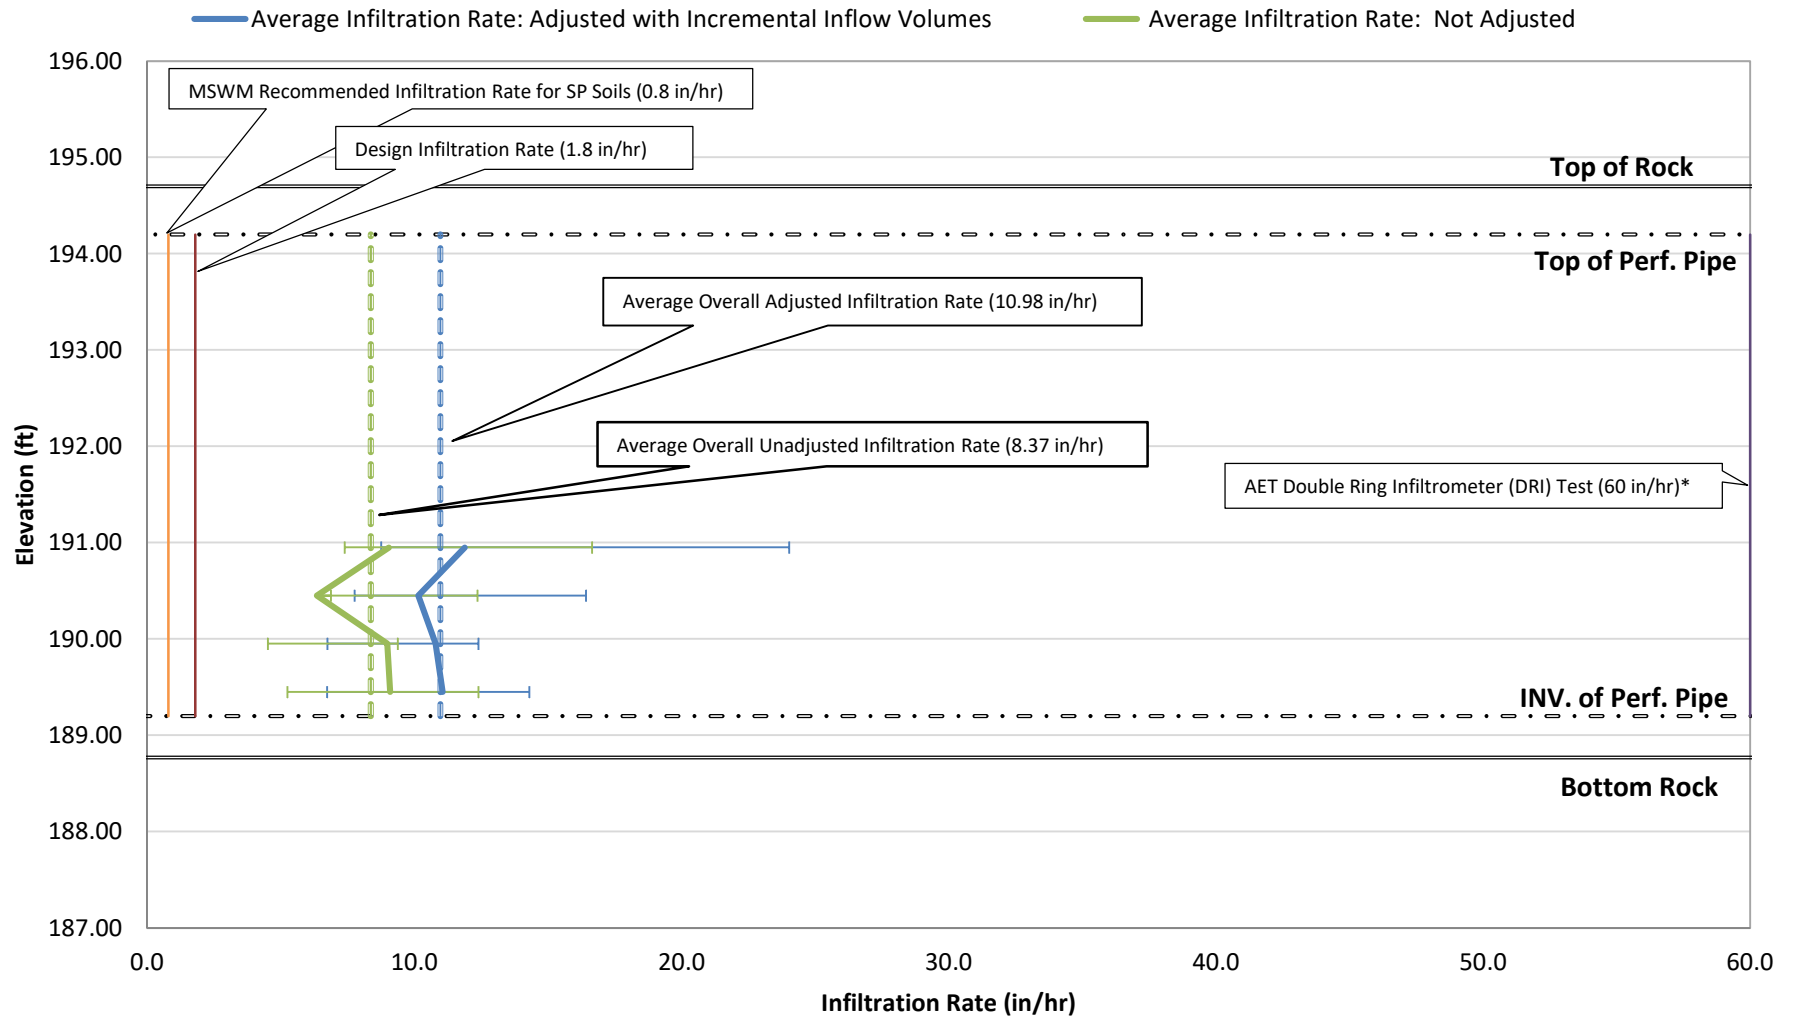
The 2025 infiltration rates are presented on **Chart A.10** of **Appendix A** and are adjusted for incremental volume flow. The adjusted average infiltration rate for the BMP was 10.98 in/hr., which is above the design infiltration rate of 1.8 in/hr. Infiltration rates at the base of site during construction were calculated to be, on average, 60 in/hr. using a Double Ring Infiltrometer (DRI). Infiltration rate trends are depicted on **Chart A.11**. Water level data shows that all 2025 events were infiltrated within 8 hours of a treatment event.

Hampden Park - Infiltration Rate Graph

(Observed 0.5 Foot Height Increments)

Note: Pipe Invert is 189.2'

Error Bars Represent 25th and 75th Percentiles

* The DRI testing was completed on top of a 5 ft layer of fine filter aggregate that was constructed above the native soils, per the design.

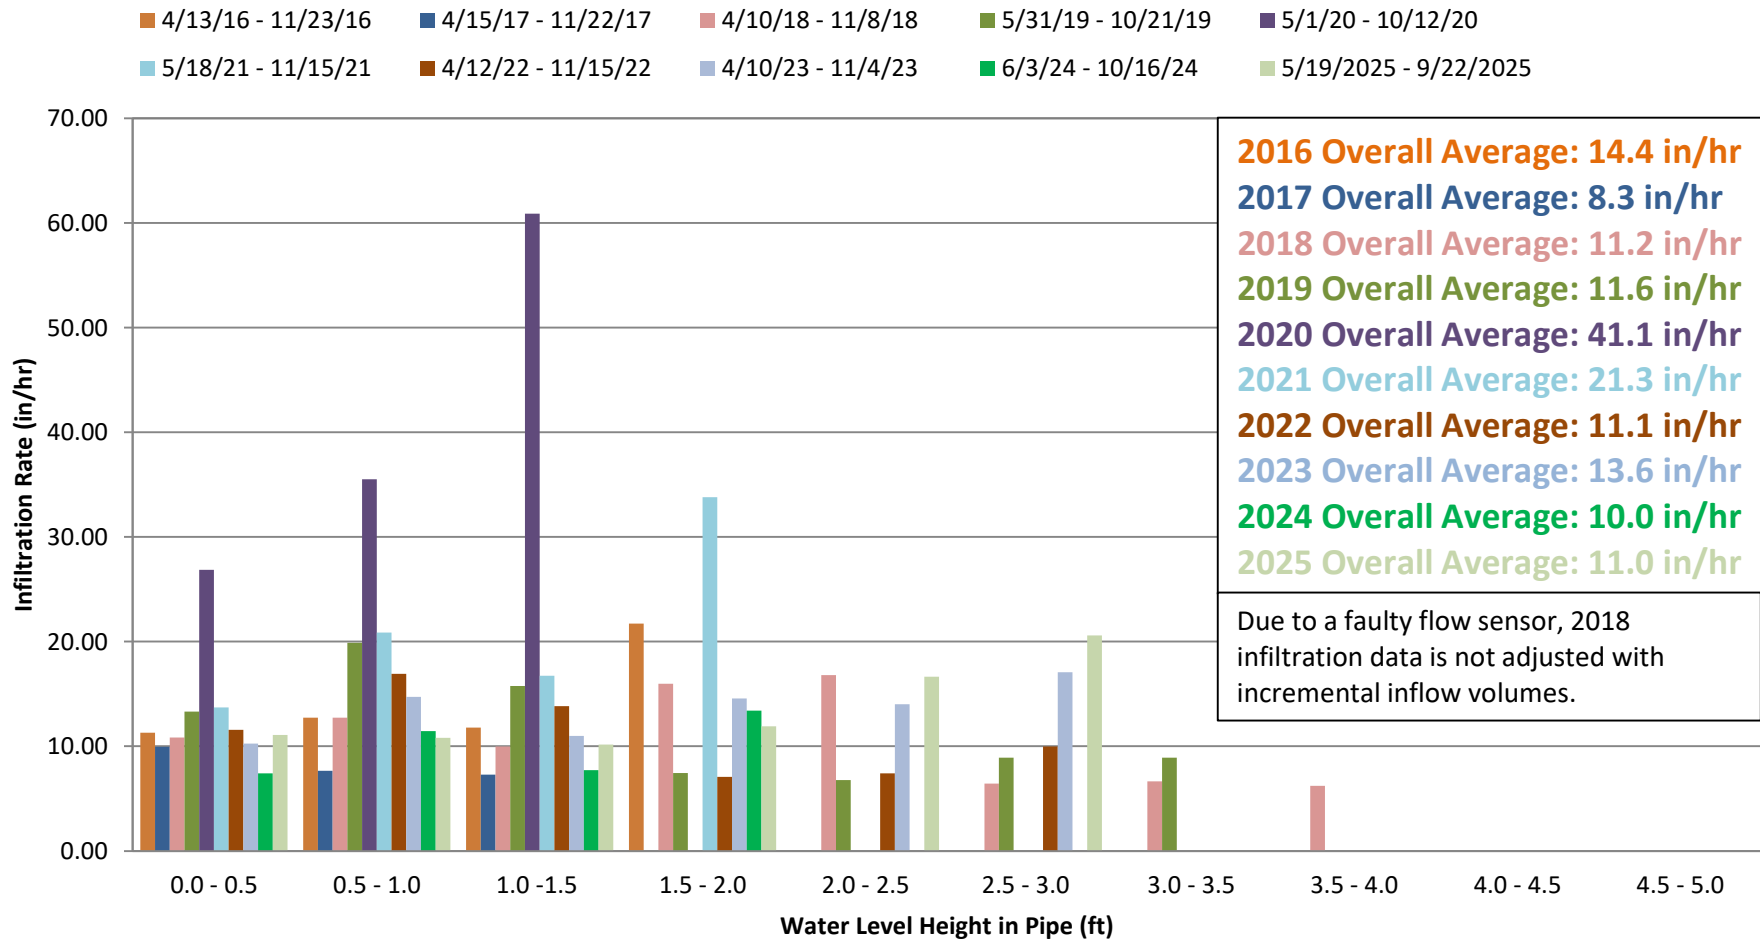
Water levels were monitored within the underground infiltration system and groundwater (P2), using electronic water level loggers. Water levels and daily rainfall for 2025 are provided on **Chart A.8** and **A.9** of **Appendix A**. Water levels within the BMP ranged from 0 to 2.8 ft. The BMP water level must exceed 6.5 ft for the system to reach capacity and for water to be conveyed back to the sewer system. Based on the 2025 level data, no flow discharged back to the sewer system. In 2025, infiltration rates increased compared to 2024 but show a generally declining trend since 2023.

Infiltration Rate Trends Hampden Park Adjusted with Incremental Inflow Volumes

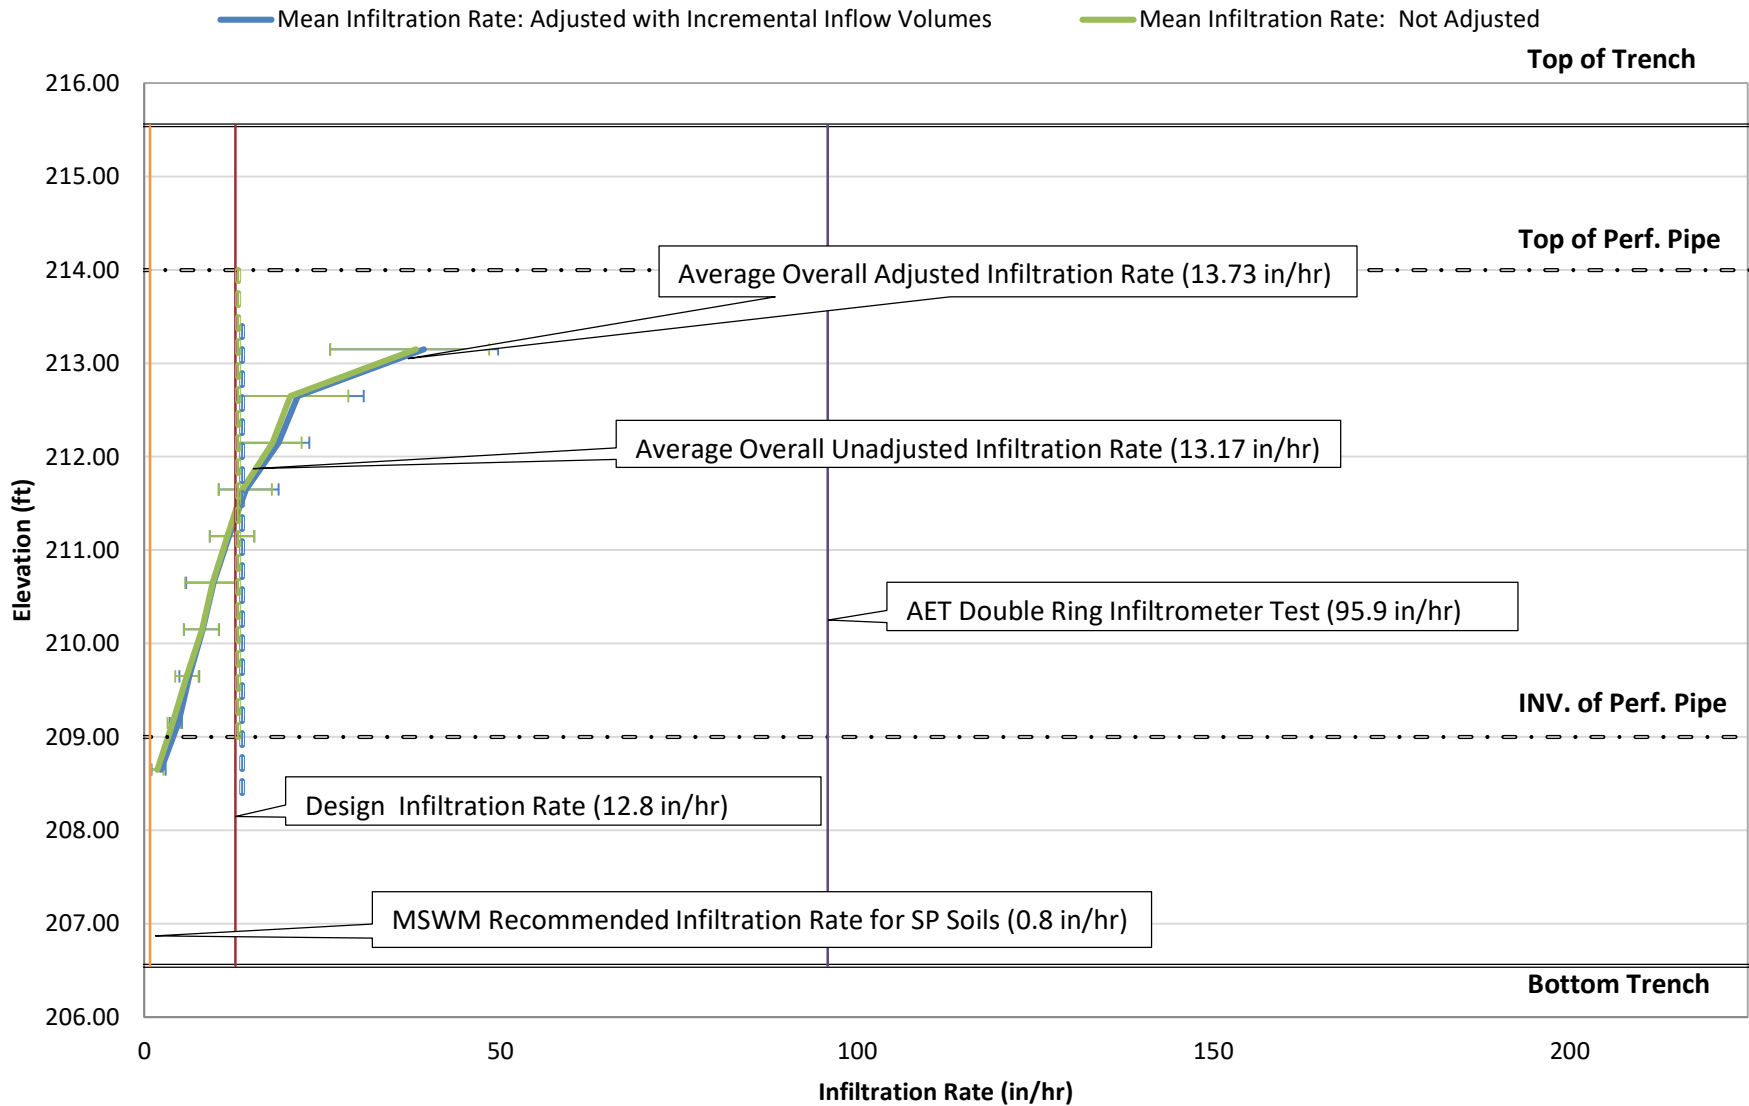
The 2025 infiltration rates are presented in **Chart A.13** of **Appendix A** and are adjusted for incremental volume flow. The adjusted average infiltration rate for the BMP was 13.73 in/hr., which is greater than the design infiltration rate of 12.8 in/hr. Infiltration rates at the base of the system during construction were calculated to be, on average, 95.9 in/hr. using a Double Ring Infiltrometer (DRI). Infiltration rate trends are depicted in **Chart A.14**. Water level data shows that all 2025 events were infiltrated within 4 hours of a treatment event.

Victoria Stage Infiltration Rate Graph (Observed 0.5 Foot Height Increments)

Pipe Invert is 209
 Error Bars Represent 25th and 75th Percentiles

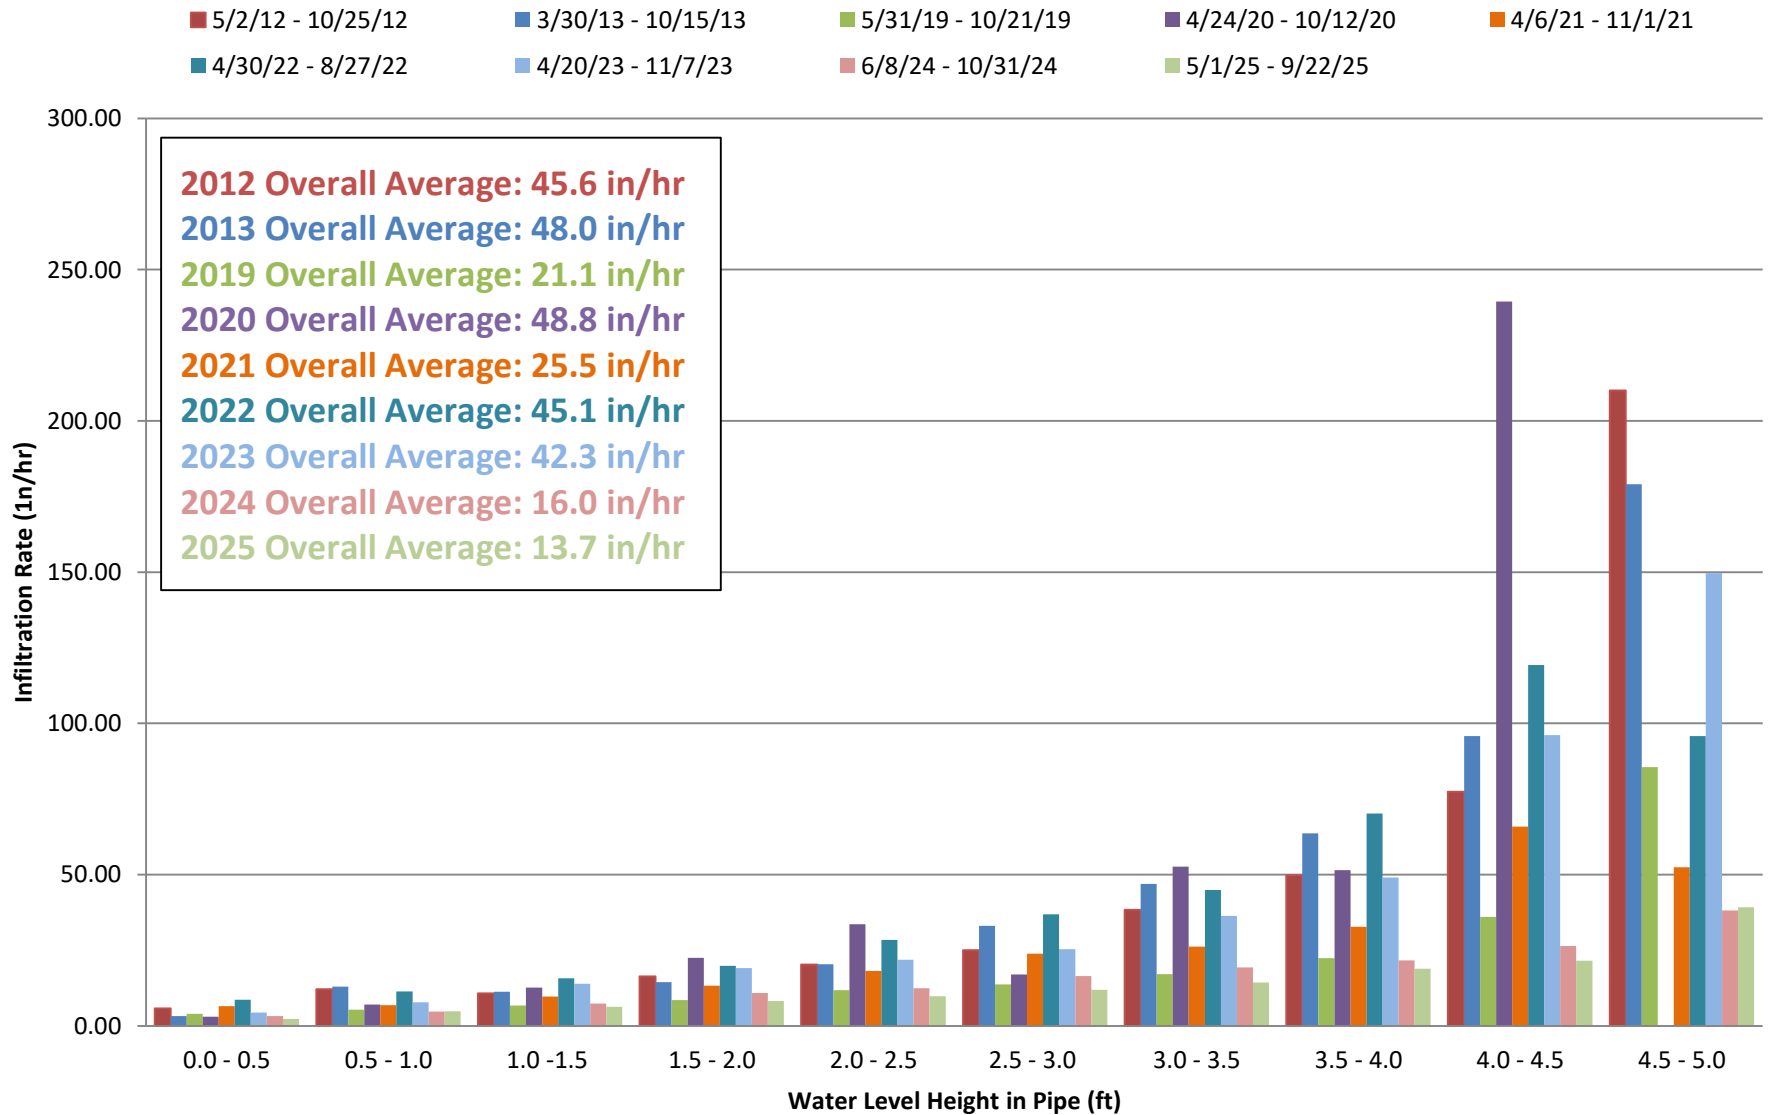
Infiltration Rate Victoria Adjusted with Incremental Inflow Volumes

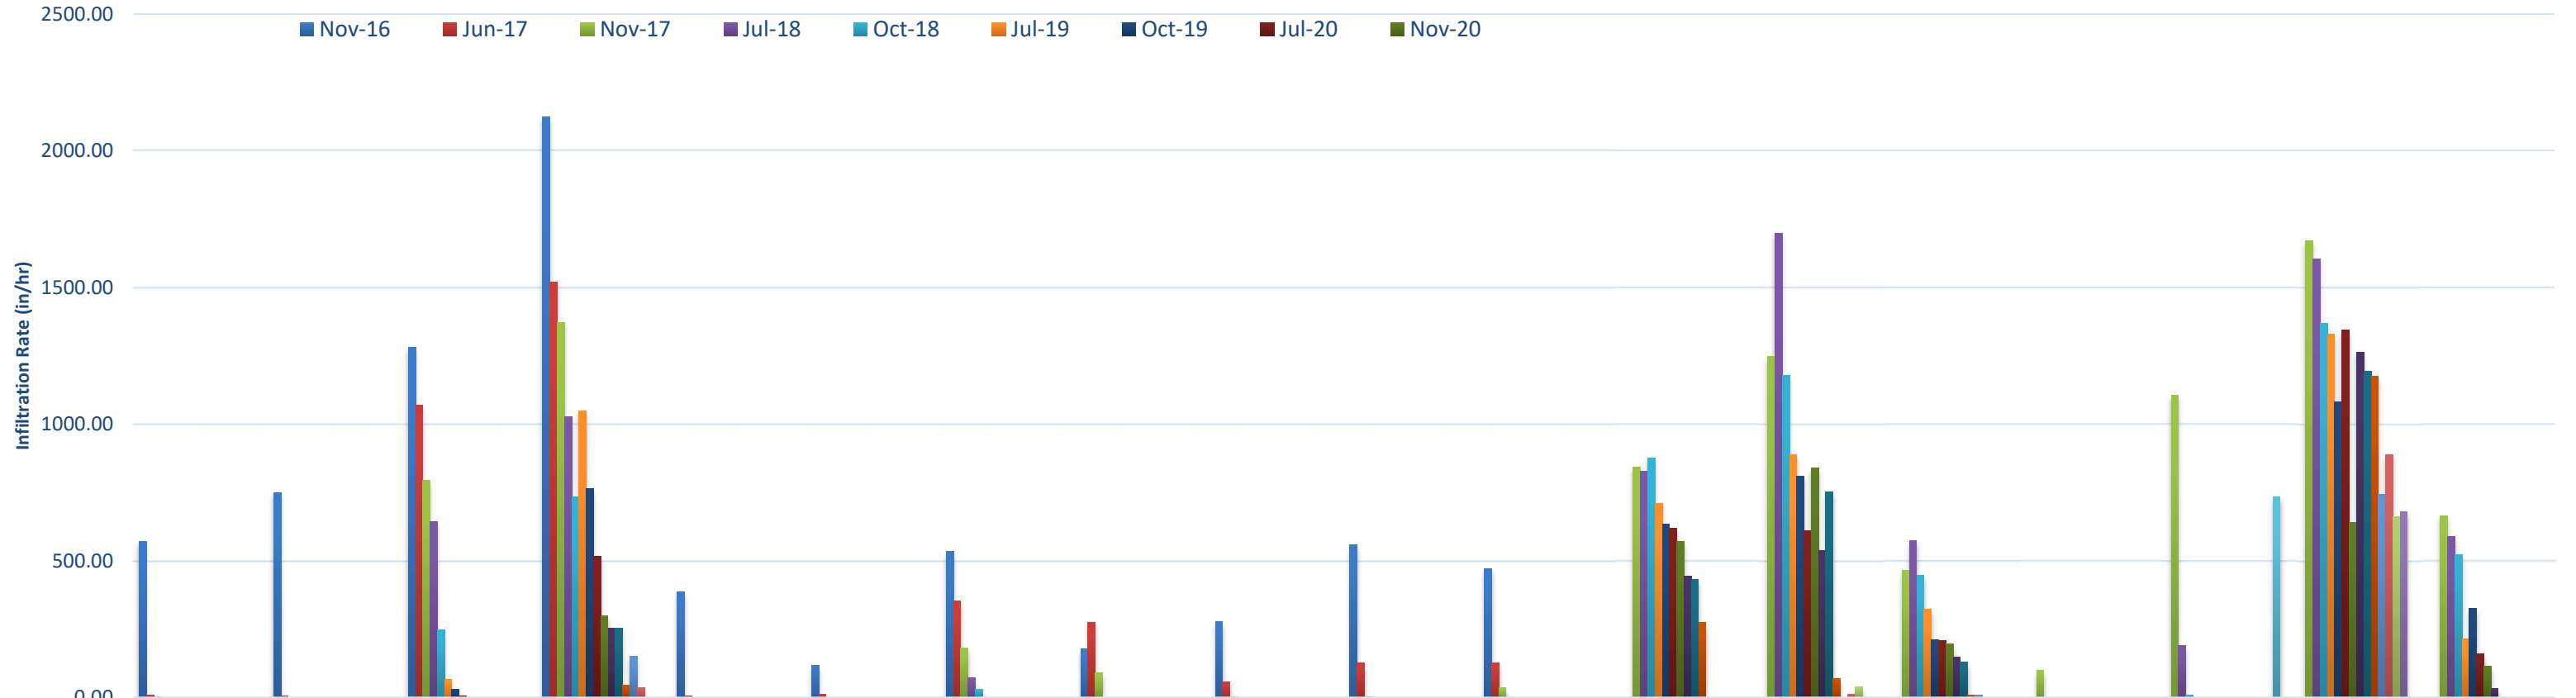
Jackson Street Infiltration Rates

JS-1	JS-2	JS-3	JS-4	JS-5	JS-6	JS-7	JS-8	JS-9	JS-10	JS-11	JS-12	JS-13	JS-14	JS-15	JS-16	JS-17	JS-18
Nov-16	572.60	750.40	1282.07	2122.21	385.88	118.70	533.72	177.47	277.93	557.90	471.54							
Jun-17	9.29	6.30	1069.04	1520.13	4.49	12.12	353.94	275.34	56.12	125.46	125.40							
Nov-17	3.86	0.00	793.76	1371.96	0.00	0.00	181.73	90.77	2.38	2.07	35.49	843.29	1246.74	464.43	99.97	1104.44	1669.95	665.40
Jul-18	0.00	0.00	642.24	1026.71	0.00	0.00	73.71	0.00	0.00	0.00	0.00	827.22	1696.93	575.13	0.00	190.07	1604.98	589.63
Oct-18	0.00	0.00	247.09	733.69	0.00	0.00	29.44	0.00	0.00	0.00	0.00	877.09	1179.25	447.48	0.00	9.02	1369.65	521.52
Jul-19	0.00	0.00	67.07	1050.08	0.00	0.00	0.00	0.00	0.00	0.00	0.00	710.52	889.49	323.26	0.00	0.00	1329.45	215.70
Oct-19	0.00	0.00	30.35	764.42	0.00	0.00	0.00	0.00	0.00	0.00	0.00	633.28	809.62	211.40	0.00	0.00	1082.13	327.70
Jul-20	0.00	0.00	7.05	516.29	0.00	0.00	0.00	0.00	0.00	0.00	0.00	620.41	608.65	207.81	0.00	0.00	1343.21	160.40

Nov-20	0.00	0.00	0.00	299.88	0.00	0.00	0.00	0.00	0.00	0.00	0.00	572.01	839.81	195.40	0.00	0.00	640.06	115.47
Aug-21	0.00	0.00	0.00	254.10	0.00	0.00	0.00	0.00	0.00	0.00	0.00	442.70	537.80	148.90	0.00	0.00	1263.50	33.00
Nov-21	0.00	0.00	0.00	253.70	0.00	0.00	0.00	0.00	0.00	0.00	0.00	432.00	753.00	128.70	0.00	0.00	1194.50	0.00
Aug-22	0	0	0	46.13	0	0	0	0	0	0	0	274.28	69.76	7.885	0	0	1173.965	0
Aug-23	0	0	0	149.9	0	0	0	0	0	0	0	0	0	10.4	0	0	744.4	0
Nov-23	0	0	0	38.1	0	0	0	0	0	0	0	0	13	0	0	0	888.6	0
Oct-24	0	0	0	0	0	0	0	0	0	0	0	0	38.5	0	0	0	661.1	0
Aug-25	0	0	0	0	0	0	0	0	0	0	0	0	0	0	0	0	679.46	0
Nov-25	0	0	0	0	0	0	0	0	0	0	0	0	0	0	0	732.17	0	0

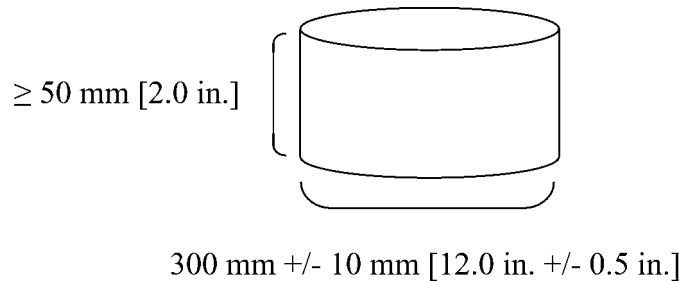
FIG. 1 Dimensions of Infiltration Ring
